# ARBORICULTURAL METHOD STATEMENT

Bersham Colliery,  
Wrexham

[1650-AMS-V1]

Bersham (Glenside) Ltd.

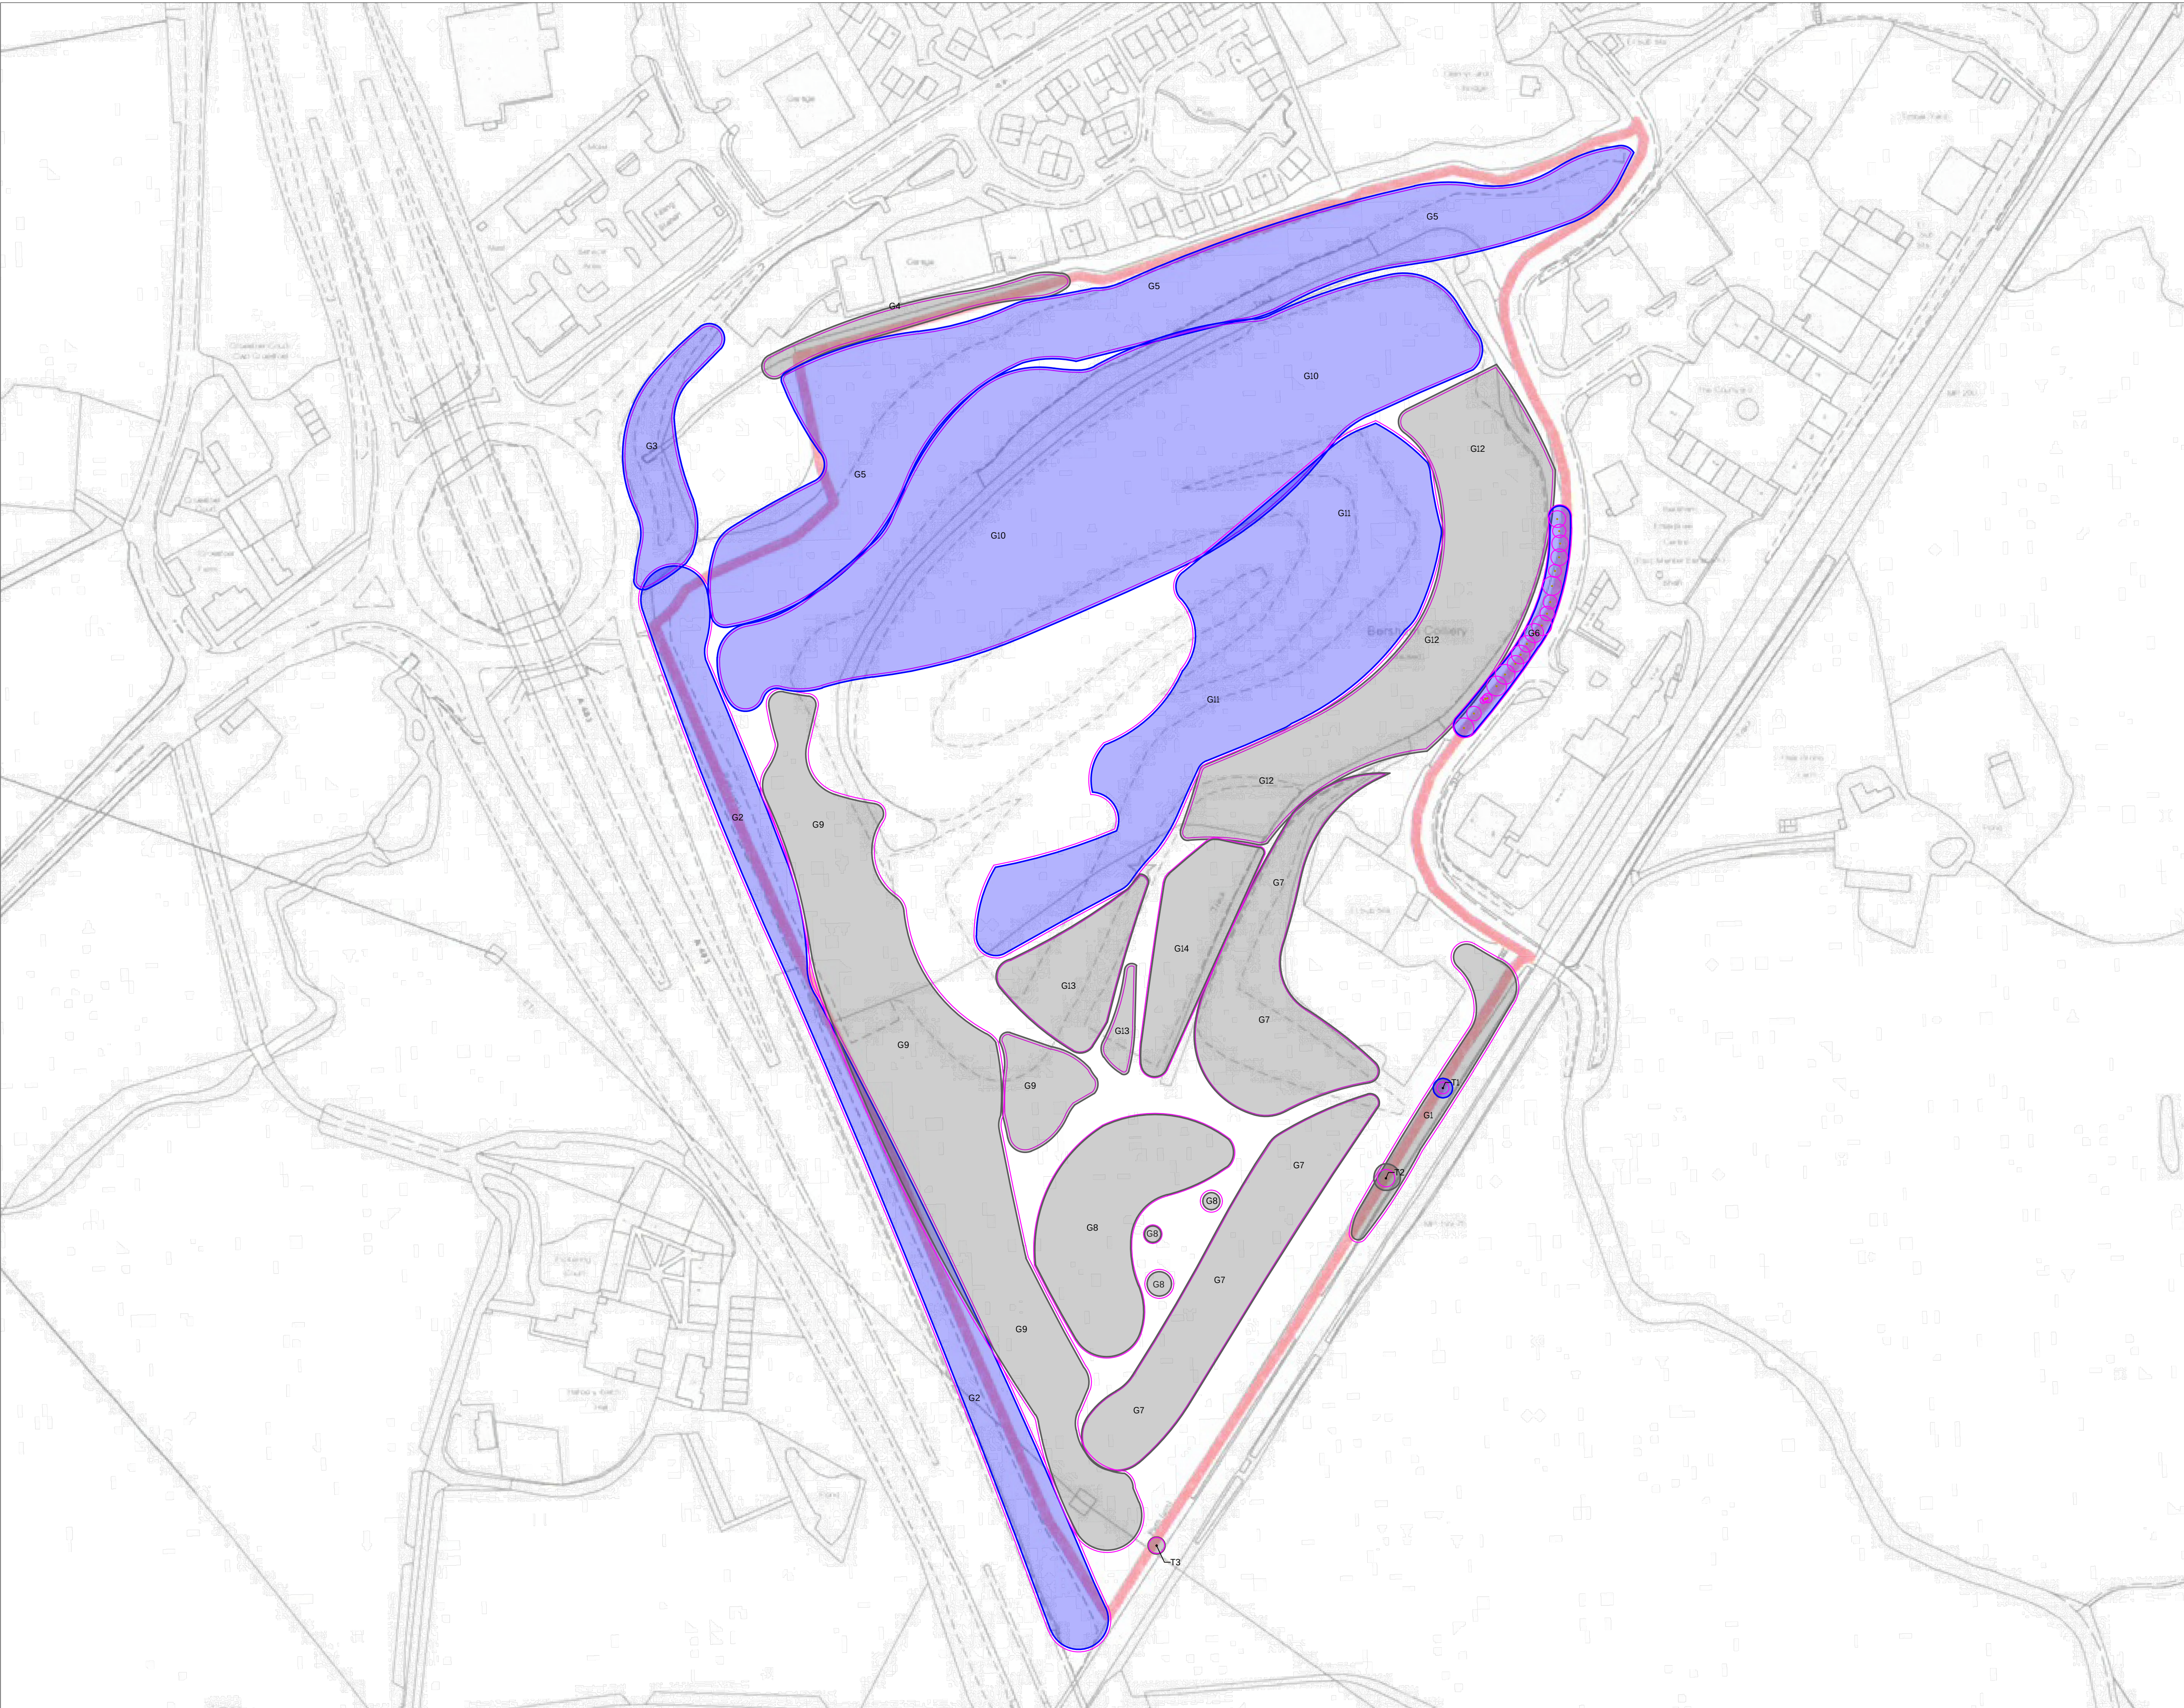
**TITLE**  
Tree Constraints Plan

**NOTES:**  
Tree locations are estimated from measurements on-site. No topographical survey available at the time of tree survey.

The survey recorded a total of 3no. individual trees and 14no. groups of trees comprising of 6no. category B and 11no. category C retention value.

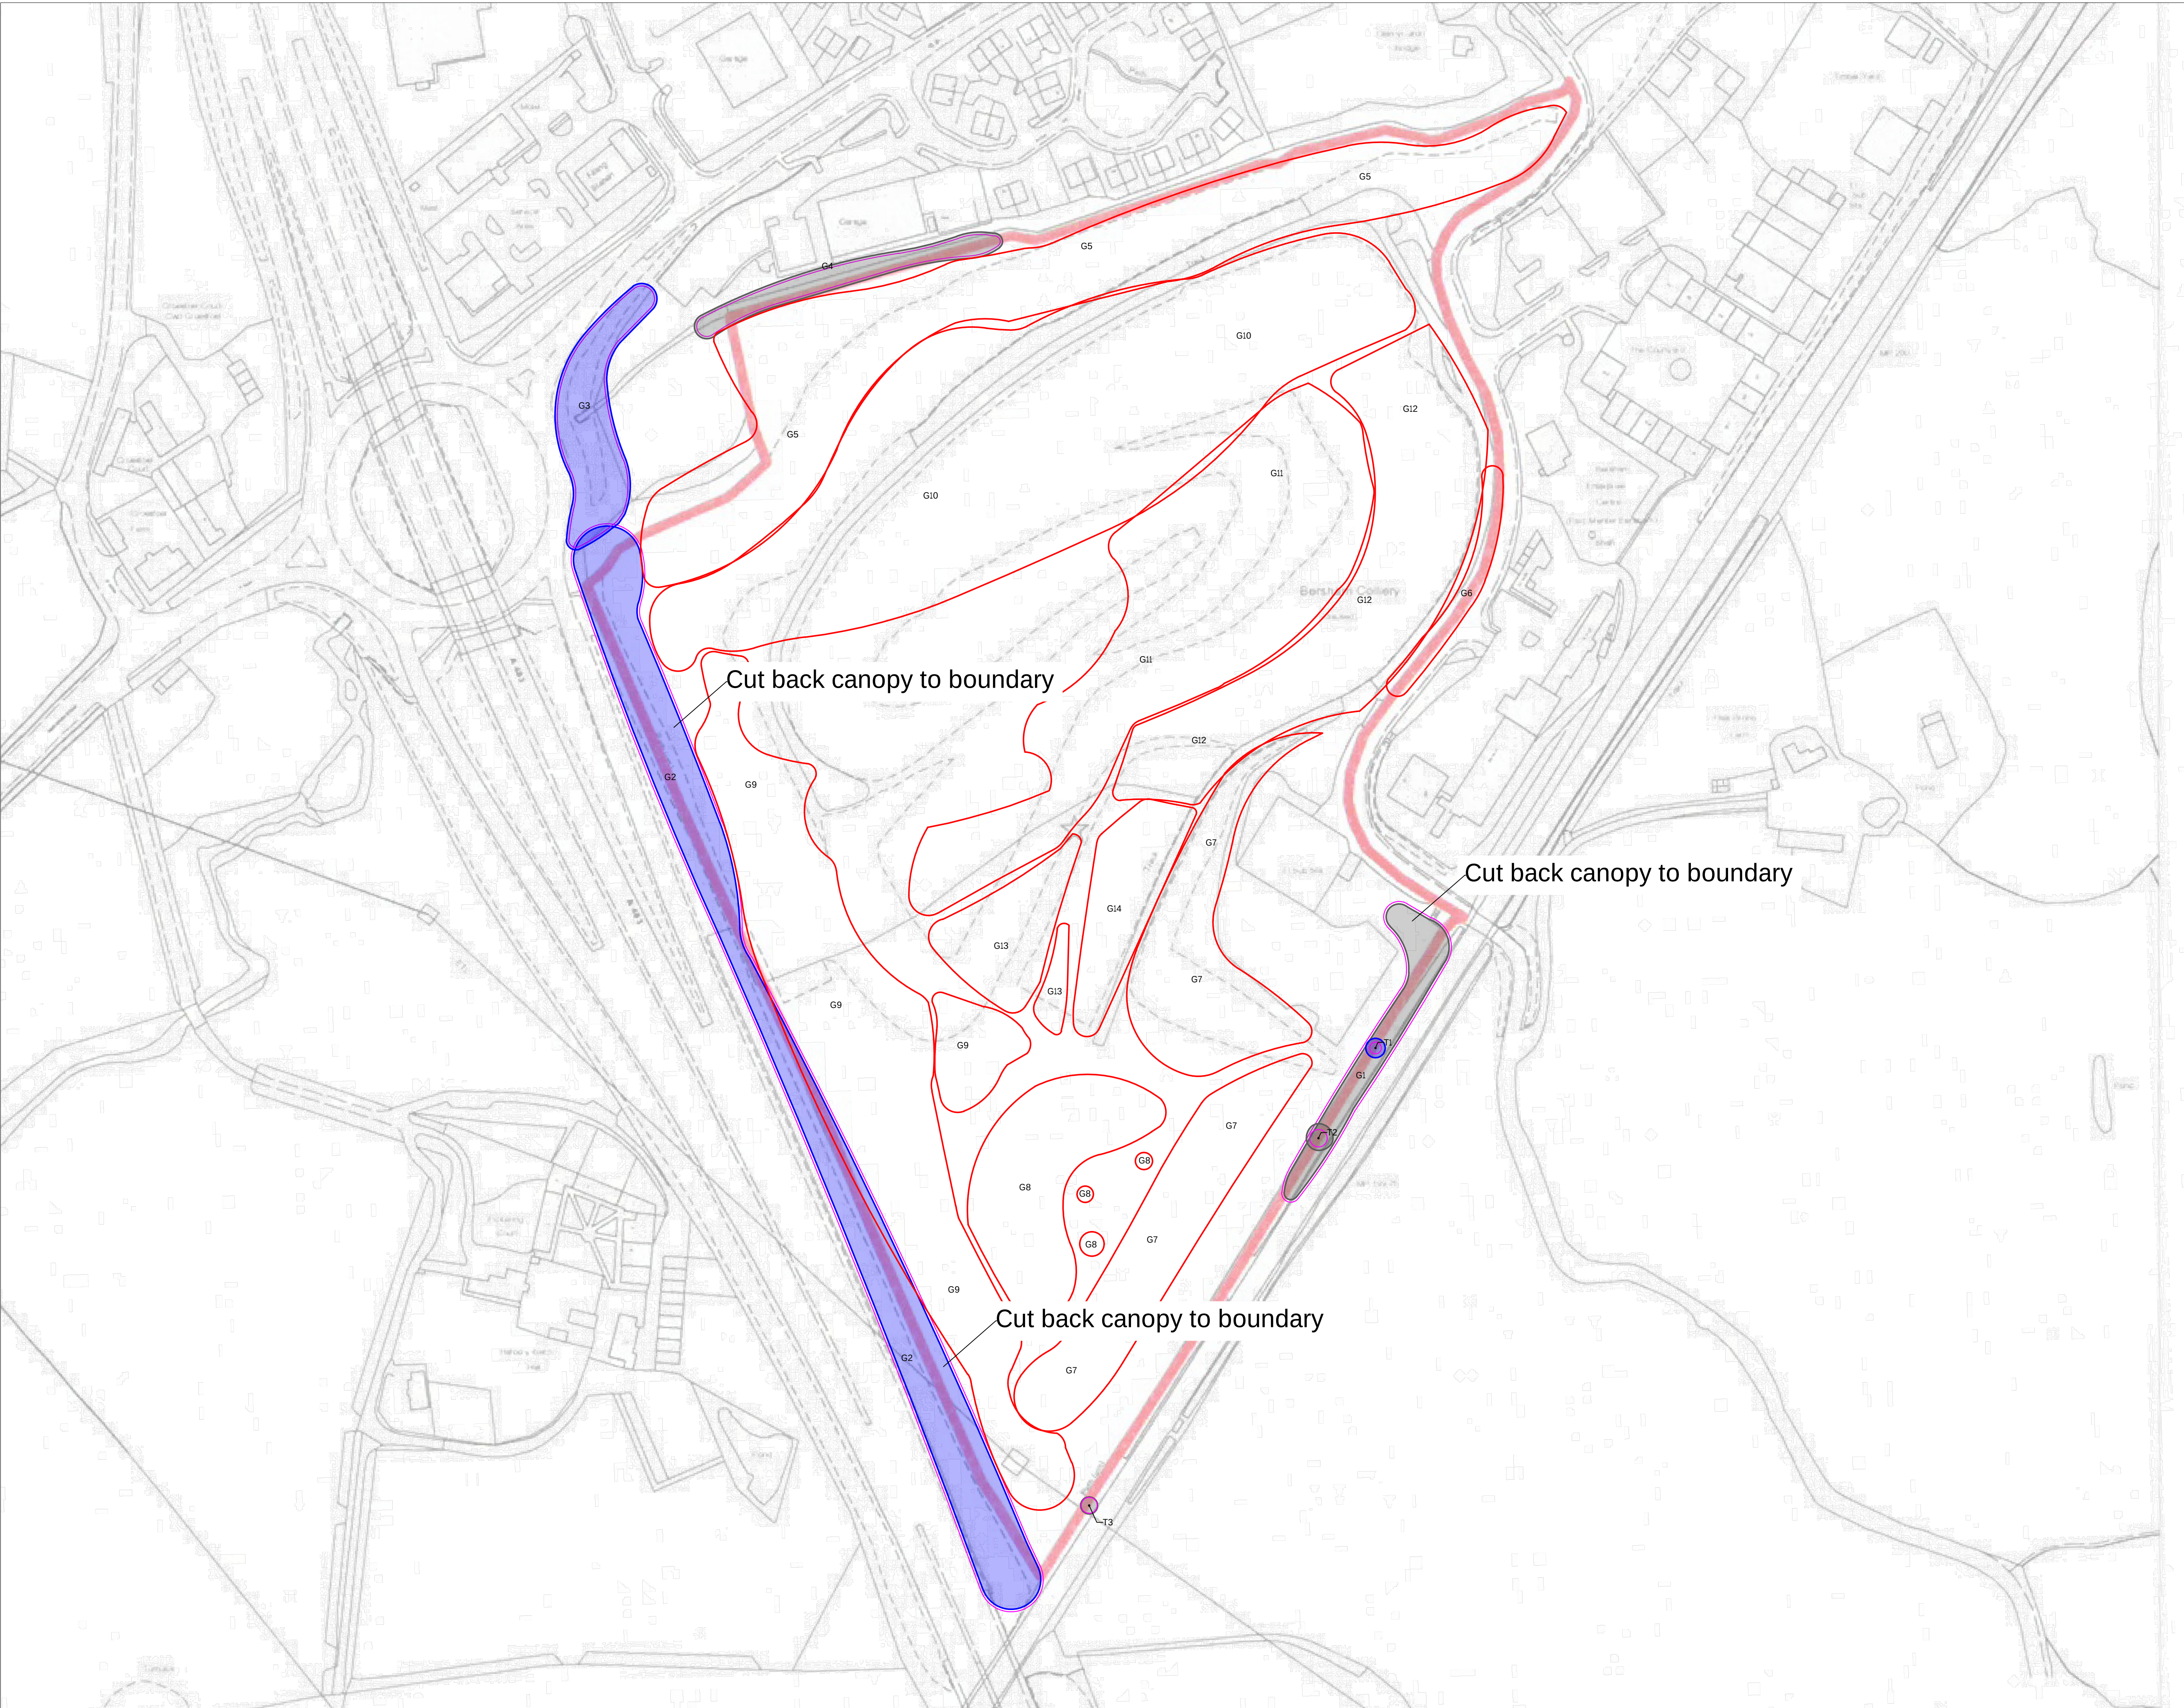
| <b>TITLE</b><br>Arboricultural Impact Plan | |

Group to be REMOVED

**NOTES:**  
Tree locations are estimated from measurements on-site. No topographical survey available at the time of tree survey.

In order to implement the Approved Development, there will be a requirement to remove 10no. groups of trees.

There will be no new RPA incursions as a result of the Approved Development.

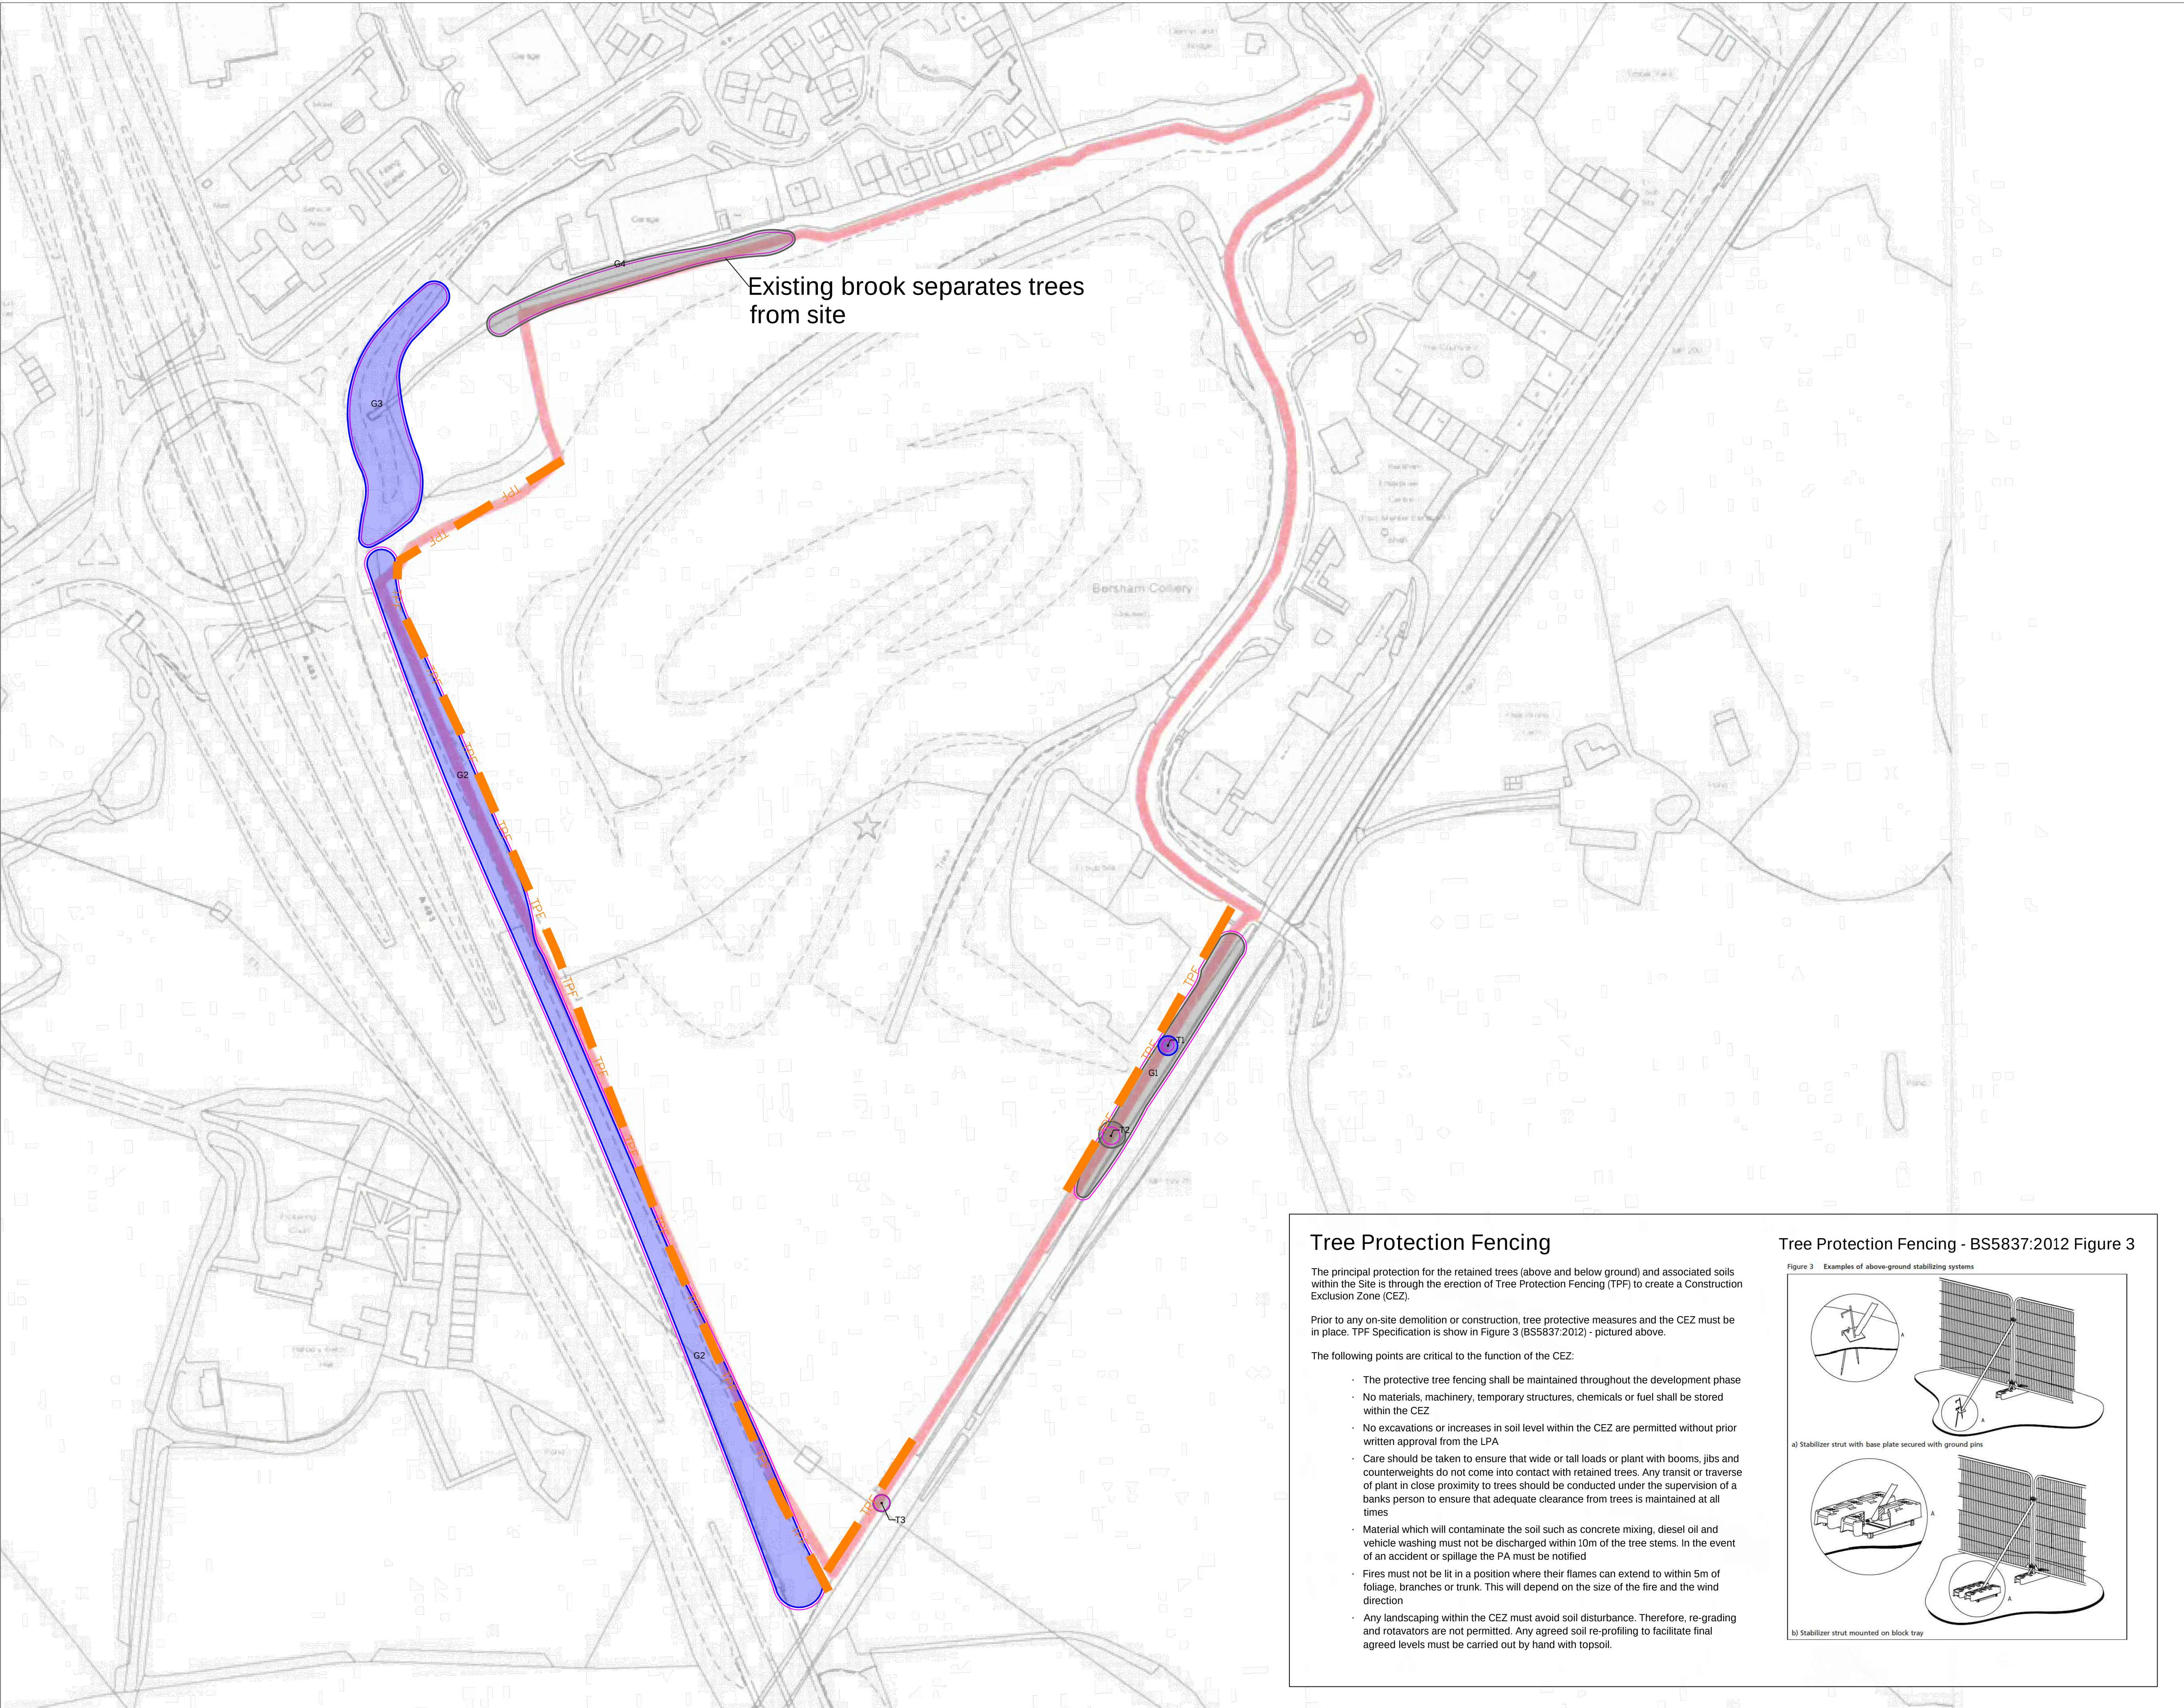
| TITLE | Tree Protection Plan |

Tree Protection Fencing

Tree locations are estimated from measurements on-site. No topographical survey available at the time of tree survey.

An overview of the recommended tree protection measures has been provided within this AMS. A Tree Protection Plan (TPP) is provided at Appendix 2.

The indicative location of Tree Protection Fencing (TPF) is illustrated on the Tree Protection Plans at Appendix 2. The existing brook will act as a barrier for the offsite trees to the north of the site.

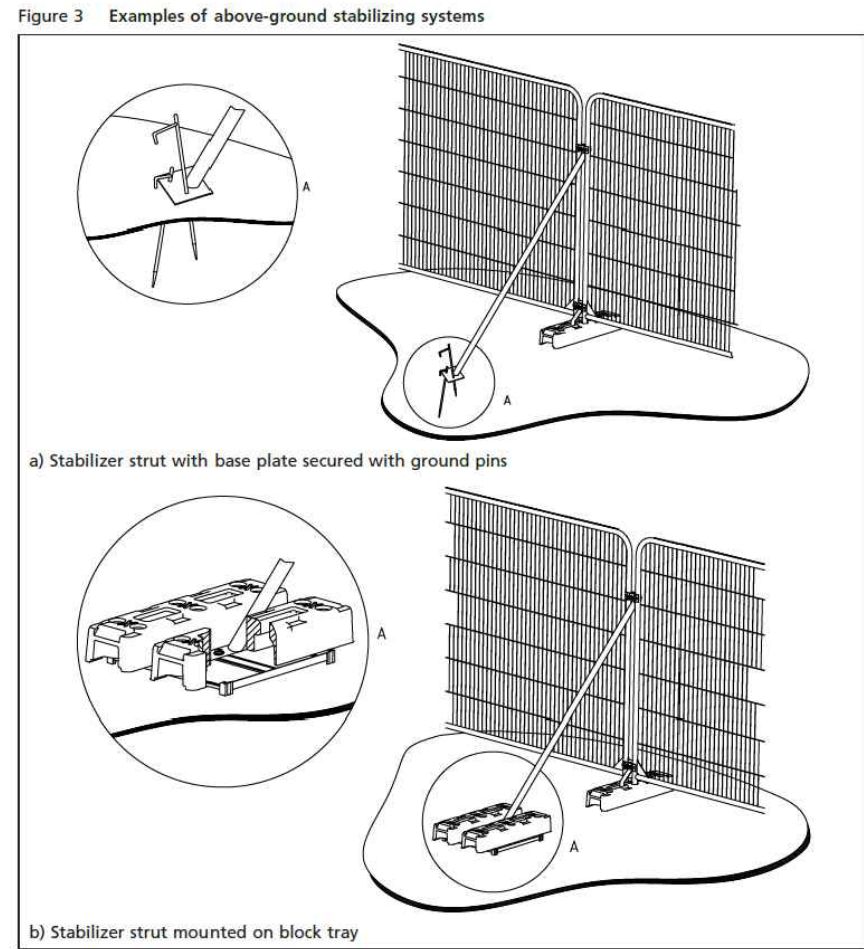
Tree Protection Fencing - BS5837:2012 Figure 3

The principal protection for the retained trees (above and below ground) and associated soils within the Site is through the erection of Tree Protection Fencing (TPF) to create a Construction Exclusion Zone (CEZ).

Prior to any on-site demolition or construction, tree protective measures and the CEZ must be in place. TPF Specification is shown in Figure 3 (BS5837:2012) - pictured above.

The most common specification as illustrated in BS5836:2012 Figure 3b (Appendix 3) comprises welded mesh panels (Heras Fencing) on rubber or concrete feet, the panels should be joined together using a minimum of two anti-tamper couplers, installed so that they can only be removed from within the fence. The distance between fence couplers should be at least 1m and should be uniform throughout the fence. The panels should be supported on the inner side by stabilizer struts, which should normally be attached to a base plate secured with ground pins. Where the fencing is to be erected on retained hard surfacing or it is otherwise unfeasible to use ground pins, e.g. due to the presence of underground services, the stabilizer struts should be mounted on a block tray.

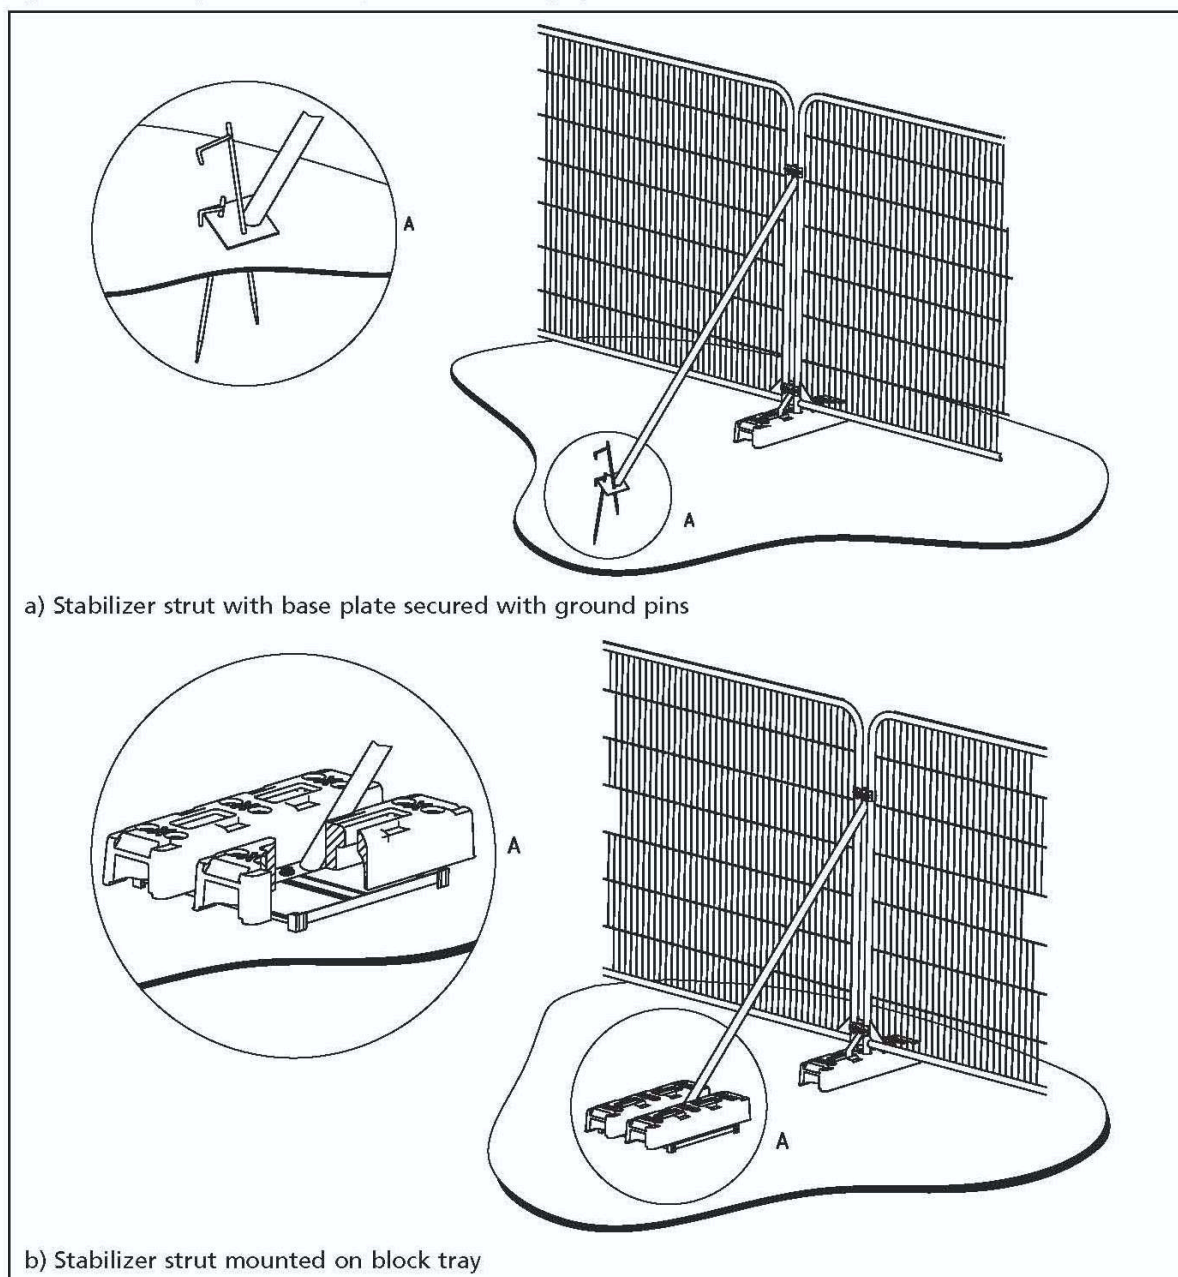
### BS5837:2012 – Figure 3

Figure 3 Examples of above-ground stabilizing systems
