# Bat and bird survey

at Roselyn cottage, Cock Bank Lane  
Marchwiel, Wrexham  
LL13 OSU

Proposed second story extension

May 2023

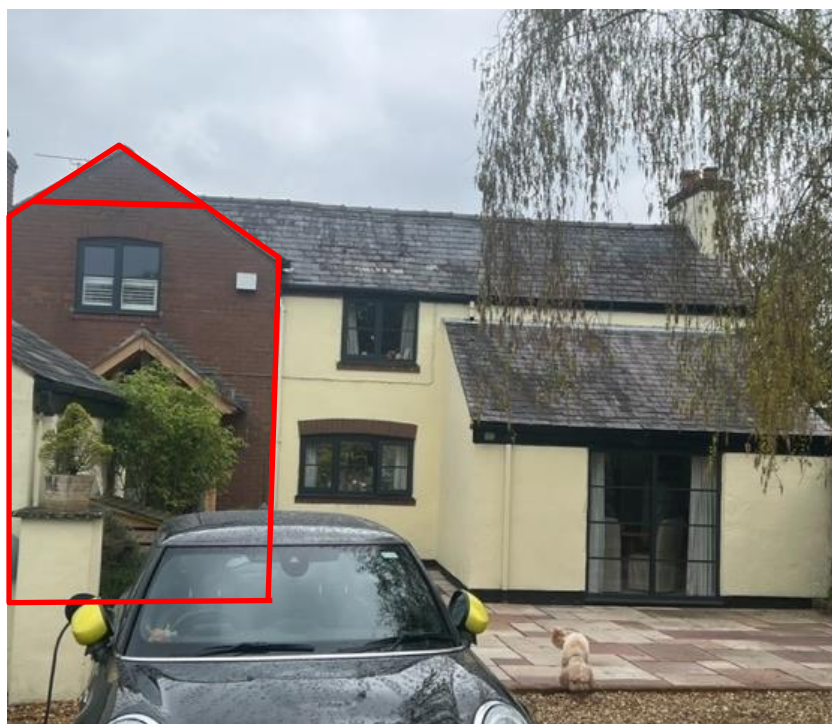
A1.1 Plate 1: View of western aspect of the Roselyn cottage. Building B1 and its roof space shown

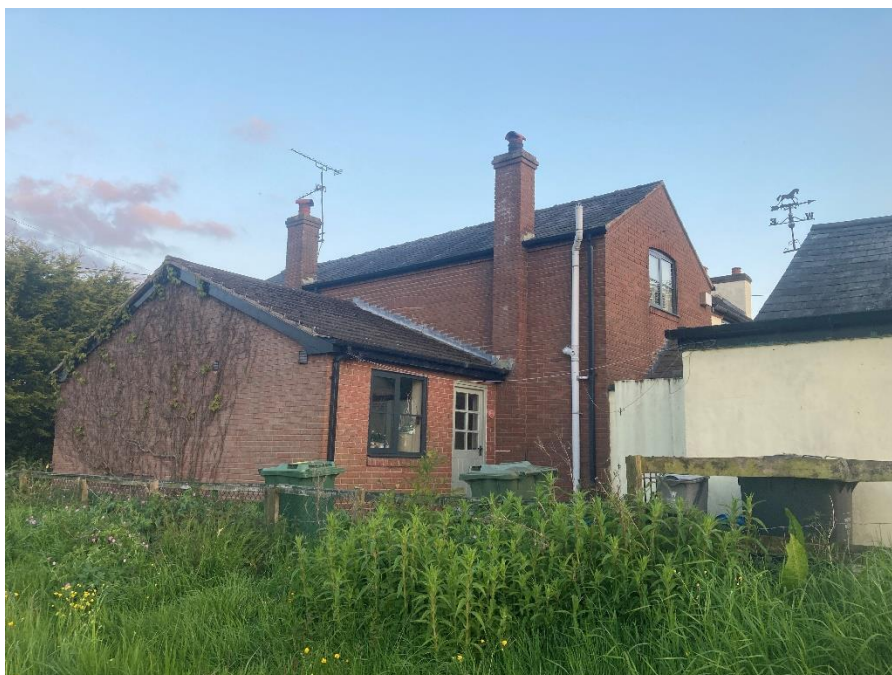
A1.2 Plate 2: View of the northern aspect showing single storey extension (B2) and two storey brick extension (B1)

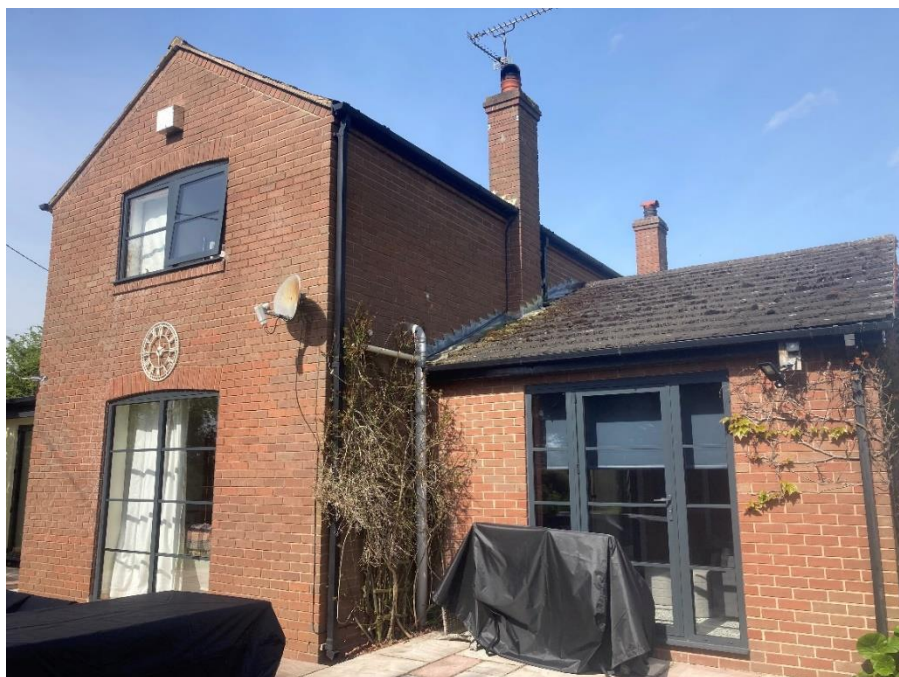
A1.3 Plate 3: View of the eastern aspect showing Building B1 and B2

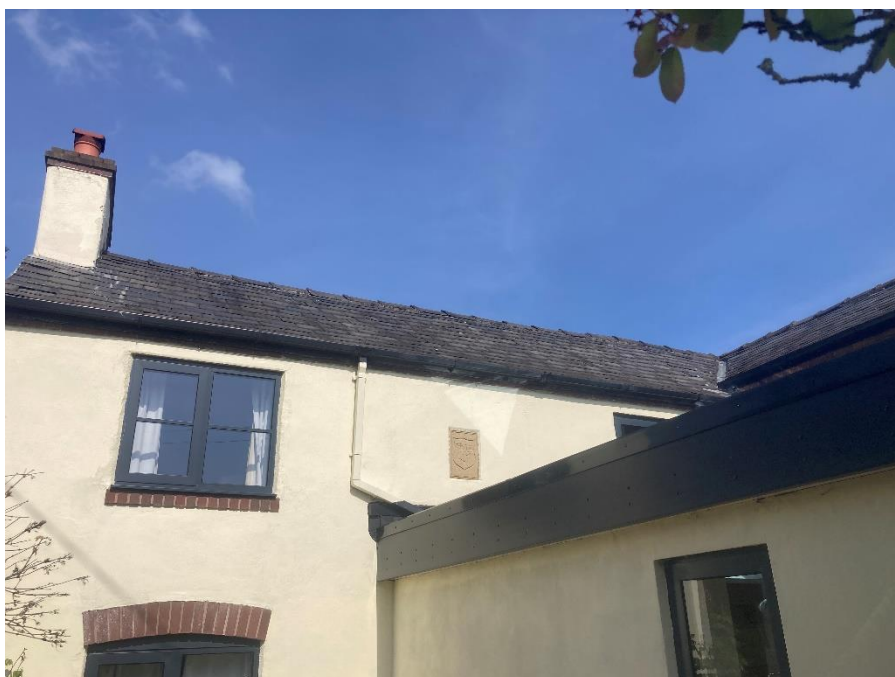
A1.4 Plate 4: Showing eastern aspect of the original cottage, roof in good condition.

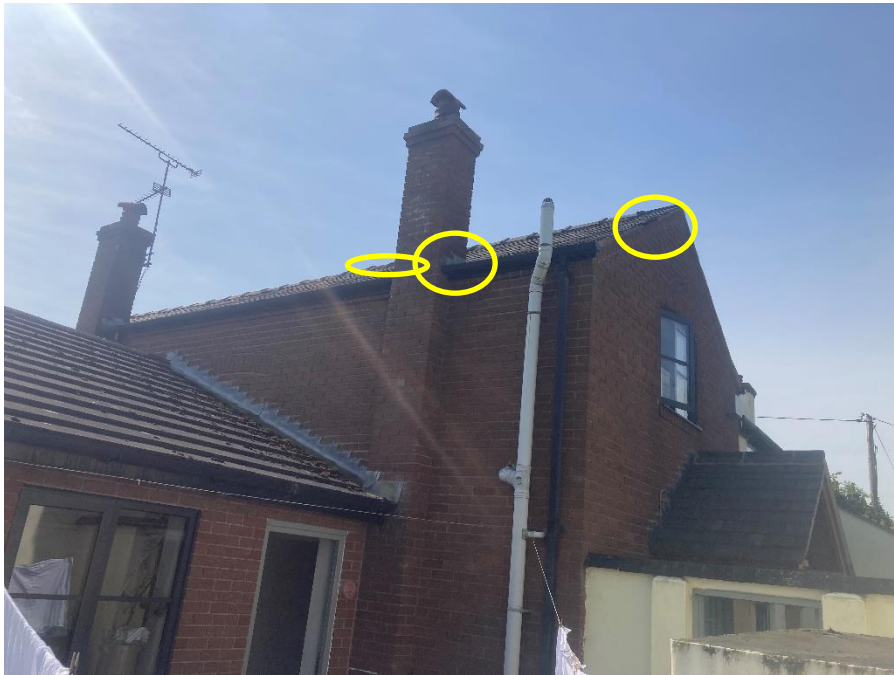
- 3.3.9 The loft space of Building B1 is being used by bats, droppings were seen within the loft space. Potential roost features with B1 are limited to raised lead flashing, two gaps in the mortar under ridge tiles and a gap in the mortar on the verge on the western aspect. Building B2 has negligible potential for bats, no PRF's were identified and no evidence of bats use seen. See Figure 3 for results of Visual Assessment.

A1.5 Plate 5: Building B1 potential roost features shown

4.3.1 No blocking of potential roost features will take place during the works. All PRF’s identified during the Visual Assessment will be unaffected during the works and remain present post works.

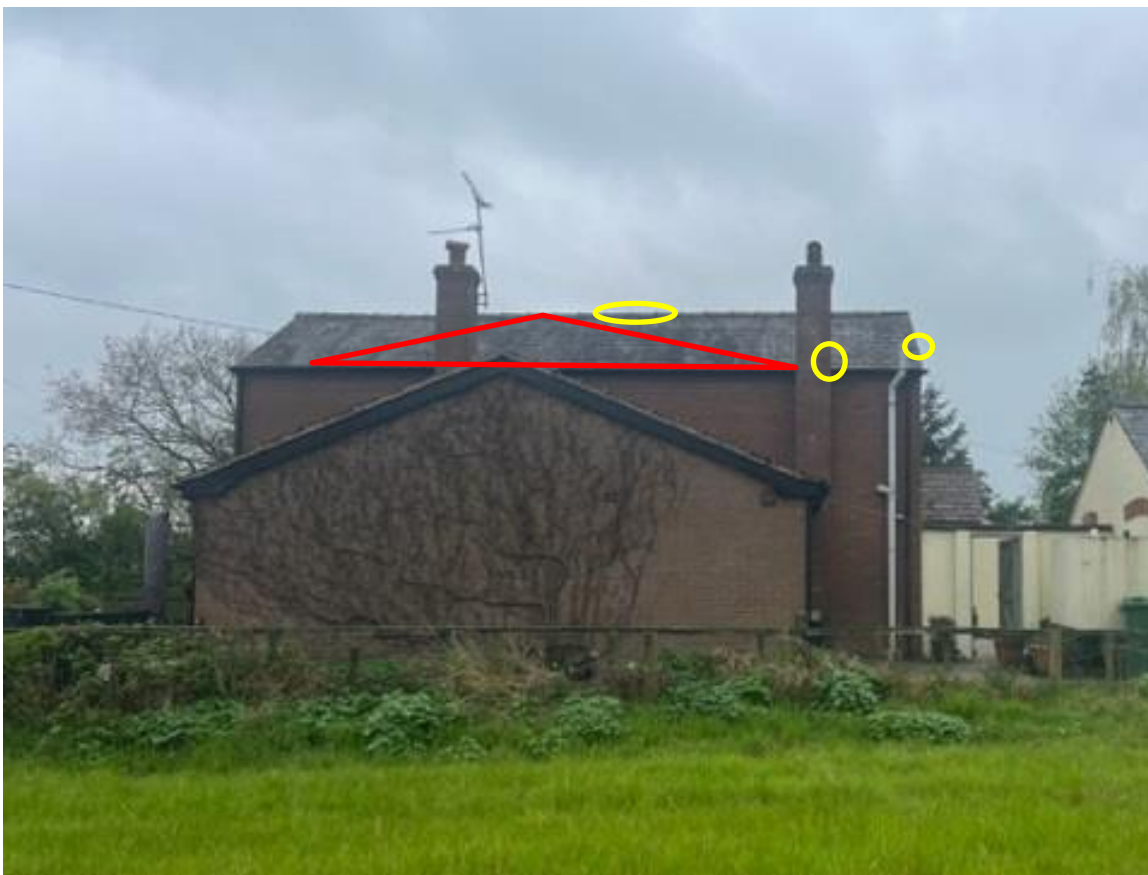
A1.6 Plate 6: Building B1 potential roost features shown and area of slates to be removed (red)

- An ecologist holding an NRW bat license or their Accredited Agent will be present during the slate removal.
- Works will be carried out under “soft works” technique to include removal of roost features by hand, carefully lifting slates and not sliding them. A licensed ecologist will provide a watching brief during the initial works and during works to areas where PRF’s are present and will be available throughout construction on an ‘on call’ basis.

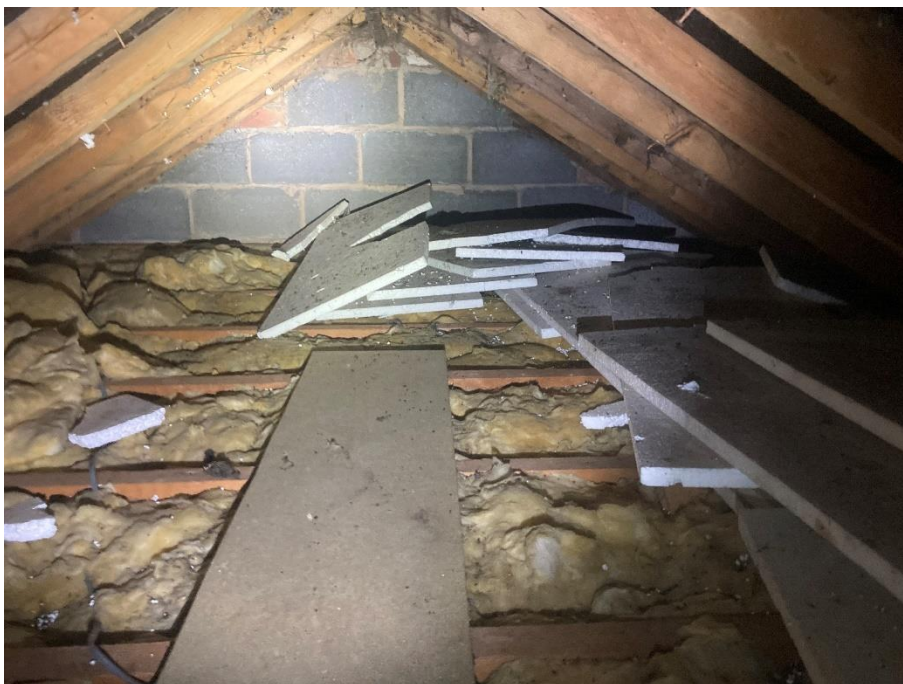
- 3.3.6 The loft space of Building B1 had a maximum height of 0.8m and was the full length of the building (approx. 9m). It was constructed of traditional timber framework with Bitumen F1 felt present. 70+ bat droppings indicative of pipistrelle bat species were found within the eastern portion of this loft space, concentrated underneath the ridge beam. The majority of the ridge timber was covered in cobwebs. These droppings were both historic and fresh. No live bats were seen. Within the western corner of the loft the original gable wall of the cottage is still present and this blocks free flight access between the two roof spaces. Possible crawling gaps were present at this wall which could allow limited passage by bats. Mouse (*Mus musculus*) droppings were abundant in the space surrounding the hatch opening.

A1.7 Plate 7: internal roof structure of B1

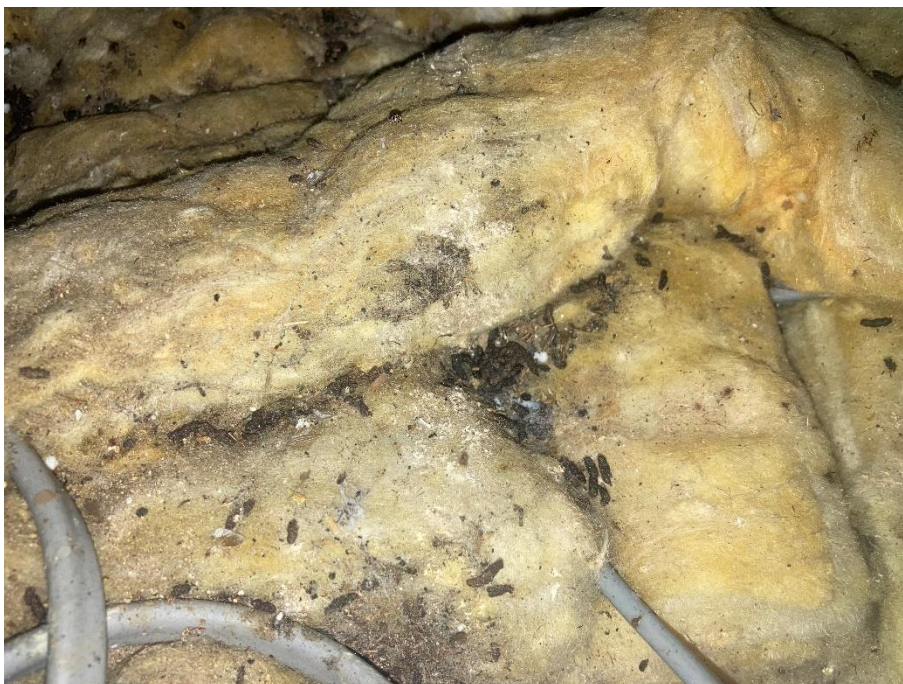
A1.8 Plate 8: Bat droppings found within B1

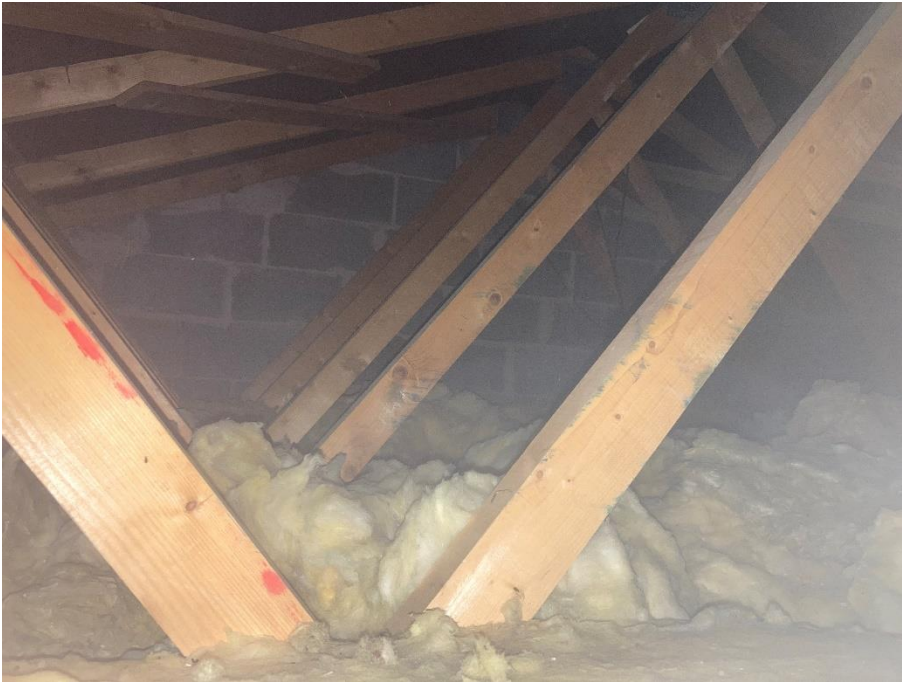
- 3.3.7 The loft space of Building B2 was above the single-story extension and was not connected to any other loft space. Its construction is truss and timber and created a cluttered space, modern underfelt was present. No bat droppings were found but rodent droppings were present.

A.1.9 Plate 9: Internal roof structure of B2

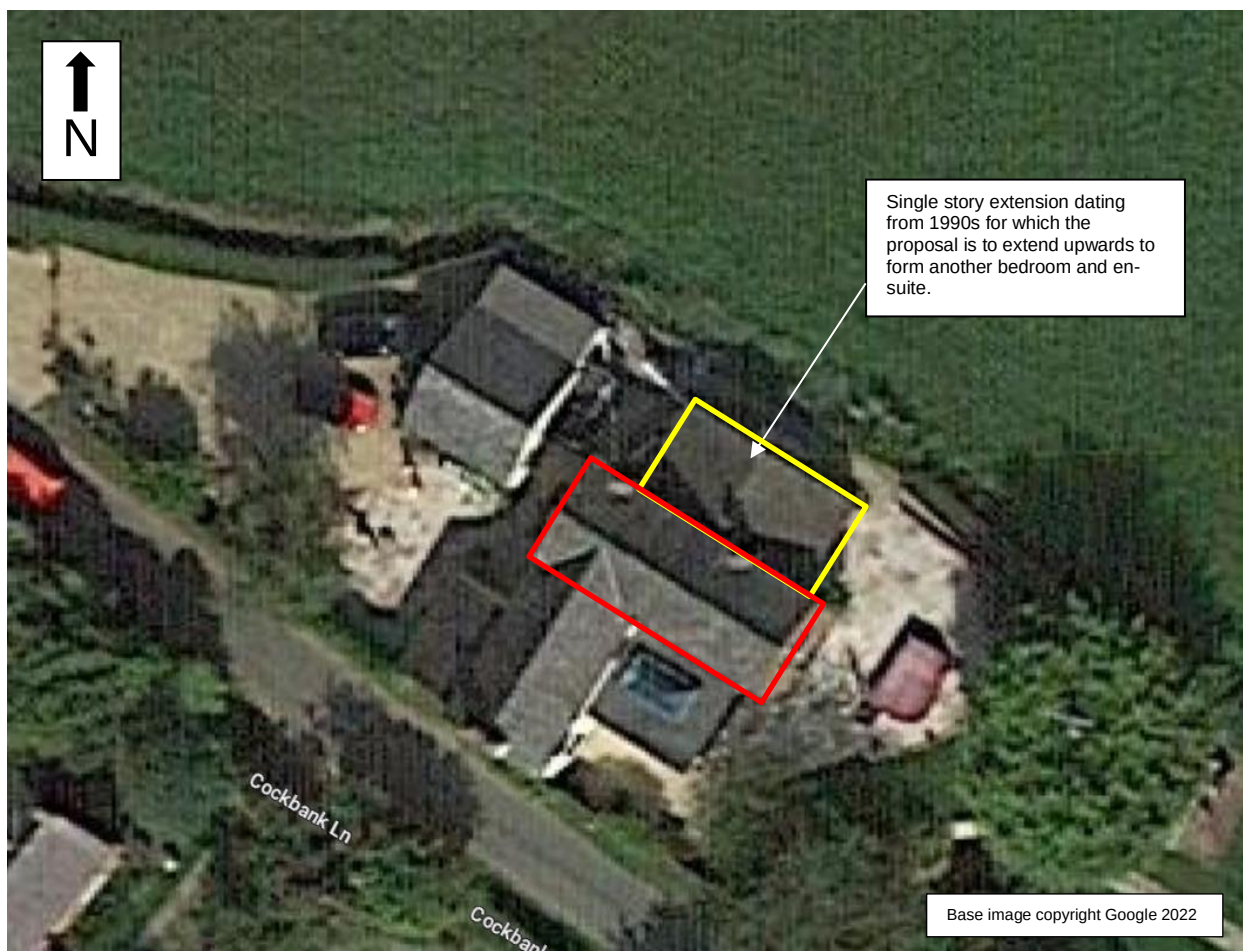
Figure 2: Roselyn Cottage. Yellow box showing single storey extension (Building B2) to have second floor added to it. Building B1 shown in red.

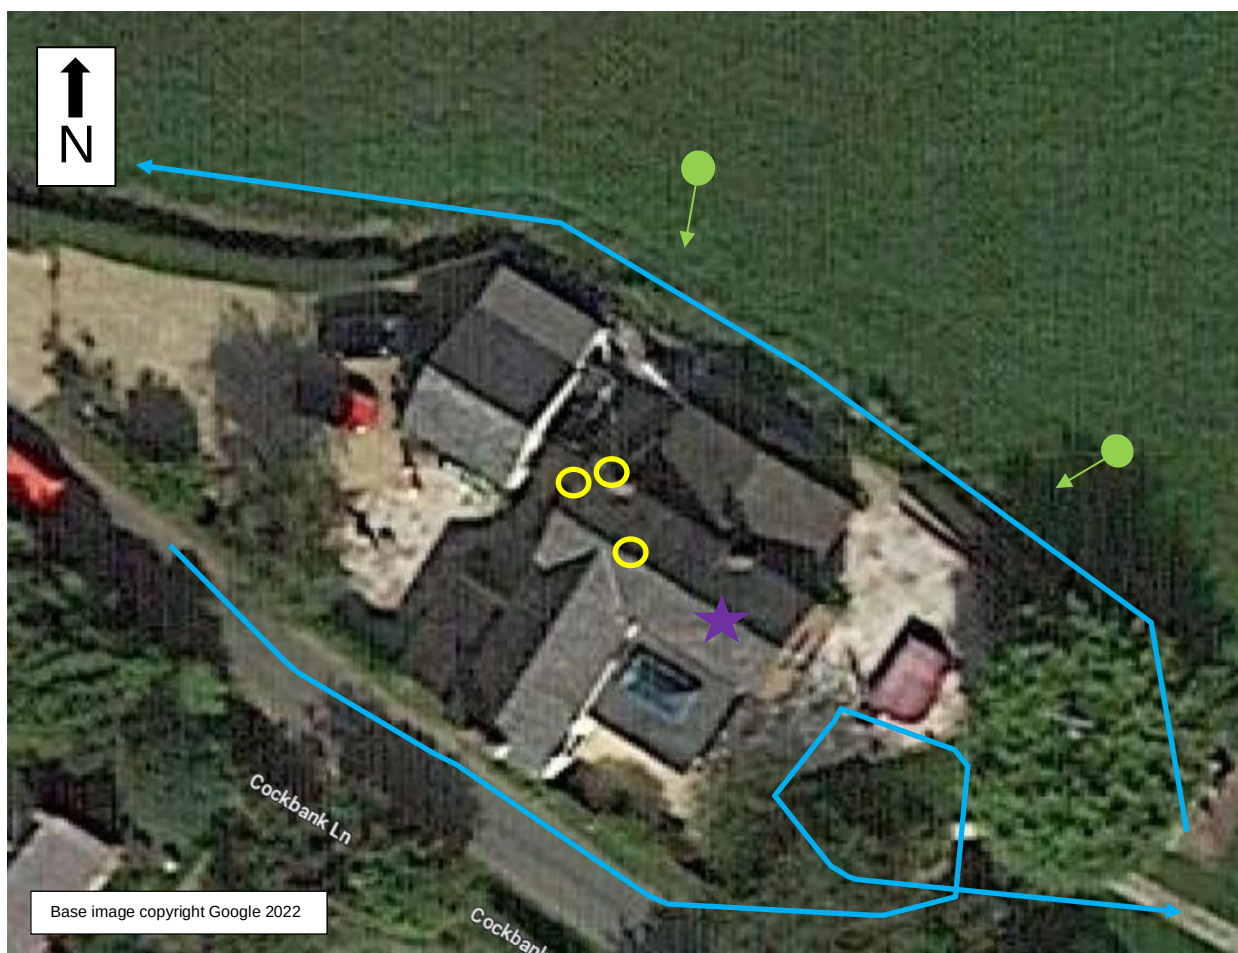
Figure 3: Survey results plan

3.7.4 No bats were seen emerging from the building during the survey. Bat activity was very low throughout the survey with only a small number of passes. Infrequent passes of common pipistrelle bats (*Pipistrellus pipistrellus*) were recorded commuting along the field boundary and within the garden to the east of the property. The first bats (n=2) recorded were at 21:35 (17min after sunset) and these were distant and seen commuting down the lane to the south of the property in west to east direction. The next bats seen were between 22:04 (47 minutes after sunset) and 22:19 and were common pipistrelles foraging within the garden and commuting along the field boundary. See Figure 3 for further details.
