# Heritage Impact Assessment

Listed building consent for various refurbishment works

Moss Villa, Chapel Lane, Bronington, Whitchurch, SY13 3HR

April 2023

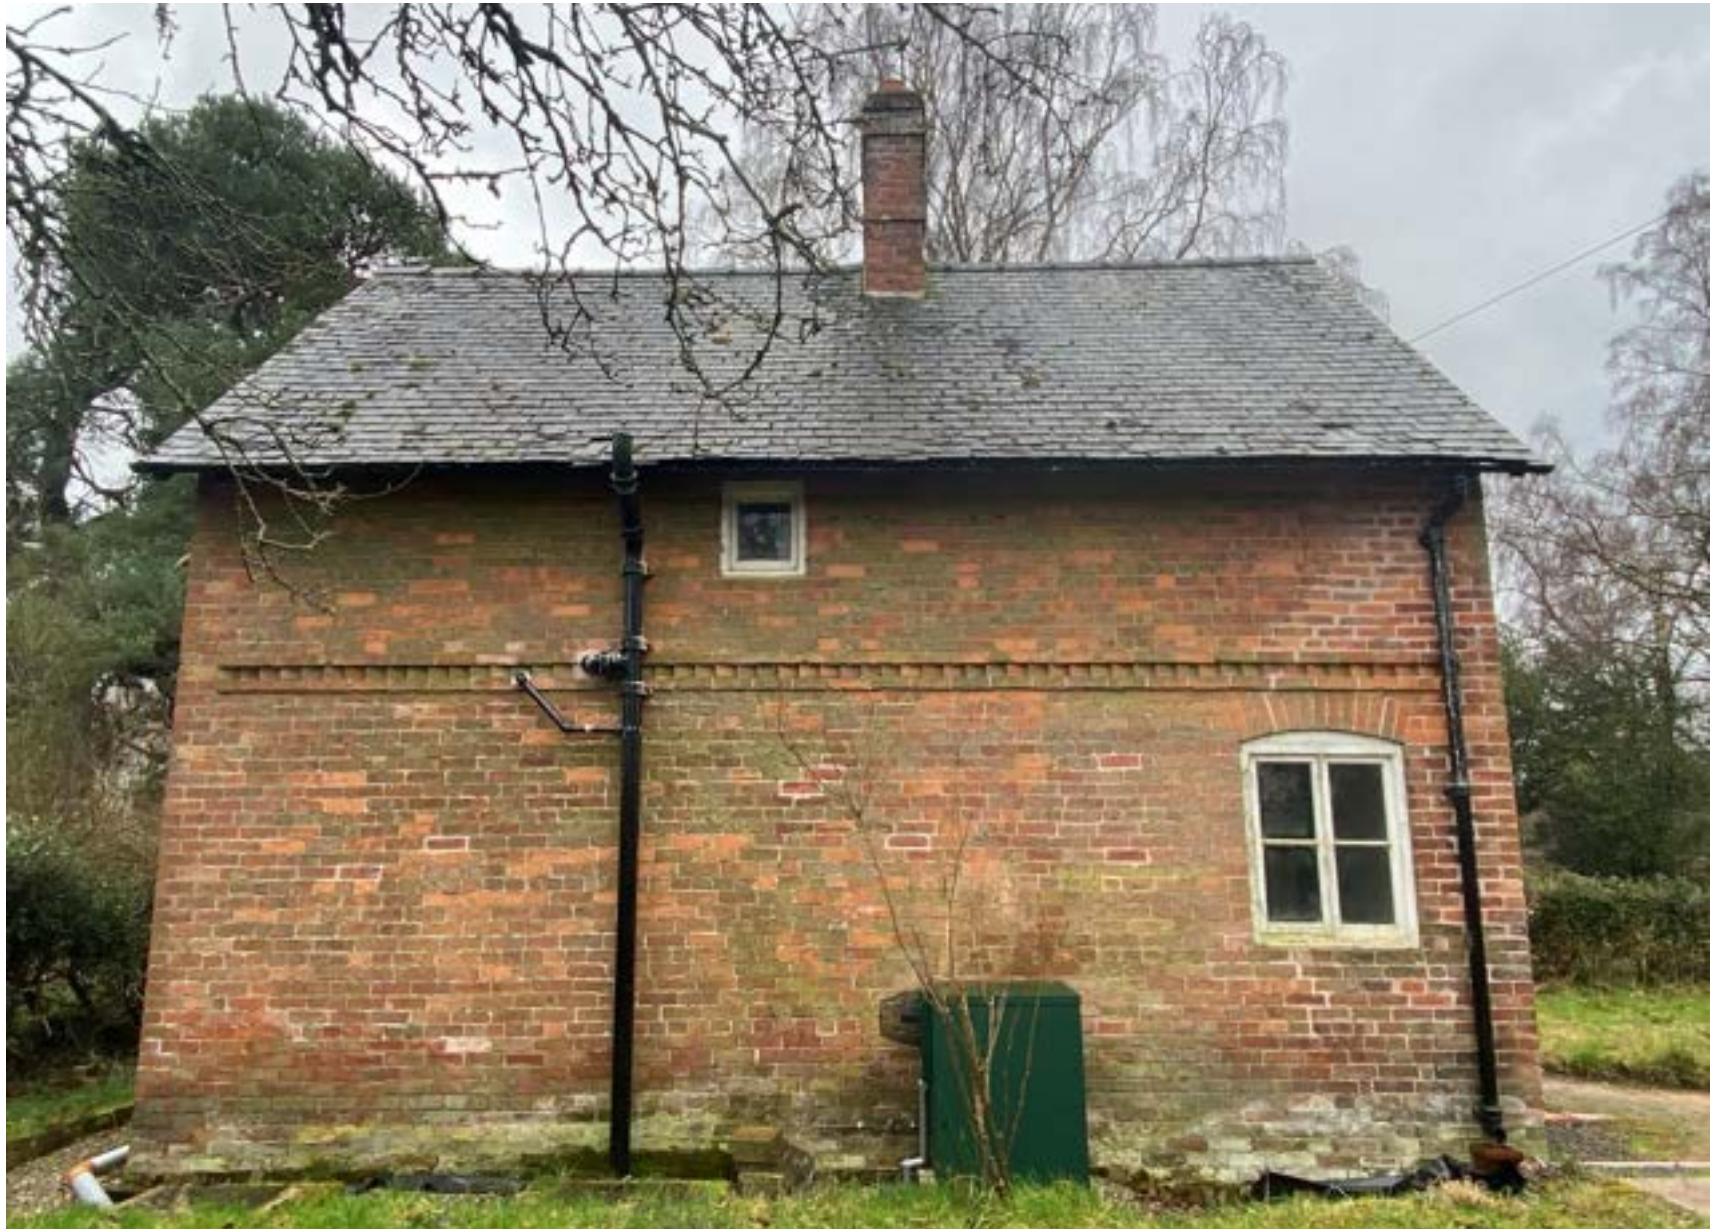
*Figure 8 – The northeast elevation of the Site. This Site features the architecturally interesting small, square window, as well as a portion of the dog toothed corbelling detail. However, the presence of the oil boiler detracts from the Site's significance.*

| Works | Significance | Impact | Justification |
|---|---|---|---|
| Removal of oil boiler | Negative | Positive | The boiler design is unsympathetic to the rural historic character of the Site. Removal will be a positive improvement for the Site. |

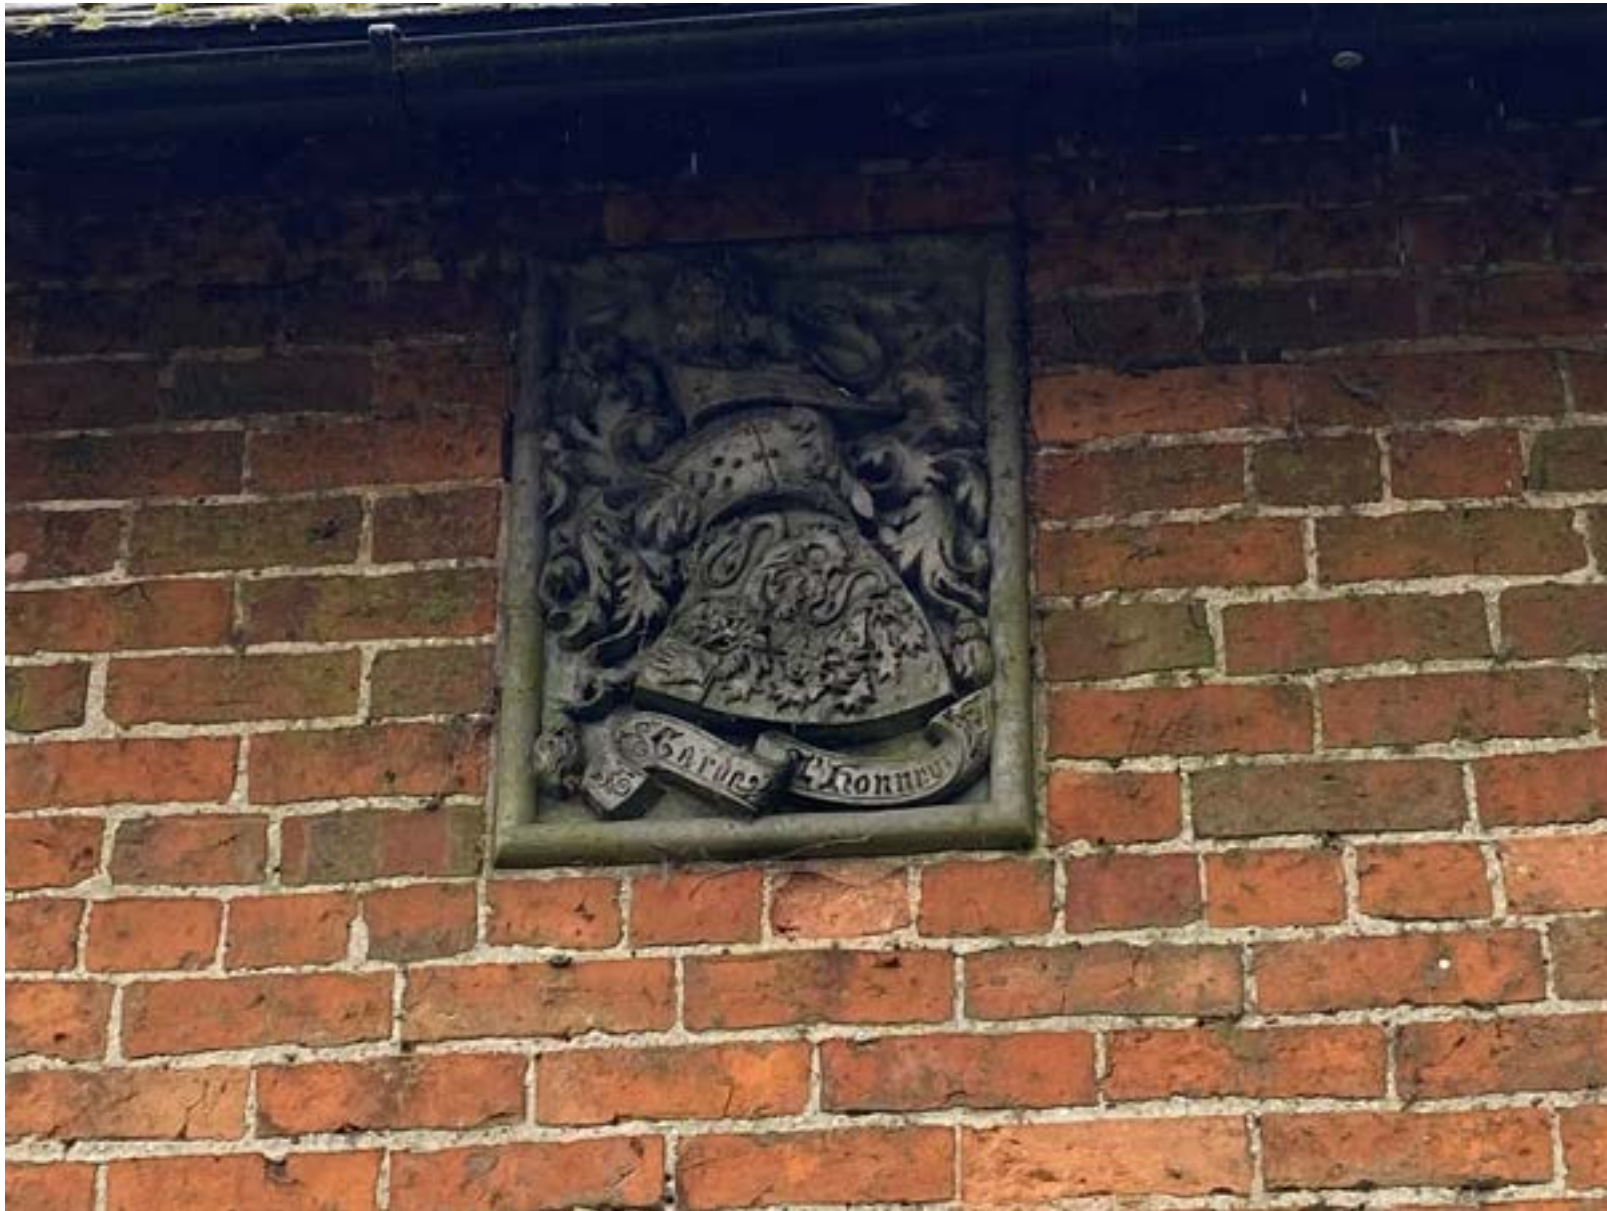
*Figure 9 - The Hanmer crest and motto. The Site formed a part of the Hanmer estate and served as a dwelling to estate workers.*

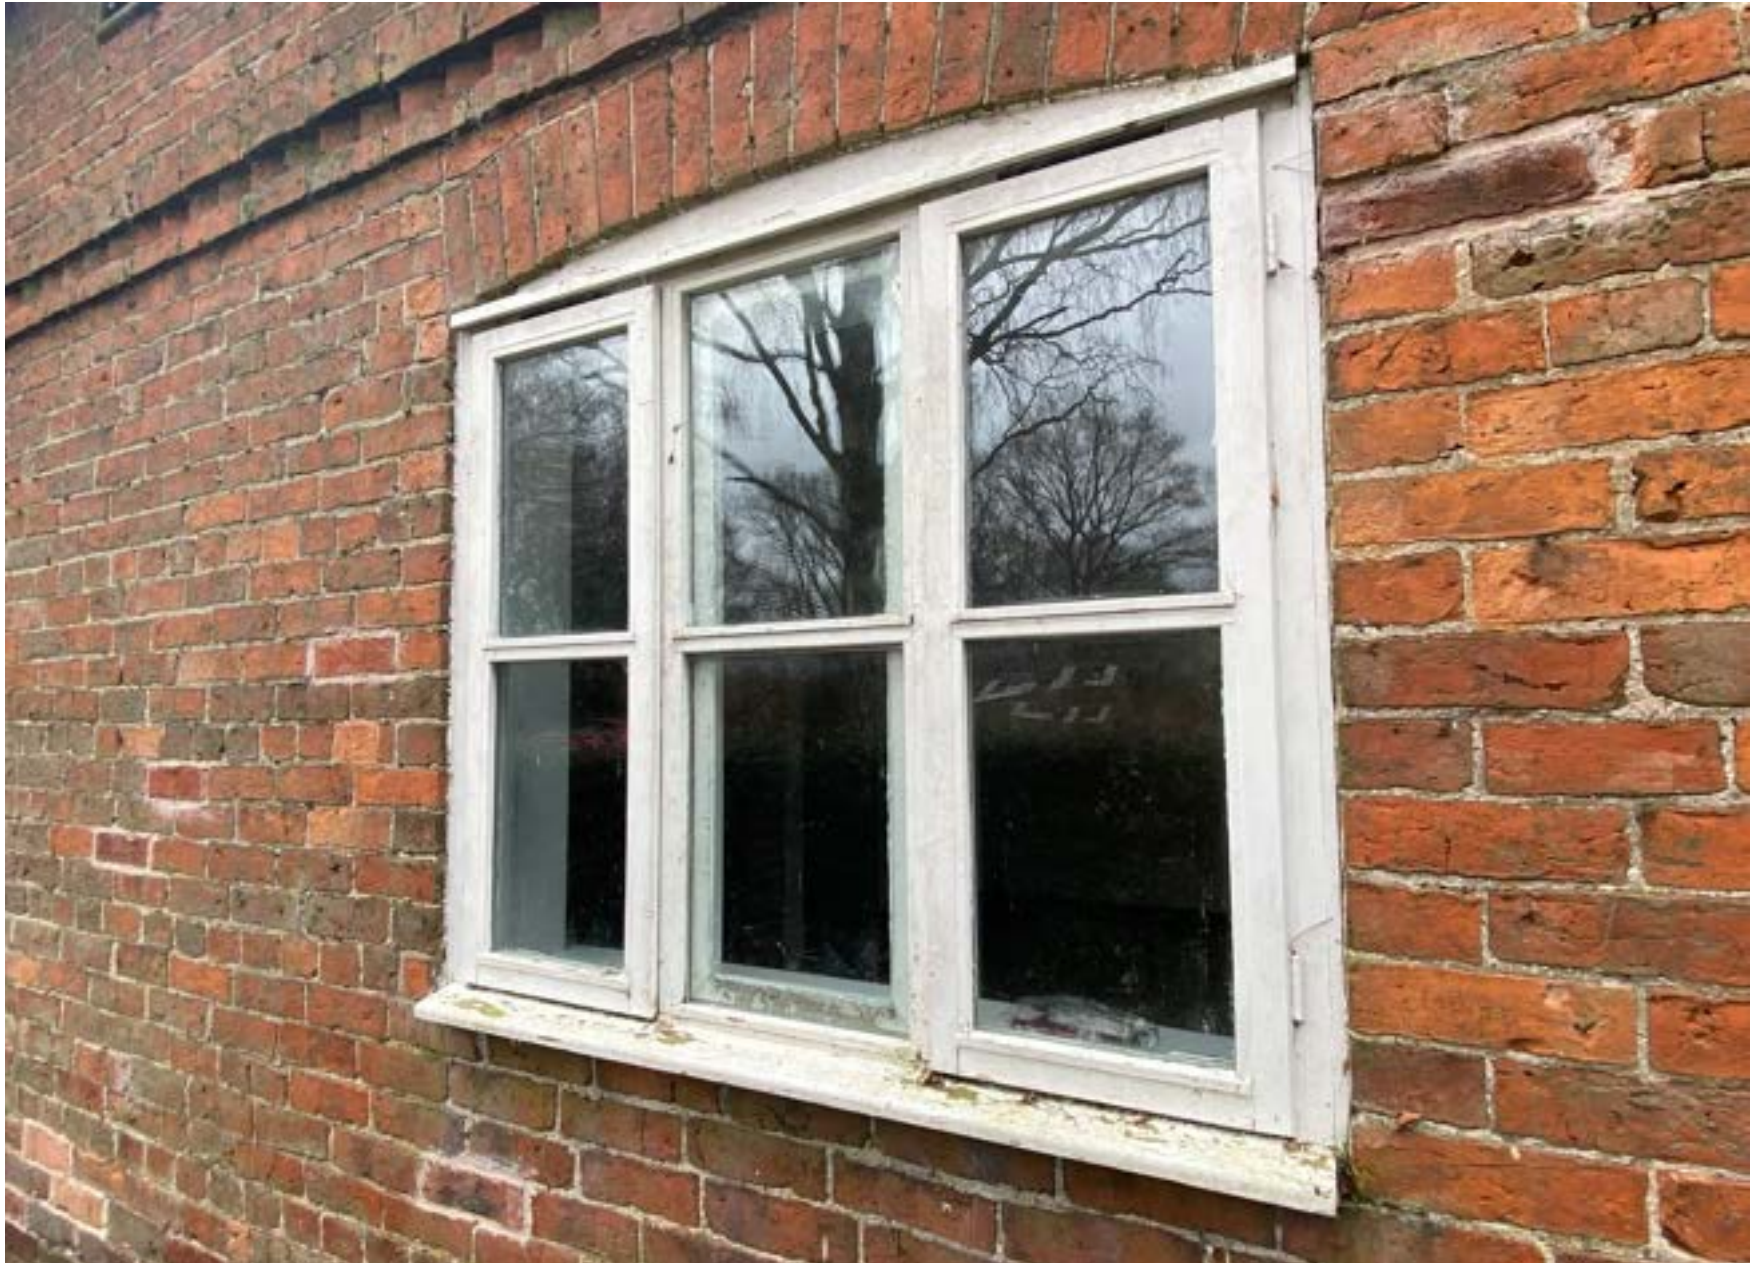
6.6 Whilst the Site is of historic and architectural significance, it should be noted that there are elements which have harmed this significance already. On the external of the main dwelling, there are several untidy/unsympathetic elements which detract from the Site's significance. On the north-east elevation of the Site a historic brick has been removed to accommodate a pair of pipes going into the building (Figure 22 & 23). This is both unsightly and has resulted in the removal of historic fabric, though the removed brick has still been retained on the Site. Further to this, there are exposed drainage pipes encircling the building at the ground level. These are divergent from the guttering and downpipes found on the property which are black and cast iron. In contrast, this ground level drainpipes appear to be modern and constructed from a mixture of plastic and copper. Whilst the windows within the Site are historic, they are not considered to be originals. Moreover, the right window on the Site's south-west elevation (Figure 10) has been replaced.

*Figure 10 – Window on the southwest elevation has been replaced with a model that is divergent in design from the rest of the Site.*

| <p>Replacement of all windows (with the exception of the small square window on the eastern elevation). New windows to be set back further to allow for new installation of new cills. Double glazing to be installed.</p> | Negative | Positive | <p>Whilst the majority of these windows are considered 'historic' due to their single glazing, they are not original to the Site and are later iterations. Most notably the right window on the south-west elevation (Figure 10). As such, it is considered that replacement of these do not give rise to harm. Currently the windows have a shallow reveal, also indicating a later replacement and sit straight onto the brick work with no cill. Long-term this is allowing water to collect, creating issues with water and</p> |

| | | | weather ingress. Replacement timber windows will allow a deeper, traditional reveal and a new timber cill to remedy any further maintenance issues. |

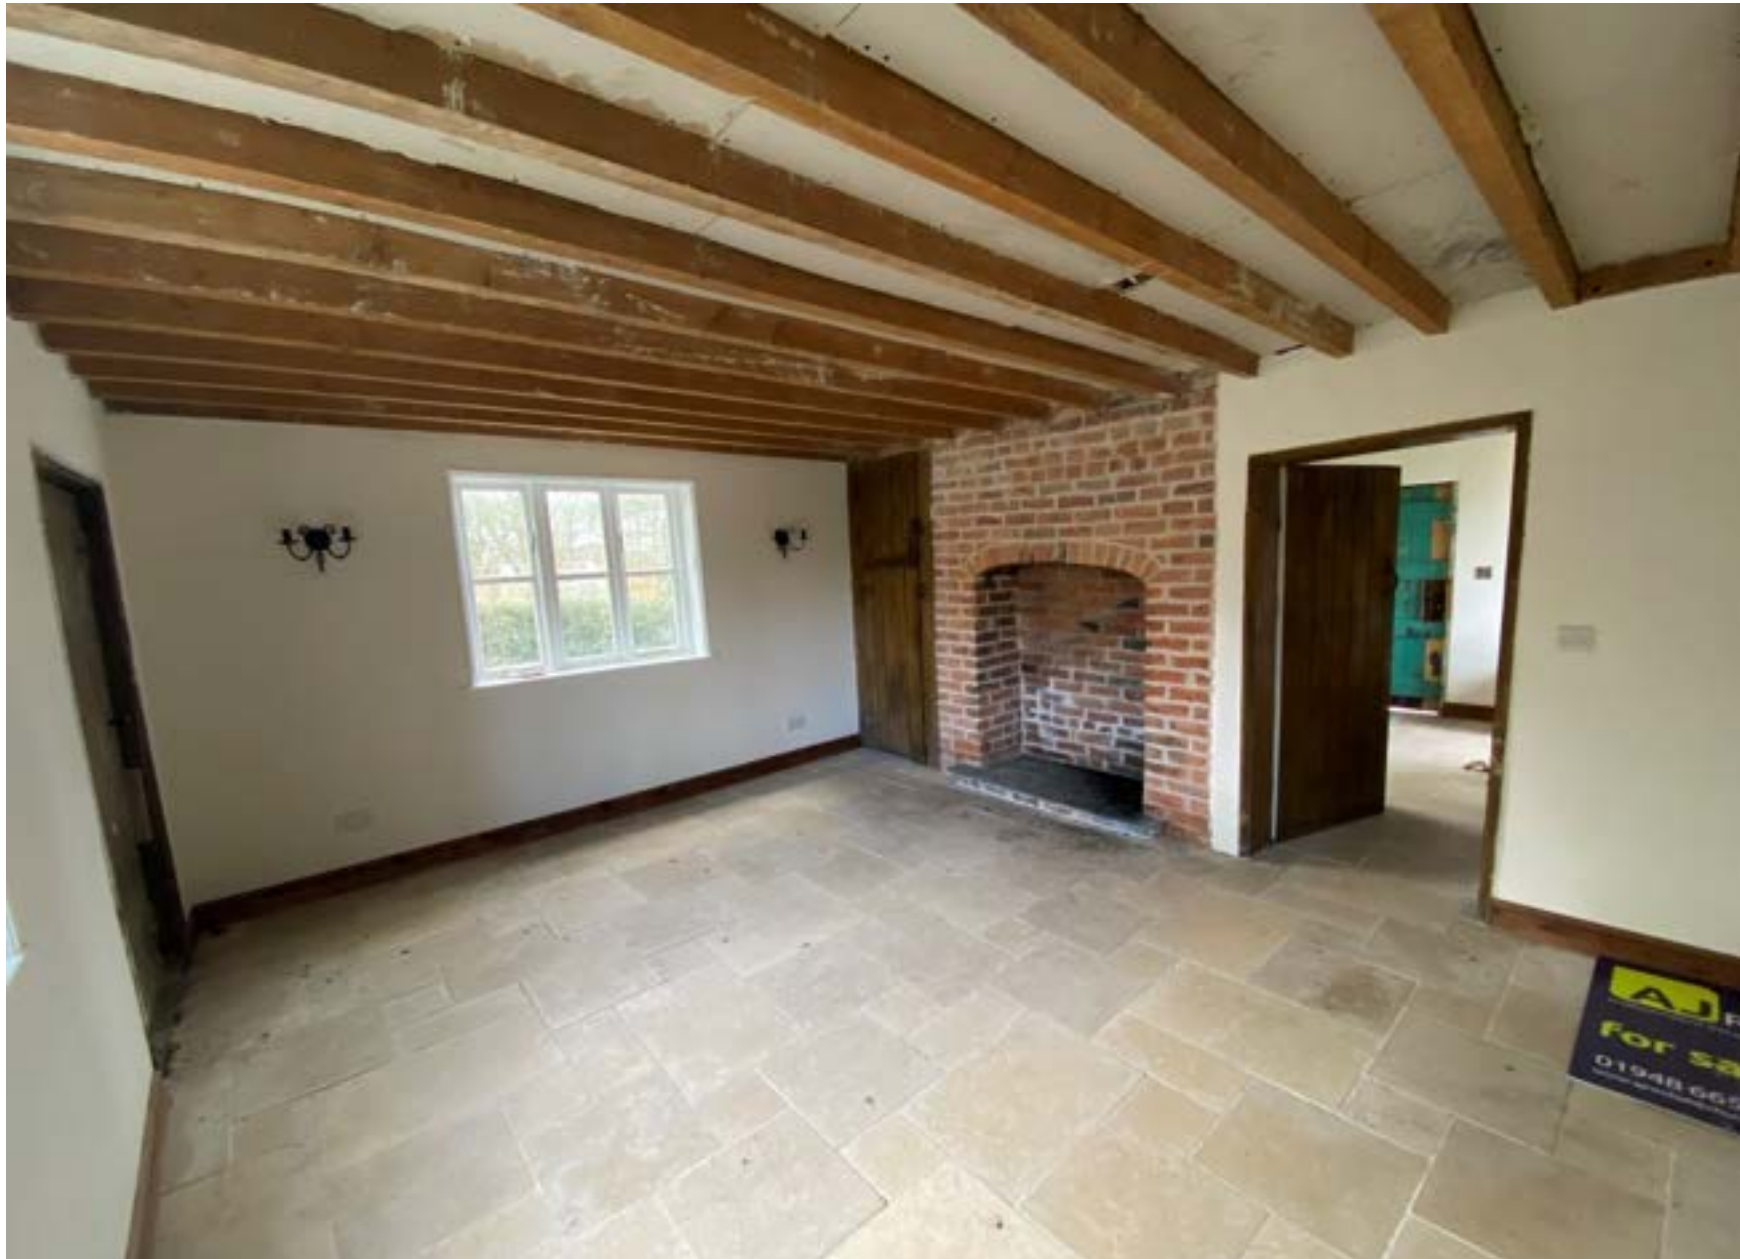
*Figure 11 – Main living space within the Site. The significant fireplace is visible, as is the newly installed skirting boards.*

| Installation of new skirting in living room | Negative | Neutral | Photographic survey discharged under P/2019/0904 shows the Site previously had brick tiled skirting within the main living room. This has subsequently been removed and replaced with timber skirting. This change is not considered to constitute harm to the Site's significance. The previous skirting was of little historic or architectural interest and their removal does not detract from the building. The newly installed skirting is simple and in-keeping with the Site's modest character. As such, the new skirting boards do not detract from the site's significance. |

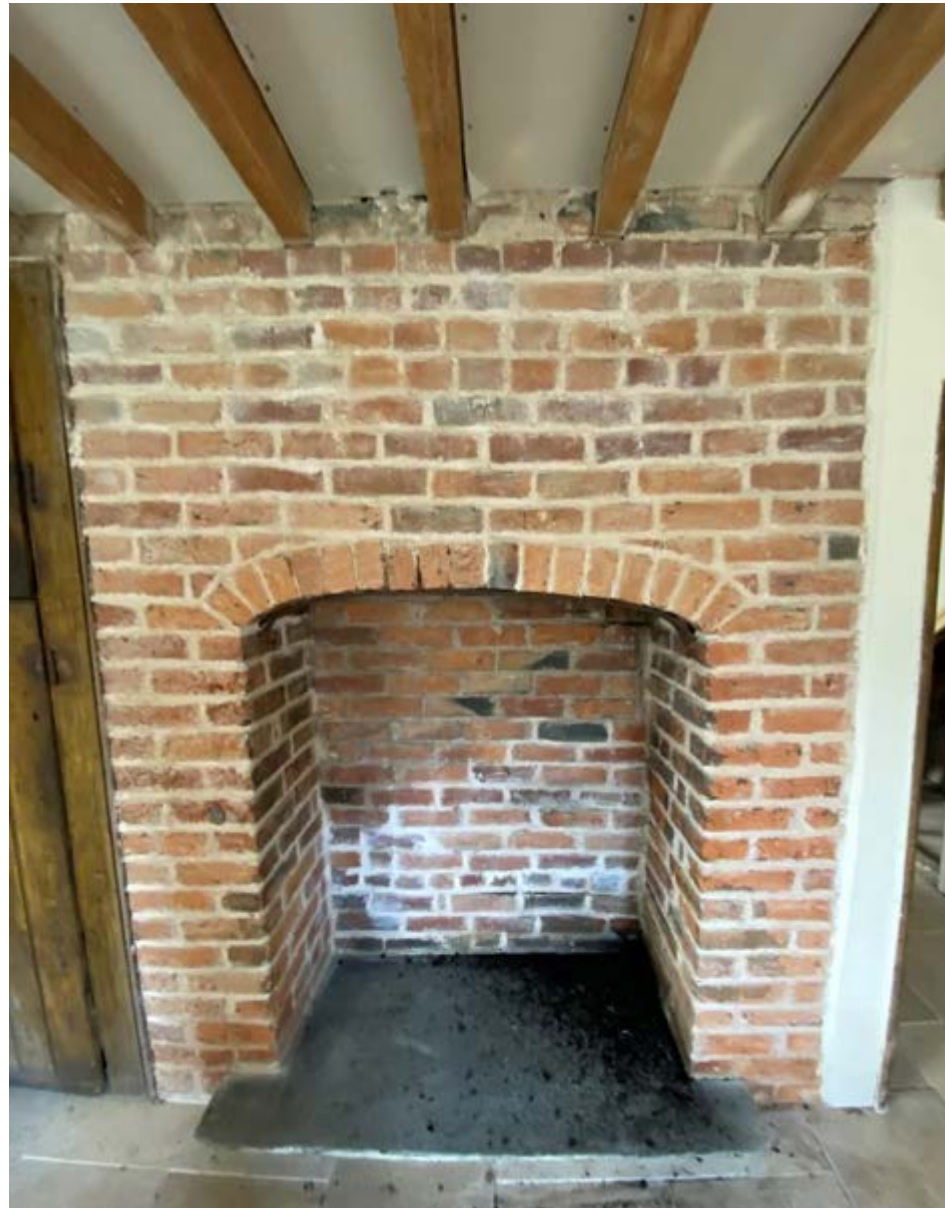
*Figure 12 - Closer view of the fireplace.*

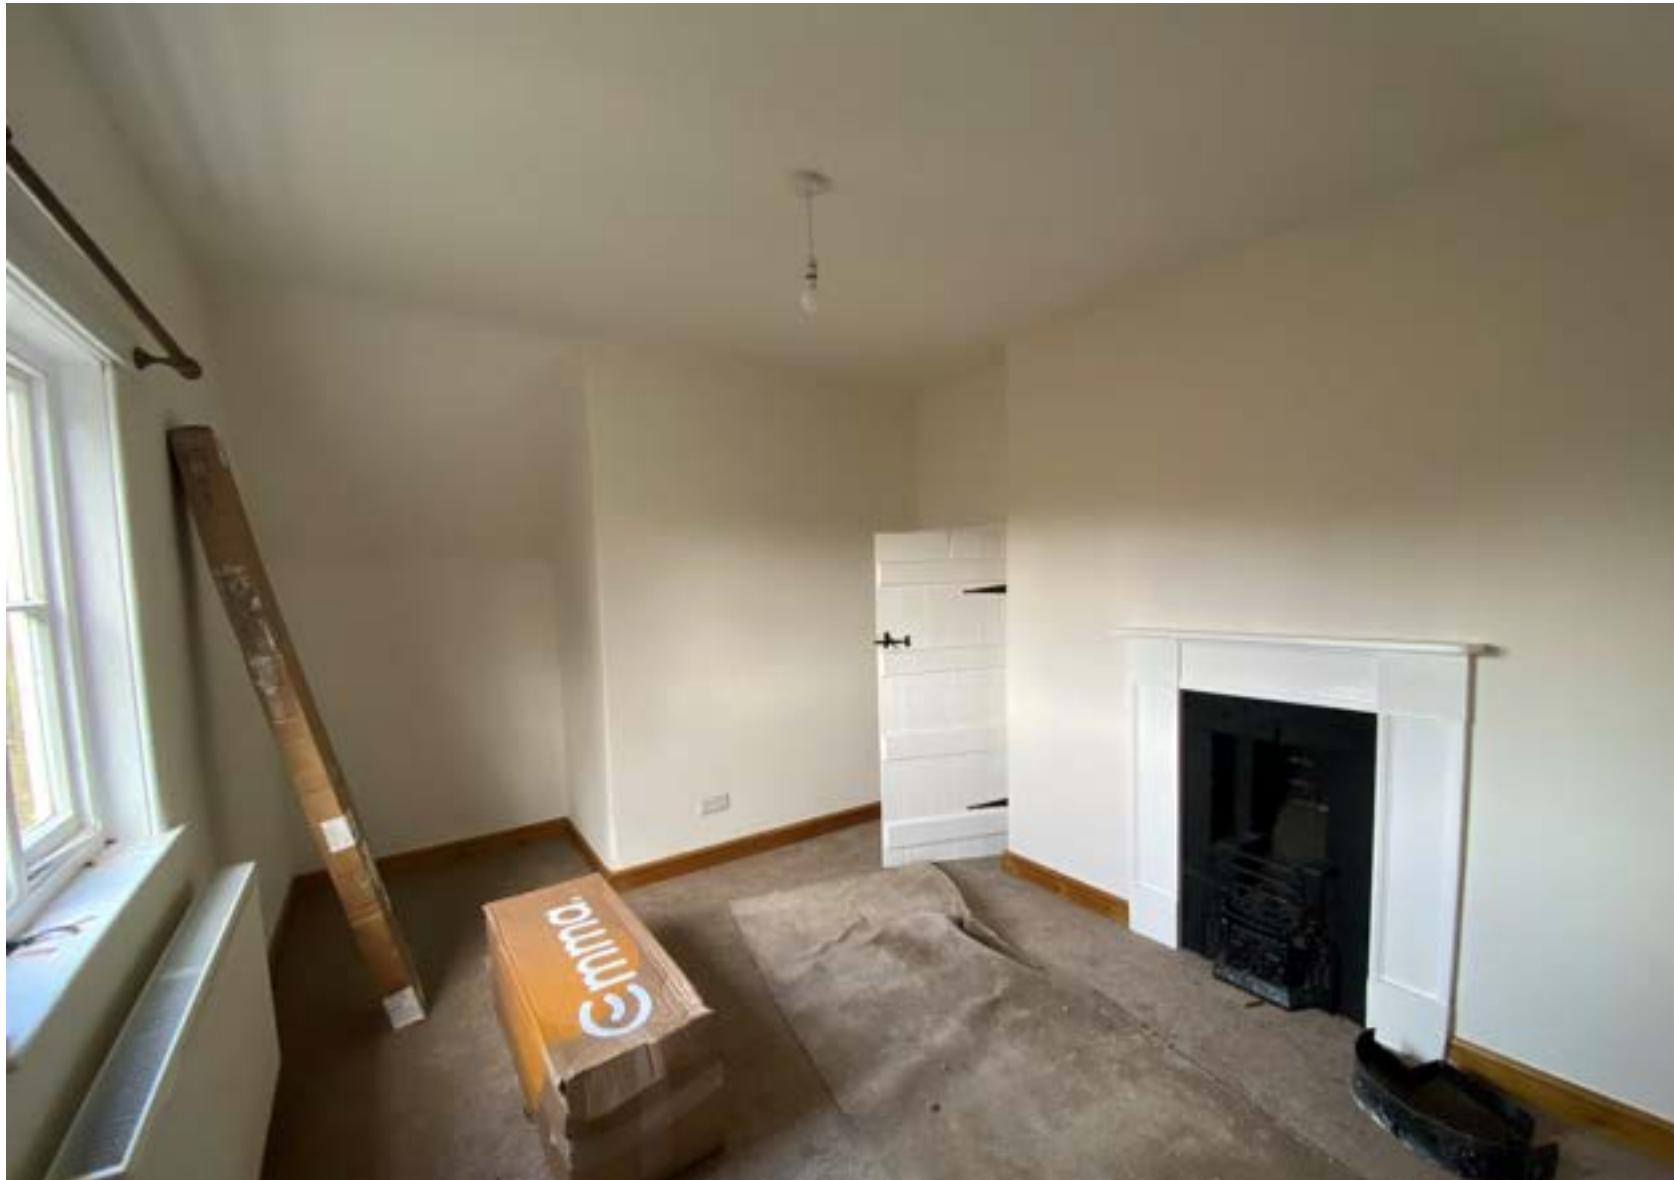
*Figure 13 - Bedroom one. The significant fireplace surround is visible on the right. On the left of the image, is the area in which the historically significant wardrobe was removed. Reinstatement will be a positive enhancement of the room and Site.*

| Works | Significance | Impact | Justification |
|---|---|---|---|
| Reinstatement of upper floor wardrobe | Negative - wardrobe was a feature of historic interest within the Site. Its removal | Positive | Correspondence between Wrexham Council's Enforcement Officer and the applicant confirms this wardrobe was to be retained as part of the conditions for the acceptance of P/2019/0904. |

| | has harmed the Site's significance. | | <p>Therefore, these works will reinstate the wardrobe within bedroom 1 that was removed without consent. Reinstatement of historic features are considered a positive enhancement for the Site. Whilst this feature is being reinstated, the design will be slightly amended to facilitate easier use for clothes hanging. This will involve raising the position of the cupboard partition, to allow the hanging of clothes. The horizontal bar which divides the two sections will echo the previous detail as seen in historic photos. The door panels will be simple and recessed which reflects the modest rural nature of the villa. Finally, the door architrave will match the existing detailing found around the existing windows.</p> |

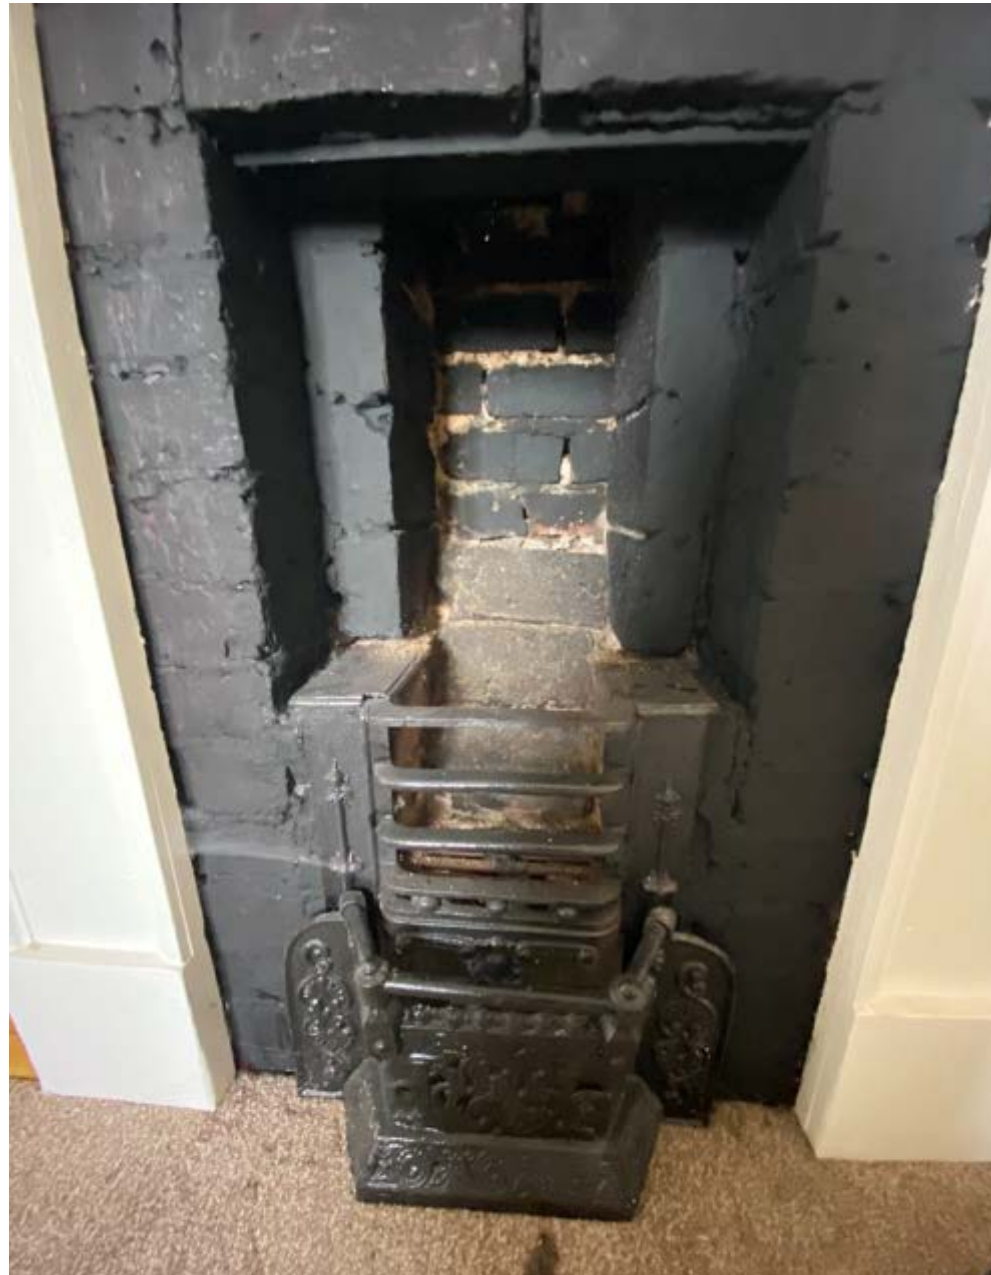
*Figure 14 - Closer view of the historic fireplace surround in bedroom one.*

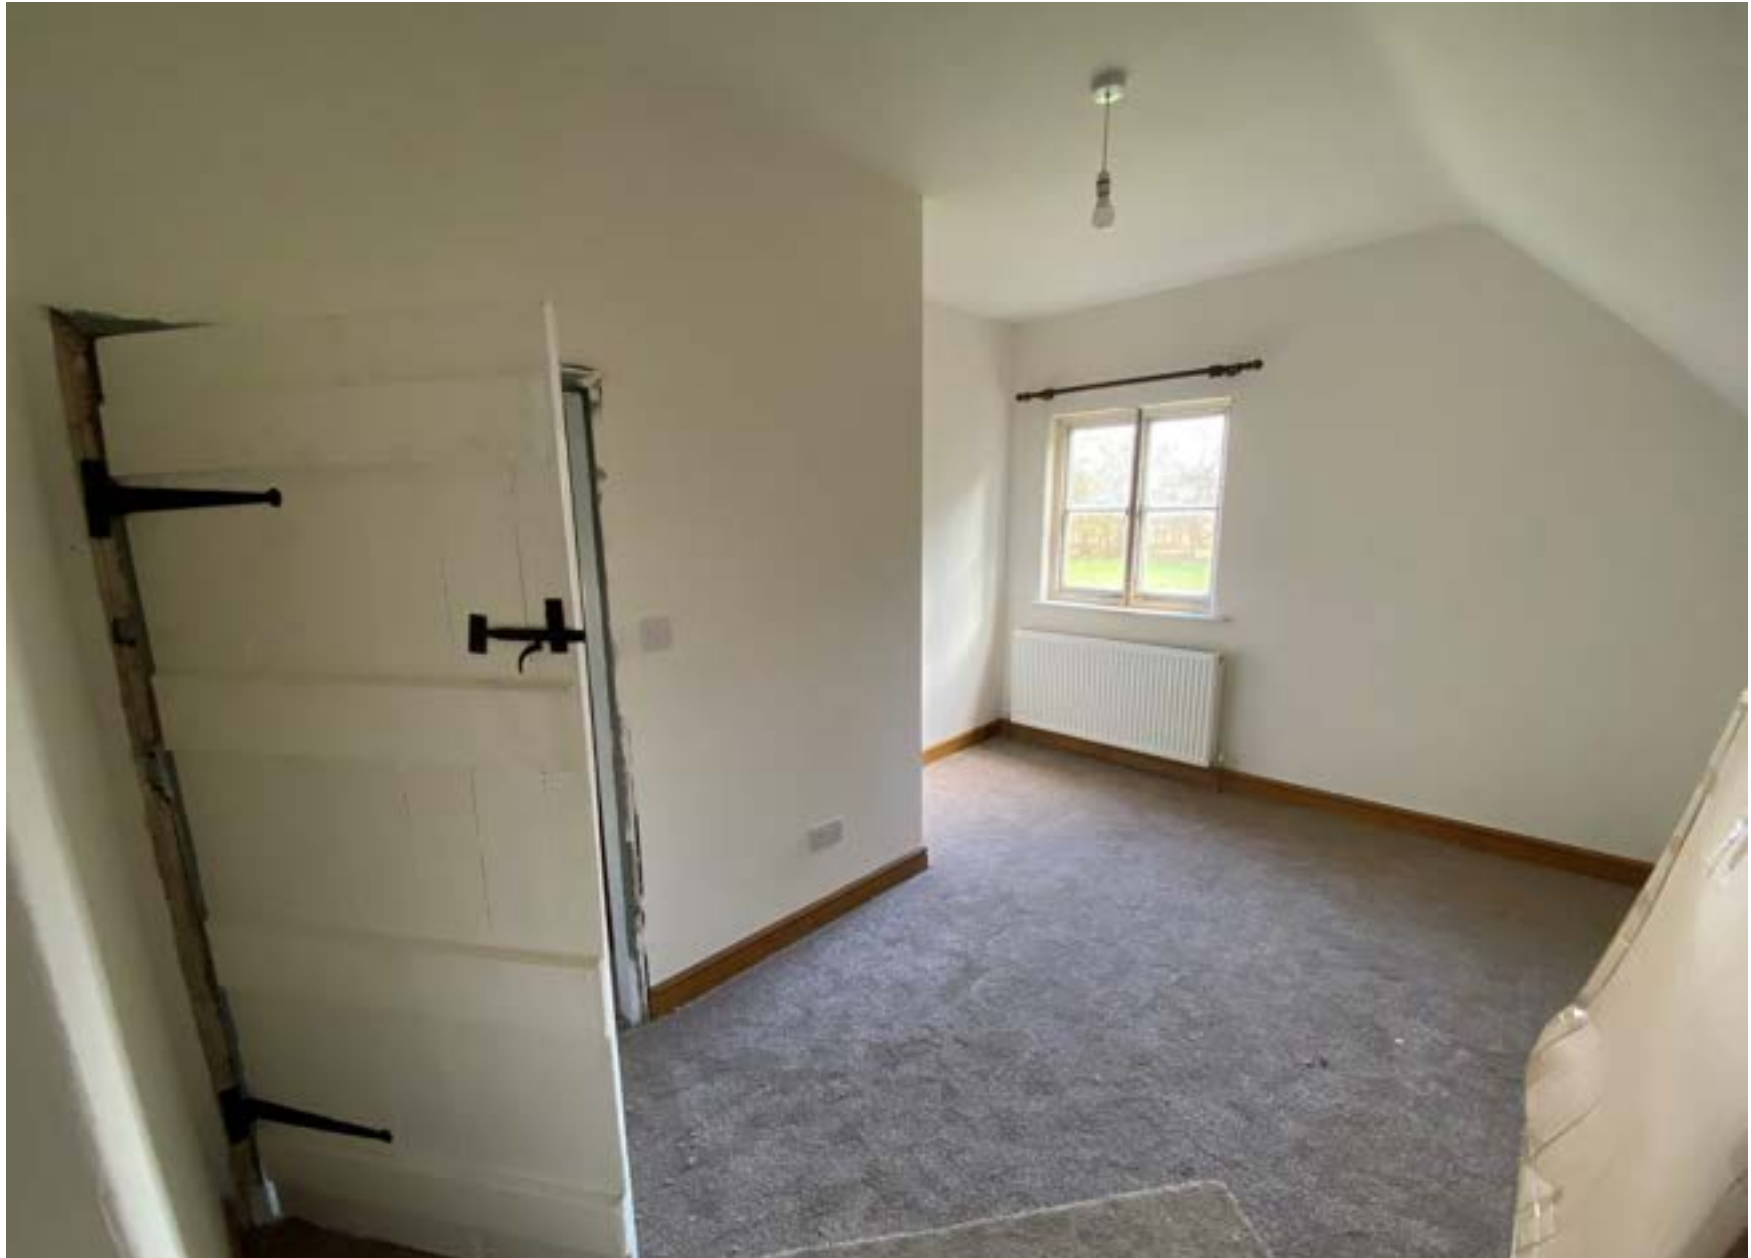
*Figure 15 - Bedroom two. The central wall is currently in an L-shape. The proposal will see this replaced with a straight stud, reflecting the pre-existing wall located here.*

| Works | Significance | Impact | Justification |
|---|---|---|---|
| Internal alterations to first floor layout, increasing size of bedroom 2 | Negative | Positive | These works are returning the wall to its historic layout (Figure 16). Photographic survey discharged under P/2019/0904 shows the framing for this wall continuing in a straight line, rather than the L-shape suggested by the pre-existing floor plans. This will provide a greater level of space in bedroom 2 and will simplify the layout of the bathroom. This helps to secure the optimum viable use of the Site as a private dwelling. |

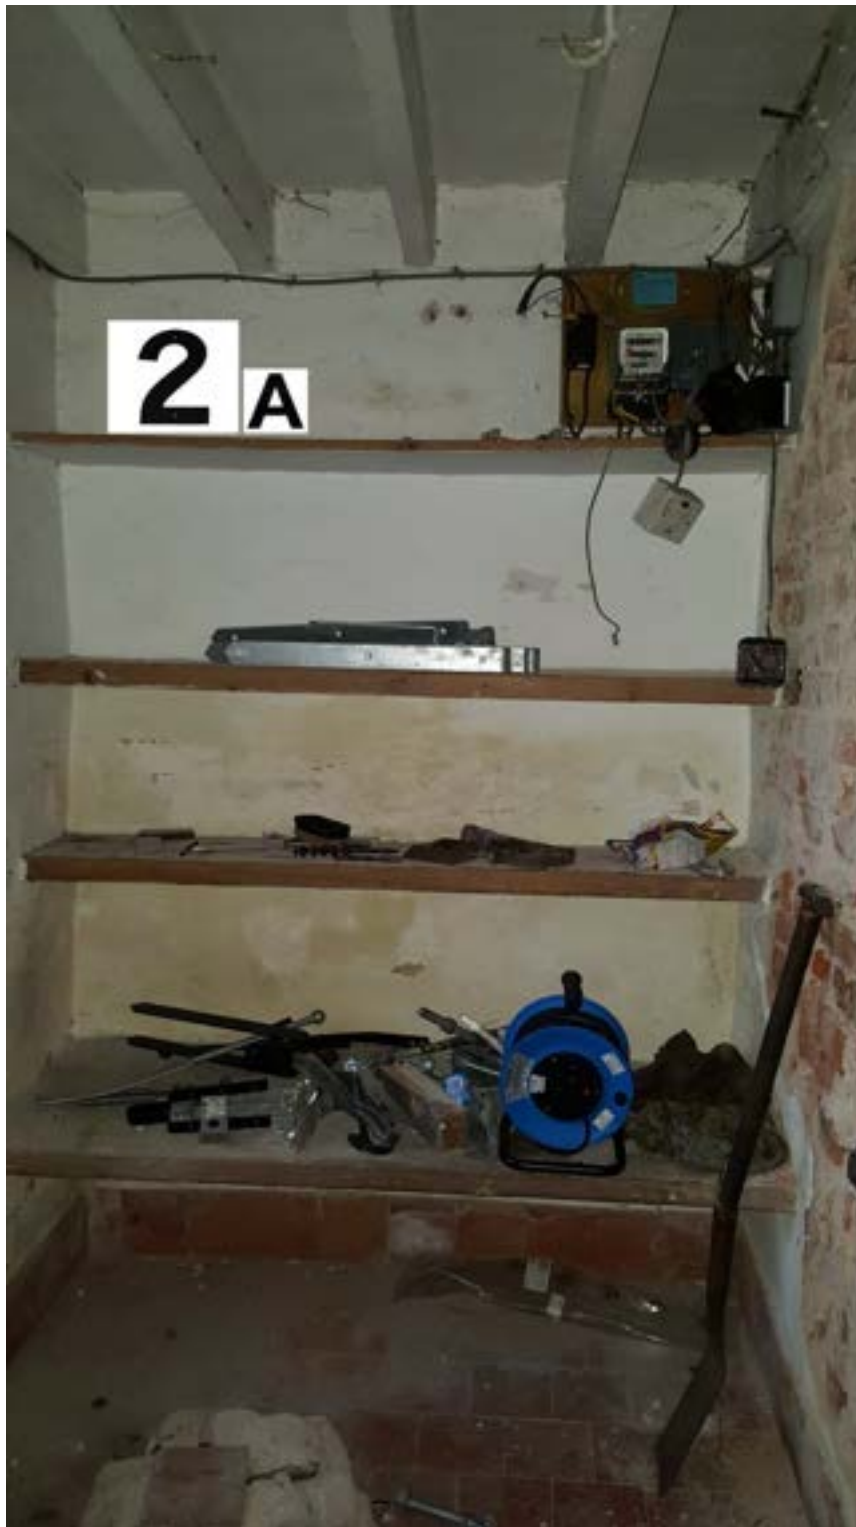
*Figure 16 – Pantry shelves which have been lost as part of works already carried out. Photo taken from photographic survey discharged under P/2019/0904.*

- 6.9 A further note to consider is that the conditions discharged under P/2019/0904 confirmed that the pantry shelves and kitchen flooring were to be retained. However, works then carried out have meant that these two features were lost, but, subsequent correspondence with the Local Planning Authority has confirmed that, on balance, this change is considered acceptable and the relevant conditions no longer necessary.

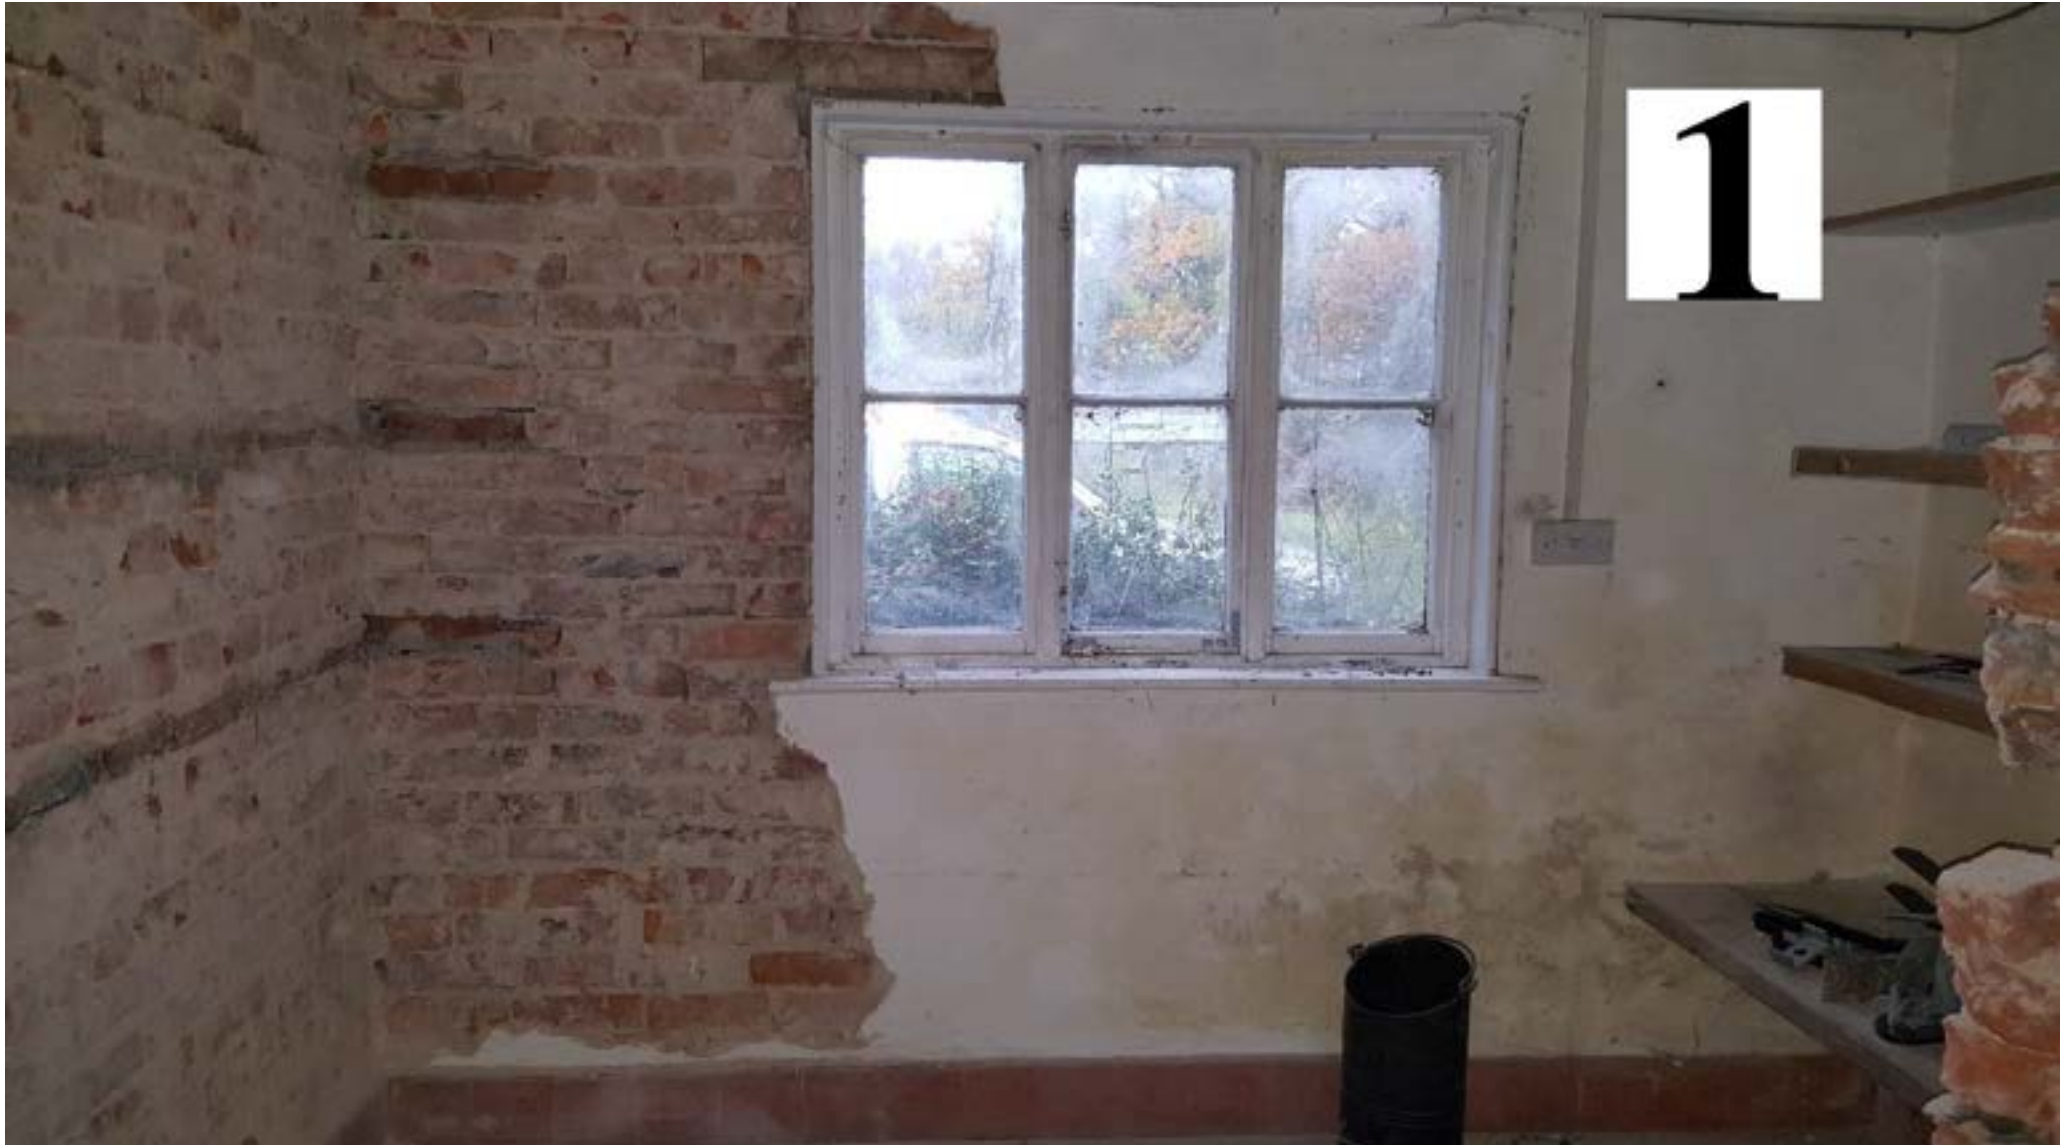
*Figure 17 – Further contextual view of pantry shelves which have been lost as part of works already carried out. Photo taken from photographic survey discharged under P/2019/0904.*

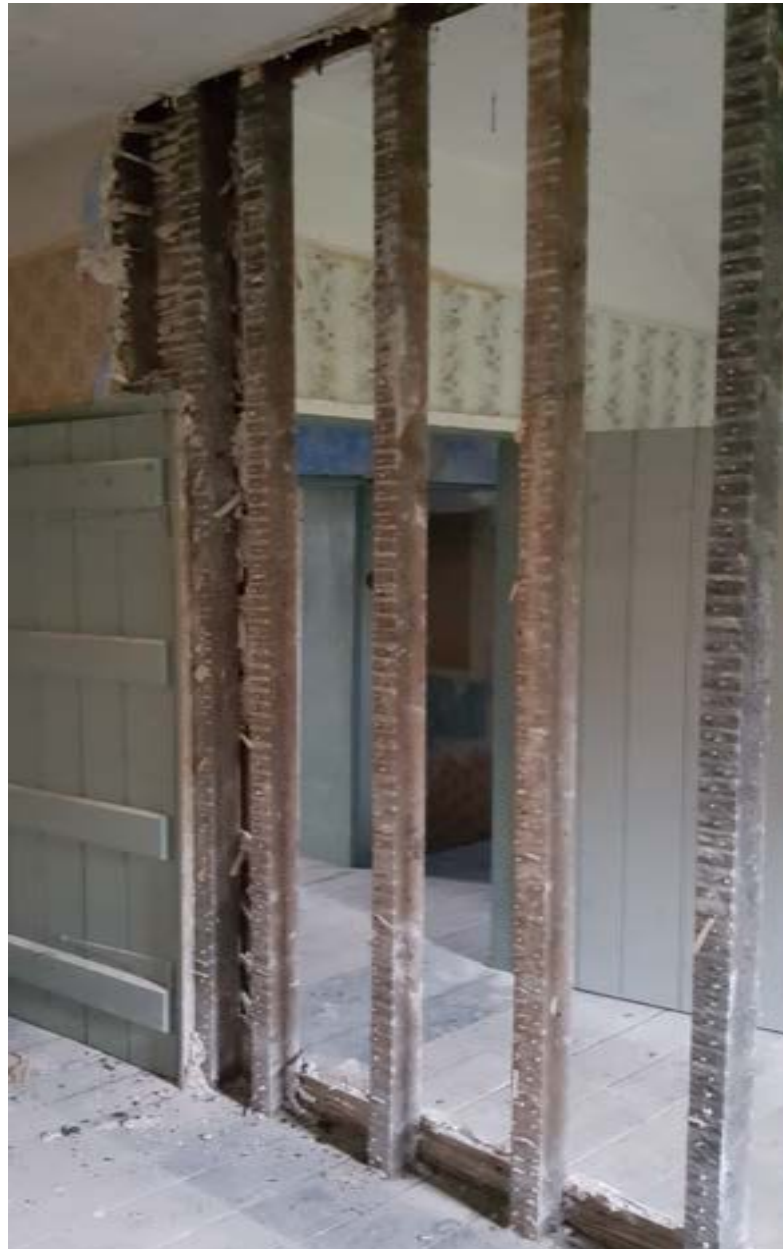
*Figure 18 - Photo showing the pre-existing form of the wall separating bedroom two from the bathroom. Photo taken from photographic survey discharged under P/2019/0904.*
