# Heritage Impact Assessment

Listed building consent for various refurbishment works

Moss Villa, Chapel Lane, Bronington, Whitchurch, SY13 3HR

April 2023

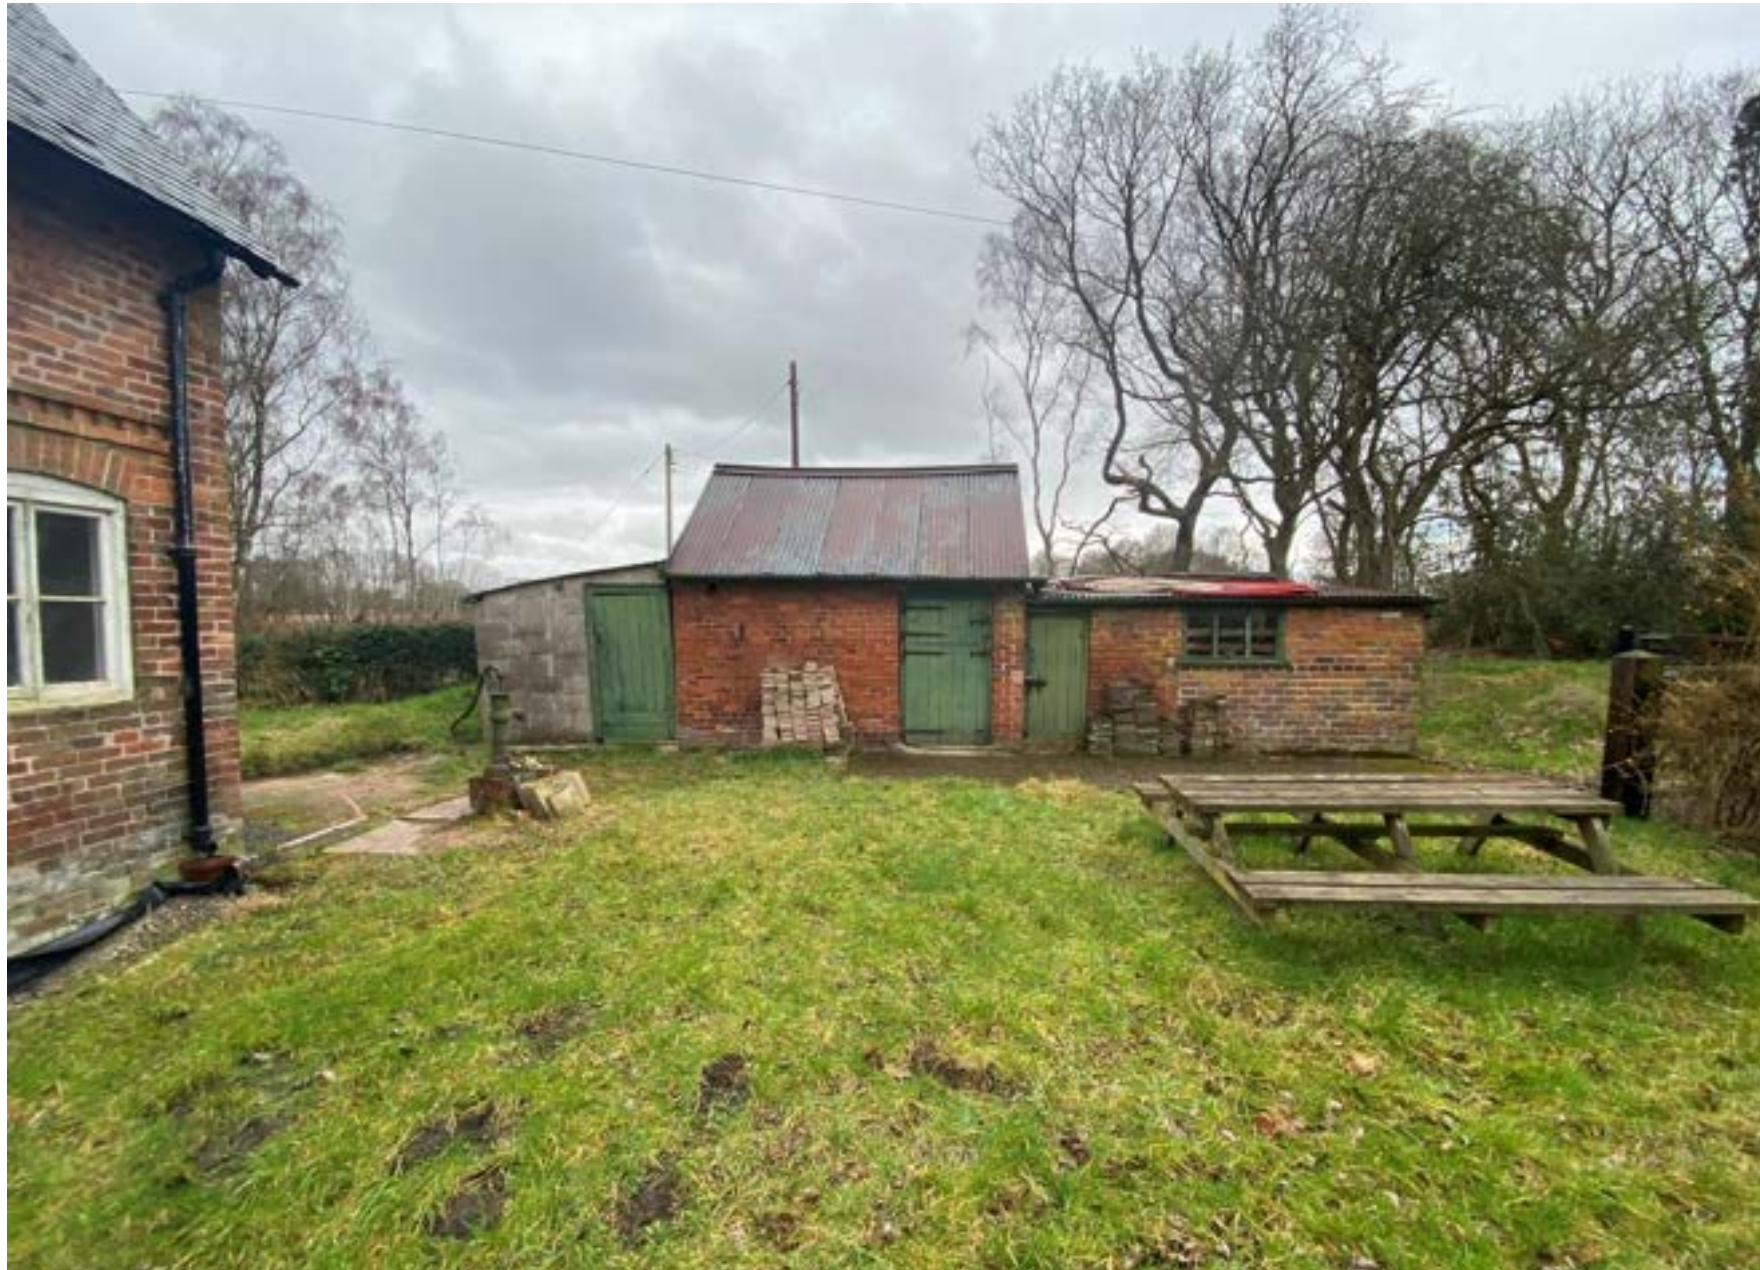
*Figure 19 - The most historically significant of the outbuildings. Map regression shows a structure in this area.*

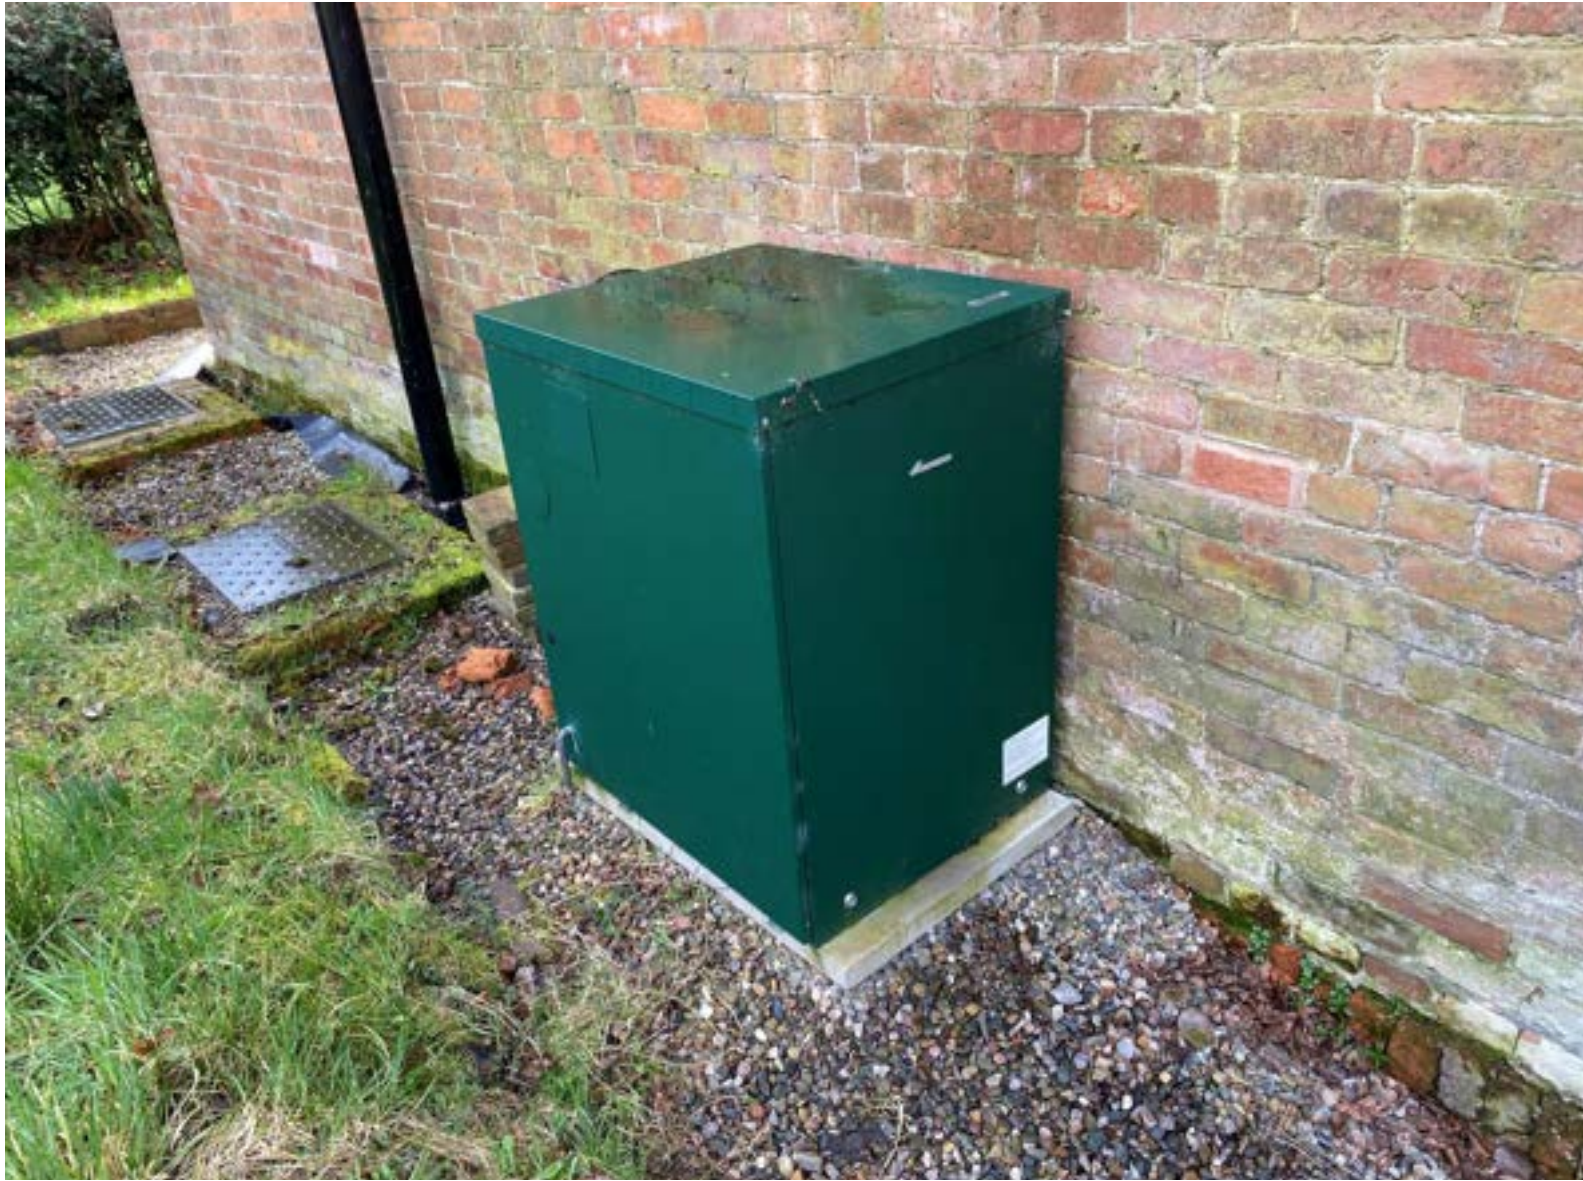
*Figure 23 - Unsympathetic oil boiler proposed for removal.*

| Works | Significance | Impact | Justification |
|---|---|---|---|
| Removal of oil boiler | Negative | Positive | The boiler design is unsympathetic to the rural historic character of the Site. Removal will be a positive improvement for the Site. |

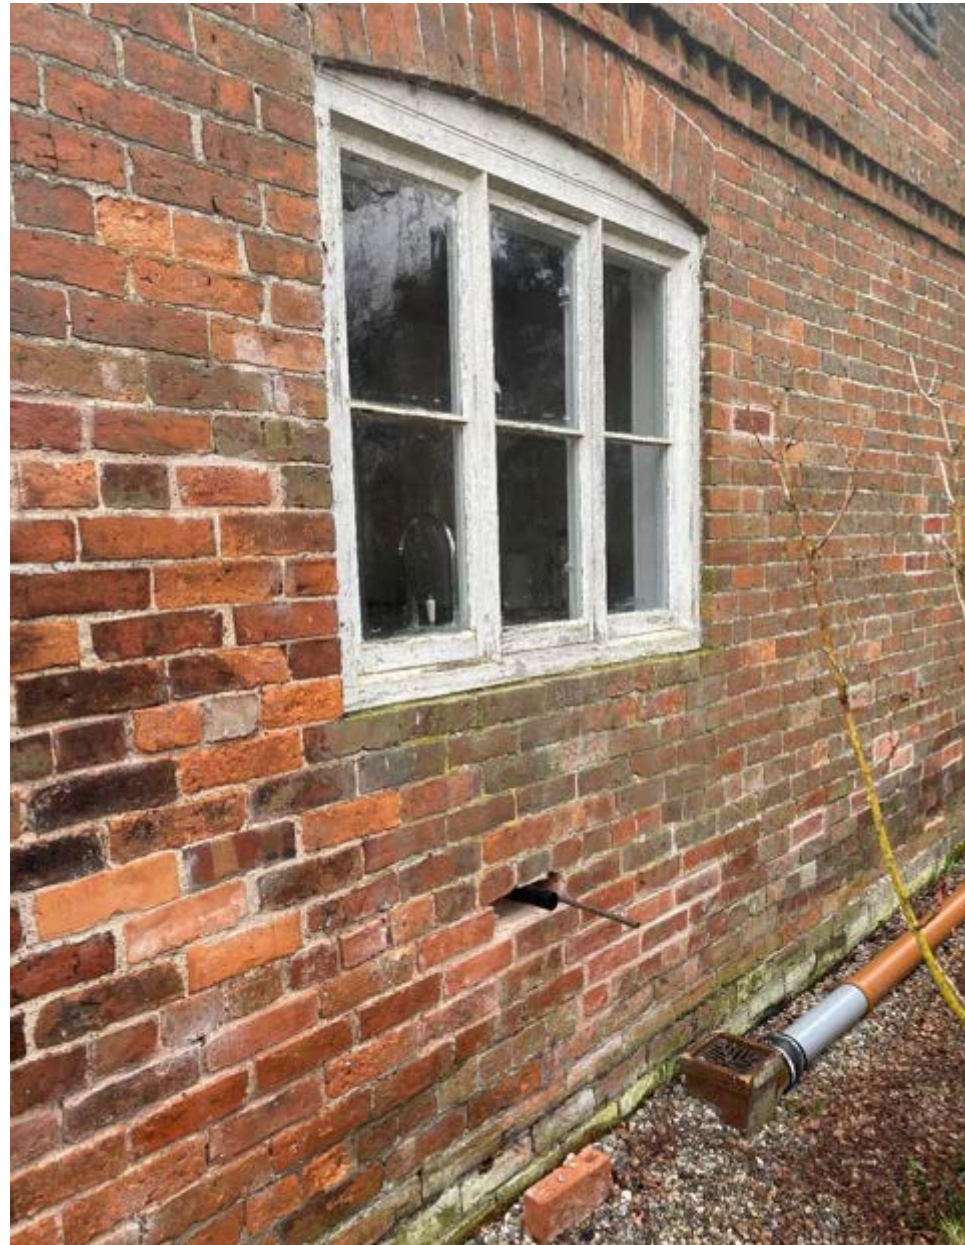
*Figure 24 - Removal of brickwork and installation of piping. Purpose is unknown.*

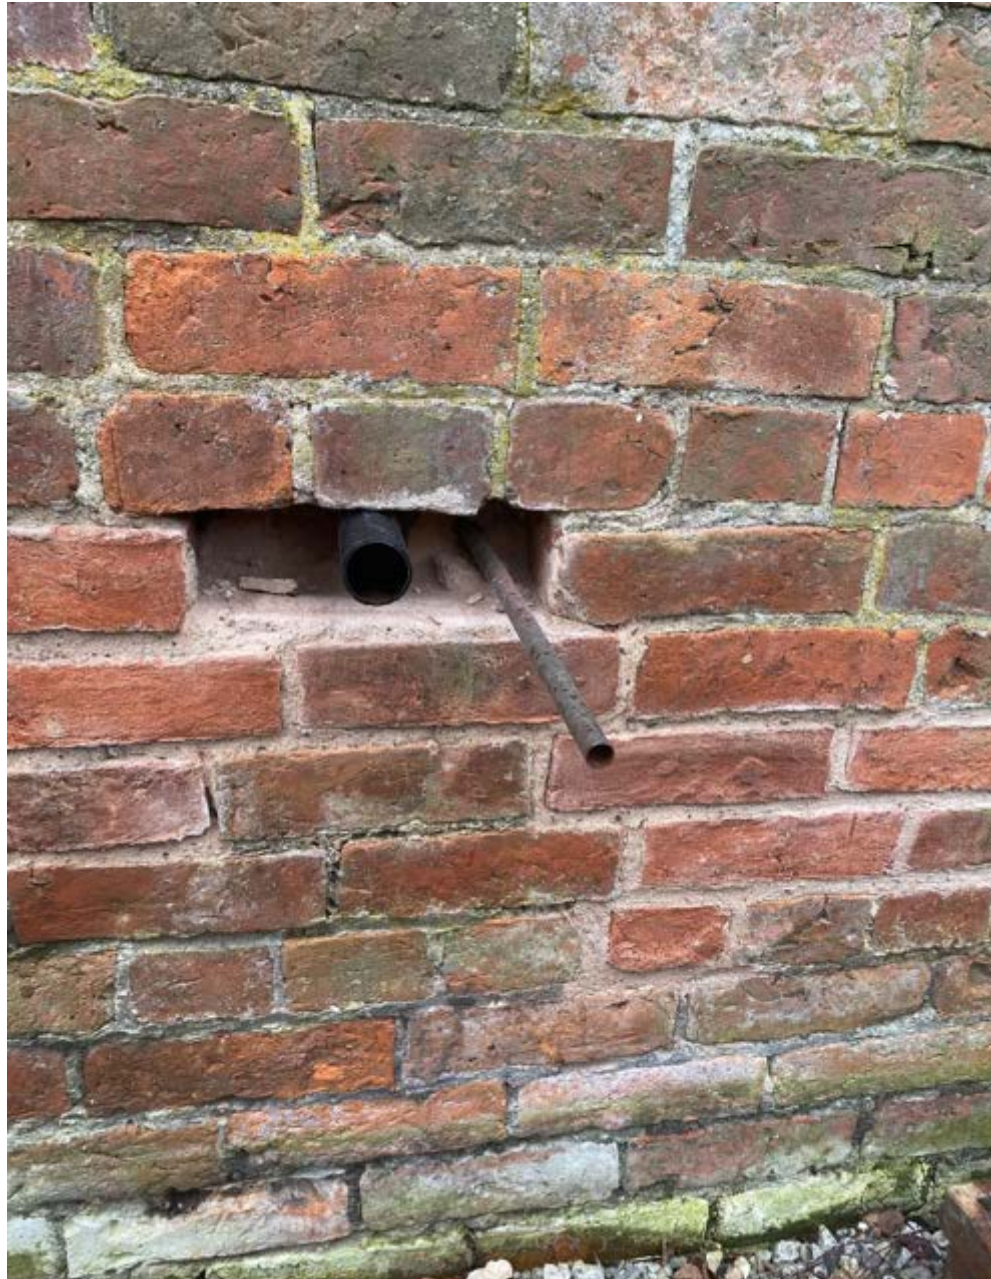
*Figure 25 – Closer view of the removed brick and installed piping.*

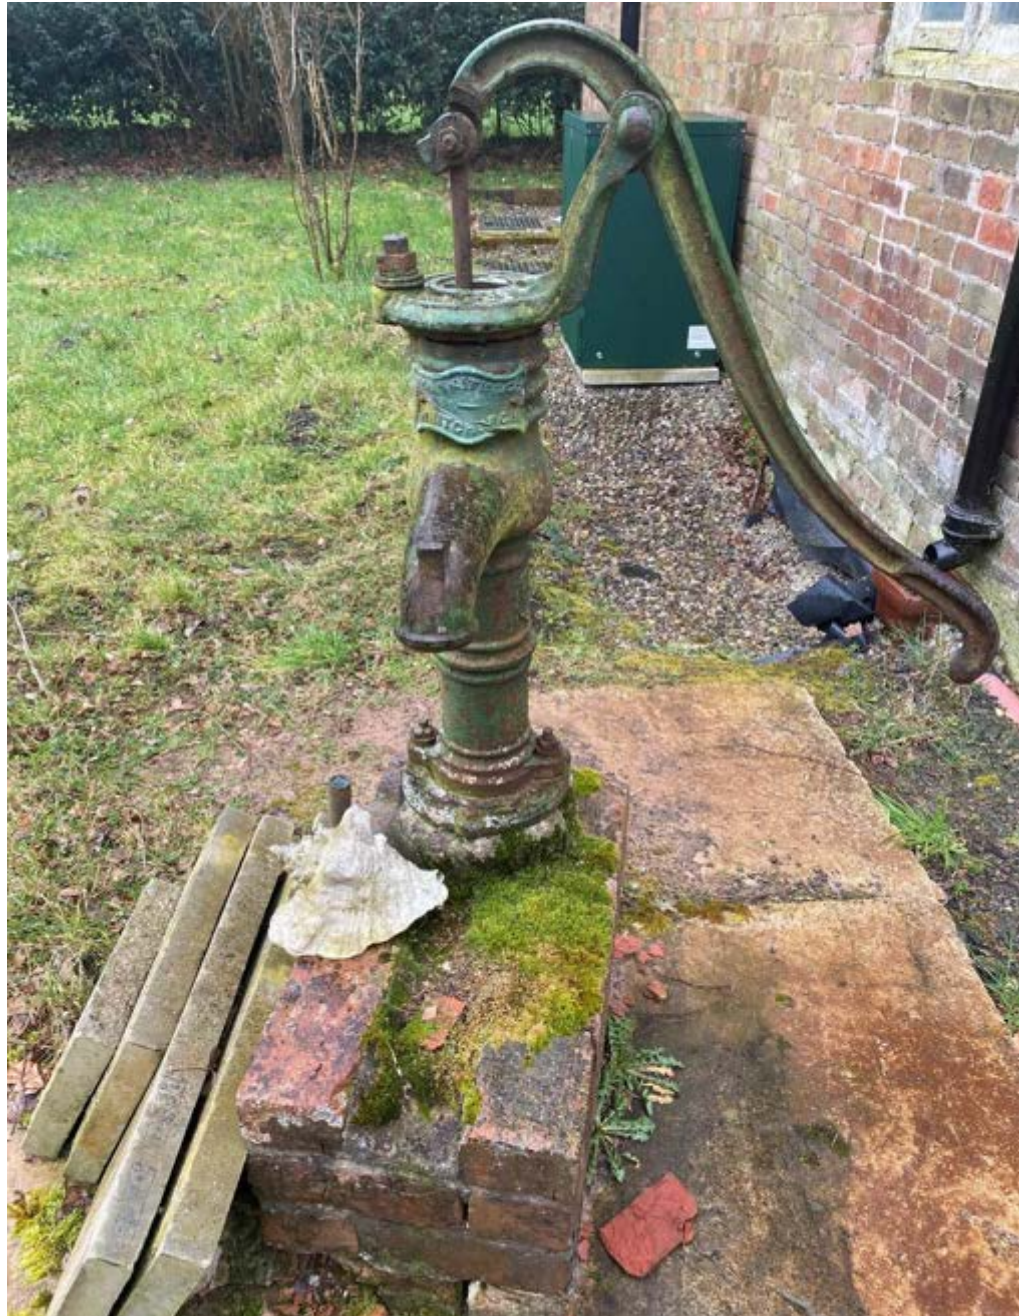
*Figure 26 - Historically interesting water pump within the Site curtilage.*
