## BRYMBO HERITAGE SITE MACHINE SHOP, PATTERN SHOP AND FOUNDRY AREA

# PRELIMINARY ROOST ASSESSMENT, EMERGENCE SURVEYS AND BIRD SURVEY

# Brymbo Heritage Site: Machine Shop, Pattern Shop and Foundry Area - Preliminary Roost Assessment, Emergence Survey and Bird Survey

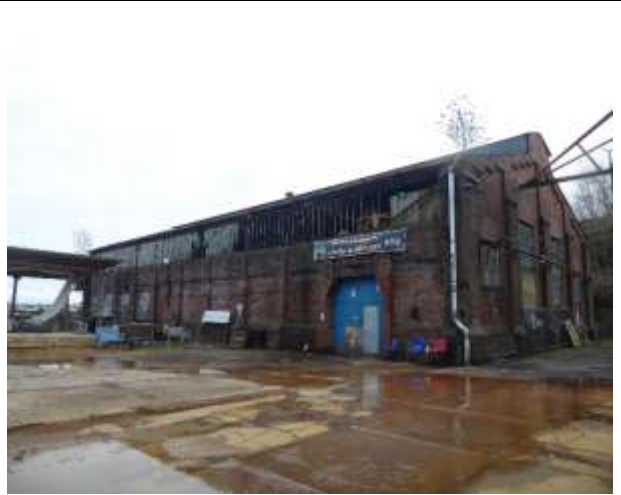
| Building Description | Photograph |
|---|---|
| <p><i>Machine Shop</i></p> <p>A large brick-built building, with a corrugated metal roof and large windows under the eaves, running the length of the building (Photo 4.1).</p> <p>Internally, it was open plan with some in-built meeting rooms, offices and toilets. It was open to the full height of the roof and had a lower ground floor level covering approximately one third of the building's footprint.</p> | <p><i>PHOTO 4.1. NORTHERN SIDE OF THE MACHINE SHOP.</i></p> |

- 5.1.1 The walls were in good condition and there were no cracks or crevices identified within the brickwork. Internally, it was very light and with a large number of window panes missing, there was a moderate airflow.
- 5.1.2 No bats or signs of bats were seen during the inspection.
- 5.1.3 Due to time of year, no active bird nests were present during the 2020 survey; a member of staff had observed swallows (*Hirundo rustica*) nesting high within the metal roof structure, but noted that the numbers had decreased over the last few years.

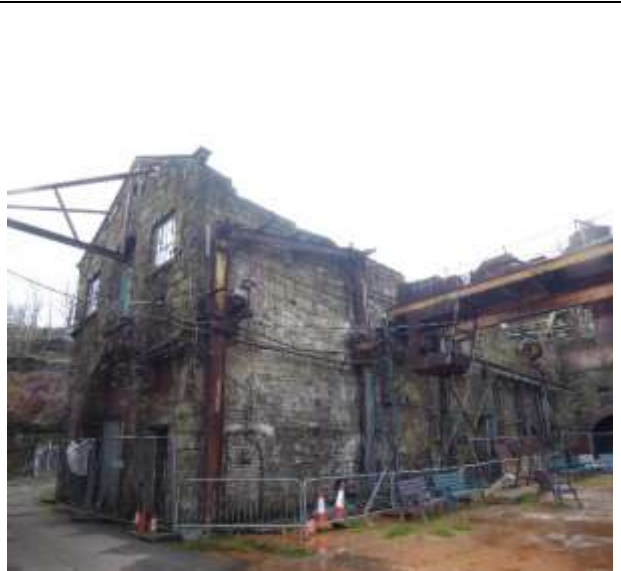
| Building Description | Photograph |
|---|---|
| <p><i>Pattern Shop</i></p> <p>A large two storey building, which had no roof (Photo 4.2). Along the northern external side of the building, at ground level, were four entrances. The first (eastern-most) was a doorway, which led into a ground floor room, which due to safety reasons, was not entered. Two entrances led into brick lined arched recesses, which were approximately five metres deep and three metres in height. One of the alcoves was bare brick and the other was clad in a foam like material (Photo 4.3). The fourth entrance (western-most) led to a mine adit (Photo 4.4). The tunnel was approximately one metre high by one metre wide, and the length is unknown.</p> | <p><i>PHOTO 4.2. NORTHERN SIDE OF THE PATTERN SHOP.</i></p> |

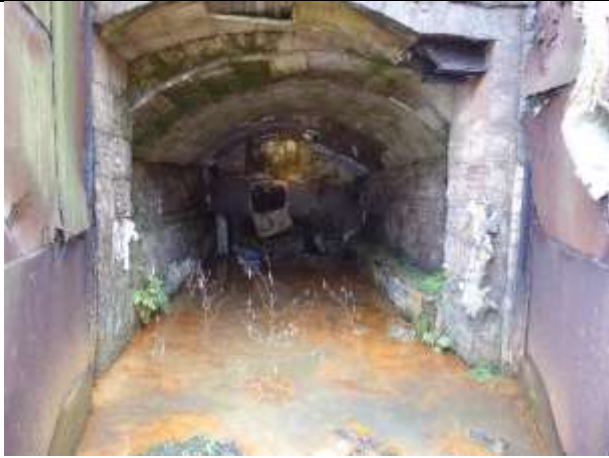
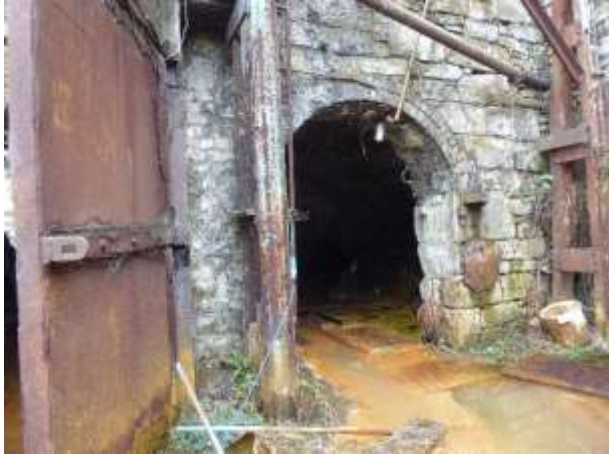
| | <p><i>PHOTO 4.3. ARCHED RECESS CLAD WITH FOAM-LIKE MATERIAL.</i></p> <p><i>PHOTO 4.4. MINE ADIT ENTRANCE.</i></p> |

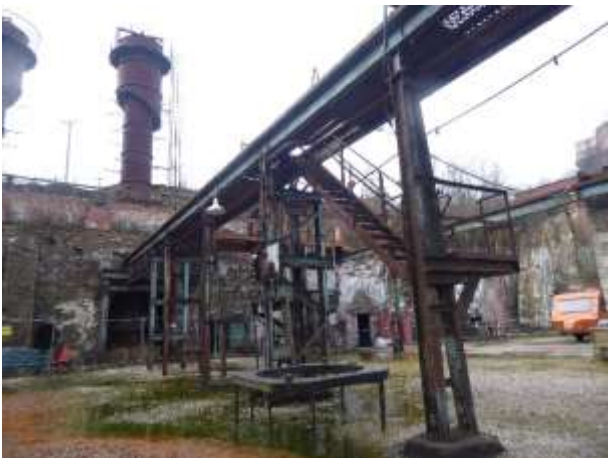
| <p><i>Foundry Area</i></p> <p>This former foundry comprised a rear wall (Photo 4.5), blast furnace to the north and a front wall to the east (Photo 4.6).</p> <p>The walls were predominantly unrendered stone with brick supports and some entrances had been bricked up. There were three open recesses along the back wall. Two housed the cupola furnaces and were tall open spaces with large open entranceways (Photo 4.7). Another recess was accessed through an open doorway and</p> | <p><i>PHOTO 4.5. REAR WALL.</i></p> |

led to a small stone- and brick-lined room with a low arched roof.

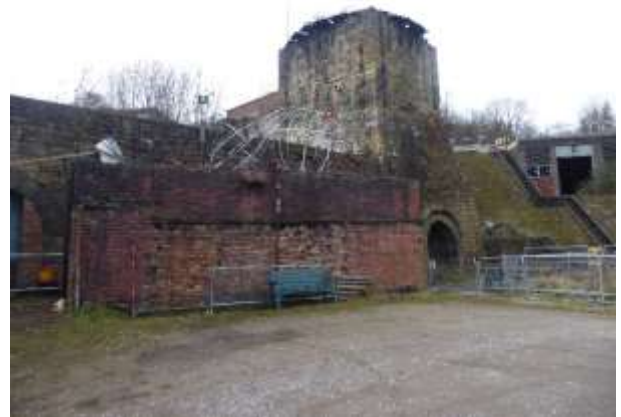
*PHOTO 4.6. FRONT WALL AND BLAST FURNACE.*

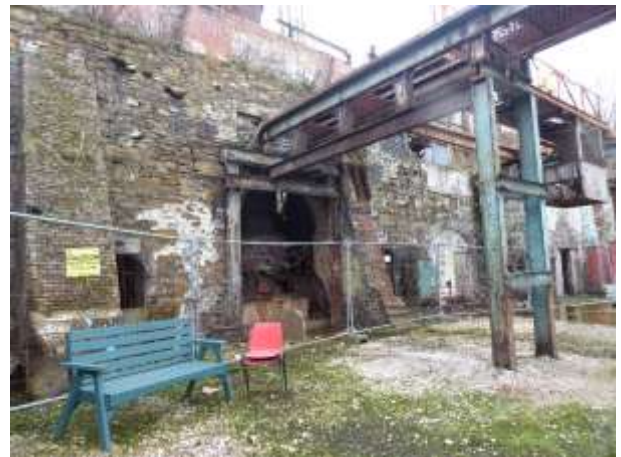
*PHOTO 4.7. CUPOLA FURNACE.*

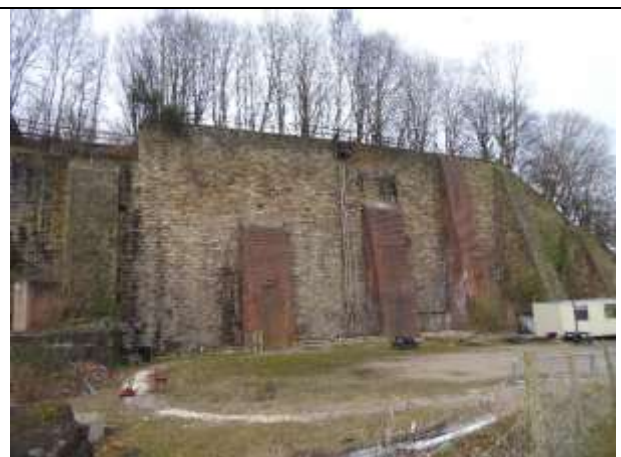
Along the northern side of the site there was a large stone retaining wall with brick supports.

*PHOTO 4.8. RETAINING WALL.*

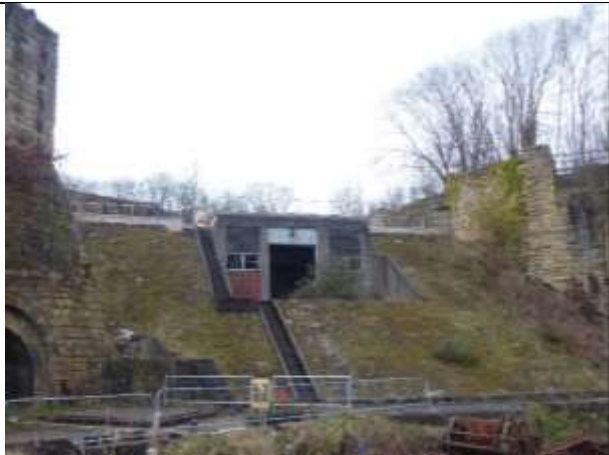
There was a small concrete, flat roofed building in the north-western corner of the site, which was built into the slope.

*PHOTO 4.9 SMALL BUILDING.*

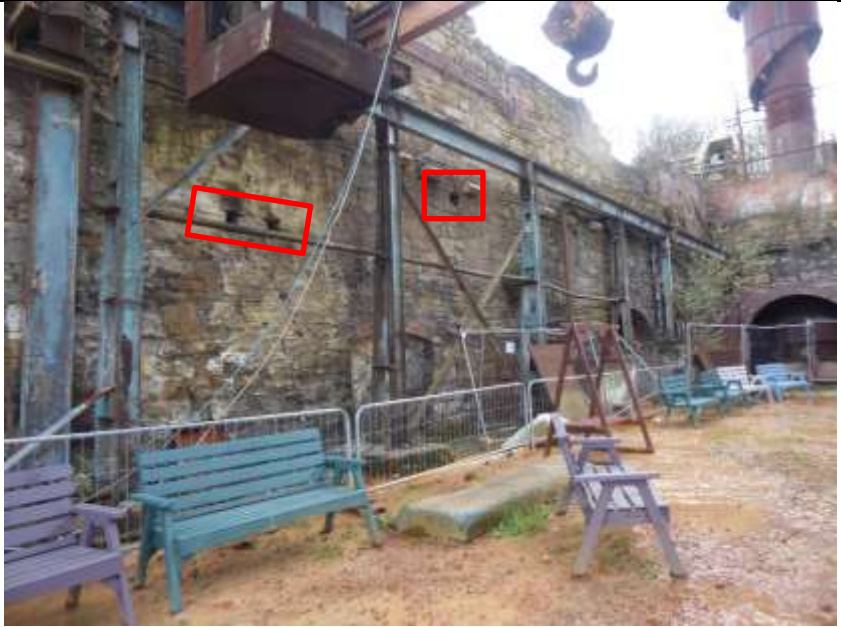
- 5.2.1 In places the stone work was in a poor condition, with many large holes, cracks and crevices, where mortar was missing. The ground floor room, appeared to be relatively large, with low light levels, and with the open doorway, the airflow was likely to be low to moderate. The brick- and foam-lined recesses were light and draughty and did not look to have any cracks or crevices within the walls. The mine adit was dark as it went further in and the airflow was low.
- 5.2.2 No bats or signs of bats were seen during the inspection.
- 5.2.3 Due to time of year, no active bird nests were present and no past nests were observed during the original surveys. There were many gaps and crevices within the stone work, which would be suitable for nesting birds. A bird (species not identified) was observed entering a hole at the base of the southern chimney during the 2023 emergence survey.

| Building/<br>Area | Description<br>of Potential<br>Roosting<br>Features | Photograph |
|---|---|---|
| <i>Pattern Shop</i> | Crevices and cracks within stone work | <p><i>PHOTO 5.1. NORTHERN WALL OF PATTERN SHOP.</i></p> |

- It is recommended that the swift boxes on the northern wall of the Pattern Shop are taken down before nesting season, which is March to September (inclusive) and put back up once the works are complete.

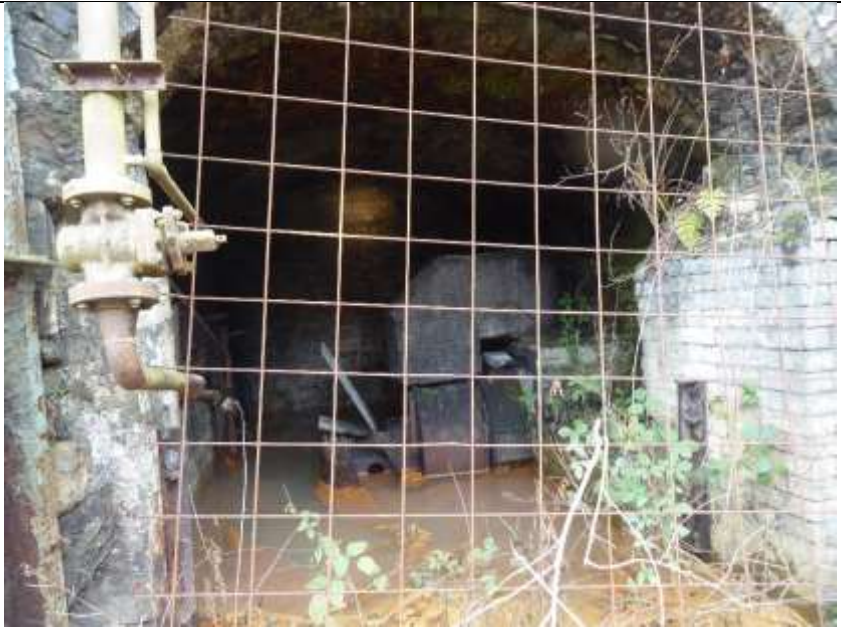
| Building/<br>Area | Description<br>of Potential<br>Roosting<br>Features | Photograph |
|---|---|---|
| <i>Pattern Shop</i> | Brick-lined recess | <p><i>PHOTO 5.2. BRICK-LINED RECESS.</i></p> |

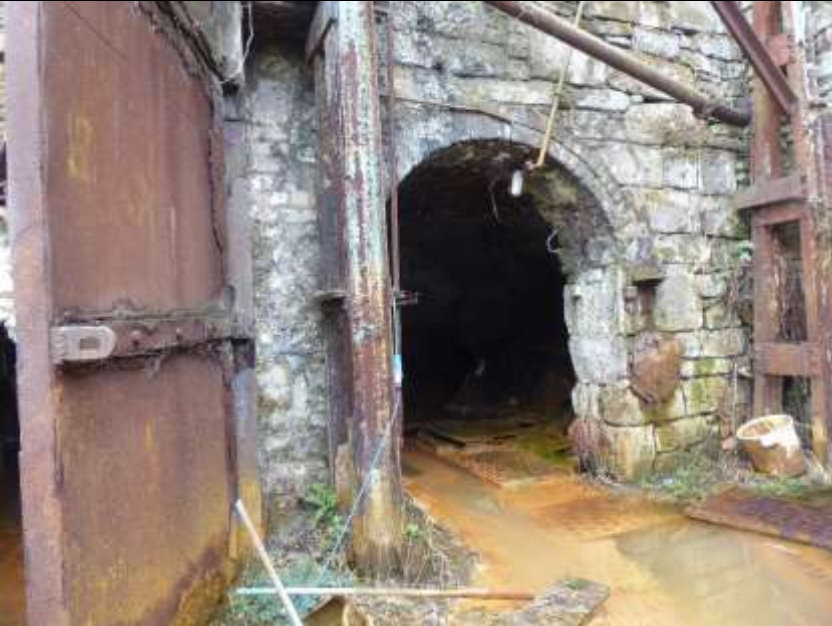
| <p><i>Pattern Shop</i></p> | <p>Mine adit entrance within the north-western corner of the Pattern Shop, leading out into the Foundry Area</p> | <p><i>PHOTO 5.3. MINE ADIT ENTRANCE.</i></p> |

- 8.1.11 The licence will include details regarding the construction works and also public access to areas nearby and additional lighting. The licence will also cover any changes to the mine adit or mine entrance including fitting a grill which will prevent human disturbance in the adit area, and a door with an opening suitable for lesser horseshoes on the recess. It is important that the environmental conditions are kept as unaltered as possible (including temperature, humidity and air flow) to both the recess and the adit. Grilles to protect sites (usually underground site) allow free access for bats but limit human access – grilles are usually made of horizontal bars with a 150mm gap and vertical bars spaced at between 450 and 750mm (Bat Conservation Trust, 2007).

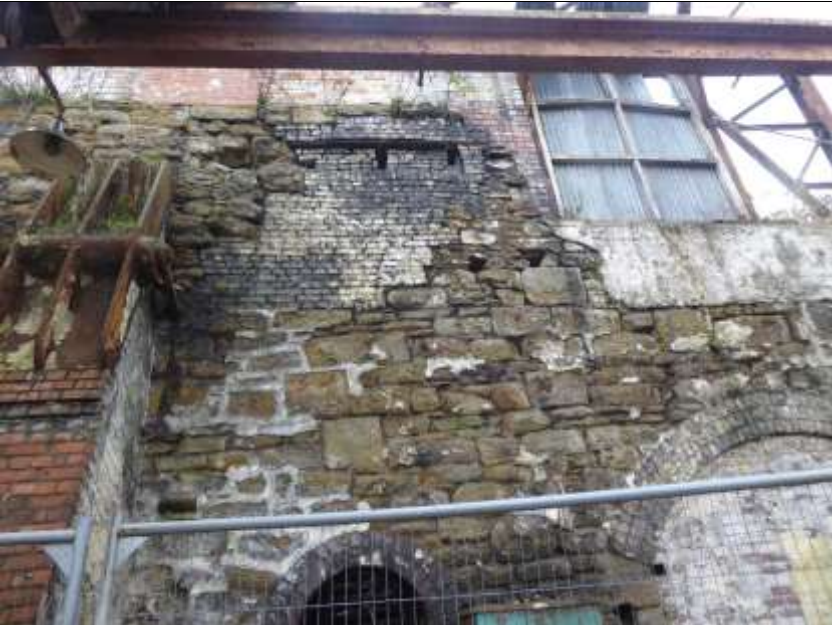
- 5.3.1 There were many large cracks and crevices within the walls throughout the Foundry Area. Along the back wall, the two recesses with the cupola furnaces were darker within the higher areas but in general had moderate light and airflow levels. The small stone- and brick-lined room had many crevices within the stone work, some of which were deep. The light levels and airflow were moderate.
- 5.3.2 No bats or signs of bats were seen during the initial PRA, however during the emergence survey visits in 2020 a lesser horseshoe was observed hanging up in one of the recesses and a small number of lesser horseshoe droppings were present in one of the recesses (which had a door on).

| <p><i>Foundry Area</i></p> | <p>Crevices and cracks within stone and brick work</p> | <p><i>PHOTO 5.4. WESTERN BACK WALL.</i></p> |

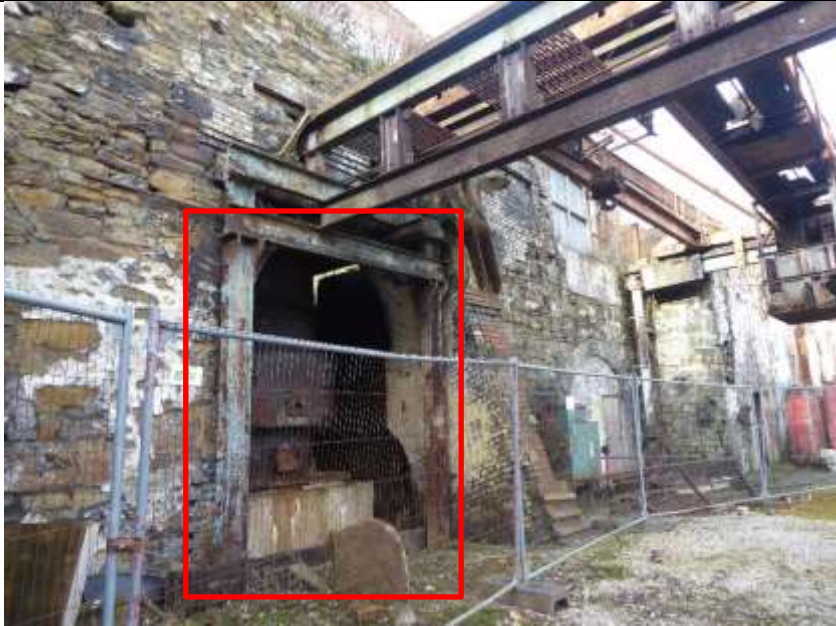
| <i>Foundry Area</i> | Cupola furnaces | |

*PHOTO 5.5. CUPOLA FURNACE.*

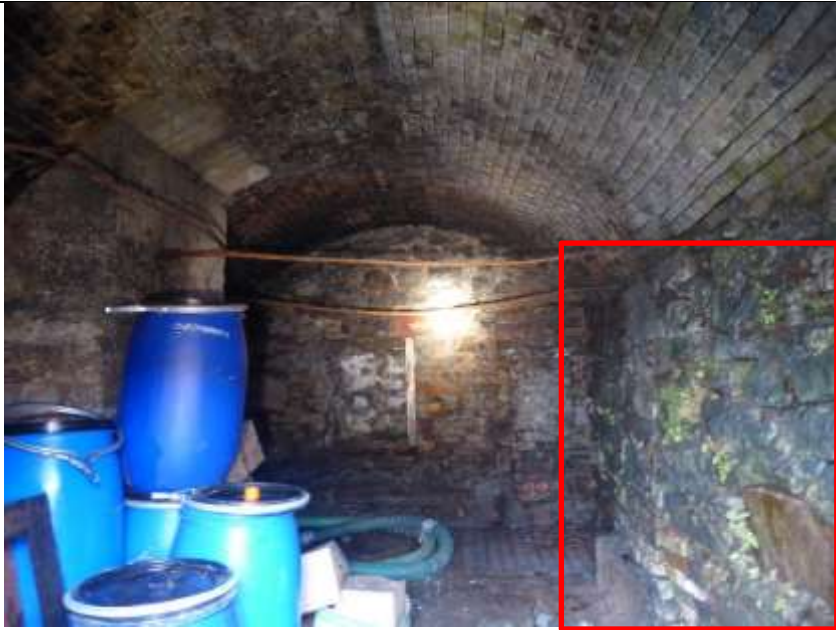
| <i>Foundry Area</i> | Small stone- and brick-lined room with deep crevices within the stone wall. | |

*PHOTO 5.6. SMALL STONE AND BRICK-LINED ROOM.*

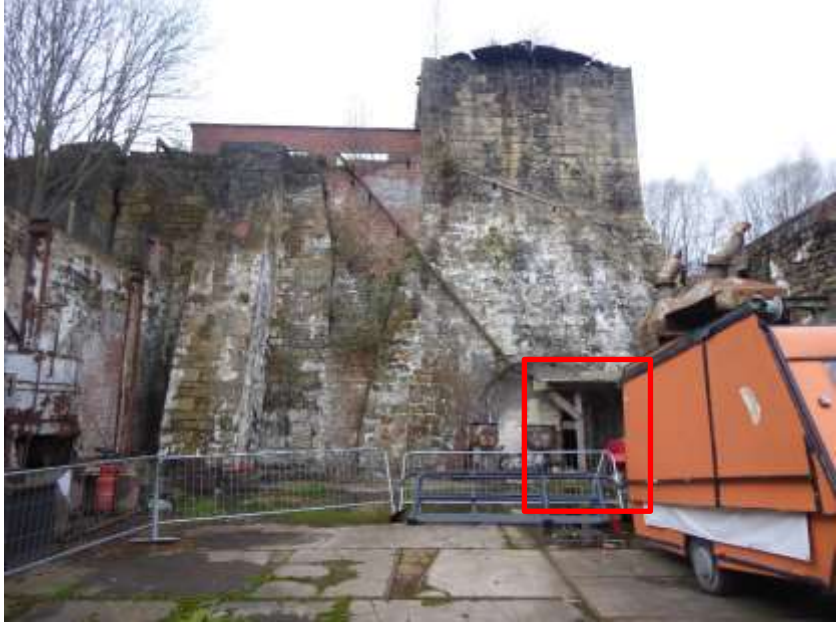
| <i>Foundry Area</i> | Bat droppings on barrels in store room | <p><i>PHOTO 5.7. STORE ROOM WITH DROPPINGS.</i></p> |

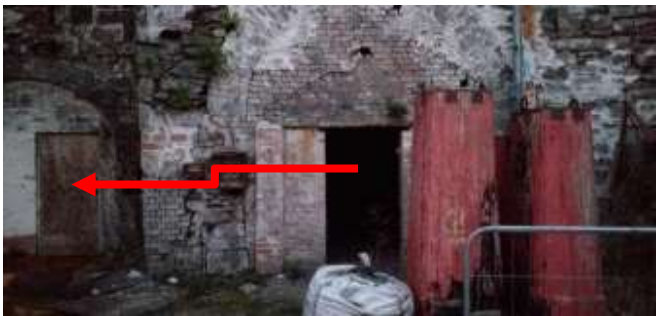
| Time | Species | Comments | |
|---|---|---|---|
| 21:12 | Lesser horseshoe | Emerged through an open doorway into the recess | |

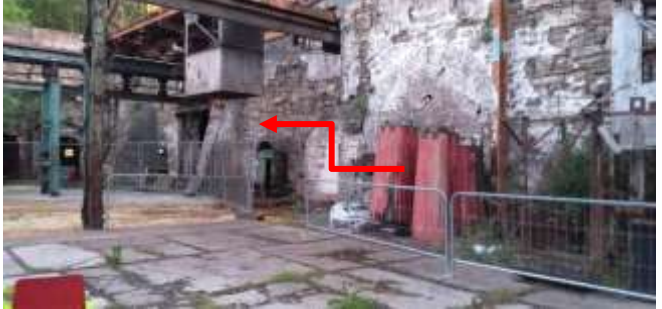
| Time | Species | Comments | |
|---|---|---|---|
| 21:17 | Lesser horseshoe | Emerged through an open doorway into the recess | |

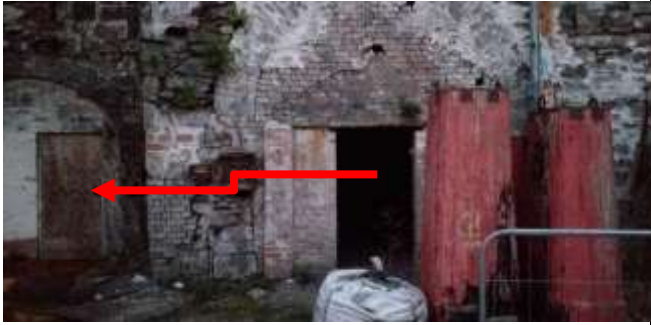
| Time | Species | Comments | |
|---|---|---|---|
| 22:04 | Lesser horseshoe | Emerged through an open doorway into the recess. It was observed hanging up inside prior to the start of the survey | |

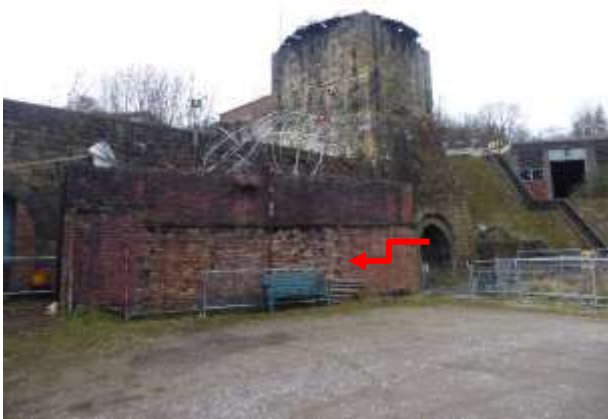
| Time | Species | Comments | |
|---|---|---|---|
| 22:15;<br>22:18;<br>22:20 | Lesser horseshoe | Emerged and re-entered the blast furnace, emerged again a few minutes later. Observed flying in and out of the furnace entrance again after a few minutes. | |

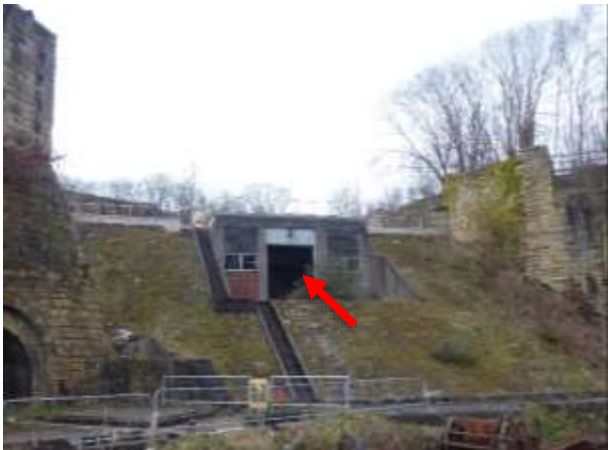
| Time | Species | Comments | |
|---|---|---|---|
| 22:36 | Brown long-eared | A brown long-eared bat was observed flying around inside the small building and entering openings in the walls. | |
