Dwg Title  
**Proposed demolition of existing outriggers and alterations and extension Existing Dwelling**

Project  
**The Old Croft (Formerly The Long Croft) Green Street Holt**

Drawing Number  
**680 PL10**

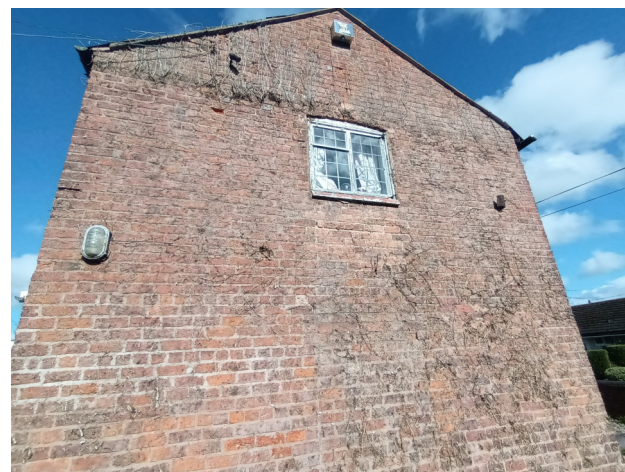
Existing Gable to be raked and epointed to agreed specification.

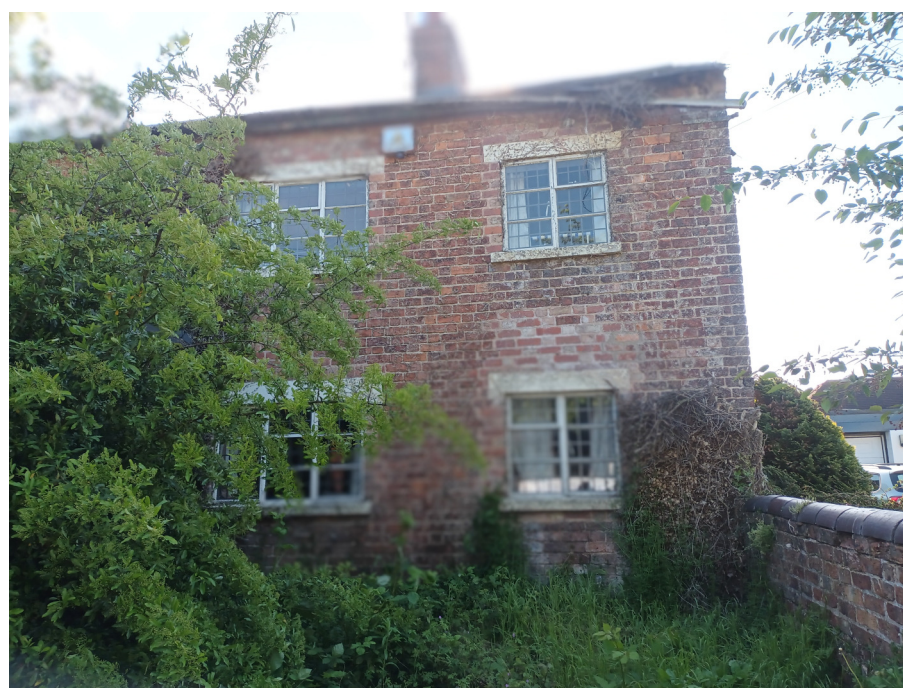
End Front Elevation Showing varying brickwork

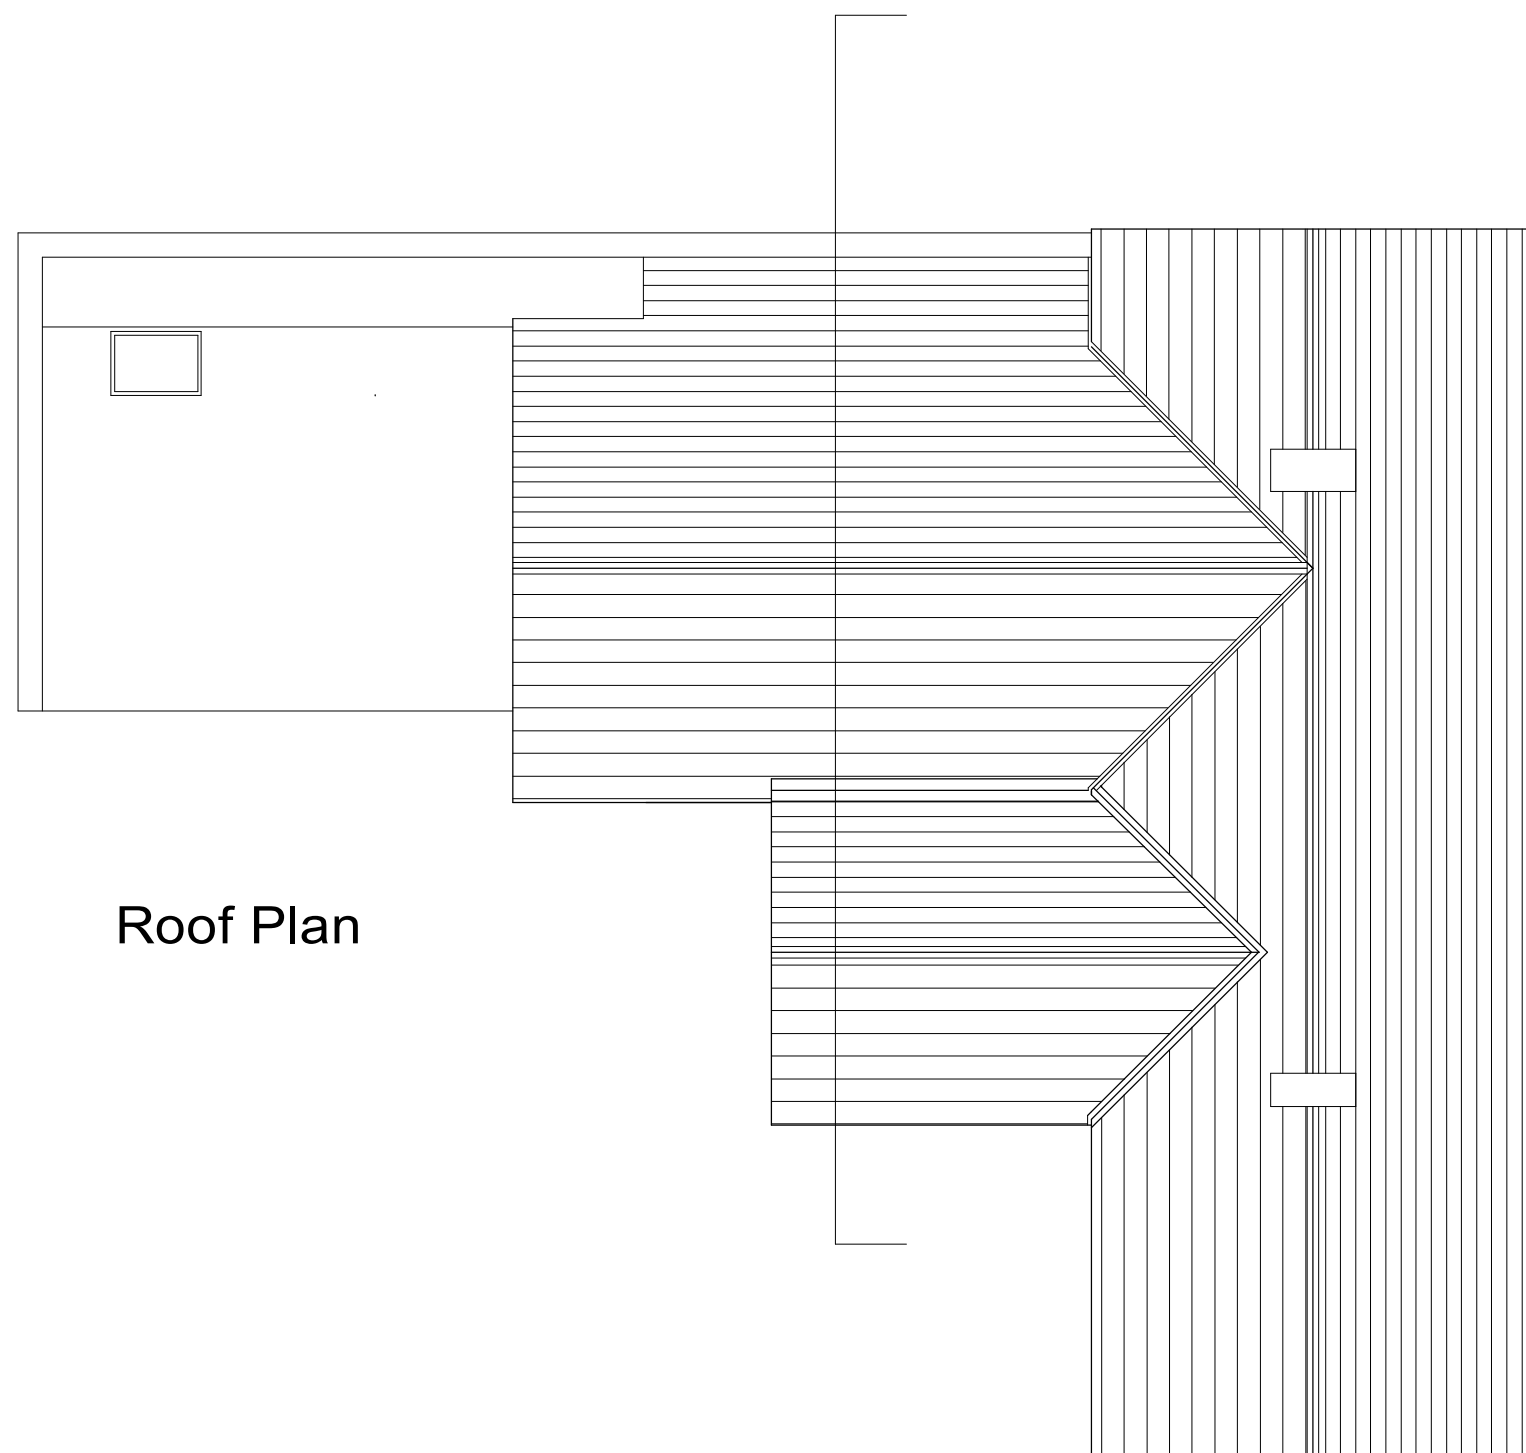
Roof Plan

**Existing Roof - Remedial Works**  
Strip off existing slate roof on store for re-use. Assume 50% loss due to breakages and damaged slates. Strip off existing battens and any underlay, recover with Vent 3 Breathable Underlay and re-batten with 50 x 25mm treated battens, re-slate to match existing with existing slates to one plane. Supply and fix new slates to match existing to remaining planes. Assume Welsh Slates to match existing. Repair and replace damaged or decayed rafters to match existing and instigate repairs to existing supporting structure subsequent to site inspection once exposed.
