## **Outbuilding at Willington Lodge, Wrexham, SY13 3BZ.**

*On behalf of CB Homes*

### **Bat Activity Survey Report**

Report number: WILL-02/23

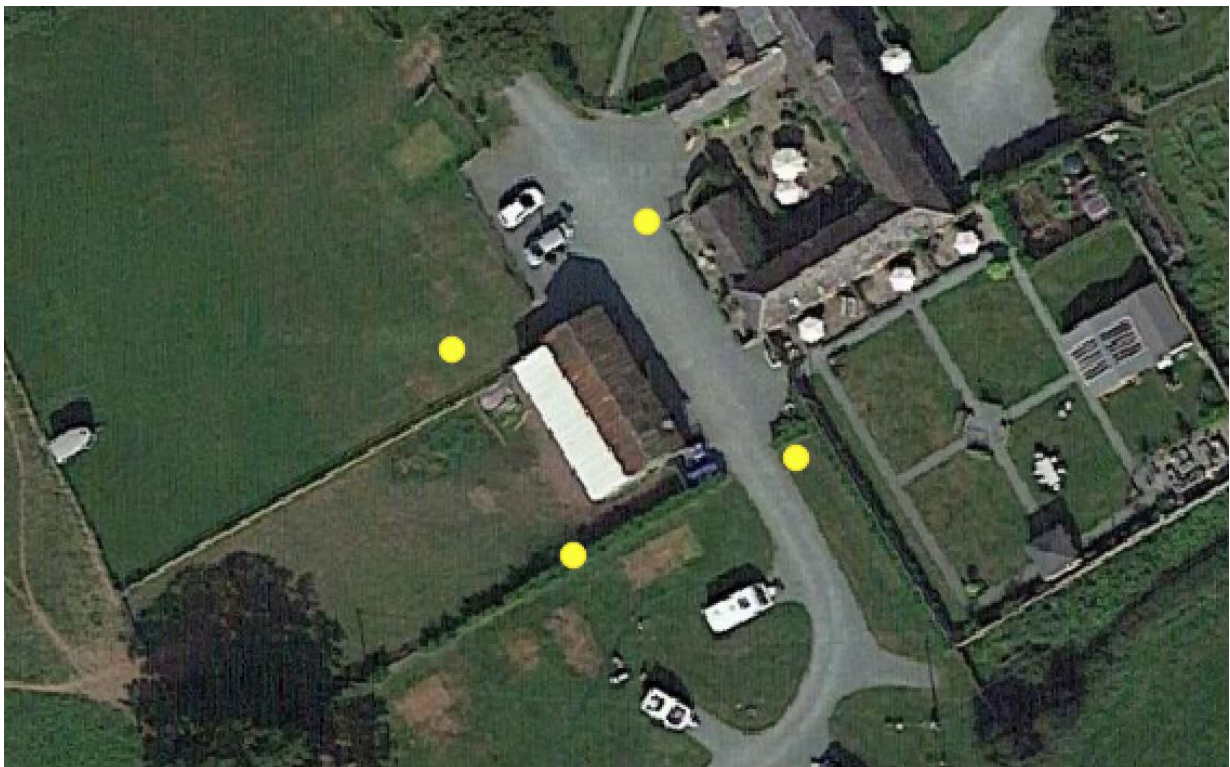
**Figure 1** - Surveyor Positions.

The surveyors used Wildlife Acoustics Echometer/IPAD 4 and EMT pro bat detectors to record the echolocations of active bats. The surveyors were positioned as shown in *figure 1*, to ensure full coverage of the building, in order to view the elevation, and roof, and gain full coverage simultaneously.

The surveyors were positioned at each corner of the building in order to view the elevation, and roof, and gain full coverage simultaneously (see surveyor location plan below).

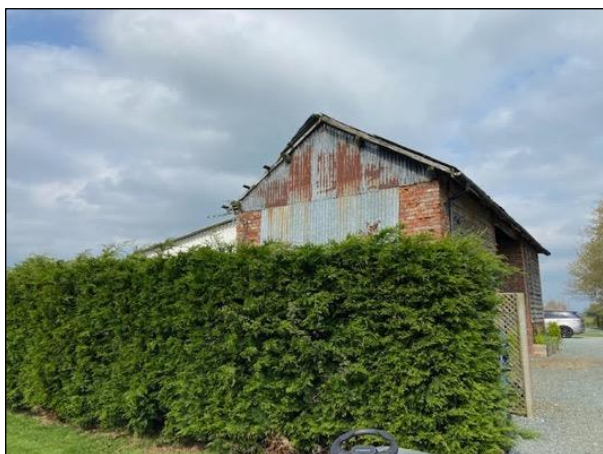
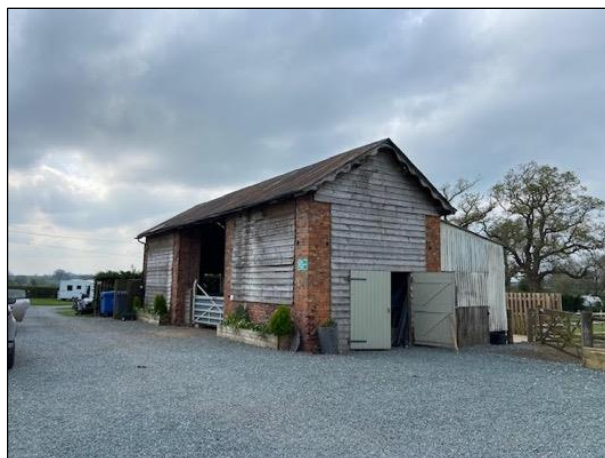
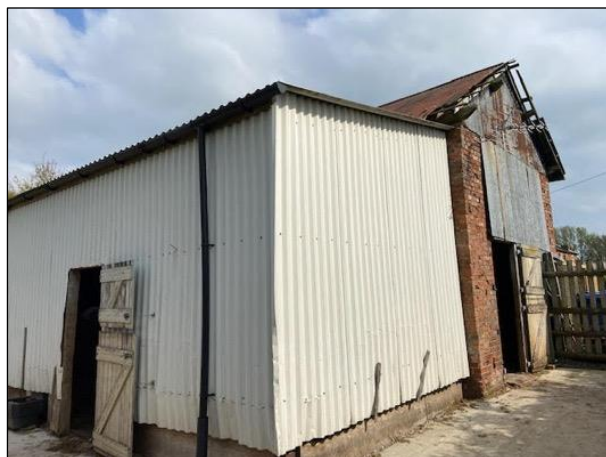
| Species | Emerged Y/N | First Registration | Approximate Number | Comments |
|---|---|---|---|---|
| Soprano pipistrelle | No | 22:15 | 1 | Seen entering the barn to forage. Constant foraging activity noted within the barn. |
| Common pipistrelle | No | 22:19 | 1 | Seen entering the barn to forage. Constant foraging activity noted within the barn. |

| | Foraging within subject building (mitigation required) |
| | Foraging in vicinity of subject building only (no action required) |
