**Erbistock Mill, Erbistock, Wrexham**  
**Further Bat Dusk Survey**

**8<sup>th</sup> July 2023**

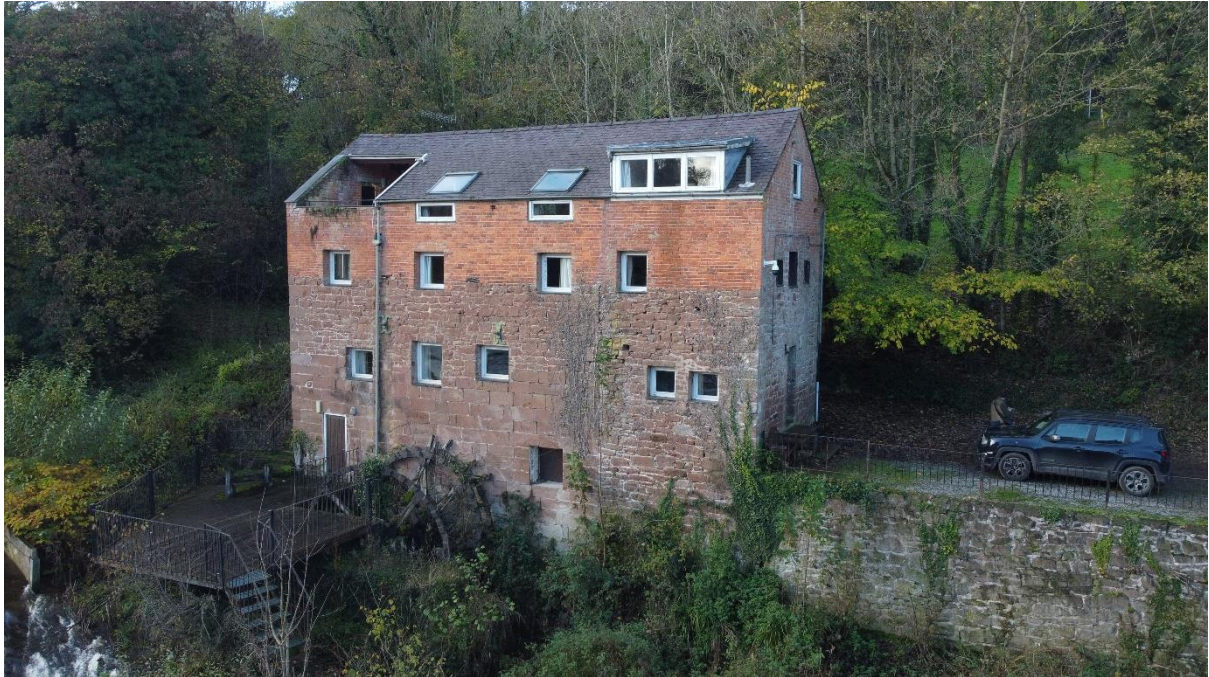
The study site comprises of Erbistock Mill which is a converted water mill building. The building is considered of pre-20<sup>th</sup> century origin. The building is located immediately adjacent to a weir on the River Dee.

*Photograph 1- View of Mill Building*

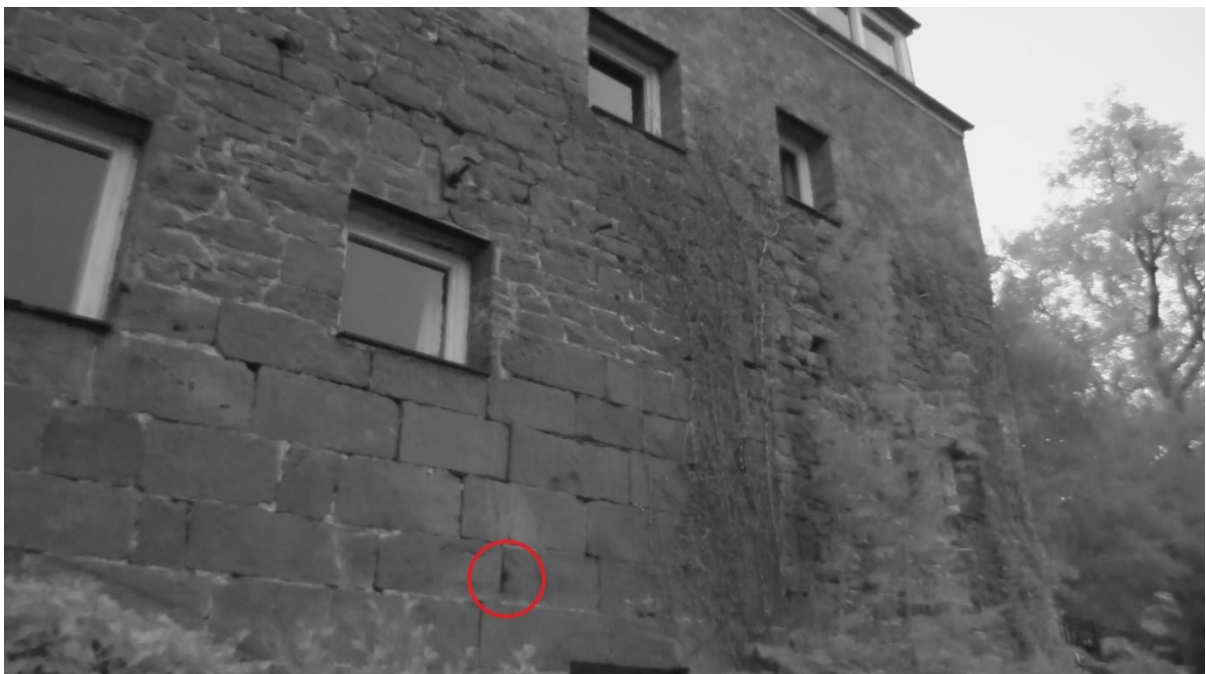
The first soprano pipistrelle bat was observed emerging from a crevice at Target Note 1 (see Figures 1 and 2) at 21:29, a second bat was identified emerging from the same crevice three minutes later at 21:32. A third soprano pipistrelle was observed flying into a further wall crevice (Target Note 2) at 21:35 and re-emerged at 21:40. No other roosting bats were identified.

*Photograph 1- Bat Roost 1 (circled)*

If any bats are observed to be present in areas of affected building, these will be carefully captured by the licensed bat worker where possible and moved to the receptor site. Where bats cannot be safely removed from the stonework, the bat roosting feature would be fitted with a bat valve for at least one week prior to works continuing in the relevant location.

The bat valve will allow animals to escape the feature but will not allow them to re-enter any crevices. The bat valve should remain in place until the licensed bat worker is satisfied that no bats remain within the potential roosting feature. Once they are satisfied the feature can be blocked/re-mortared.

New gaps and crevices between the sandstone blocks will be created where any re-mortaring of the mill is to take place. This will be achieved by inserting wooden battens (2cm x 5cm in cross-section) into the wet mortar and removing these before the mortar sets to create suitable roosting crevices and bat access into the existing stone walls.

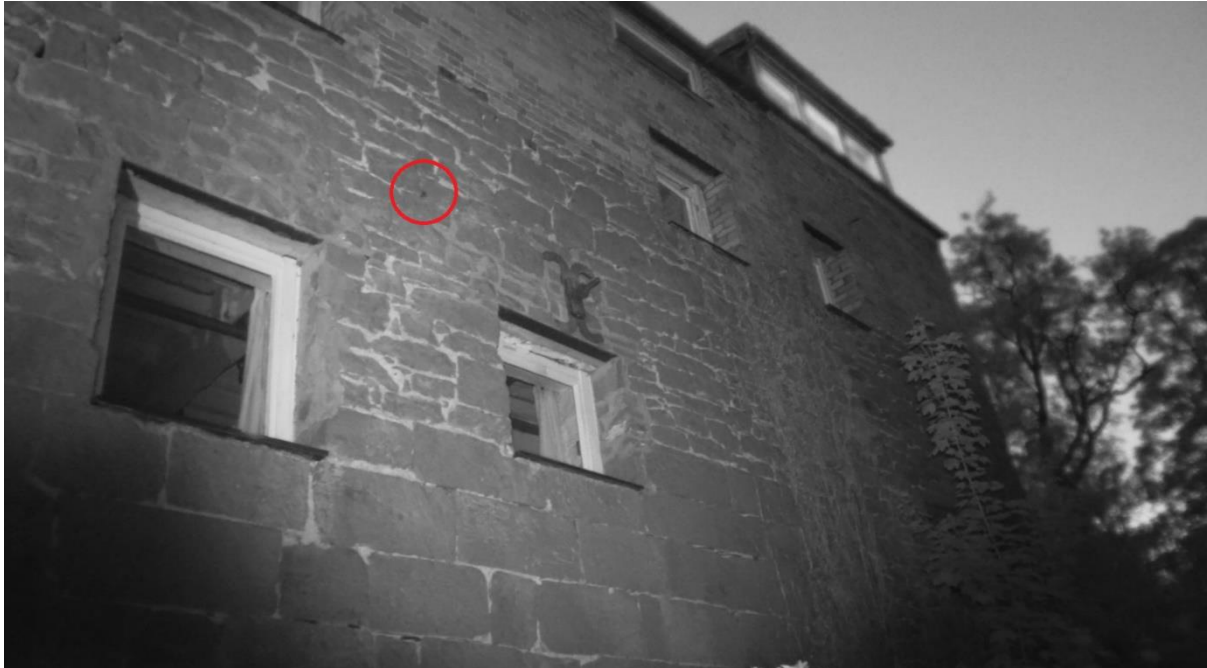
*Photograph 2- Bat Roost 2 (circled)*

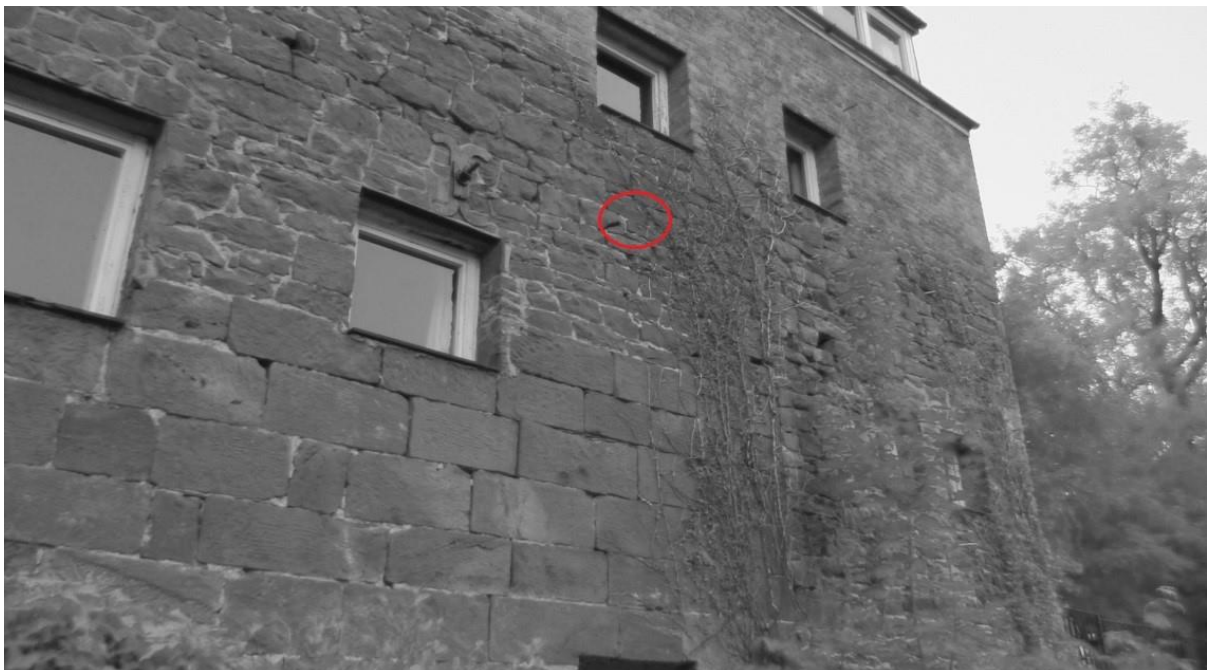
In summary, two individual soprano pipistrelle bats were recorded roosting within crevices between sandstone blocks on the east facing elevation overlooking the river. The first soprano pipistrelle was observed emerging from a wall crevice at 21:34 (Target Note 3). The second pipistrelle was observed flying into a wall crevice at 22:07 (Target Note 4), the bat was not observed to emerge from the crevice. High levels of soprano pipistrelle bat activity were again recorded throughout survey. This included bats foraging on the adjacent River Dee and also along adjacent woodland edge habitats.

*Photograph 3- Bat Roost 3 (circled)*

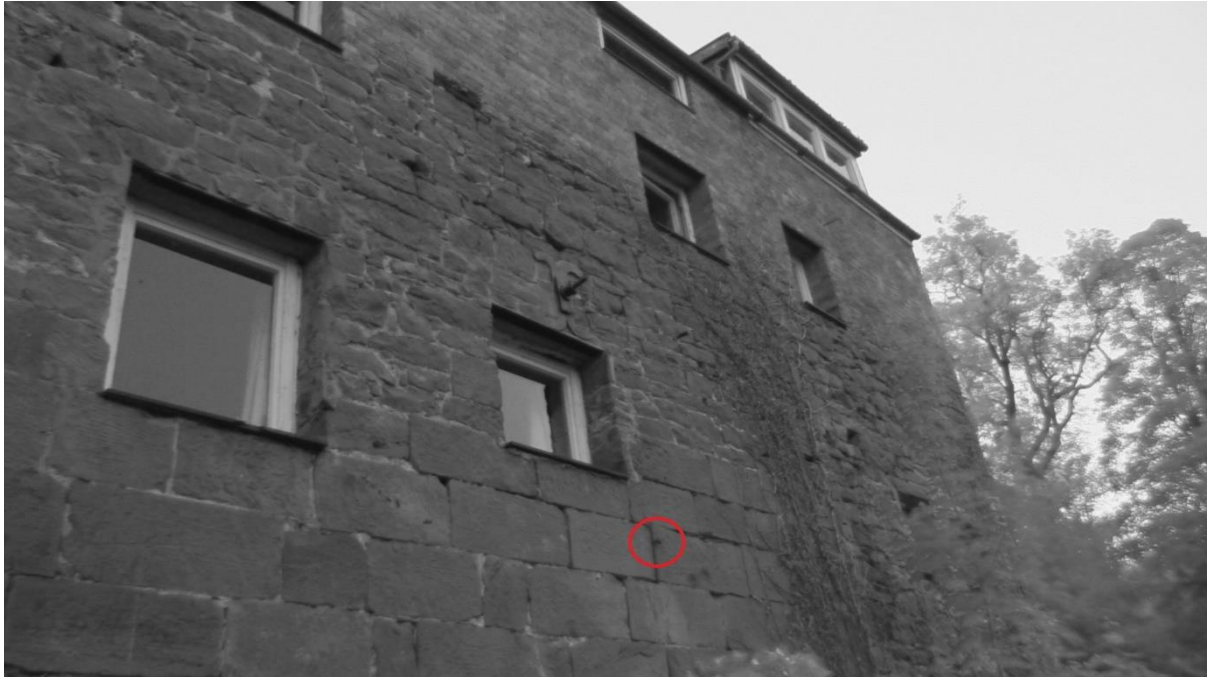
*Photograph 4- Bat Roost 4 (circled)*

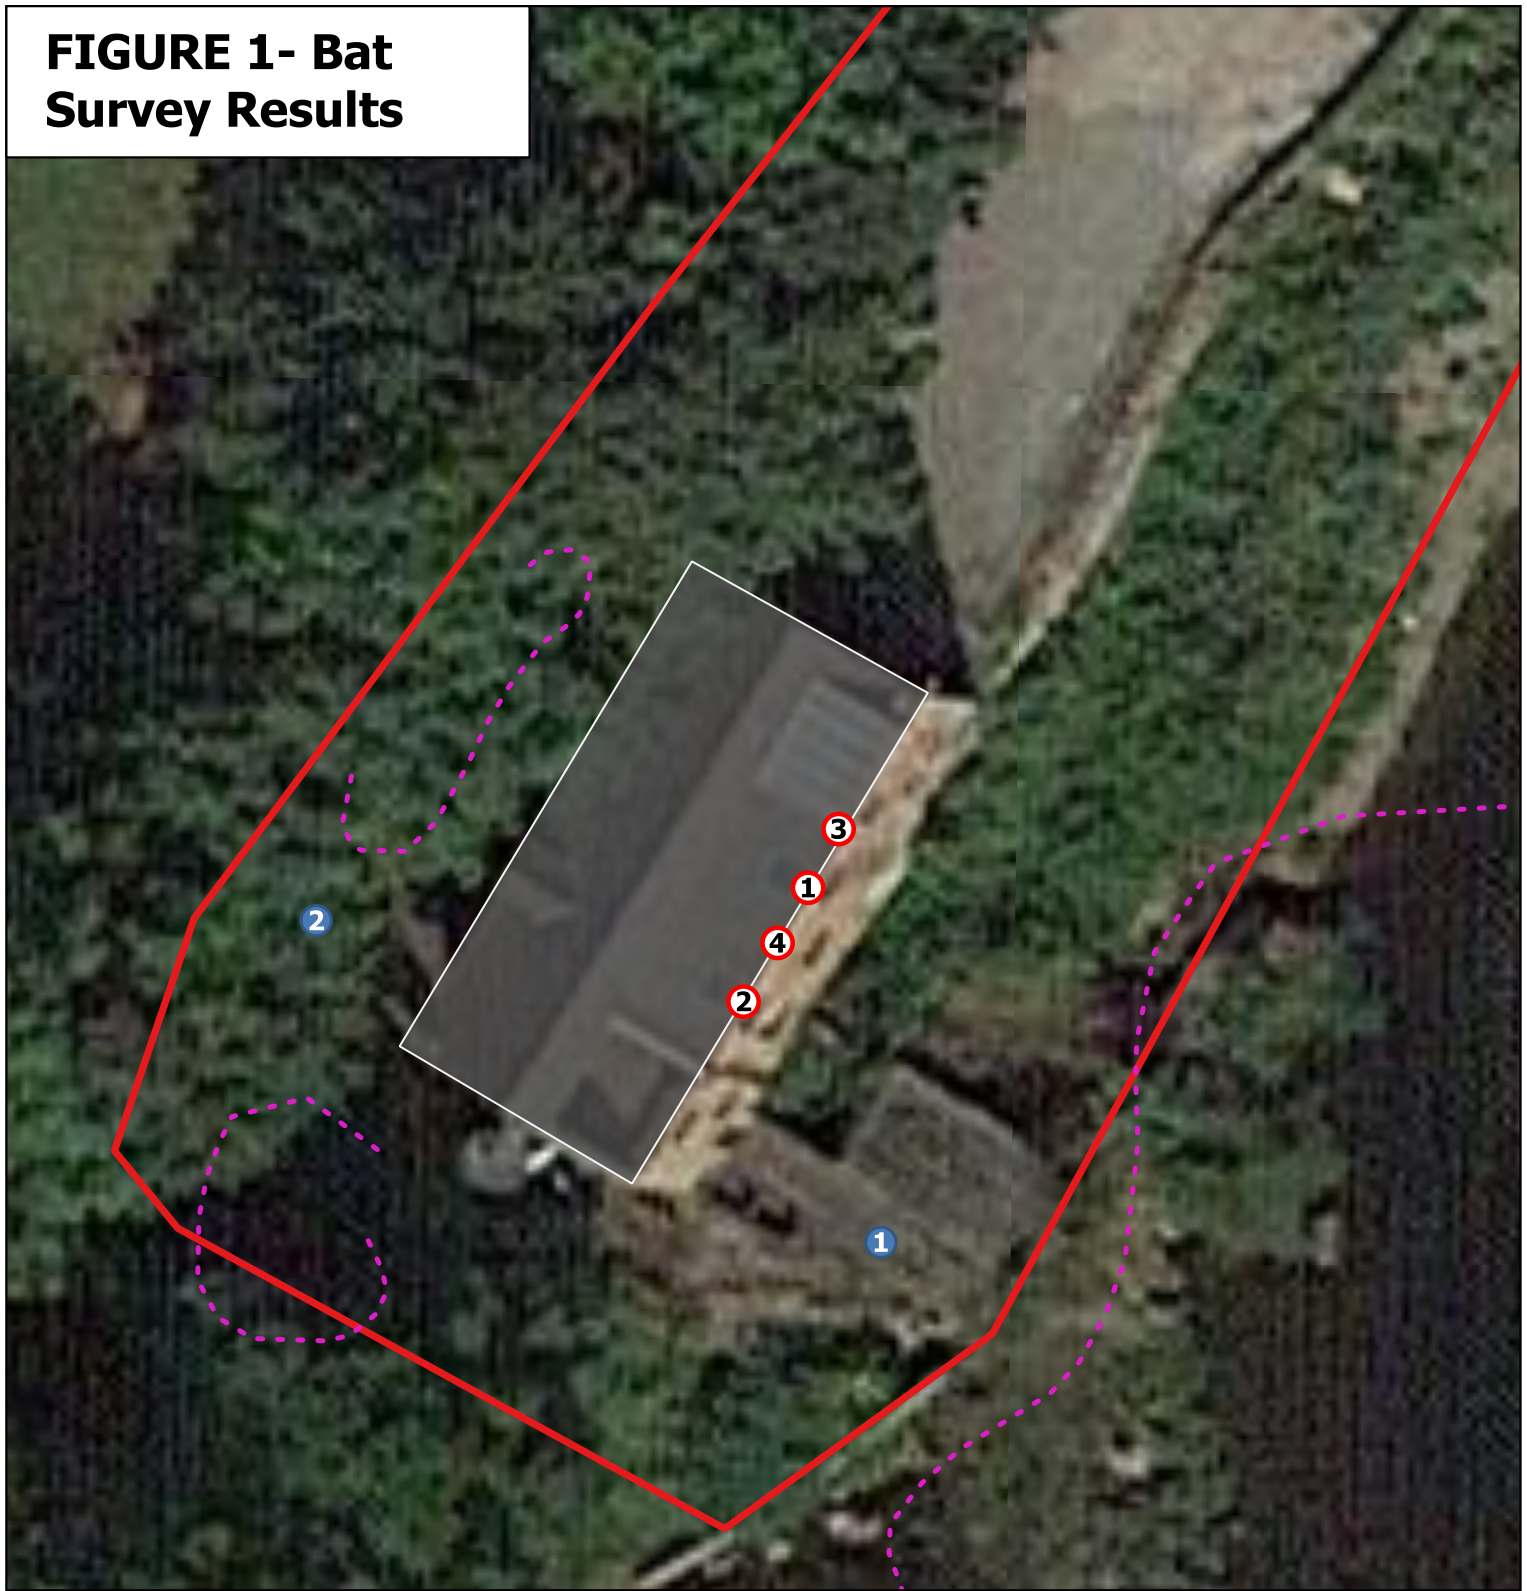
**FIGURE 1- Bat  
Survey Results**

Given the size of the building and the location of potential bat roosting features, it was considered appropriate to use two surveyors, with one surveyor positioned at the building's east face and one at the building's west face. Surveyor locations are shown on Figure 1 in the Appendix.

In summary, three individual soprano pipistrelle bats were recorded roosting at the site with bats roosting within crevices between sandstone blocks on the east facing elevation, overlooking the river. Bat Roost locations are shown on Figures 1 and 2 and all Photographs in the Appendix.

No other bat species or other significant bat activity was recorded. The results and target notes are shown on Figures 1 and 2 in the Appendix. Photographs of the roosting locations are also provided in the Appendix.
