**BAT ASSESSMENT REPORT**  
Plas Coch Campus, University of  
Wrexham

**December 2018**

**Our Ref: ECO00246**

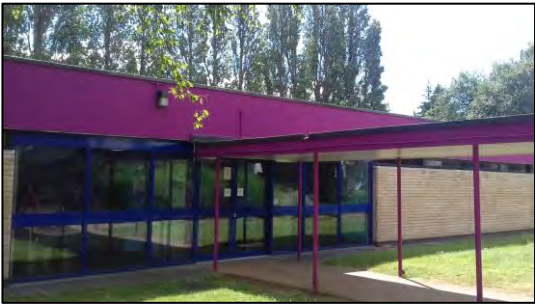
Figure 3: B06

| Building Ref | Description | Potential Bat Roosting Features | Evidence of Bats | Bat Roosting Suitability |
|---|---|---|---|---|
| B06 | B06 comprised a single storey, flat roofed, brick-built building with metal frame doors and a combination of metal and wooden framed single glazed windows. Internally the building had a false ceiling with no loft voids present and no gaps recorded along the roof. | Gaps were recorded under the barge boards at the back of the building where the material had warped. Due to the height of the features it was not possible to inspect them further. | No evidence of bats was noted at the time of the survey. | <b>Low</b> |

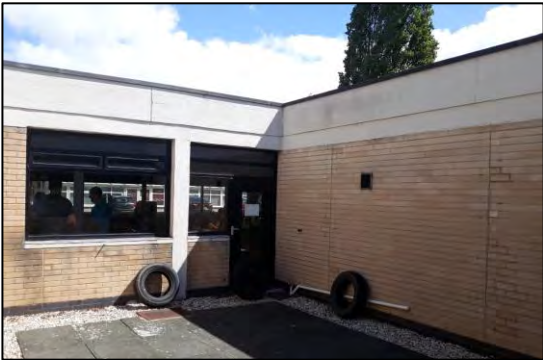
Figure 4: B07

| Building Ref | Description | Potential Bat Roosting Features | Evidence of Bats | Bat Roosting Suitability |
|---|---|---|---|---|
| B07 | B07 comprised a single storey, flat roofed, brick-built building with wooden framed doors and windows. Internally the building had a plasterboard roof with skylights. No loft void was present. No features were recorded along the walkway. | A cobwebbed crevice was recorded in the courtyard between the lean to shelter and the brick wall. The crevice was shallow and didn't lead further into the building. | No evidence of bats was recorded at the time of the survey. | <b>Negligible</b> |

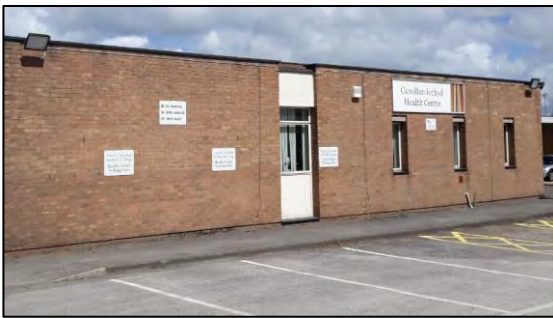
Figure 5: B08

| B08 | B08 comprised a single storey, flat roofed, brick-built building with UPVC windows and wooden framed doors. The roof external was felted with skylights present. Internal access was not available at the time of the survey. No features leading into any potential loft voids were recorded. | A single area of missing mortar was noted in the brickwork above the door lintel. The crevice was fully inspected with no evidence of bats. | No evidence of bats was recorded at the time of the survey. | <b>Negligible</b> |

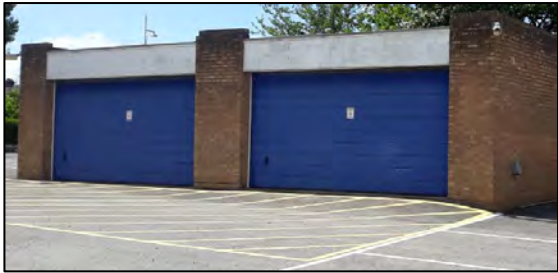
Figure 6: B09

| B09 | B09 comprised a brick-built double garage with wooden ply wood above the roller shutter doors. The building had a flat roof with a parapet and gutter. Internally the building was of breeze block construction with no loft void present. | None recorded. | No evidence of bats was recorded at the time of the survey. | <b>Negligible</b> |

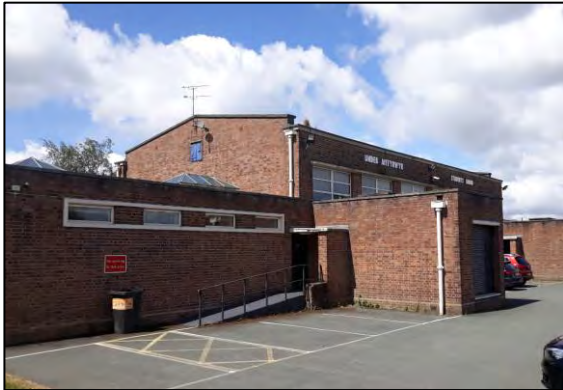
Figure 7: B10

| B10 | B10 comprised a two storey, brick-built building with no internal second floor. UPVC windows and wooden doors were present, with roller shutter doors recorded to the north of the building. The external roof was felted with sections of flat and pitched roof. | A number of features were recorded along the building such as cracks in the mortar and cracks in the facias board along the south east pitched roof section. | No evidence of bats was noted at the time of the survey. | <b>Low</b> |

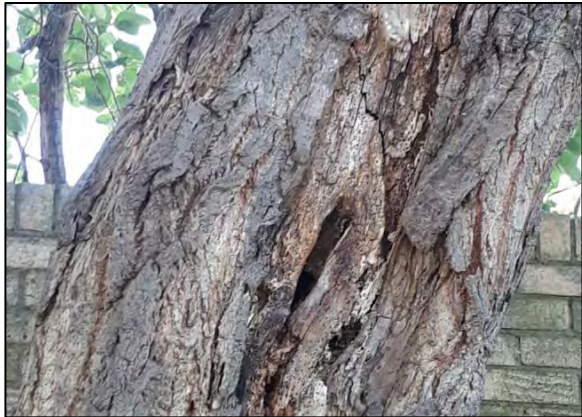
A single tree (T1 see Appendix A) surveyed in the 2018 walkover was considered to have suitable roosting feature for bats. This tree was located outside of the survey area but was directly adjacent to the garages proposed for demolition. As such, recommendations for works near the tree have been made. The recommendations and mitigation detailed in the 2017 remain valid and are outlined in this report.

A single tree (T1) located outside of the site boundary was considered to have suitable roosting features for bats. As such, recommendations for safe works near the tree have been made.

Figure 9: Feature on T1

A single tree was recorded outside the site boundary, adjacent to the garages (B11) proposed for demolition. Where the works are considered to pose a negative impact to the tree from noise, vibrations or lighting, the tree should be inspected via endoscope to establish the presence / likely absence of roosting bats prior to the works. Where bats are found to be roosting, delays to the works may be incurred and the method of works altered.

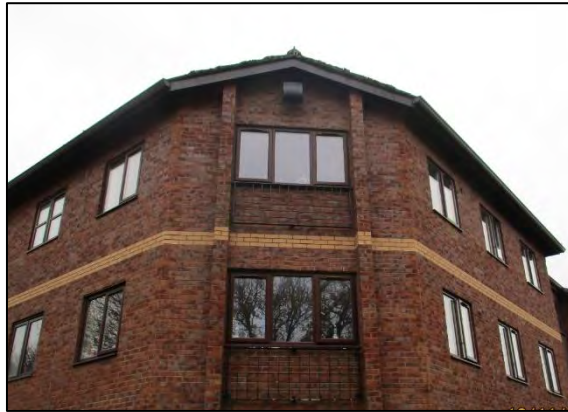
During the dusk emergence conducted on B01 towards the north of the site (see Appendix 1) a large bat was observed emerging from the north west aspect of the building. Following a specific inspection of the area, a suitable access point was recorded in the soffit above the third-floor kitchen window with access leading into the roof void. During the inspection no evidence of bats such as droppings, feeding remains or staining was recorded.

**Figure 10: B01 showing soffit feature**

A bat was recorded emerging from the soffit on the north west aspect of the student accommodation building (B01). The bat was noted as being a larger bat species, emerging early on in the survey (19.21, 17 minutes after sunset). As such, it is considered the bat be either *Nyctalus* sp. or *Serotine*. All three species have been recorded roosting in buildings, although this is less common for *Noctule*, however *Serotine* and *Leisler* are considered less widespread in Wales than *Noctule*.

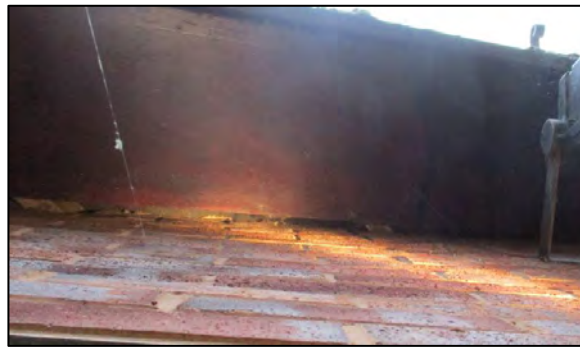
Activity commenced at **19:21** with an unidentified bat emerging from the soffit above the third-floor kitchen window. Commuting was recorded during the survey; however, activity levels were considered low. Both soprano pipistrelles (calls recorded at **19:51** and **20:10**) and common pipistrelles (recorded at **20:16**) were noted during the survey. Activity was concentrated to the north-western corner of the site.

Following the emergence recorded on 25<sup>th</sup> September 2018, a specific inspection was carried out in order to establish the feature the bat had emerged from and to record any evidence of bats such as droppings, staining or feeding remains<sup>1</sup>. The survey was conducted by Stuart Thomas<sup>2</sup> and assisted by Phillipa Mudd. The survey found that there was a suitable gap in the wooden soffit box from which a bat would be able to access the loft void directly above the north western section of the building, however no staining, which would suggest routine use, was recorded.

**Figure 11: Soffit feature from which bat emerged**

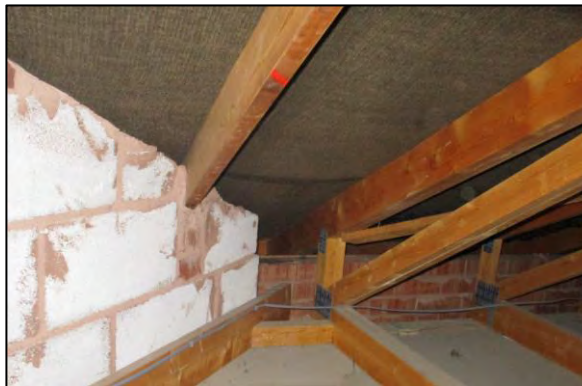
The internal loft void comprised machine cut beams with bitchumastic membrane present. The membrane was in generally good condition and well-sealed with the only gaps recorded around the window areas on each side. No insulation was present within the void. No evidence of bats such as droppings or feeding remains were recorded during the internal loft inspection. The soffit was inspected internally using an endoscope from the gaps around the window. No evidence of bats such as droppings or feeding remains were recorded within the soffit box however a full inspection was not possible due to the position of the feature.

**Figure 12: Internal roof structure of B01**
