**Medra**

**Berse Road, New Broughton**

## **PHASE II GEO-ENVIRONMENTAL REPORT**

**Doc ref:** 5073-CAU-XX-XX-RP-O-3002

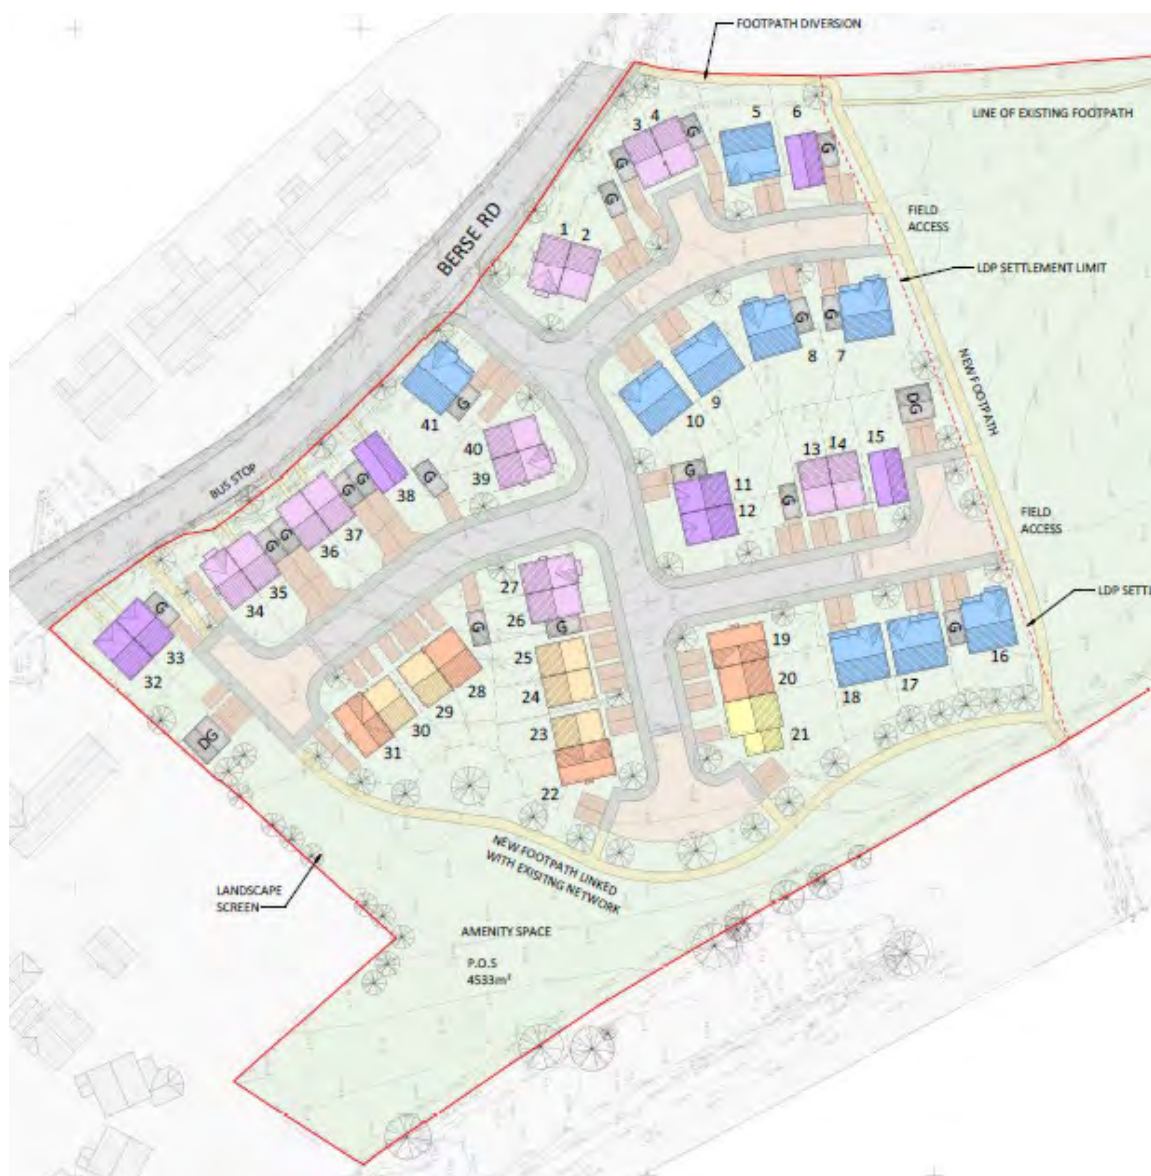
**Figure 1 – Proposed Development Area**

- 2.1.1 A development layout is yet to be finalised; however, it is anticipated the development will comprise of approximately thirty residential detached and semi-detached two storey houses, with associated access roads, private driveways, gardens and public open space.
- 2.1.2 An indicative development layout is presented as Figure 1; an extract is provided below.
- 2.1.3 No construction details, structural loads or site wide elevations have been developed to date. It is assumed the building will be of traditional load bearing masonry wall construction.

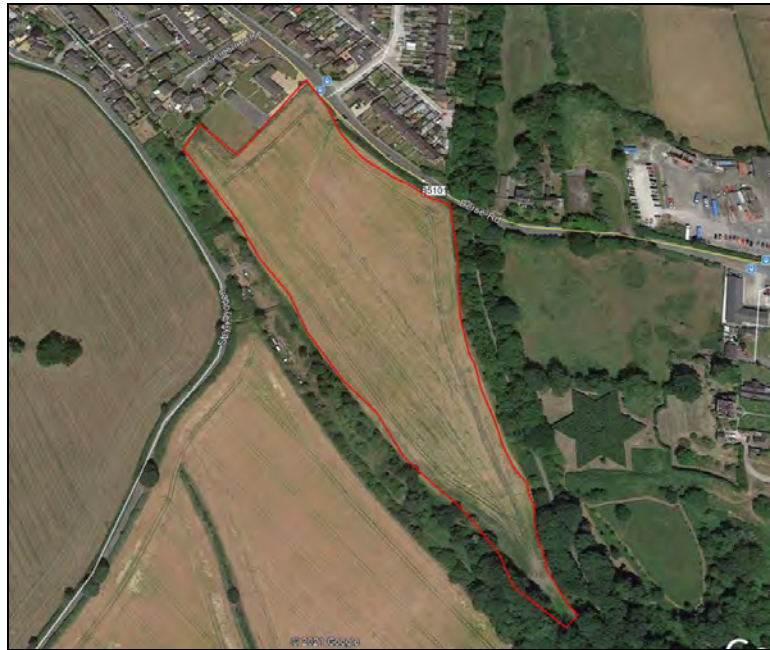
**Figure 1 - Site Location Plan**

3.1.1 The Site is located to the southeast of New Broughton, Wrexham and to the south of Berse Road, LL11 6TP (British National Grid Reference 331373, 350975). The site location plan is presented as Figure 1 below.

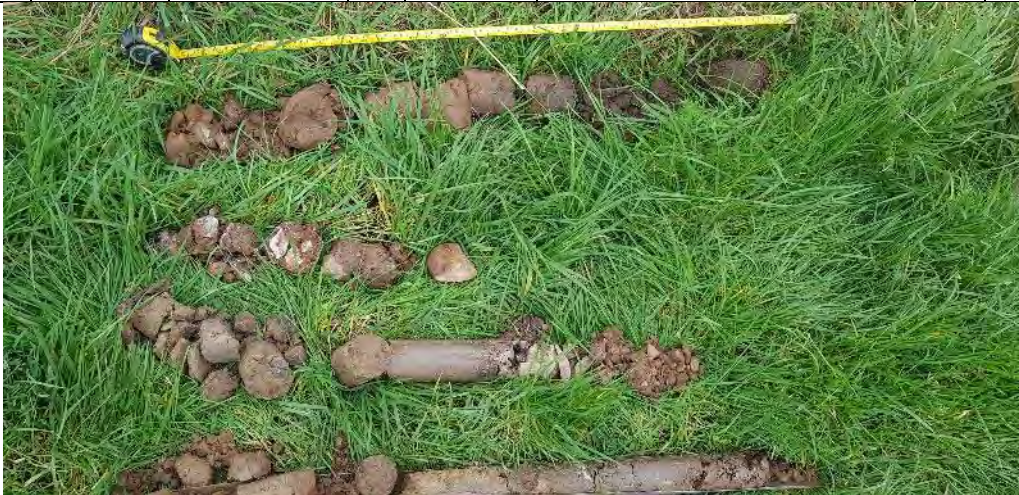
The photograph shows four soil samples, each approximately 400mm long, laid out horizontally on a dark, moist soil surface. A yellow measuring tape is positioned above the samples, indicating their length. The samples are composed of various soil types, including dark brown silty clay, lighter brown sandy soil, and some reddish-brown soil. The samples are arranged in a row, with some showing signs of disturbance or fragmentation. The background shows a grassy area and a wooden fence.

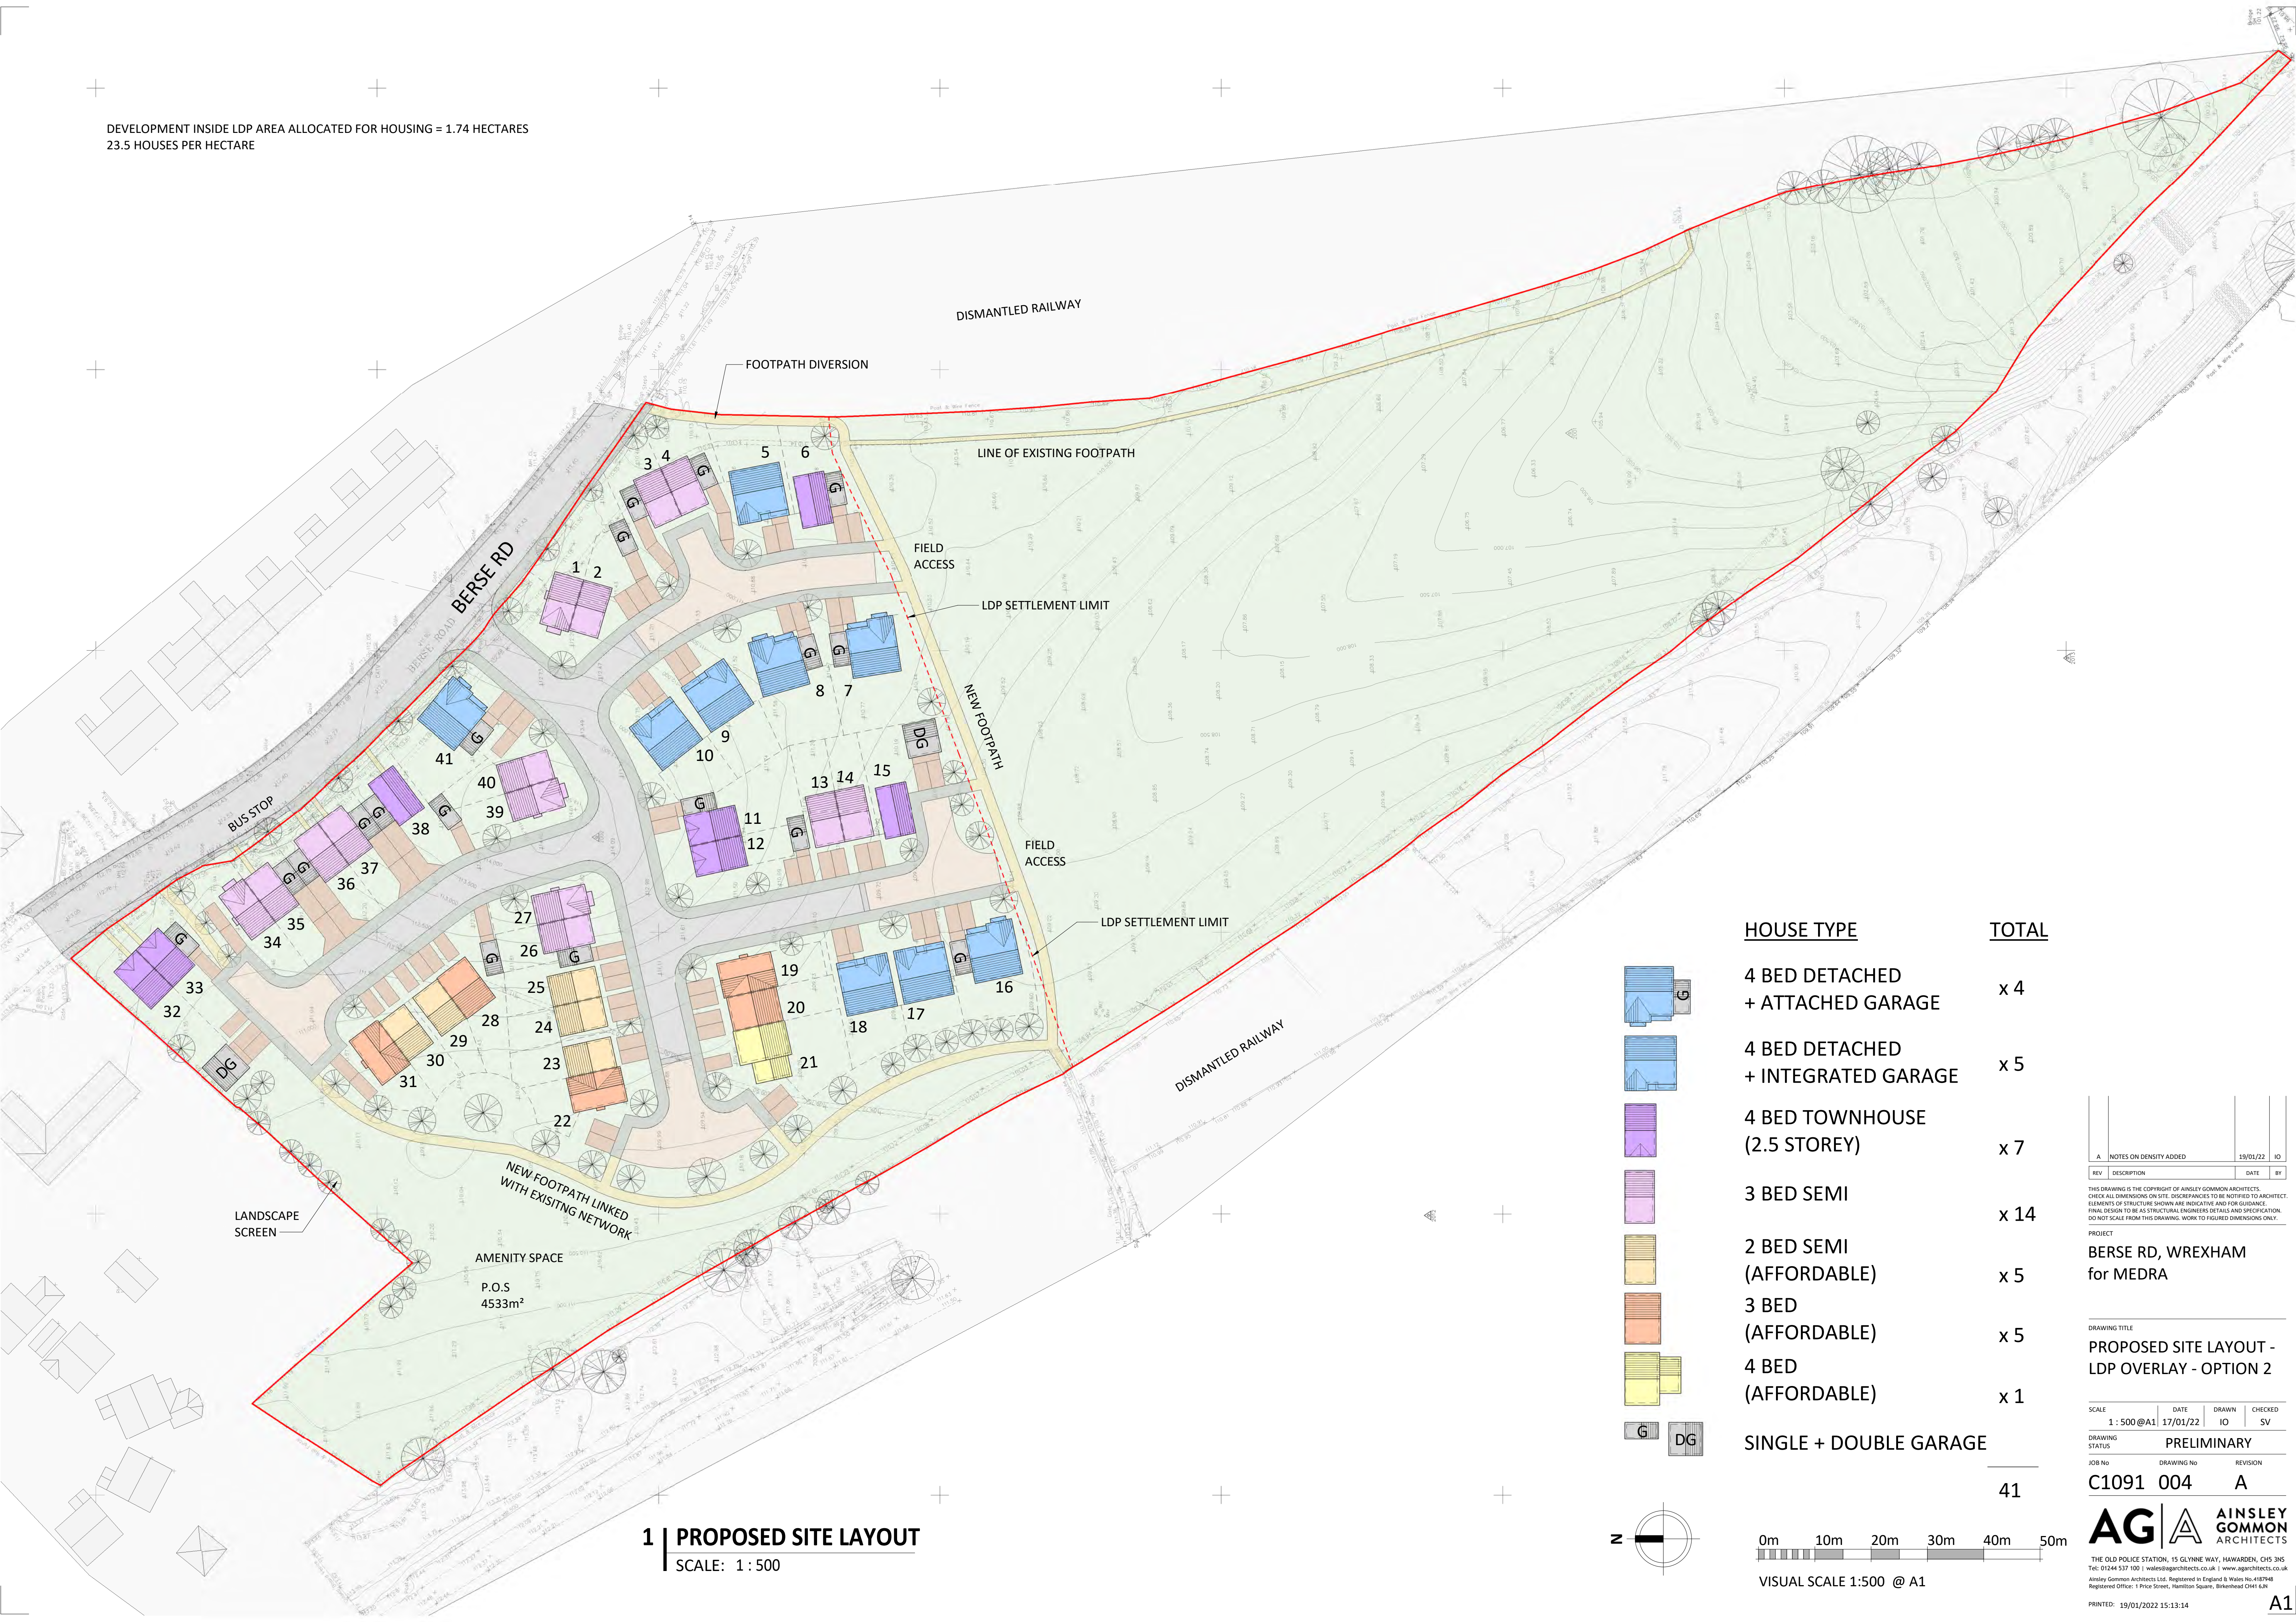
1 | PROPOSED SITE LAYOUT  
SCALE: 1 : 500

DEVELOPMENT INSIDE LDP AREA ALLOCATED FOR HOUSING = 1.74 HECTARES  
23.5 HOUSES PER HECTARE
