# BAT SURVEY REPORT

**Wrexham County Borough Museum and Archives,**  
Regent Street,  
Wrexham,  
LL11 1RB

| <b>Project:</b> | Wrexham Museum | | | |
| <b>Title:</b> | Bat Survey Report | | | |

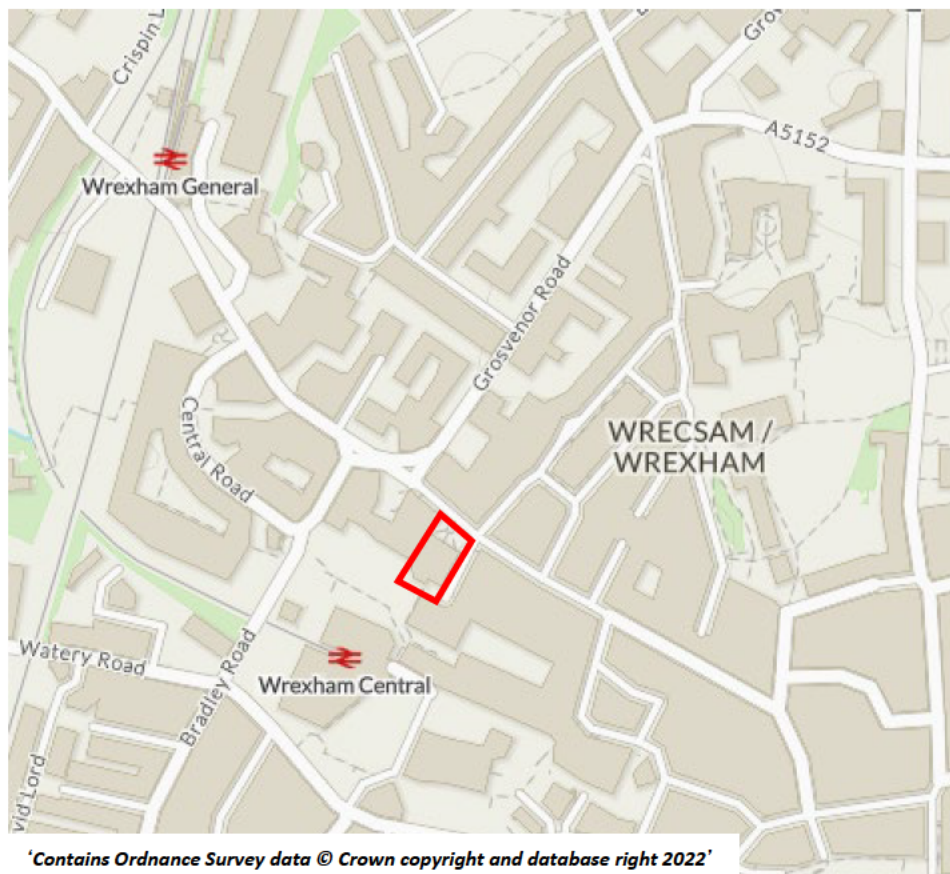
Figure 1 – Site Extent

The site is located at National Grid Reference SJ 33179 50447 and comprises a total area of approximately 0.2ha (see Figure 1).

The site is located within the centre of Wrexham, approximately 50m north of Wrexham Central train station. Commercial, industrial, and residential buildings are present on all aspects of the building, with Bellevue Park present approximately 200m south of the site.

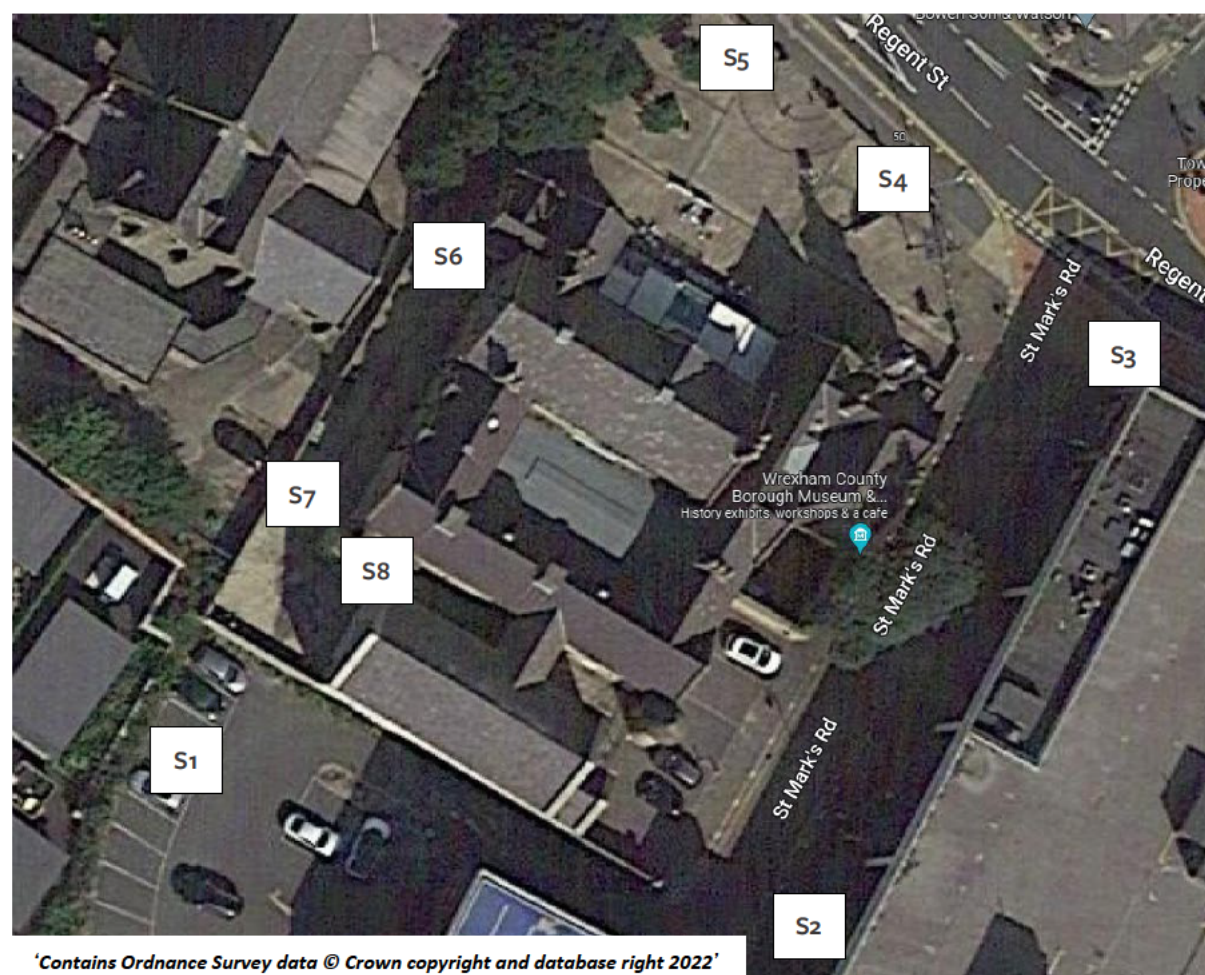
Figure 2 – Surveyor vantage points

The surveys were conducted using handheld BatScanner bat detectors. Surveyors were positioned around the features to observe the Potential Roosting Features (PRF) identified during the PRA. The emergence survey started at least 15 minutes before sunset and continued until approximately 1.5 hours after sunset. The re-entry survey started approximately 1.5 hours before sunrise and continued until 15 minutes after sunrise.

Summary of the survey details are provided in Table 2. Figure 2 provides a plan illustrating surveyor positions.

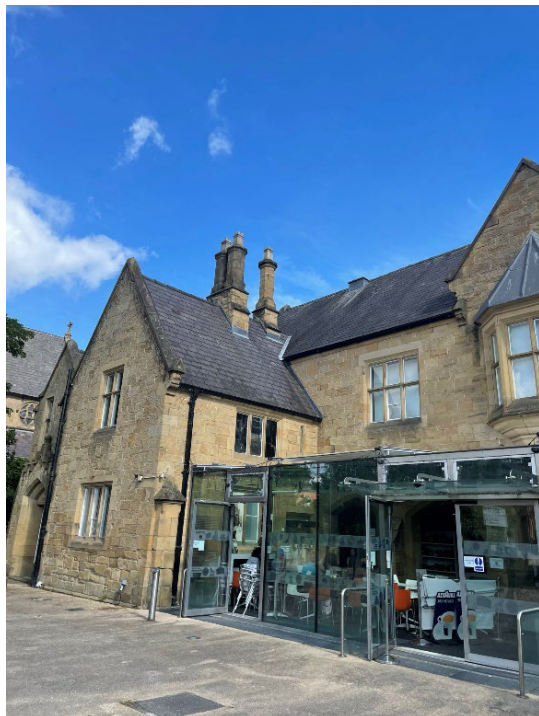
| Aspect Reference | Description and evidence |
|---|---|
| Northern aspect | <p>The northern aspect of the building forms the front entrance to the museum. The stonework is in very good condition throughout, with no gaps in the mortar or gaps present around door or window frames. The edges of the tiles on the roof were also sealed with stone, preventing access to the underside of the tiles.</p> <p>However, there are multiple lifted tiles present within the roof and along the ridge which could offer suitable roosting opportunities for crevice dwelling species such as pipistrelles (<i>Pipistrellus spp.</i>).</p> <p>The lead flashing along the base of the chimney stacks appeared to be in very good condition and was tight to the stonework throughout.</p> |

**Photograph 1 – Northern aspect of building, looking to east.**

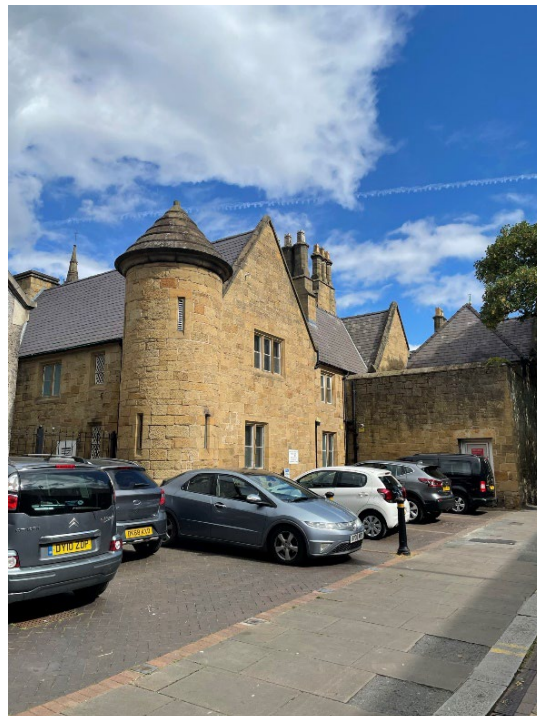
| Aspect Reference | Description and evidence |
|---|---|
| Eastern aspect | <p>The eastern aspect of the building comprises gable ends of the multiple pitched roofs and a wall approximately 4m in height. This wall was in very good condition throughout, with no defects in the mortar observed.</p> <p>The gable ends were sealed with stone and were noted to be in good condition throughout, offering no potential roost features. A tree partially obscured some of the view of the building from this aspect, however this is not a significant constraint.</p> <p>As with the northern aspect, there some minor lifted tiles present on the roof visible from this aspect that would provide PRFs for crevice dwelling bat species.</p> |

**Photograph 2 – Eastern aspect.**

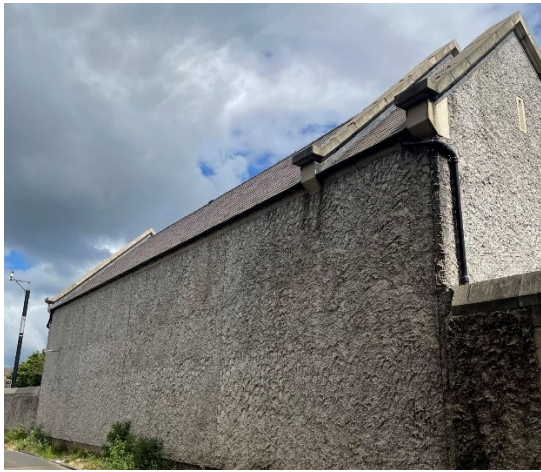
| Aspect Reference | Description and evidence |
|---|---|
| Southern aspect | <p>The southern aspect was the least visible of all aspects as it was mostly formed of the exterior wall of the museum, with an adjacent building in close proximity that allowed for a slightly obstructed view of the roof. The wall was in good condition throughout, with no defects noted. The tiles on the roof had minor defects through lifted tiles that could support a small number of crevice dwelling bat species.</p> |

Photograph 4 – Southern aspect

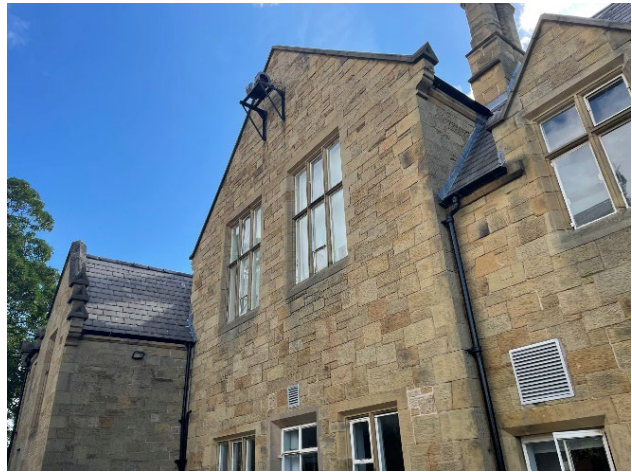
| Aspect Reference | Description and evidence |
|---|---|
| Western aspect | <p>The western aspect of the building forms another gable end, with multiple smaller pitched roofs also present on this aspect. The stonework of the building was on very good condition throughout and was well sealed around the roof tiles and window/door frames. Minor defects were noted in the roof tiles again on this aspect, with some lifted tiles present that could provide roosting habitat for crevice dwelling bat species.</p> |

Photograph 4 – western aspect of building showing gable ends
