## Template Method Statement to be used within a Bat Development Licence Application

| <b>Method Statement Title:</b> | Oakfields, Isycoed |
| <b>Site Address:</b> | Oakfields, Isycoed, Clwyd, LL13 9RY |

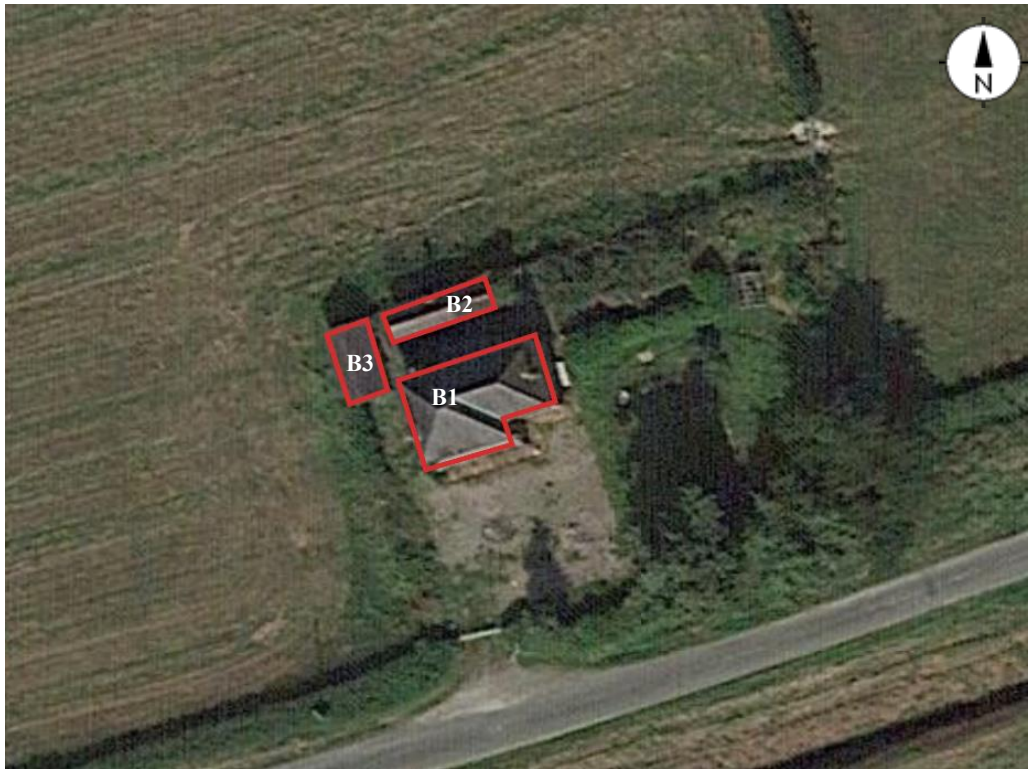
**Figure 1:** An aerial photograph of the surveyed site at Oakfields, Isycoed (as shown by the red outline). The arbitrary building numbers referred to throughout this report are also illustrated.

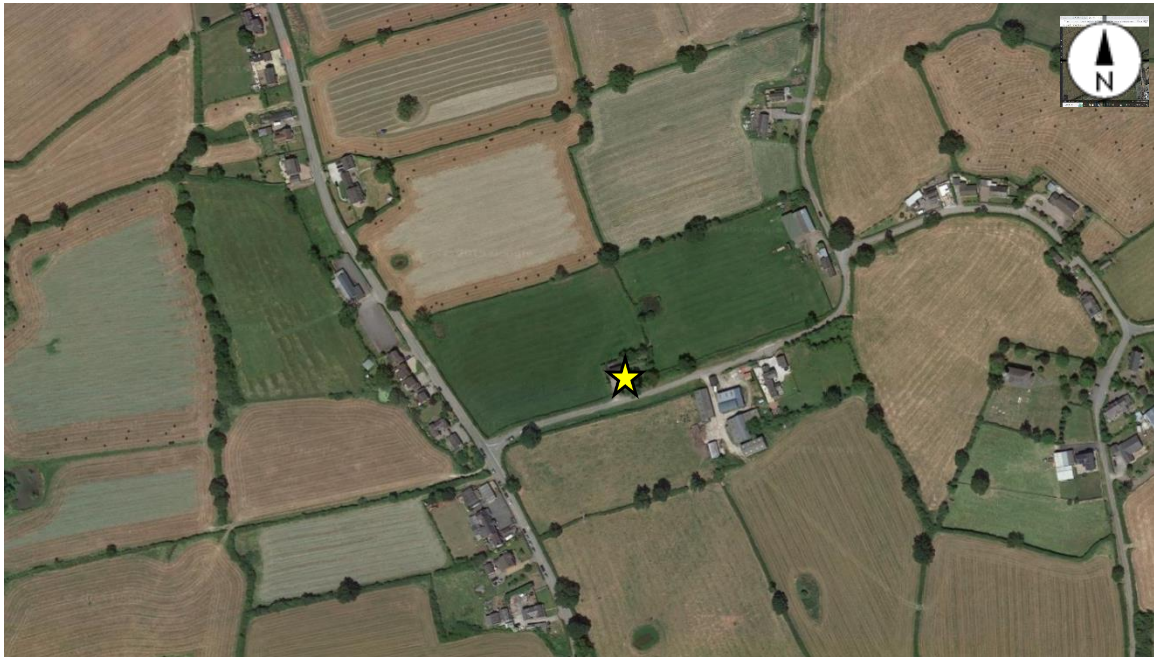
**Figure 2:** An aerial photograph of the surveyed site (yellow star) and some of the nearby habitats to Oakfields, Isycoed.

The wider landscape is comprised of arable land, scattered trees and hedgerows. There is a large waterbody located 600m to the west of the site, and the site offers good connectivity to the wider landscape. Therefore, the habitats that are present in and around the site contains all of the elements that are considered to be critical in both bat and bird life cycles.

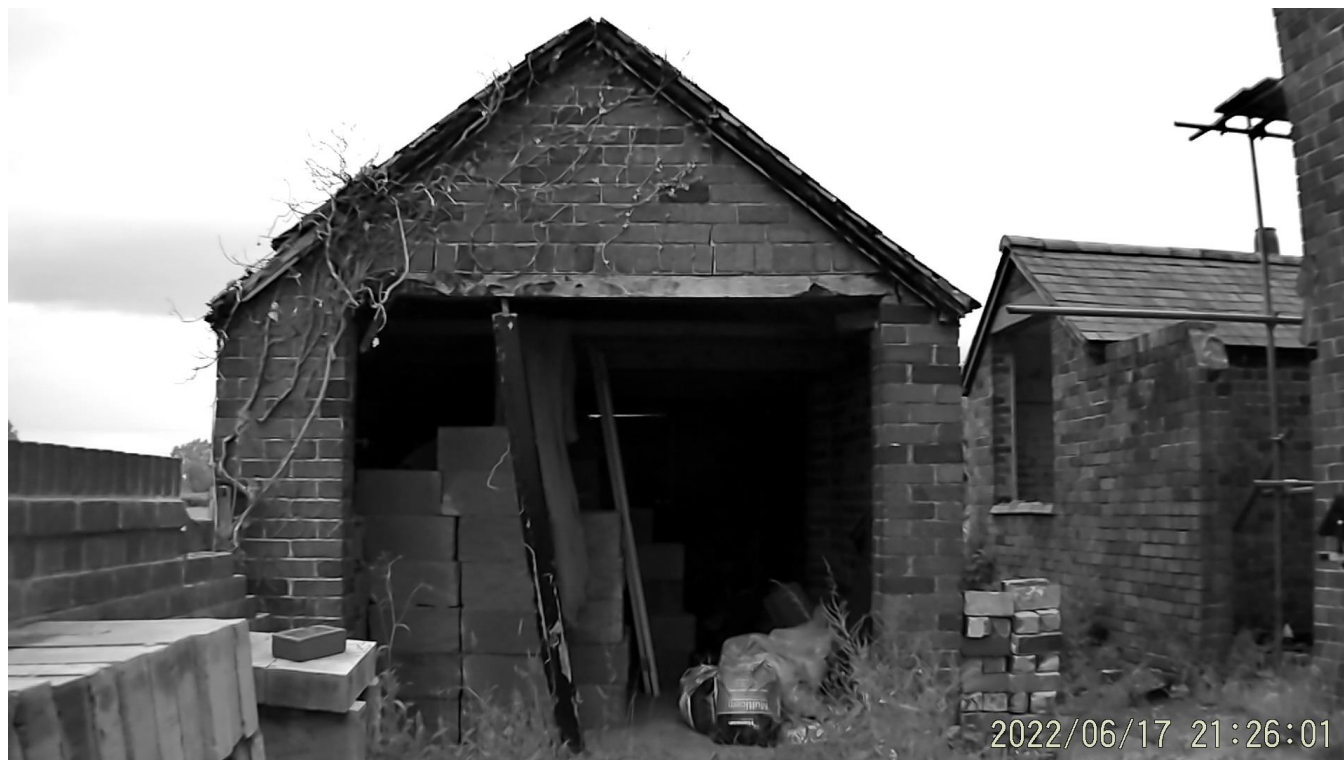
**June 2022 Video Screenshot (Outbuilding Roofs Intact)**

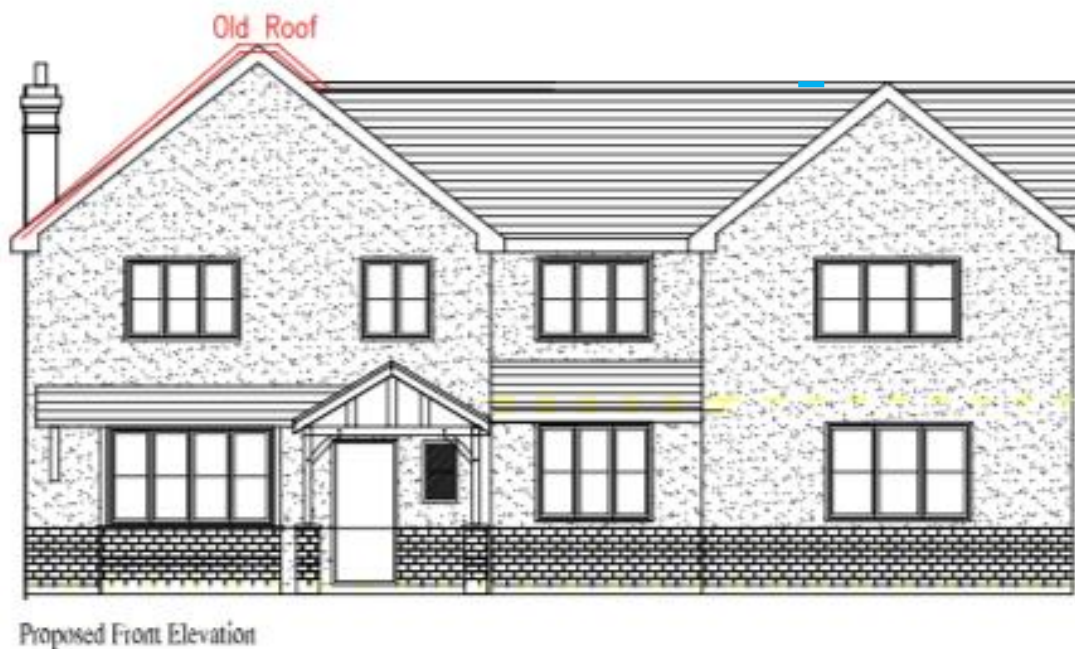
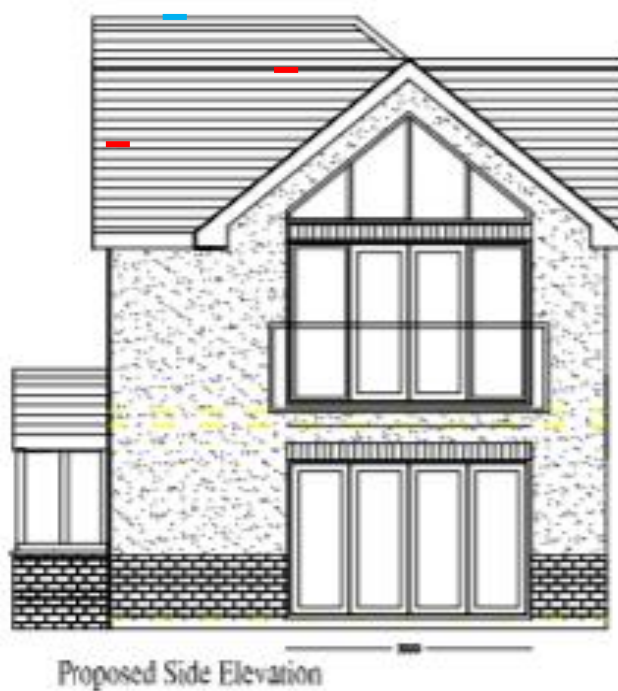
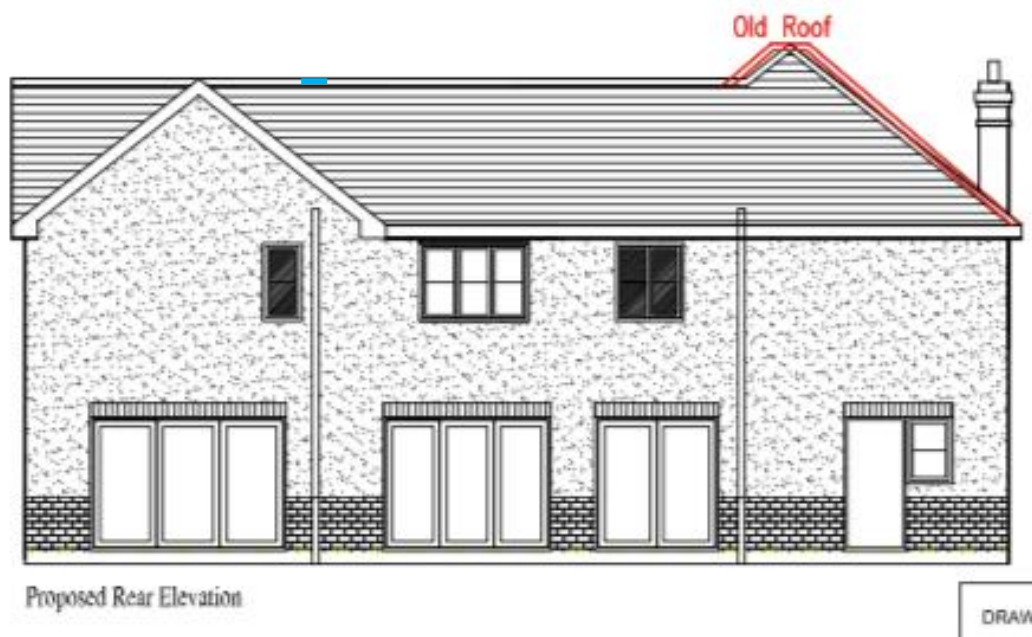
**Figure 8:** Annotated site plans for the location of the access points. The Bat Access Tiles are shown by the red markings, with the blue markings showing the location of the purposefully lifted ridge tiles. **Please note** – the annotations on this image are not to scale.

- To compensate for the presence of void dwelling bats within the loft, access into the new loft will be facilitated. This should either be through the retention of the currently used access points, or the incorporation of [Bat Access Tiles](#) and purposely lifted ridge tiles.

A number of additional measures should be included to ensure that the roost is of the highest value possible to the target species. These measures include incorporating two [Schwegler 2F bat boxes](#) should be placed along the ridge board. Finally, a ply-board lining should be introduced [approximately] half way up the roof (heading towards the apex) in order to provide further roosting opportunities for the bat species present.

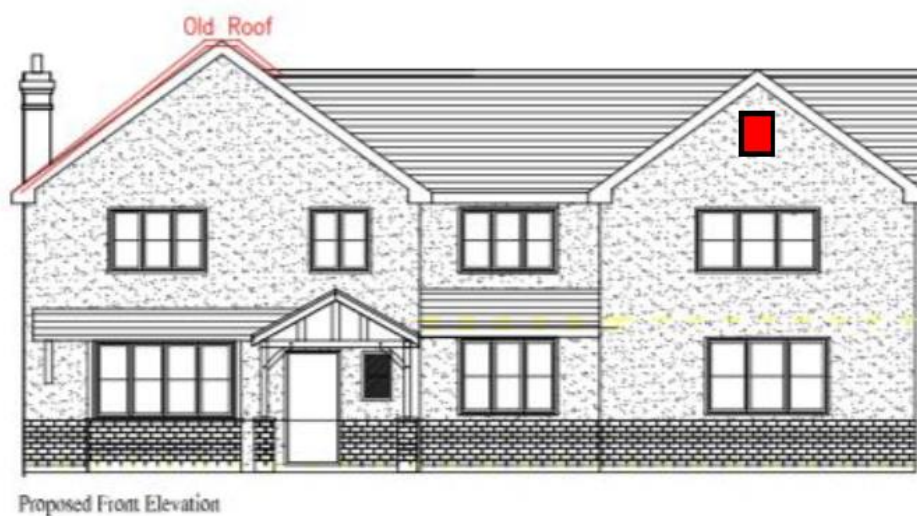
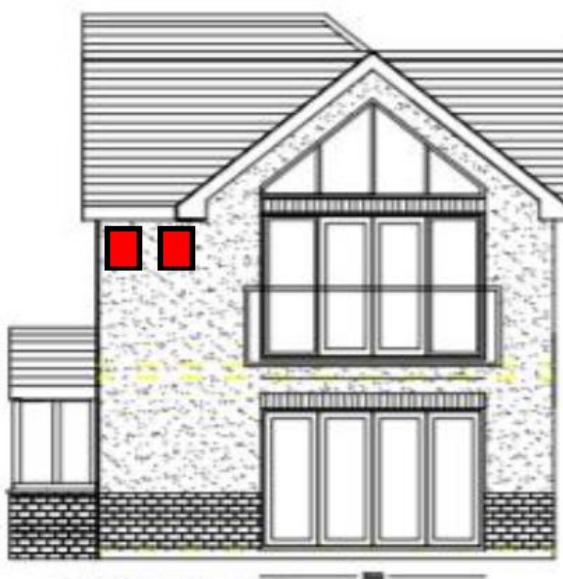
**Figure 9:** Annotated site plans for the location of integrated bat boxes (red shapes). **Please note** – the annotations on this image are not to scale.

- The site will need to incorporate three [Integrated Eco Bat Box](#), One with a crevice roosting chamber and two with a cavity roosting chamber, the location of which are shown in figure 9.

The site will need to incorporate three [Integrated Eco Bat Box](#), One with a crevice roosting chamber and two with a cavity roosting chamber, the location of which are shown in figure 9 below. Including these boxes will providing further roosting opportunities. These should avoid any artificial lighting, whilst being sighted facing east, south-east, south, south-west and/or west.

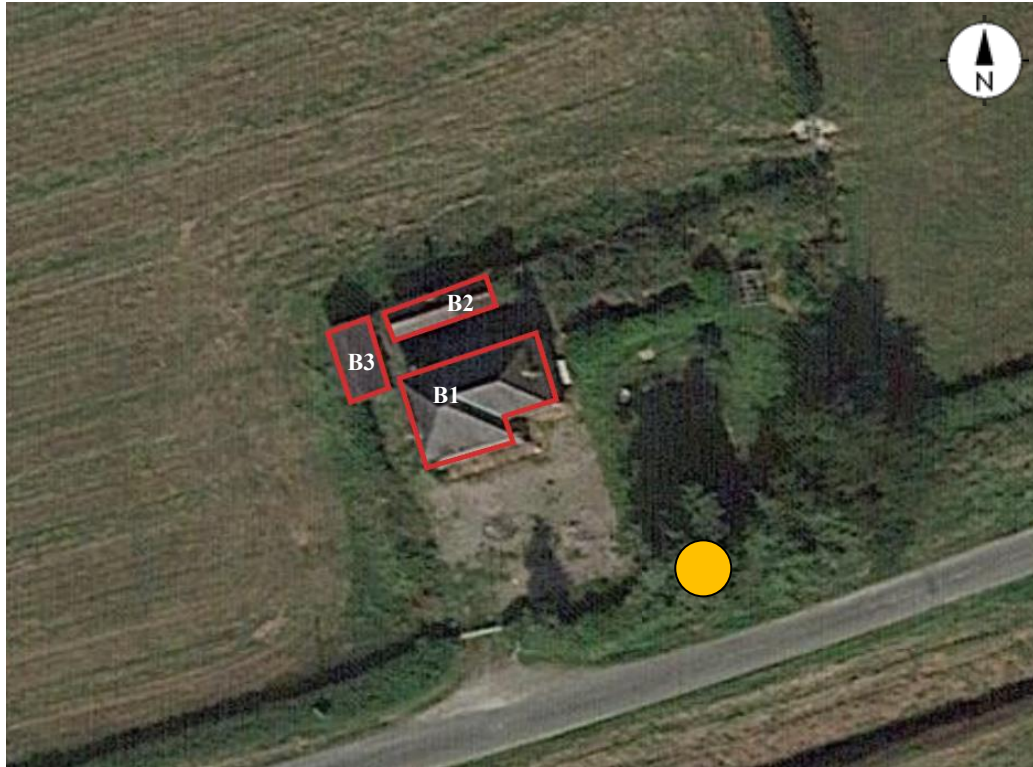
**Figure 10:** An aerial photograph of the surveyed buildings (red outline). This photograph illustrates the location of the translocation bat box (orange circles).

Prior to the soft demolition/searching, the translocation bat box (Schwegler 1FS or similar) will be installed (5m from the ground and facing north) on a nearby mature tree, which is situated just to the north of the building proposed for re-development (please see section E2.5). This translocation bat box is to be installed on the morning prior to the commencement of any soft demolition/searching works (as a preventative measure against small birds roosting inside the box). If bats are found, they will be translocated to the nearby hibernation bat box. The destructive search of the buildings will take place on dry days where the daytime temperature is above 8°C, to reduce the impacts upon any potential bats. Monmouthshire Bat Group will also be contacted if any injured bats are found.
