Our Ref: 70079705 / 11901(2)  
10 August 2023  
PUBLIC

**Re: Remediation Strategy for Land off Heol Offa, Johnstown, Wrexham, LL14 2BD**

This document comprises a combined Remediation Options Appraisal (ROA) and Remediation Strategy (RS), providing an appraisal of the available options for remediation of the soil. This letter report follows current guidance for contamination land assessment and management. The ROA and RS are required to discharge planning conditions, under planning application P/2021/1018.

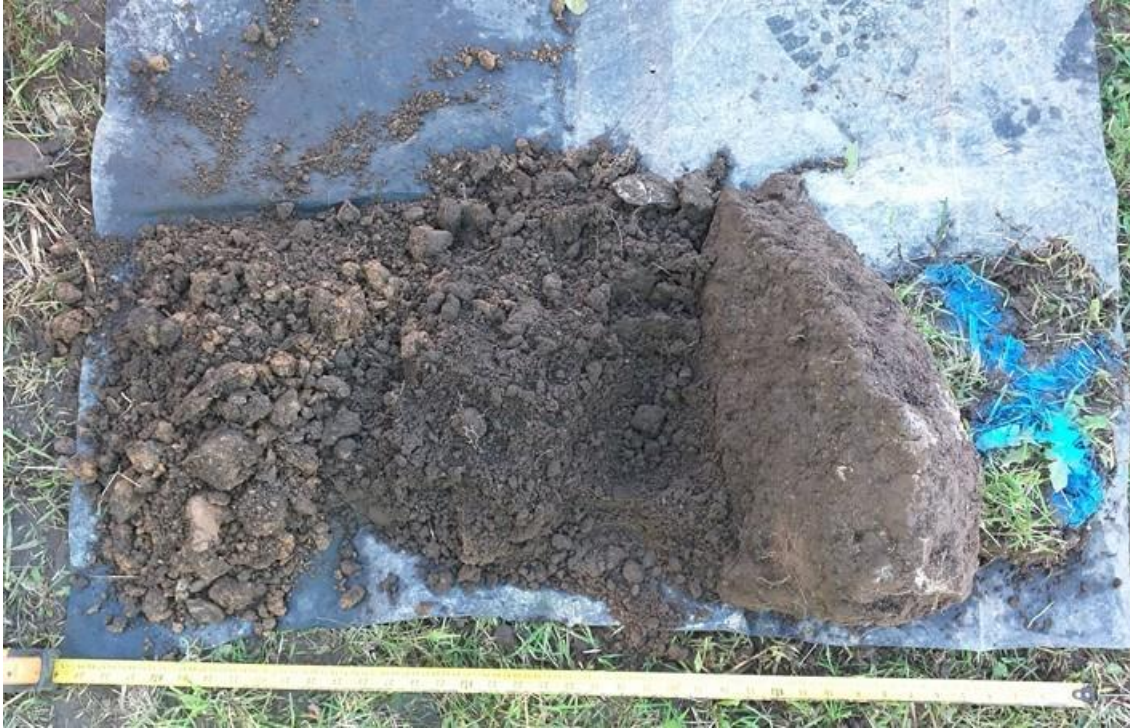
**Photo 1:** HP01 arisings recovered from 0 to 0.55mbgl. Depth below ground increases from right to left of image.

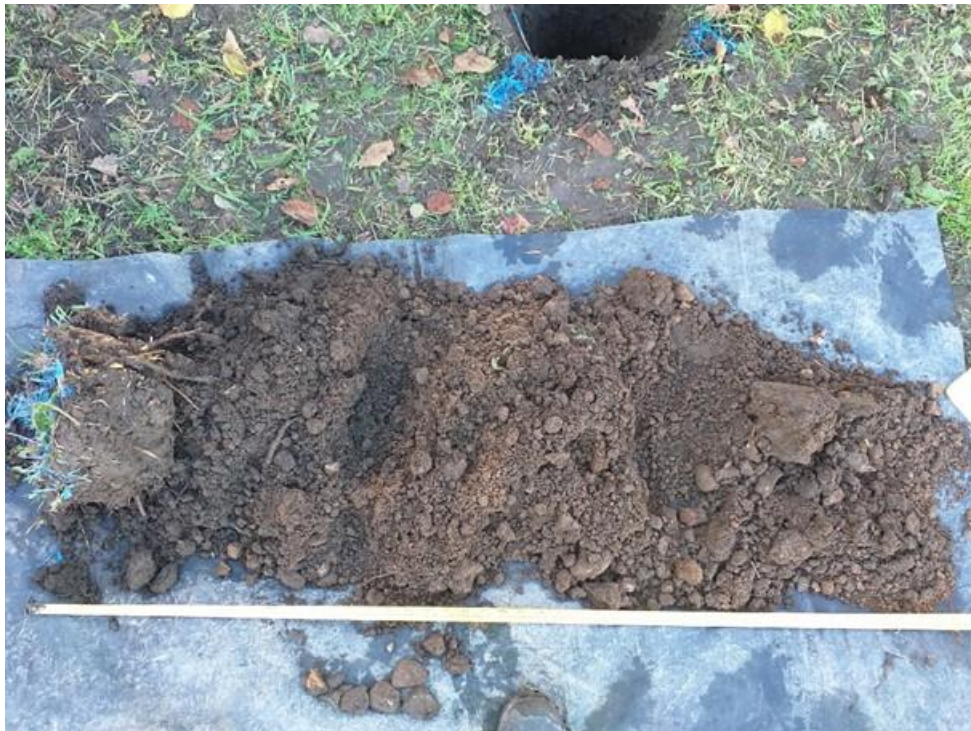
**Photo 2:** HP02 arisings recovered from 0 to 0.65mbgl. Depth below ground increases from left to right of image.

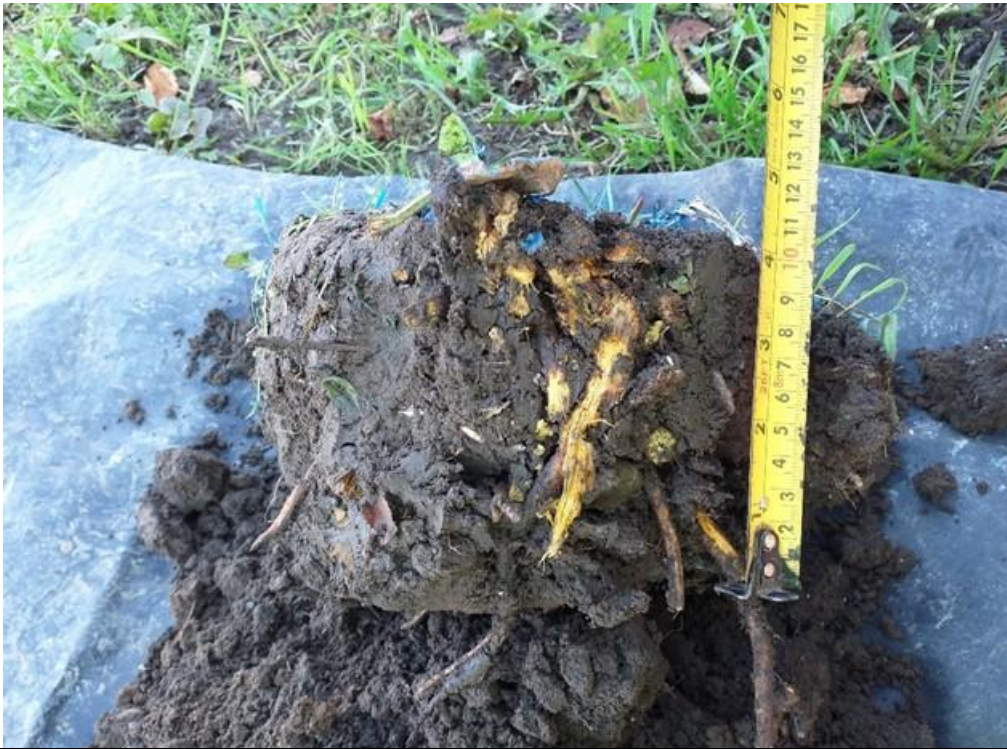
**Photo 3:** HP02 topsoil to 0.1mbgl containing roots.

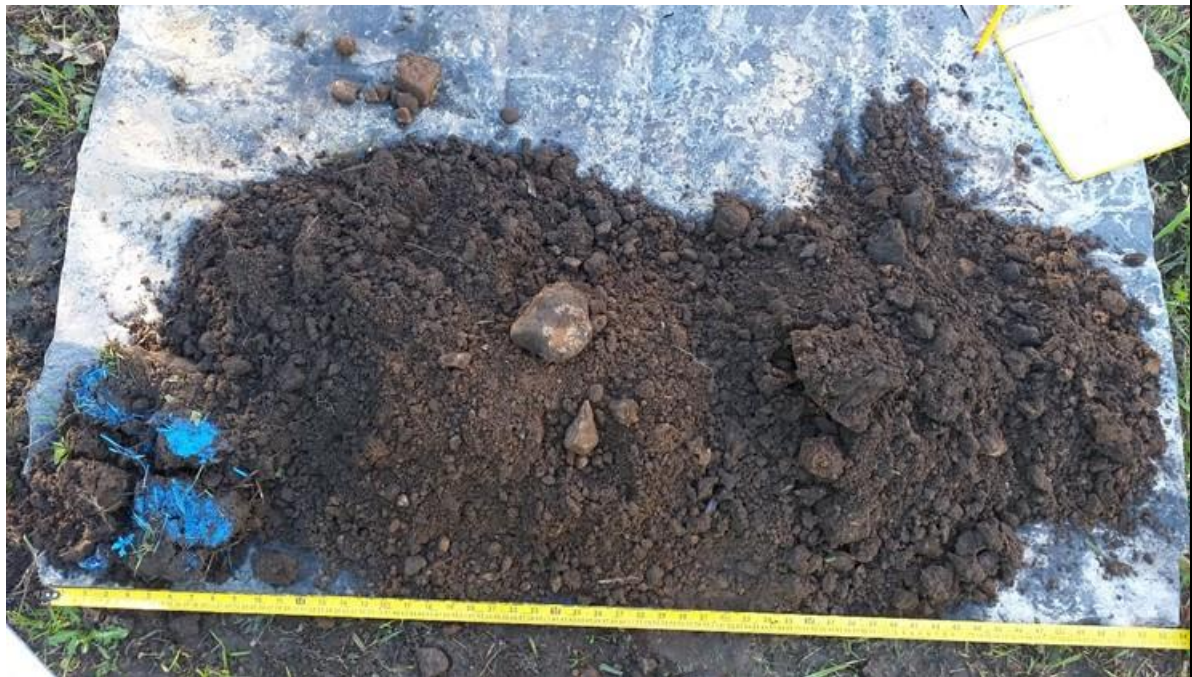
**Photo 4:** HP03 recovered arisings from 0 to 0.8m bgl. Depth below ground increases from left to right of image.

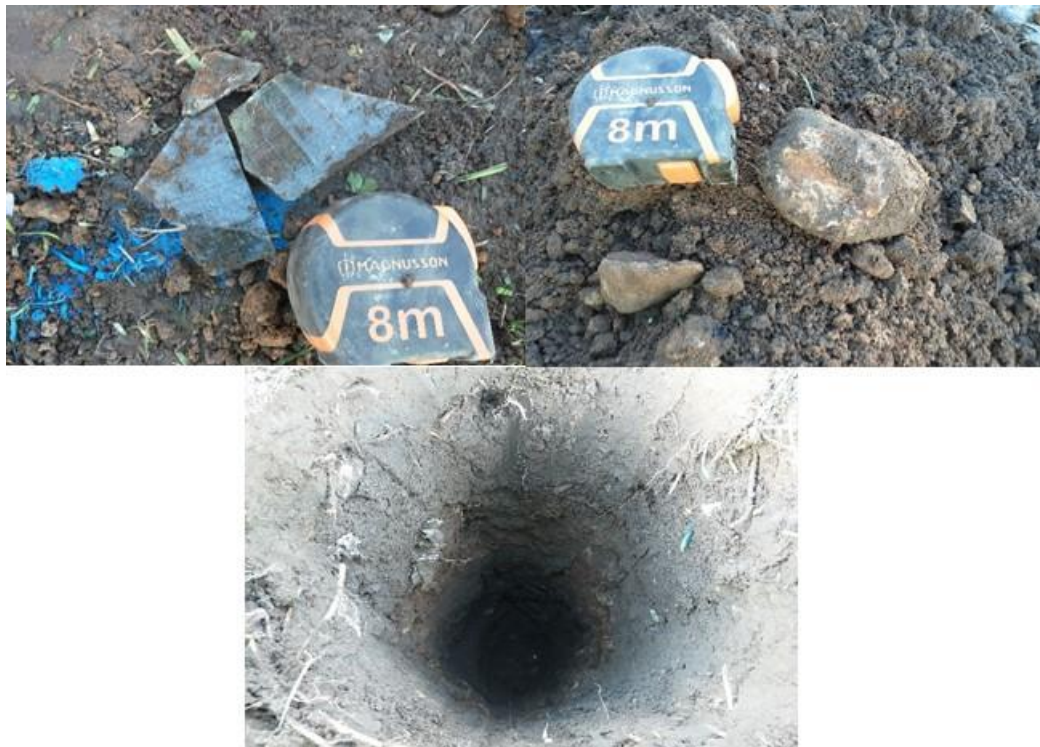
**Photo 5:** HP03 features of interest: Top left- reinforced glass found from 0.05 to 0.1mbgl. Top right- rare cobbles of concrete found in made ground (0.05 to 0.7mbgl). Bottom- Plastic sheeting seen in hand pit walls 0.1 to 0.25mbgl.

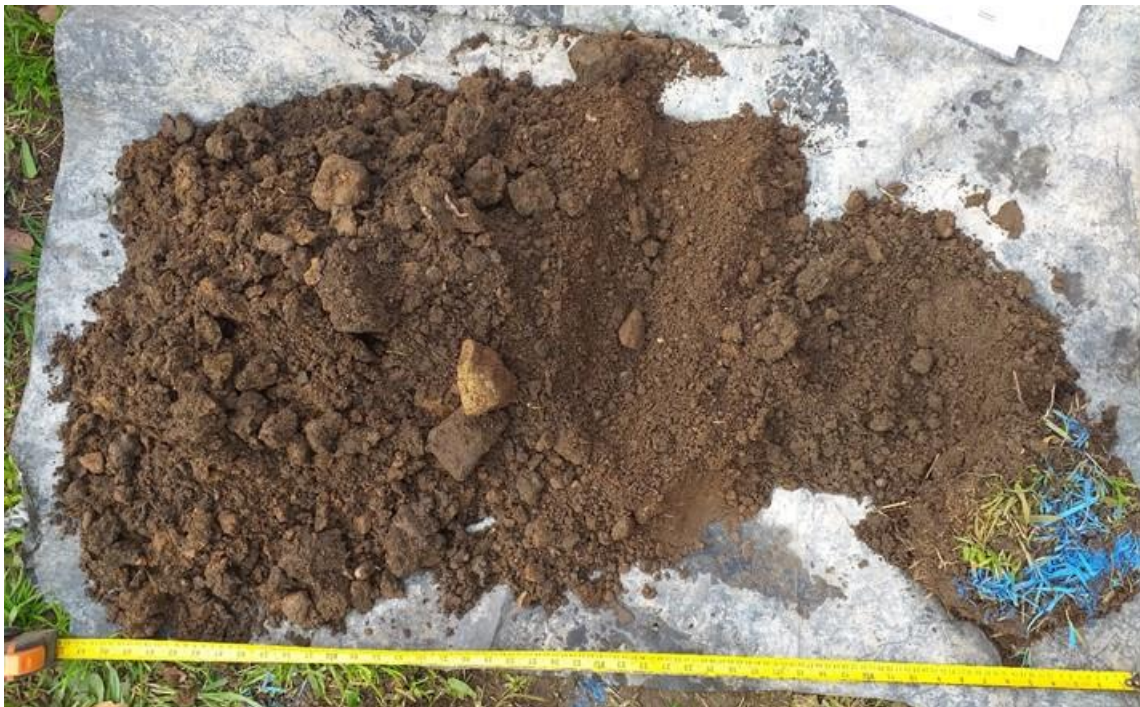
**Photo 6:** HP04 arisings recovered from 0 to 1.02mbgl. Depth below ground increases from right to left of image.

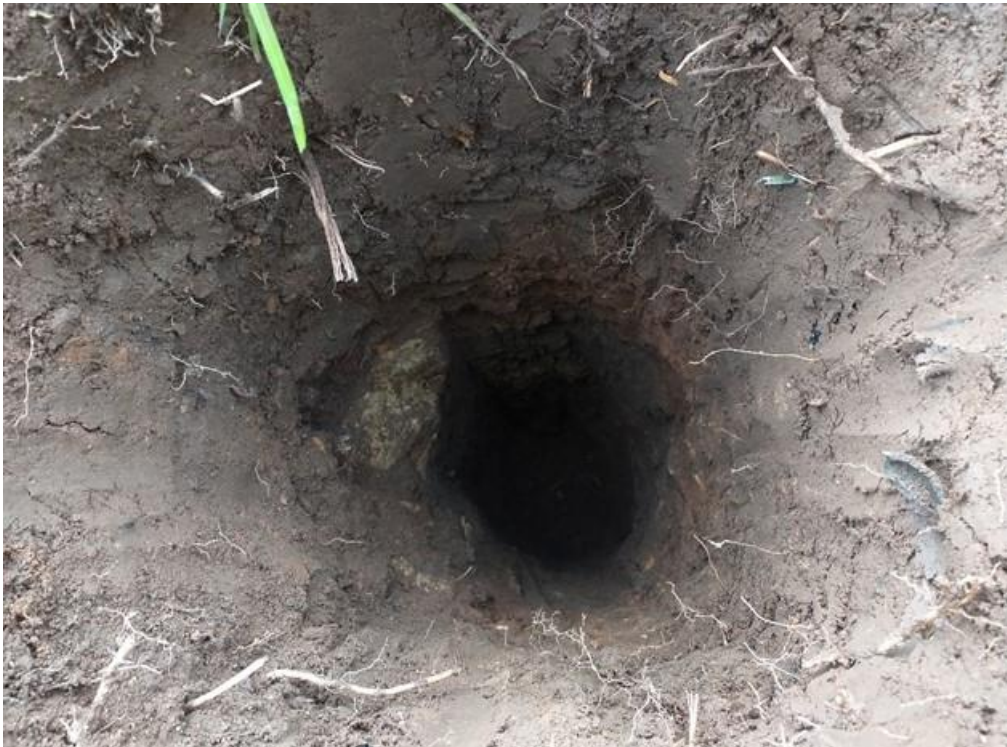
**Photo 7:** HP04 hand pit wall shows occasional concrete or sandstone cobbles seen in made ground between 0.09 and 0.6mbgl.

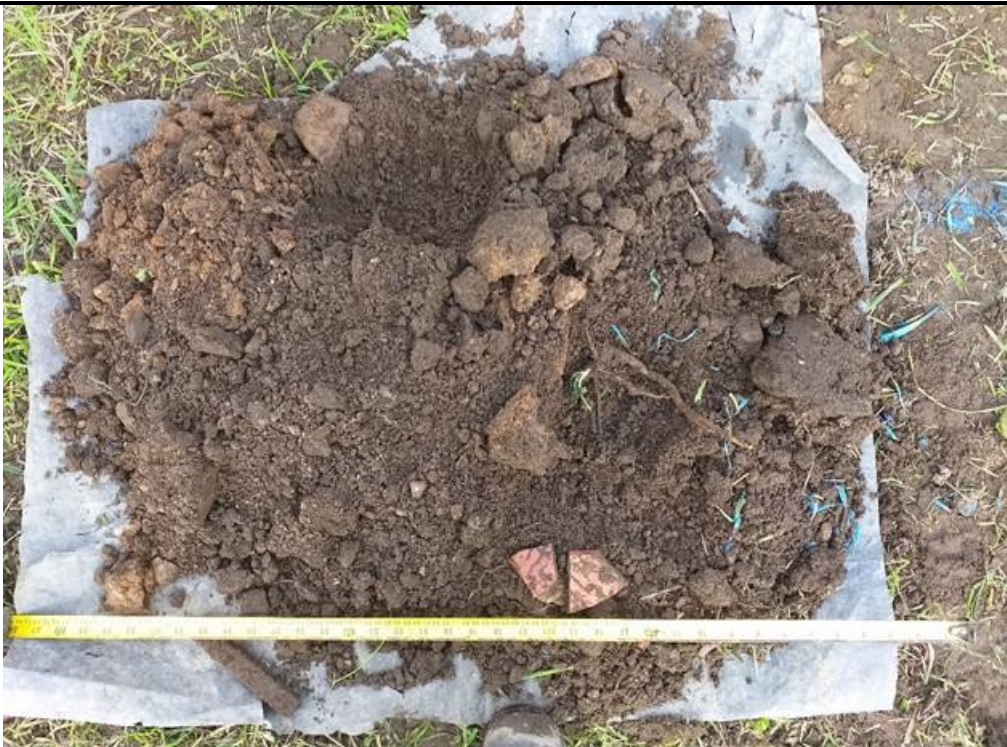
**Photo 8:** HP05 arisings recovered from 0 to 0.75mbgl. Depth below ground increases from right to left of image.

One possible Asbestos Containing Material (ACM) observation was noted during the supplementary hand pit works at HP05 in Made Ground <0.6m bgl. Following laboratory testing on the suspected ACM and surrounding Made Ground soil, it was confirmed by ALS laboratories that the sample did not contain asbestos.

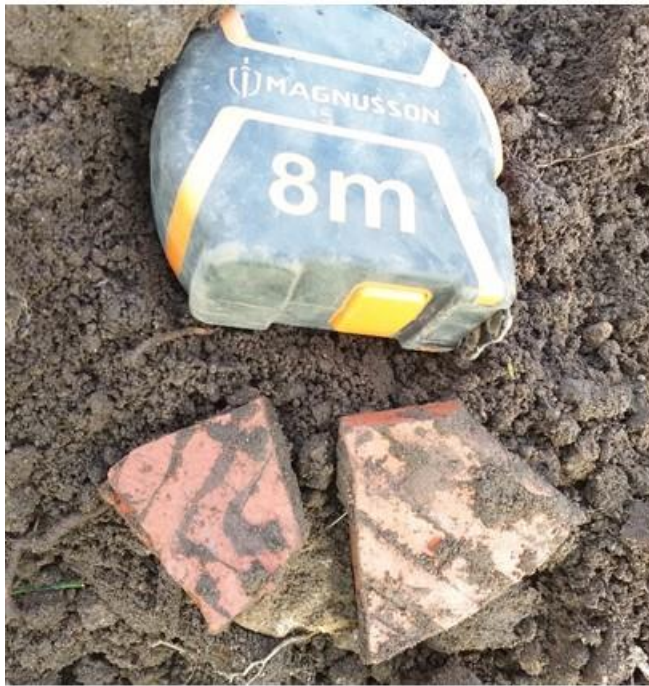
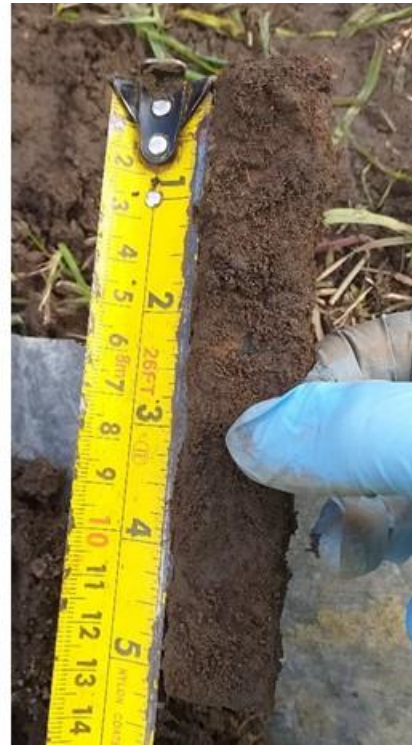
**Photo 9:** HP05 features of interest recovered in made ground (0.05 to 0.6mbgl): left-roof tile fragments. Right-metal bar 0.13m long.

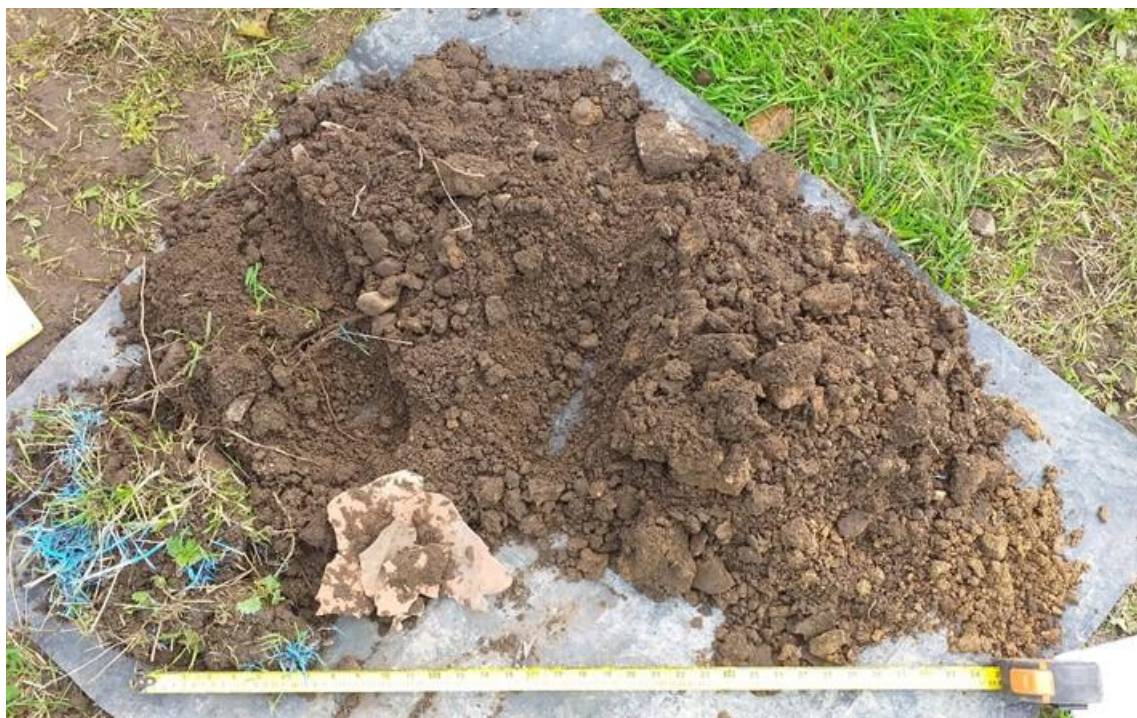
**Photo 10:** HP06 arisings recovered from 0 to 0.6mbgl. Depth below ground increases from left to right of the image.

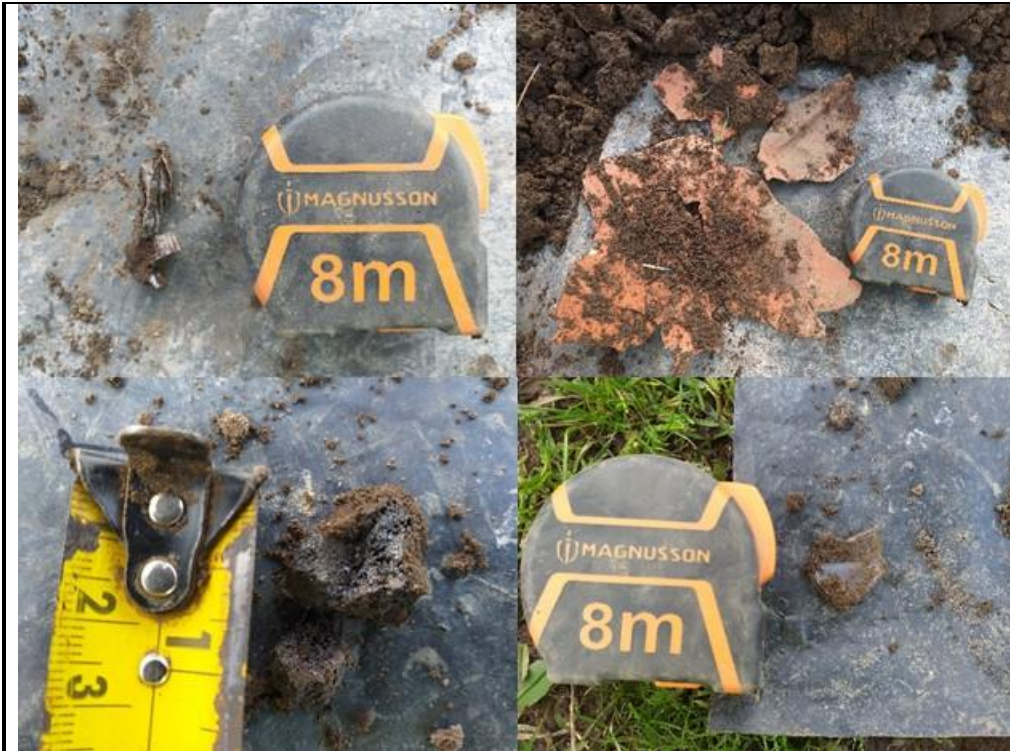
**Photo 11:** HP06 features of interest in made ground (0.05 to 0.55mgb): top left- plastic wrapping, top right-brittle plastic plant pot, bottom left-black combustible material, bottom right-glass fragments.

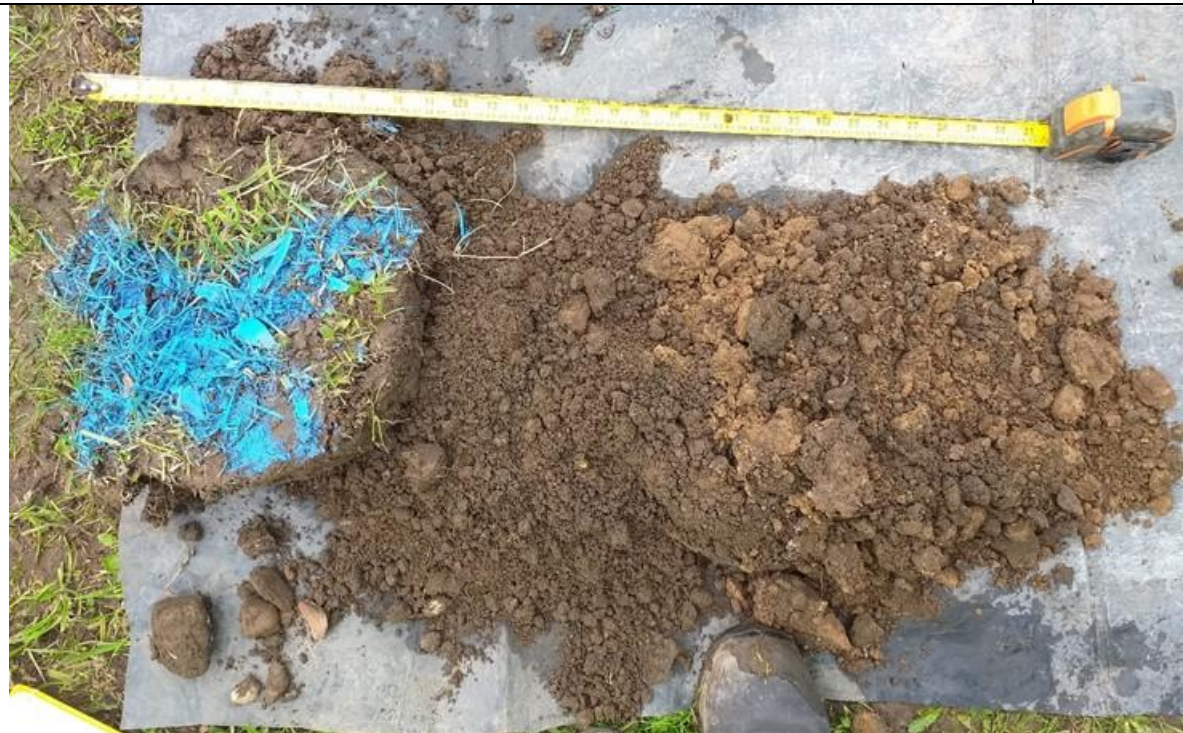
**Photo 12:** HP07 arisings recovered from 0 to 0.4mgb-l-shallow made ground (0.1 to 0.3mgb). Depth below ground increases from left to right of image.

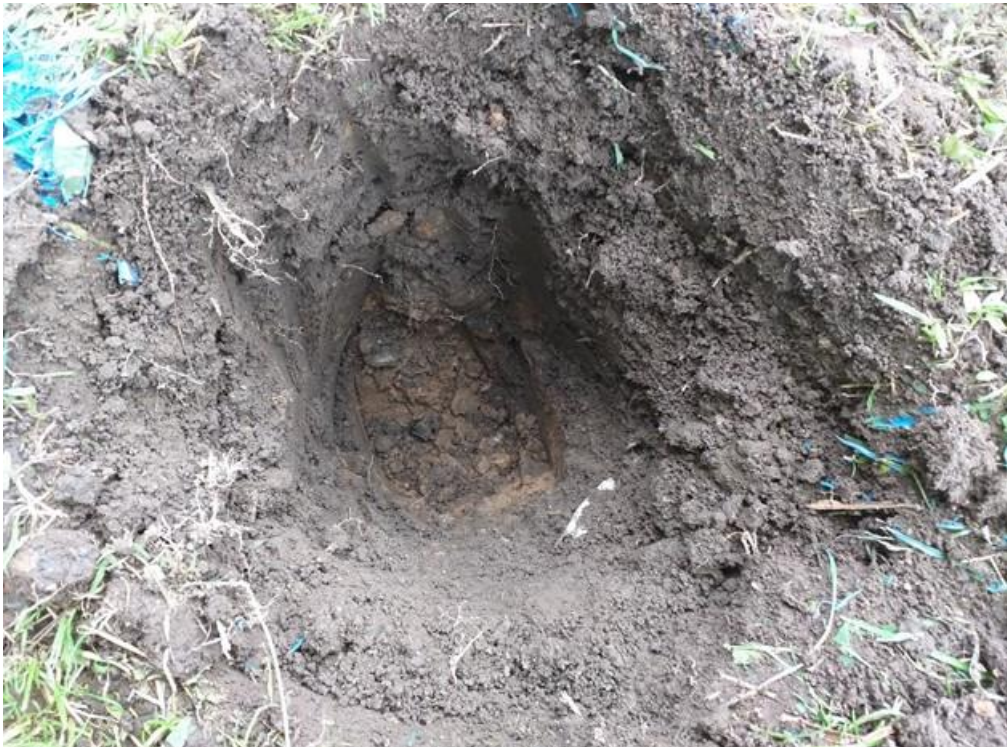
**Photo 13:** HP07 shallow made ground, natural material clearly visible at base of hand pit.

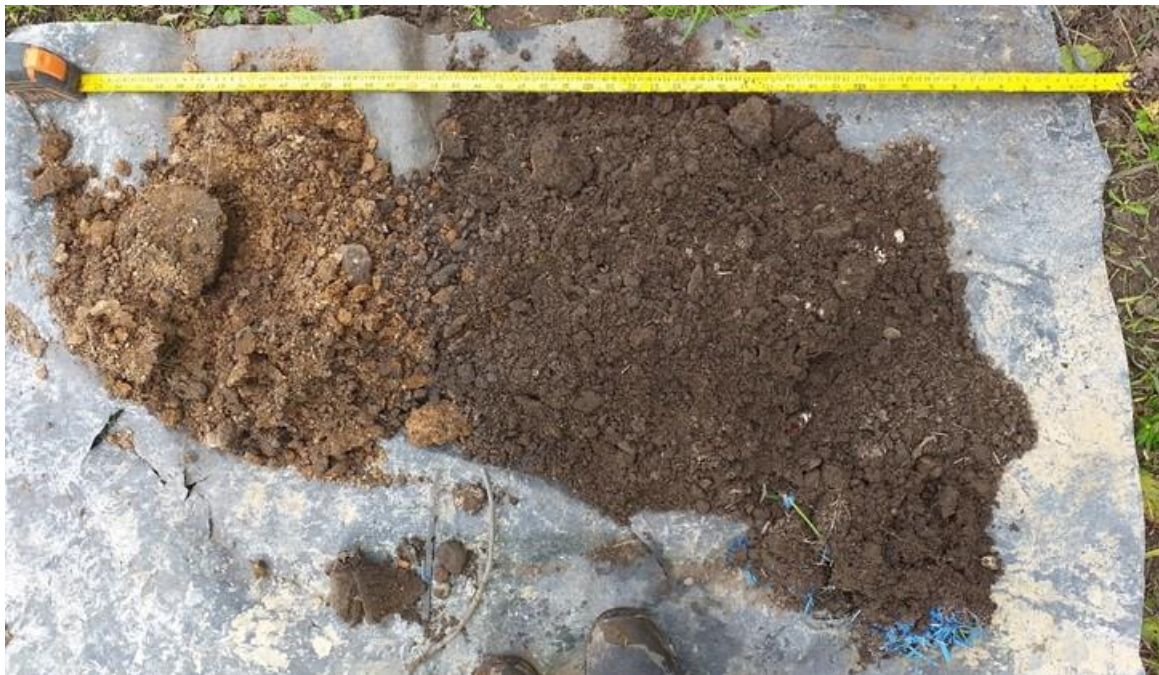
**Photo 14:** HP08 arisings recovered from 0 to 0.63mbgl. Depth below ground increases from right to left of image.

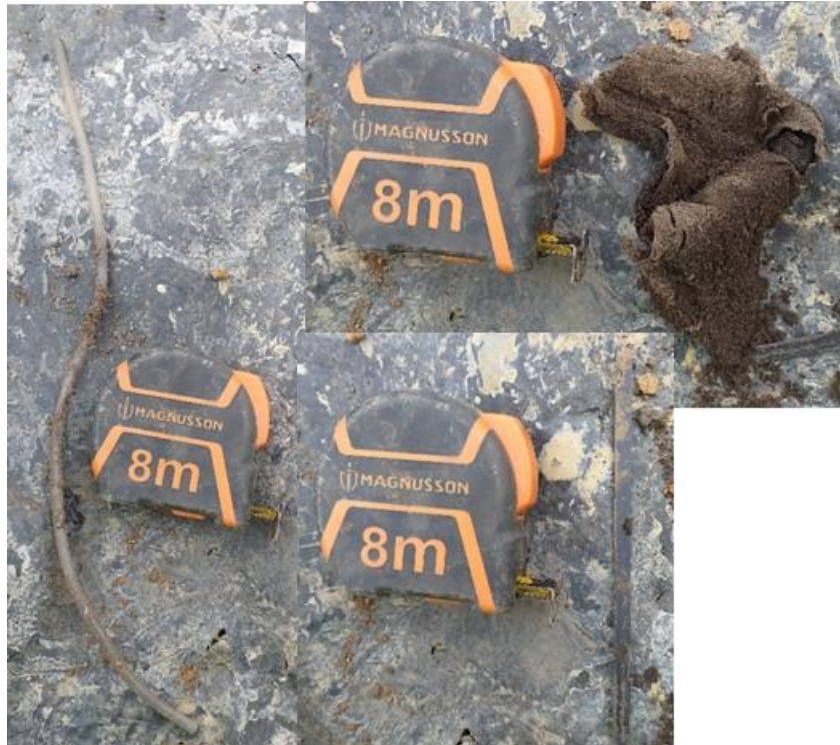
**Photo 15:** HP08 features of interest: left- 5mm diameter plastic tubing found near surface (0.05mbgl). In the made ground (0.07 to 0.4mbgl): top right- fabric, bottom right-metal bar.

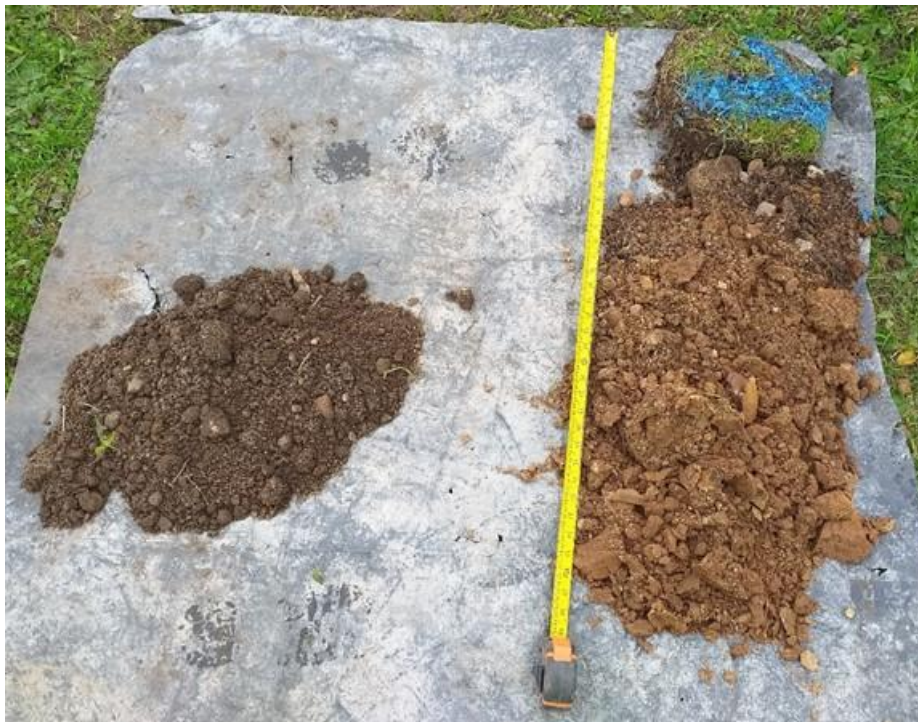
**Photo 16:** HP09 arisings recovered from 0 to 0.53mbgl. Depth below ground increases from top to bottom of image.

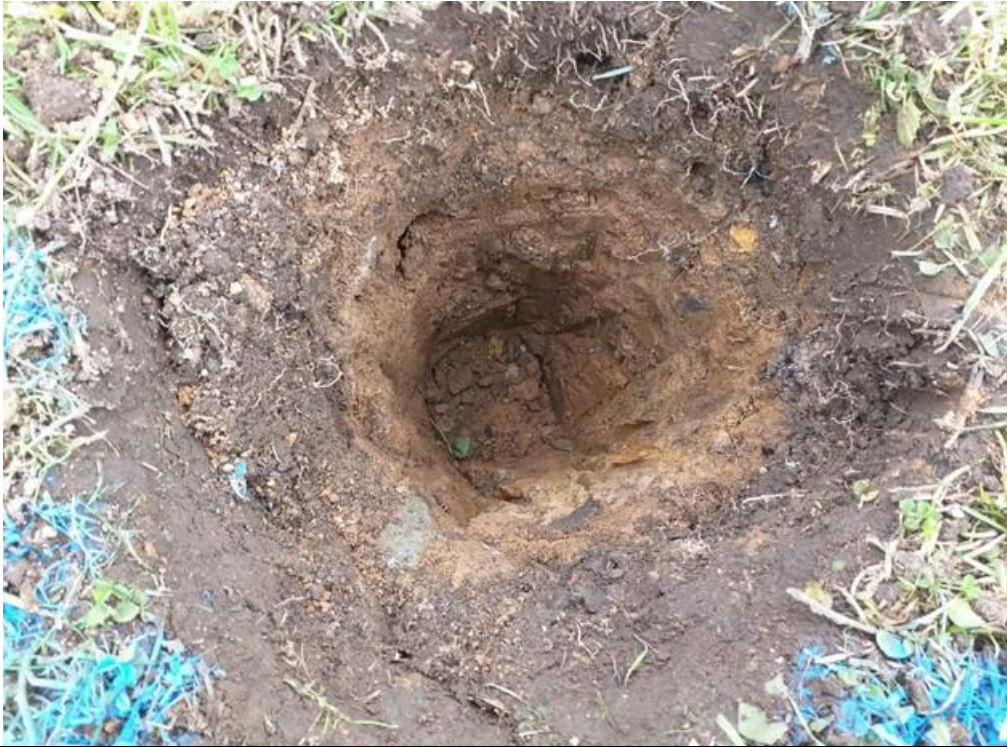
**Photo 17:** Shallow made ground (0.09 to 0.2mbgl) in HP09, natural material clearly visible in hand pit.

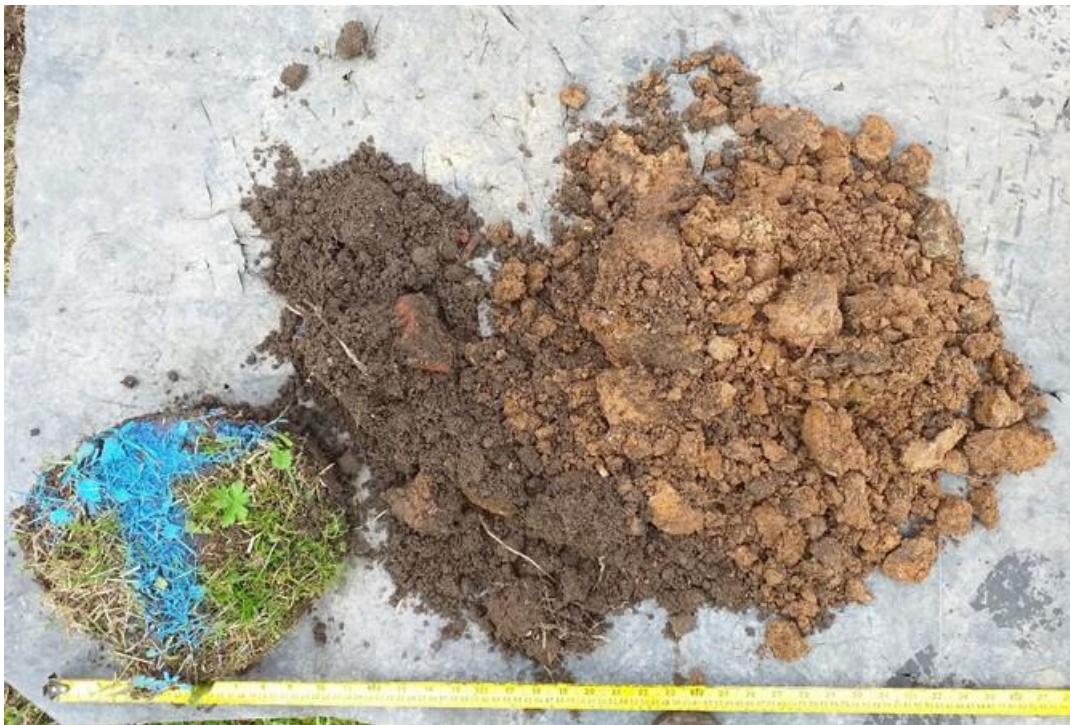
**Photo 18:** HP10 arisings recovered from 0 to 0.5mbgl. Depth below ground increases from left to right of image.

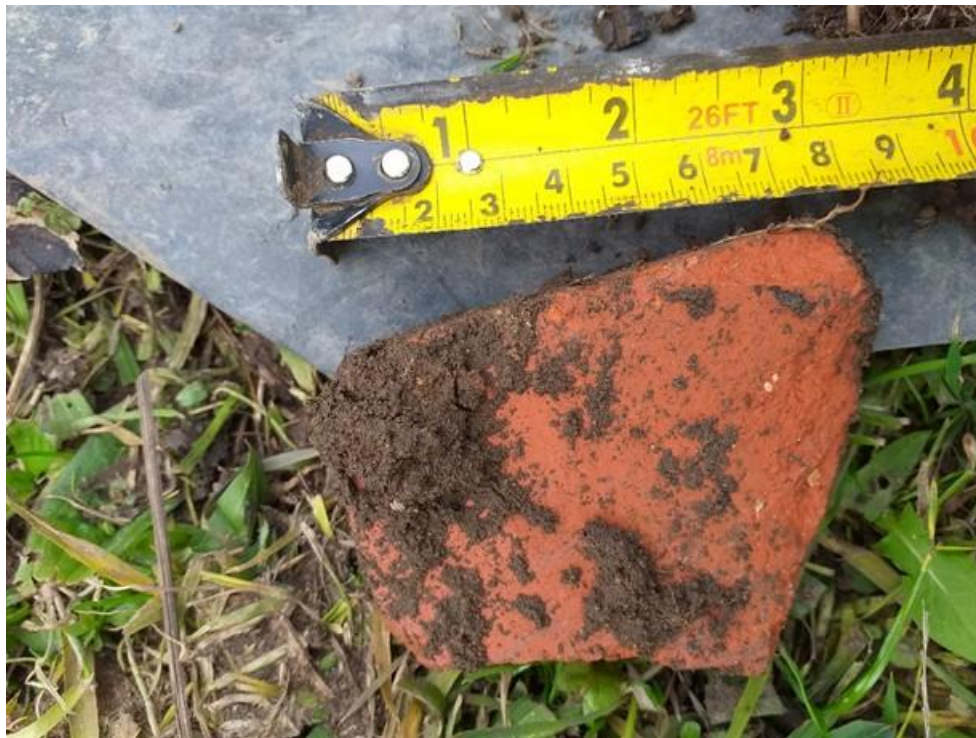
**Photo 19:** HP10 rare cobbles of brick in made ground (0.08 to 0.25mbgl).

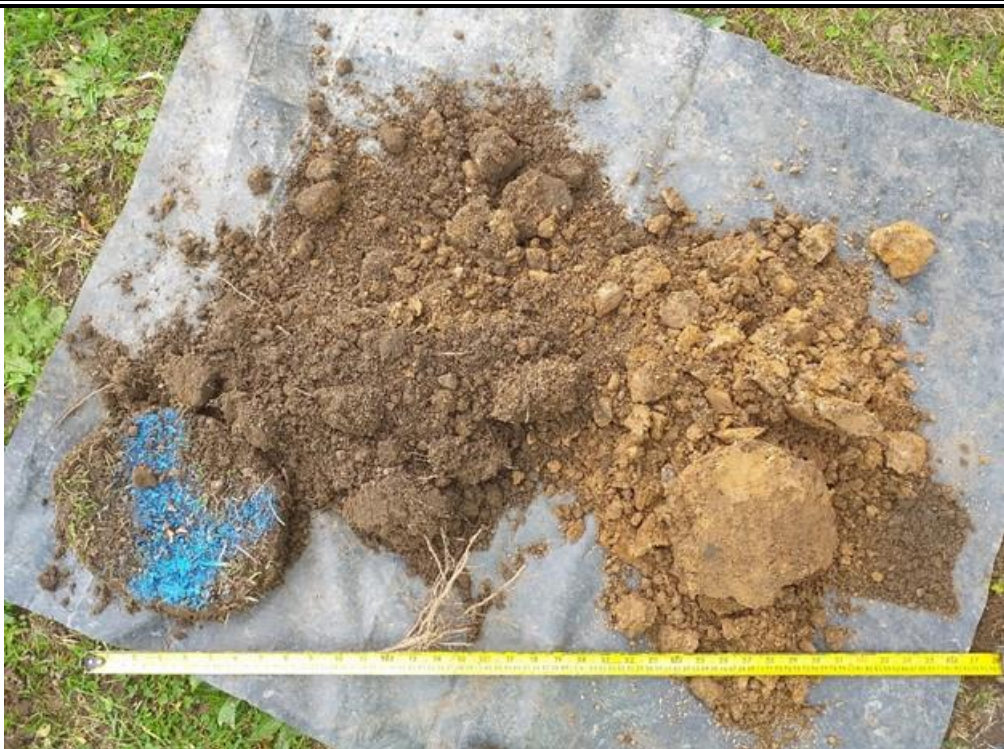
**Photo 20:** HP11 arisings recovered from 0 to 0.5mbgl. Depth below ground increases from left to right of image.

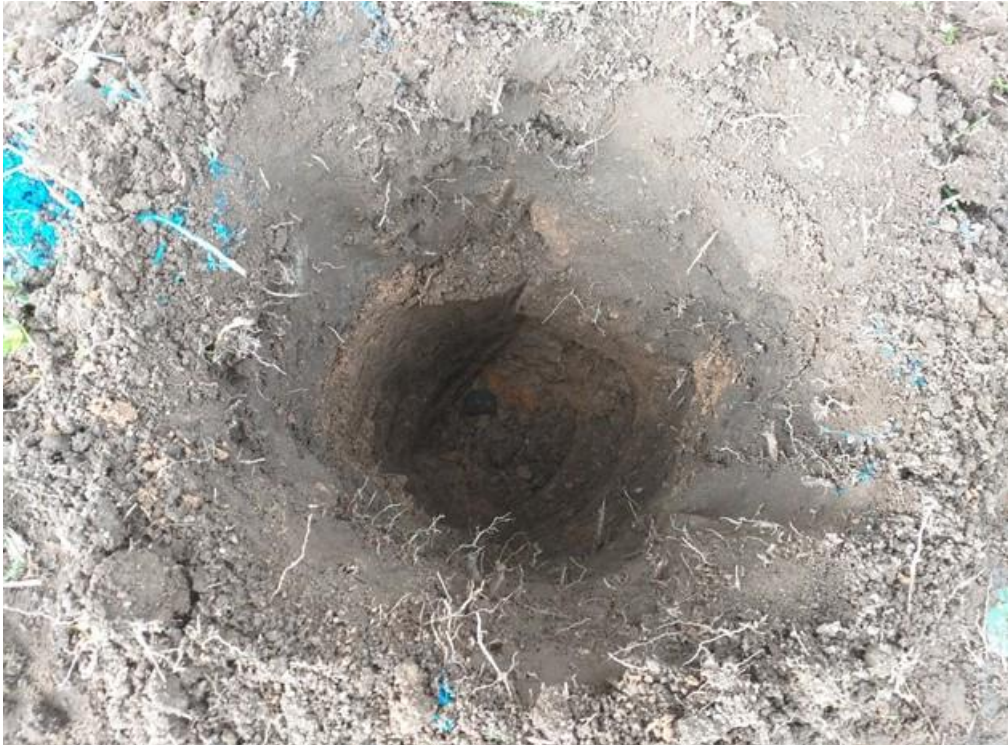
**Photo 21:** HP11 shallow made ground (0.05 to 0.25mbgl) so natural material is visible in hand pit.

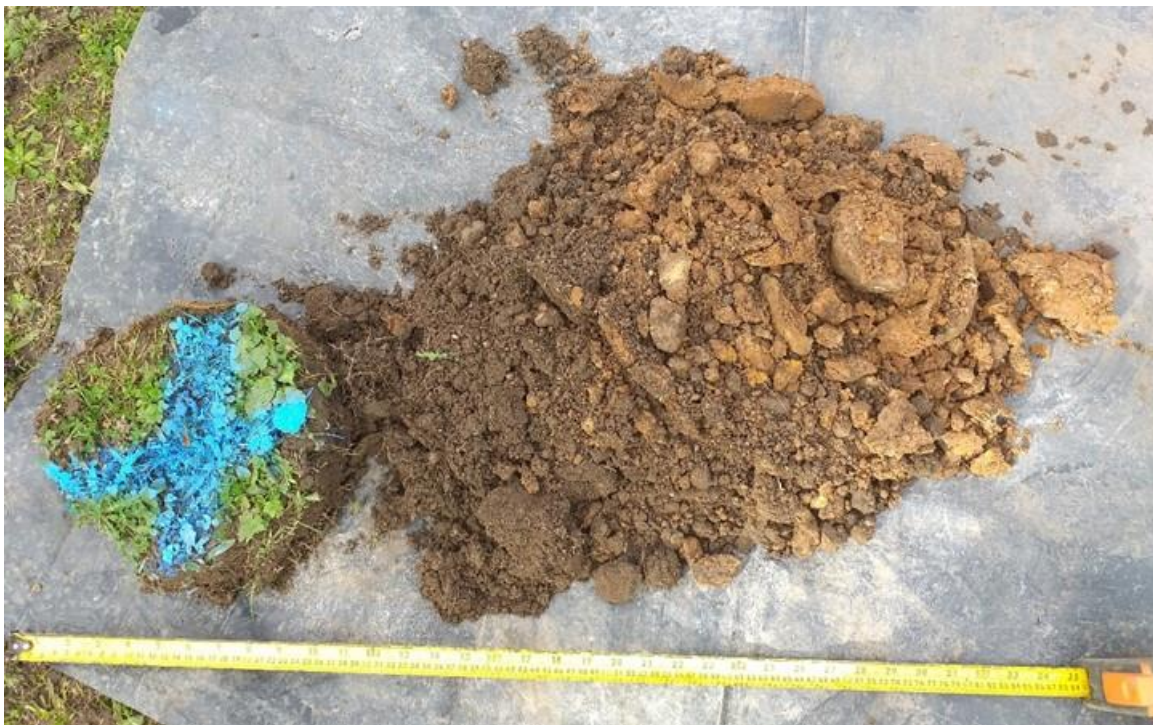
**Photo 22:** HP12 arisings recovered from 0 to 0.4mbgl. Depth below ground increases from left to right of image.

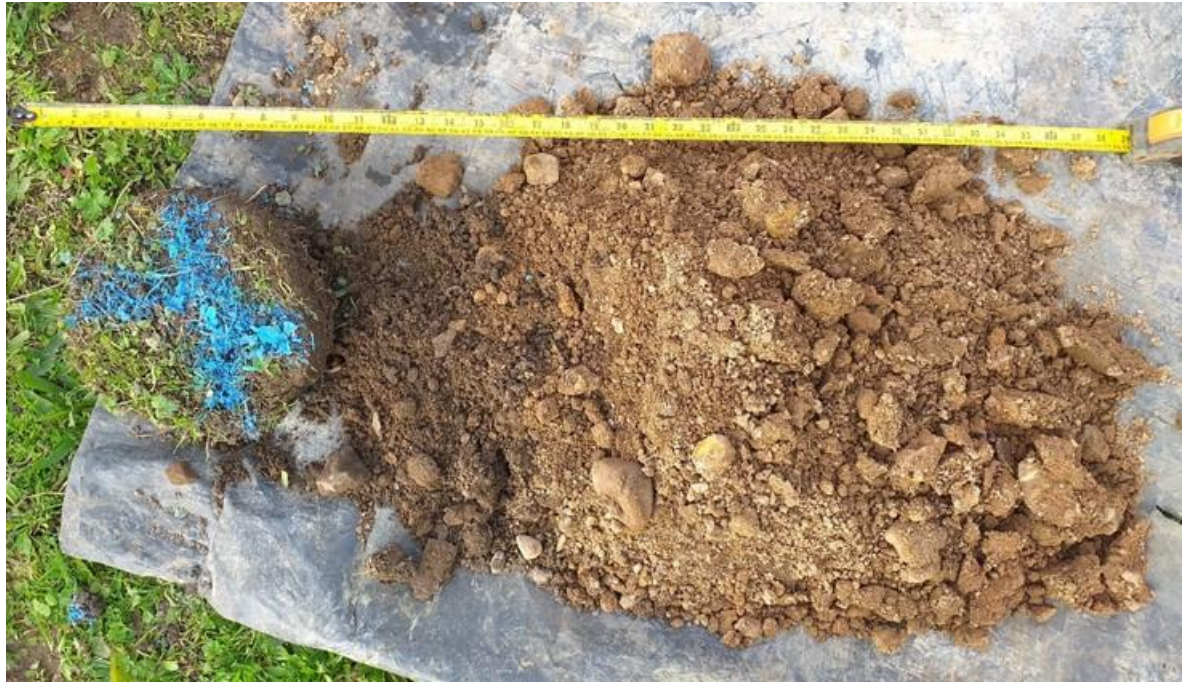
**Photo 23:** HP13 arisings recovered from 0 to 0.45mblg. Depth below ground increases from left to right of image.

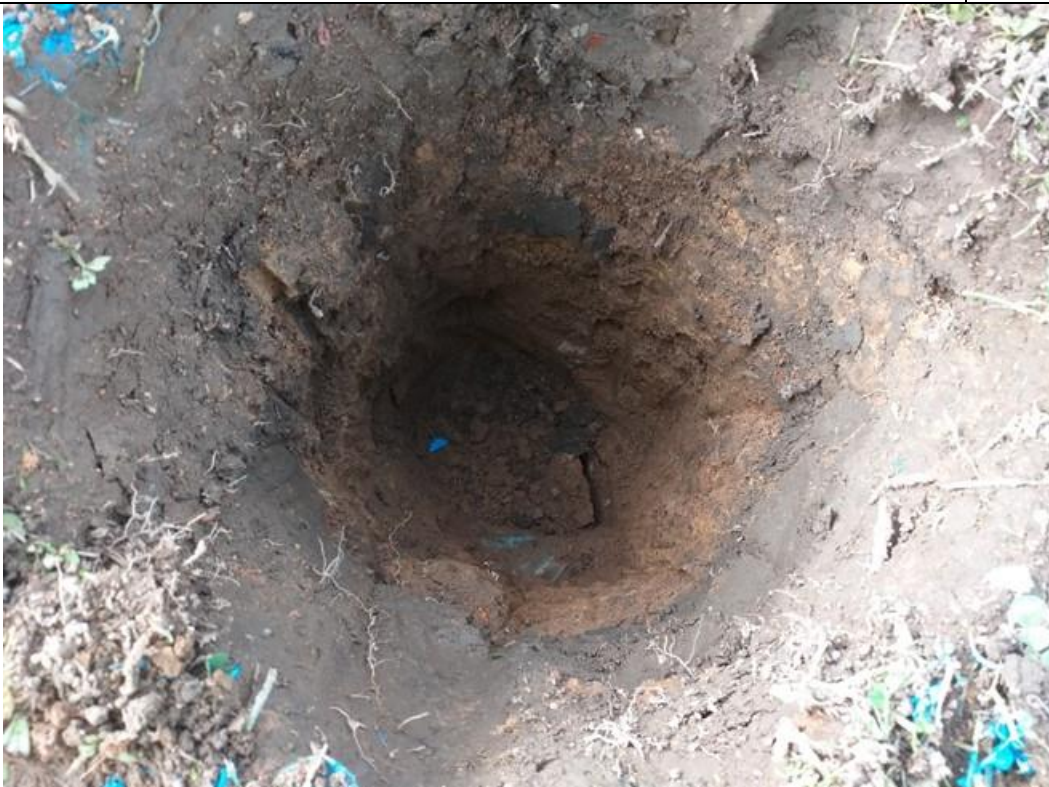
**Photo 24:** HP13 orangish brown natural material visible below shallow (0.08 to 0.2mblg) made ground.

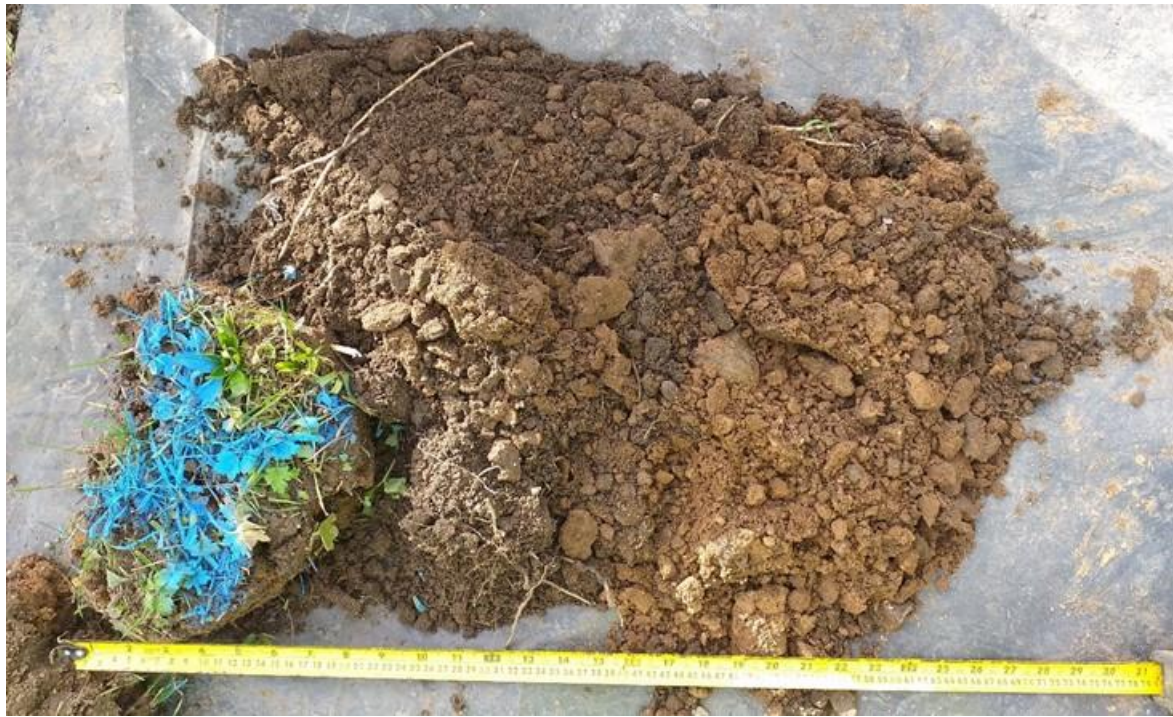
**Photo 25:** HP14 arisings recovered from 0 to 0.4mbgl. Depth below ground increases from left to right of image.

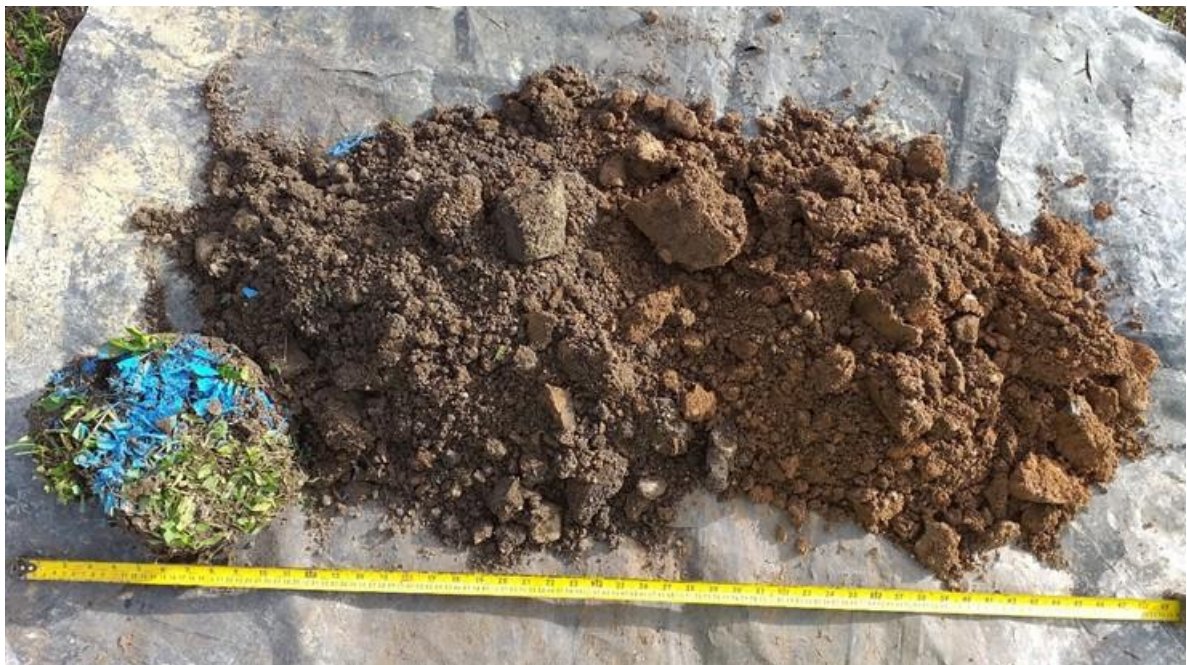
**Photo 26:** HP15 arisings recovered from 0 to 0.6mbgl. Depth below ground increases from left to right of image.

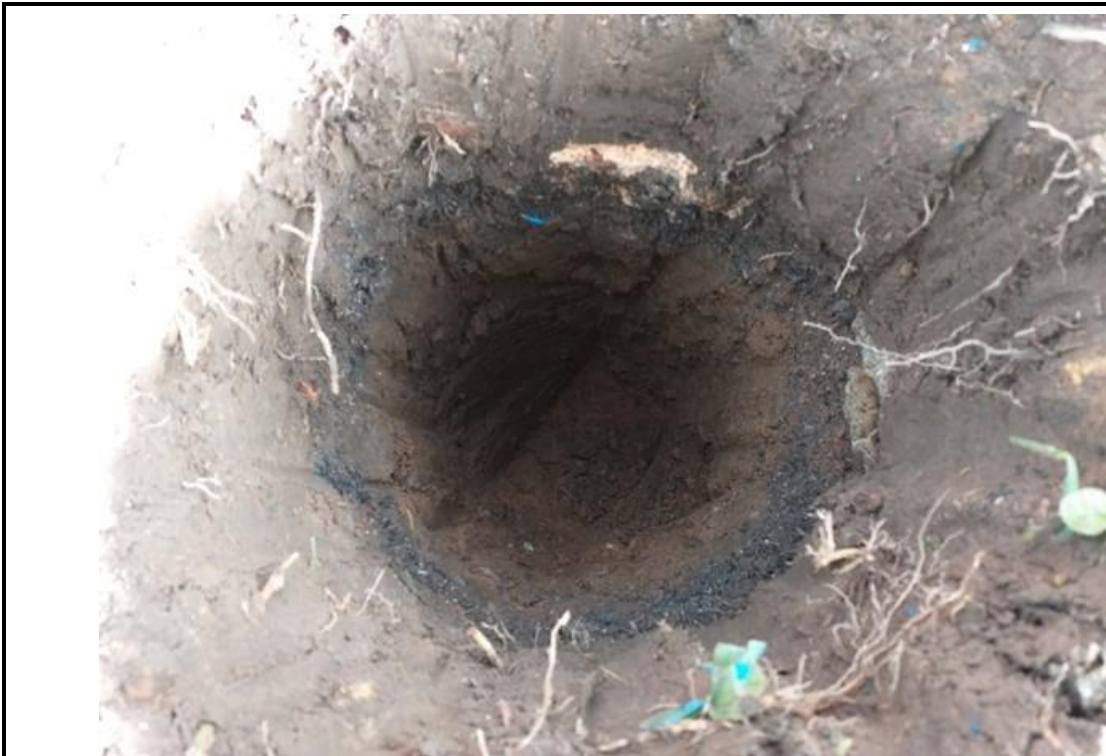
**Photo 27:** HP15 greyish black ashy horizon visible at 0.2 to 0.25mbgl within made ground (0.09 to 0.3mbgl). Orangish brown natural material visible below made ground (0.3 to 0.6mbgl).

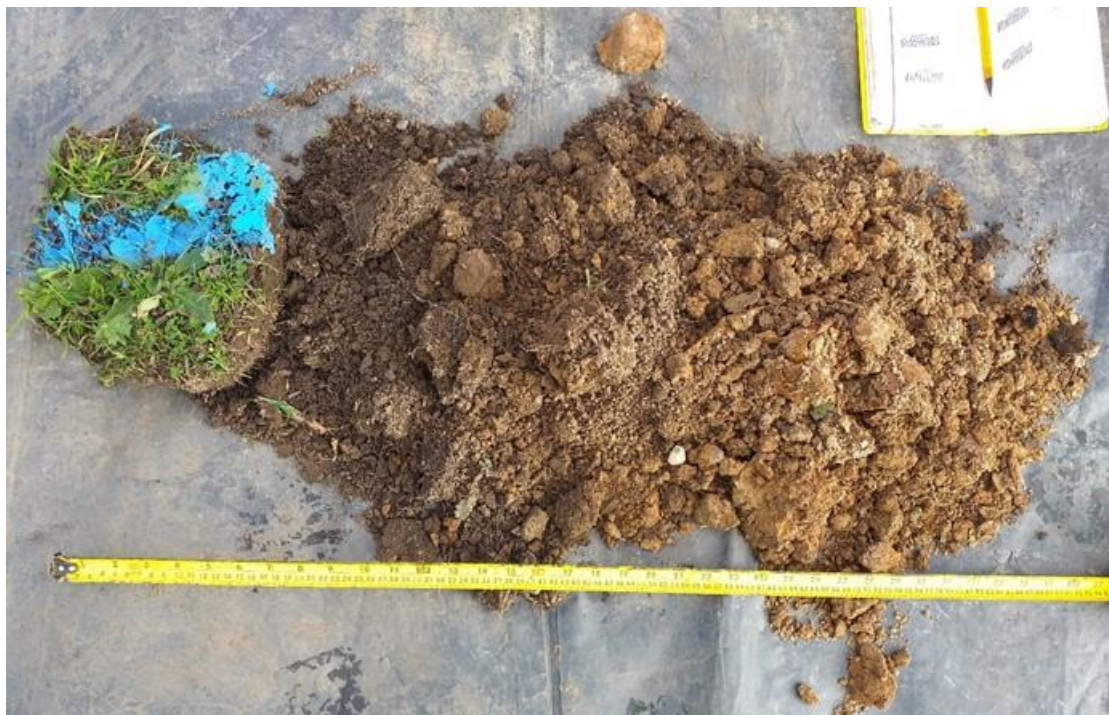
**Photo 28:** HP16 arisings recovered from 0 to 0.47mbgl. Depth below ground increases from left to right of image.
