Our Ref: 70079705 / 11901(2)  
10 August 2023  
PUBLIC

**Re: Remediation Strategy for Land off Heol Offa, Johnstown, Wrexham, LL14 2BD**

This document comprises a combined Remediation Options Appraisal (ROA) and Remediation Strategy (RS), providing an appraisal of the available options for remediation of the soil. This letter report follows current guidance for contamination land assessment and management. The ROA and RS are required to discharge planning conditions, under planning application P/2021/1018.

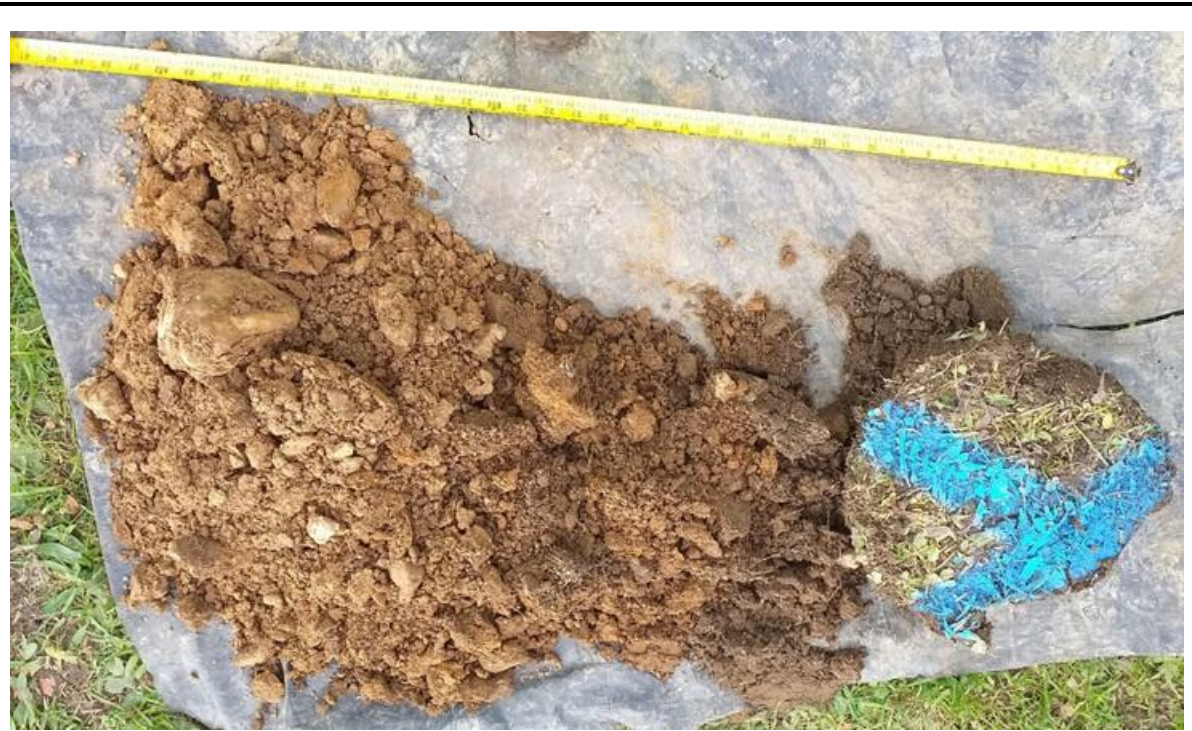
**Photo 29:** HP17 arisings recovered from 0 to 0.6mbgl. Depth below ground increases from right to left of image.

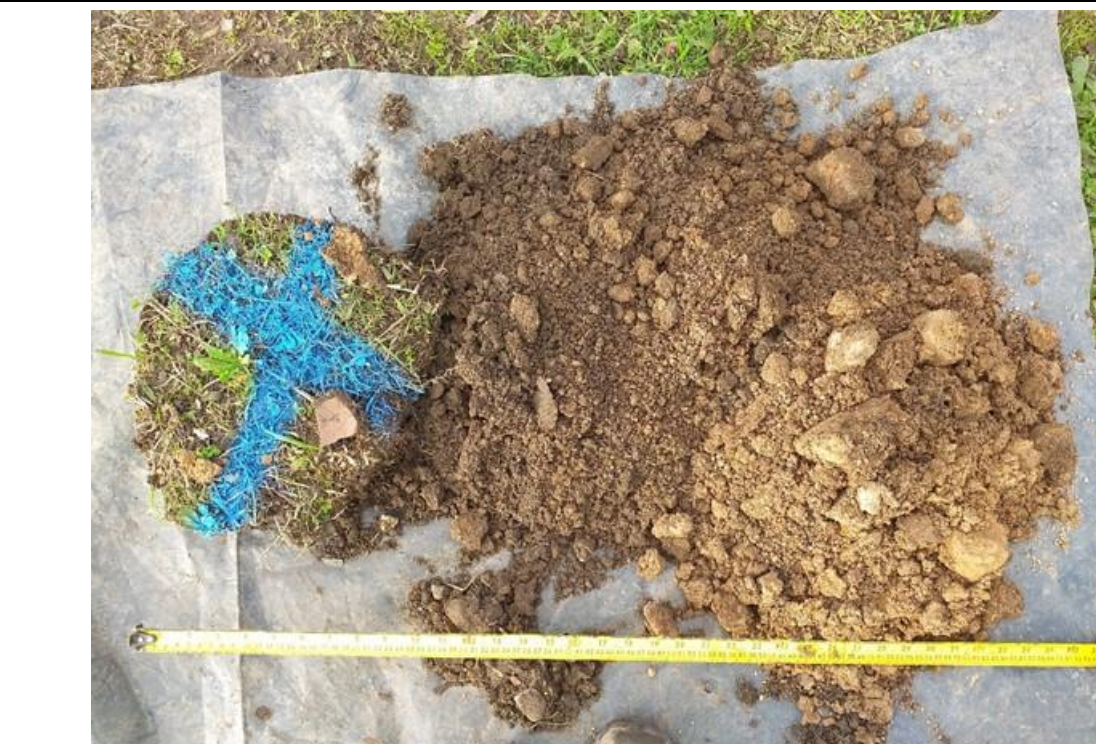
**Photo 30:** HP18 arisings recovered from 0 to 0.6mbgl. Depth below ground increases from left to right of image.

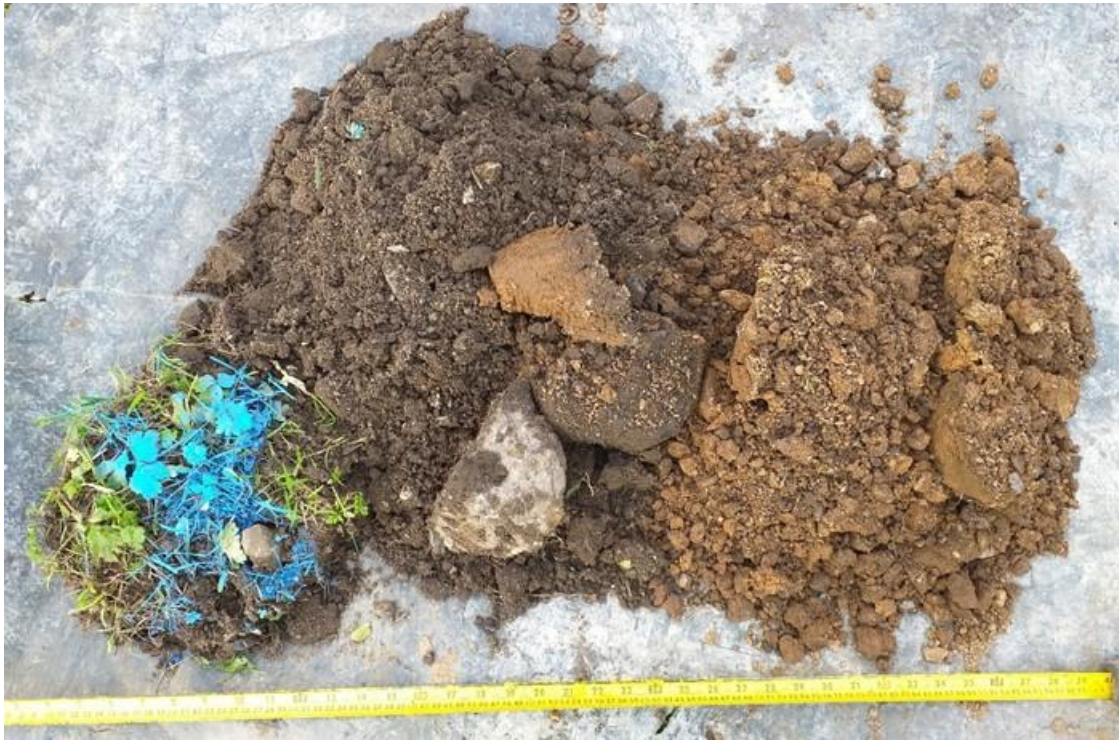
**Photo 31:** HP19 arisings recovered from 0 to 0.55mbgl. Depth below ground increases from left to right of image.

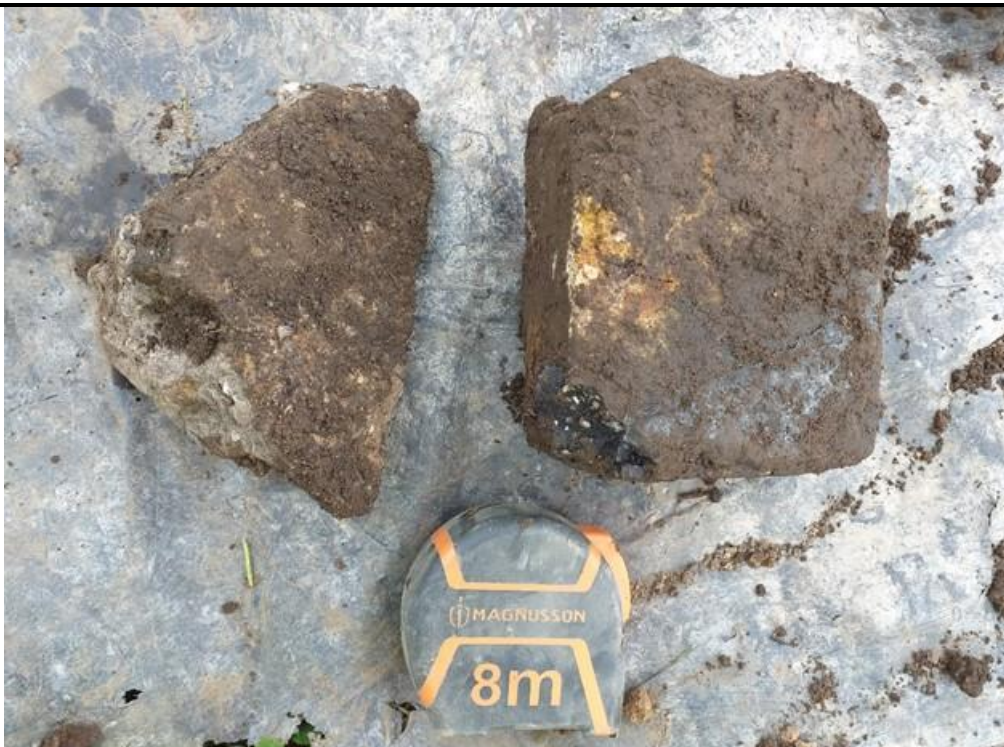
**Photo 32:** HP19 features of interest: rare cobbles of concrete (left) and brick (right) found in made ground (0.06 to 0.35mbgl).

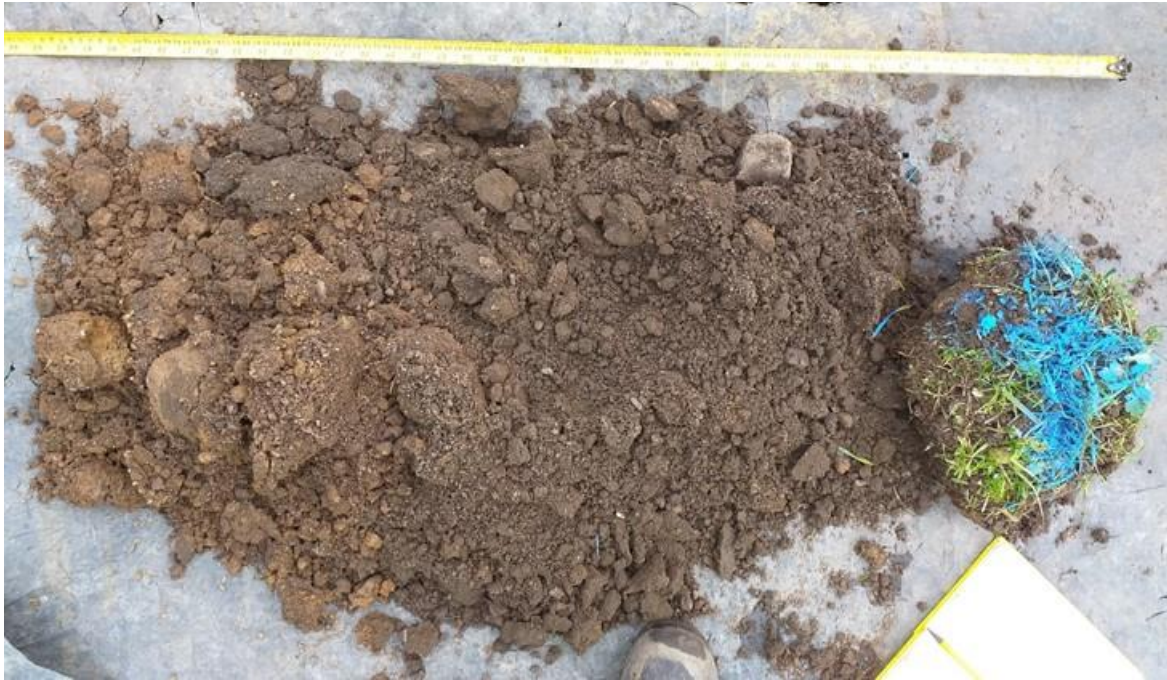
**Photo 33:** HP20 arisings recovered from 0 to 0.7mbgl. Depth below ground increases from right to left of image.

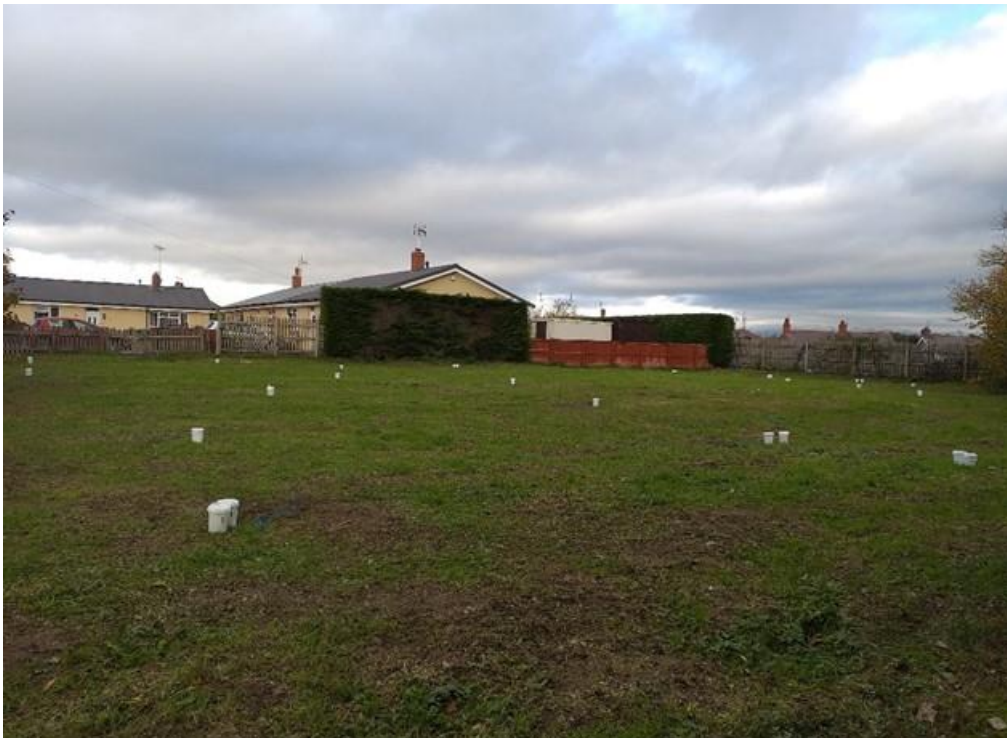
**Photo 34:** Spread of hand pit locations across site (soil samples taken at all locations).
