# EXTENDED PHASE 1 HABITAT SURVEY & DAYTIME BAT SURVEY

TYN Y COED, CHESTER ROAD,  
ROSSETT, WREXHAM

APRIL 2022

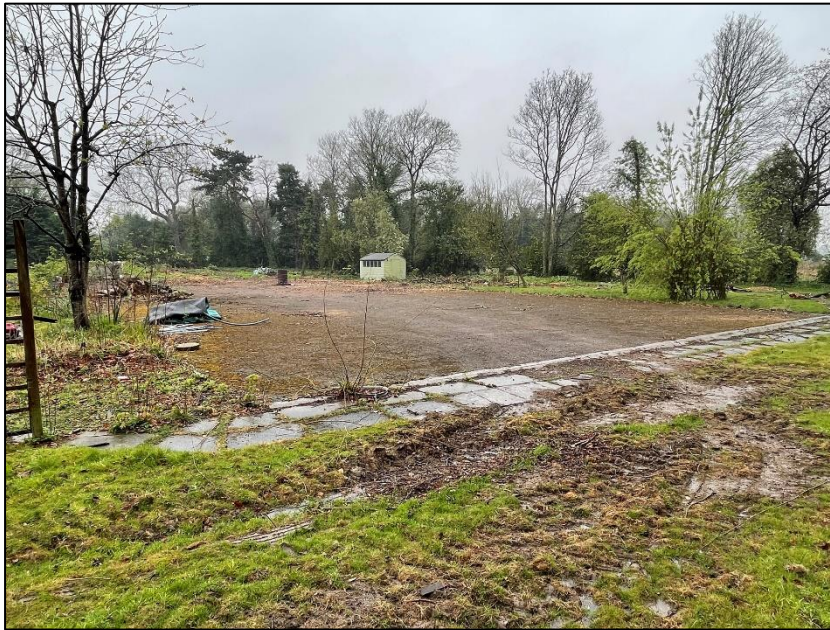
- 3.2 The site supports hardstanding, at the disused tennis court (see Photograph 1), access driveway and parking areas. Much of the vegetation, including trees, on site has been recently cleared and this has left bare ground (see Photograph 2).

*Photograph 1 showing the hardstanding at the tennis court*

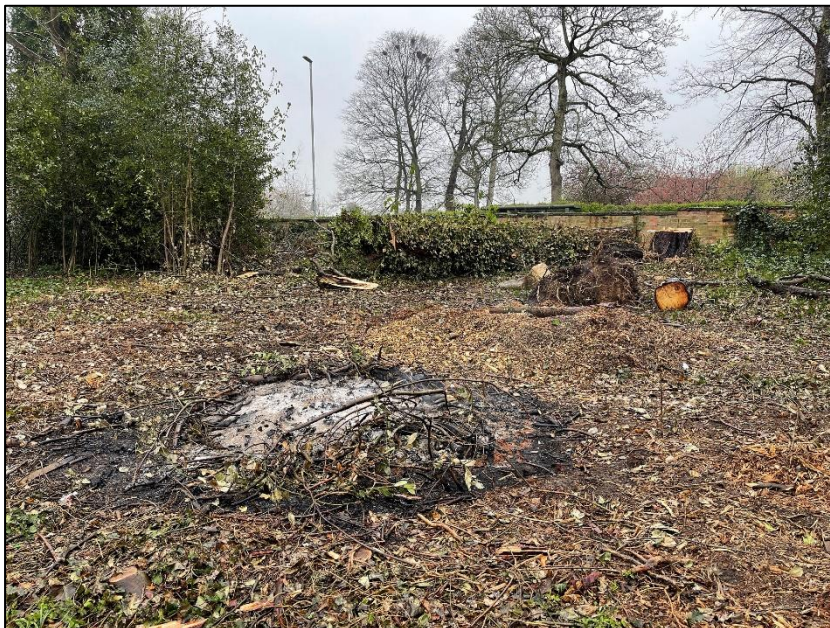
*Photograph 2 showing the cleared bare ground on site*

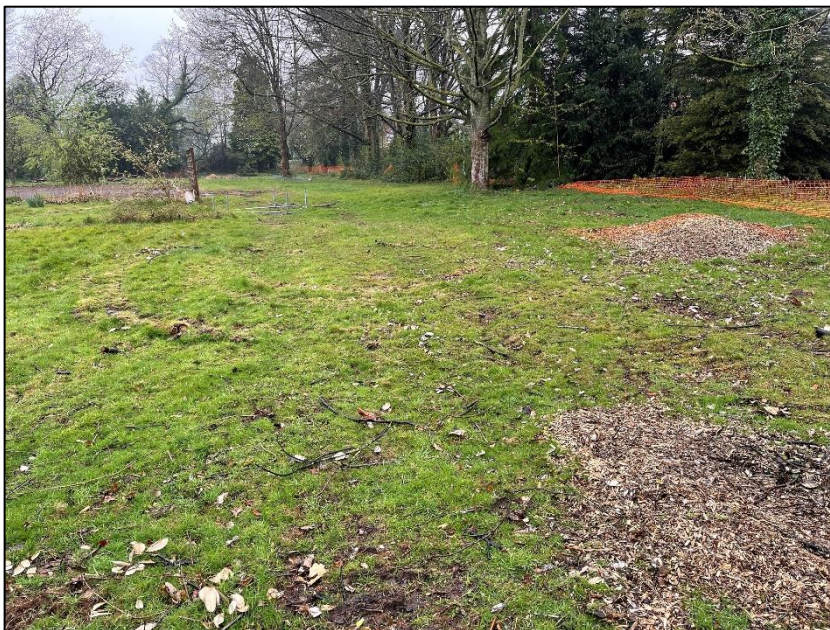
- 3.3 Amenity grassland occurs across a lot of the site, as mown lawns (see Photograph 3). The habitat is species-poor and include mostly Perennial Rye-grass *Lolium perenne* with Annual Meadow-grass *Poa annua*, Creeping Buttercup *Ranunculus repens* and Red Fescue *Festuca rubra*.

Photograph 3 showing the amenity grassland

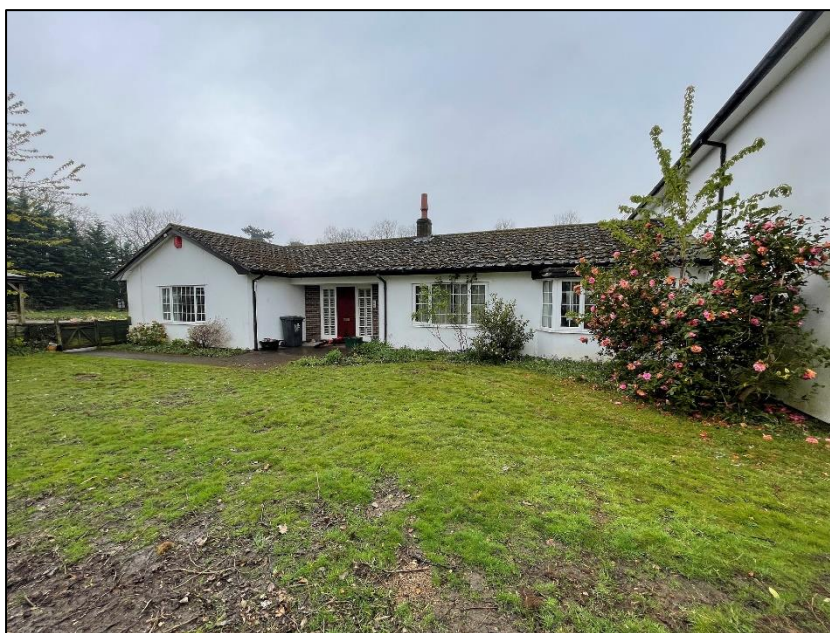
- 3.4 Small shrub beds occur on site (see Photograph 3). These include amenity varieties such as roses, conifers and bulbs.

Photograph 4 showing the one of the shrub beds

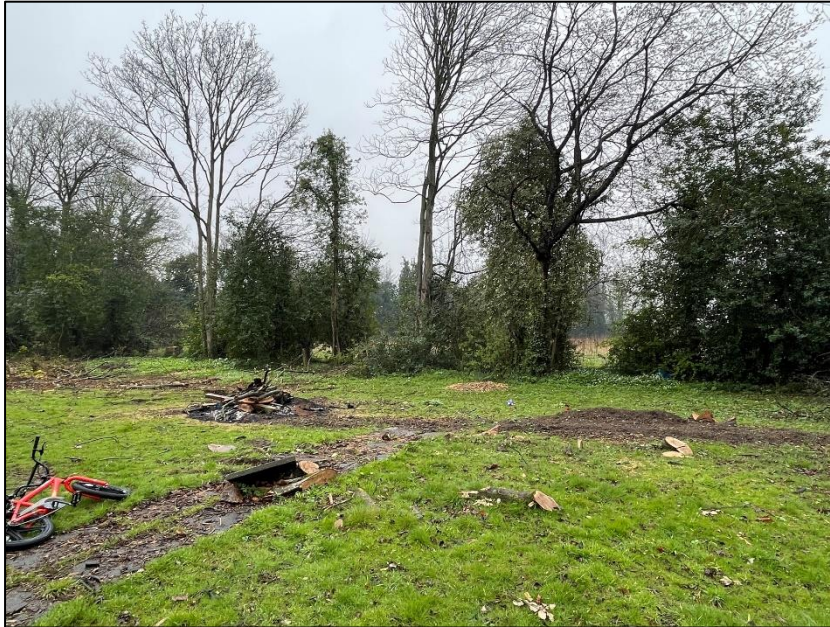
- 3.5 A belt of coniferous and deciduous trees exists along the western and part of the southern boundary (see Photographs 5 and 6). These include Lawson's Cypress *Chamaecyparis lawsoniana*, Sycamore *Acer pseudoplatanus*, Variegated Holly *Ilex* var., Cherry *Prunus* var., Hemlock *Tsuga* sp. and Leyland Cypress *C. x leylandii*.

Photograph 5 showing the plantation woodland belt along the western boundary

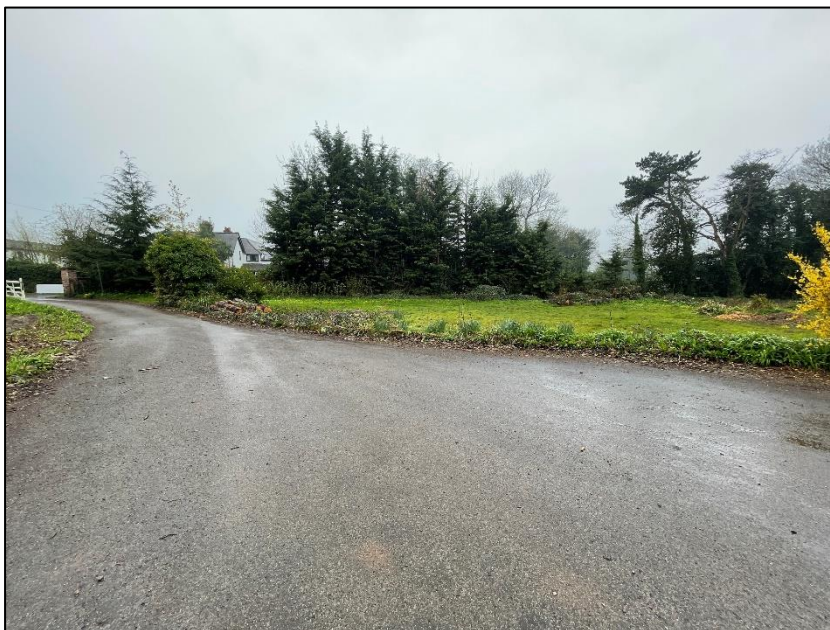
Photograph 6 showing plantation woodland belt along the southern boundary

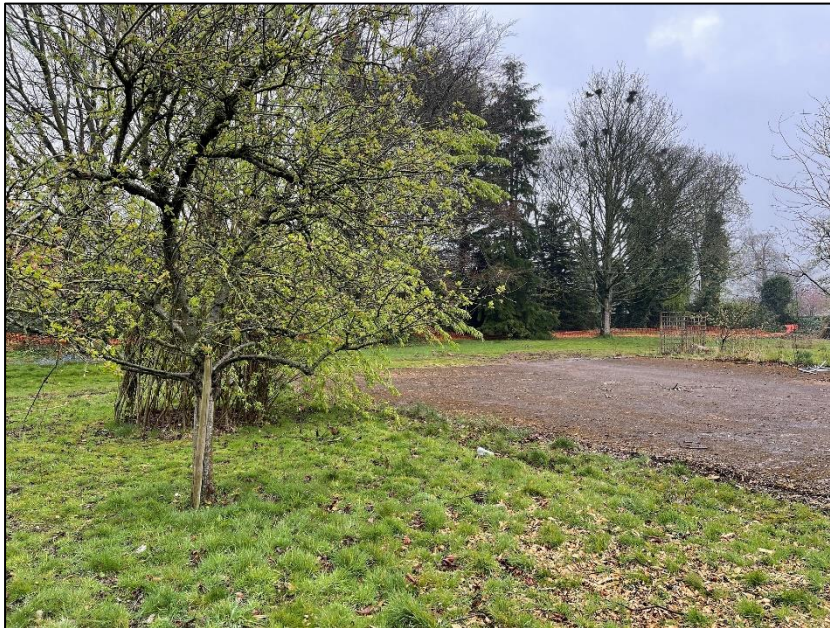
- 3.7 A small number of scattered trees exist on site, including fruit trees and trees that form part of a deeper tree belt along the northern boundary (see Photograph 7). Species include Sycamore *Acer pseudoplatanus*, Apple *Malus* var. and Beech *Fagus sylvatica*.

Photograph 7 showing the scattered trees

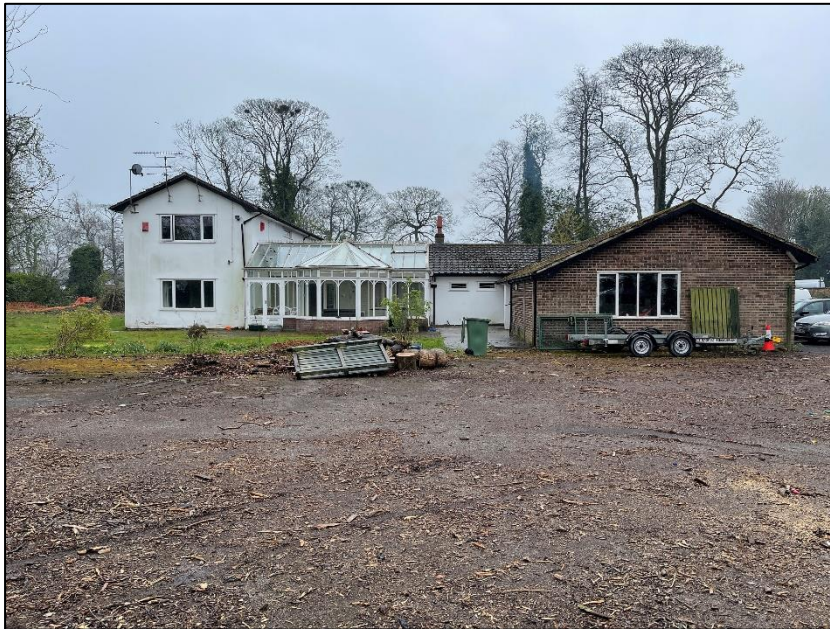
- 3.13 The dwelling is part single-storey and part double-storey, with an attached garage and is in use. It is constructed of brick, which has been mostly rendered and painted white. The garage remains as exposed brick (see Photographs 8 and 9). The brickwork and render are in good condition, with no missing bricks or mortar. The window panes are all intact and the window and door frames are flush to the surrounding masonry. A glass conservatory exists at the rear and this is also intact.

*Photograph 8 showing the exterior of the dwelling at the rear*

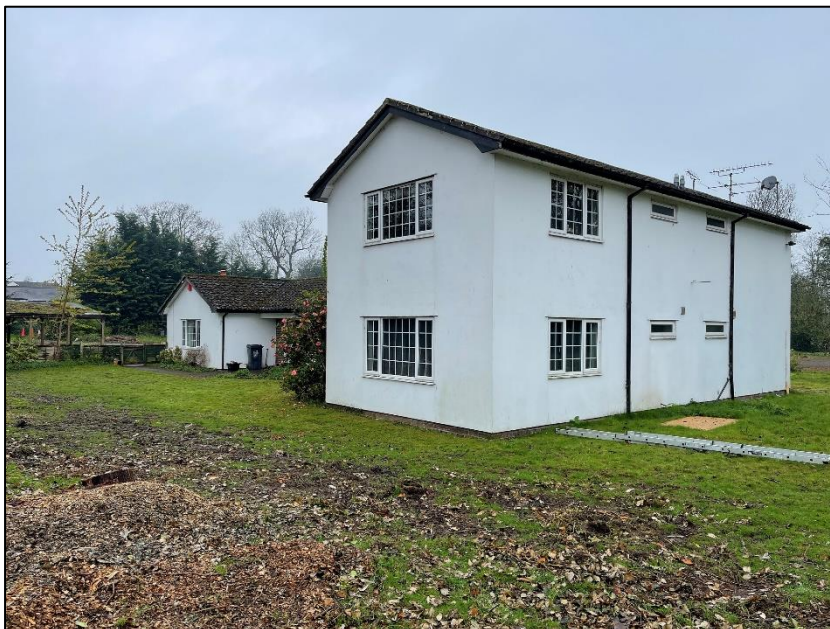
*Photograph 10 showing the front of the dwelling*

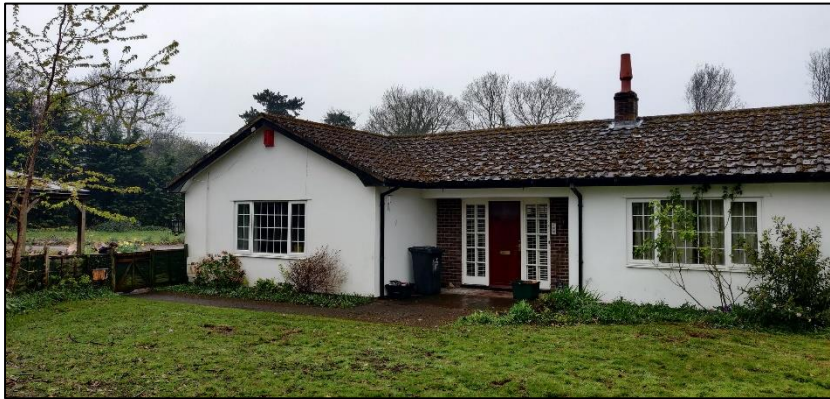
- 3.14 The building has pitched, tiled roofs (see Photographs 10 and 11). All tiles are in place, with no missing or slipped tiles. Most are covered in moss. Where chimneys and ventilation pipes occur, the lead flashing is intact and flush to the tiles. The chimney stacks are intact.

*Photograph 10 showing the roof at the front of the dwelling*

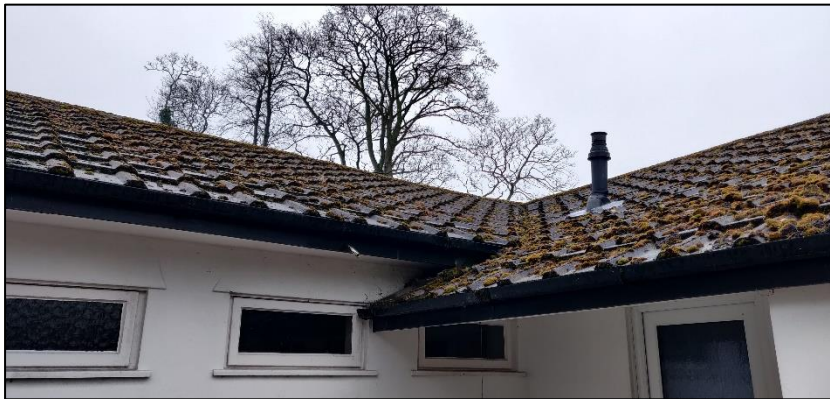
*Photograph 11 showing the roof at the rear as well as lead flashing*

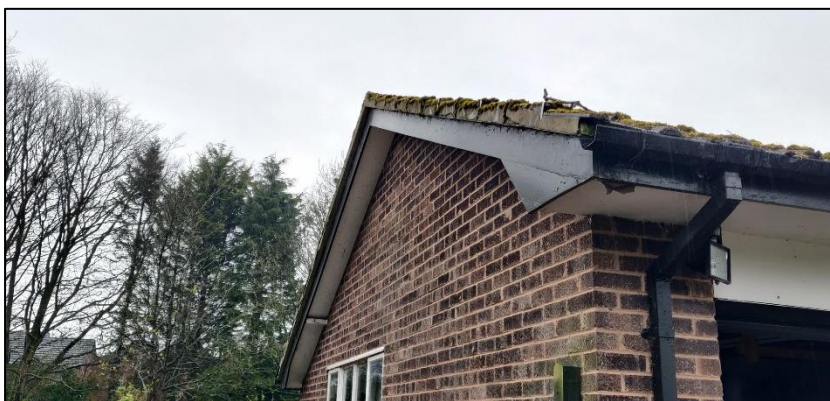
- 3.15 The roof edges are generally well-sealed, with most mortar intact although parts are crumbling (see Photograph 12). Soffits and bargeboards exist in places. These are mostly intact and flush to the walls (see Photograph 13), but some have small gaps between wooden panels.

*Photograph 12 showing the roof edge at the garage*

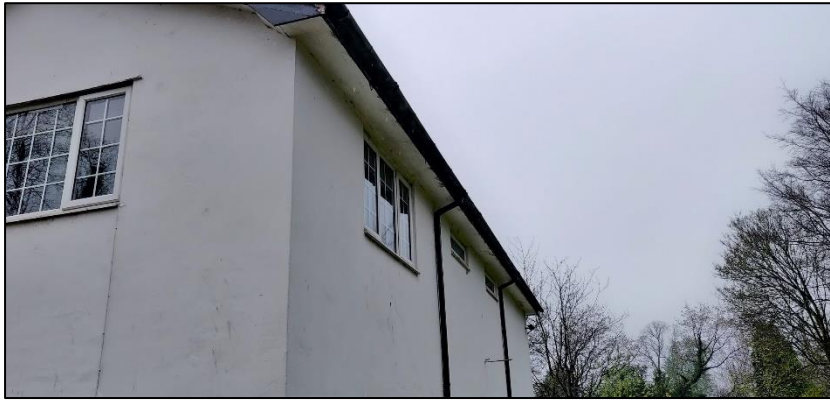
*Photograph 13 showing the soffits at the two-storey section*

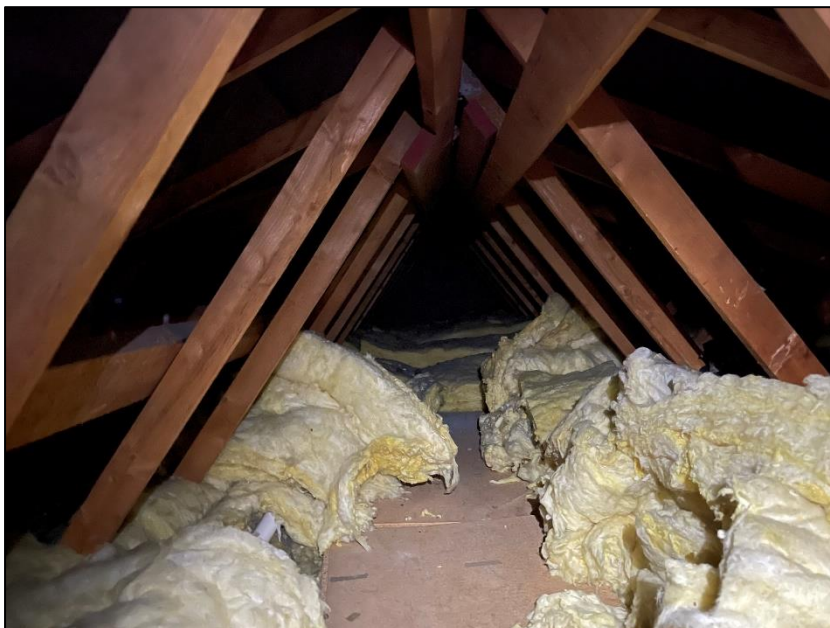
- 3.16 The ground and first floor rooms of the dwelling are in use and well-sealed. They do not support suitable bat roosting habitat.
- 3.17 Two loft spaces are present; one above the single-storey section and one above the two-storey section. The garaging is open to the roof. The single-storey loft void is shallow, with a layer of insulation (see Photograph 14). It was difficult to access the whole void. The roof timbers are in excellent condition and offer no gaps or cavities for bats to exploit. The roof void is boarded. The internal walls are intact. The roof tiles are lined and the lining is intact. A small number of bat droppings (<5) were found scattered on top of the insulation.

*Photograph 14 showing the roof void above the single-storey part of the dwelling*

- 4.5 A small number of scattered bat droppings were found within both loft voids of the dwelling. The building is well-maintained and very few potential bat access points were found. The building is located close to good quality bat foraging and commuting habitat (the tree belts and surrounding landscape). No evidence of a bat roost of high conservation concern, such as a maternity bat roost, was found. The dwelling is considered to offer **moderate** bat roost suitability and two dusk emergence surveys are recommended. These would allow a robust characterisation of the bat roost present and allow a derogation licence to be applied for.

- **Bats** - Two dusk emergence surveys (or dawn re-entry surveys) of the dwelling are required to determine the type of bat roost present. A minimum of four surveyors are required and these surveys must be undertaken between May and September. If an active bat roost is present, a derogation licence will be required prior to demolition and bat mitigation must be designed into the site.

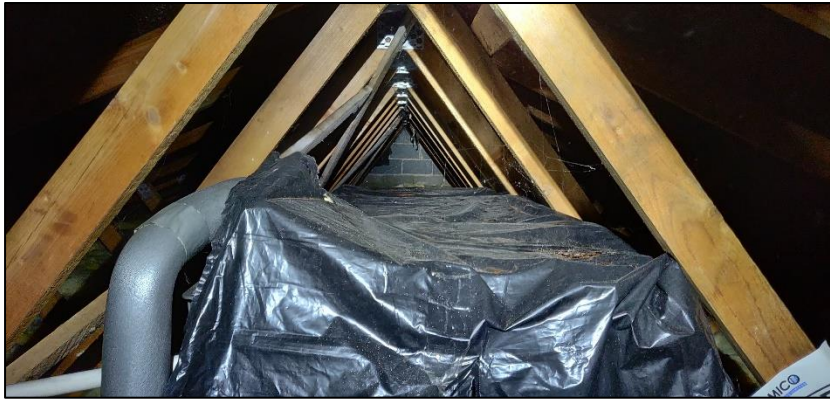
- 3.18 The double-storey loft void is also shallow, with a deep layer of insulation (see Photograph 15). It was difficult to access the whole void. The roof timbers are in excellent condition and offer no gaps or cavities for bats to exploit. The roof void is boarded. The internal walls are intact. The roof tiles are lined and the lining is intact. A small number of bat droppings (<5) were found scattered on top of the insulation.

*Photograph 15 showing the roof void above the double-storey part of the dwelling*

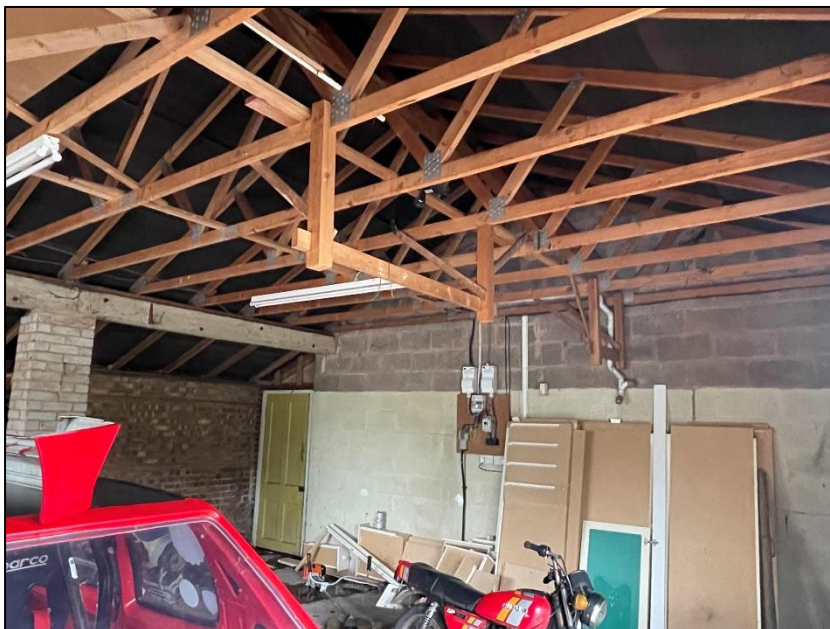
- 3.19 The row of garages is open to the roof, with no voids or cavities (see Photograph 16). The roof timbers are in excellent condition. The roof is lined with bitumen felt and this is intact. The garages are well-lit and the internal walls are all intact. No evidence of bat activity was found within the row of garages.

*Photograph 16 showing the interior roof of the garaging*

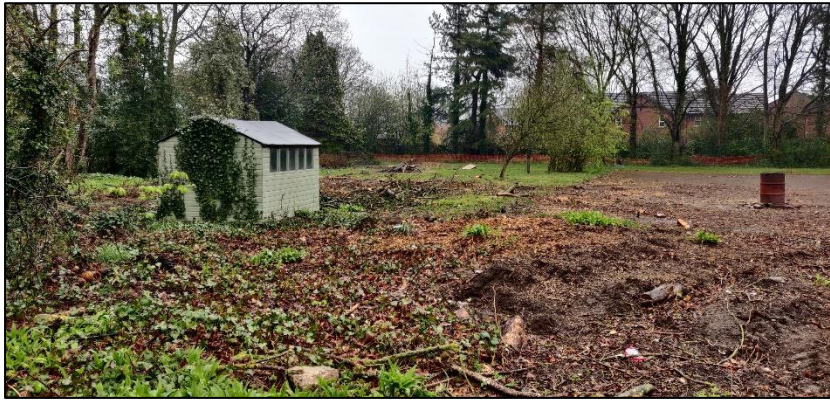
- 3.20 A wooden shed with a pitched bitumen felt roof exists on site (see Photograph 17). This is in good condition and offers no suitable bat roosting opportunities. A woodstore also exists on site (see Photograph 18). This is open, with no walls and also offers no suitable bat roosting opportunities.

Photograph 17 showing the shed

- 4.6 No bat droppings or other evidence of bat activity was found within the sheds on site and these are considered to offer **negligible** bat roost suitability. No further survey work is required on these.

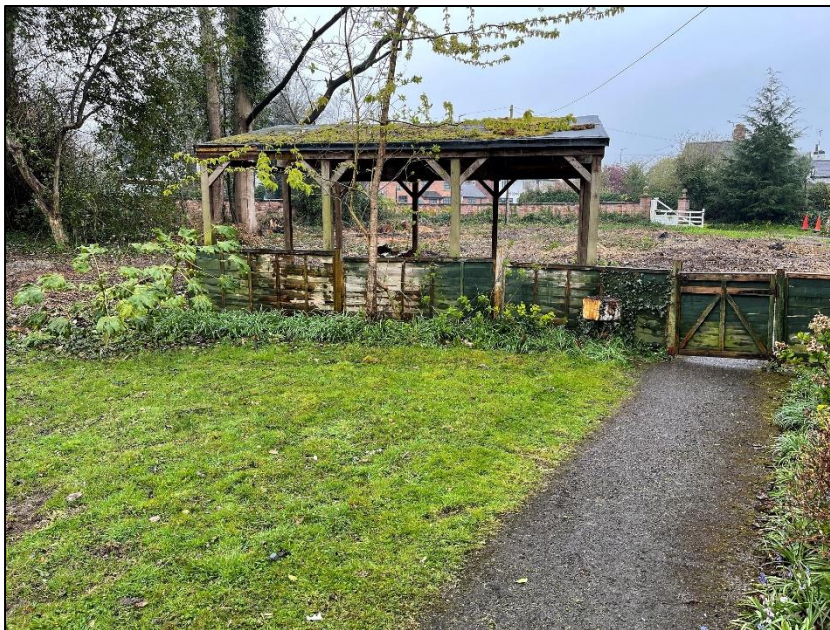
Photograph 18 showing the woodstore

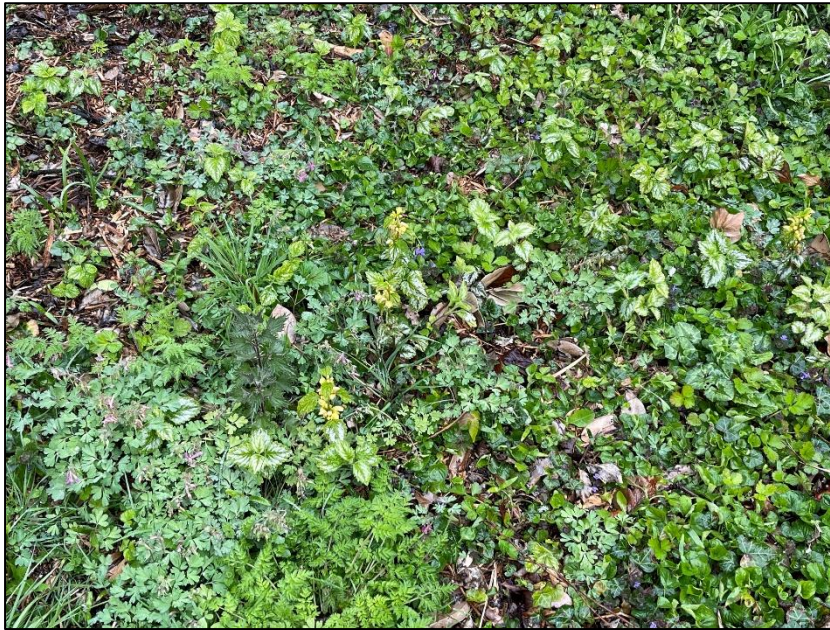
- 3.26 Variegated Yellow Archangel *Lamiastrum galeobdolon* subsp. *argentatum* exists on site, within the ground beneath the tree belts (see Photograph 19). This is a non-native, invasive species and is listed on Schedule 9 of The Wildlife & Countryside Act 1981 (as amended), making it an offence to allow this species to spread into the wild.

Photograph 19 showing the Variegated Yellow Archangel on site.

- 4.10 Variegated Yellow Archangel is present on site. This is an invasive, non-native species and should be removed using an approved methodology as part of the site clearance works.

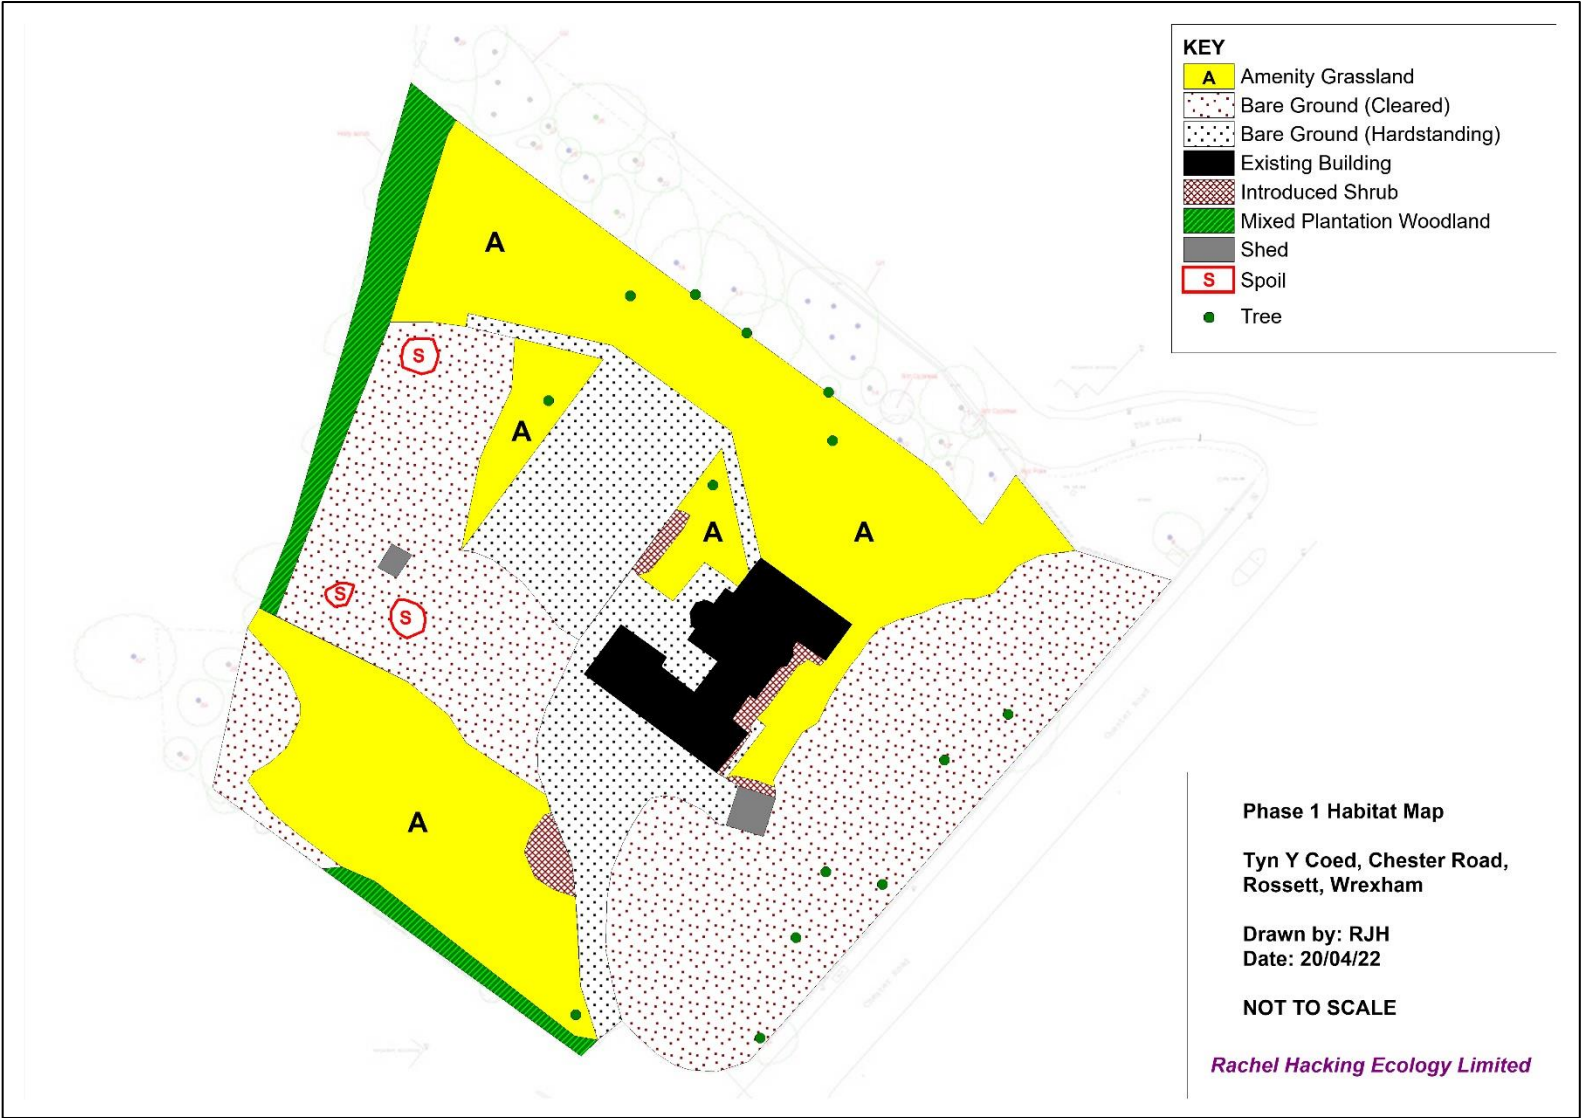
APPENDIX A – PHASE 1 HABITAT MAP

- 3.1 The Phase 1 Habitat Map can be found at Appendix A.
