# CAFFI WYLFA, CHIRK:

## BAT AND NESTING BIRD SURVEY

Report Ref: EE.963.21.KW

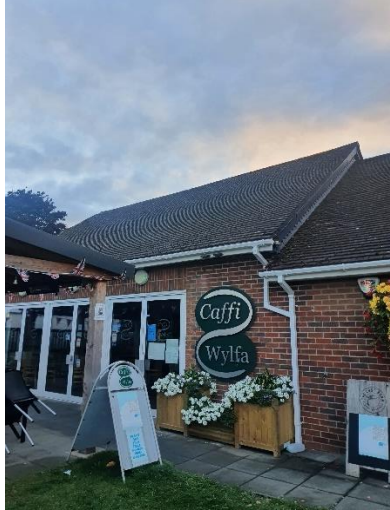
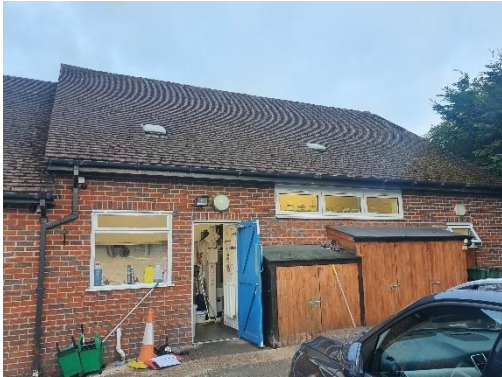
| Building 1 | | | |
|---|---|---|---|
| <p>Building 1 had brick walls with a tiled roof and concrete ridge tiles. Building 2 was attached to the eastern gable end of Building 1, with the roof pitch Building 1 being slightly higher.</p> <p>The fascias were wooden and the door and window frames were new plastic.</p> <p>Soffits to the north were wooden and plastic to the south.</p> | <p><b>SOUTH ELEVATION</b></p> <p><b>NORTH ELEVATION</b></p> | <p>The loft space of Building 1 was approximately 10m x 10m x 3.75m high, and had breezeblock gable ends with a wooden frame. The loft space was lined with felt with insulation on floor.</p> <p>The loft space was warm with little air flow and no light.</p> | <p><b>LOFT SPACE 1</b></p> |

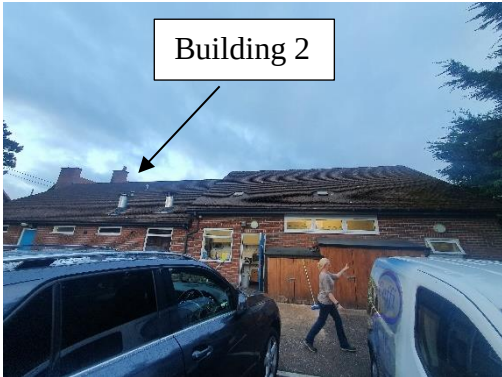
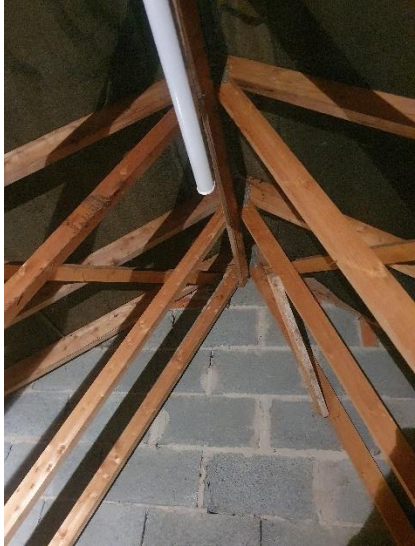
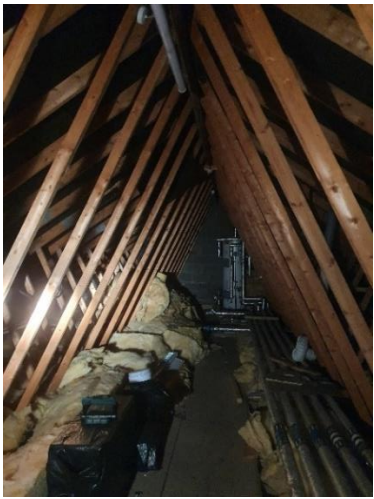
| Building 2 | | | |
|---|---|---|---|
| <p>Building 2 was of similar design to Building 1 with exterior brick walls.</p> <p>The roof was pitched with concrete ridge tiles; it was set lower than the roof of Building 1 and adjoined the eastern gable end of Building 1.</p> <p>The fascias were wooden and the door and window frames were new plastic.</p> <p>Soffits to the north were wooden and plastic to the south.</p> | <p><b>NORTH ELEVATION</b></p> <p><b>SOUTH ELEVATION</b></p> | <p>Internally the loftspace was approximately 12m x 10m x 3.5m high, and also had breezeblock gables with a wooden frame.</p> <p>The western gable end of Building 2 was connected to Building 1, however the separating wall between the two buildings was completely sealed.</p> <p>There was a boiler unit in LS2.</p> <p>There were few light spots and low air flow.</p> | <p><b>AREA WHERE BOTH SECTIONS ATTACH FROM INSIDE LOFT SPACE 1.</b></p> <p><b>LOFT SPACE 2</b></p> |

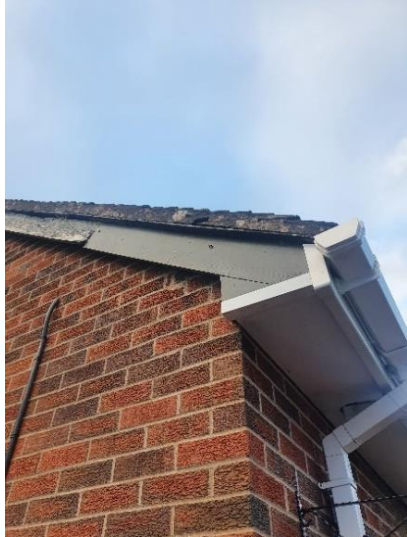
| Location | Description | Example Photos |
|---|---|---|
| <b>Building 1</b> | Gap in mortar under tile on western gable | |

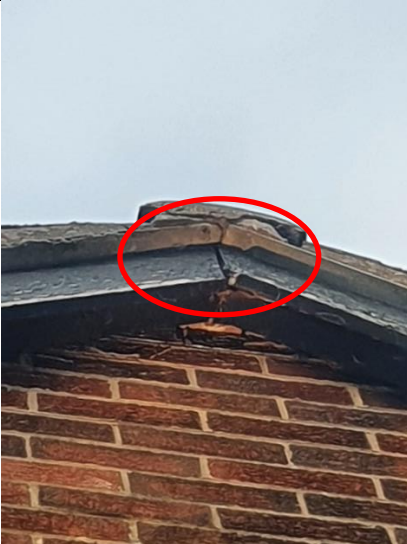
| Location | Description | Example Photos |
|---|---|---|
| <b>Building 1</b> | Gaps in barge boards at the apex of the western gable, providing access into the loft space | |

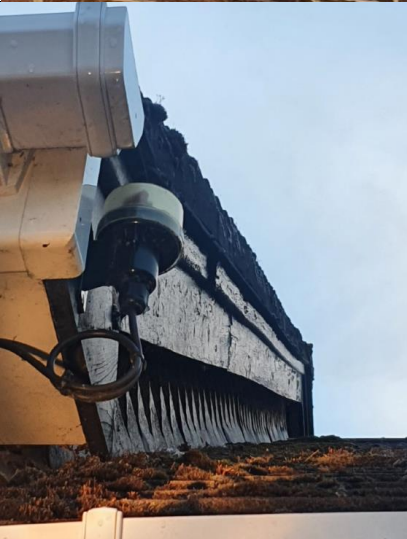
| Location | Description | Example Photos |
|---|---|---|
| <b>Building 1</b> | Gaps under barge boards on eastern gable, above where Building 2 attaches. The gaps were shallow and exposed and did not appear to give access into the loft space. | |

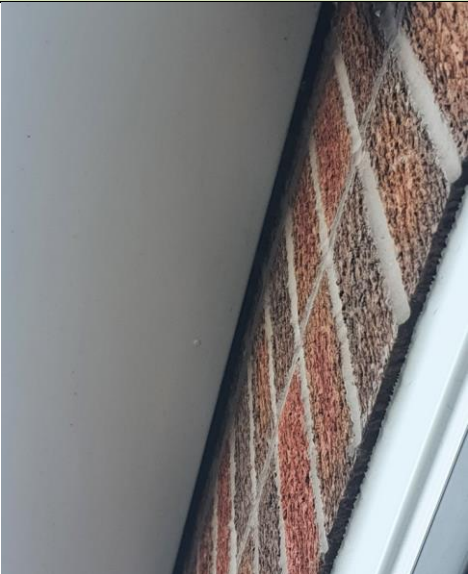
| Location | Description | Example Photos |
|---|---|---|
| <b>Building 2</b> | Gaps behind the fascias and soffits; the gaps were quite narrow and did not appear to give access into the loft space. | |

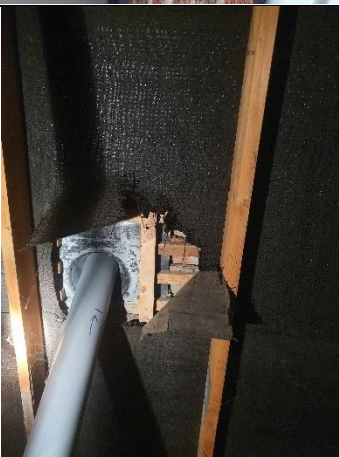
| Location | Description | Example Photos |
|---|---|---|
| <b>INTERNAL - Building 2</b> | One light gap where felt had torn around the chimney | |

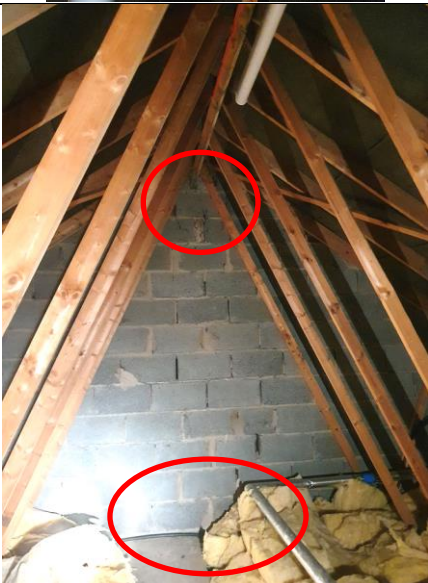
| Location | Description | Example Photos |
|---|---|---|
| <b>INTERNAL – Western gable end of Building 1</b> | Pile of droppings characteristic of pipistrelle on the floor and stuck on the gable wall next to the entrance from under the barge boards at the apex. | |

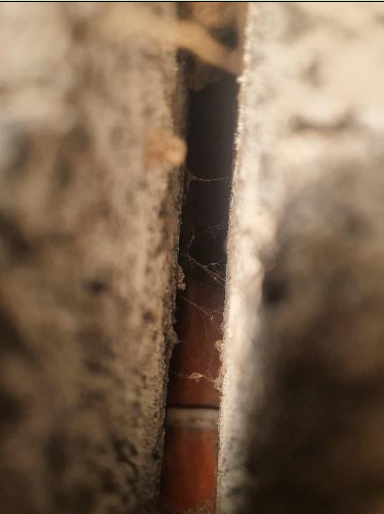
| Location | Description | Example Photos |
|---|---|---|
| <b>INTERNAL –<br/>Western<br/>gable end of<br/>Building 1</b> | Cavity wall gap (approx. 10cm) | |

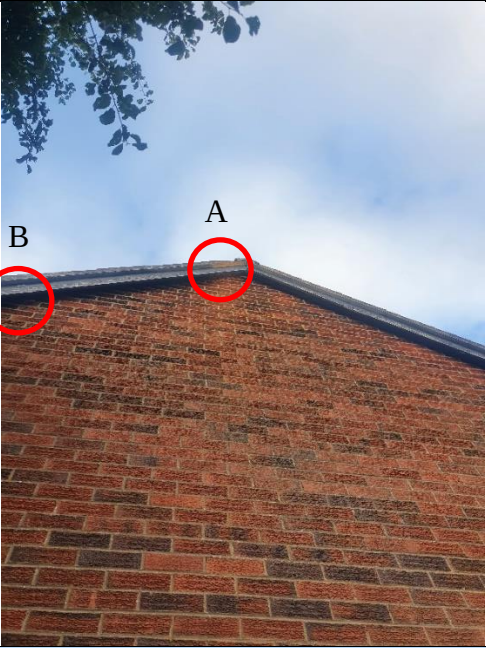
| Emergences | | | |
|---|---|---|---|
| 20:20 | Soprano pipistrelle | From the gap in the apex of the western gable (A) | |

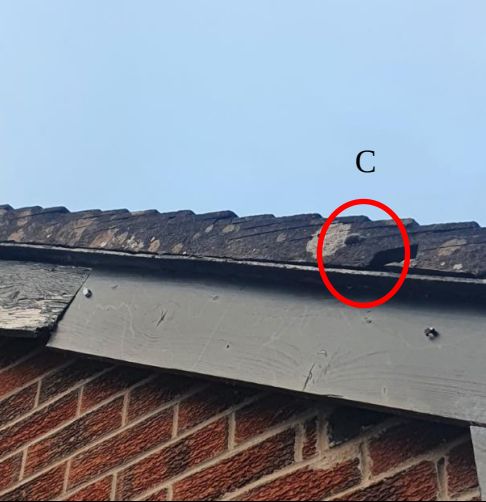
| Emergences | | | |
|---|---|---|---|
| 20:51 | Common pipistrelle | Emerged from gap in mortar under a tile on the western gable (C) | |

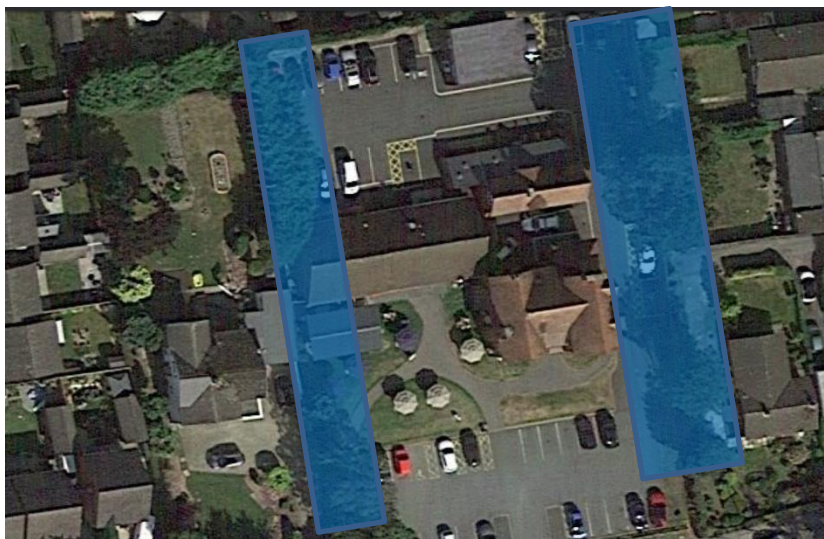
**FIGURE 6.1. PROPOSED DARK ZONES (BLUE). BASE IMAGE © MAGIC MAPS 2022**

- There must be no lights focused on the hedgerows and trees to the west and east of the site. There will be no illumination of the recommended bat mitigation and bird boxes (see below), including the western gable end of Building 1, once the works are complete (see Figure 6.1).
- As the new extension proposes additional lighting (in the form of additional windows), internal luminaires in all new rooms should be designed to minimise light spill and glare via the windows and sky lights; either through being recessed, using dimmer switches, lamp shades, directed away from the windows and/or through the use of blinds and curtains during the summer months.
