**Althrey Woodhouse**  
**Overton Road**  
**Bangor-on-Dee**  
**LL13 0DA**

## **Bat Survey Report; 2022**

**Moss Company**

13 July 2022

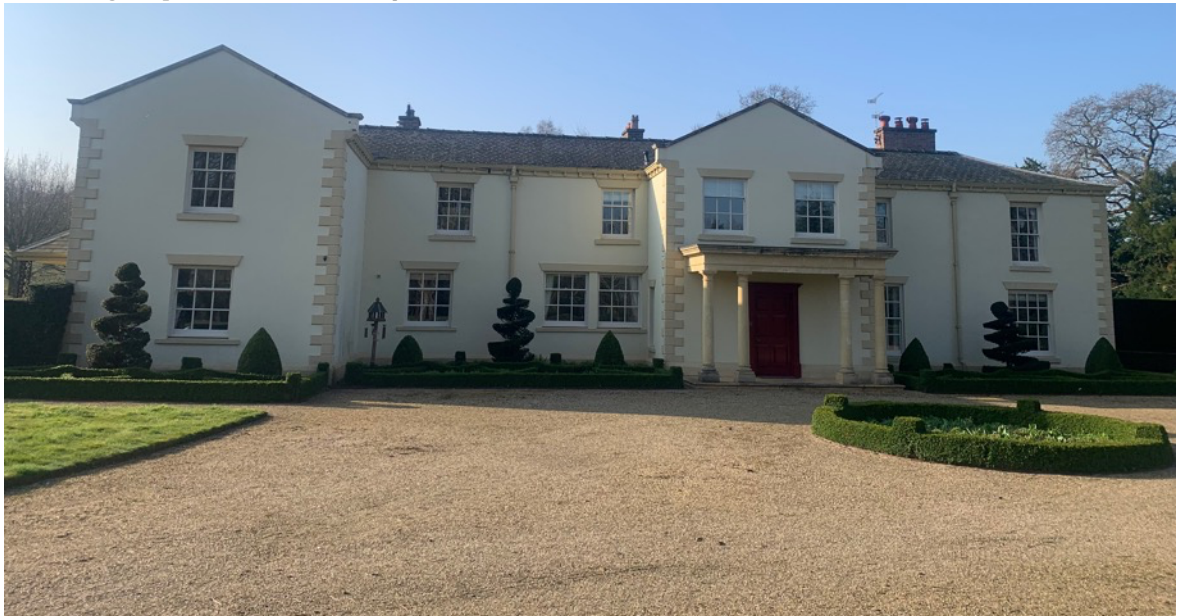
**Photograph 1.** Althrey Woodhouse

Althrey Woodhouse is a detached dwelling (**Photograph 1**) with lawns and shrub beds to the west and south and an area of tarmac forming a parking area to the east of the house.

The existing house was brick built with all external walls rendered and painted. Each corner of the house featured stone quoins. The house is rectangular in outline with two pavilions extending from the eastern elevation (**Photograph 1**).

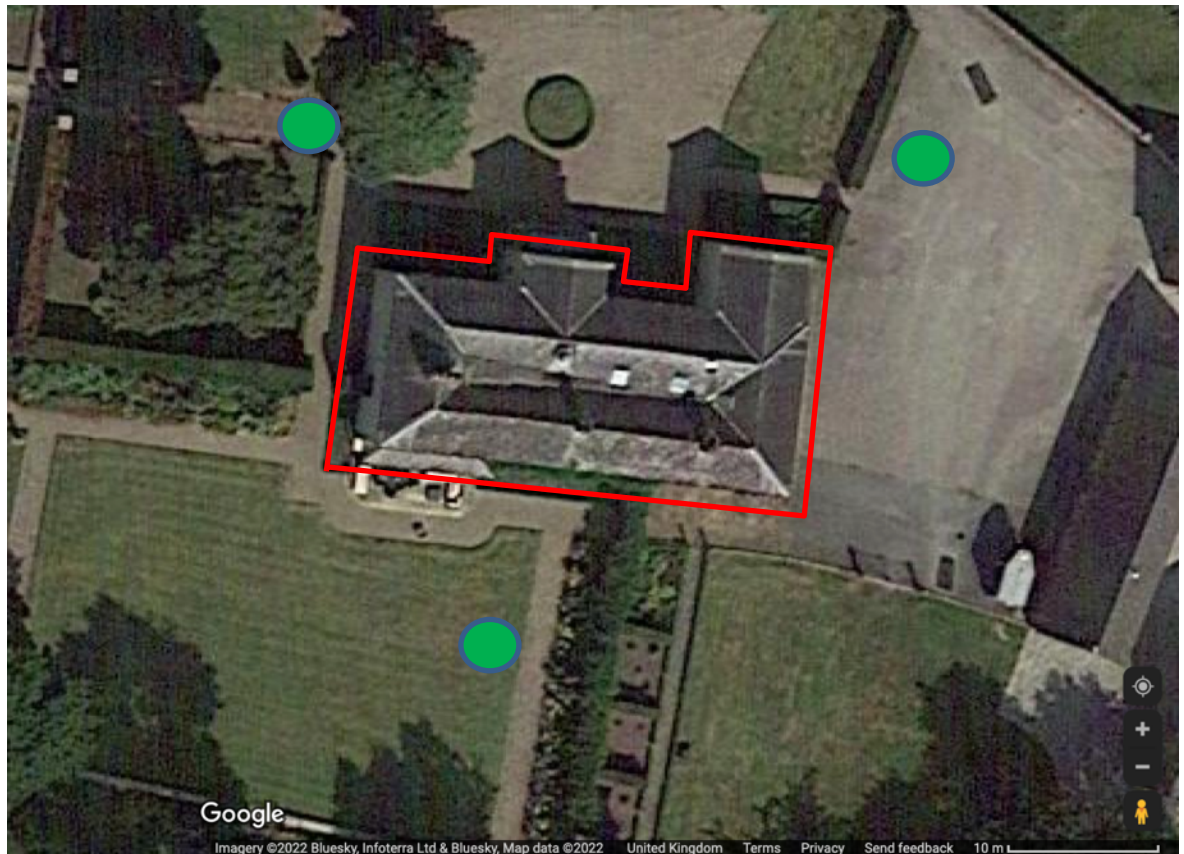
**Figure 2.** Surveyor locations

To ensure coverage of all potential bat access points/roost features, surveys were completed by three surveyors (Figure 3). Surveyors were equipped with electronic bat detectors (EM Touch Pro 2 and Peersonic) and sound files were analysed with appropriate bat analysis software (Kaleidoscope) once the surveys were completed, if required. InfraRed cameras (Saance) were also used during each survey, to focus on PRFs.

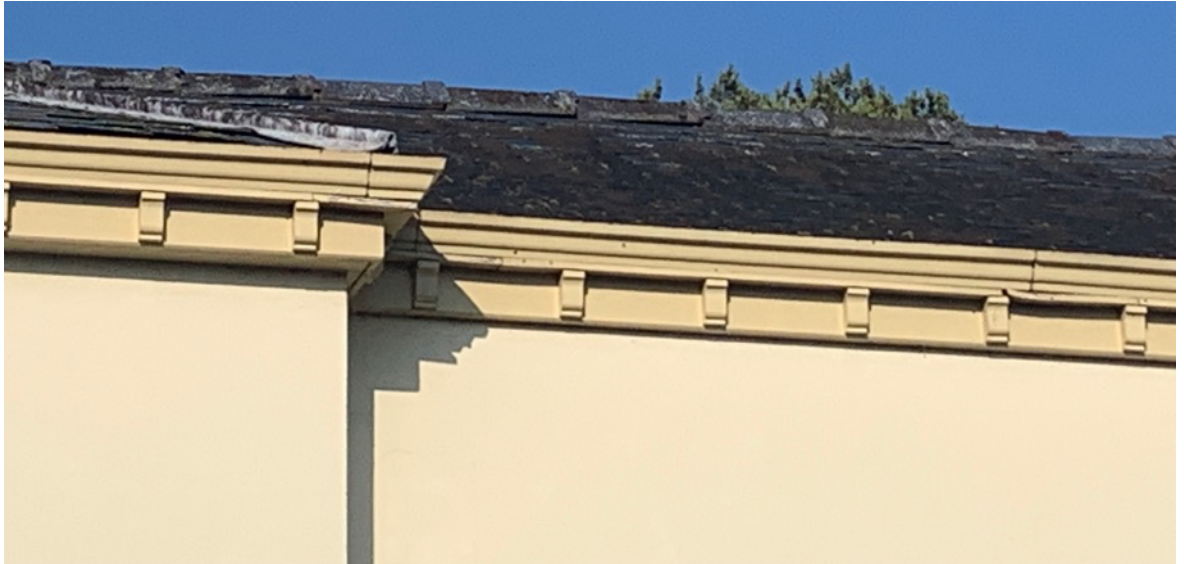
**Photograph 2.** Gaps at ridge tiles

- Gaps beneath slates (**Photograph 2**).
- Gaps at ridge tiles (**Photograph 2**).
- Gaps around lead flashing (**Photograph 2**).
- Damage to soffit boxes (**Photograph 3**).

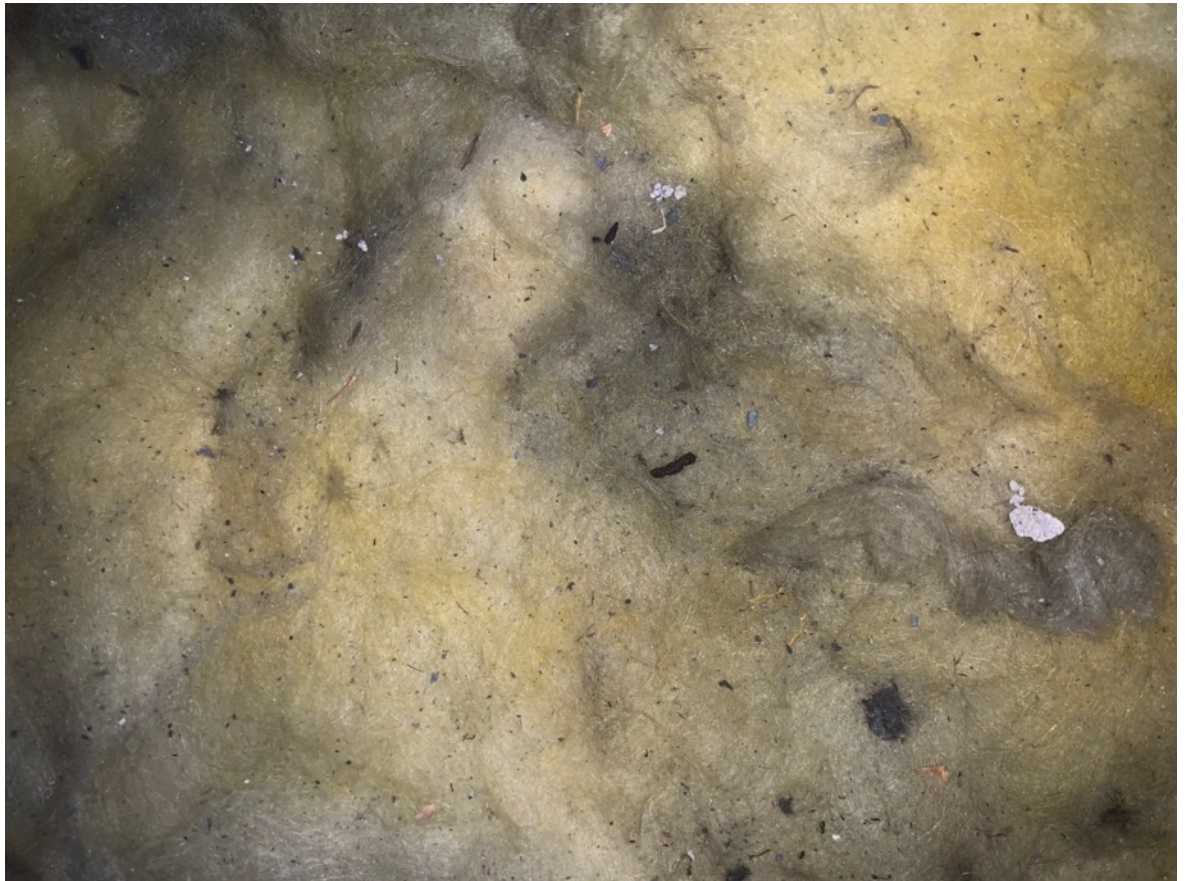
**Photograph 4.** Bat dropping within roof void

Within the accessible area of the void ten relatively old, unidentified (to species) scattered bat droppings were present (**Photograph 3**), not obviously associated with any PRFs.

Given the presence of PRFs and old bat droppings, the house was assessed to be of **MODERATE POTENTIAL** for roosting bats (**Table 1**).

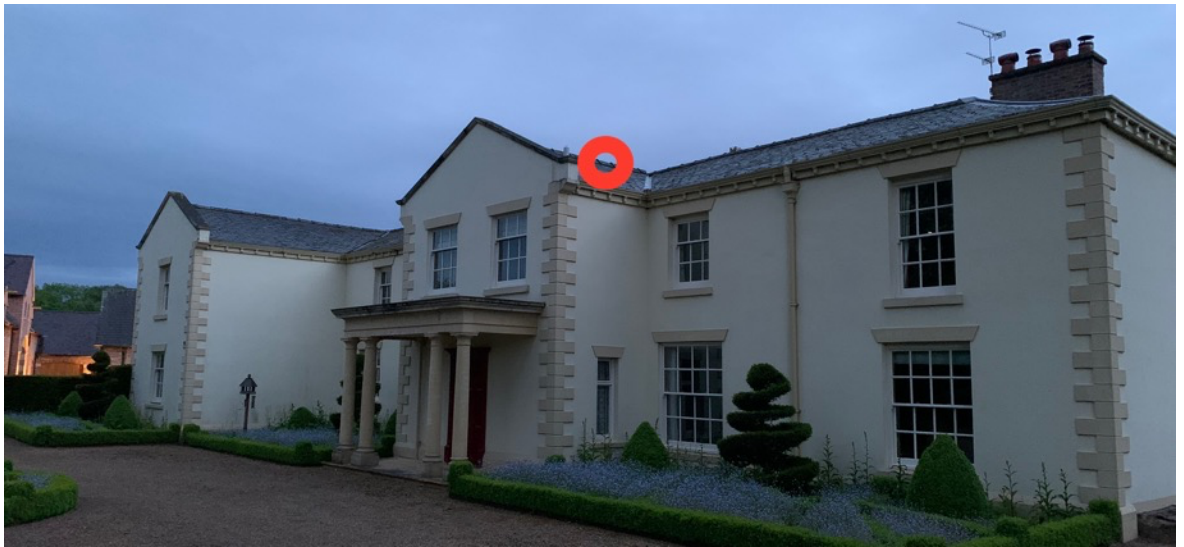
**Photograph 5.** Roost Access Point 1

One Common Pipistrelle exited a day roost at the verge of the ridge on the northern side of the building (Roost Access Point (RAP) 1), **Photograph 5**) at 21:28. The roost location of this bat is not known, although it is likely between the slates and roof lining near the location of the RAP.

One Common Pipistrelle exited a day roost via RAP 1 (**Photograph 5**) at 22:19.

The confirmation of roosting bats within the house means that a licence from Natural Resources Wales will be required to enable the proposed works to proceed lawfully.

Works in the area of the roosts will need to be supervised by a licenced bat worker. Prior to works commencing, the ecologist would provide a 'toolbox talk' to those contractors on site in which details of e.g. best working practices and what to do in the event of discovering a bat will be discussed.

During supervised works to the area of the roost the licenced bat worker would capture any bats that do not fly away and move them to a temporary bat box (erected on a nearby tree prior to works commencing).

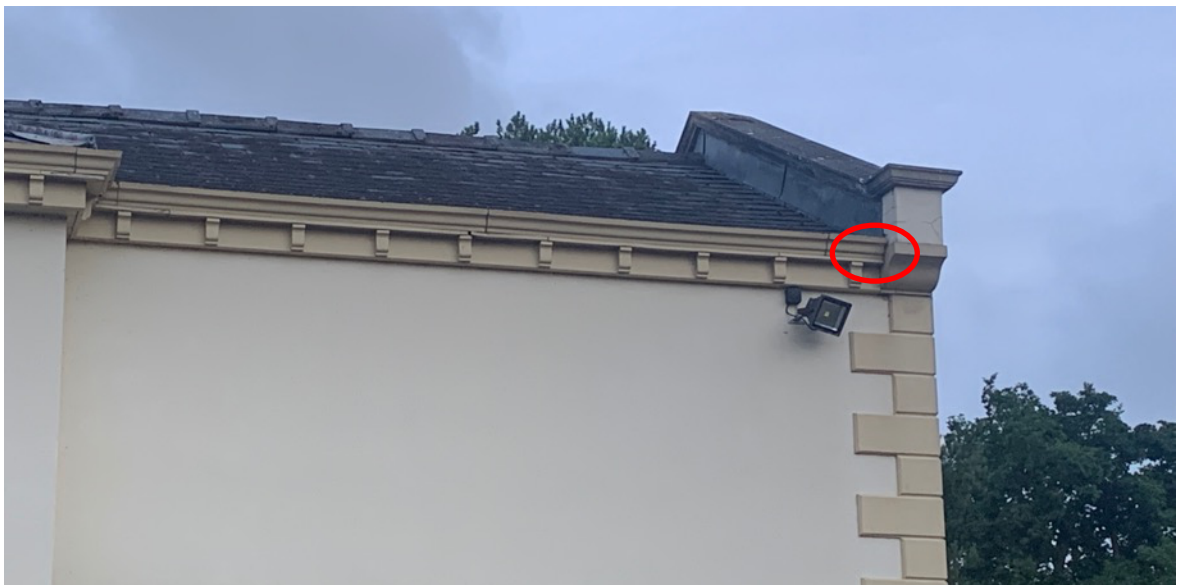
**Photograph 6.** Roost Access Point 2

One Soprano Pipistrelle exited a day roost near the eaves on the eastern side of the house, adjacent to the north-eastern gable (RAP2, **Photograph 6**) at 21:32.

Three Soprano Pipistrelles entered a day roost via RAP2 (**Photograph 6**) at 04:26, 04:31 and 04:45.
