# **SALEM CHAPEL RHOSLLANERCHRUGOG**

Joyce Heberden BA MSc

Doc Ref: LP4070C-HBR-v.1.4

A level 3 building survey (PRN 213770) was carried out at Salem Chapel, Bank Street, Rhosllanerchrugog, on the 6<sup>th</sup> July 2022 by L - P : Archaeology. This document has been prepared by Joyce Heberden of L - P : Archaeology on behalf of the client Blueprint Architectural. The work was undertaken in response to a condition of planning consent for the demolition of the existing building, a disused chapel, and erection of 2 domestic dwellings (P/2021/0543).

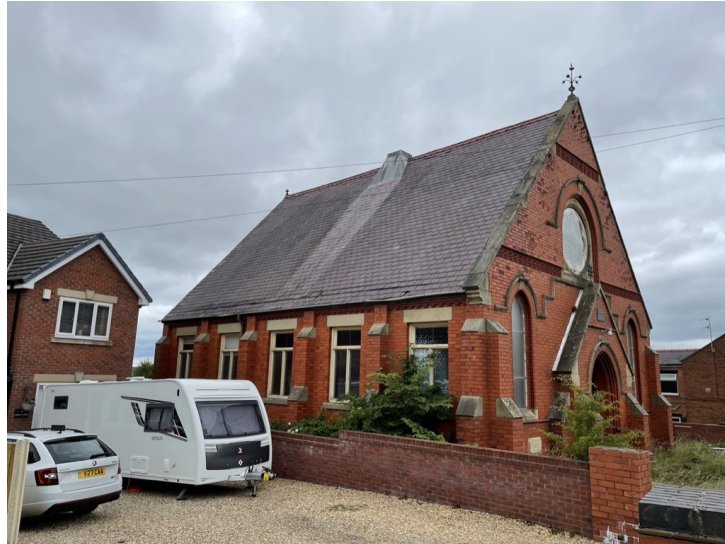
Plate 1 - View of Salem Chapel, looking northeast

6.2.The building is an independent chapel of red brick, five bays north-south by three bays east-west. The structure is two storeys high, with a single storey and undercroft annex to the north. The building has a steep pitched slate roof, with gable ends at the north and south (PLATE 1).

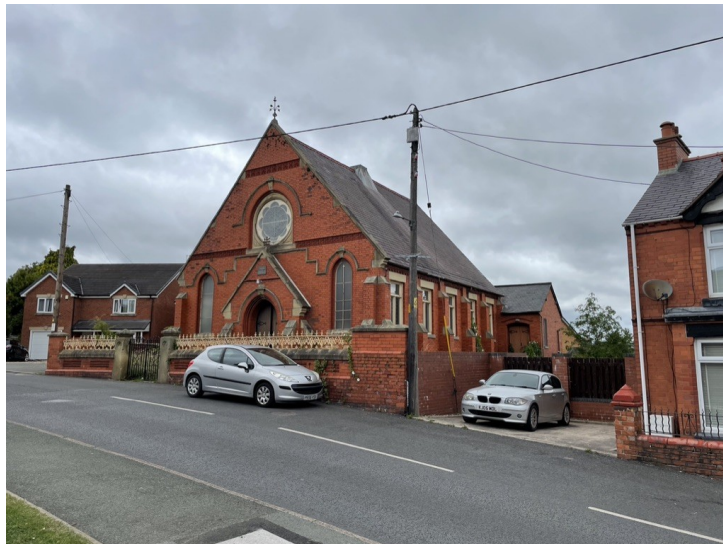
Plate 2 - The setting of the chapel, looking northwest

6.3.The chapel lies in a residential area near the top of the hill (PLATE 2), with mid to late 20<sup>th</sup> century, and early 21<sup>st</sup> century, dwellings to the east, west and south, and the

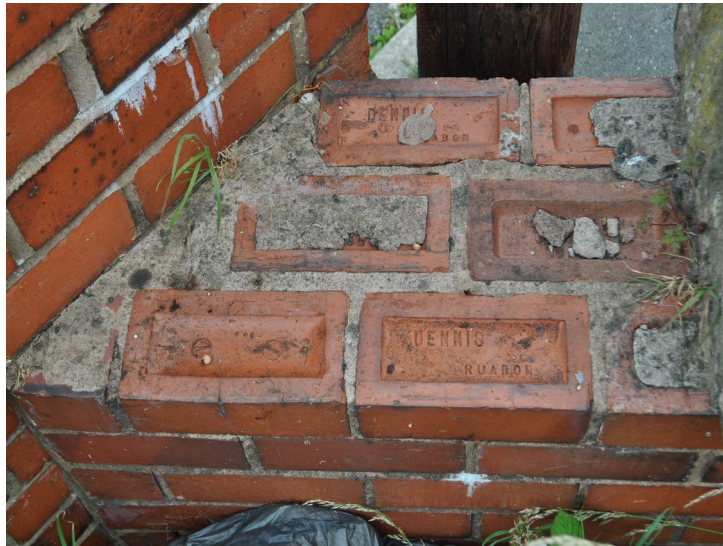
Plate 3 - Exterior wall, brick detail

6.5.1. The exterior wall surrounding the plot (PLATE 3) was built contemporaneously to the chapel. Built with Ruabon brick of the Dennis Ruabon Tiles Ltd. company, and laid out in a traditional stretcher-bond style. The south facing sections of this wall, surrounding the gate, contain decorative ceramic panel inserts in the shape of rosettes.

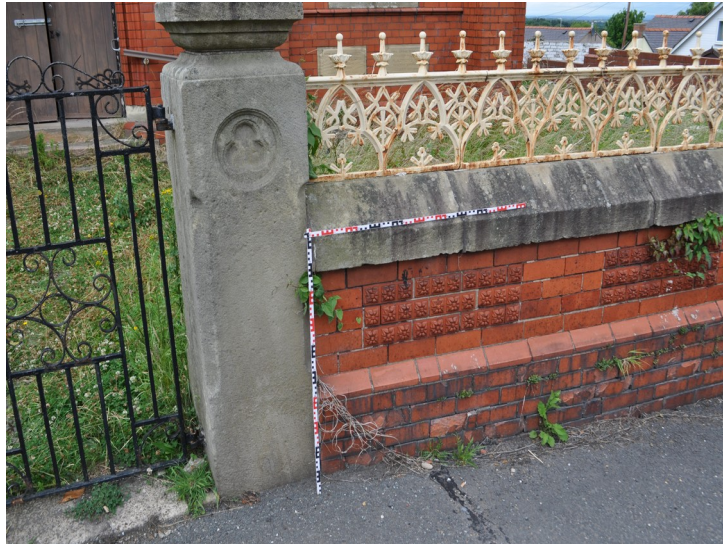
Plate 4 - Exterior wall, panel and fence detail

6.5.2. Resting upon the foundation brick wall are sandstone coping stones (PLATE 4), which themselves are overlain by ornate metal fencing, with a repeating geometric floral design. The sandstone used throughout the building of this wall and the chapel seem to be local, perhaps Cefn sandstone due to it's proximity to the historic Gardden Wood quarries.

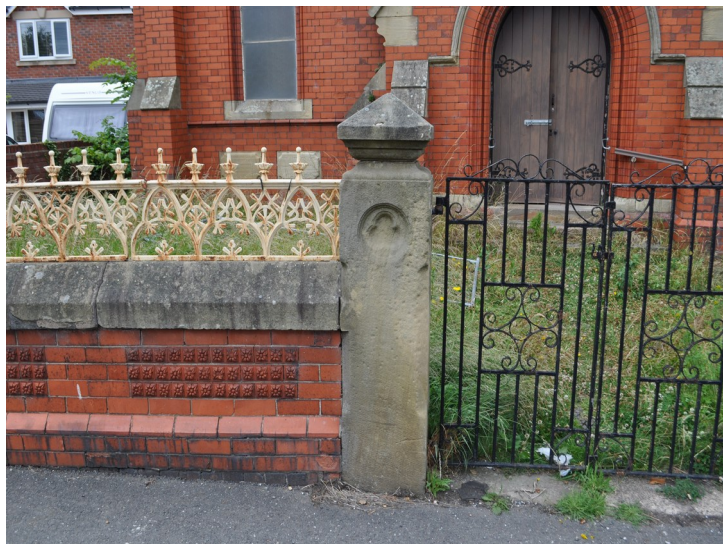
Plate 5 - Exterior wall, gate and gate post detail

6.5.3. The metal entrance gate is a similar height to the wall, with two simple, but ornate gates. The gate posts (PLATE 5) are made of sandstone and decorated with trefoil knots. They are topped with capping stones.

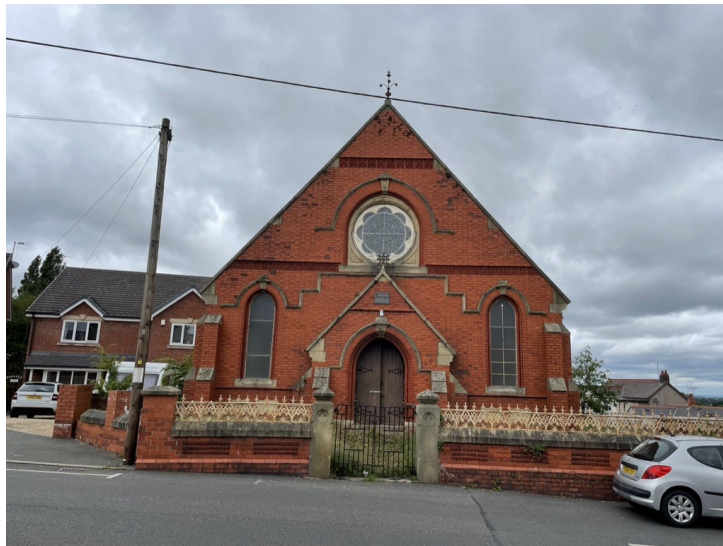
Plate 6 - South elevation

- 6.5.4. The south elevation of the chapel is the most prominent and ornamental (PLATE 6). The façade is composed of Flemish bond, which rises to a gabled point to the roof.

- 6.5.5. A decorative metal weathervane sits at the apex of the gable. A sandstone trim borders the roof plate down to two sandstone blocks, on either side. These act as kneeler quoins, pushing out the roof plate to align it with the buttresses on each side of the building. The bottom sandstone block acting as a quoin is slightly ornamental in a cyma reversa profile. Two decorative panels, similar to the one of the exterior wall, run horizontally in the top and second thirds of the façade. On the bottom third of the façade, four dedication stones are laid out two-by-two on either side of the entrance. They read from west to east:

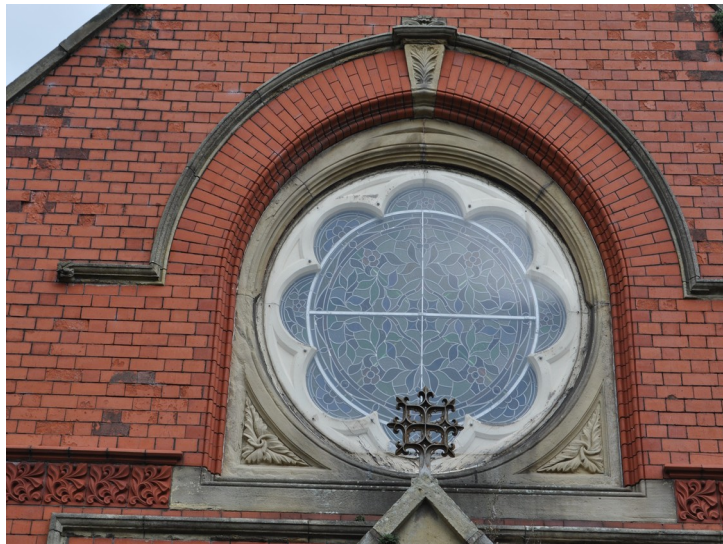
Plate 7 - South elevation, multi-foil rosette window

6.5.6. The second panel of the façade is interrupted in its centre by a large multi-foil rosette stained glass window (PLATE 7). Plexiglass and modern bolts were attached to the front of it at a later time, perhaps as a protective measure. It is framed by sandstone with decorative foliate detailing at its base.

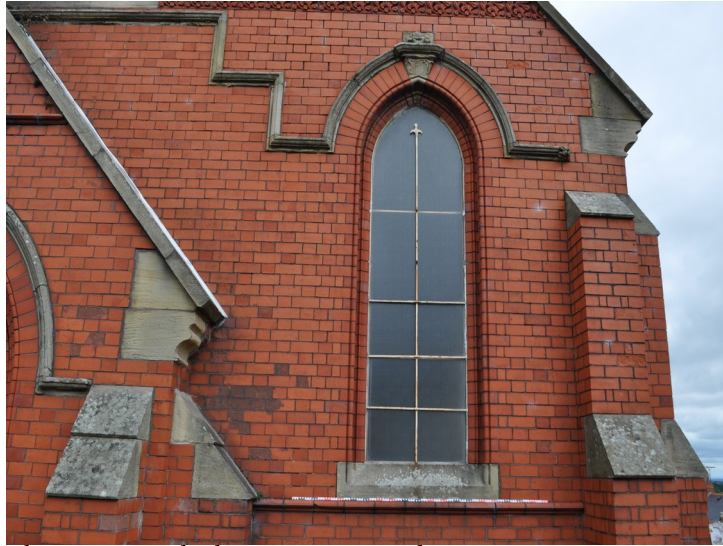
Plate 8 - South elevation, east window

6.5.7. Two Norman-style single panelled windows (PLATE 8 & PLATE 9) with pointed apexes and keystones adorn the bottom third of the façade on either side of the

entrance. The glass used in the panelling is textured. The window on the east side has exterior metal framing, to simulate multiple window panels. All the windows are mantled by sandstone string courses.

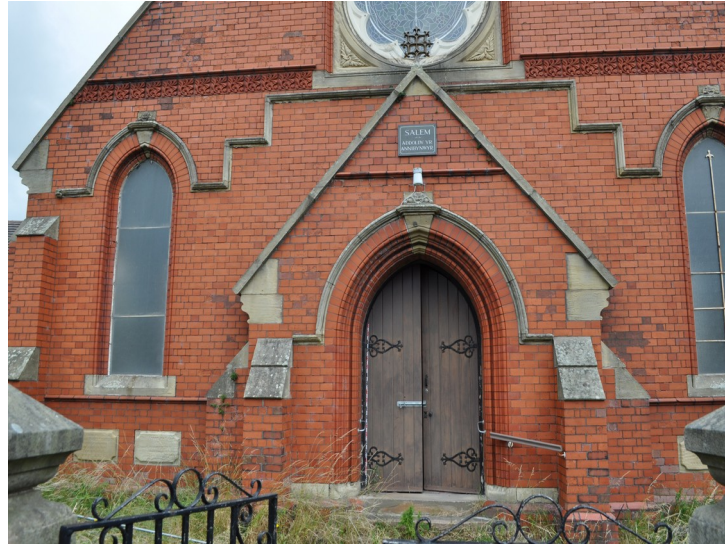
Plate 10 - South elevation, grand canopy entrance

6.5.9. The main entrance door rests in a pointed Norman-style door frame, surrounded by sandstone trim, similar to the trim above the three windows, and a foliate decoration rests at the apex of the door frame (PLATE 10). The same decoration can be found above the two mirrored windows. The brick decoration surrounding the doors is laid out in a Gothic-inspired piped ornamental style. The door itself is not original, but the decorative strap hinges attached on all four sides are, albeit repainted. Three sandstone steps lead up to the entrance, the second of which has been repaired with concrete. Leading up to the entrance from the gate, are ceramic tiles, serving both decorative and utilitarian non-slip purposes (PLATE 11). At a later point, hand rails were attached to the east side of the entrance.

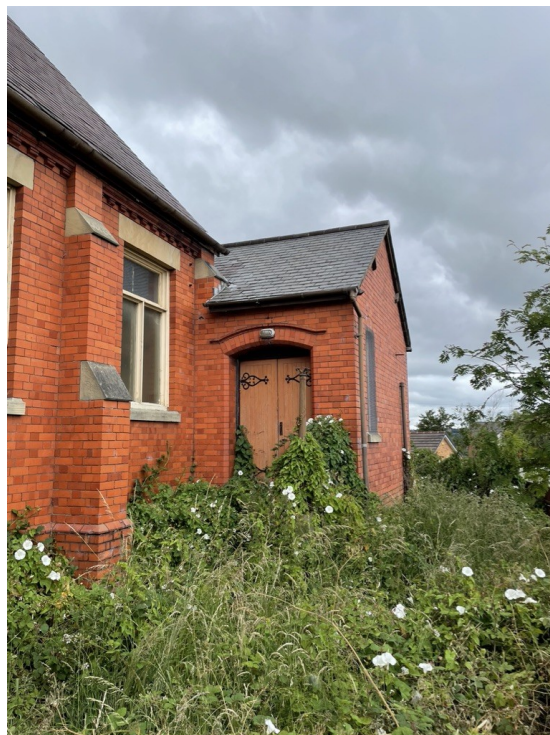
Plate 12 - Vestry, looking north

6.5.10. The south elevation of the entrance of the vestry keys into the sixth buttress of the east elevation of the chapel (PLATE 12 & PLATE 13). It consists of Flemish-bond brickwork. The roof plate covering it is lined by a gutter at its bottom edge. The entrance of the vestry is thought to have been open originally, and that the door in its place was added at a later date.

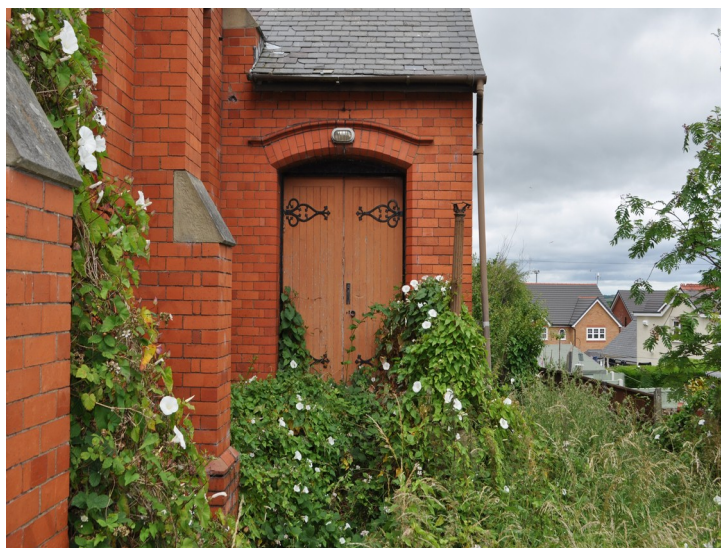
Plate 13 - South elevation, vestry entrance

6.5.11. Above the entrance is an ornamental arched brick string course. The steps

leading up to the entrance are made of sandstone and are enclosed to the east by a brick-made retaining wall, decorated at its base by a lamppost.

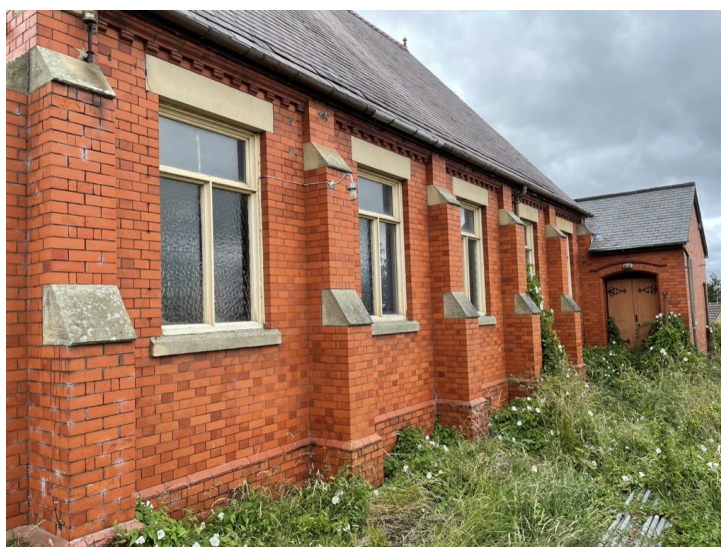
Plate 14 - Eastern elevation

6.5.12. The east elevation of the chapel (PLATE 14) is constructed in a Flemish-bond, in bright coloured, smooth, brickwork, with dark grey pointing.

6.5.16. A disconnected telephone line connection still rests atop the southernmost buttress, and the second buttress up still carries the brackets for the missing telephone wire. A down pipe branches off from the gutter on the north side of the fourth buttress. Some of its brackets are missing.

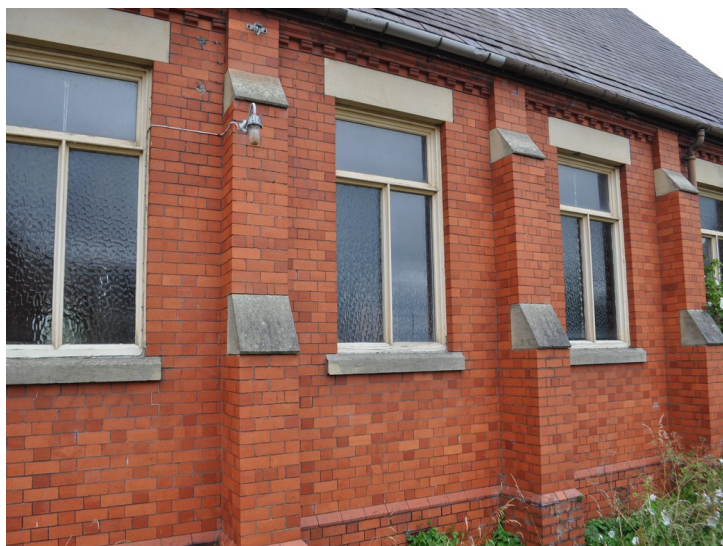
*Plate 15 - East elevation, detail*

6.5.13. At the top of the elevation (PLATE 15), a metal gutter lines the bottom of the roof plate. Directly under the gutter, there is a decorative brick trim resembling a reeding moulding, and below this are faux beam end brick corbels forming a string course at wall plate level.

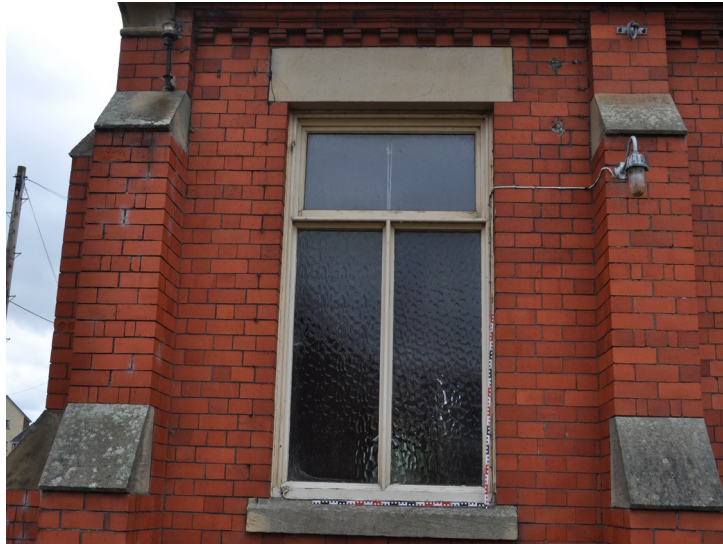
Plate 16 - East elevation, southernmost window detail

6.5.15. There are five windows on this elevation with the same design which consists of a painted wooden frame, a rectangular sandstone sill and lintel. The paint colour on the muntins is slightly different from the lower horizontal muntin of the wooden frame, suggesting some repainting or other upkeep. The glass is textured, similarly to the glass of the south windows, and separated into three windowpanes by two muntins (PLATE 16).

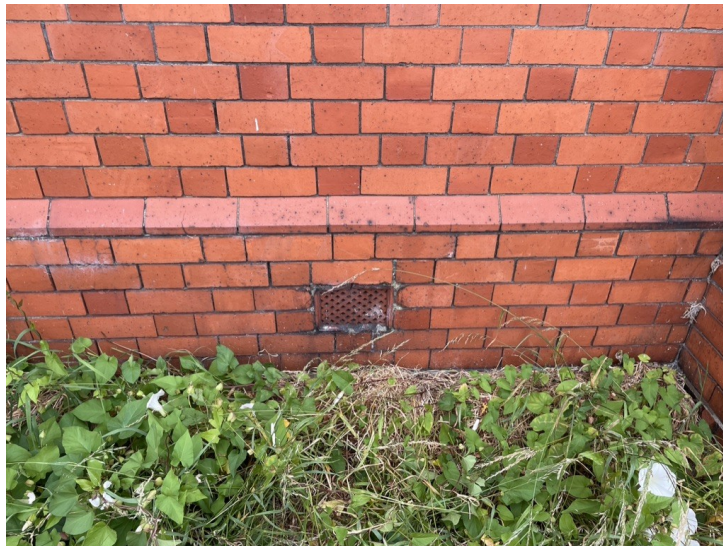
Plate 17 - Base of eastern elevation

6.5.17. The base of the chapel has a stepped brick plinth, six courses high, topped by chamfered brick (PLATE 17). Below each window along the elevation, within the plinth, are set ceramic vents.

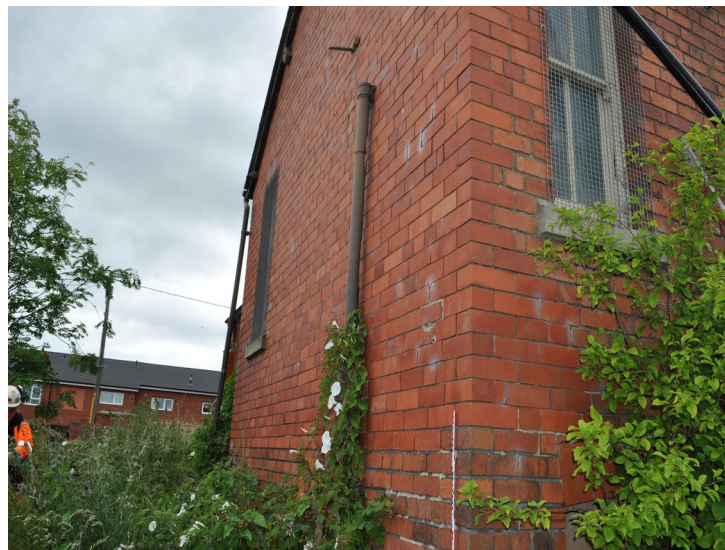
*Plate 18 - East elevation of vestry*

combination of Flemish-bond and stretcher-bond, ending upwards in a gable (PLATE 18). Directly below the roof plate are two purlins and two pole plates at equal distances from each other. A single window is found on this elevation toward the south end. It is made of textured glass, and framed by a sandstone sill, two muntins dividing the window into four window panes and brick arch at its top. It has been covered by a modern metal grate, judging by the newer bolts holding it on, and was perhaps added on later as security. A gas pipe has been fitted through the brickwork on the northern end of this elevation.

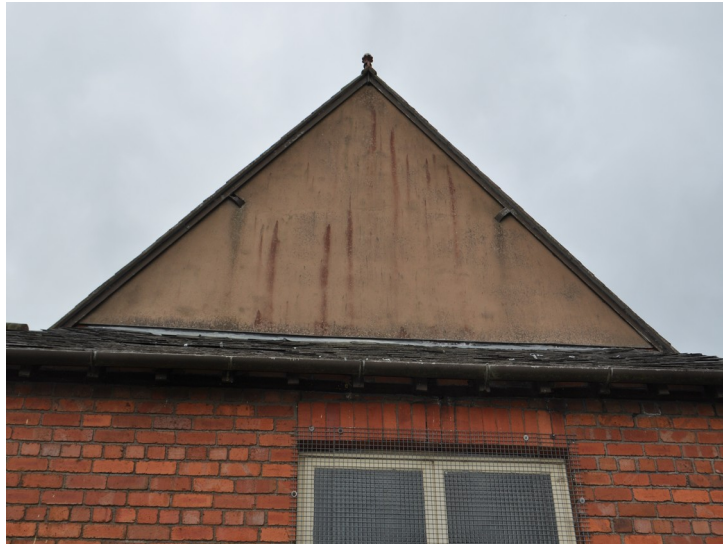
Plate 19 - North elevation, rendered wall and finial

6.5.19. The north elevation is the least ornamental. Below the gabled roof of the main chapel structure, the brickwork has been rendered on the top third of the wall (PLATE 19). The purlins of the roof are still visible through the plaster on either side. The bottom two thirds of the brick work are still exposed and show a Flemish-bond.

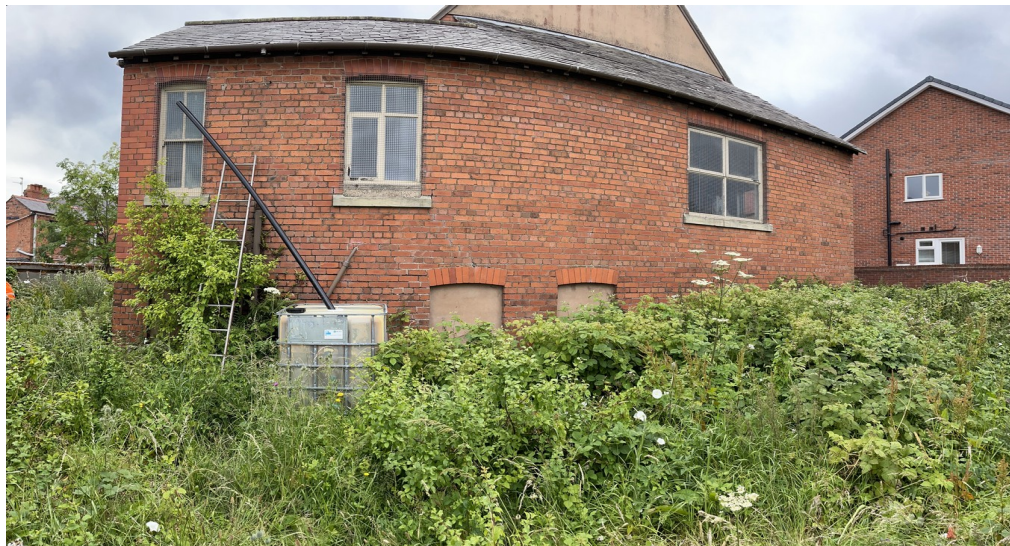
Plate 20 - Panoramic view of northern elevation

6.5.20. As the lean-to roof of the vestry descends toward the north side, the roof plate ends at a gutter (PLATE 21). The brick-laying style of the vestry section of the north elevation is in an English garden wall bond. The bricks are non-decorative as patches are visible, creating an uneven colour on many of them as opposed to the uniformly coloured bricks on the south elevations (PLATE 20).

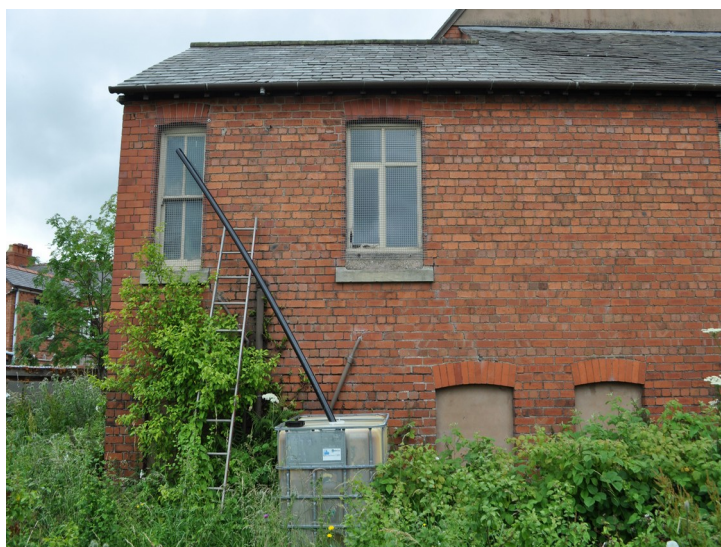
Plate 21 - North elevation of vestry

attached to the exterior of the window (PLATE 21). On the middle window of the north elevation, a coarse concrete repair has been carried out on the sandstone sill.

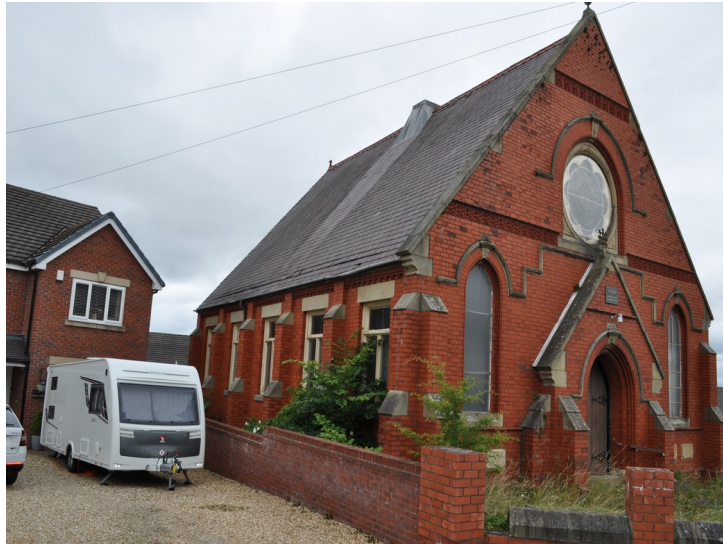
Plate 22 - West elevation of Salem Chapel

6.5.23. The west elevation of the chapel is identical to the east elevation as seen in PLATE 22.

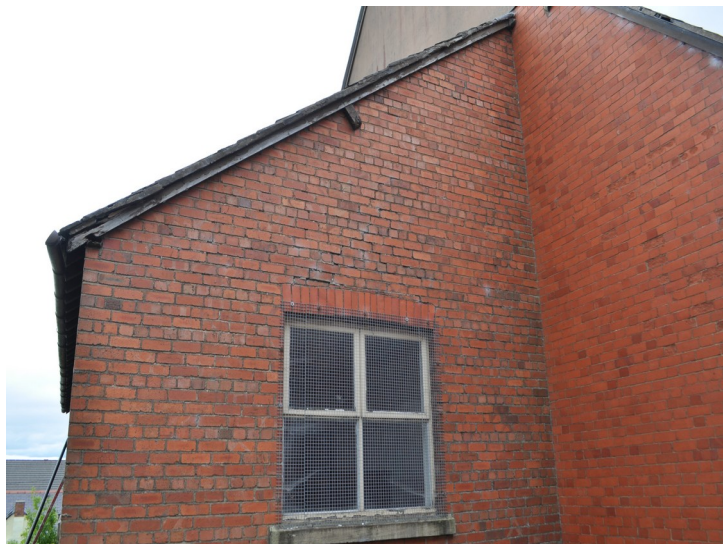
Plate 23 - West elevation of vestry, with window

6.5.24. The west elevation of the function room demonstrates an English garden wall bond, consistent with its north elevation. A purlin is visible from the roof plate (PLATE 23). There is a single window, with a design consistent with the other windows of the vestry extension including a wooden frame, a sandstone sill, a brick arch at the top, two muntins dividing the window into four window panes and a metal grate on the exterior. Below this window is a cellar window which has been closed off with contemporary bricks.

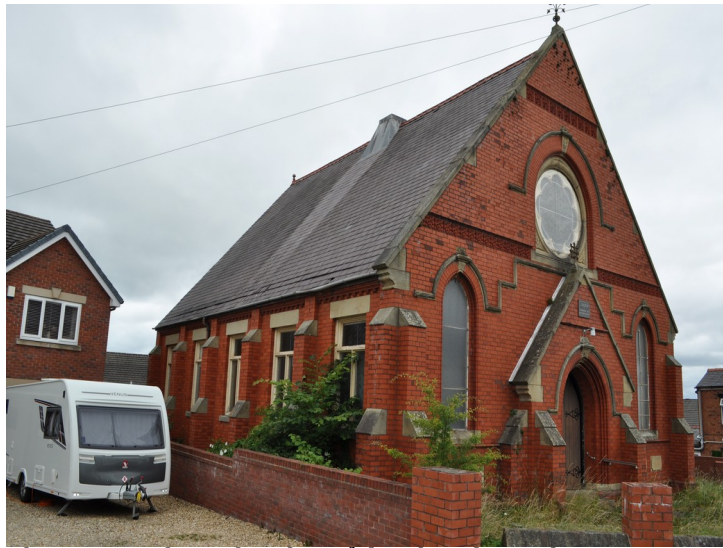
Plate 24 - Salem Chapel, roof detail with weathervane, zinc chimney and finial (Right to left)

6.5.25. The roof of the chapel is composed of square slate tiles on a steep pitch (PLATE 24). The ridge of the gable is covered in ceramic ridge tiles from end to end. The south end of the gable is decorated with a metal weathervane, whereas the north end is decorated with a ceramic finial. Interrupting the ridge tiles in the middle of the roof is a zinc vent, perhaps connecting to the boiler system of the building.

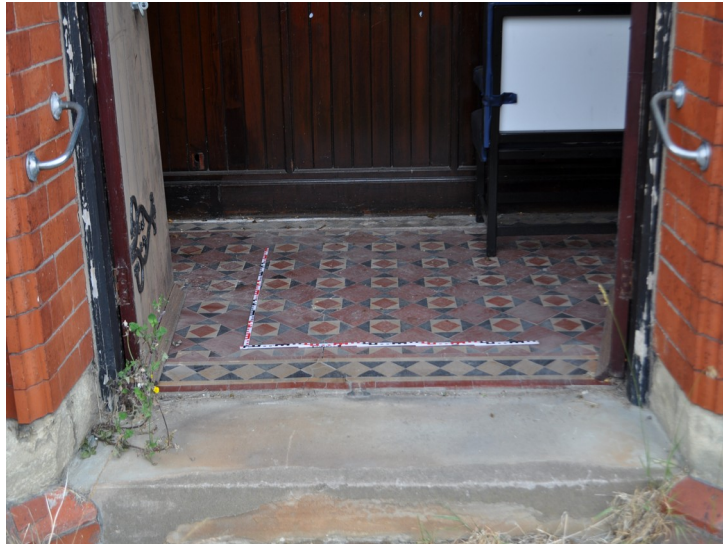
Plate 25 - Vestibule floor detail

6.6.2. The vestibule measures 2m<sup>2</sup>. The floor is decorated with Ruabon quarry tile in a geometric Victorian style (PLATE 25). The west, south and east walls are panelled by dark wood slats and dark wood framing. It appears the wood is pine with dark staining and varnish. Lining the ceiling edges is a lighter coloured wood trim with reeding moulding details (PLATE 26).

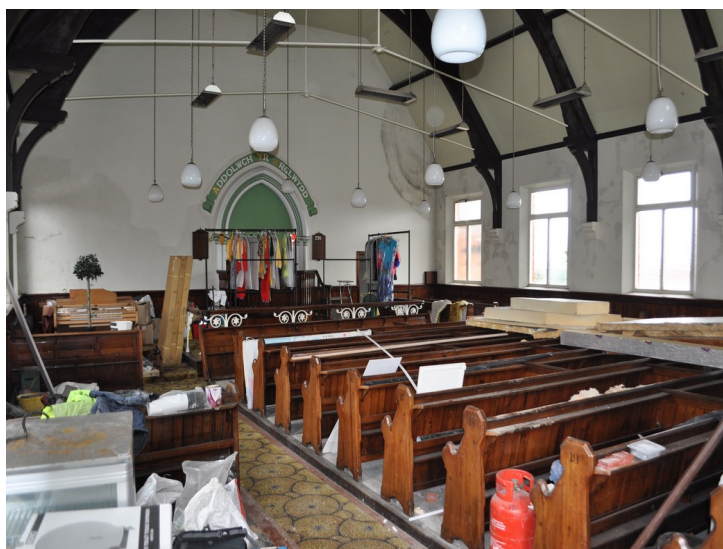
Plate 28 - Main chapel

6.6.4. The main chapel space measures 135m<sup>2</sup> with a ceiling height of 7.32m (PLATE 28). The floor is of parquet flooring, covered by geometric-patterned runner rugs along the lengths of the pews. The widest seven pew stalls, directly facing the pulpit, sit upon a 10 cm raised parquet floor. On either side of the main pew stalls are two narrower pew stalls, of seven rows each. To the east side of the pulpit are two rows of pews facing it.

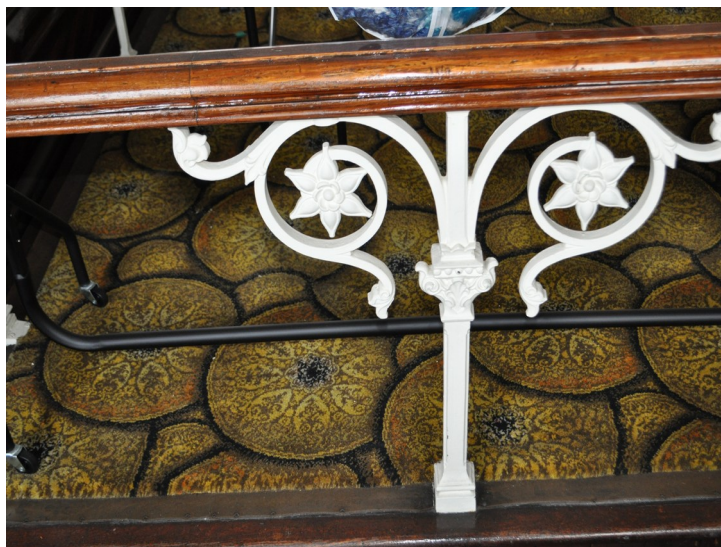
Plate 29 - Handrail detail

6.6.5. The pulpit rests upon a raised dais, by about 30 cm, enclosed by a dark wood balustrade, which itself sits on a raised carpeted floor of about 10 cm, which is also enclosed by a handrail with ornamental metal fixtures (PLATE 29).

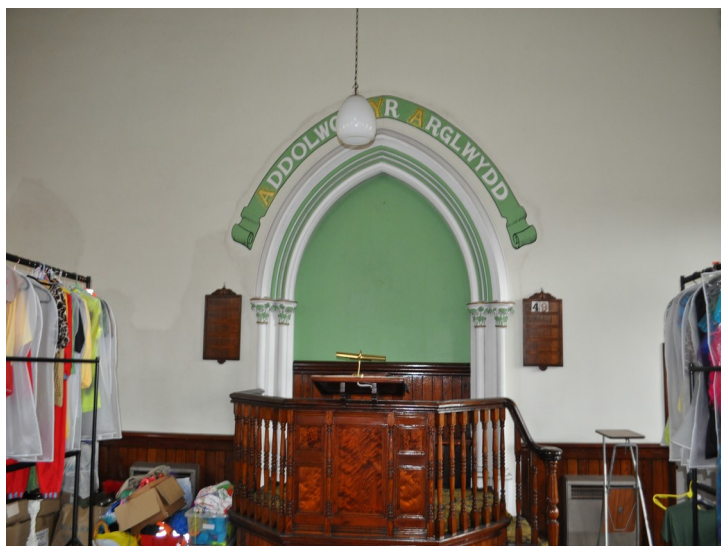
Plate 30 - Main chapel pulpit and dais, balustrade detail

6.6.6. Behind the pulpit on the main wall is an inset pointed arch recess, mirroring the entrance to the chapel (PLATE 30). Its sides are decorated by piping details ending in two Corinthian style pillars on either side, for a total of four pillars. The background of the arch is painted the same lime green found in the vestibule. The top of the arch is mantled by a painted faux-banderole reading Worship the Lord in Welsh:

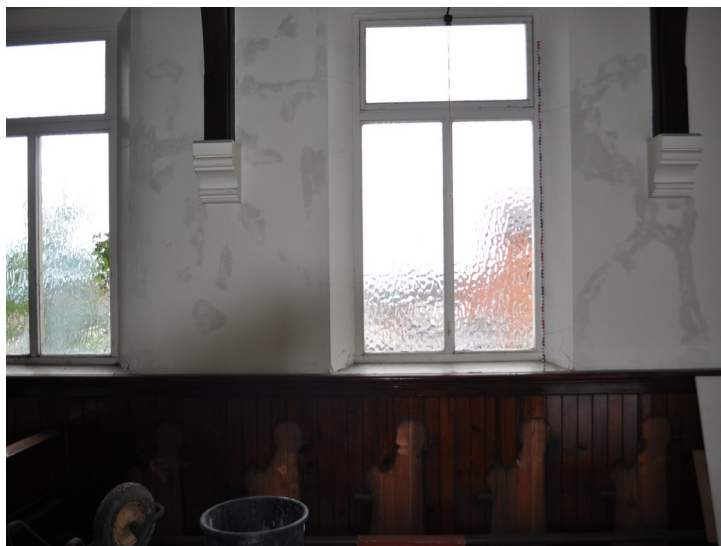
Plate 31 - Window form and wainscotting in chapel

6.6.7. The walls in the chapel, apart from the decorative arch, are all painted white. The bottom section of the walls is decorated with simple wood panelling similar to the wood in the vestibule. The windows on east and west faces are rectangular in form with chamfered sides forming a recess (PLATE 31). This recess form can also be seen on the south face arched windows.

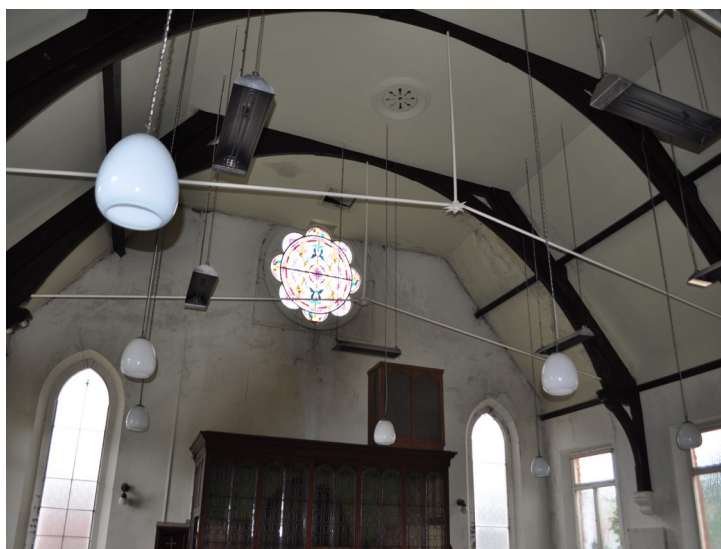
Plate 32 - Hammer beams, tie-beams, ceiling vents and lighting detail

fixtures. The ceiling itself has two ceiling vents, with ornamental circular motifs. There are a total of eighteen pendant light fixtures hanging from the ceiling, none of which are original (PLATE 32).

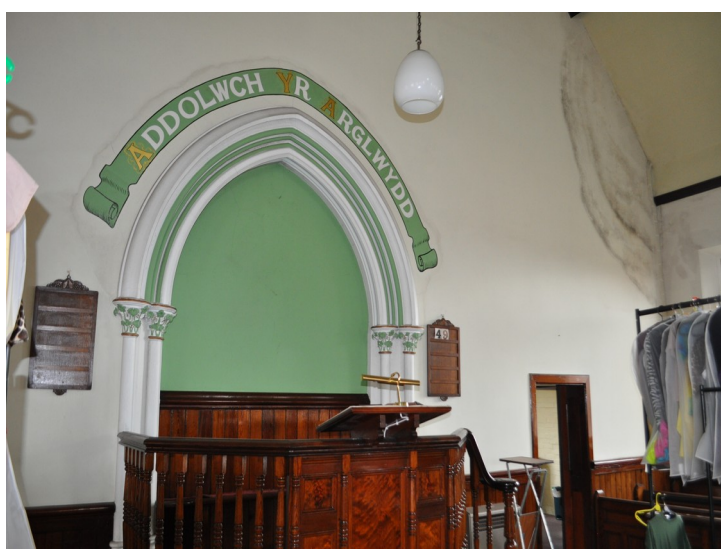
Plate 33 - North wall with alcove and access to annex

6.6.9. Access to the northern annex is via a doorway to the east of the Dias, which has a thick frame, showing that this is via a structurally load bearing wall (PLATE 33). There is no evidence that this has been inserted, in terms of ghosting or damage surrounding the doorway, indicating an original feature.

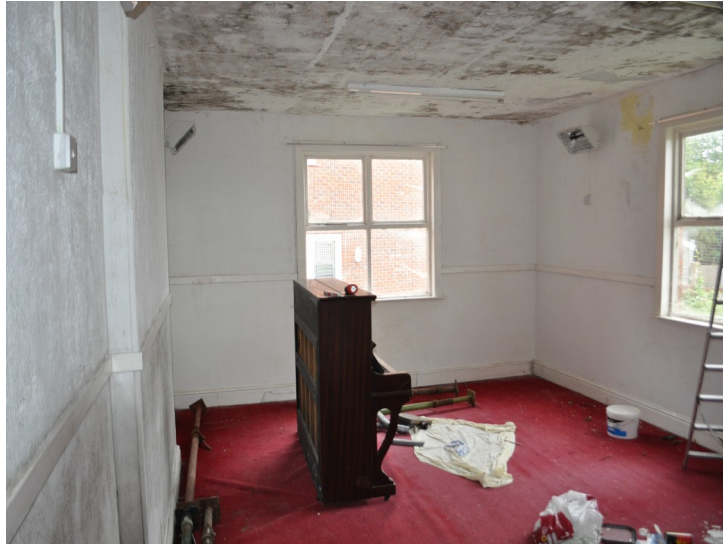
Plate 34 - Function room

6.6.10. The function room north of the chapel measures 24.27m<sup>2</sup> and is accessed via the chapel area to the south and corridor. The floor is covered in a red carpet and topped by a simple white skirting board (PLATE 34). The centre of the walls is divided by a white trim horizontally, mimicking simple wainscotting.

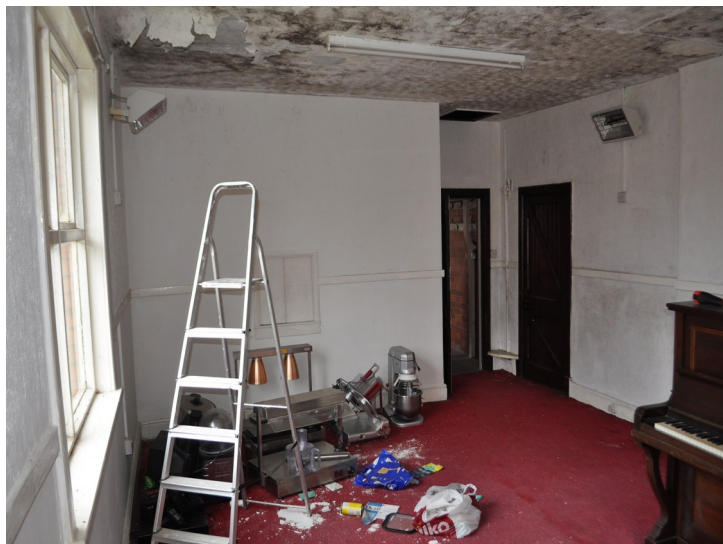
Plate 35 - Function room, looking east

6.6.11. The windows are all wooden frame, square, sash windows. A dog leg in the eastern wall allows for the kitchen area to reach into the room, and a small hatch is present to allow communication between the kitchen and function room (PLATE 35).

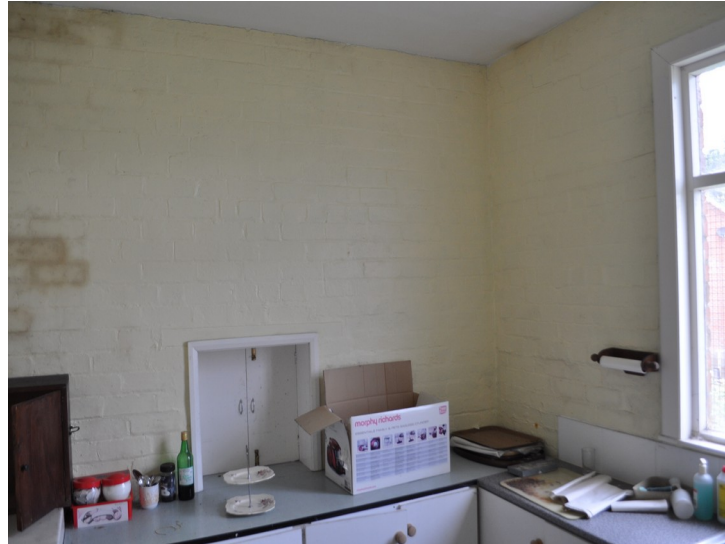
Plate 36 - Kitchen, looking west

6.6.12. The kitchen east of the function room measures 8.26m<sup>2</sup>. The door at the entrance is a white plank and batten door (PLATE 36). A single window occupies the northern wall, and the hatch between the kitchen and function room can be seen on the western wall.

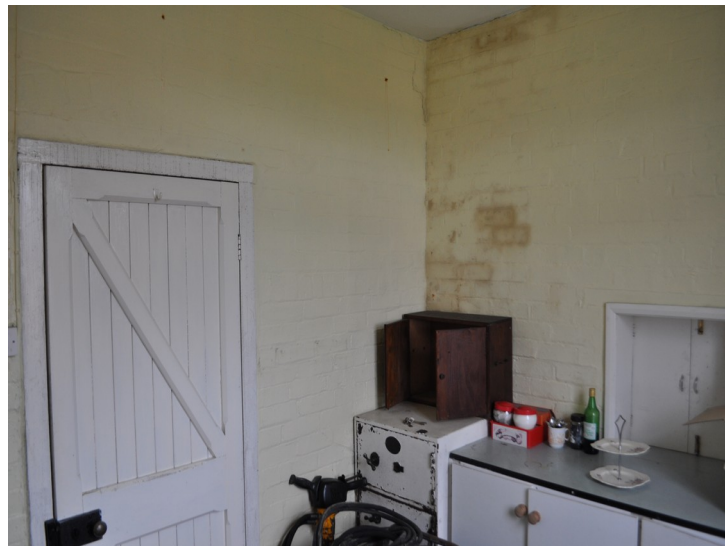
Plate 37 - Kitchen

6.6.13. The walls appear to match the exterior wall bricklaying, only painted in a magnolia colour. There are simple cabinets and a sink (PLATE 37).

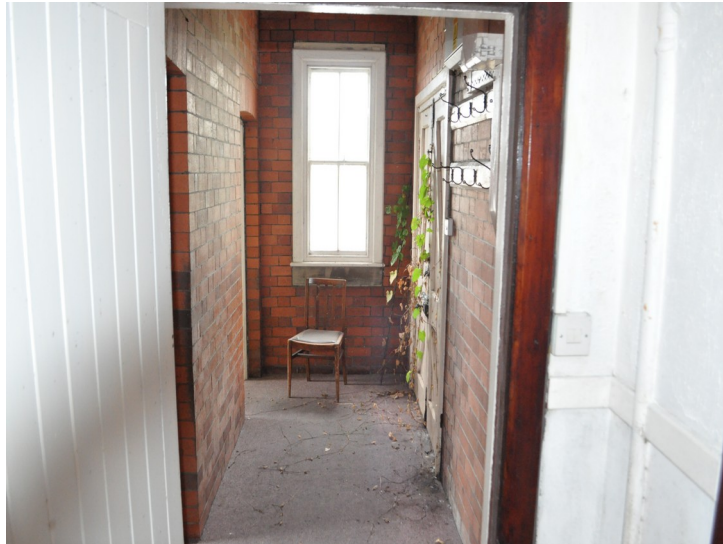
Plate 39 - Corridor, facing east

6.6.15. The corridor, south of the kitchen and water-closet room allows access to the chapel and function room, from the east, and, measures 5.38m<sup>2</sup>. It is thought it was originally open and the door was added at a later point, hence the external appearance of the brickwork. The walls are composed of unpainted bricks, similar in composition to the exterior walls, in a Flemish-bond (PLATE 39 & PLATE 40).

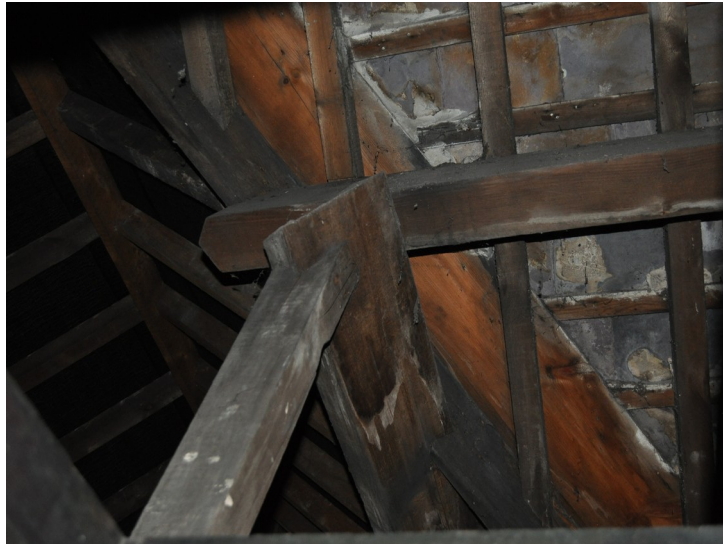
Plate 41 - Roof structure in annex

**6.6.16.** An access hatch at the entrance between the corridor and function room allowed a view of the roof construction. This was of machine cut timber, and appears to be original (PLATE 41).

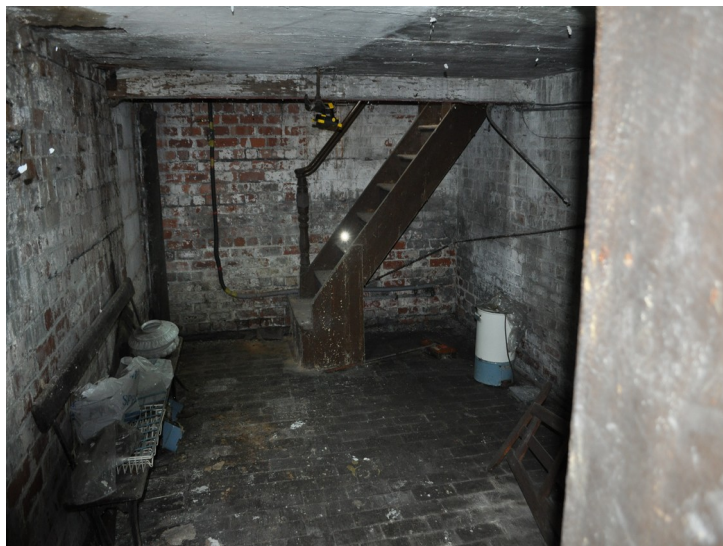
Plate 42 - Access to cellar, looking east

6.6.17. The cellar is divided into three main sections: the entrance from the hatch in the water-closet room, the main cellar room below the function room, and the crawlspace below the main chapel. Throughout the entire cellar the height of the ceiling is 1.95m (PLATE 42).

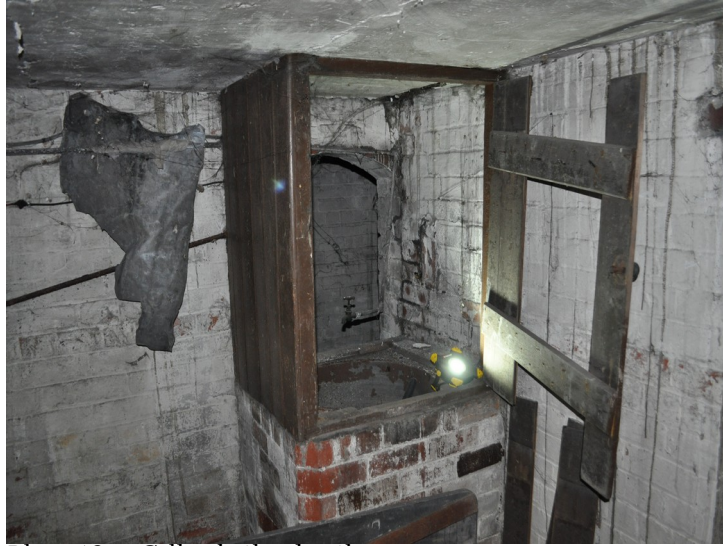
Plate 43 - Cellar boiler detail

6.6.18. The entrance from the hatch gives into a small room of 11m<sup>2</sup>. The walls are composed of a stretcher-bond, painted white (PLATE 44). The southwest corner of this room encloses the boiler (PLATE 43). An arched wooden doorway leads

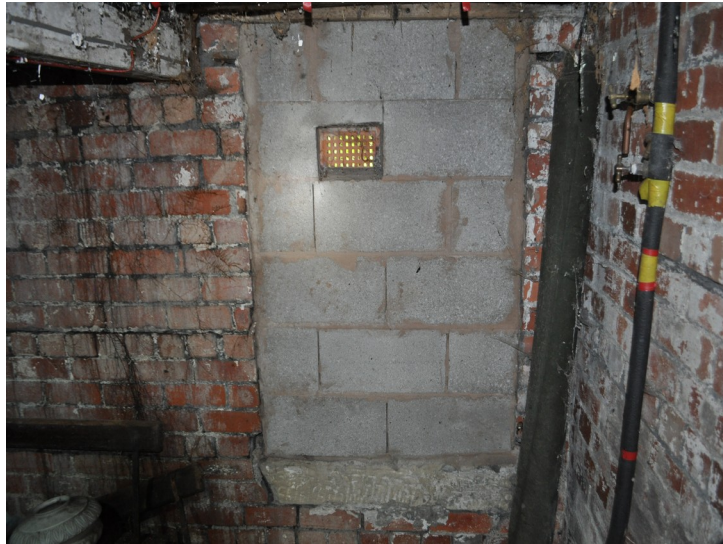
Plate 45 - Breeze blocked window on north wall of cellar

6.6.19. The larger cellar room under the function room measures 24m<sup>2</sup>. The walls of this room are composed of an English garden wall bond, painted white. The floor is composed of grey bricks, laid out in a stretcher-bond style. The west wall shows a bricked-up window (PLATE 46), while the other windows in the cellar are closed off with breeze-blocks (PLATE 45), this window was closed off with bricks similar in form to the chapel's construction material. The south wall of this room gives entrance to the crawlspace (PLATE 47).

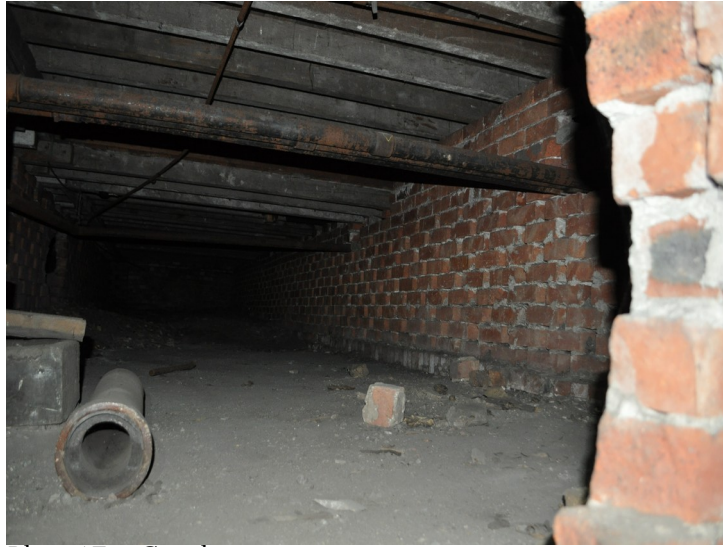
Plate 47 - Crawlspace

running southward, as a measure to evenly distribute heat from the boiler. The boiler itself being positioned in alignment with the entrance to the crawlspace.

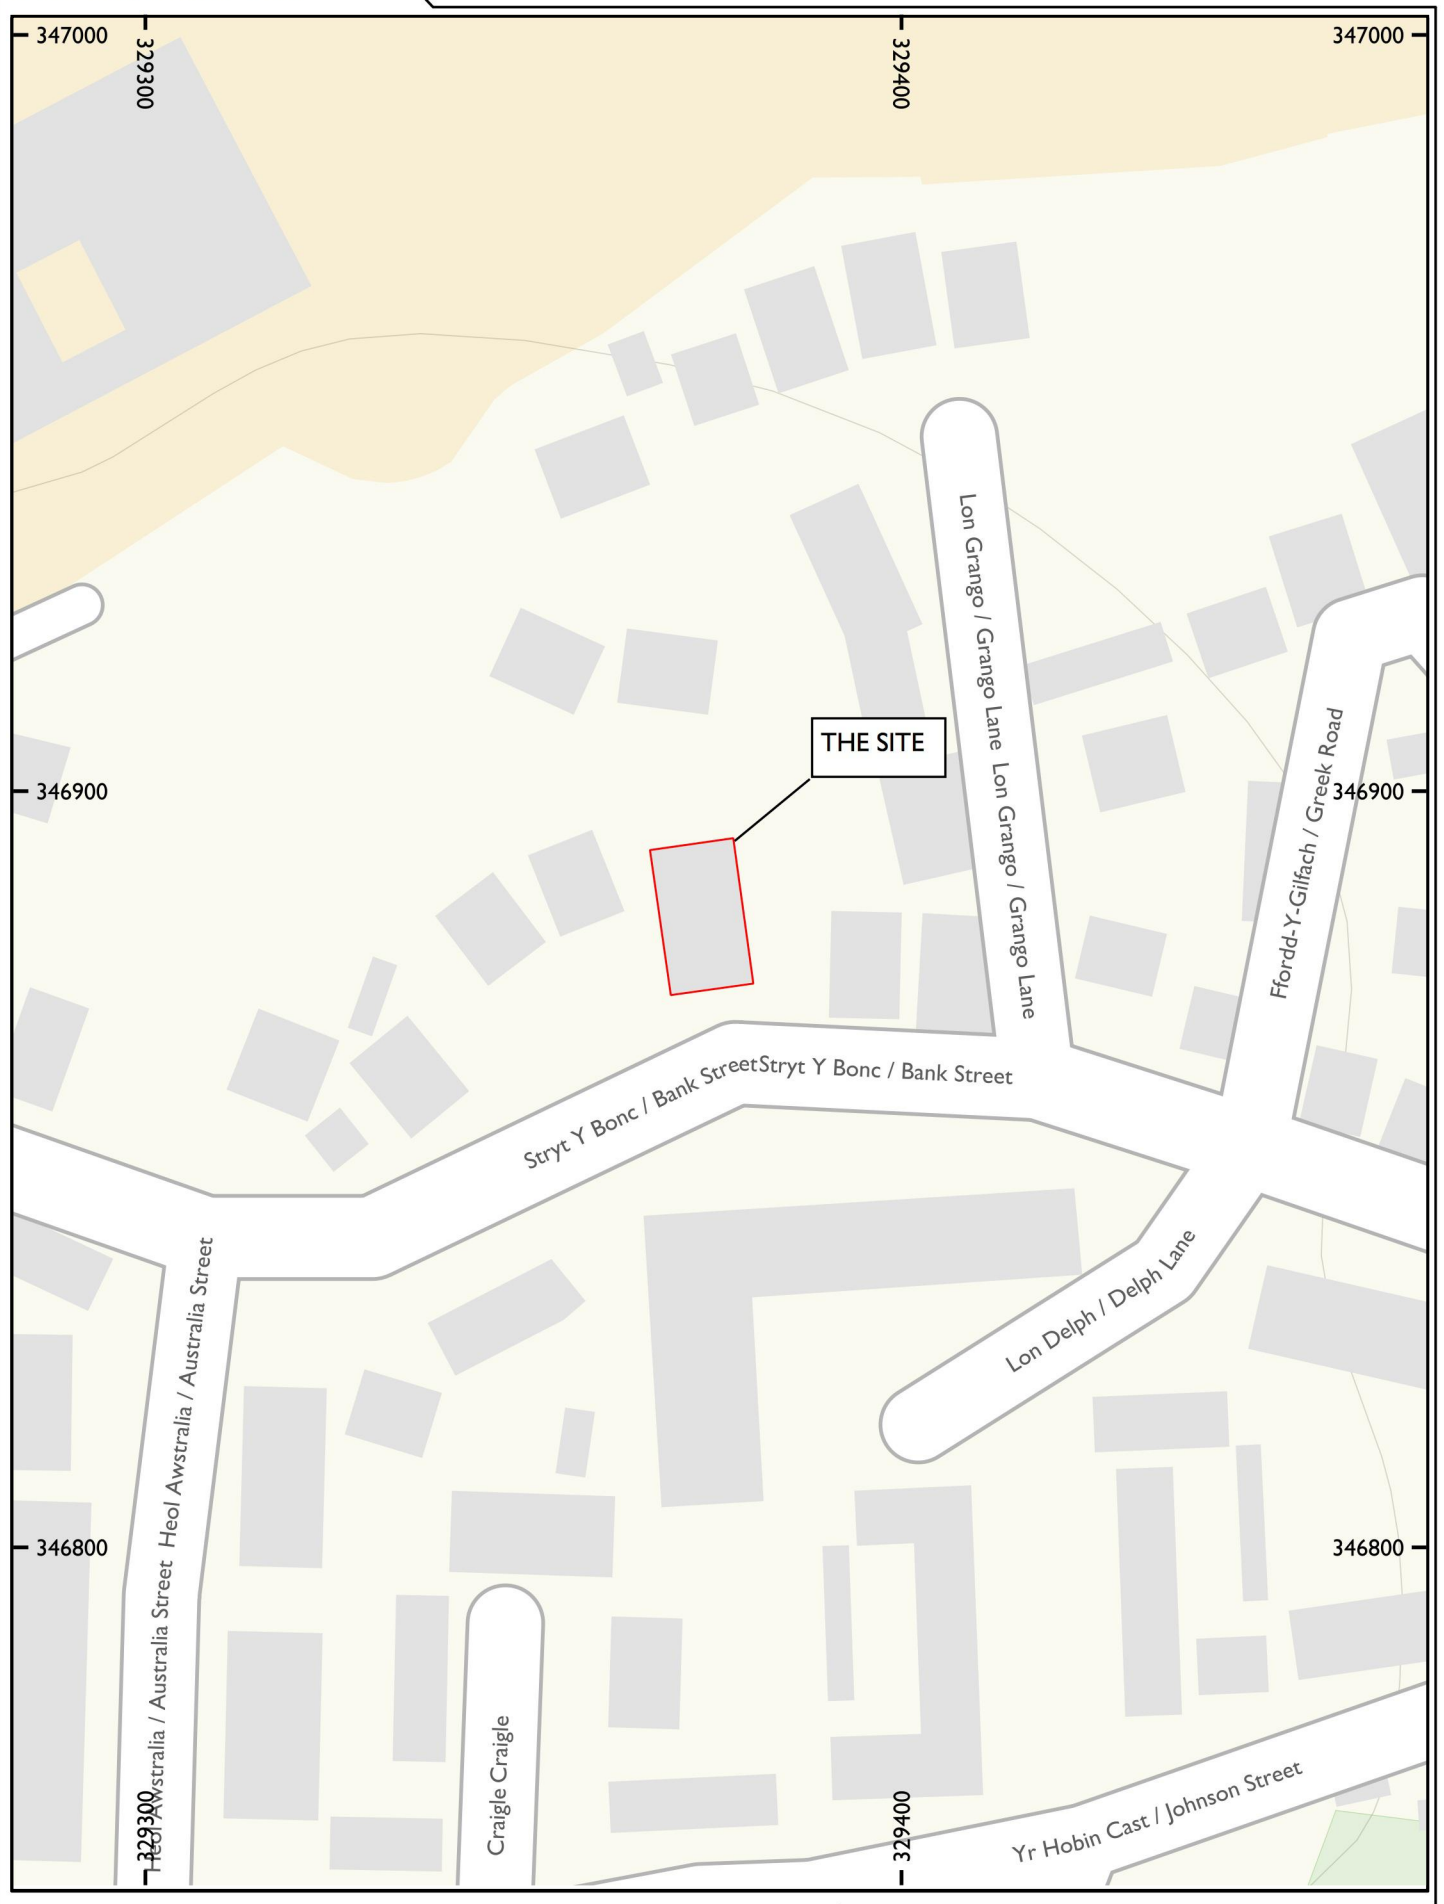
FIGURE 2 // Site Location - Detail

2.3.2. The site (FIGURE 2) is located in the village of Rhosllanerchrugog, halfway between the townscapes of Wrexham to the north and Oswestry to the south. The site is situated on the north side of Bank Street. The site itself lies on fairly flat land at approximately 175m Ordnance Datum. The site comprises a sub rectangular parcel of land, which is bound by residential housing to the north, east and west, and Bank Street to the south.
