# **SALEM CHAPEL RHOSLLANERCHRUGOG**

Joyce Heberden BA MSc

Doc Ref: LP4070C-HBR-v.1.4

A level 3 building survey (PRN 213770) was carried out at Salem Chapel, Bank Street, Rhosllanerchrugog, on the 6<sup>th</sup> July 2022 by L - P : Archaeology. This document has been prepared by Joyce Heberden of L - P : Archaeology on behalf of the client Blueprint Architectural. The work was undertaken in response to a condition of planning consent for the demolition of the existing building, a disused chapel, and erection of 2 domestic dwellings (P/2021/0543).

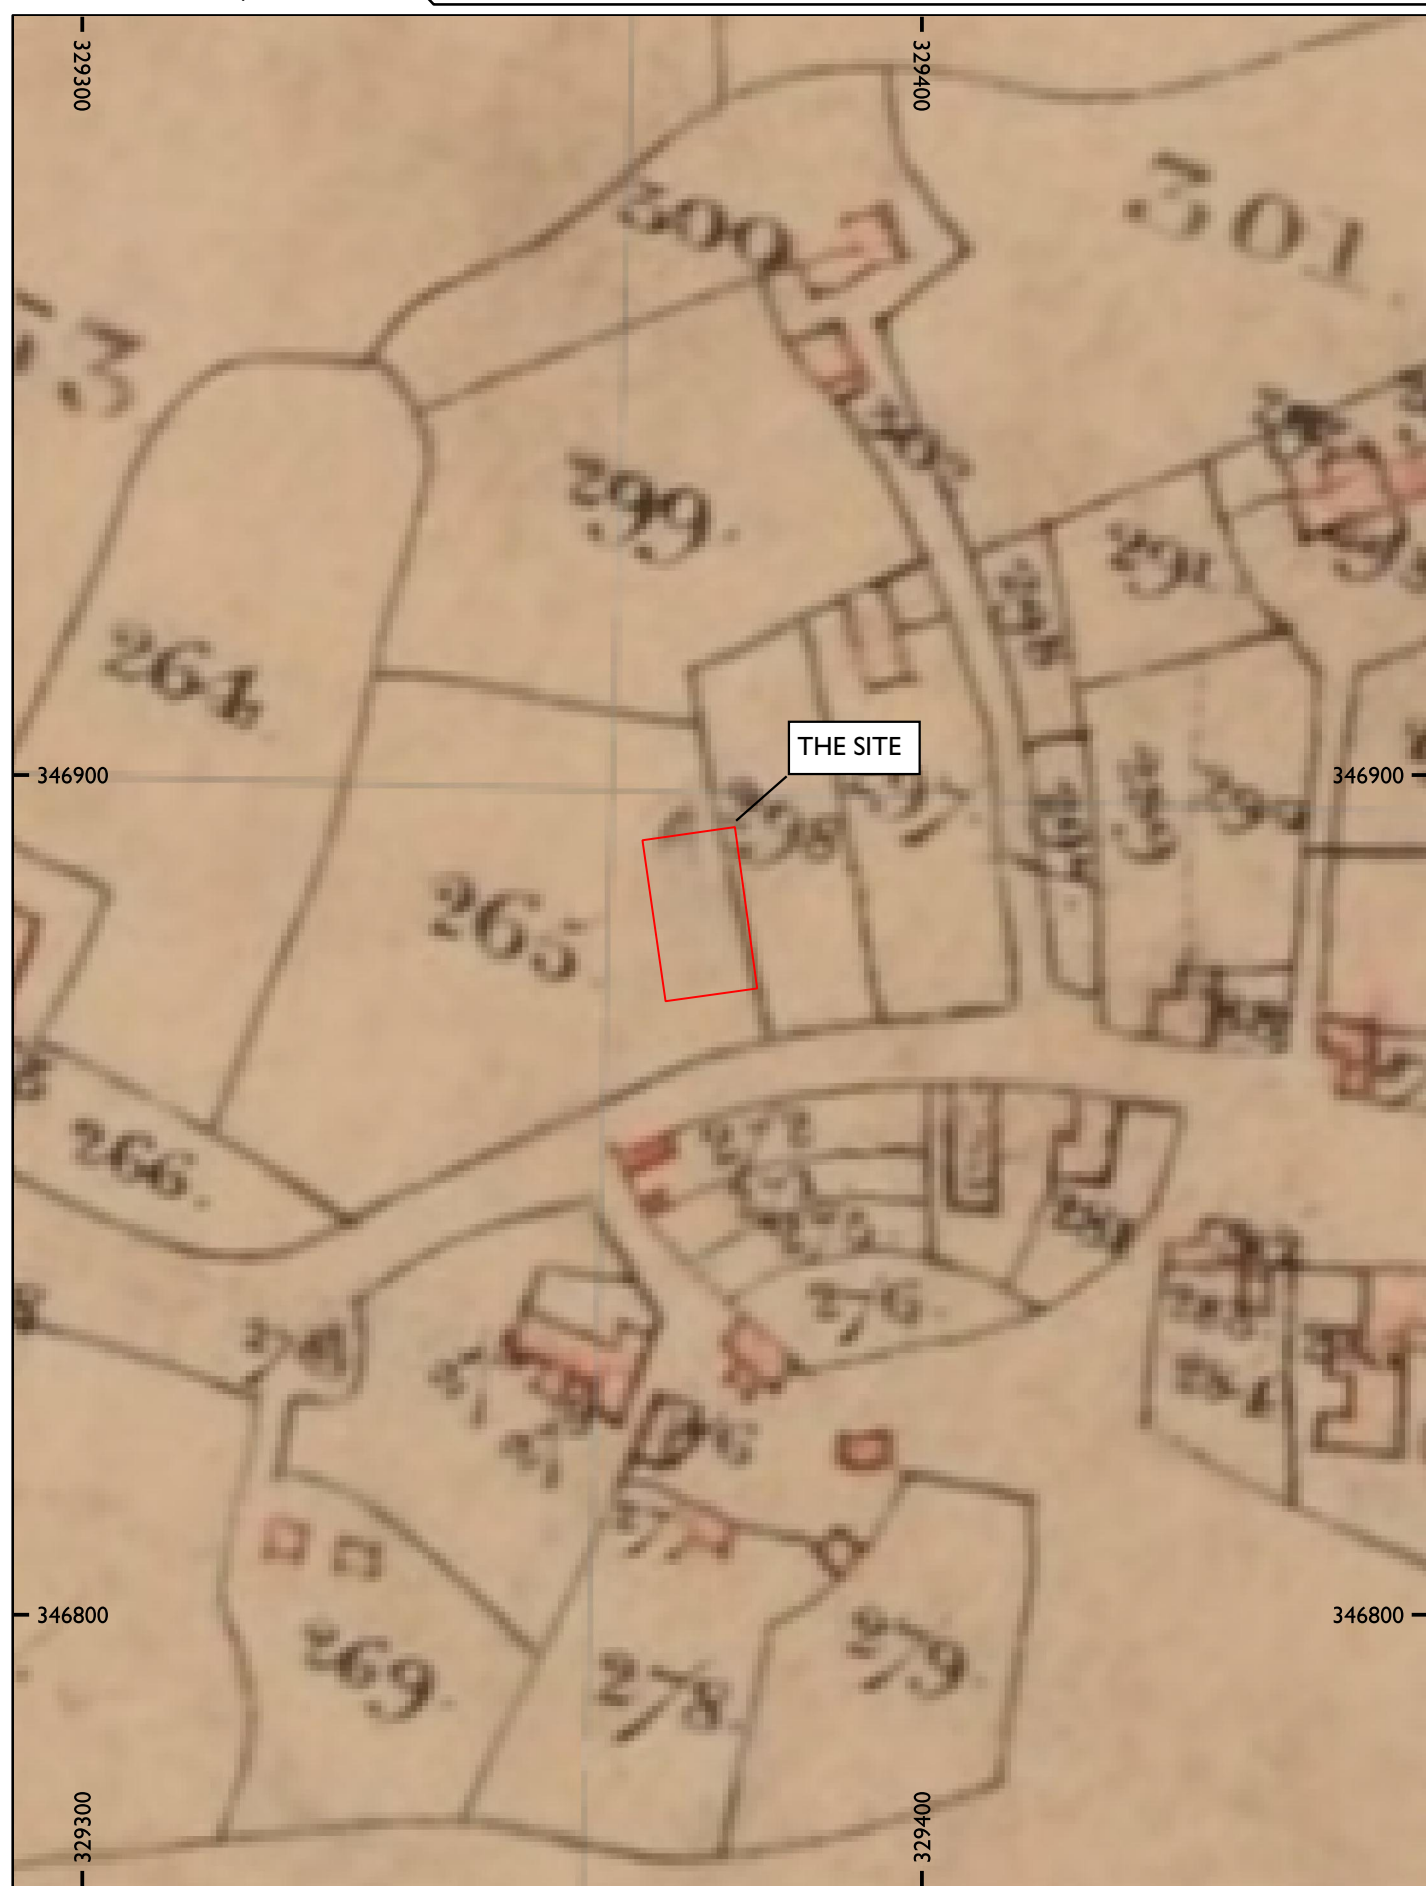
FIGURE 4 // 1845 Tithe Map

4.3.1. The original plot of the chapel, plot 265 of the 1845 Tithe Map (FIGURE 4), shows it as a vacant croft, within Moreton Above Township. It is described as arable land, owned by the Hon. Frederick West and occupied by Anne Evans (YATES 1845).

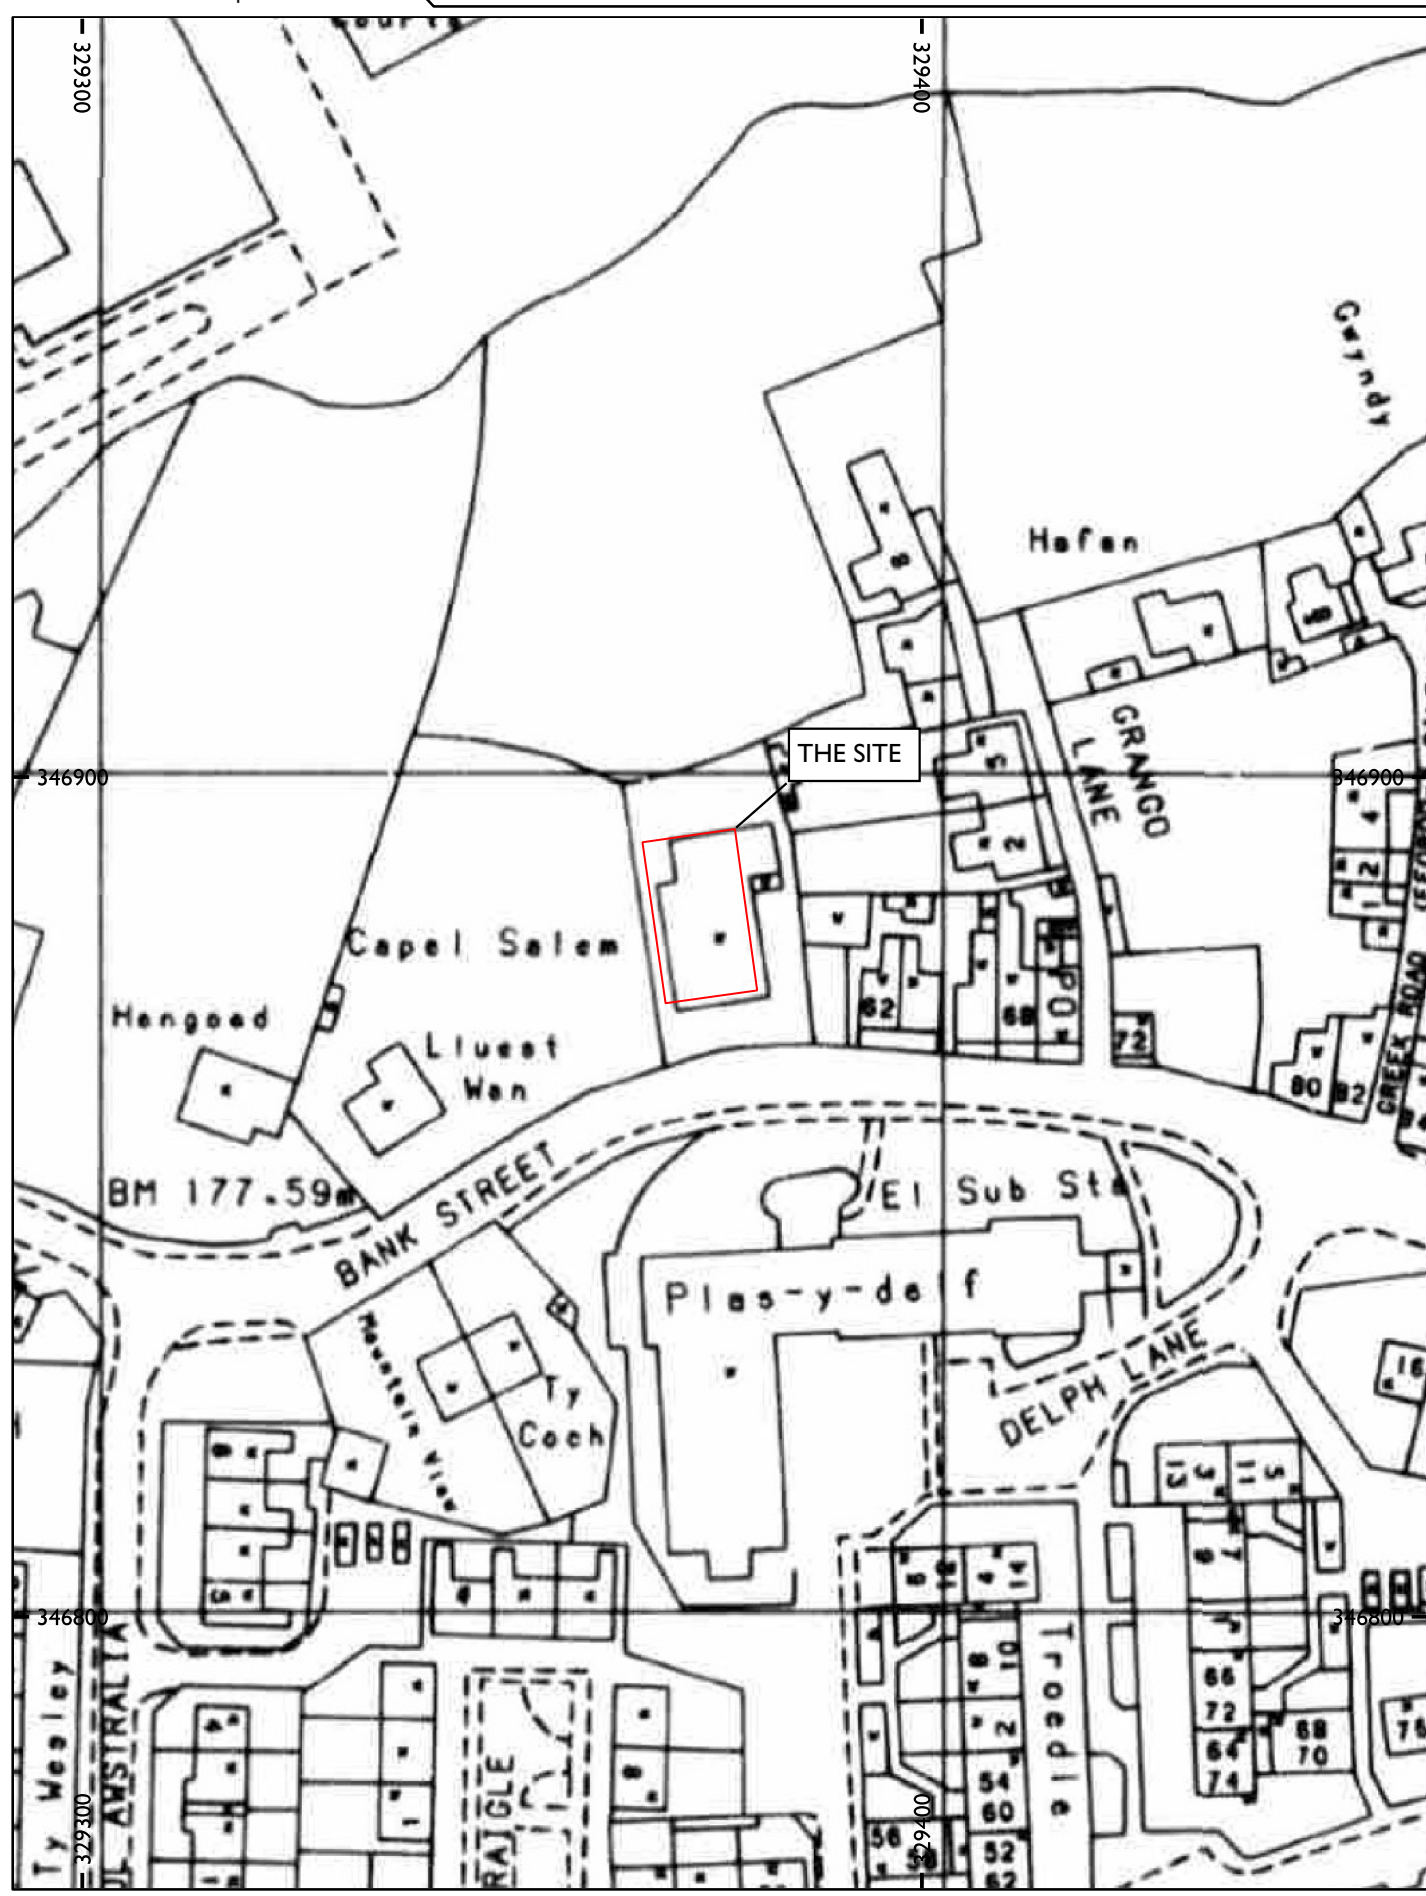
FIGURE 11 // 1992 OS Map

- 4.3.7. By the 1992 25-inch OS map (FIGURE 11), the empty plot across from the chapel is shown to have been replaced by Plas-y-delph, a nursing home, which was still present and in use at the time of the report. From 1992 onwards, the footprint of the structure or its environment do not change.

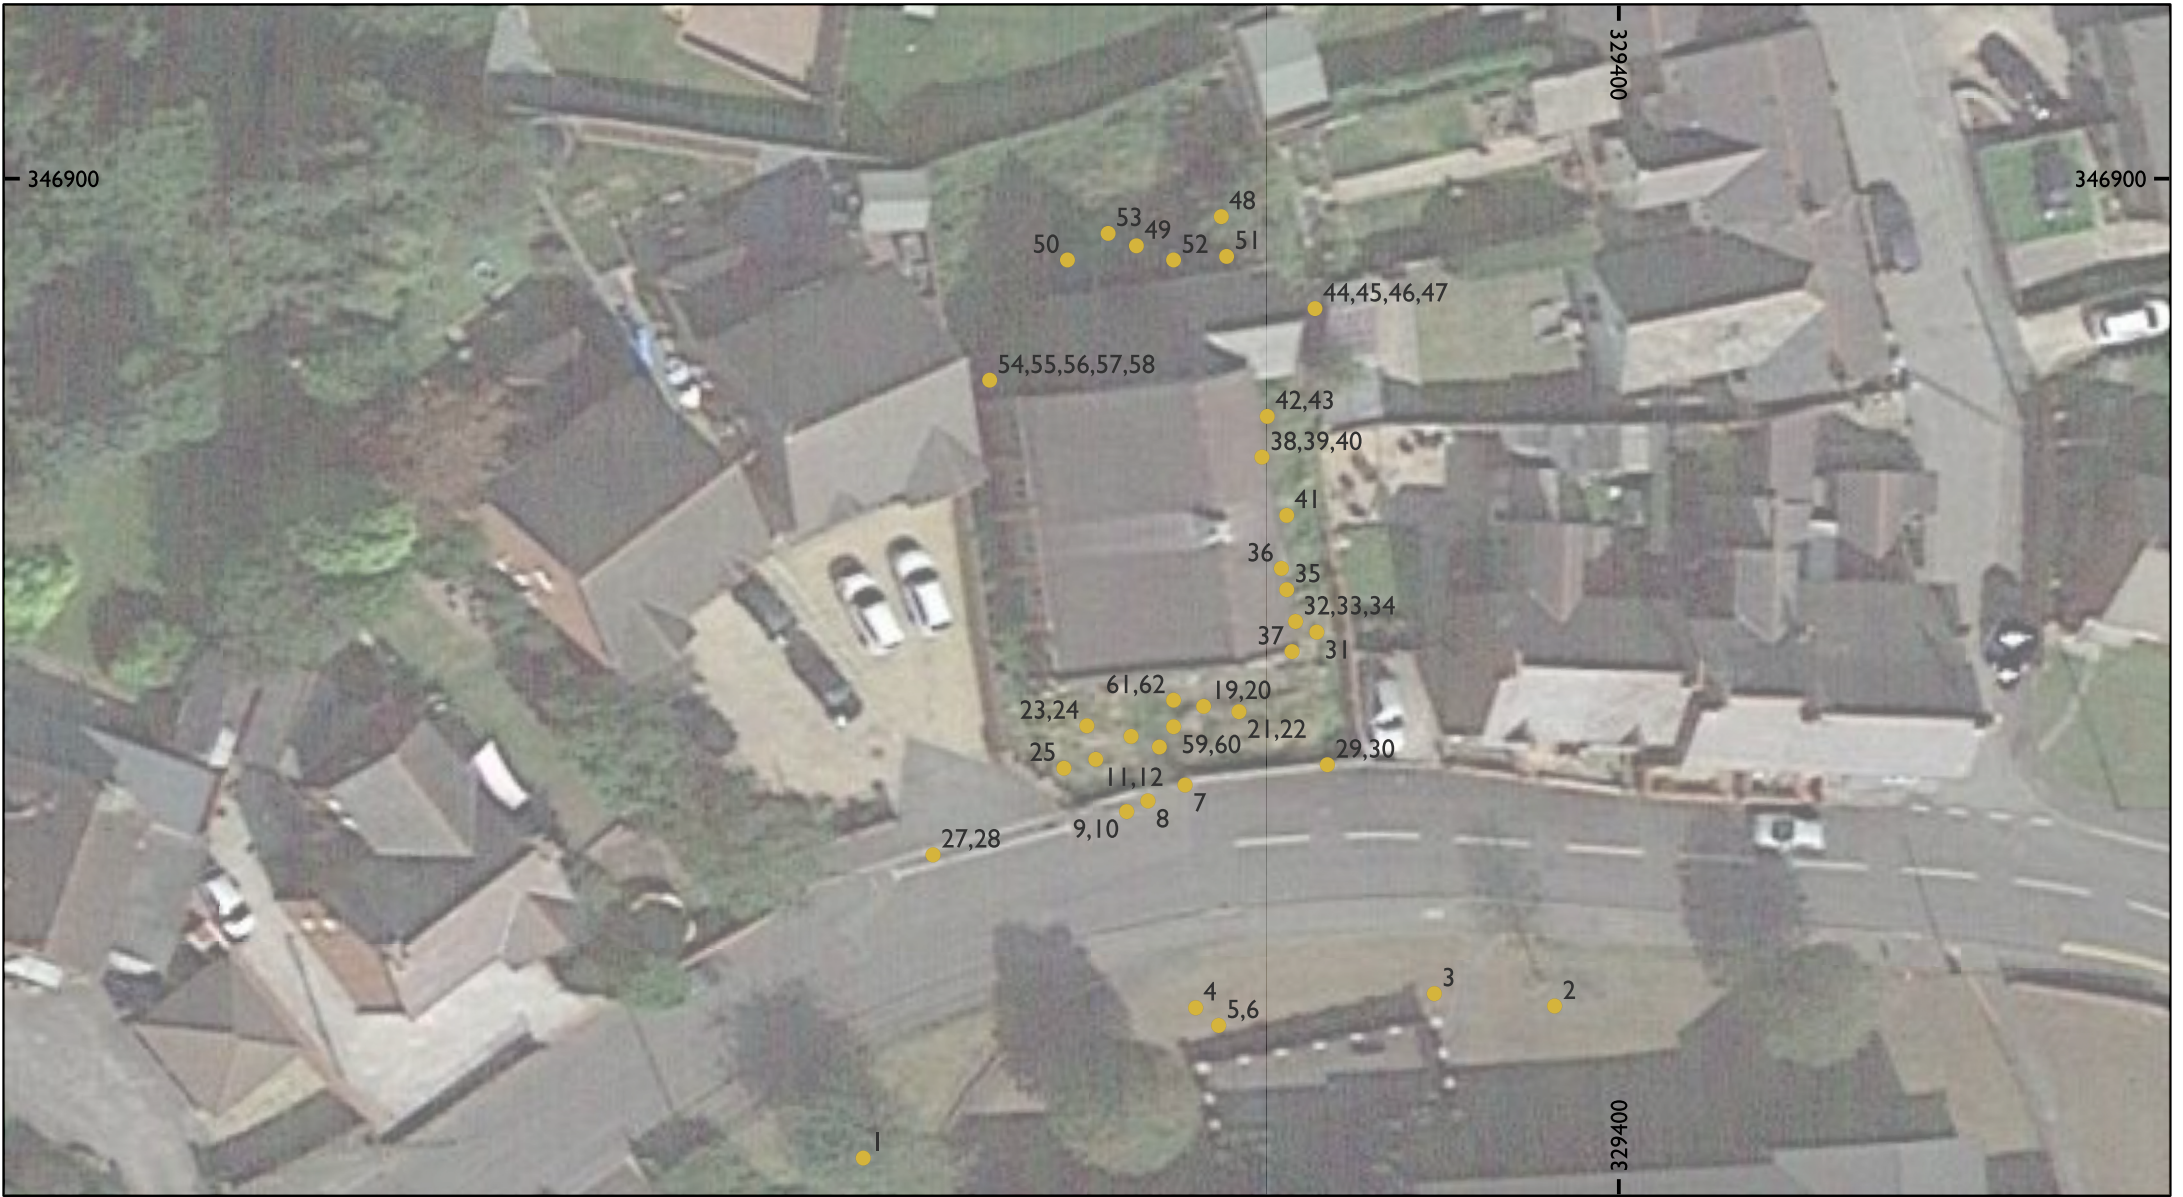
FIGURE 16 // External Photos

- ◆ Views of elevations (FIGURE 16)
- ◆ Views of external appearance
- ◆ Views of all internal rooms (FIGURE 17)
- ◆ Internal and external structural detail
- ◆ Fixtures, fittings, machinery, related contents
