**COBBLESTONES, ROSSETT.**

**PRELIMINARY ECOLOGICAL APPRAISAL.**

**Ref No: 221147.**

**Date: 9<sup>th</sup> December 2022.**

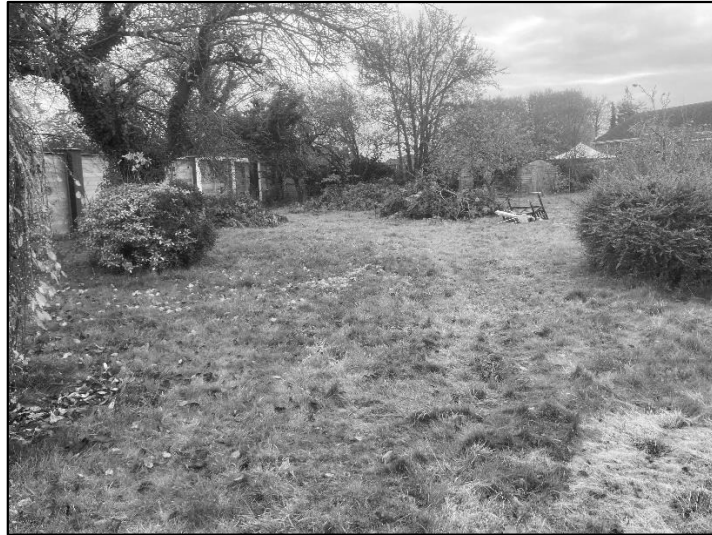
3.3.1.1. The back garden of the existing dwelling is a large lawned area classed as amenity grassland. Species present include annual meadow grass (*Poa annua*),

perennial ryegrass (*Lolium perenne*), false oat grass (*Arrhenatherum elatius*) plus white clover (*Trifolium repens*), ragwort (*Senecio jacobaea*), creeping buttercup (*Ranunculus repens*), dock (*Rumex sp.*), cow parsley (*Anthriscus sylvestris*), cleavers (*Galium aparine*) and dandelion (*Taraxacum officinale*).

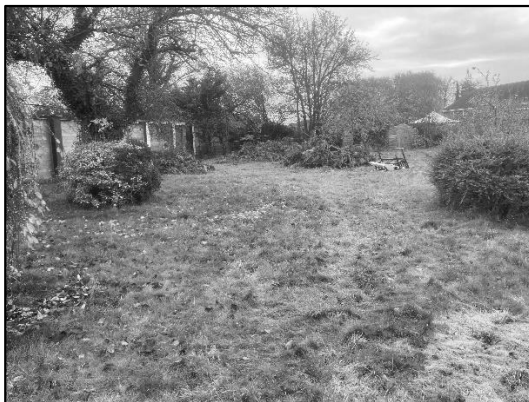
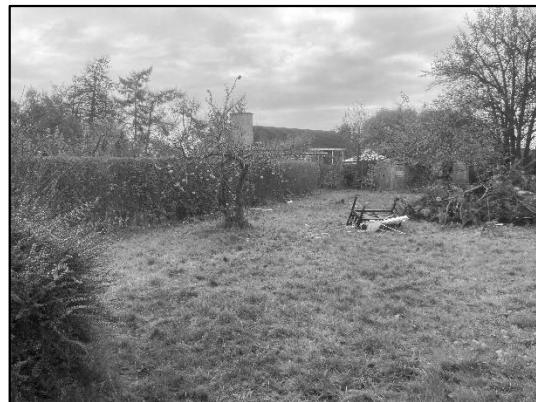
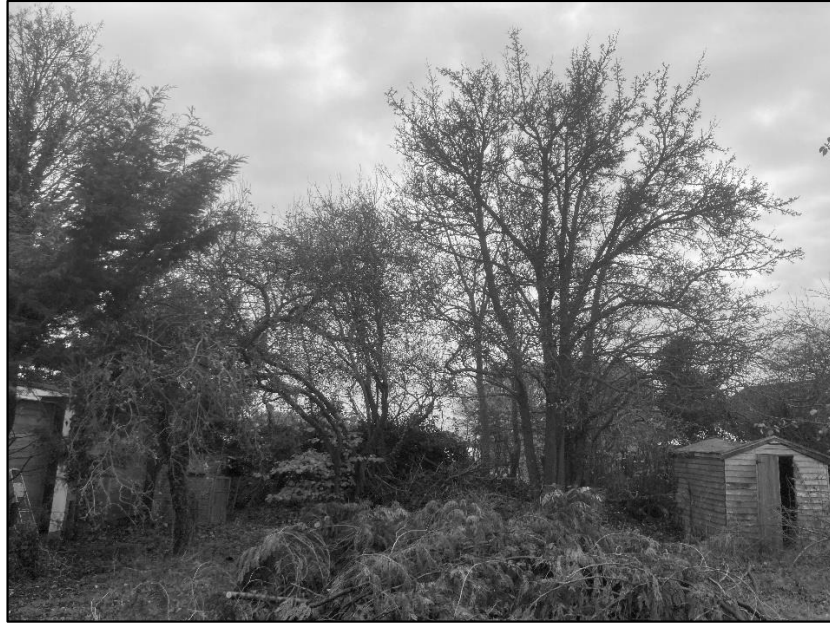
3.3.2.1. There are a few scattered trees in the garden, two are apple trees and there is one sycamore (*Acer pseudoplatanus*) and one ash (*Fraxinus excelsior*) at the bottom of the existing garden.

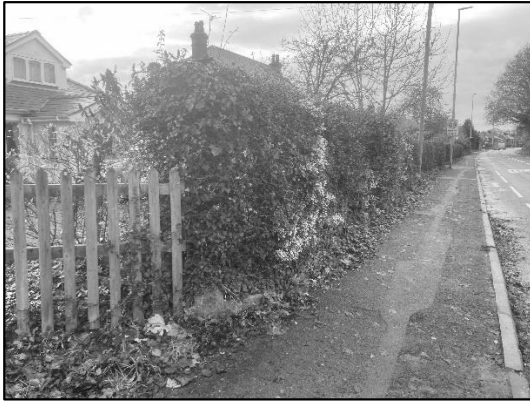
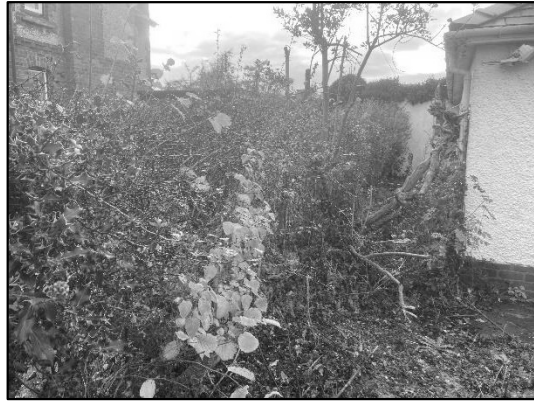
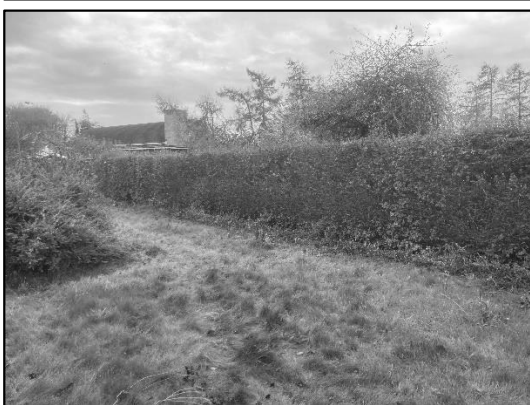
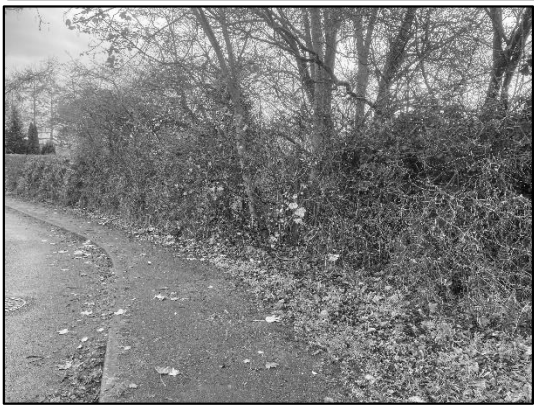
3.3.3.1. There are species poor hedgerows around the site boundaries comprising Hawthorn (*Crataegus monogyna*), privet (*Ligustrum vulgare*), holly (*Ilex aquifolium*), laurel, hazel (*Corylus avellana*), Firethorn (*pyracantha Sp*), beech (*Fagus sylvatica*), Spindle (*Euonymus japonica*), buddleia (*Buddleia davidii*) and ivy (*Hedera helix*).

5.1. It is recommended that the hedgerows along the southern and eastern site boundaries are retained and that a new, native, species rich hedgerow is planted inside the new site boundary fence along the northern site boundary. Along with the retention of the existing garden habitat and trees, this will ensure a beneficial level of biodiversity for the development.

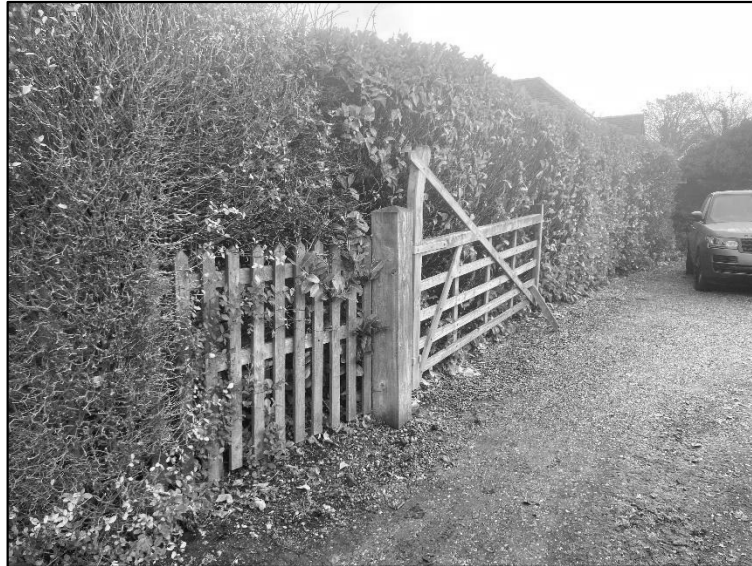
The northern boundary hedgerow comprises a laurel and conifer hedgerow between the front yard and the neighbouring dwelling.

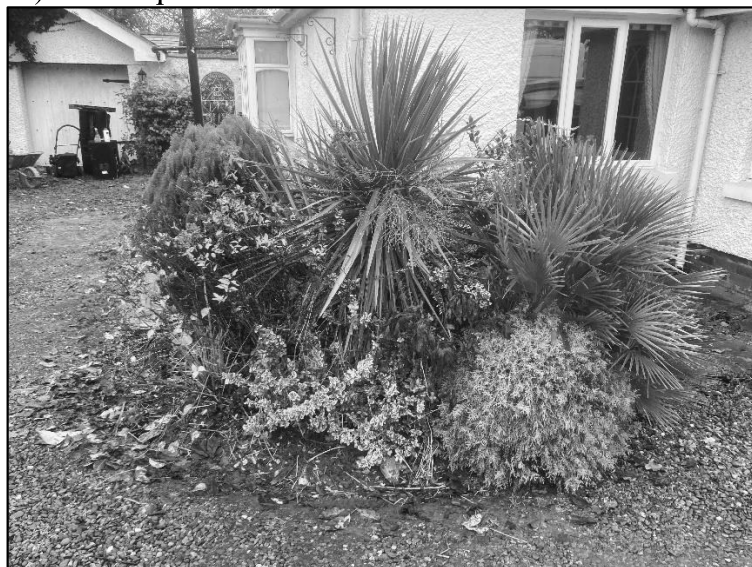
There are areas of ornamental planting within the garden including the border shown below at the front corner of the property. Species present include spiraea (*Spiraea japonica*), Spindle (*Euonymus japonica*), hydrangea (*Hydrangea Sp*), conifer, holly (*Ilex aquifolium*) and fan palm.

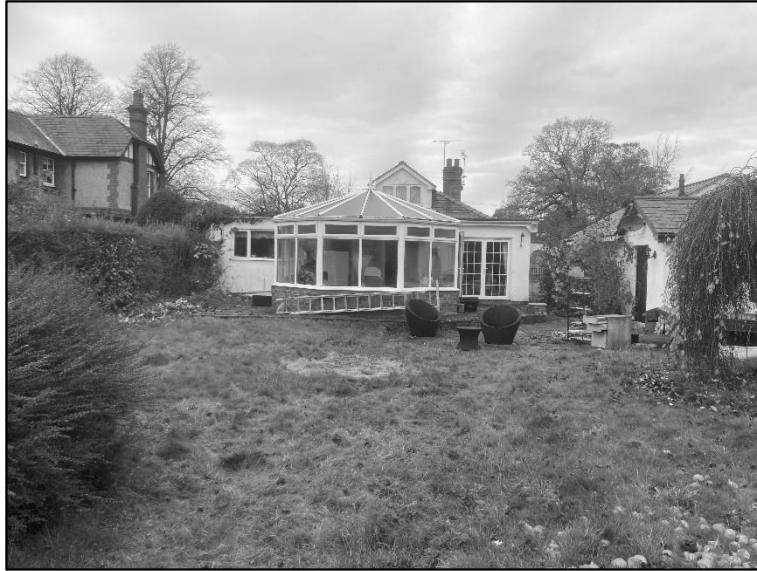
There is the main dwelling present on the site with a large sun lounge to the rear along with a separate block comprising double garage to the front and an office to the rear. These are dealt with in more detail later in this report.

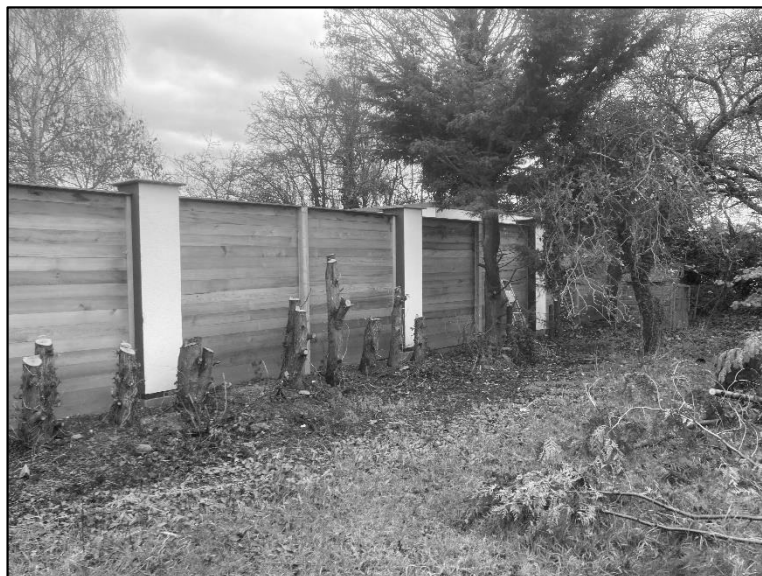
There has been some recent development of the site to the north. Part of that development included the removal of an overgrown conifer hedgerow between the two properties and replacement with a substantial fence as shown below.

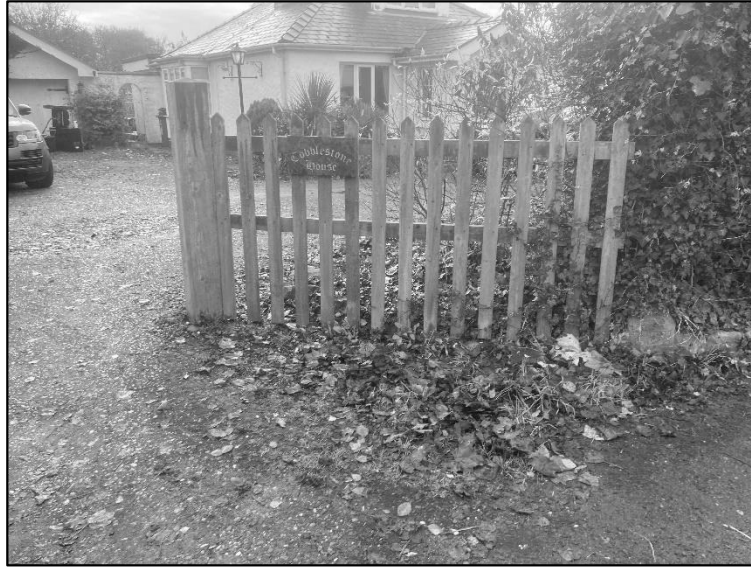
There is an area in front of the dwelling and garage for access from the road, turning and parking. This area is covered with hard packed gravel and has been classed as bare ground.

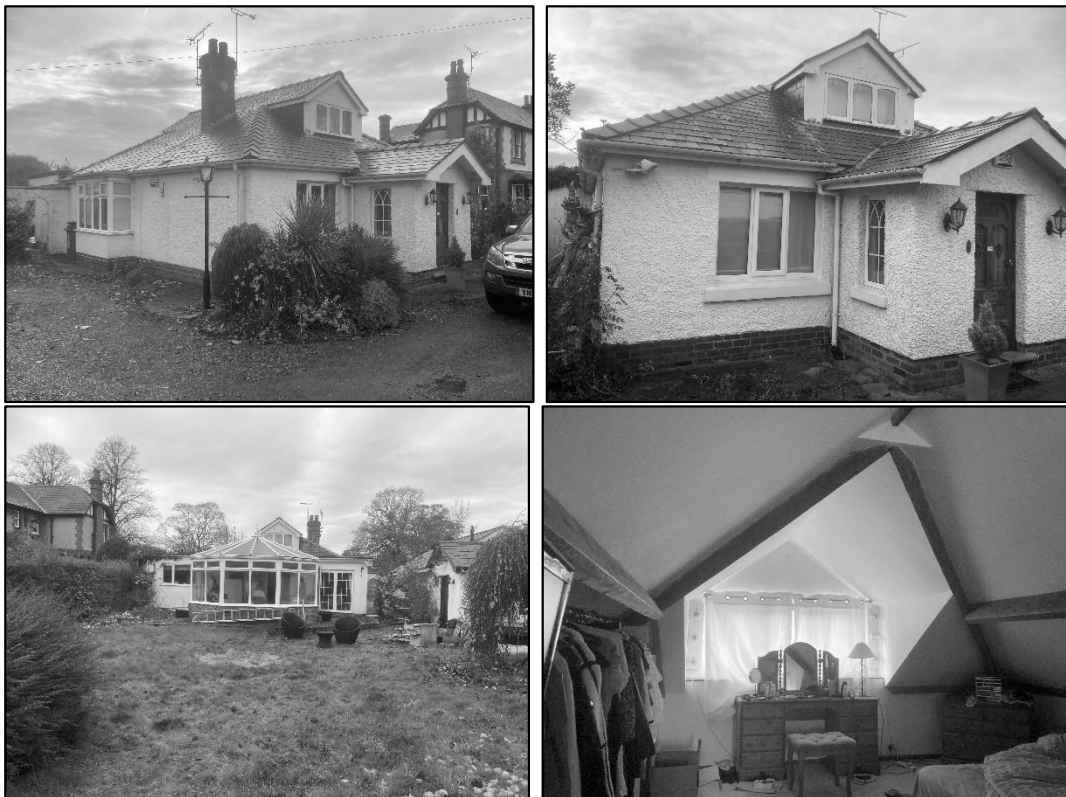
3.4.3.1.1. The house is predominantly a single storey dwelling with a spiral staircase leading up to a single bedroom on the floor above that extends to the underside of the roof space.

3.4.3.1.2. The walls are cavity walls rendered externally and painted white. These are in good condition with well-sealed window and door frames and fascia boards that provide no access points for bats.

3.4.3.1.3. The roof is covered with thin slates that are close fitting and provide no access for bats and with well-sealed ridge tiles. There was one slate missing low down that leaves a void into the roof, but this was low down and could be inspected for potential bat access. No bat field signs were found and the opening was covered with fresh cobwebs. This slate was replaced immediately after the inspection to ensure no bats were trapped as a result.

3.4.3.1.4. The internal bedroom extends under the roof leaving no loft space suitable for loft dwelling species.

3.4.3.1.5. To the rear of the dwelling there is a flat roofed extension area and then a large and modern plastic and glass sun lounge. These are both of a design that is unsuitable for roosting bats.

3.4.3.1.6. The dwelling was assessed to have negligible potential for roosting bats in line with the Bat Conservation Trust Good Practice Guidelines.

5.3. It is recommended that the existing buildings be demolished with due care. The buildings have been assessed to have negligible potential for roosting bats but individual bats can seek temporary shelter almost anywhere. In the unlikely event that a bat is found, it is recommended that it be covered and protected from harm, work should cease at that location and Whitcher Wildlife Ltd contacted for further advice.

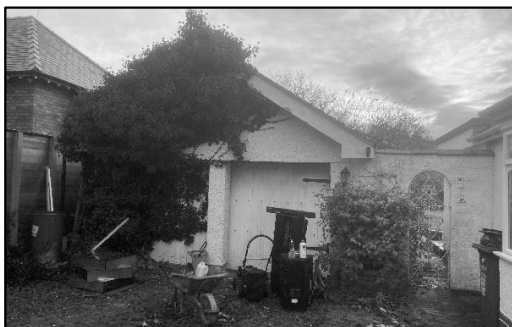
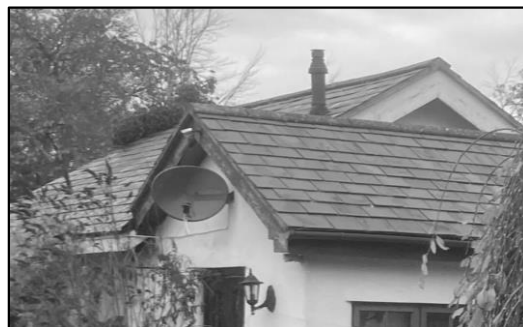
3.4.3.2.1. The garage is a single storey block built with solid brick walls that are rendered and painted white to match the house. They have a pitched roof supported by a timber frame covered with thin slates.

3.4.3.2.2. There is a dense clump of ivy growing up the front of the building and over the back side of the roof.

3.4.3.2.3. Internally the garages are used for storage purposes accessible through a side pedestrian door only. These are open to the underside of the roof slates.

3.4.3.2.4. The garage was assessed to have negligible potential for roosting bats in line with the Bat Conservation Trust Good Practice Guidelines.

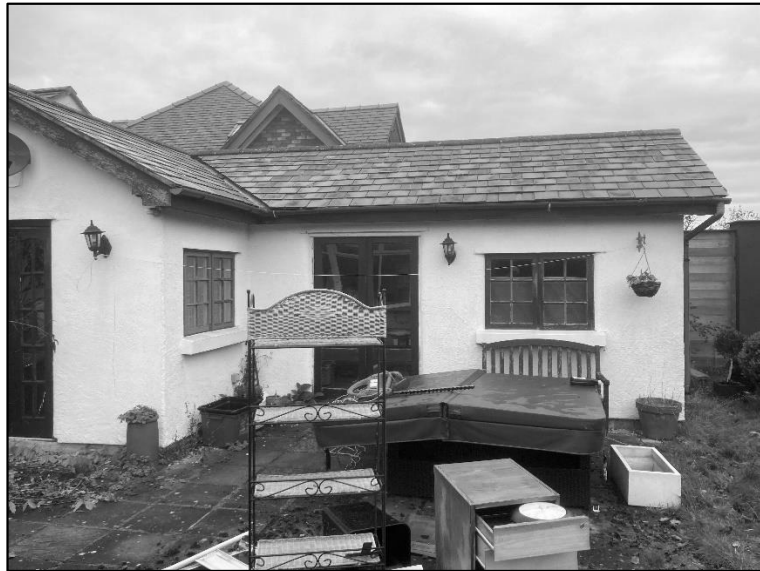
3.4.3.3.1. The outbuilding is a single storey block built with brick cavity walls that are rendered and painted white to match the house. They have a pitched roof supported by a timber frame covered with thin slates.

3.4.3.3.2. The walls are in good condition with well-sealed window and door frames and fascia boards that provide no access points for bats.

3.4.3.3.3. The roof is covered with thin slates that are close fitting and provide no access for bats and with well-sealed ridge tiles. There is no accessible loft space.

3.4.3.3.4. The outbuilding was assessed to have negligible potential for roosting bats in line with the Bat Conservation Trust Good Practice Guidelines.

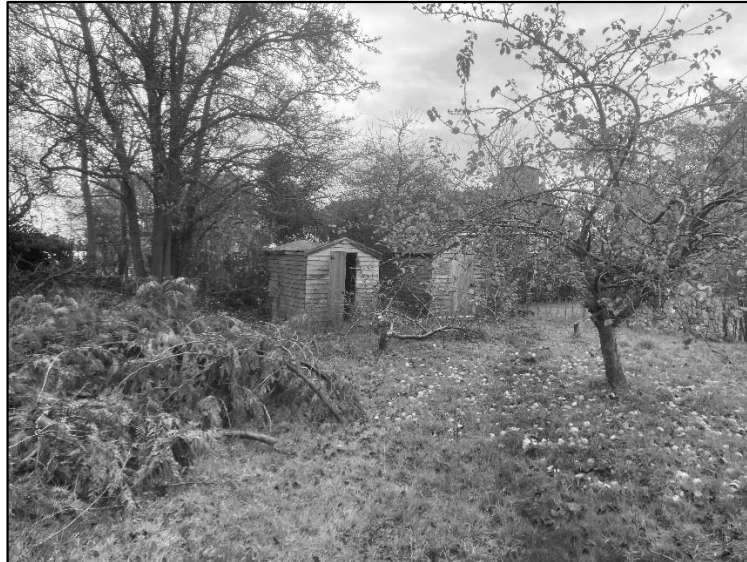
There are two timber garden sheds at the eastern end of the plot that are unsuitable for roosting bats and will be retained within the existing garden.
