## **COAL MINING RISK ASSESSMENT**

**11 HILL STREET  
RHOS  
WREXHAM  
WALES  
LL14 1LN**

**ARKIFY**

**8<sup>th</sup> September 2022**

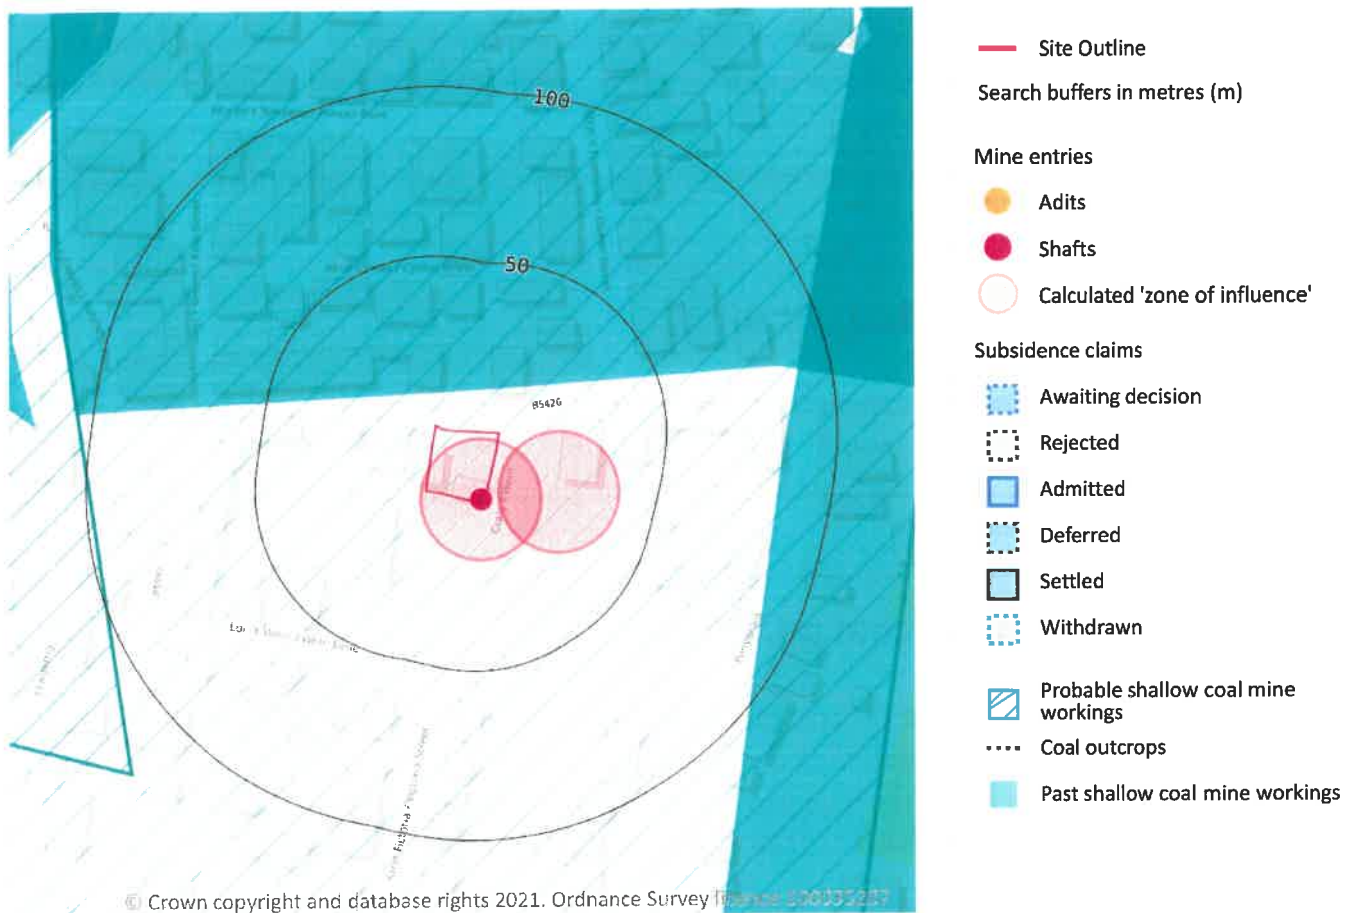
## Coal mining (CON29M)

The map above shows relevant, mappable hazards identified that could constitute a risk to the property. It does not necessarily show all features or potential issues identified in this report.

Further details of any features shown indicating the location of Mine Entries or Subsidence Claims can be found in the relevant sections of this report (4 and 9 respectively).

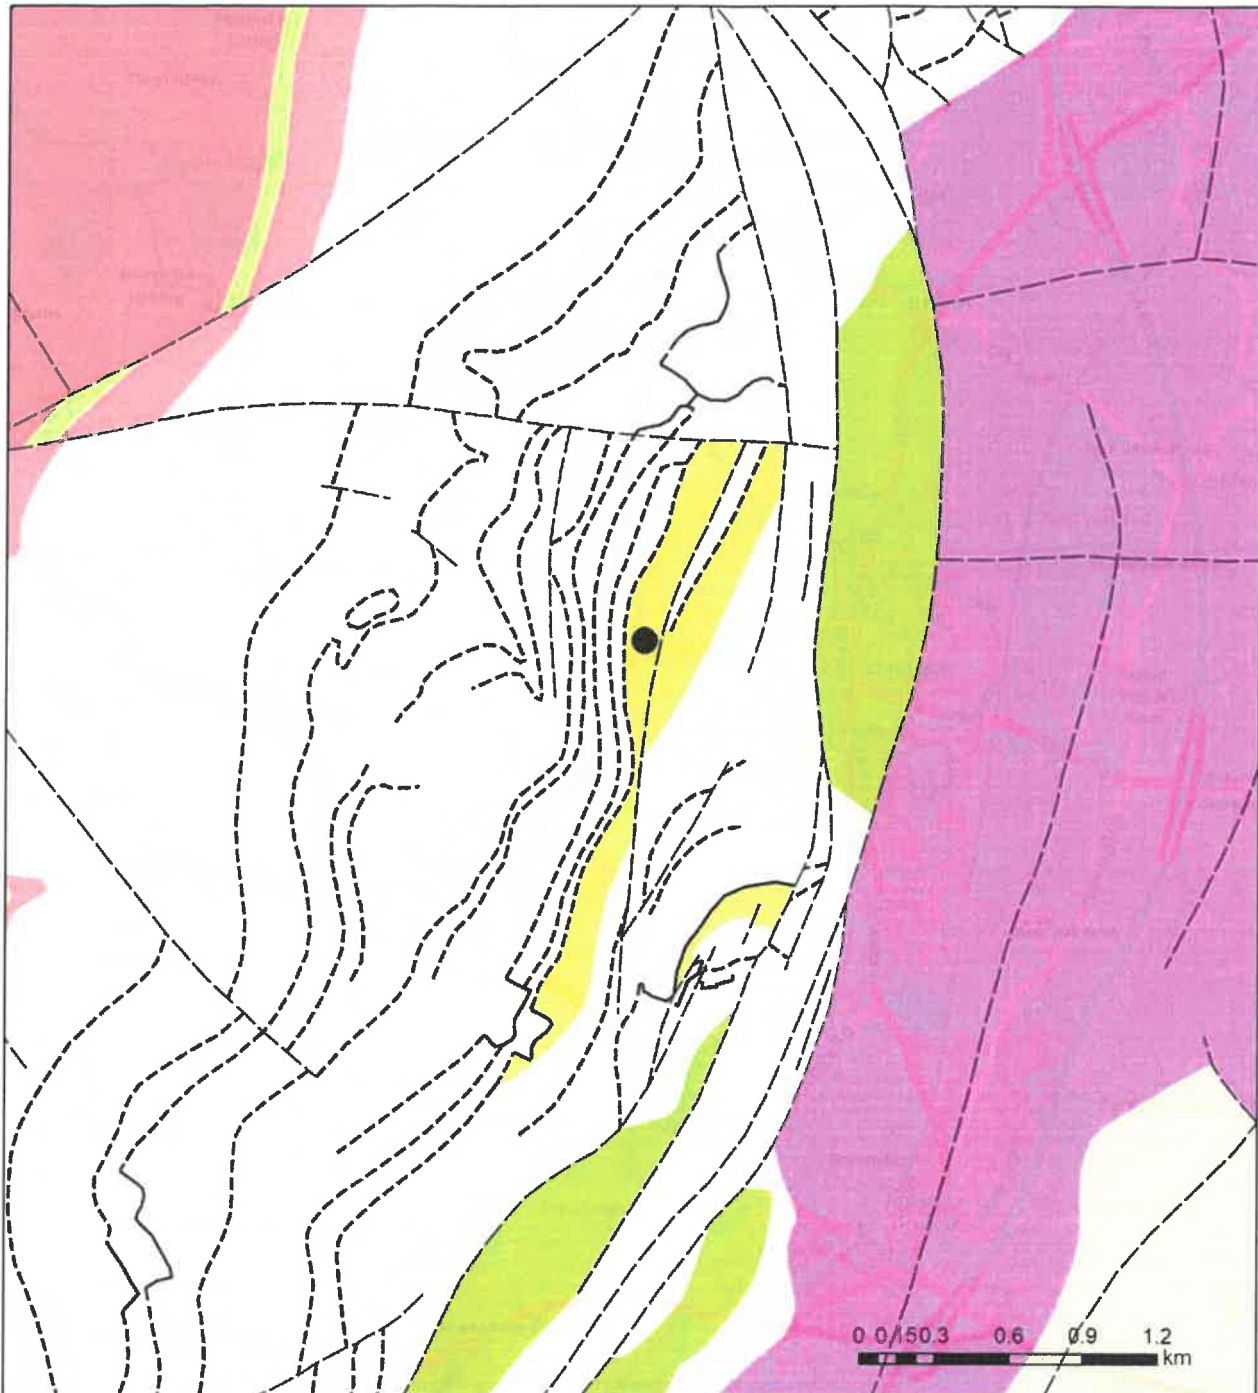
Bedrock geology 1:50,000 scale

PENNINE LOWER COAL MEASURES FORMATION AND PENNINE MIDDLE COAL MEASURES FORMATION (UNDIFFERENTIATED) - MUDSTONE, SILTSTONE AND SANDSTONE

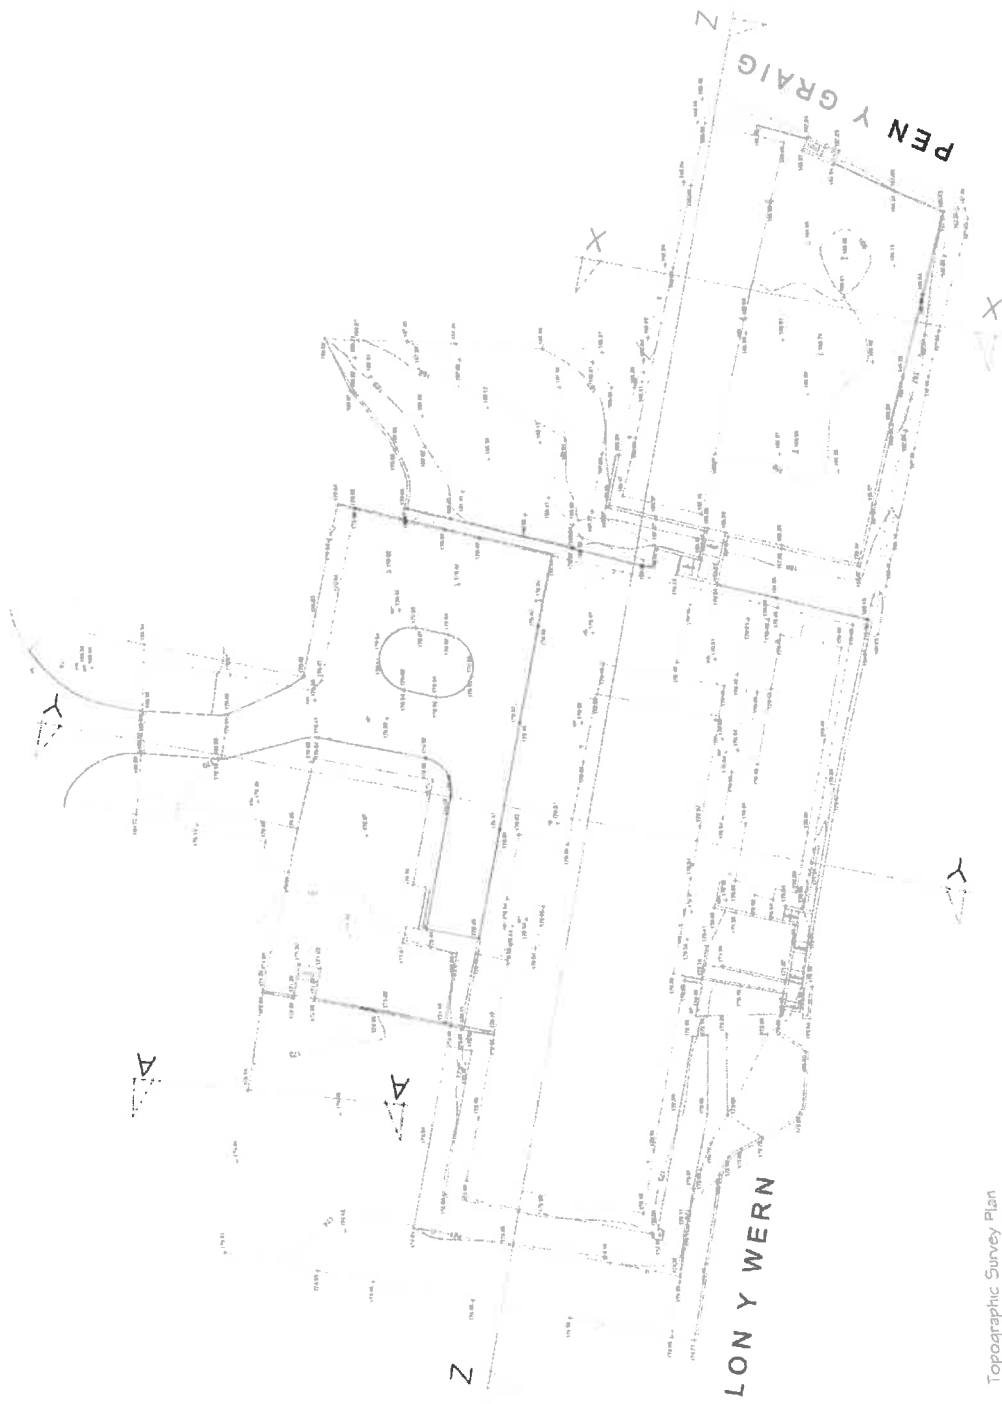
**FIGURE 2**

Topographic Survey Plan

**EXISTING  
SITE LAYOUT**

The Main coal outcrop is shown to be located in close proximity to the site (see **Figure 2**) and is likely to be encountered at shallow depths. Further outcrops of coal are located further to the west. The Main Coal appears to be missing from Coal Authority records.

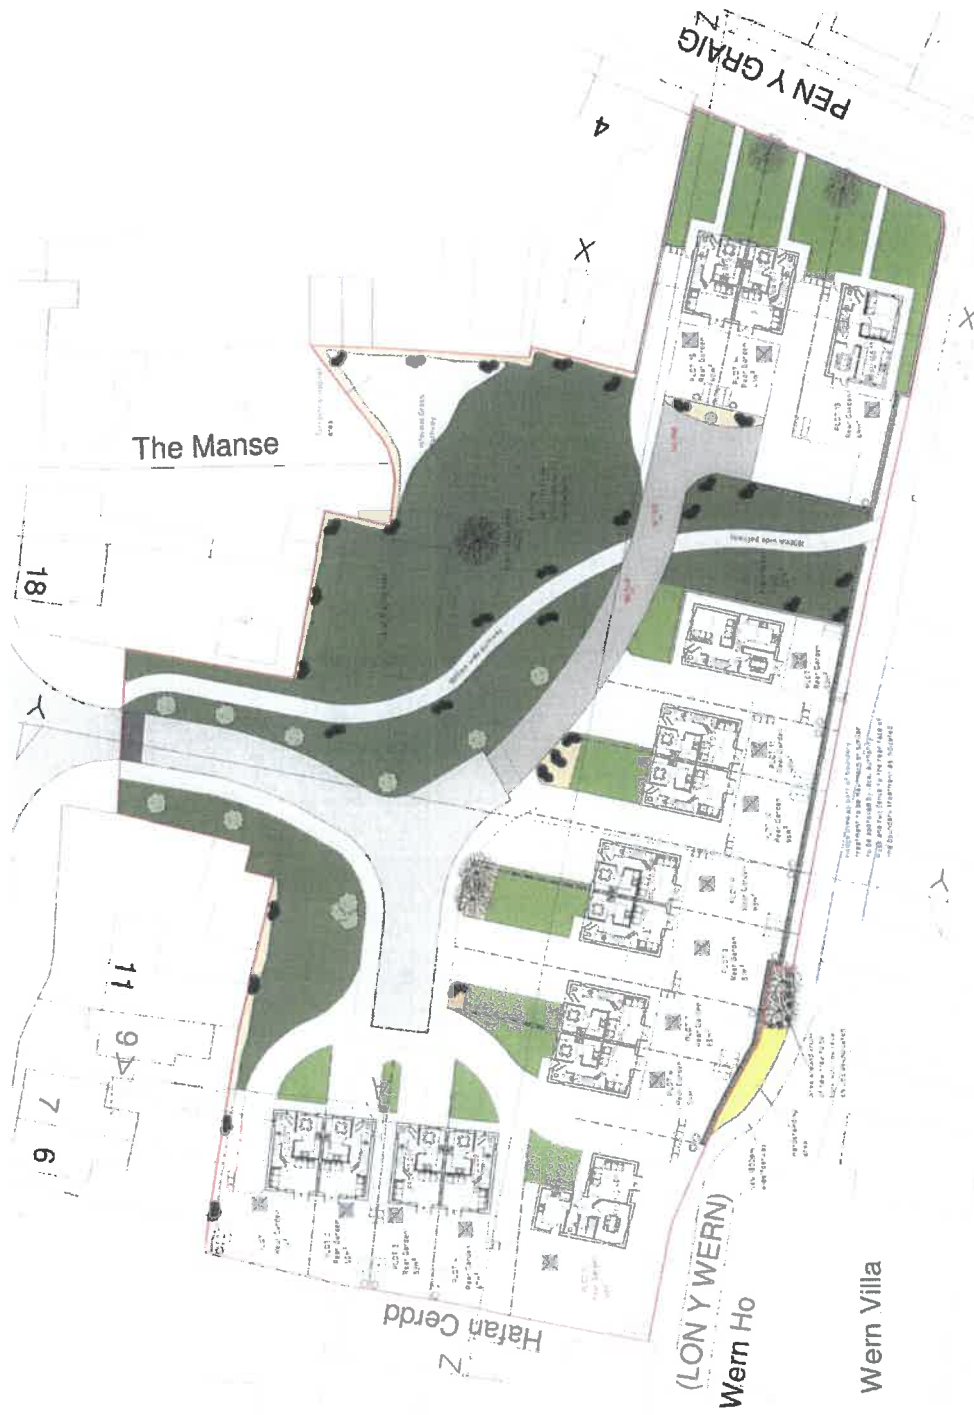
**FIGURE 4**

**PROPOSED  
LAYOUT**

Based on the above discussion, it is recommended that Plot 13 be moved. If this is possible, it would also make sense to move Plots 14 and 15 as well. These three plots could be moved to the upper area in the proposed area of the public open space, with this area being re located to the eastern section of the site. This has the advantage in that strip foundations could be used

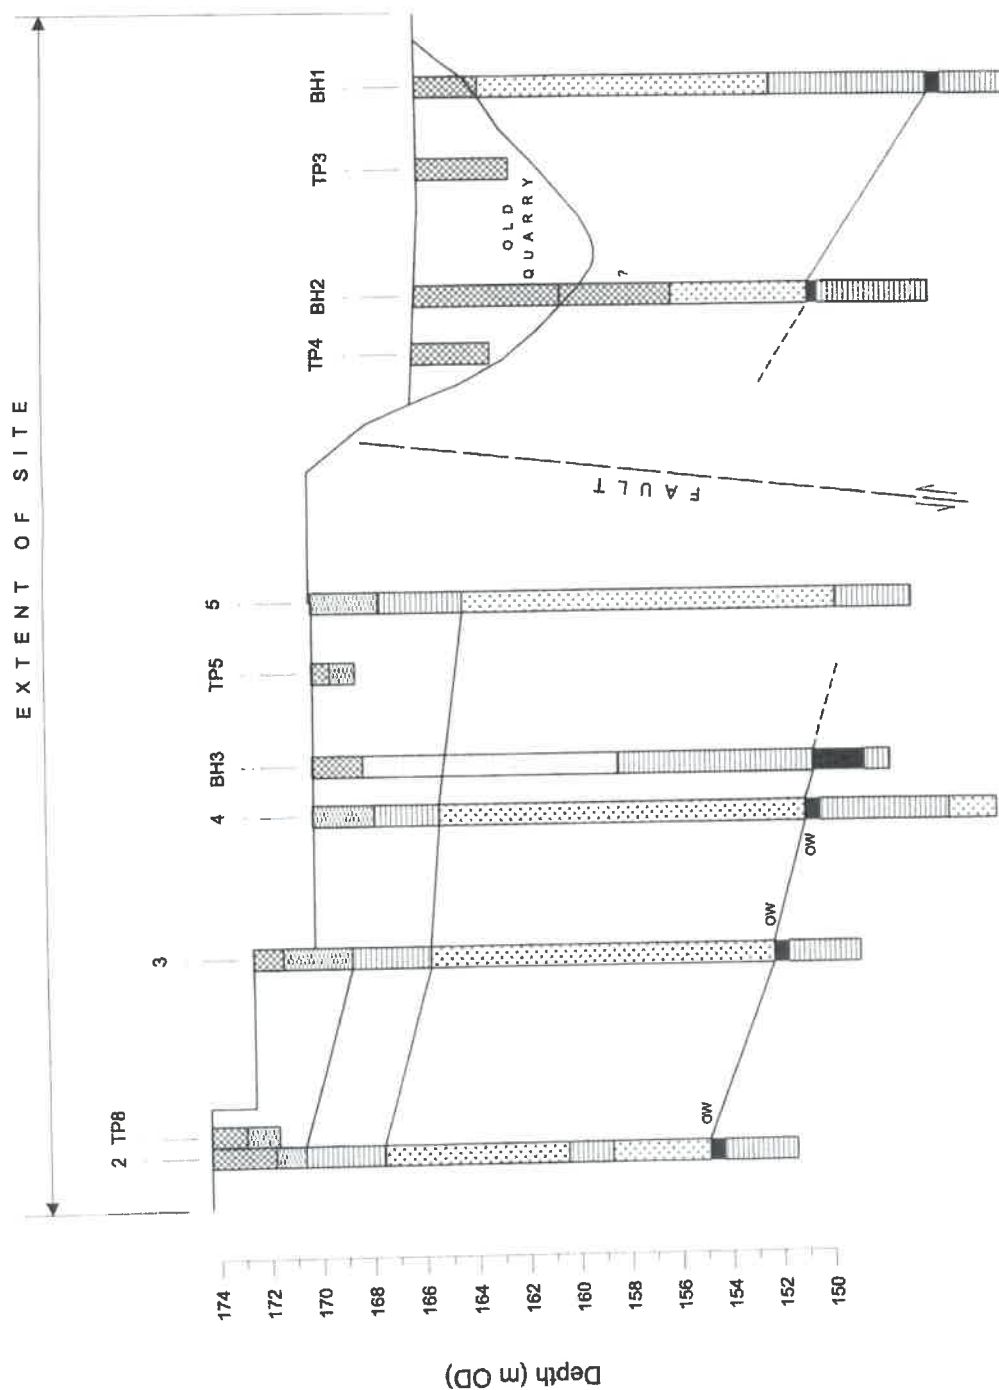
FIGURE 6

Section A - A

Depth of Shaft

## GEOLOGICAL CROSS SECTION

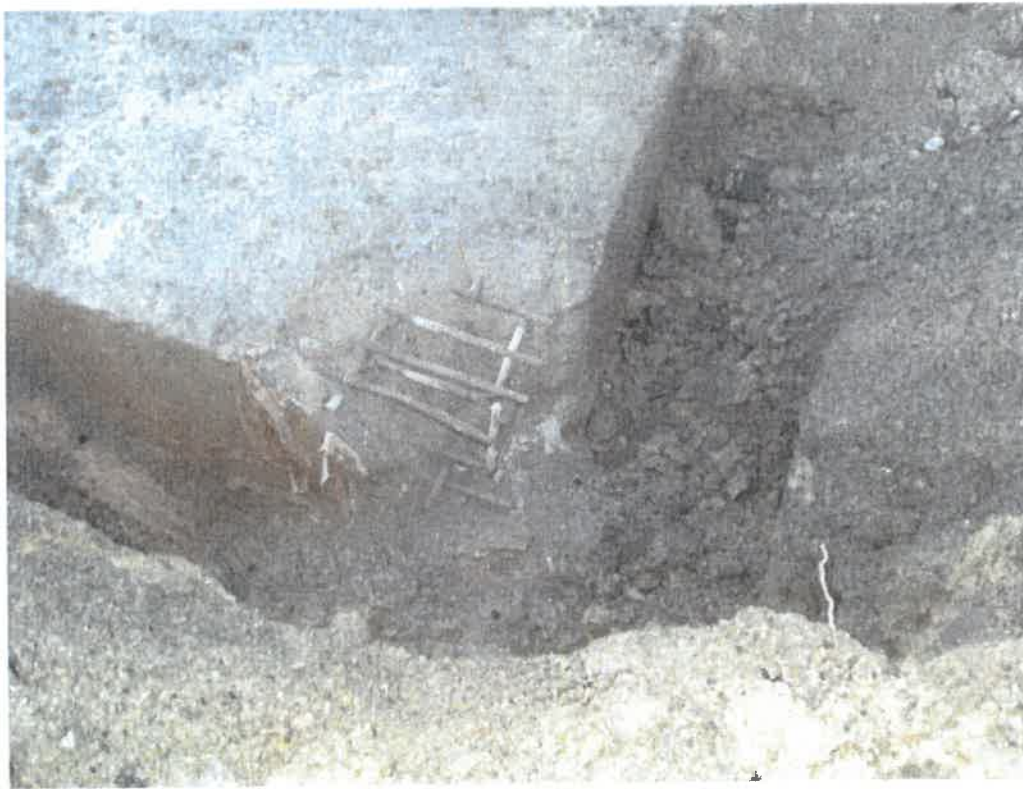
Photograph 5 Showing reinforcement in cap

The shaft cap was found to be some 600mm thick with visqueen at its base resting on 100 to 200m of concrete blinding. It was 9.15m<sup>2</sup>.
