Heritage Impact Statement Regarding repair to Existing Wall attached to Pate Gate and Vehicular Entrance to Property.

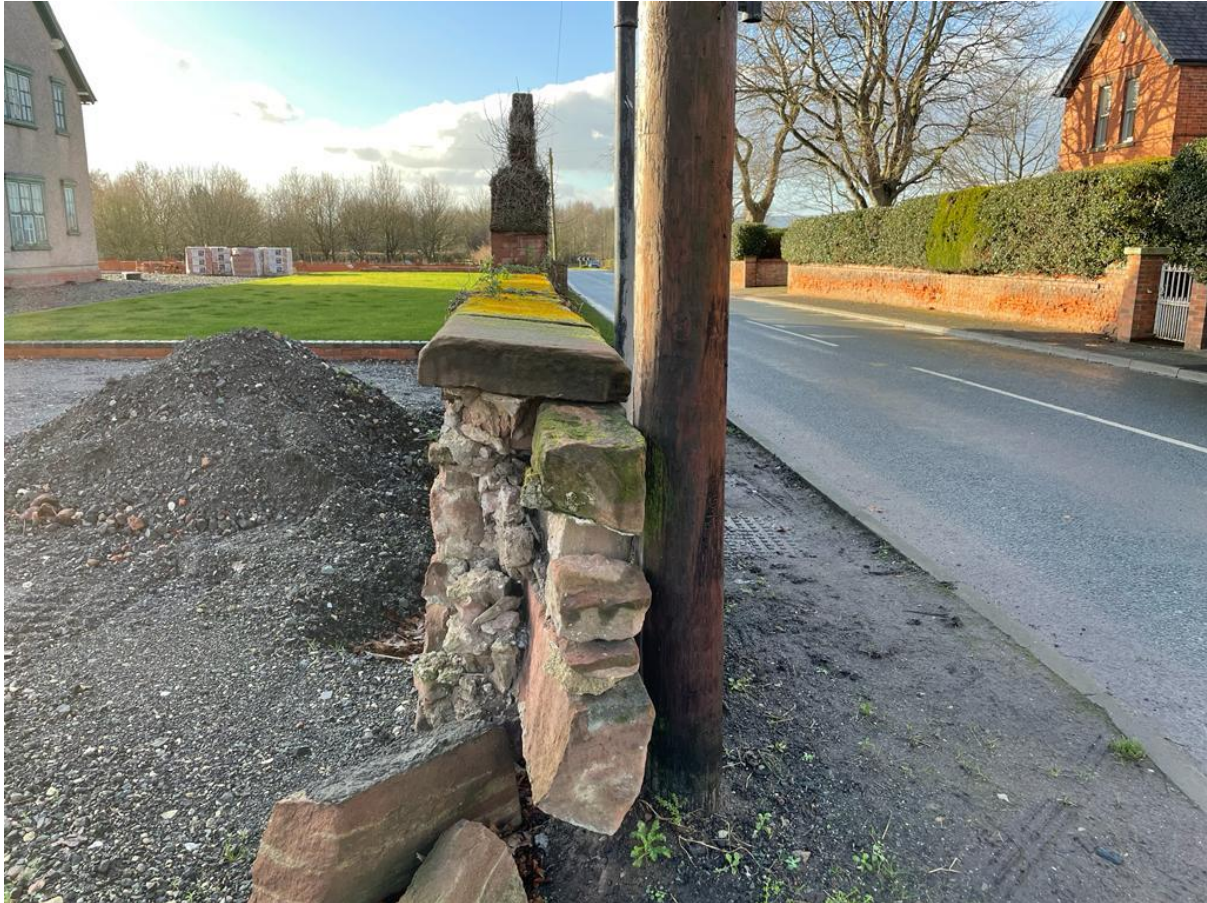
1/

Current Condition of Wall – Leaning substantially towards Roadway

2/ Wall is Coursed and 4m +/- to be removed and straightened on a new foundation using Lime mortar and washed sand mix -internal wall is of random design. Intention is to improve structural integrity without any change to walls appearance

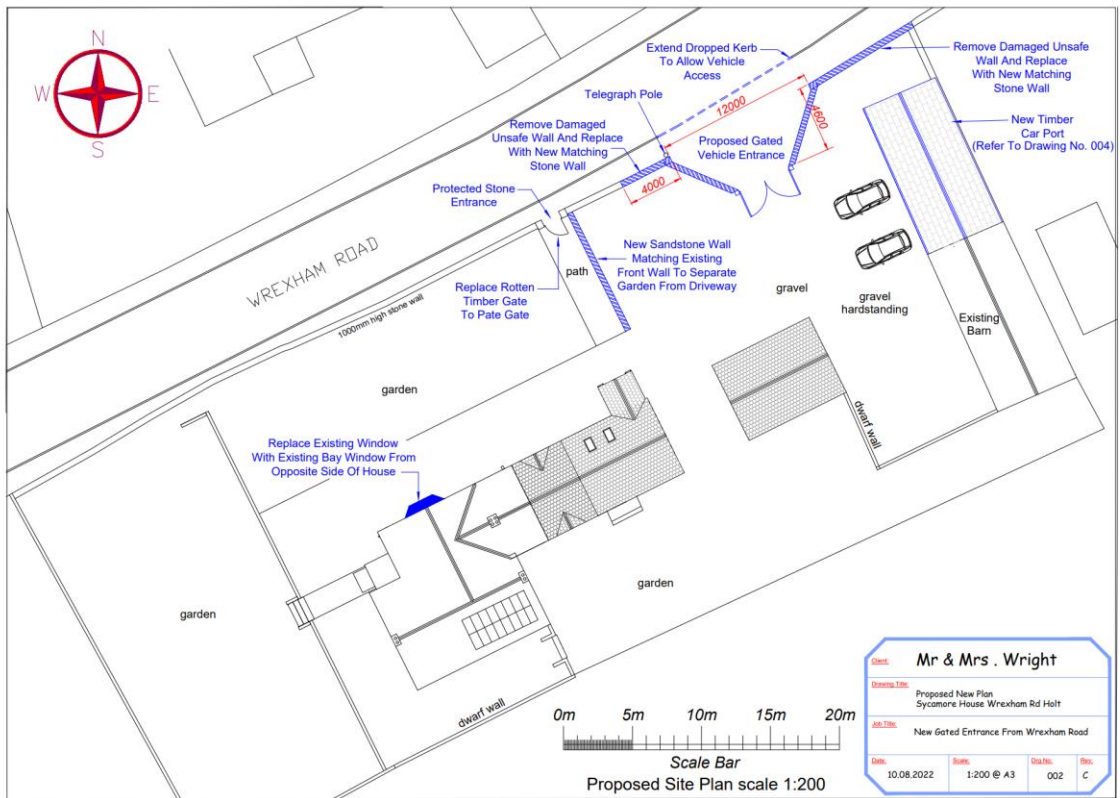
Final Entranceway with separation between Garden and Parking Area shown. Existing Gate to Pate Gate will be improved Edwardian themed design.
