Full Report for Listed Buildings

| Former County Buildings | |

WREXHAM COUNTY BOROUGH MUSEUM  
c o n s e r v a t i o n P L A N

Wrexham County Borough Museum  
Conservation Plan

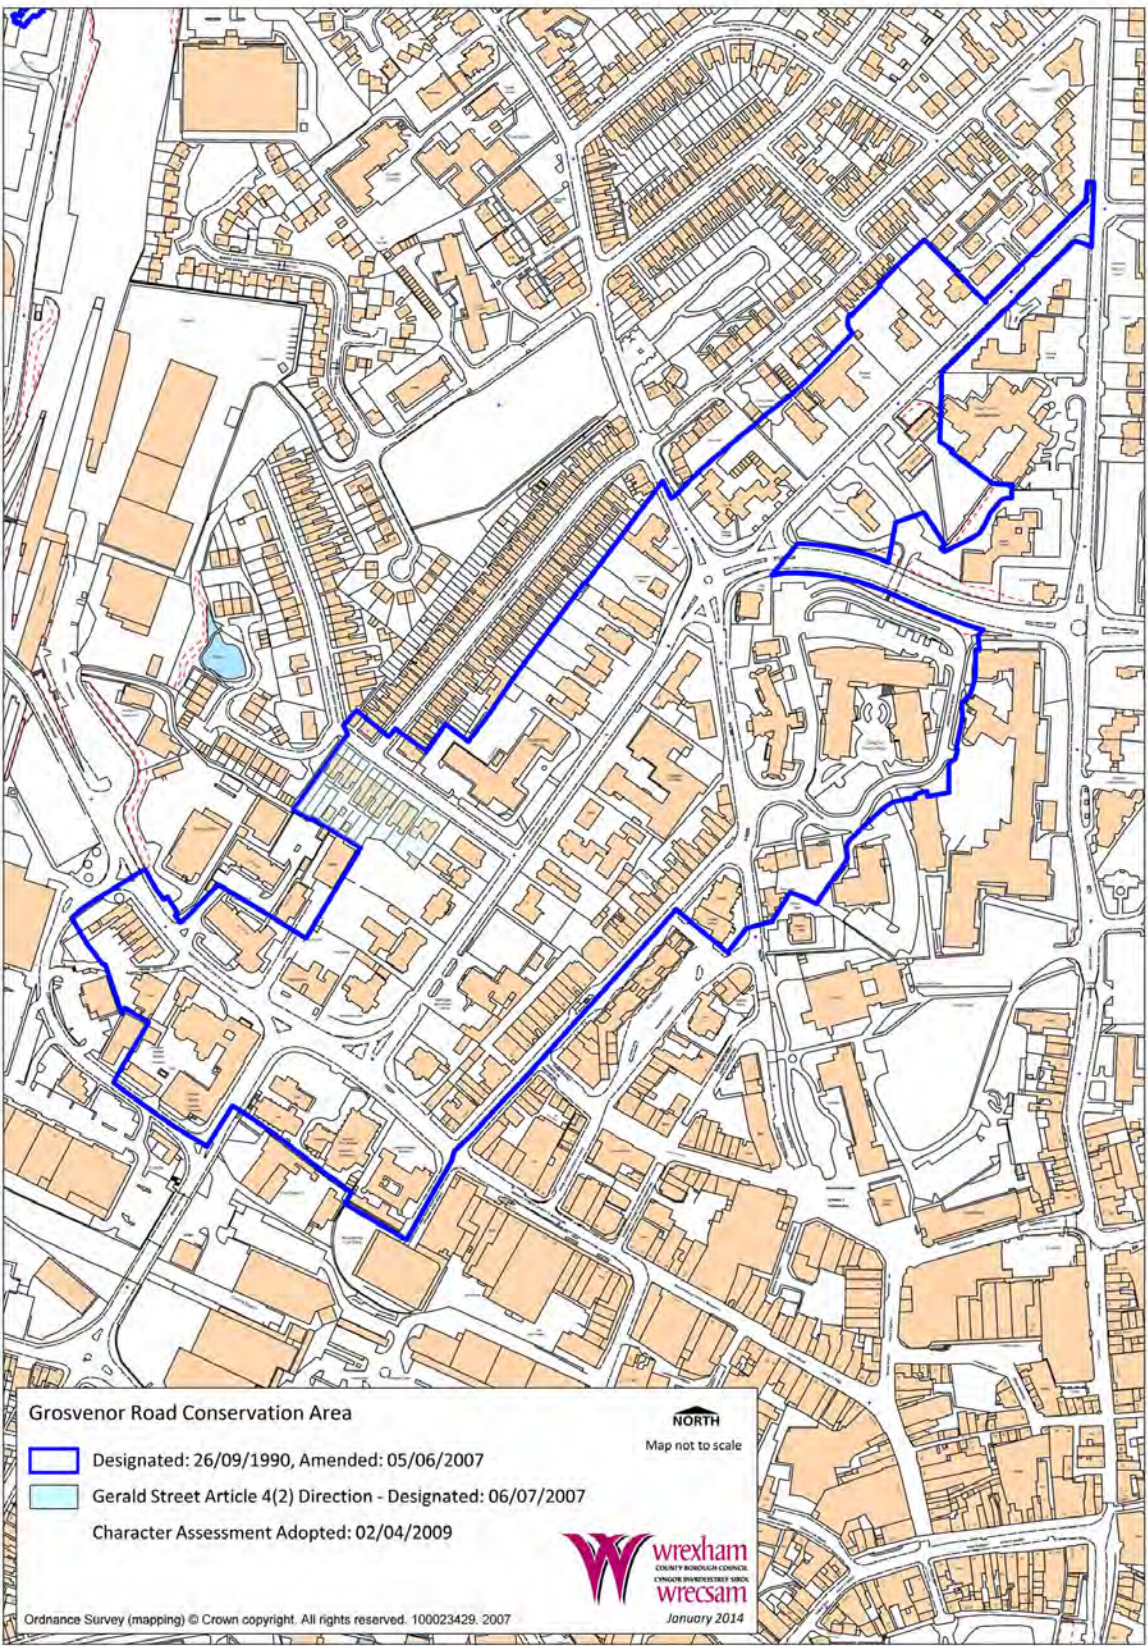
Conservation Area map of Grosvenor Road shows a blue line outlining the extent of the Grosvenor Road Conservation Area boundary designated on the 26th September 1990, and was amended on the 5th June 2007, the blue shaded area within the Grosvenor Road Conservation Area indicates the area covered by the Gerald Street Article 4 (2) Direction designated on 6th July 2007..

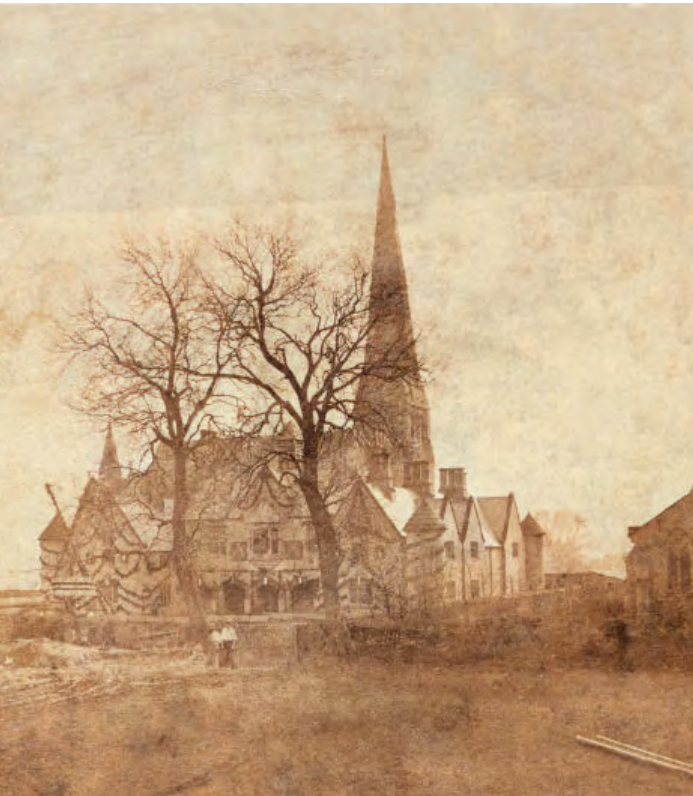
**Plate 6** The earliest known surviving view of the Militia Barracks. Certainly prior to 1878 this must be after 1862 when St. Mark's spire was completed. A possible date is the marriage of the Prince of Wales (and Earl of Chester – future Edward VII) to Alexandra of Denmark in March 1863 – an 'A' is clearly visible in the decorations present on the building.

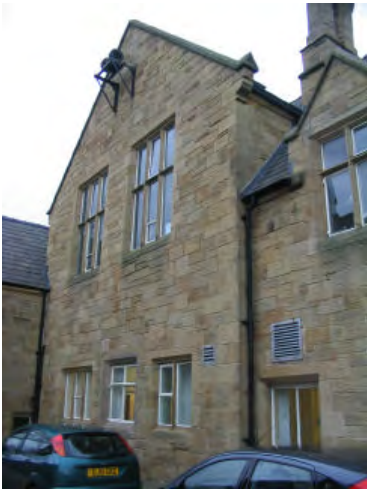
Plate 7 Gable created during 1879 extension.

To the front the Store Room and the Guard Room were combined, the passage enclosed and a cross passage created to access the cells. The cells were not constructed as shown on the initial plan, as the loggia was not enclosed, these changes to the plan are presumably those referred to in the Easter Quarter Session Minutes and resulted in the cells being arranged much as they are in 1896 (refer to the drawing of this date). To the rear additional accommodation was created by enclosing the courtyard. (refer also to the elemental gazetteer).

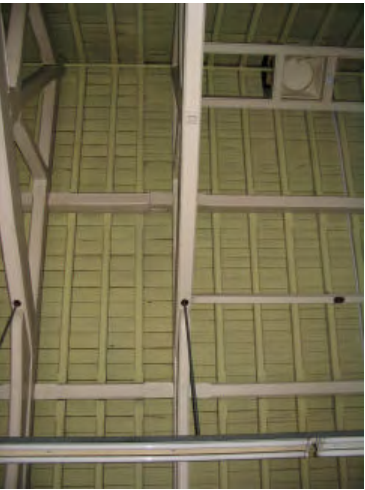
Plate 8 The difference in boarding sizes illustrates the original extent of the Regimental Store. The 1857 boarding being much wider

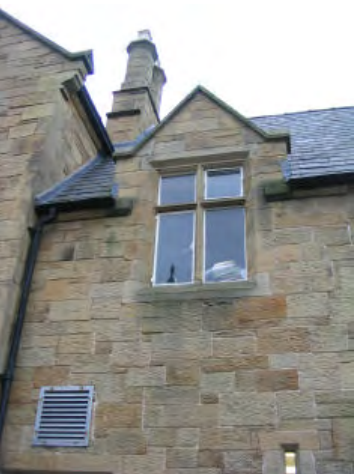
Plate 9 Dormer window added c.1917

The building continued largely in this form for much of its working life. Alterations were undertaken gradually as the need for the provision of accommodation receded and the requirement for additional office and mess accommodation increased. The most prominent change to occur during this transition was the conversion of part of the Bridewell Sergeant's Quarters into a parade room and a canteen or recreation room. These alterations were in place by 1930 and there stylistically there is no reason to question W.E. Wilson's assertion that the work was undertaken c.1917.

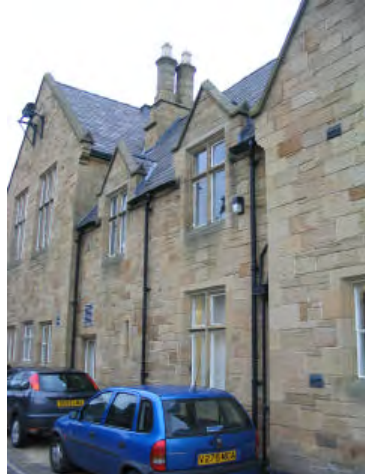
Plate 10 Overall view of the c.1917 changes.

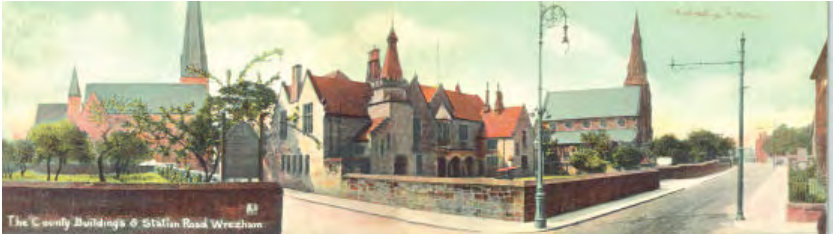
**Plate 11** View of the building c.1900, before the construction of Church House. The canon was still in situ at this time.

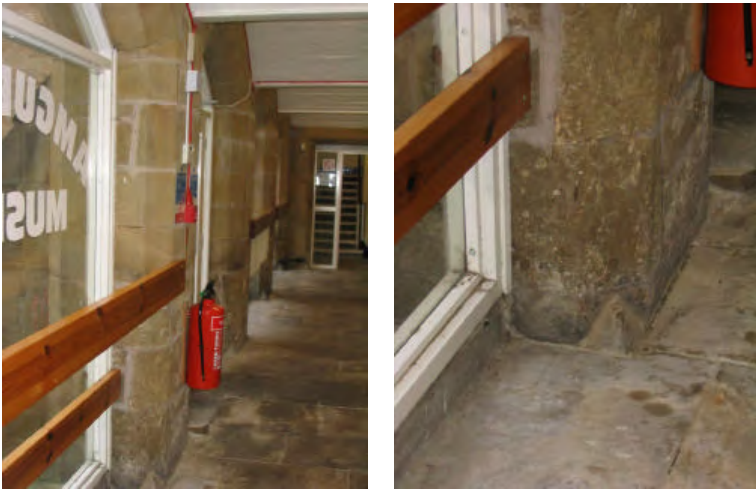
**Plate 12 & Plate 13** General view of Loggia, modern screens are clearly visible. On the right the plinth detail has been largely lost as the level of the flags has been raised.

The junction of the flags against the plinth suggests that the floor level has been raised, which has created level access into the adjacent office areas. The flags appear to be the originals re-used. The contract provides evidence for this also as it discusses 'stairs into the arcade' and the 'steps out of the doorways into the arcade' (including the sergeant major's quarters) suggesting the original level was probably significantly different.<sup>27</sup>

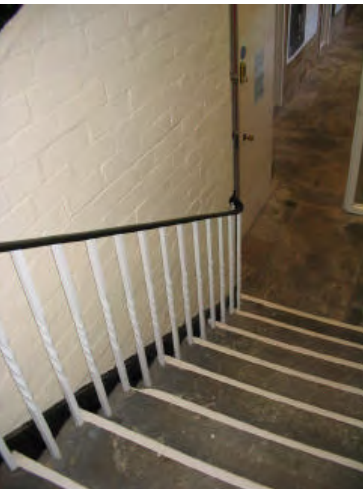
The Staircase is the original for the Militia Barracks, installed when the building was first constructed in 1857. The floor between the staircase and the loggia entrance is flagged in york stone and these appear to be of the same date (some alterations having been undertaken). The iron balustrade to the centre of the staircase also would appear contemporary with the stair, there is no visible evidence of change where the balusters are cored into the treads and secured with lead. The balustrade, made entirely of iron with simple twist-turn balusters and newel cast to match the chamfered stone detailing, has the slightly robust, utilitarian feel of the original Militia building which sits as an interesting contrast with the later, more elaborate, court alterations.

**Plate 14** Stair and Original balustrade

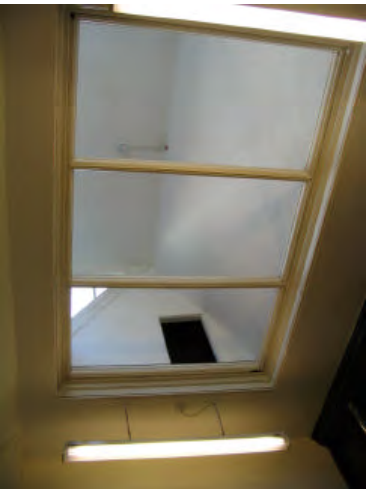
**Plate 15** Lay-light showing framing for glass panels.

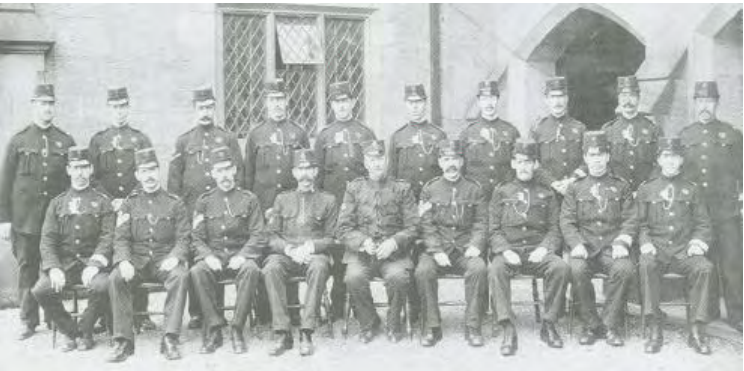
Plate 16 Wrexham Police, probably pre-1896. Diamond pattern casement visible in the background.

There are two original windows, with chamfered timber surrounds and the moulding to the bases, a motif which runs through the original militia work and was replicated in the court alterations. There are slots in the reveals which probably relate to war-time shutters rather than the security shutters of 1857. The hopper lights are probably inter-war. The windows were initially diamond pattern iron casements with a top hung opening light as can be seen in the photograph which is dated c1900 (but must be earlier). Interestingly this photograph also reveals that security bars were in situ at this time.

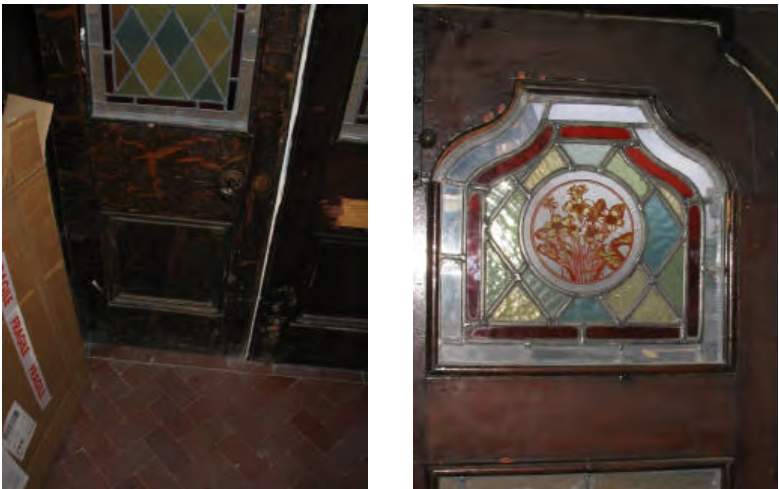
The double entrance doors from the front courtyard are the originals and retain decorative leaded lights with original stained glass and floral motifs to the upper panels. The entrance door to the under stairs cupboard is of contemporary date although there have been alterations with provision of ventilation and the frame has been renewed and altered.

Plate 17 & Plate 18 Entrance doors to Court 2 Entrance, showing the original finish, leaded lights and stained glass.

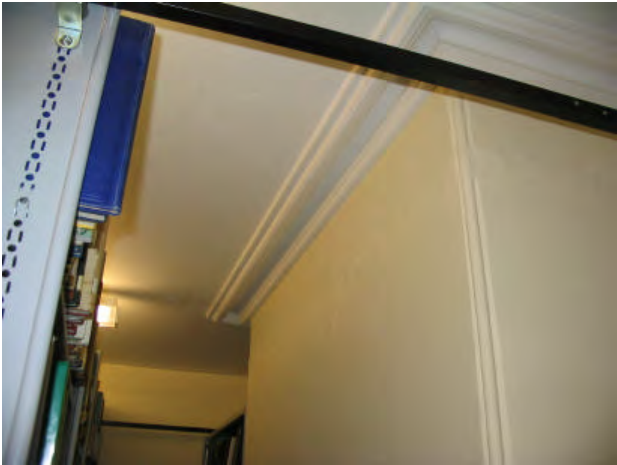
**Plate 19** Original (c.1896) corning and moulding to chimney breast. The modern ductwork can be seen in the rear of the photograph.

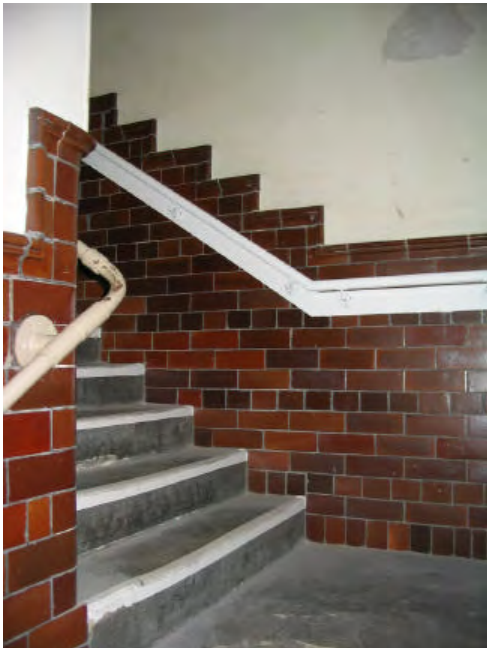
**Plate 20** Glazed brickwork, original and modern handrails to G40.

The floor finish is of glazed tiles of terracotta colour laid in a herringbone pattern, the staircase itself is in york stone. Up to dado level the walls are finished in a glazed brick which follows the alignment of each step, with a moulded capping. The original iron handrail is also still in situ, with a modern handrail installed to the outer perimeter. The walls are plastered above. Window surrounds are stone with a lightly banded tooled finish to match the risers of the stair.

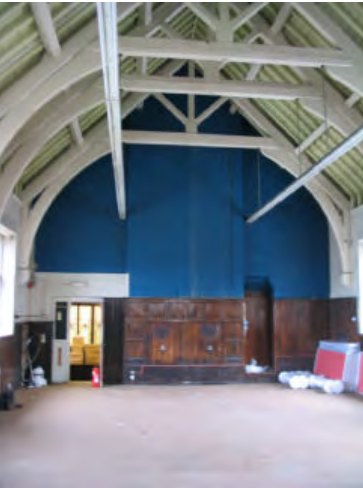
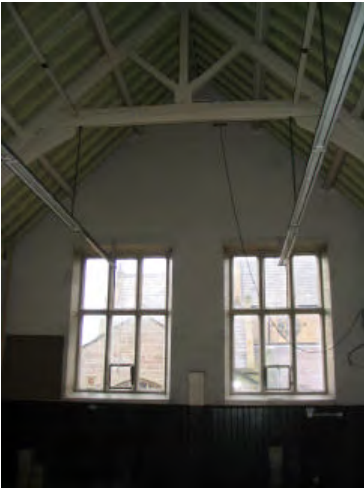
According to the specification the walls were to be lined with tongue and groove elm boards. These remain largely in situ, although some are missing, with a capping strip which appears to be oak. The extended section of the court is readily identified by the change in width of boarding both in the elm to dado height and the boarding to the roof. In both cases the boarding being narrower.

**Plate 21 & Plate 22** Looking towards former bench position, the panelling behind the bench is of 1896, other panelling of 1857. On the right, the 1878 extension.

The panelling to the rear of the judge's bench area replaced more elm boarding and a fire place in 1879.

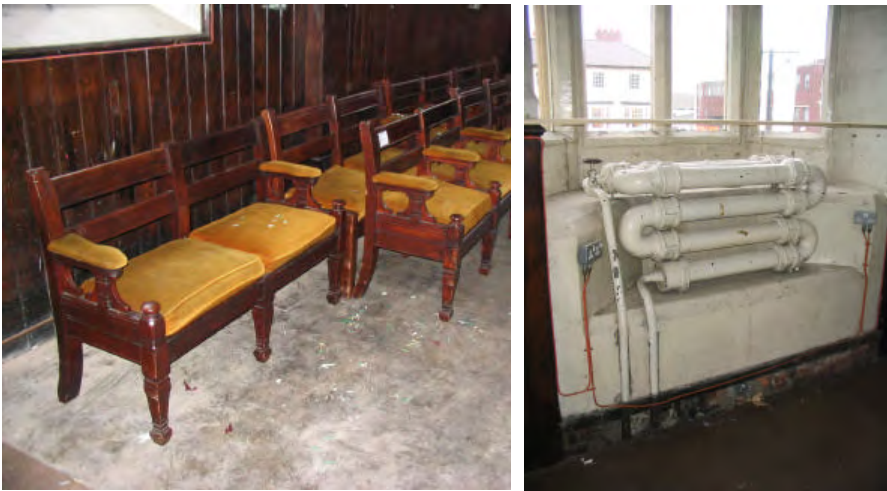
Plate 23 & Plate 24 Court room furniture stored in Court 1. To the right, 19<sup>th</sup> century heating pipes to the oriel window.

Much of the original courtroom furniture is still resident in the building which should be tagged, labelled and stored, or perhaps partially returned to the room if appropriate to the scheme. It is understood however that the ownership of the furniture does not reside with the museum. Every effort should be made to ensure that the furniture is retained in its original context.

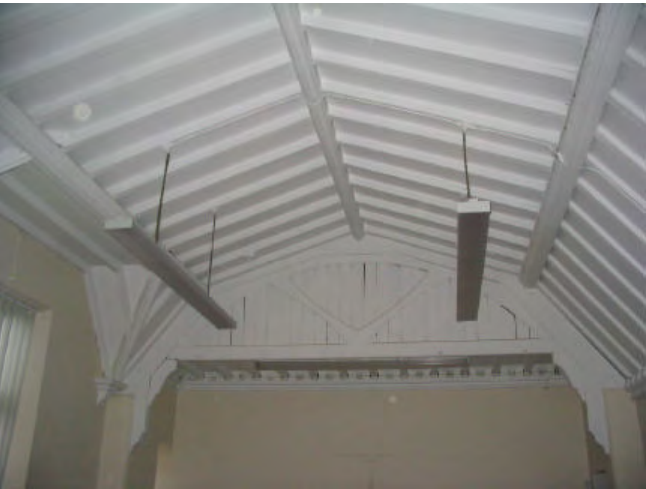
**Plate 25** Roof of Court 2, which remains largely as constructed in 1896. Panelling to the far wall (rear of the bench) has been lost.

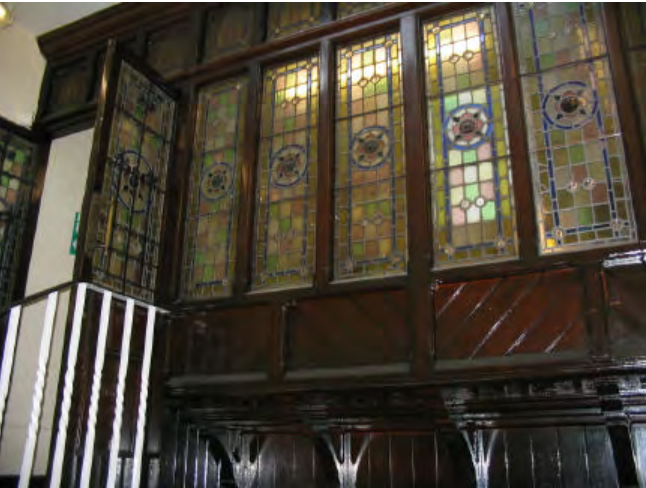
Originally the upper landing of the Militia Stair, this space was much altered in the 1896 conversion with the addition of a timber screen with bench and double doors at the top of the stairs.

**Plate 26** Screen to the top of the staircase. The hand-rail is of militia date and the screen of 1896.

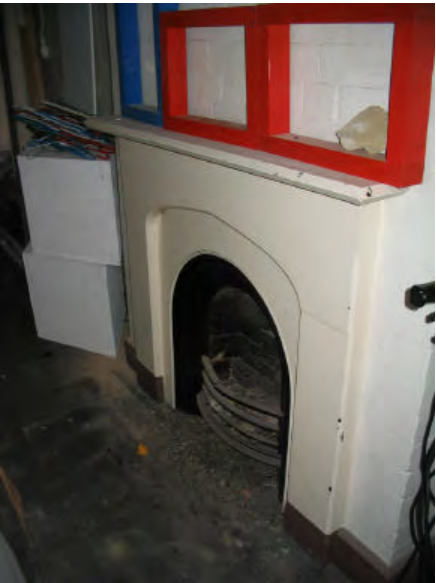
Plate 27 Militia fireplace (from the reading room/hospital) to the Magistrate's Retiring Room.

The simple gothic fireplace is probably original militia of 1857. It is a slate surround which ties in well to the reference in the specification, backing up the assertion that it is of the original phase. The fireplace retains its grate and has not been boarded over as elsewhere. The simple skirtings may also be of the militia phase.

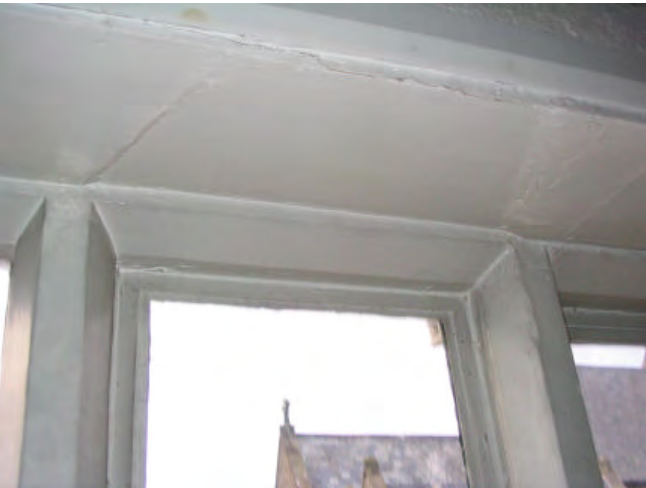
Plate 28 Evidence of former position of partition to F18.

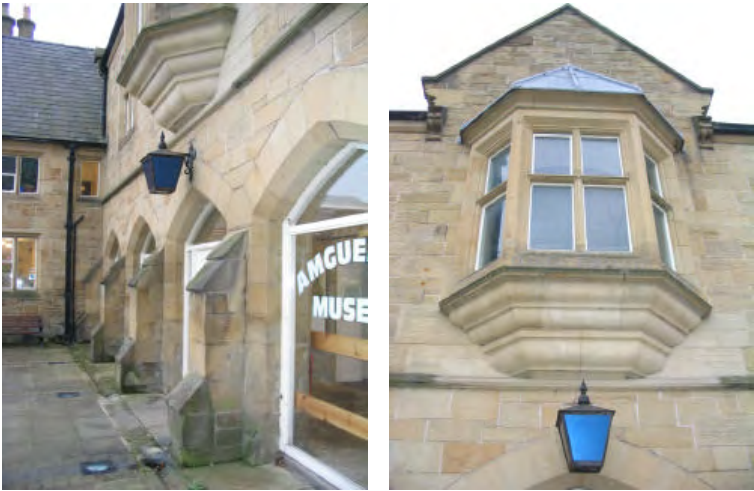
The loggia has had modern joinery inserted (refer to G01), the floor level has been modified and consequently any steps lost.

Plate 29 & Plate 30 Loggia, with poor quality modern joinery and Oriel Window.

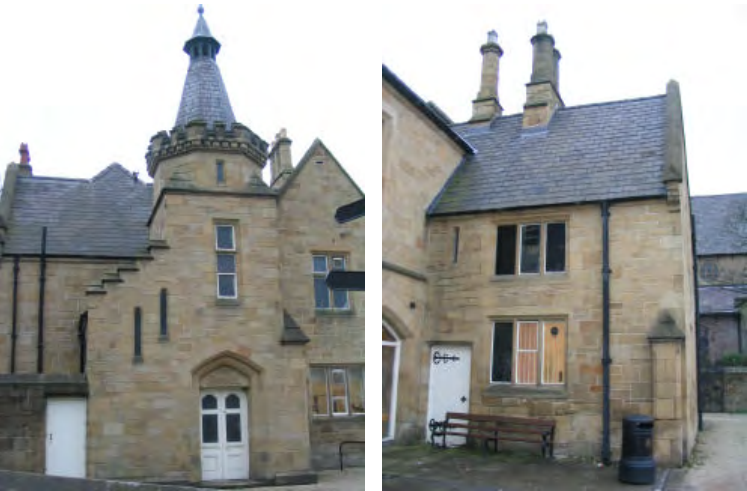
Plate 31 & Plate 32 Entrance to Court 2 (1896) and blank window to F23. Tooling is visible behind the central pane as noted in the text.

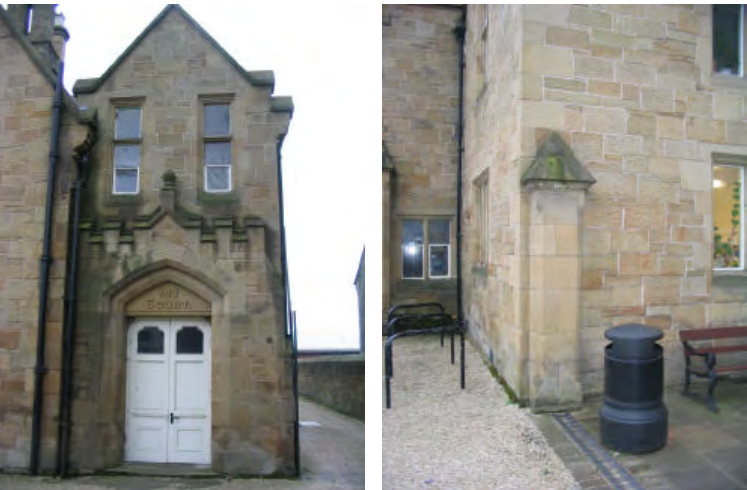
Plate 33 & Plate 34 Entrance to Court No.1 showing the more restrained detailing. To the right, the piers which were to form a boundary with railings to the front of the building, but there is no evidence it was installed beyond these piers.

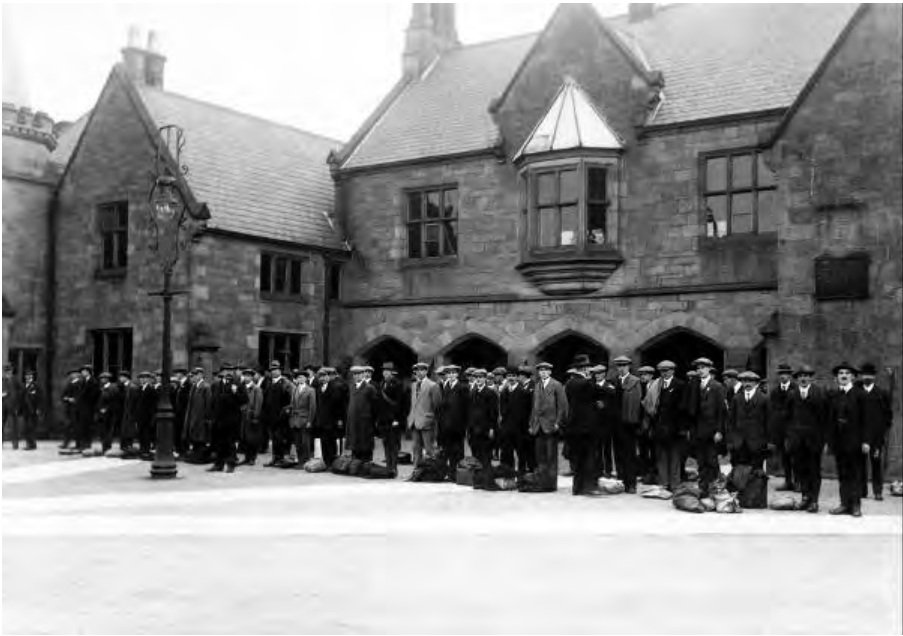
**Plate 35** The entrance front c.1914. This view has changed remarkably little. The diamond pattern casements have been replaced largely in single panes and many of the hopper and pivot lights still survive today.

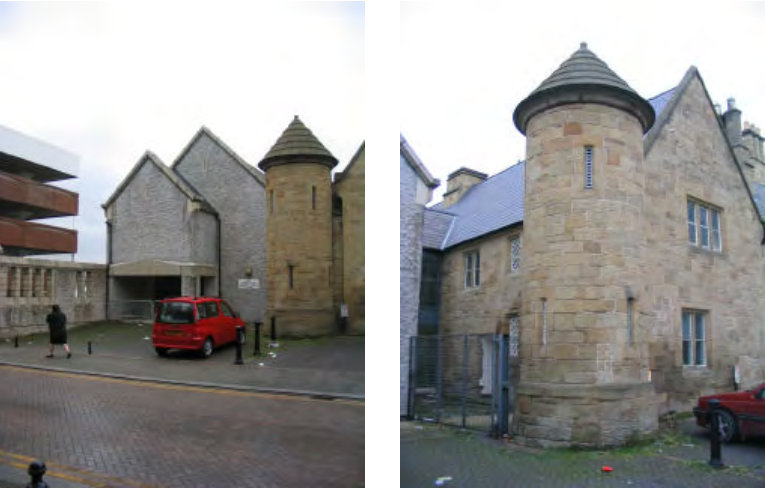
The wall between the tower and the exercise yard is largely as it was built in 1857. The window between the yard and the rear gable replaced a smaller window in 1896.

**Plate 36 & Plate 37** Original Militia Tower and 1997 extension. The 'dead' space between the two and this area generally requires reconsidering.

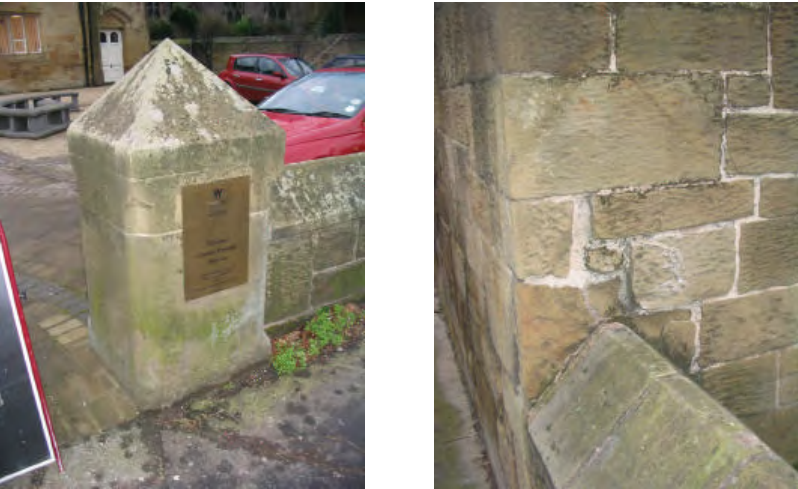
**Plate 38 & Plate 39** Entrance Pillar, which has been reduced in height. Evidence of the original (1896) wall height on the Court No. 2 Entrance.
