# Brunett Barns, Ty Broughton.

Heritage Impact Assessment relating to the  
Adaptation and Refurbishment of The Barns

– June 2022

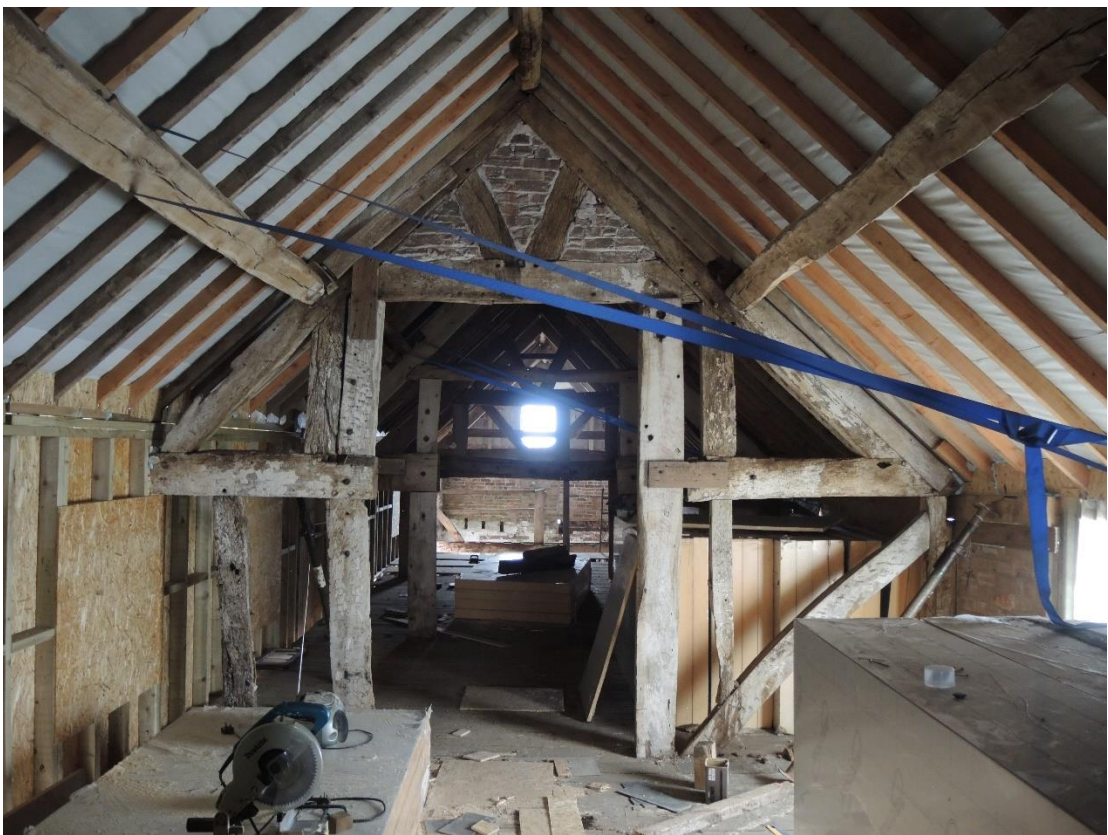
Figure 1 - Part of the timber frame construction to shippon 1 which might originate in the C16

The study has postulated that the central section of shippon 1 might be of an earlier C16 century origin (currently described as being C18 in the listing description) and consists of seven upright

timber posts and three diagonal tension braces to the SE elevation and three upright posts beneath the internal trusses to the NE elevation. Two hand-hewn bressummer beams may denote the original footprint of the building and perhaps a jettied first floor. The study suggests that the building was extended to the NE in a single phase during the C17 or C18 and this was probably mirrored by a similar phase of construction to the SW during the same period. The original cross brace design has been repeated, which might also reinforce that the extensions were constructed at the same time. Whilst much of the brick infill has currently been removed from these elevations for repairs to be undertaken, the position of window and door openings with their corresponding head and sill details are clearly visible.

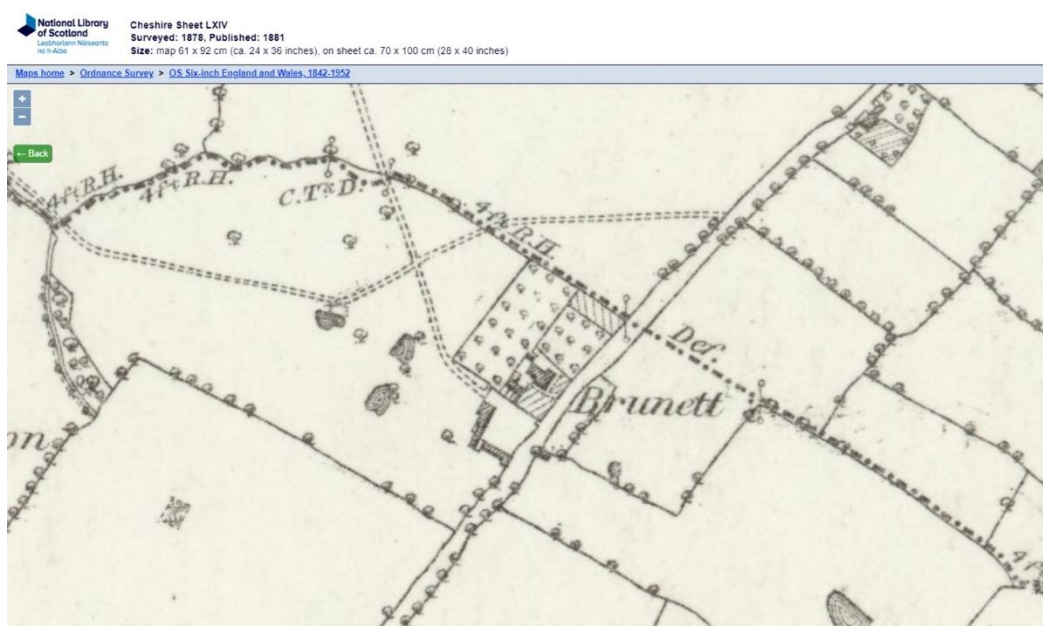
Figure 2 - OS 6-inch map of 1878 without the buildings to the west of shippon 1  
( © National Library of Scotland on-line map collection)

A review of the late C19, 6-inch Ordnance Survey Maps of the area and property indicate that Shippons 2 and 3, together with the outline of what is described as the modern barn (building 4) was constructed between 1878 and 1897. It is not assumed that the construction of these buildings was concurrent, but the expansion was completed by 1897 when the present footprint/outline of the agricultural outbuildings is clearly visible. Prior to this period, the Ordnance Survey map edition of 1873 is very similar in content to the Tithe Map of 1843, where only Shippon 1 and the Stable building can be seen to the SW of the farmhouse at Brunett Farm. The shippons are generally constructed of handmade bricks, though subsequent alterations and rebuilding has taken place. The window openings have radiating brick voussoirs and two courses of plinth stretchers to the cills. Windows are a five-paned painted timber design, consisting of two lower fixed panes of glass with a three paned inward opening hopper over. There is a central sliding door opening to the block and high level rooflights to the SW facing pitch of the roof. Internally, the space is open to the underside of the slated and battened roof covering. The roof structure consists of sawn timber rafters on notched rectangular purlins that sit on three equally spaced sawn King strut trusses. The most recent configuration of the

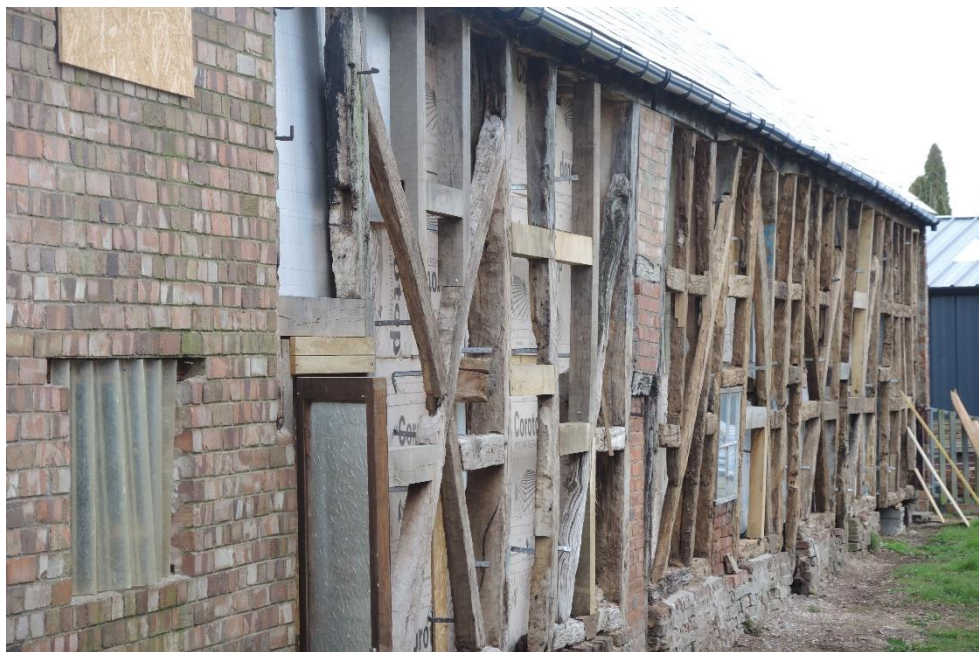
Figure 4 - Image of the NE facing elevation and the timber frame structure of shippin 1

When viewed from the highway, it is the structural timber frame and the length/profile of the original 2-storey shippon 1 that is most pronounced at 31.7m long and 5.1m wide. Infill panels between the oak frame members are mainly quarter/third bonded handmade stretcher brickwork, whilst the larger panels of brickwork at low level are constructed in an English garden wall bond. The remains of diamond shaped ventilator openings in the brickwork are visible on the NE and SW facing gables. The duo-pitched roof covering of natural Welsh slate (recently recovered) has a ridge line that runs NE to SW. The building sits parallel to the road and towards its southern end, the single storey (with loft) timber framed stable block stands perpendicular to shippon 1 building 5). The ridgeline of the stable building runs NW to SW and measures approximately 17.2m in length, by 5.7m in width. The SE gable faces the highway at the east boundary to the property. The handmade brickwork to the boundary approximates an English garden wall bond and incorporates a door opening to the loft and slotted ventilator openings at ground floor level (now infilled)
