DEVELOPMENT AT JACQUES YARD, JACQUES WAY, REGENT STREET, WREXHAM, LL11 2BY  
PHASE 4 - SITE REMEDIATION VERIFICATION REPORT

REPORT No. E1659.PH4.VER.R1  
NOVEMBER 2022

**Document Title:** PHASE 4 - SITE REMEDIATION VERIFICATION REPORT

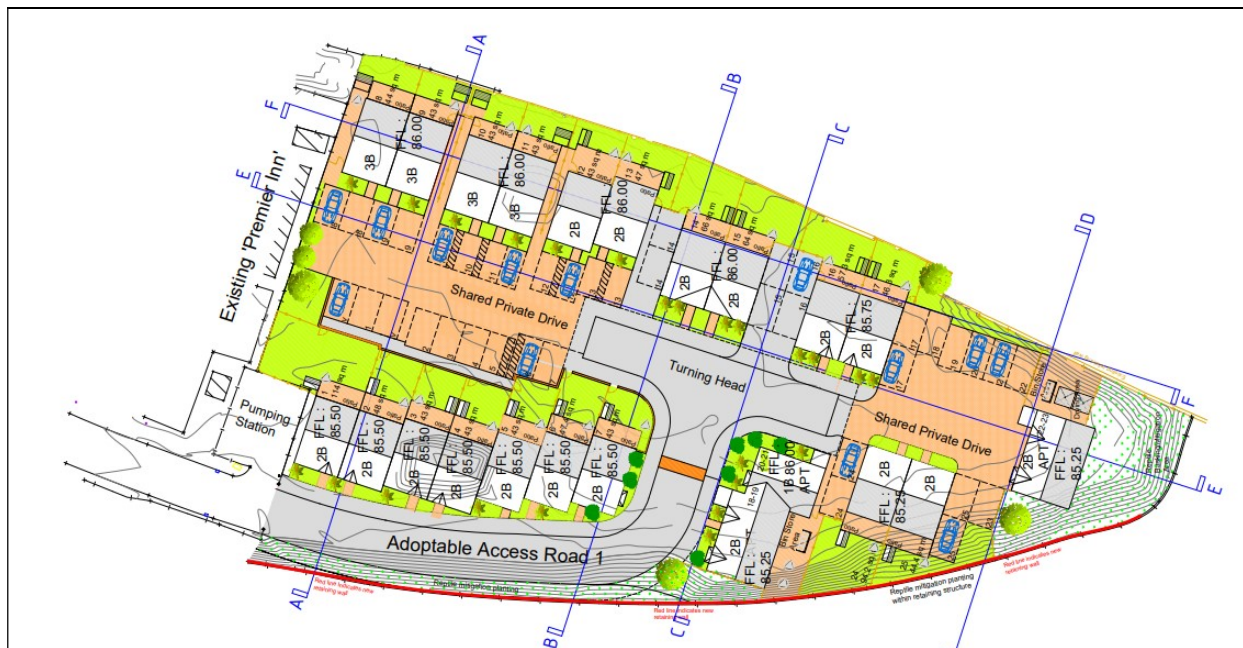
Figure 2 – Development and Area

- 2.4.1 The proposed development comprises 25 residential units with associated car parking and access roads. The proposed layout is shown as Figure 2.

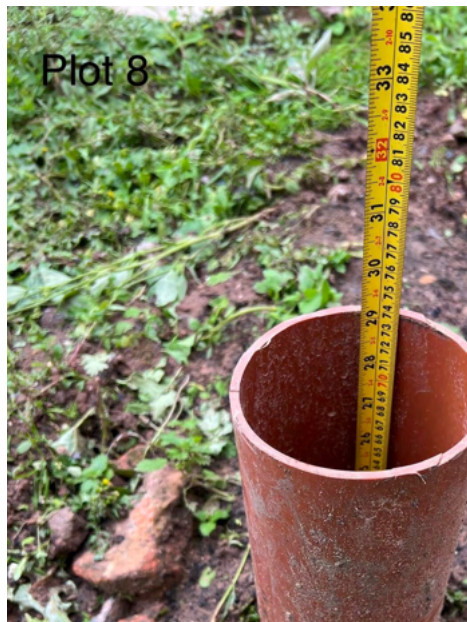
Plate 1 – Plot 8

| PLOT NR | Soil Depth (Subsoil + Topsoil) mm | Turf and Topsoil mm | TOTAL DEPTH mm |
|---|---|---|---|
| 8 | 570 | 70 | 640 |

- 5.1.4 Photographic evidence of soil material placement and the achieved depths is presented below:

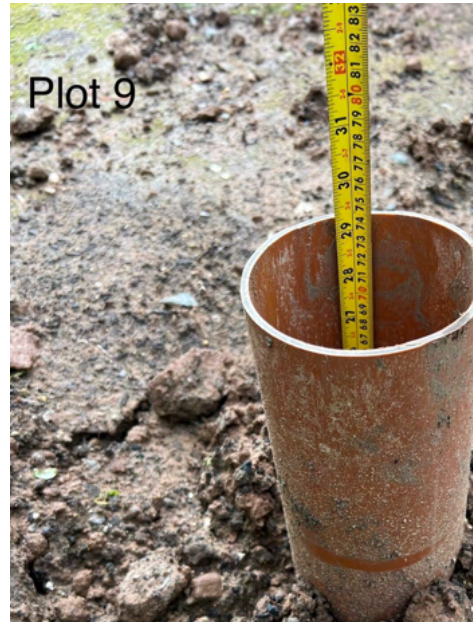
Plate 2 – Plot 9

| PLOT NR | Soil Depth (Subsoil + Topsoil) mm | Turf and Topsoil mm | TOTAL DEPTH mm |
|---|---|---|---|
| 9 | 580 | 70 | 650 |

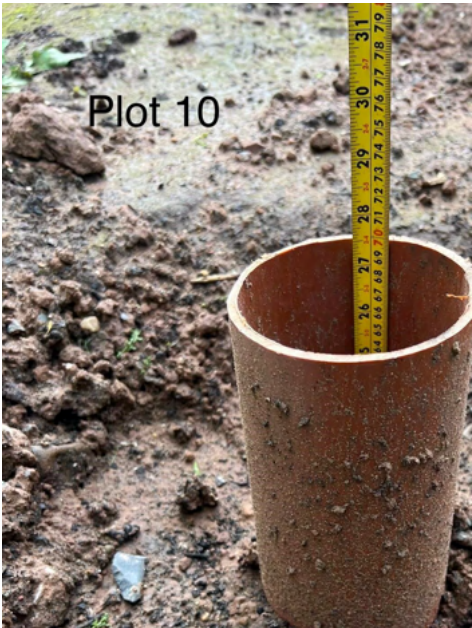
Plate 3 – Plot 10

| PLOT NR | Soil Depth (Subsoil + Topsoil) mm | Turf and Topsoil mm | TOTAL DEPTH mm |
|---|---|---|---|
| 10 | 550 | 70 | 620 |

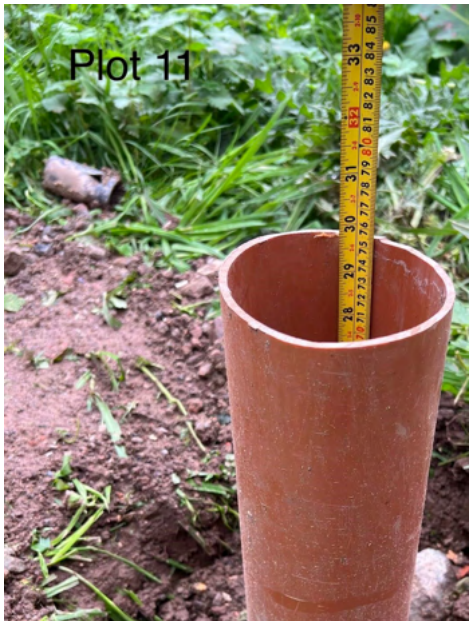
Plate 4 – Plot 11

| PLOT NR | Soil Depth (Subsoil + Topsoil) mm | Turf and Topsoil mm | TOTAL DEPTH mm |
|---|---|---|---|
| 11 | 550 | 70 | 620 |

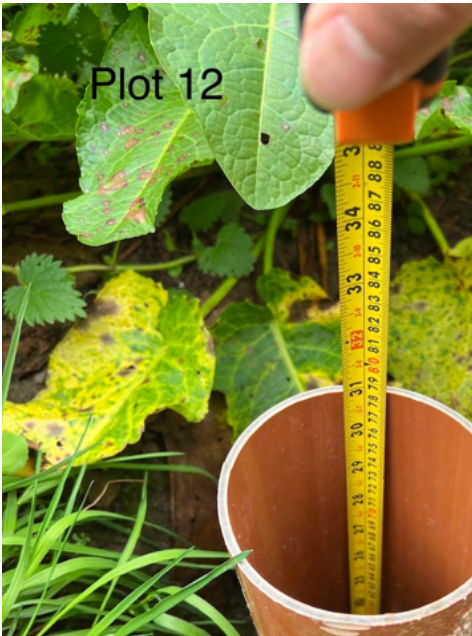
Plate 5 – Plot 12

| PLOT NR | Soil Depth (Subsoil + Topsoil) mm | Turf and Topsoil mm | TOTAL DEPTH mm |
|---|---|---|---|
| 12 | 650 | 70 | 720 |

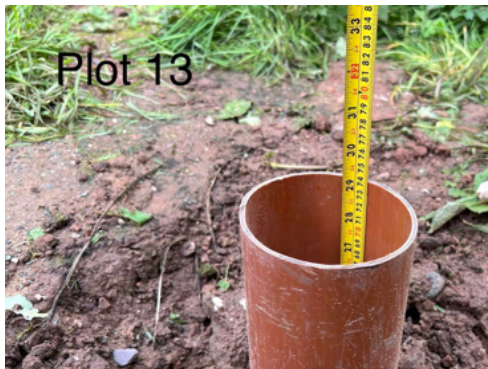
Plate 6 – Plot 13

| PLOT NR | Soil Depth (Subsoil + Topsoil) mm | Turf and Topsoil mm | TOTAL DEPTH mm |
|---|---|---|---|
| 13 | 610 | 70 | 680 |

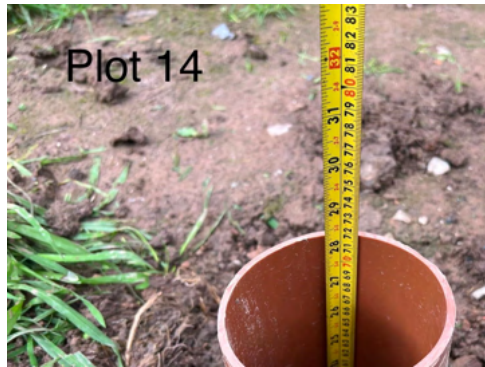
Plate 7 – Plot 14

| PLOT NR | Soil Depth (Subsoil + Topsoil) mm | Turf and Topsoil mm | TOTAL DEPTH mm |
|---|---|---|---|
| 14 | 570 | 70 | 640 |

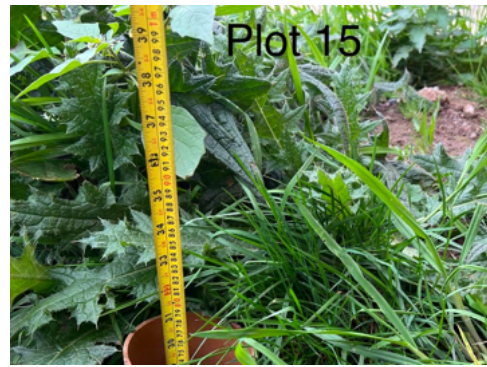
Plate 8 – Plot 15

| PLOT NR | Soil Depth (Subsoil + Topsoil) mm | Turf and Topsoil mm | TOTAL DEPTH mm |
|---|---|---|---|
| 15 | 700 | 70 | 770 |

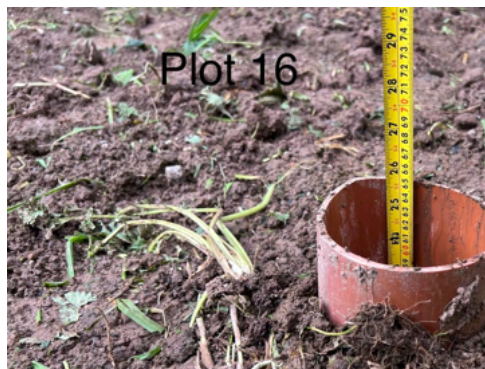
Plate 9 – Plot 16

| PLOT NR | Soil Depth (Subsoil + Topsoil) mm | Turf and Topsoil mm | TOTAL DEPTH mm |
|---|---|---|---|
| 16 | 600 | 70 | 670 |

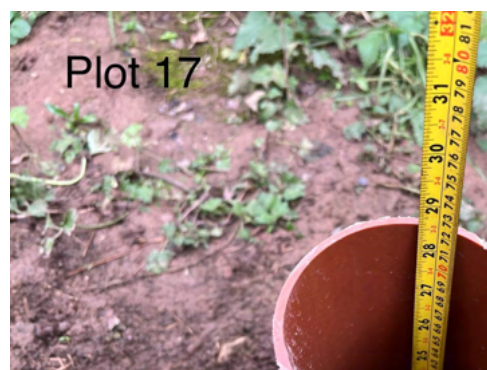
Plate 10 – Plot 17

| PLOT NR | Soil Depth (Subsoil + Topsoil) mm | Turf and Topsoil mm | TOTAL DEPTH mm |
|---|---|---|---|
| 17 | 550 | 70 | 620 |

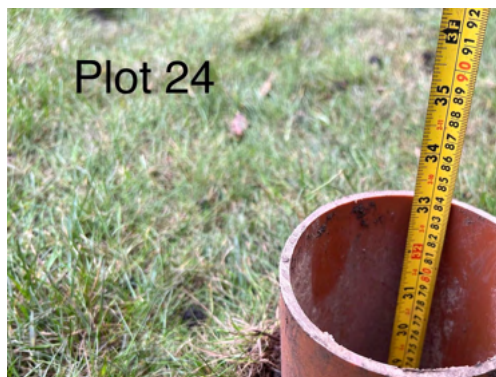
Plate 11 – Plot 24

| PLOT NR | Soil Depth (Subsoil + Topsoil) mm | Turf and Topsoil mm | TOTAL DEPTH mm |
|---|---|---|---|
| 24 | 750 | incl | 750 |
