Health & Safety Report – Car Park  
Glebe Equestrian Centre  
Glebe Farm  
Bronington  
SY13 3HU

## 1. Introduction

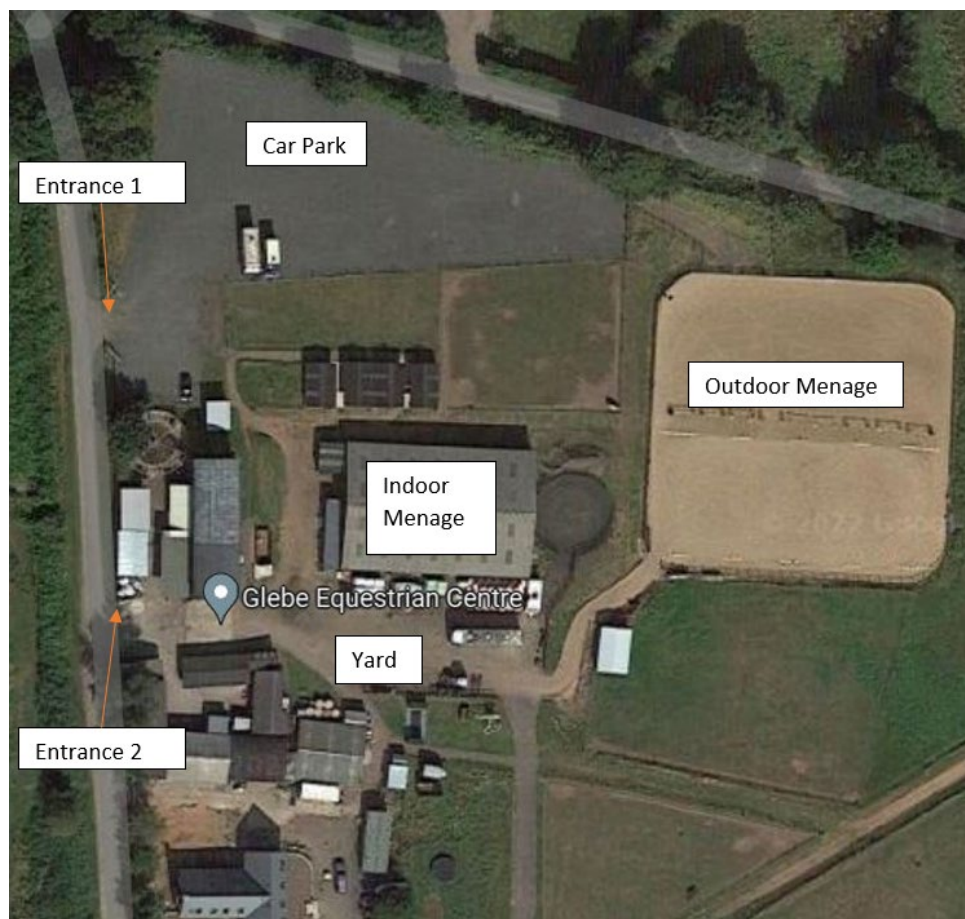
Diagram 1

- 2.1 Glebe Equestrian Centre provides the following services: livery for clients, lessons to clients, training clinics and events.
- 2.2 The Centre is made up of an outdoor and indoor menage, several stables, toilets, and other buildings.
- 2.3 The maximum number of vehicles would be 25 horse boxes and 10 cars. There would also be machinery which would be used for the centre, including tractors, excavators, and other farming type equipment.
- 2.4 There are also large numbers of horses on the premises, with more movement on event days.

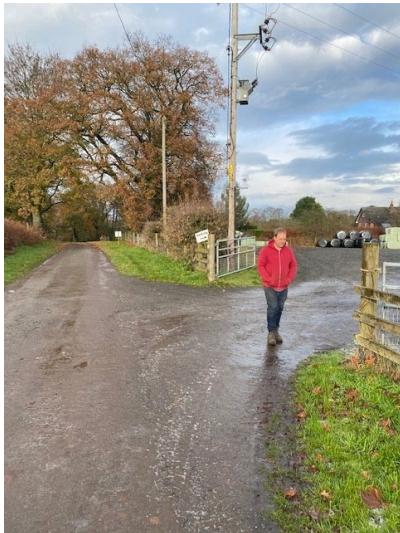
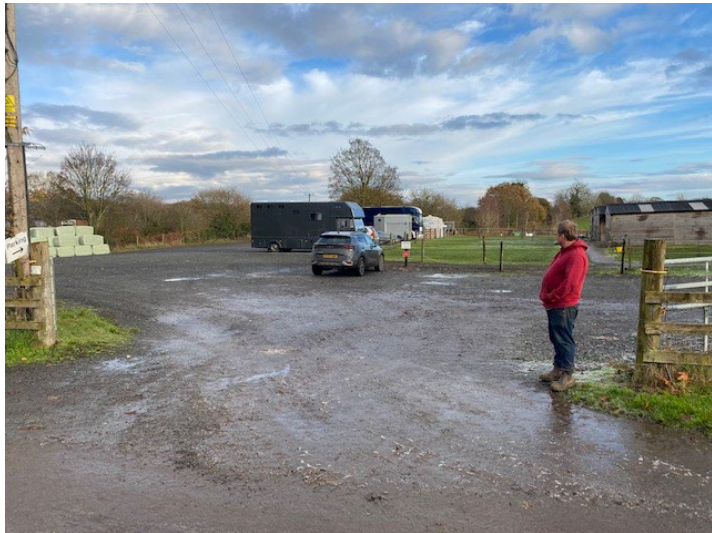
#### 4.1 Car park

- 3.1 Where the car park has been situated it has good visibility, away from buildings with no blind spots (see car park photo's)
- 3.2 The entrance/exit has good vision from both entering or leaving the car park (See car park photo's).

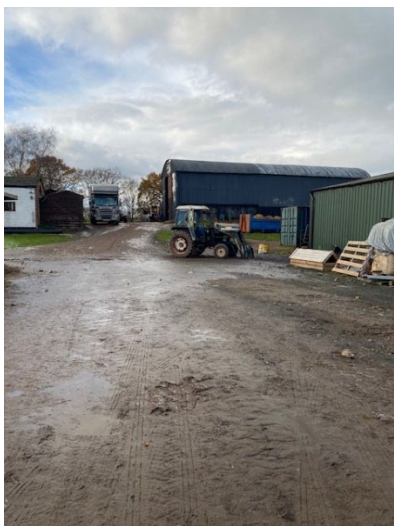
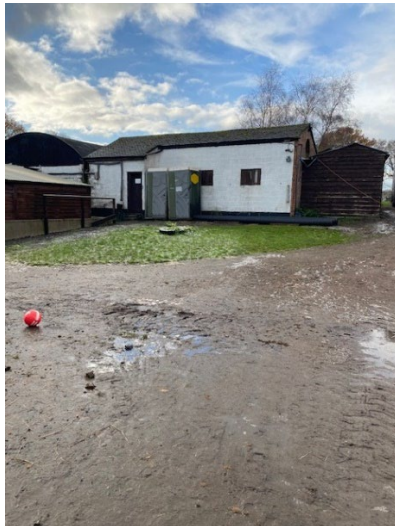
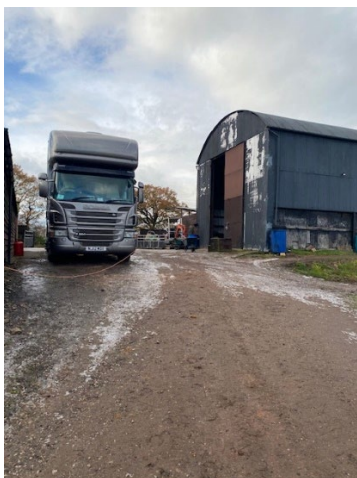
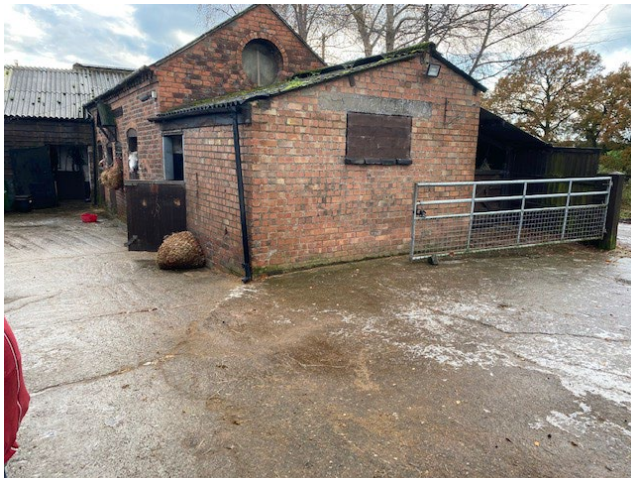
#### 4.2 Yard

- 3.3 The positioning has reduced the number of vehicles within the yard area which has several blind spots (see yard photo's).
- 3.4 The yard area also will have shared pedestrian and animal use. To prevent being struck by moving vehicles it is imperative to reduce so far as reasonably practicable the interactions of people and vehicles, by having the car park it significantly reduces the number of vehicles within the yard (See yard photo's).
