Cellar access – Fox Hall, Wynnstay Estate

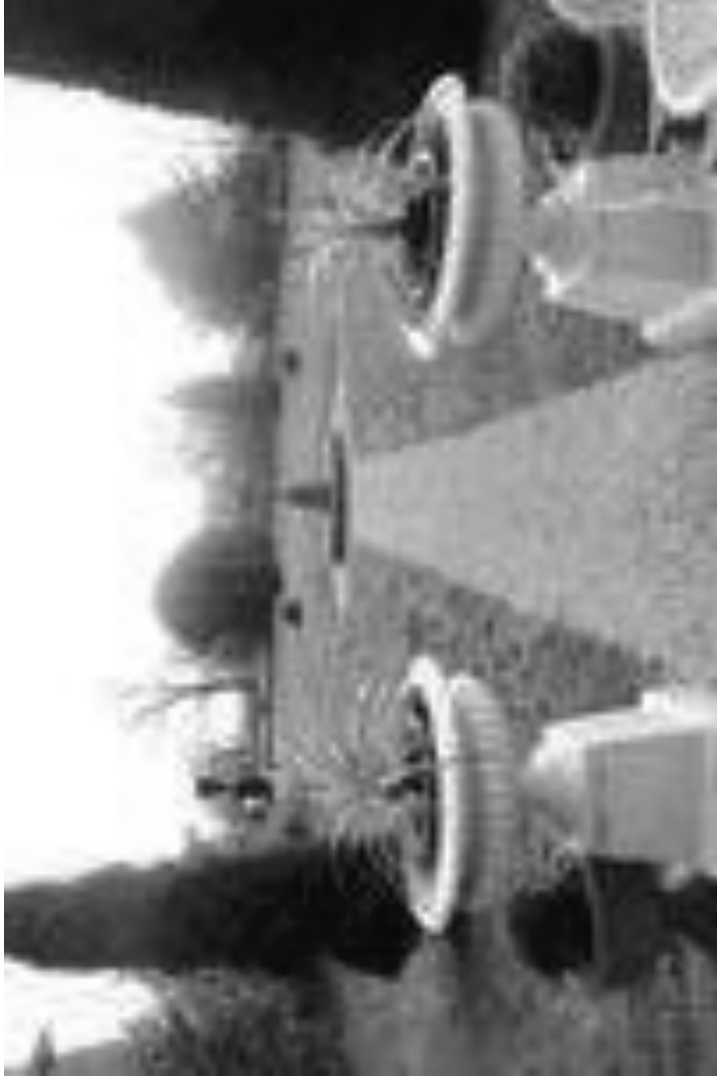
Garden view from what is now the front door. It would have been a window.

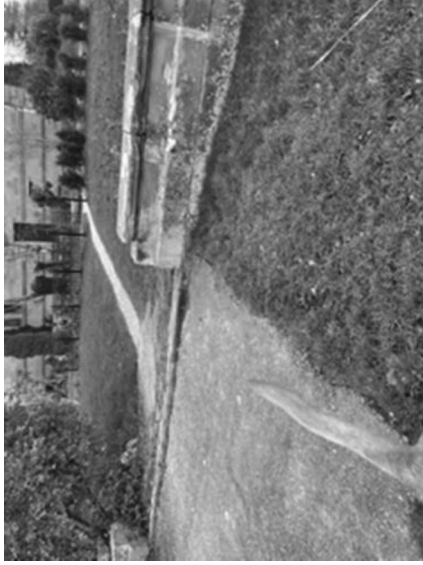
Current access to house and garden.  
This is wide opening from the visitor car park across a neighbours garden.

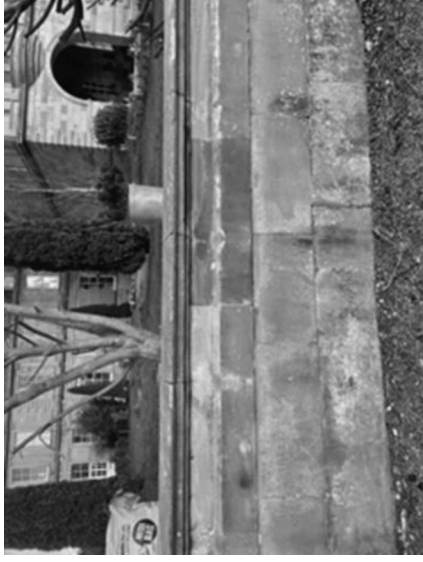
Garden wall as it currently stands,  
\*please note that the trees and shrubs have been cut back in this picture following 20 years of neglect\* .

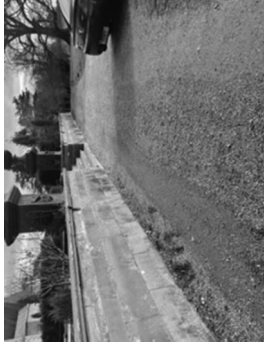
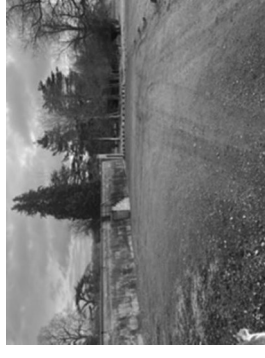
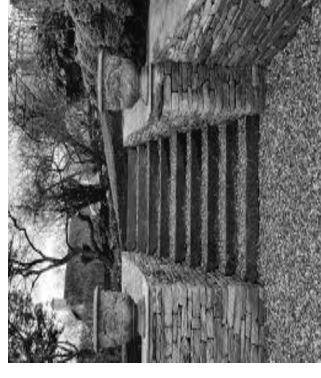
To improve privacy, safety and security the proposal is to resight the garden entrance to the bottom keeping within the property boundary with the bottom step aligning to the wall. In addition this will bring the property in line with neighbouring houses and achieve a form of coherence to the development.

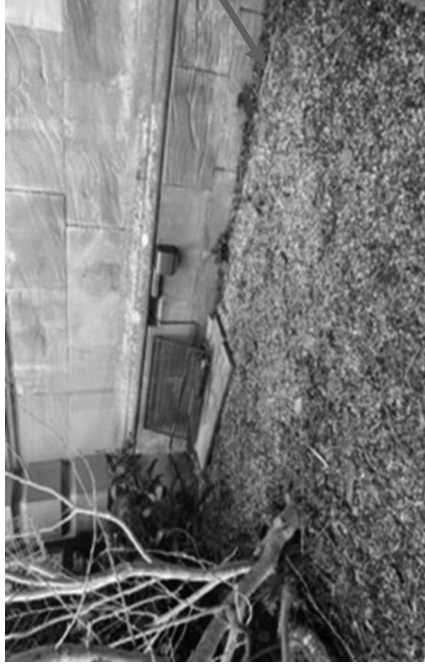
This is the current state of the cellar well. At some point this has been blocked up. The proposal is to re-instate to allow for secondary access and use for garden storage, removing the need for sheds in the garden. The current access to the cellar is unstable and not safe in terms of escape in a fire. Re-instating this access point would give a emergency point to access utilities. The service tunnel for the whole building finishes in this properties cellar.

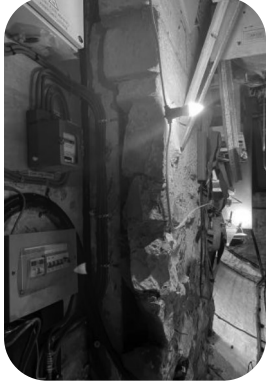
Original cellar access, now blocked off

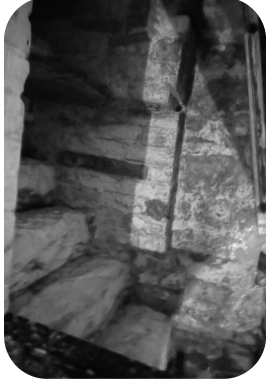
Underneath of original cellar stairs (blocked off)

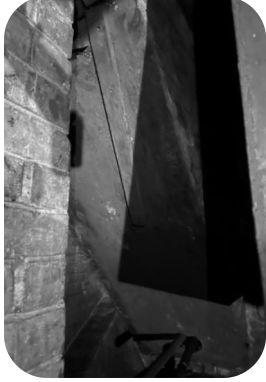
Proposed re-opening of cellar access to garden area

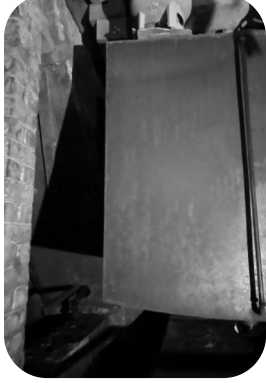
Old oil tank, fire hazard cannot be removed until access points installed

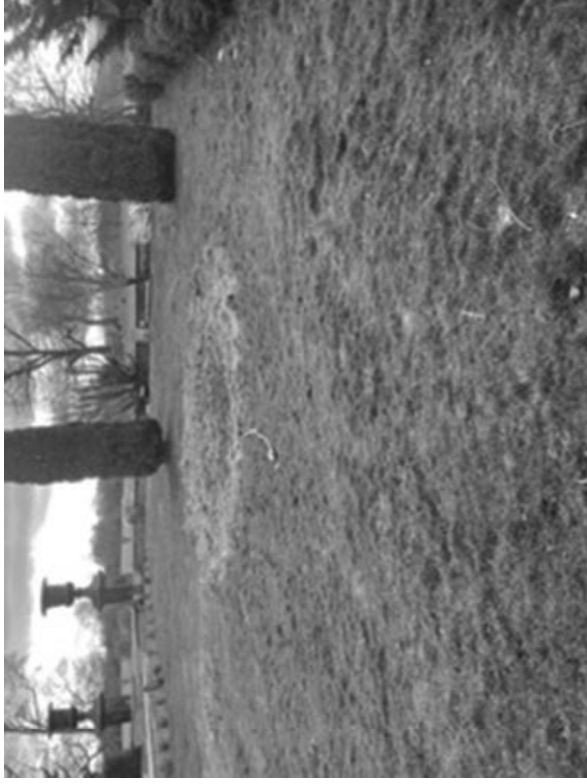
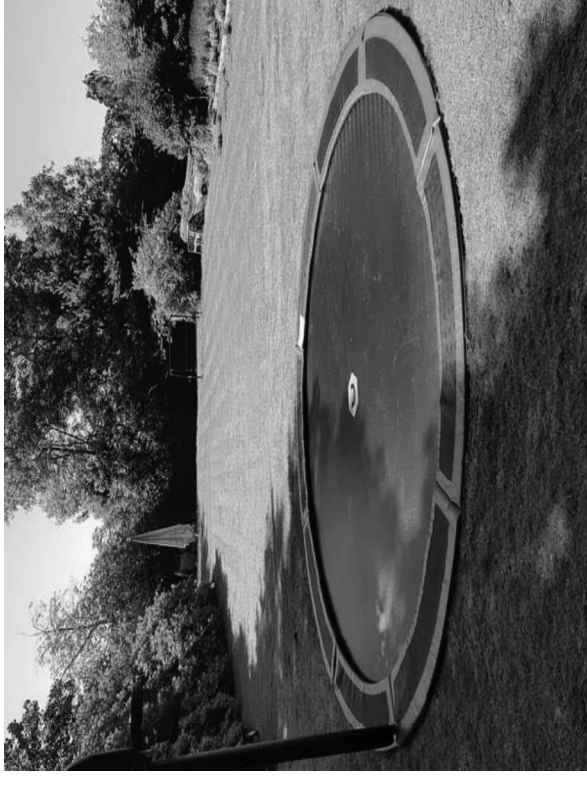
First picture shows garden as is currently, the brown circle representing where the old trampoline stood. The second picture is an example of purposed. This approach will preserve the outlook from the property, while allowing for family living and minimise any intrusion on neighbouring properties.

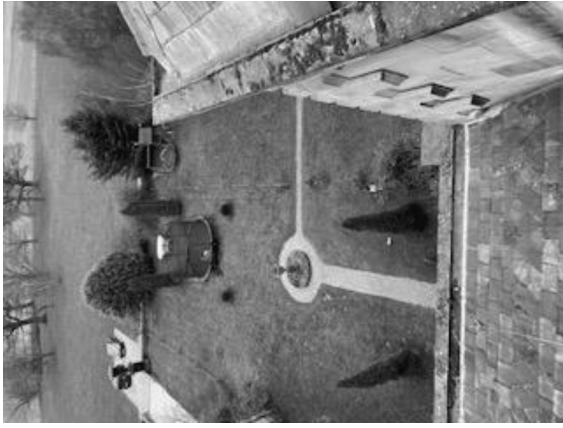
View from the roof of Fox Hall, looking down to the garden. Shows old trampoline above ground. The proposed new trampoline to be sunken would not have the netting making it less intrusive and safer.

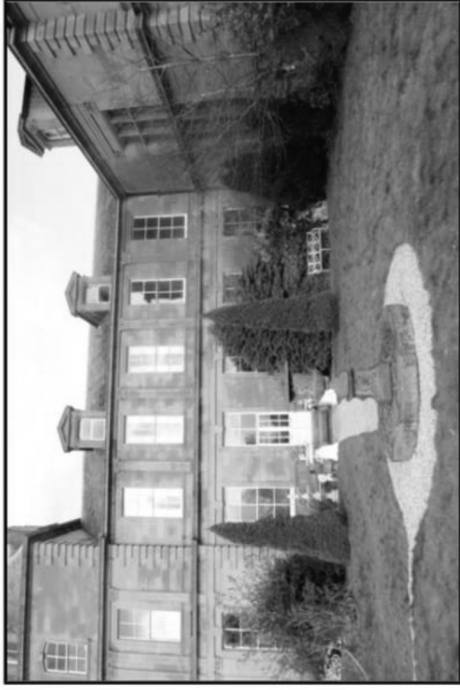
What is currently the front door and main entrance/exit. This door has been made up and is not original, it was once a window. The door is flimsy and does not lock, this causes insurance complications as well as security. The proposal is to replace with a new solid oak door of the same style.

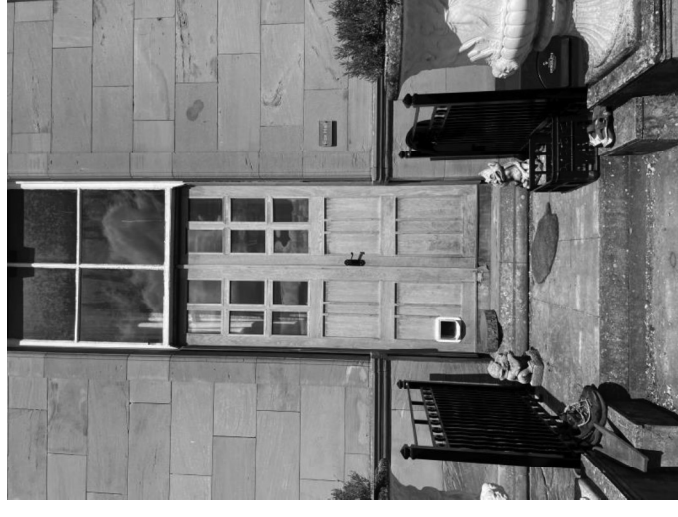
This door will be painted white. It is of solid oak construction. The previous door would not lock, only access point. The steps were put in when it was converted.
