**Leigh Ecology Ltd**

Community Building,  
Darlands Lane,  
Rossett,  
Flintshire.

## **Bat Scoping Survey Report**

**Report number:** ILEX/21/01

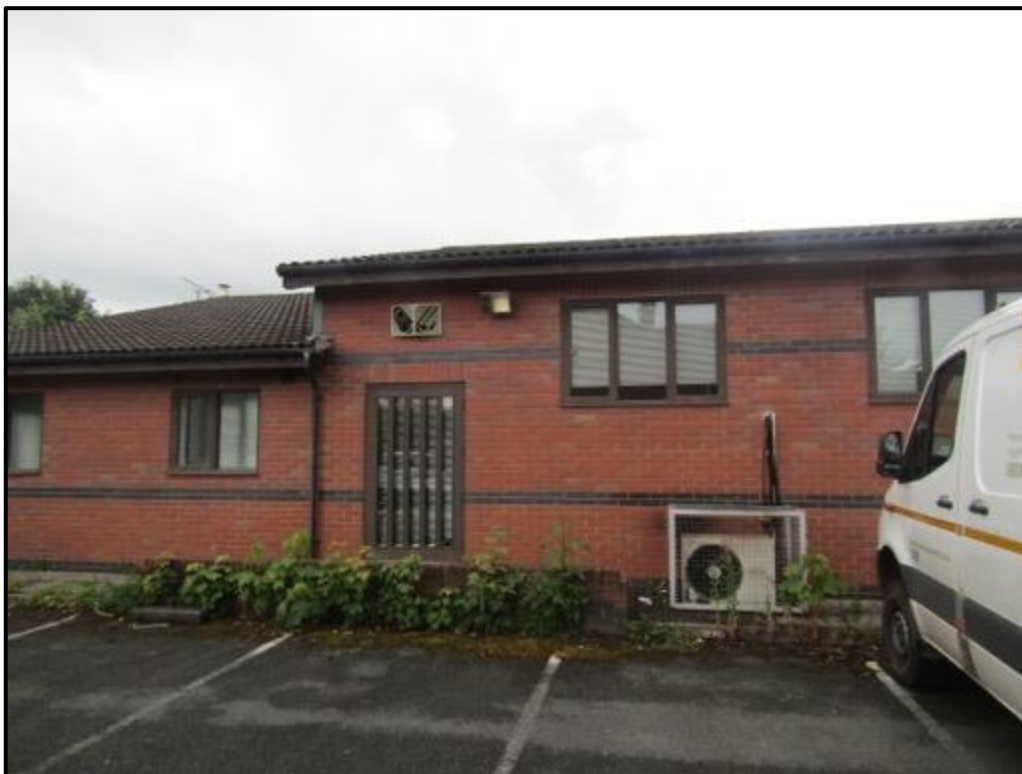
**Fig 2:** The target building, showing the front elevation. The building is circ <20 years old and in very good condition.

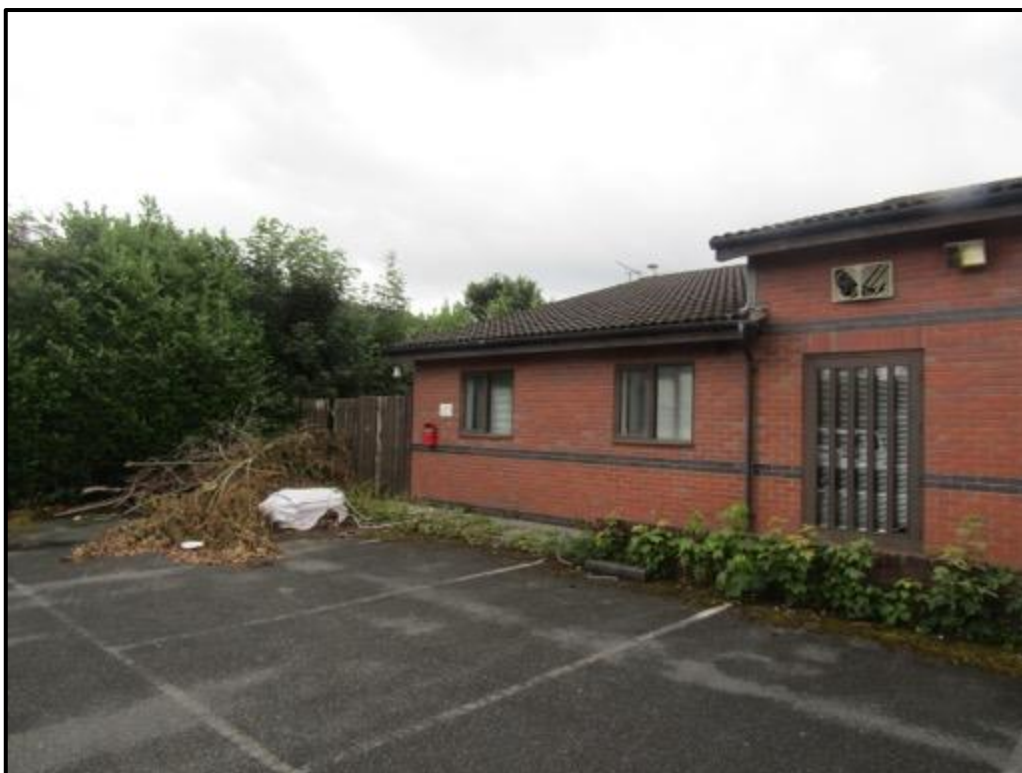
**Fig 3:** The building is set on hard standing and bounded by laurel, privet hedges.

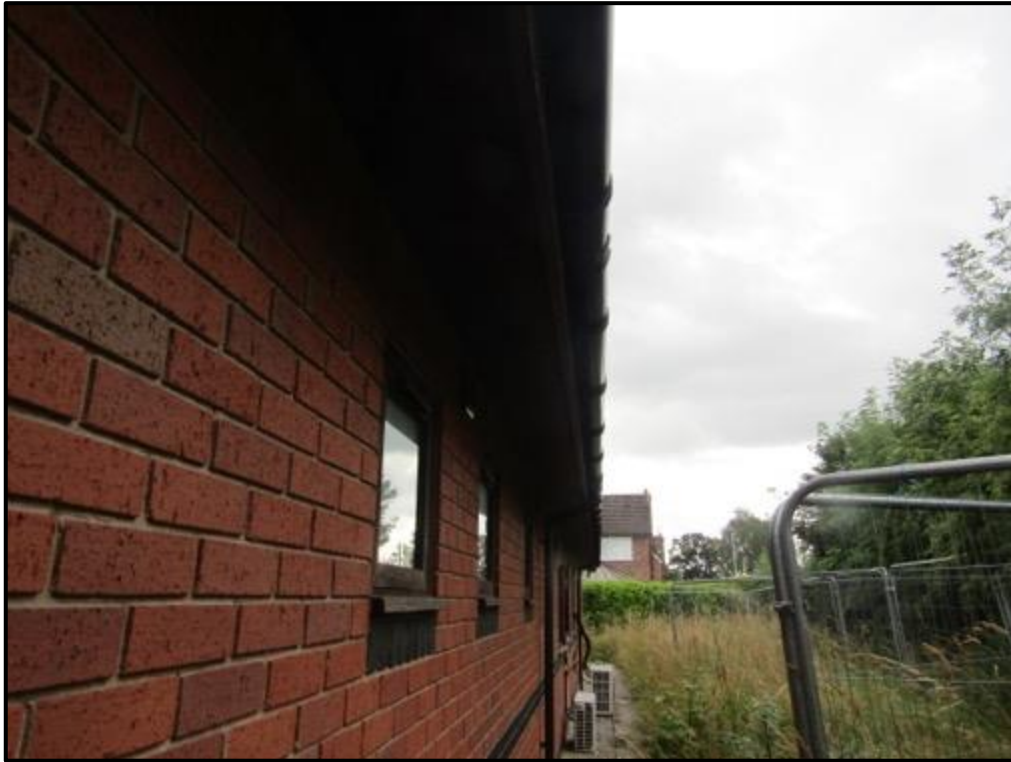
**Fig 4:** The fascia boards and soffits are all in good condition sealed to the exterior walls.

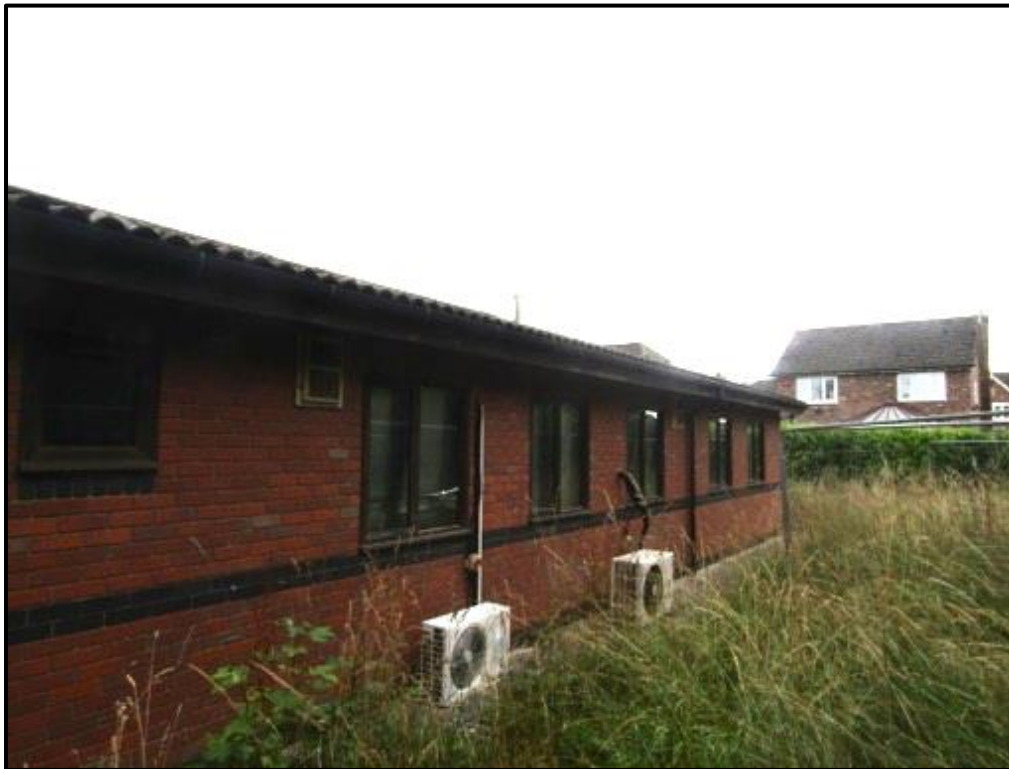
**Fig 5:** The rear elevation is in good condition; the yard/garden area is dominated by commoner succession grasses and weeds. No invasive species were noted.

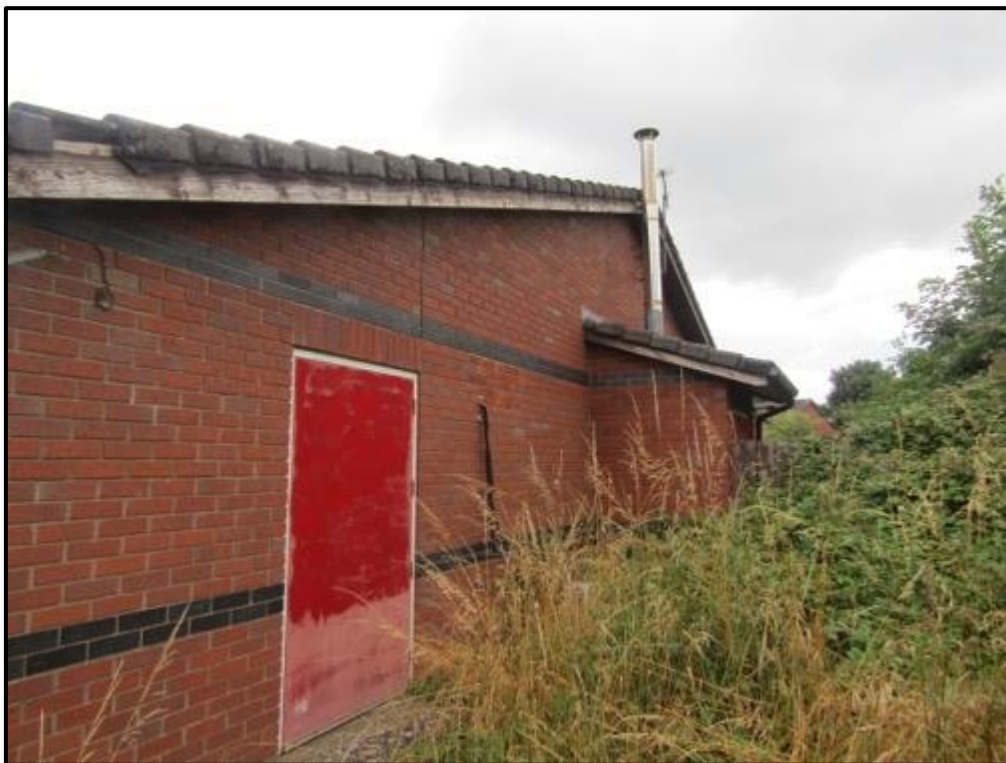
**Fig 6:** The side gable is well sealed; the wooden fascia board is weathered but well sealed. Also, the overlapping tiles are fitted tightly against the board.

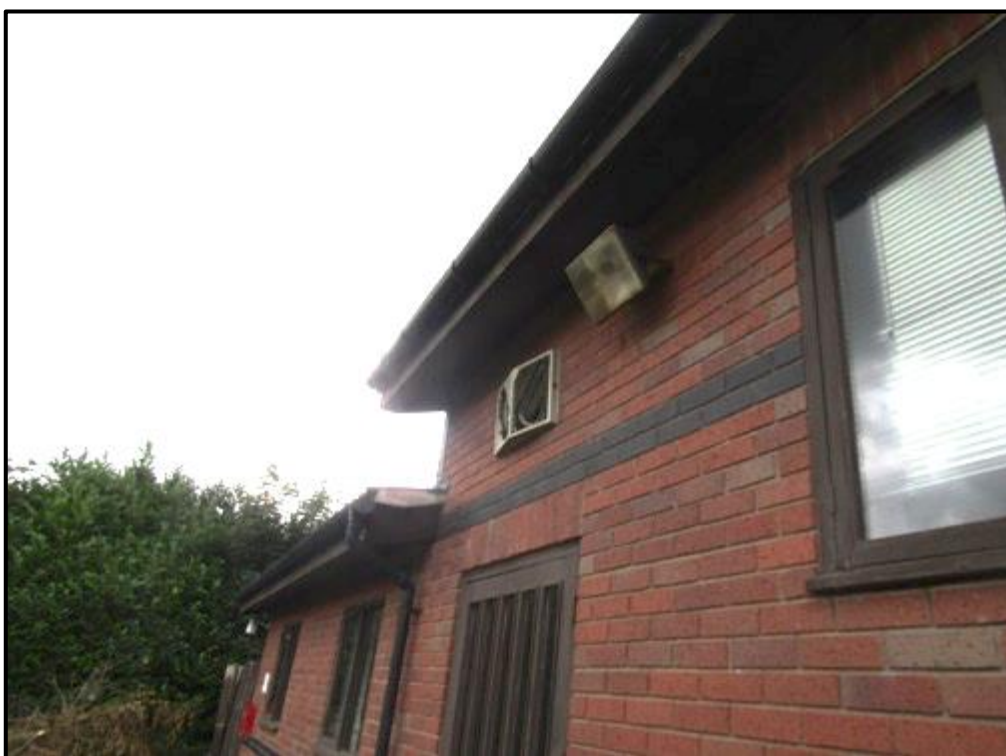
**Fig 7:** The frontage is also well sealed; the fascias are well sealed against the external wall and the roof.

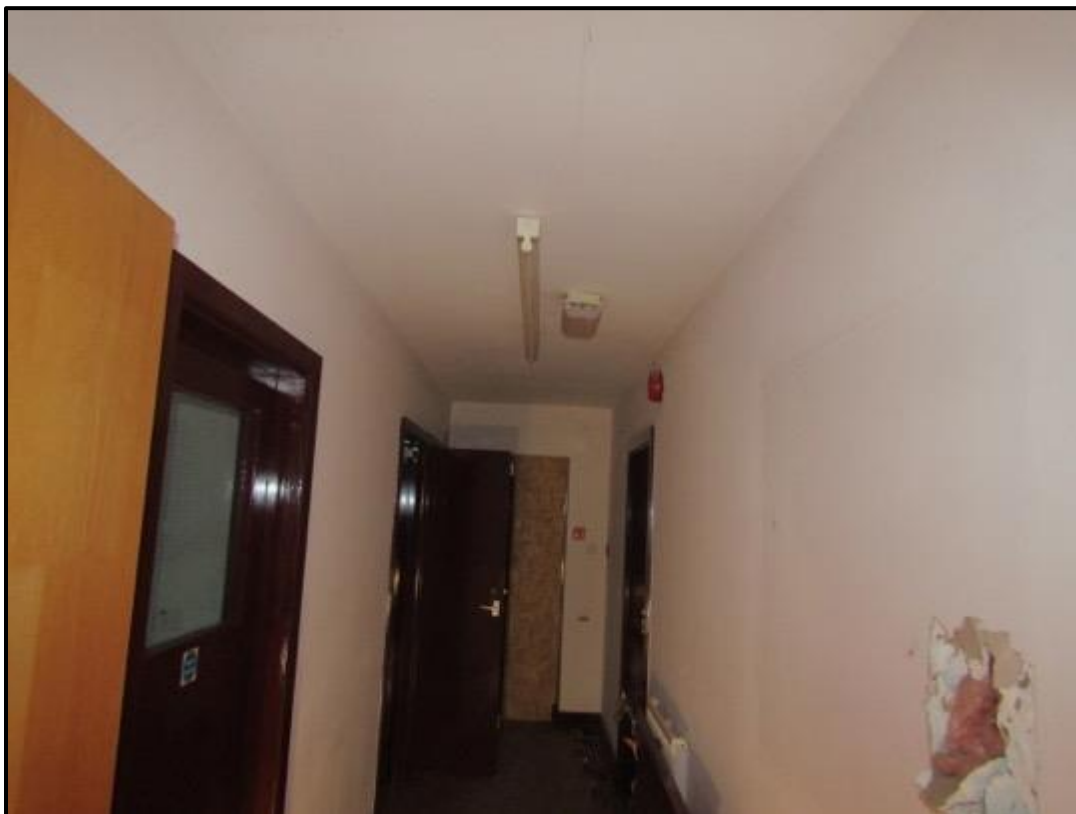
**Fig 9:** The remainder of the building is configured into corridors and small rooms; no signs of bats or birds were noted.

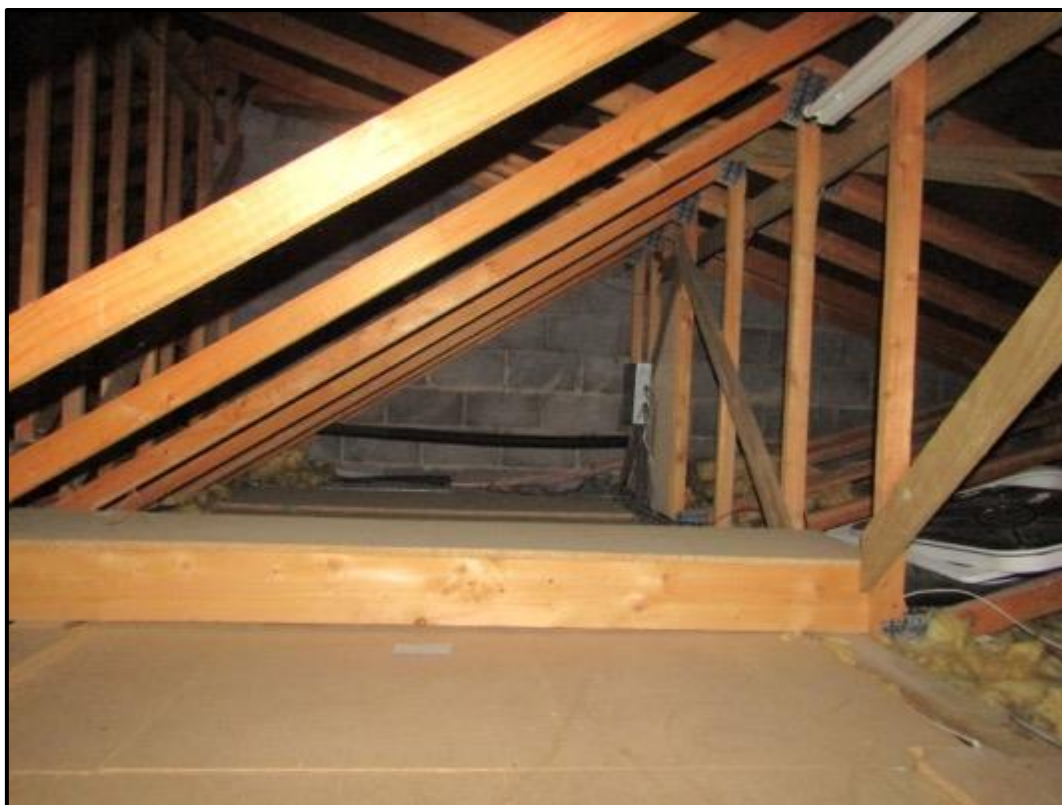
**Fig 10:** The roof void is configured into a complex A frame support structure.

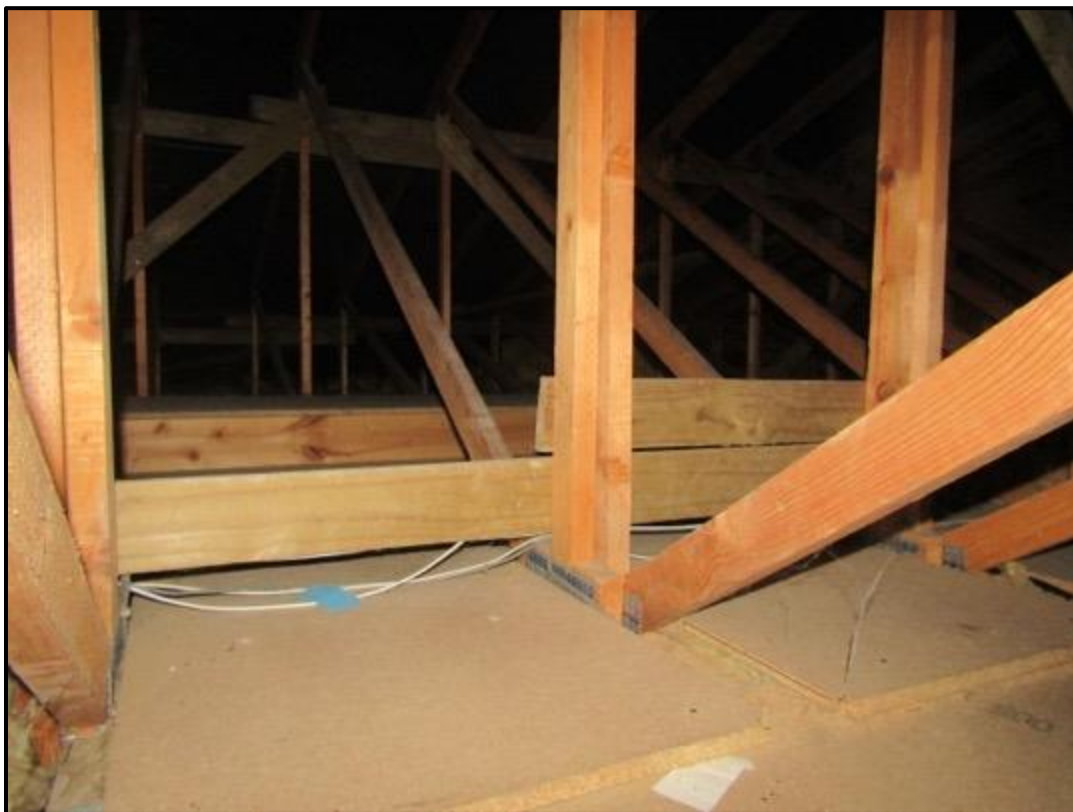
**Fig 11:** The loft space was searched for any signs of bat usage, none where noted.

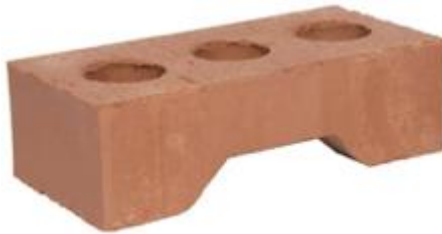
- 5.1.1 Given that the building offers negligible bat roost potential, some enhancements of the proposed new builds are recommended to enhance the building through the use of purpose-built bat bricks. These could be incorporated into the brickwork, such as 1FR/2FR Schwegler Bat brick (see below).
