# Protected Species Survey- Bats

Land at New Mill, Halghton

**Bleazard and Galletta**

Date: 21st July 2021

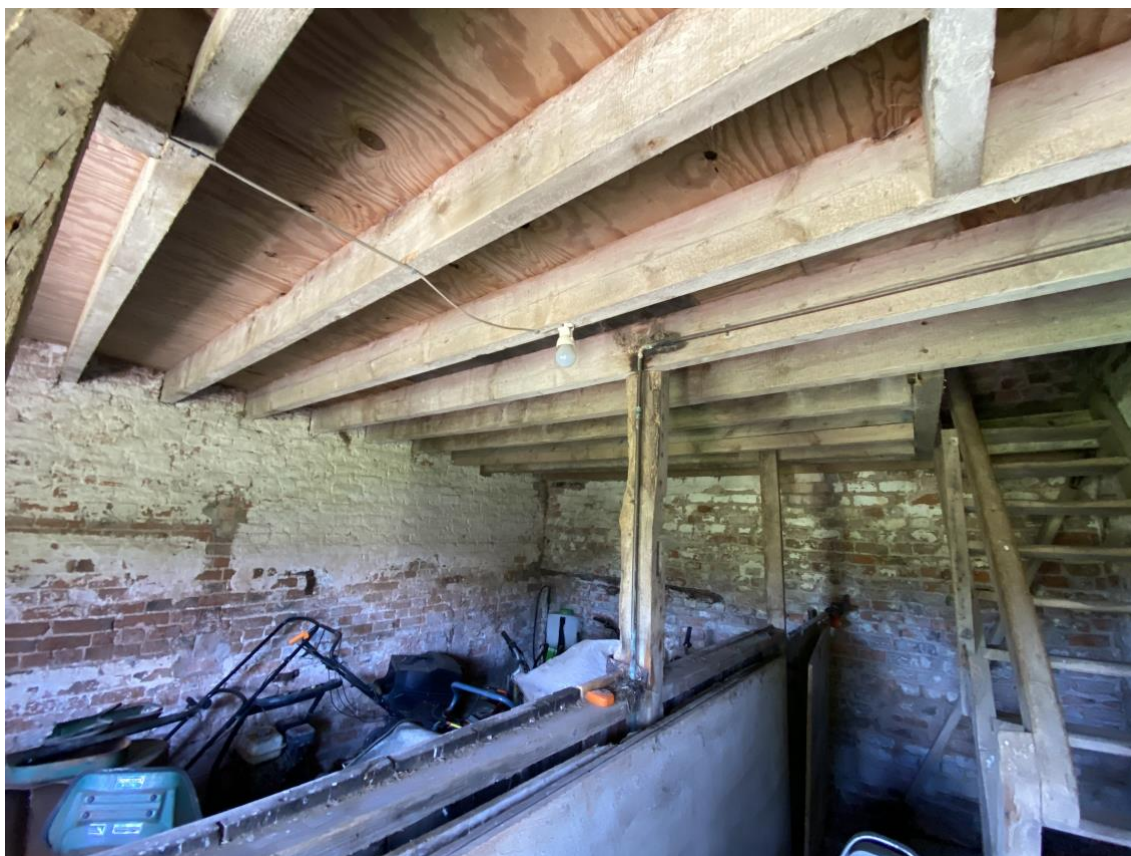
**The ground floor of the building. No evidence of bats found within the ground floor**

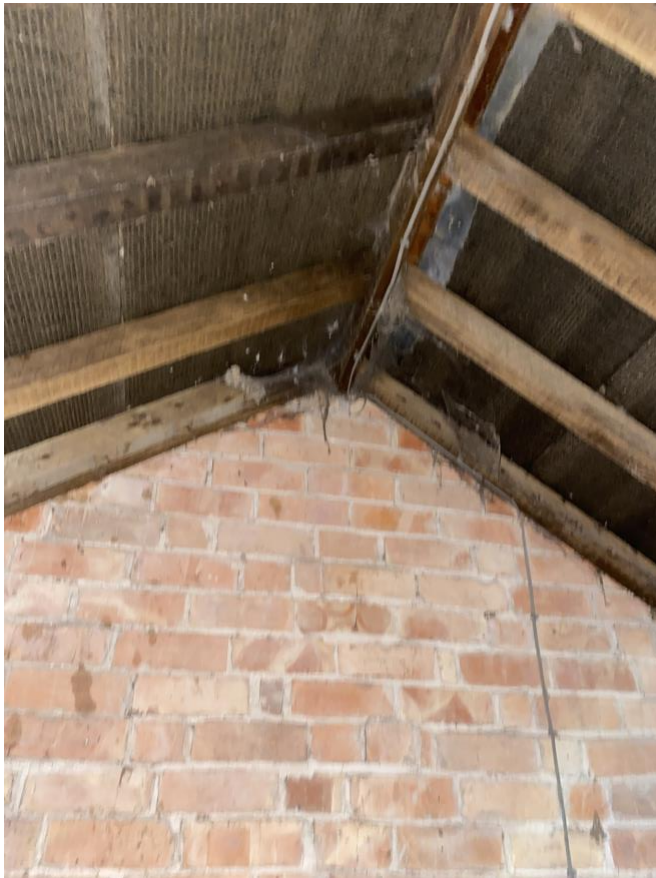
**The roof liner is present beneath the roof slates within the building**

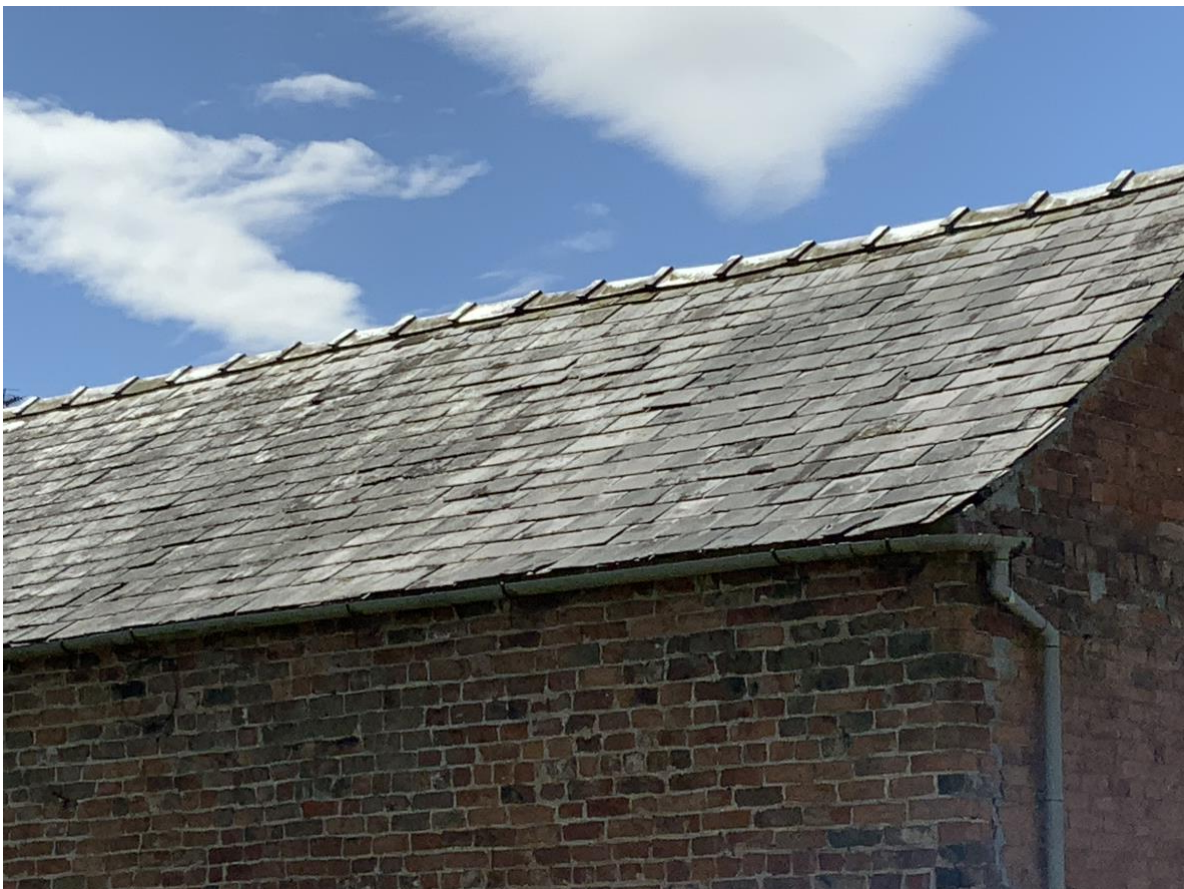
**The roof slates are in fairly good condition and there are few roosting opportunities beneath the slates.**

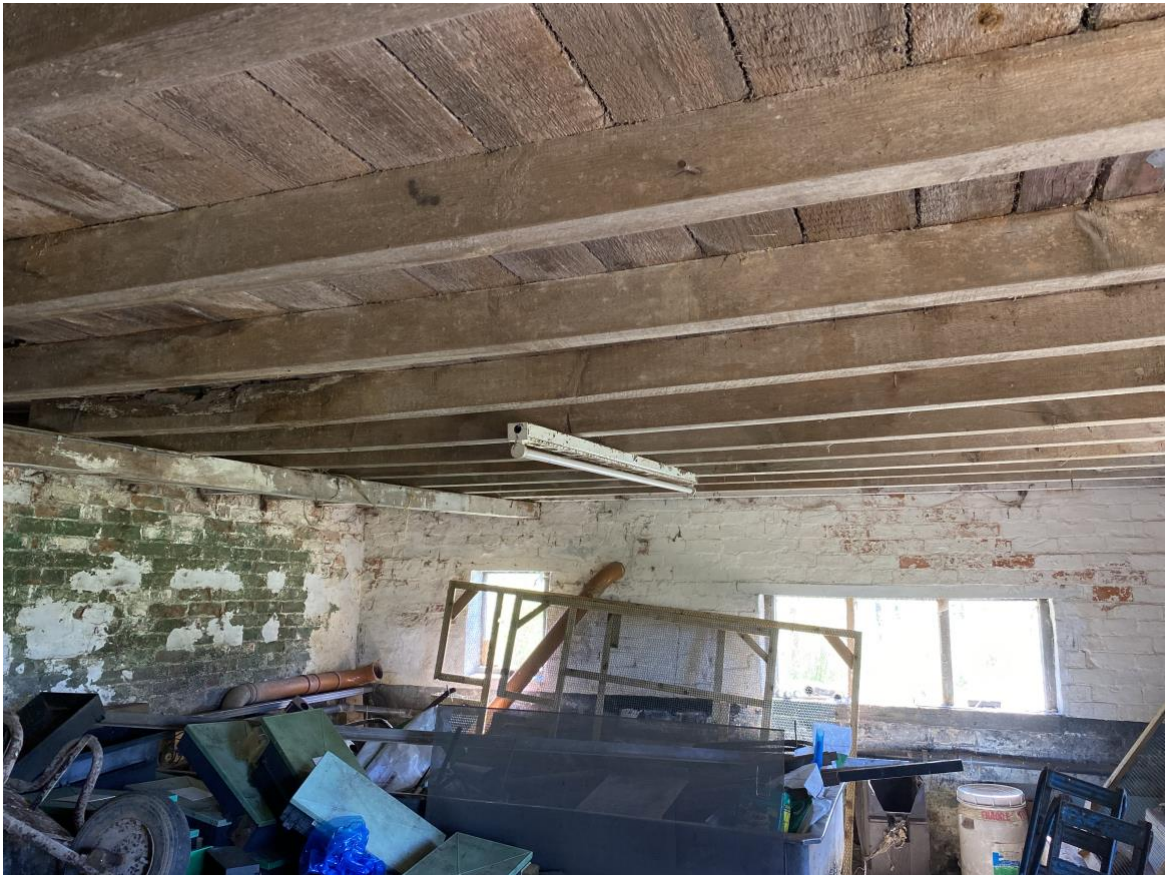
**The ground floor of the building has no evidence of bats and there is very little access available into the ground floor for the species.**

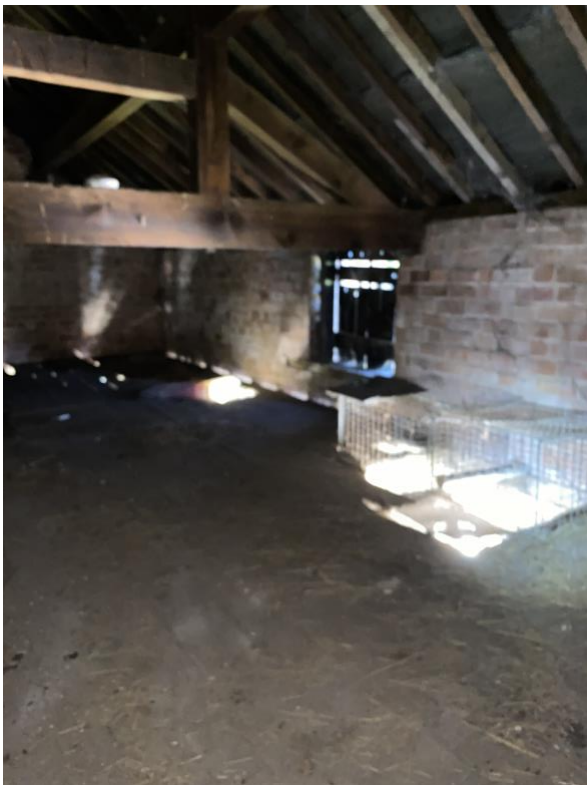
**Access into the first floor for bats is possible via ill fitting windows, however there was no new evidence of bats from the preliminary roost assessment to the activity survey.**

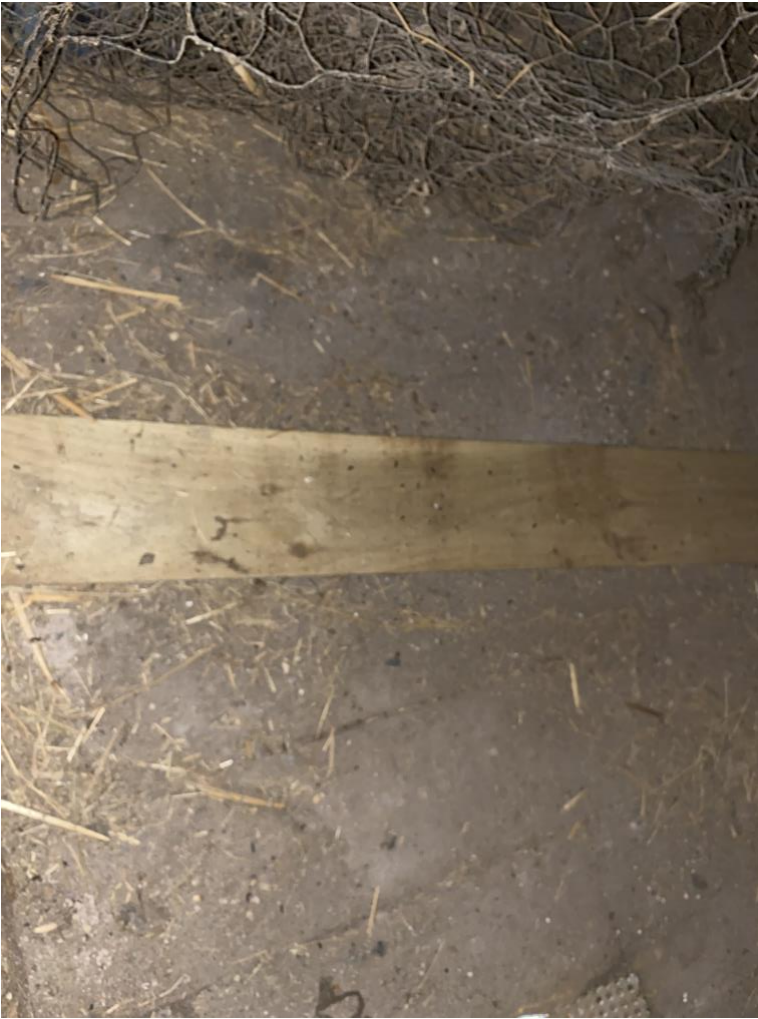
There were a small number of bat droppings found within the central section of the first floor. These droppings appeared to be concentrated in one place, with very few scattered droppings around the rest of the building. There were no feeding signs found within the internal space, although the southern end of the first floor could not be thoroughly inspected due to safety.

**There were scattered droppings in the middle of the first floor, but no feeding signs found. The numbers of droppings did not increase between the PRA and the activity survey.**
