**REMEDIATION STRATEGY POLICY FOR  
PROPOSED RESIDENTIAL DEVELOPMENT  
WOODLANDS FARM, DODDS LANE  
GWERSYLLT, WREXHAM**

**MAY 2022**

**REMEDIATION STRATEGY  
14155/REM/002**

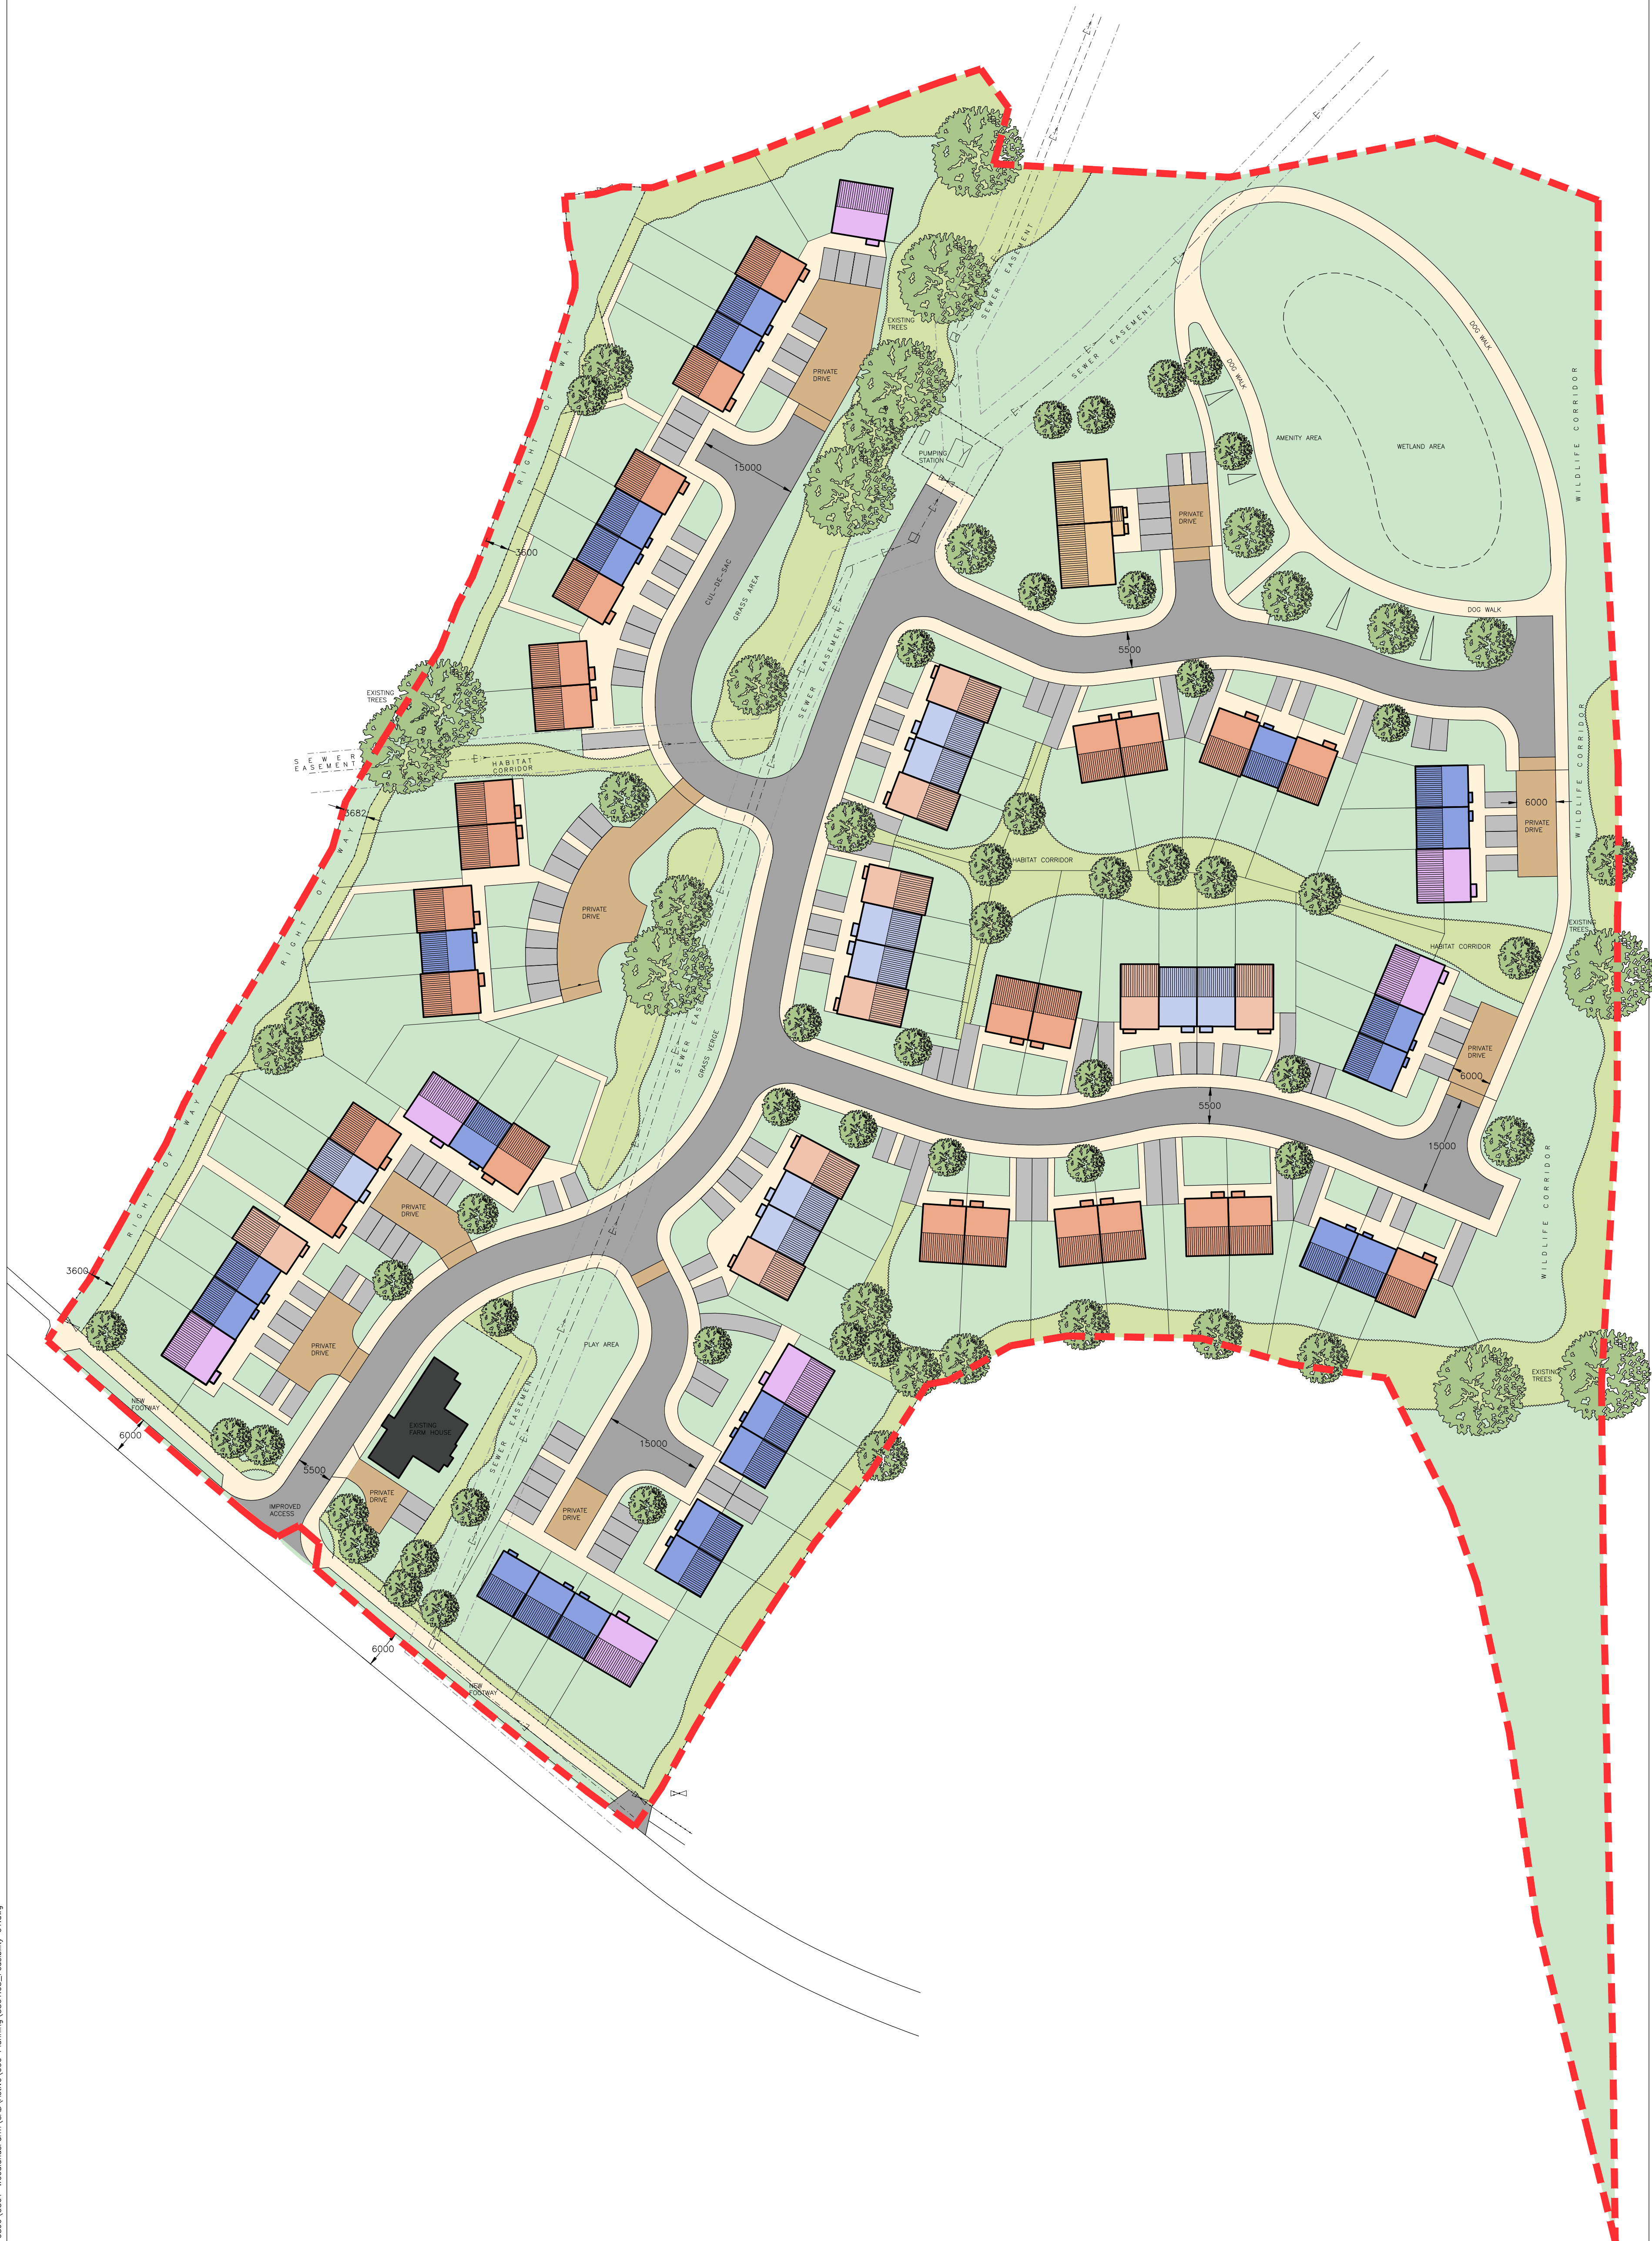
Drawing FEASIBILITY SITE  
PLAN

- 4P2B WIDE
- 4P2B NARROW
- 5P3B WIDE
- 5P3B NARROW
- 6P4B HOUSE
- 3P2B WALK UP APARTMENTS

4P2B = 31  
5P3B = 35  
6P4B = 7  
3P2B = 4  
APARTMENTS  
TOTAL = 77
