**Report Type:** Ecological Appraisal

**Site Address:** Brunett Barns  
Lower Wych Lane  
Ty Broughton  
Whitchurch  
SY13 3BA

**Report Reference:** 20-05 107.1R

**Date of Issue:** October 2021

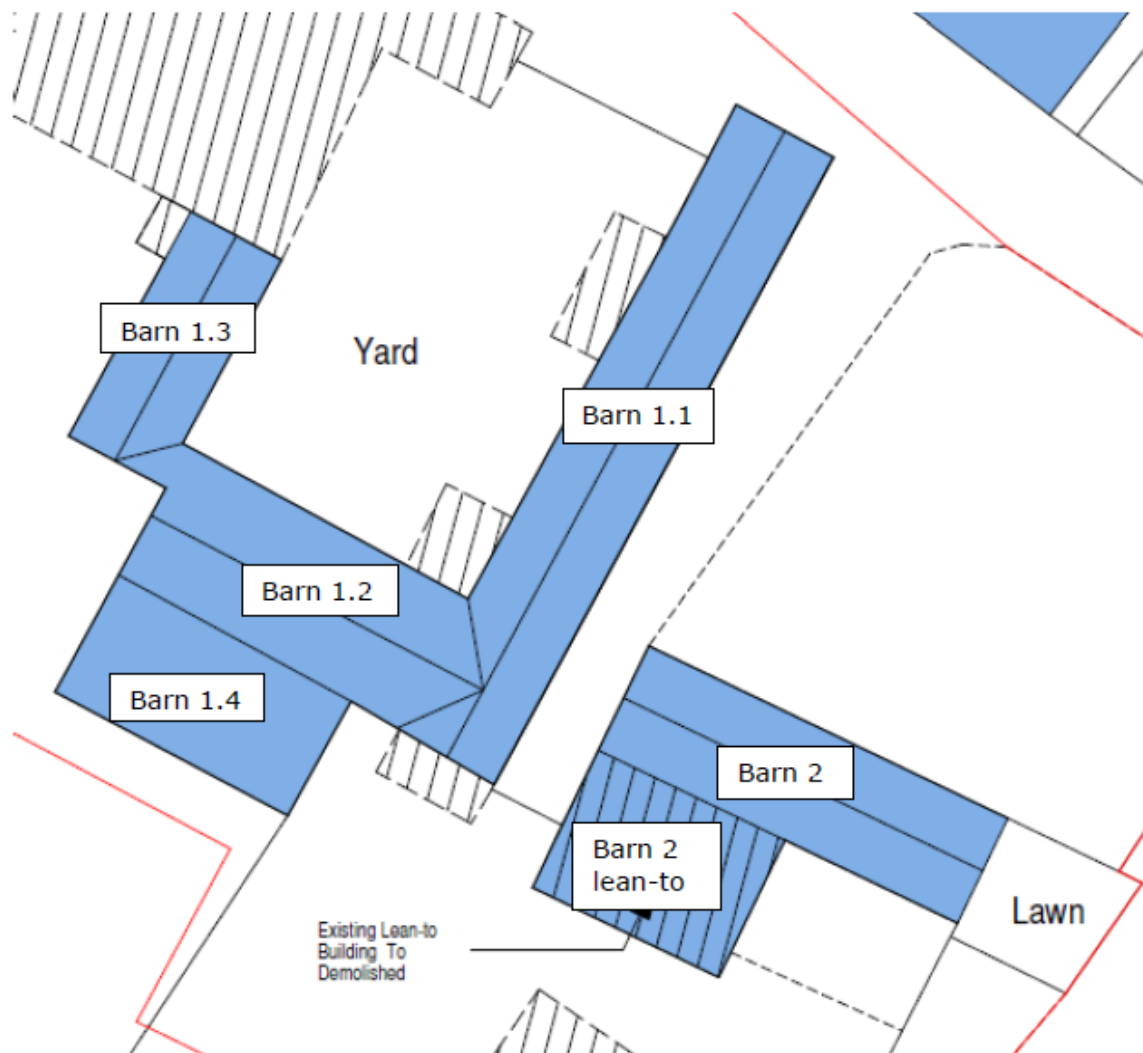
**Figure 4.1. Buildings on site 2018**

The same notation for the barns has been used as in the Greenscape report from 2018

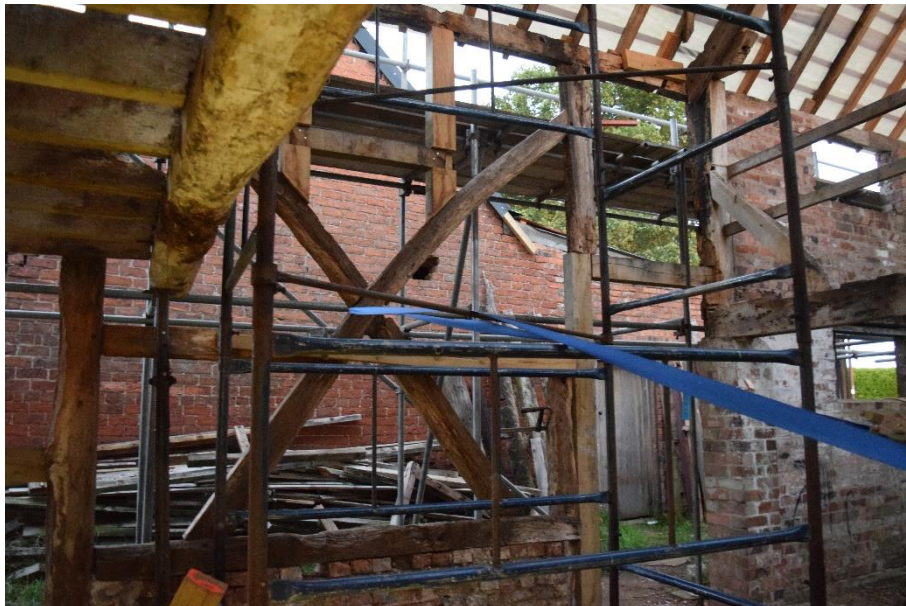
**Figure 4.3. View from interior through eastern elevation**

Scattered bat droppings were seen on the mezzanine floor to the north of the building. These seemed to be associated with areas where there remains open mortice joints in the timbers.

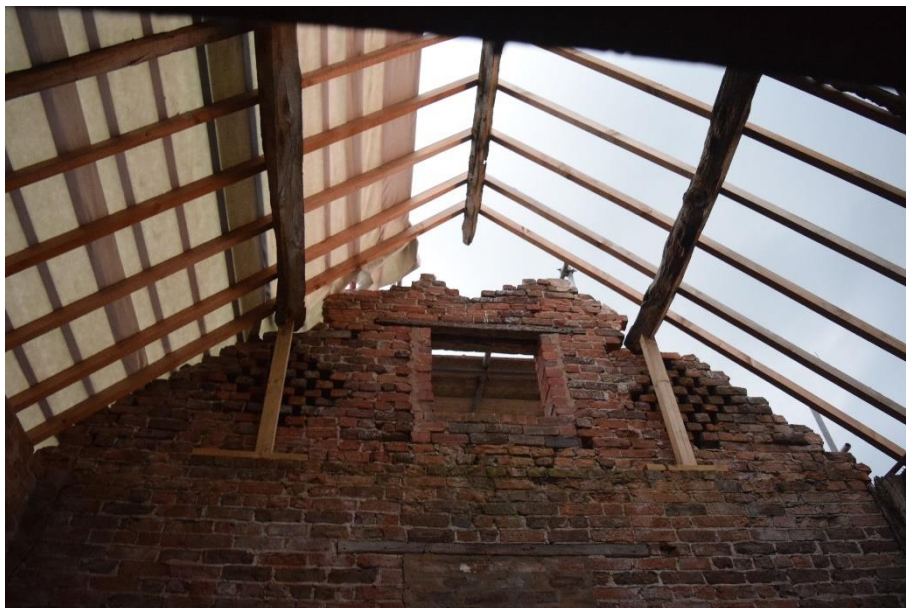
**Figure 4.5. Southern gable end**

Work has been stopped on this building by the council. The southern gable end was seen to be in as poor condition as in 2018.

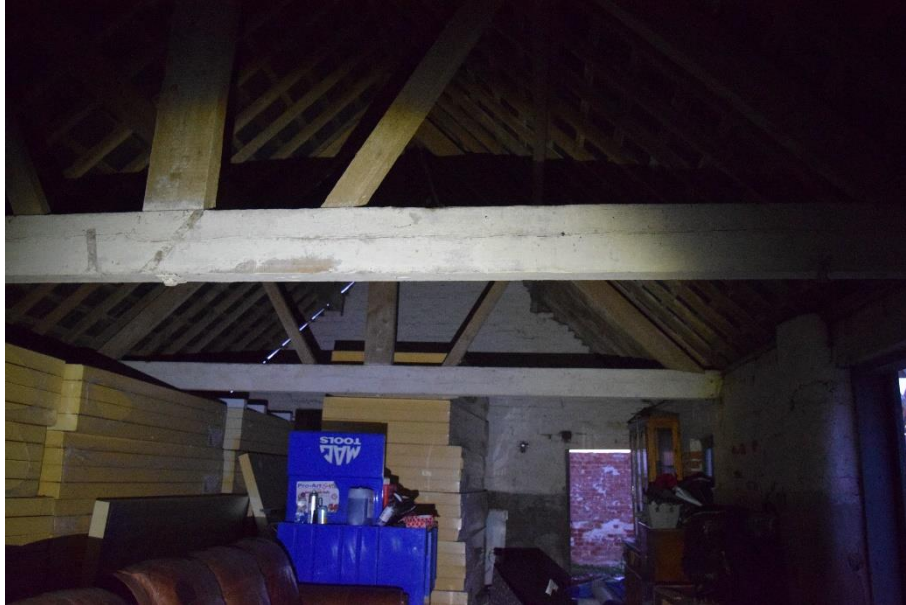
**Figure 4.8. Showing gap along western elevation**

This section of the building remains dark, but the slate roof is not lined and clear gaps can be seen between the roof and the western gable end. The building offers low opportunity for bats.

Scattered bat droppings were observed within the building on stored items, but there was not enough accumulation of droppings to suggest the presence of a maternity roost.

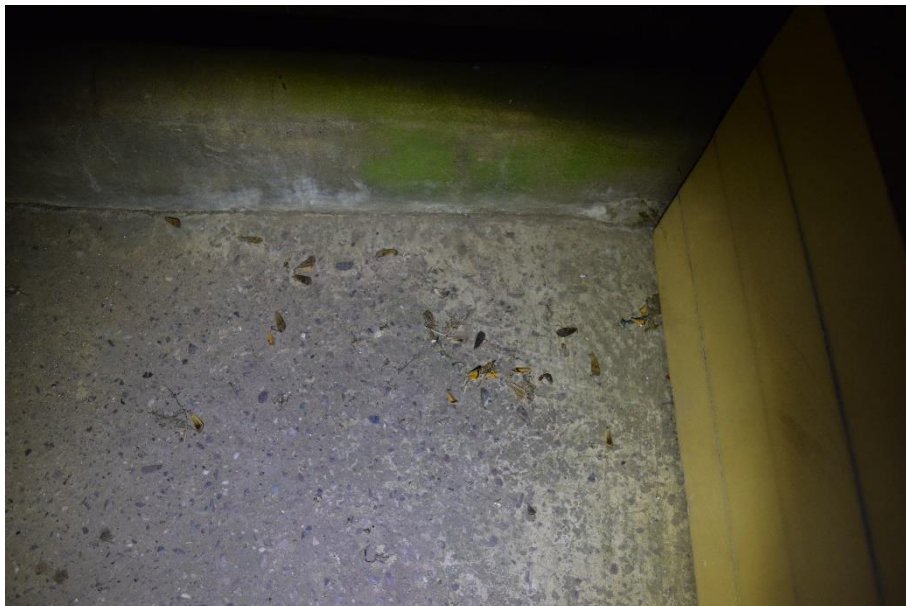
**Figure 4.9. Feeding remains**

Feeding remains of yellow underwing moth were observed suggesting presence of a brown long eared bat.

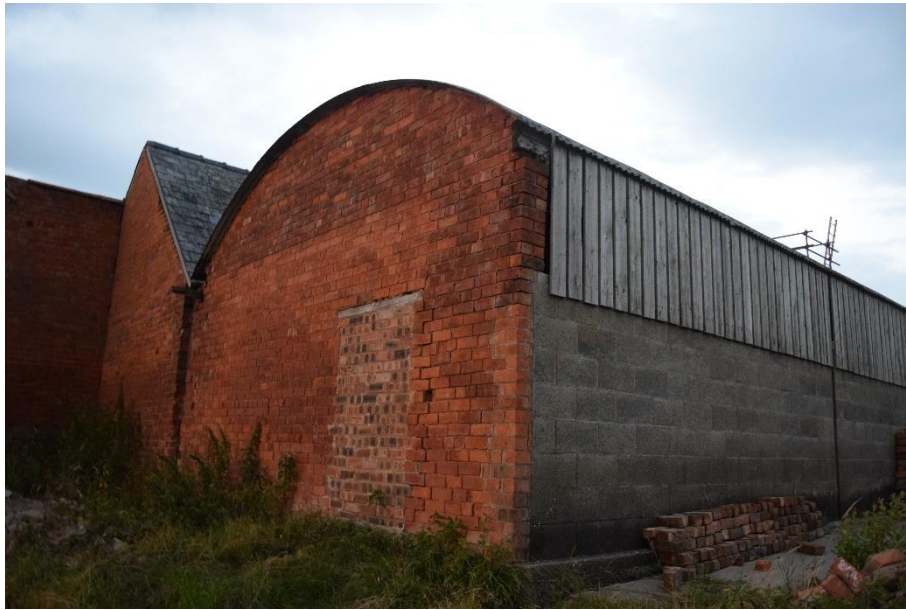
**Figure 4.11. Building 1.4**

There have been no alterations to building 1.4 since 2018. This is still a metal roofed structure with block and timber on the southern elevation.

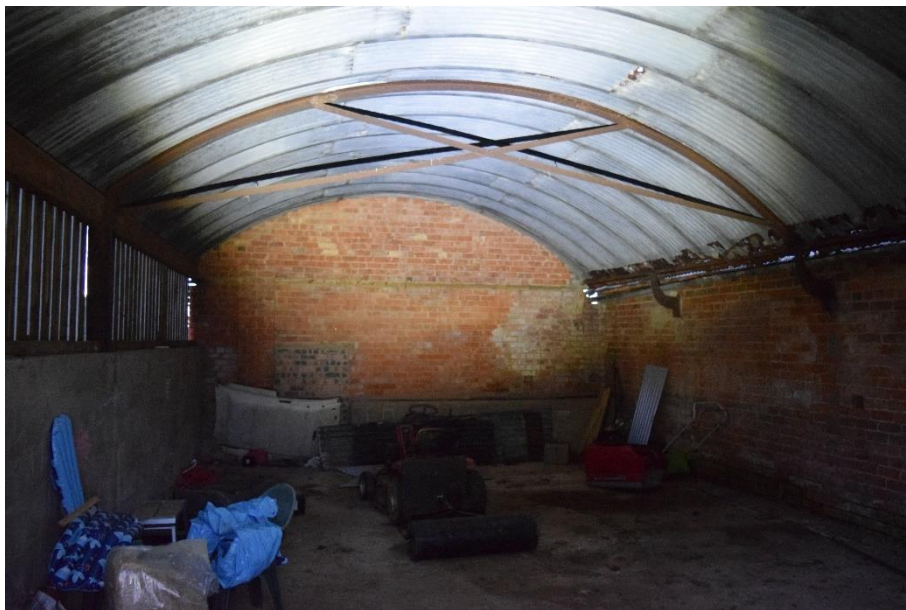
**Figure 4.12. Interior of B1.4**

No bat droppings were seen within this building and with gaps along the wall plates is is considered to have low potential for bat roosts.

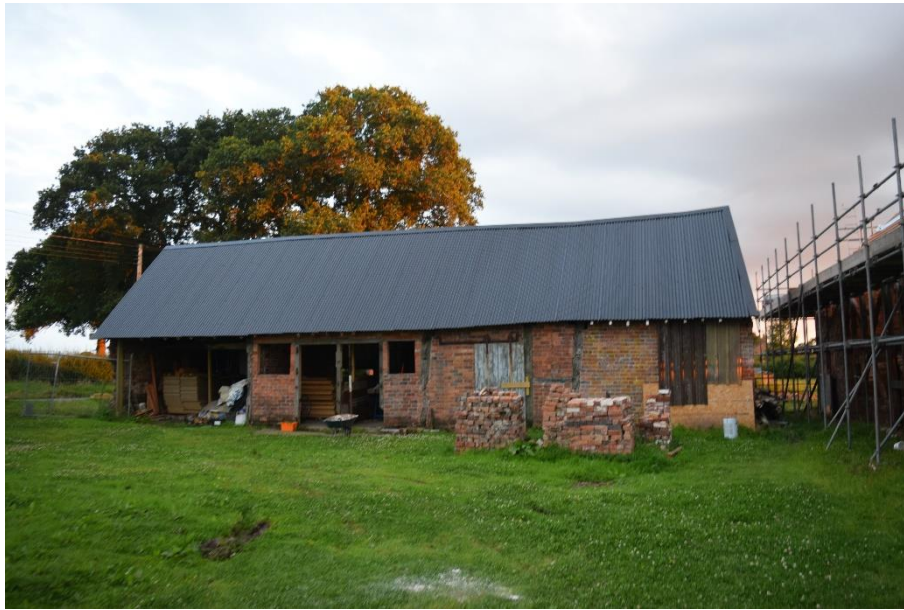
**Figure 4.13. Building 2**

Barn 2 has been re-roofed with a replacement metal roof and breathable membrane.

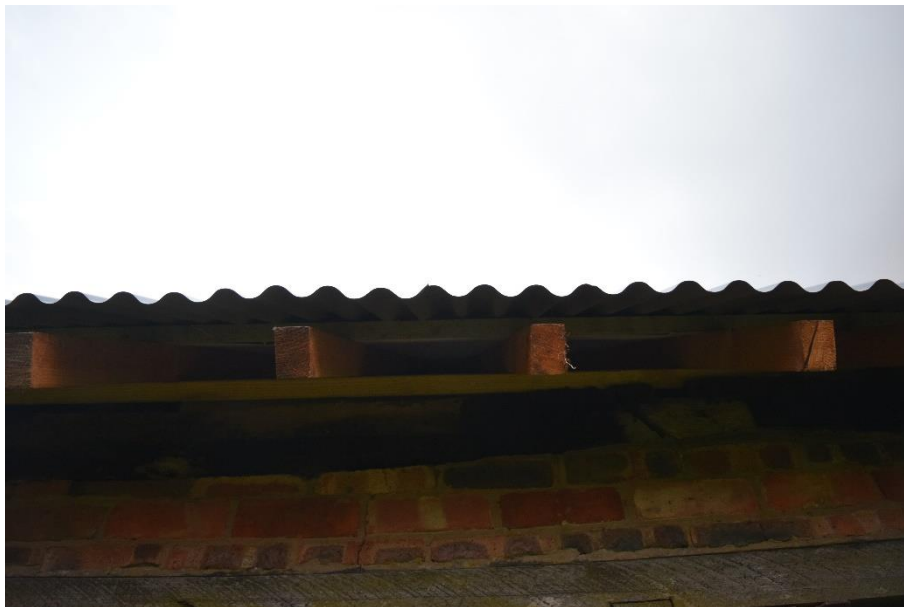
**Figure 4.14. Showing potential bat access areas.**

Large spaces are visible into the roof void of the building which allows continued access for bats.

The building is being used for storage and no further construction work is anticipated now the building has been stabilised.

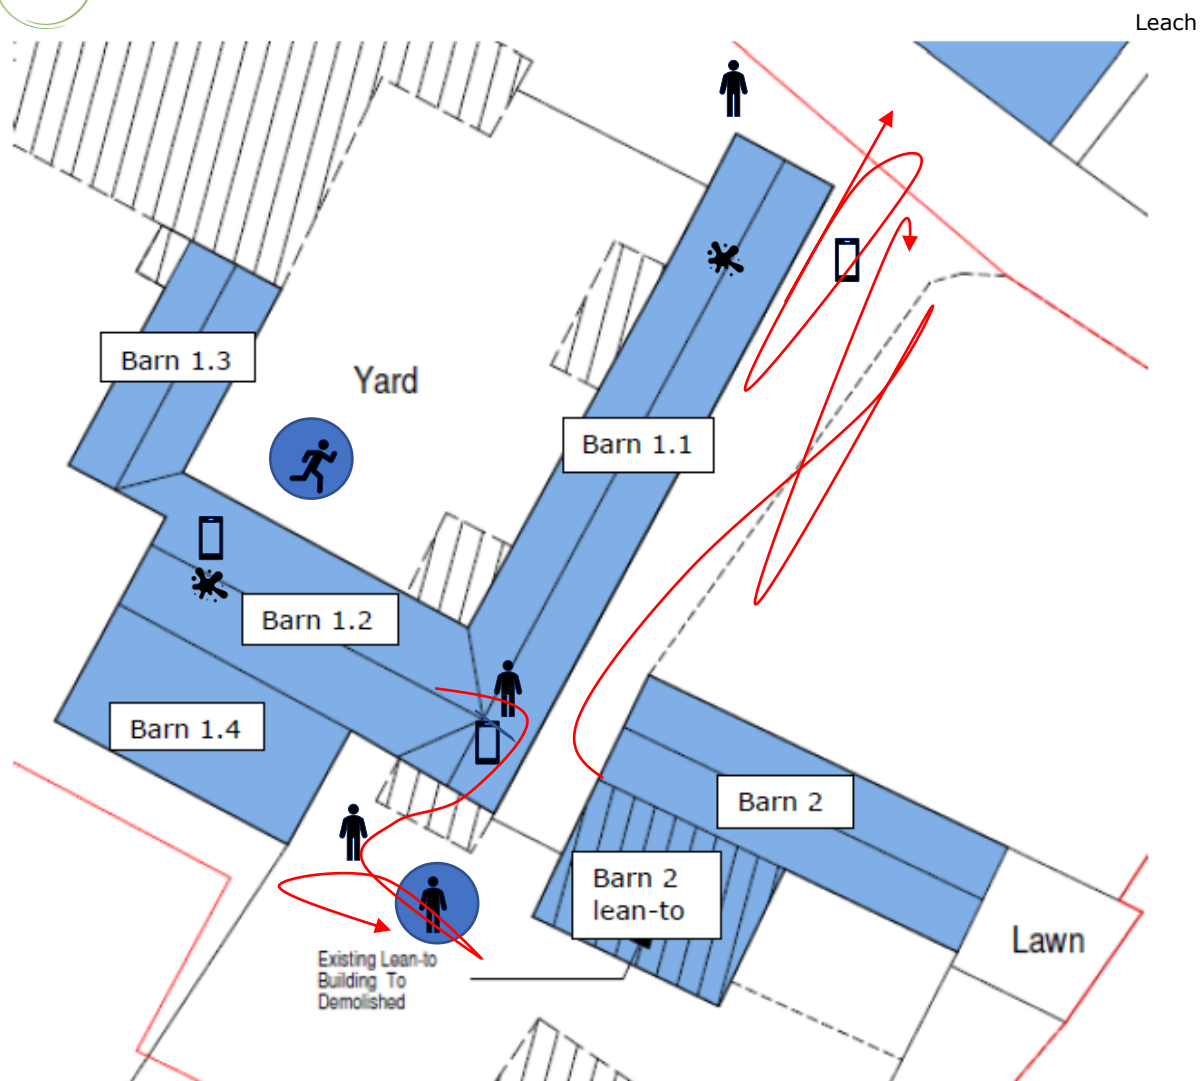
**Figure 4.15. Survey area showing observations**

From the position of the droppings, the roost positions in barn 1.2 is under the central ridge.

No bat activity was recorded from barn 1.4.
