# The General Market, Wrexham.

Heritage Impact Assessment relating to the  
Remodelling and Refurbishment of The Wrexham Markets

— August 2022

for Lawray Architects, on behalf of Wrexham County Borough Council

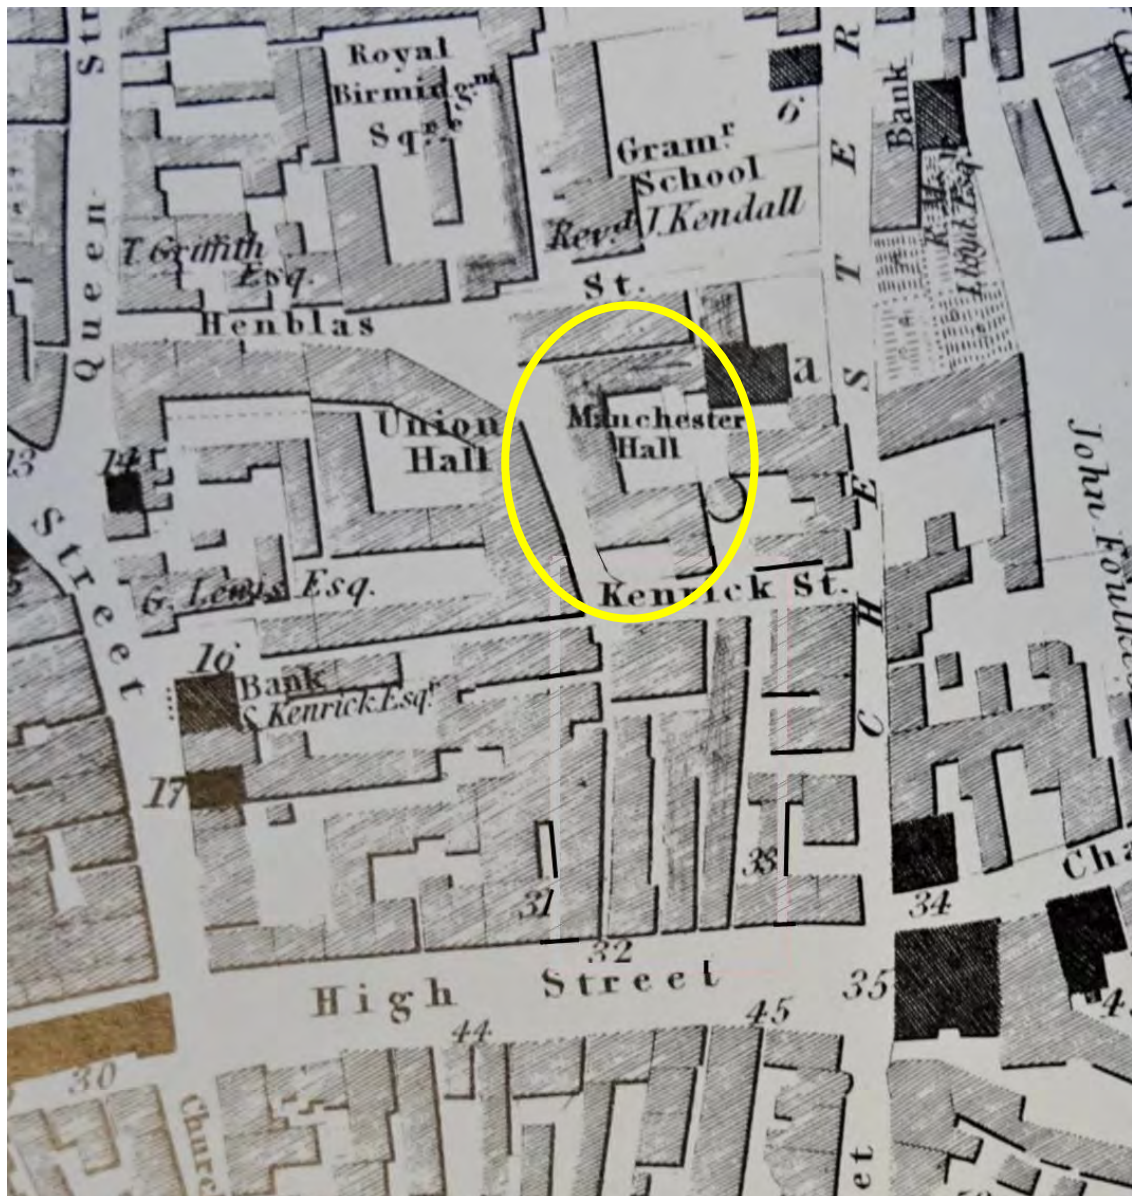
Figure 6 - Map of 1833 indicating Manchester Hall on the current site of The General Market

The town map of 1833 describes the land on which the General Market now stands as Manchester Hall. This area was probably the location of 'Manchester Square' where traders from Lancashire brought woollen and linen cloth with other items for sale. To the northwest of this location, traders from the Midlands sold iron and steel wares in a space called Birmingham Square, which was later to become the site of the covered Vegetable Market, constructed in 1910. The map of 1833 also indicates the circular plan form of 'the cockpit' to the east of Manchester Hall, a structure that was first mentioned in c.1712 was described as being derelict in 1883 and was pulled down in 1884 (see RCAHMW record NPRN 32719).

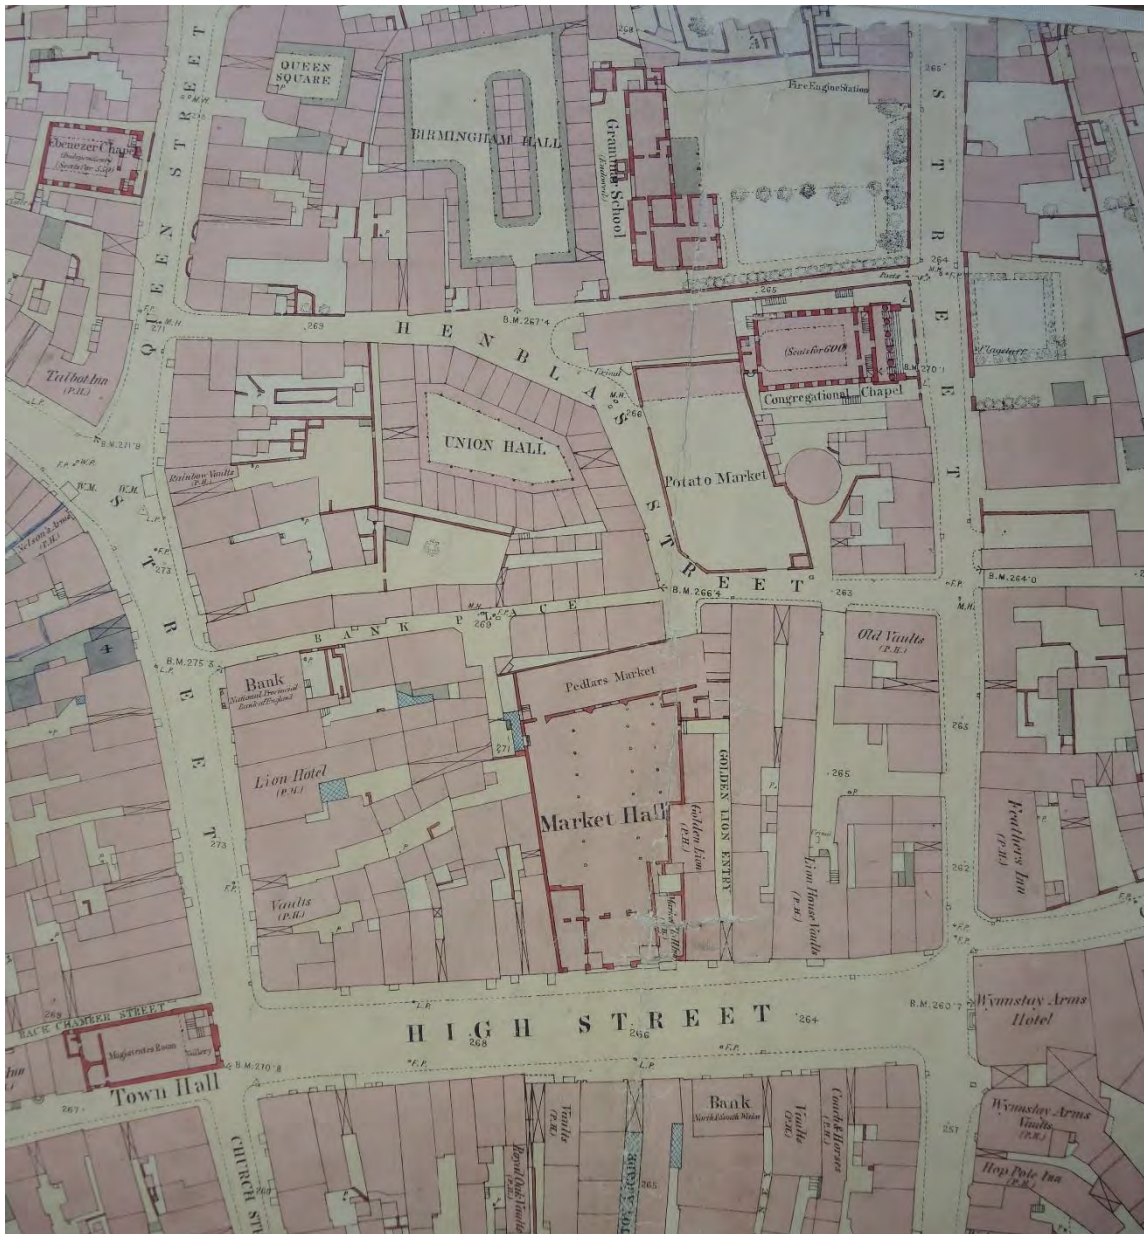
Figure 7 - Image of The Street Atlas of Wrexham 1872, prior to the construction of the General Market and when described as The Potato Market. Note also the location of the Cockpit to the east the Congregational Chapel to the NE, and The Music Hall immediately to the north  
© Wrexham Museum and Archive

The Street Atlas of Wrexham 1872, (prior to the construction of The General Market or The Butter Market as it was originally known in 1879) has the land described as The Potato Market. The Congregational Chapel on Chester Street has been constructed and the Cockpit is also clearly visible. The Guildhall/Music Hall takes up the site on the north side of the General Market site.

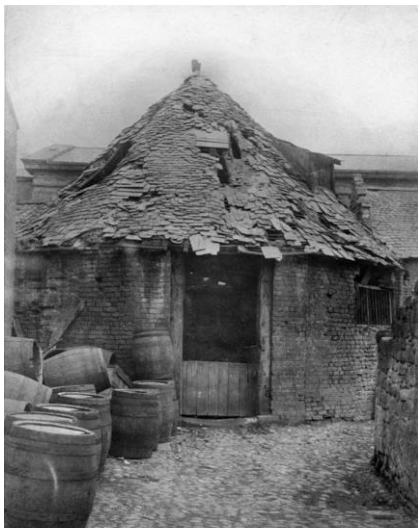
Figure 8 - The Cockpit when derelict in 1883 (demolished 1884) © RCAHMW

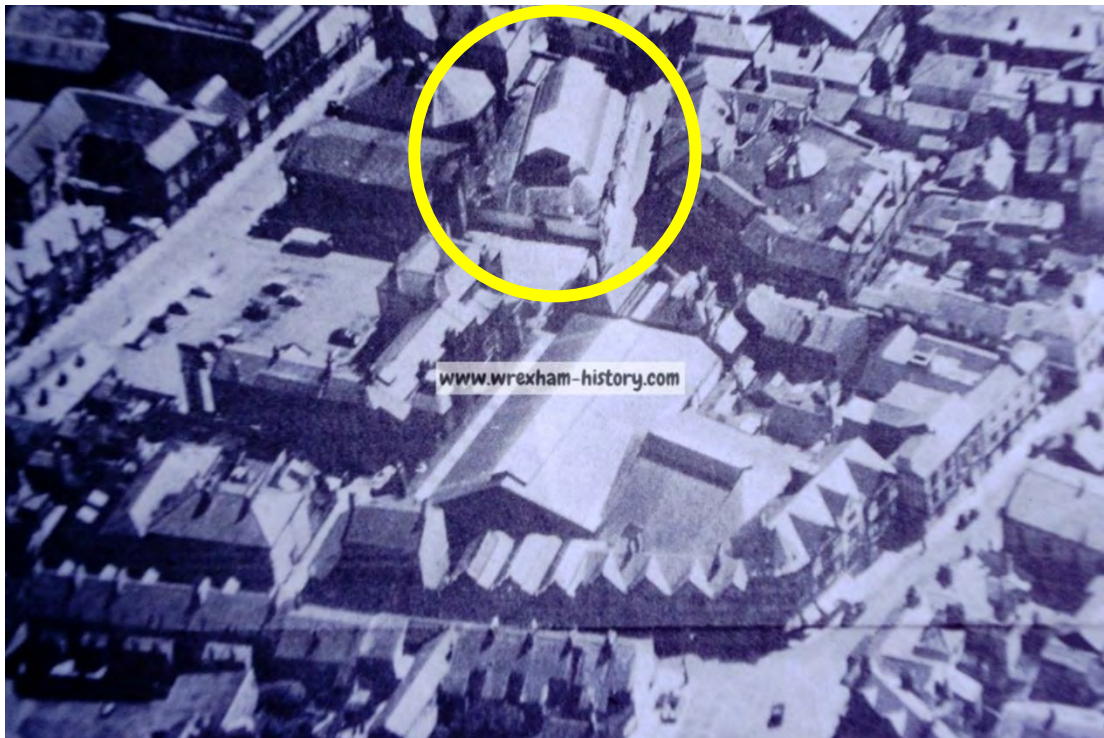
Figure 11 - Image of The General Market prior to the demolition of the Congregational Chapel in 1960  
© Image from [www.Wrexham-History.com](http://www.Wrexham-History.com)

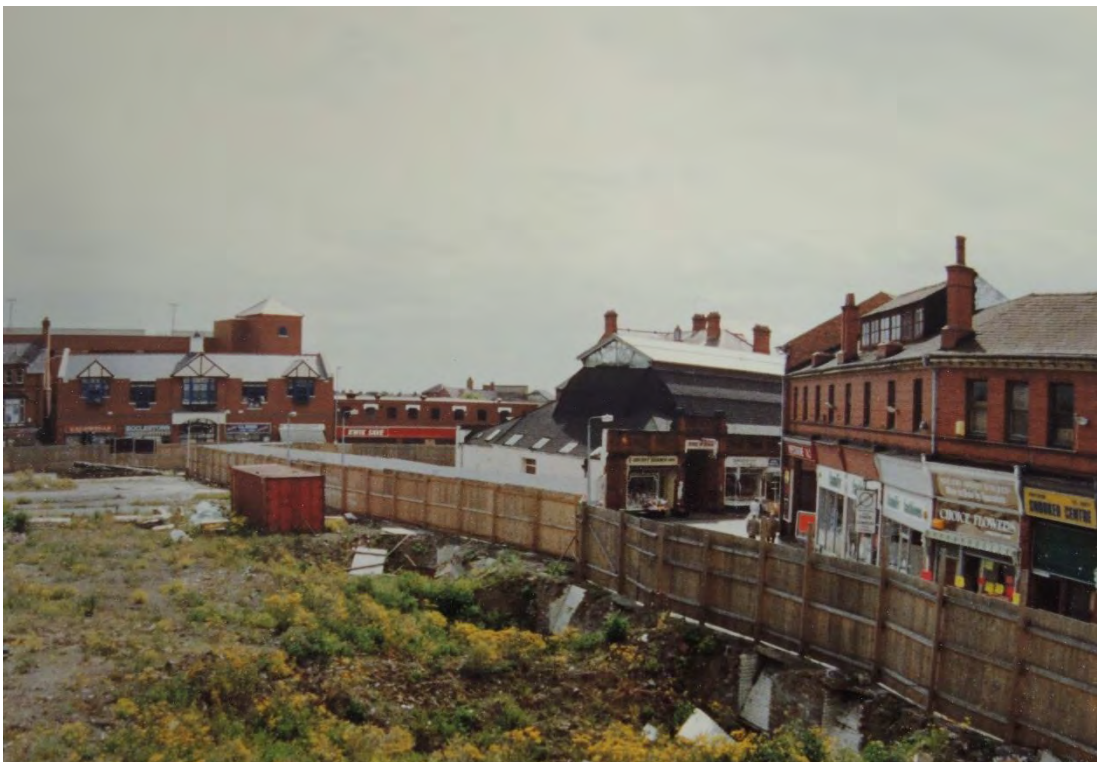
Figure 5 - Image of The General Market following the demolition of The Vegetable Market Site (note also the 'Turnerised' roof coating)  
© Image from The Wrexham Museum Archive

More recently, images taken following the demolition of buildings that included The Vegetable Market, illustrate that the roof covering had been 'Turnerised' a reinforced, bitumen coating used to extend the service life of the covering (though few slates could be later salvaged and reused as a result of this application). It is assumed that these works occurred during the mid-1970's at the same time as works were taking place to the adjacent Butcher's Market. It is also noted that the north wall had been decorated with a white paint or limewash at this time. It is noted that a flat roofed boiler room / plant room extension has been constructed on the east wall of the building since these photographs were taken during the early 1990's.

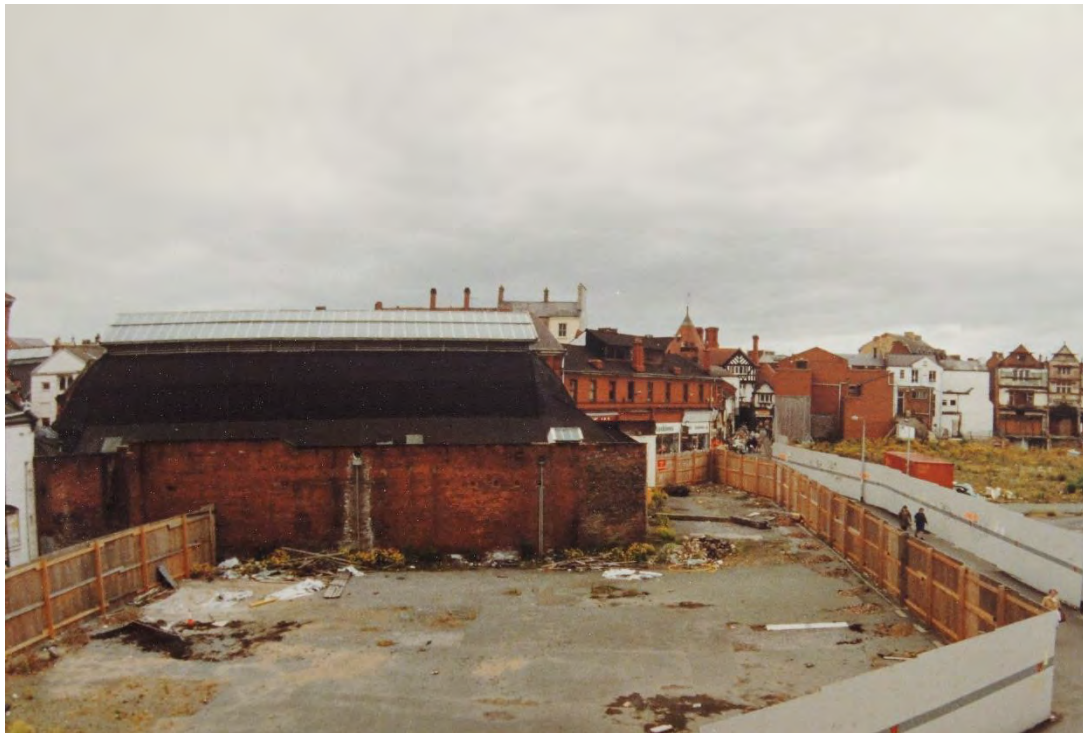
*Figure 14 - Photograph taken following the demolition of The Vegetable Market Site of the east elevation to The General Market (note the 'Turnerised' roof coating and east wall details minus the current boiler room  
© Image from The Wrexham Museum Archive*

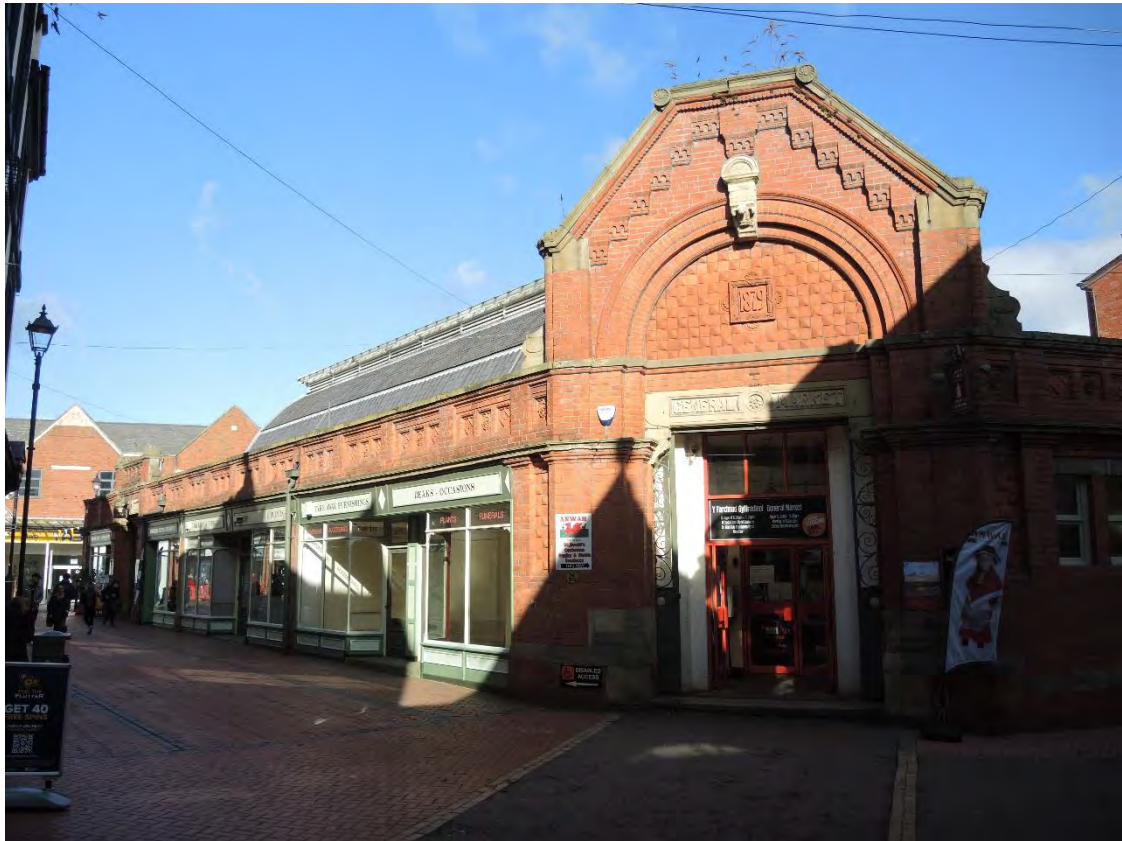
*Figure 15 - Photograph of the entrance at the SW corner and of the west facing elevation*

The south and west facing elevations to Henblas Street have been constructed of various pressed brick and terracotta components, interspersed with banding courses, lintels, corbels and copings of carved Cefn sandstone. The exact supplier of the bricks and terracotta details is not currently known, but is assumed to be from Tref y Nant, Pen y Bont or works in the Ruabon or Rhosllenerchrugog areas (further research or investigation is necessary but could easily be done with an inspection of any manufacturer or letter/initial stamps). The raised lettering to the wording above the SW facing entrance is in an Art Nouveau and is very similar to that used by the works of J C Edwards on various projects e.g. to the remains of the boundary wall at their offices in Trevor.

The composition and coordination of the brickwork and terracotta detailing of the tympanum and segmental arch above the SW facing entrance is of considerable value as is the brickwork detailing above the shopfronts at the parapet and to the elevation that contains the public conveniences, its door and window/porthole openings and pilaster details. The dressed sandstone in key locations further coordinates and unifies the overall composition.

The extent of the retention of original materials and details to the shop units that line the west facing elevation along Henblas Street is not known, though they do hold character that makes a positive contribution to the aesthetic values and the presentation of the building to the street.

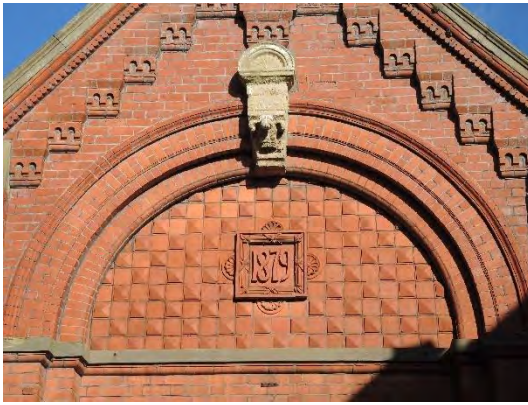
Figure 16 - Note the style of letting to the Typanum

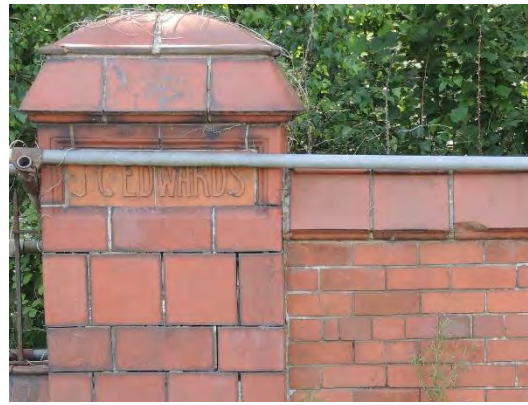
Figure 6 - Letting on the gate posts to the former J C Edwards company offices in Trevor

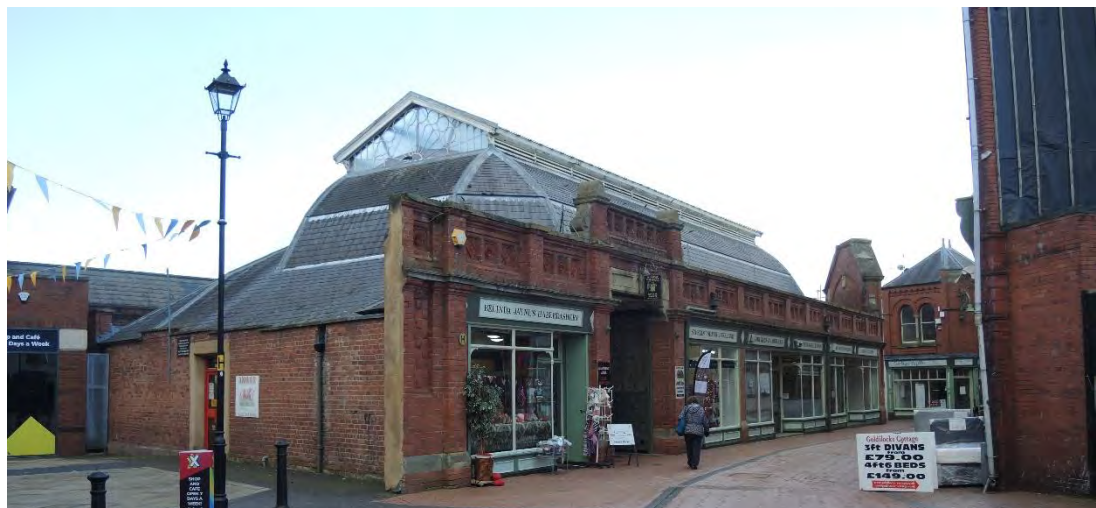
Figure 18 - Photograph of the north and west facing elevations to Henblas Street and Henblas Square

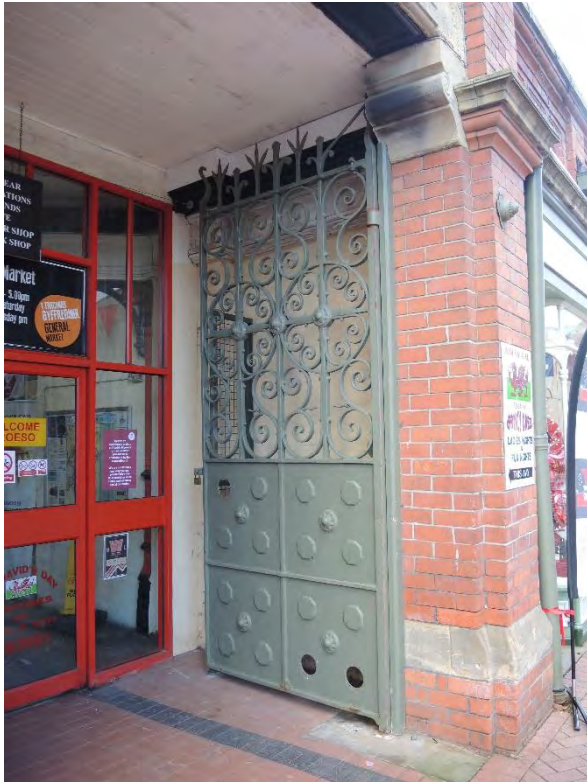
*Existing Gates to the NW entrance on the West Elevation*

The pair metal sliding at the SW entrance and a hinged version of the same at the north end to the west facing elevation is of considerable value. Many of the original components and adjacent reveal details are original and of heritage value.

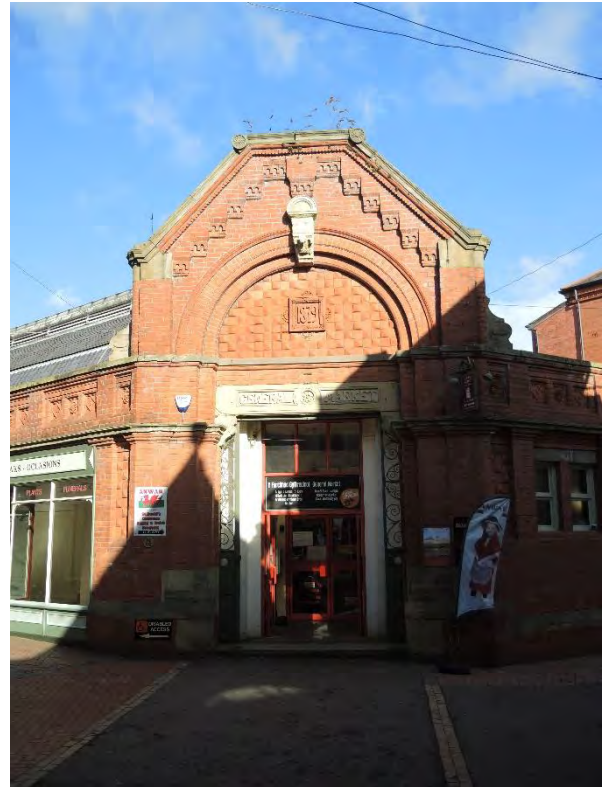
*Existing entrance to the SW facing elevation*

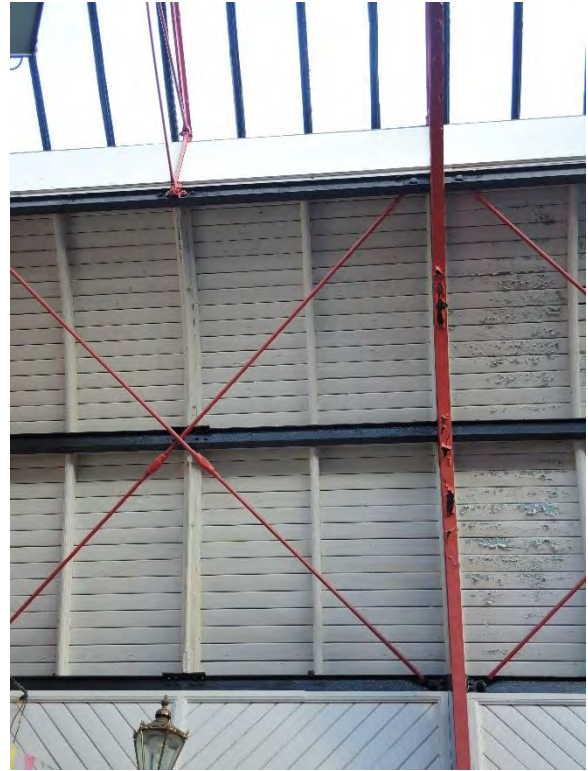
*Existing roof structure*

The glazed cast iron panels (assumption) to each gable and the elegantly formed trusses, purlins, beams and cross-braced rods that frame/form the upstand that carries the blanked off zone of louvered panels and which carries the central rooflight structure is a very rational configuration of plated struts and tie rods. Much of the roof structure appears to be original, with only some panes of glass to the rooflight having been replaced during the intervening period. Details about the sections and profile of the glazing bars to the roof glazing is not currently understood and would require further investigation at a later date.

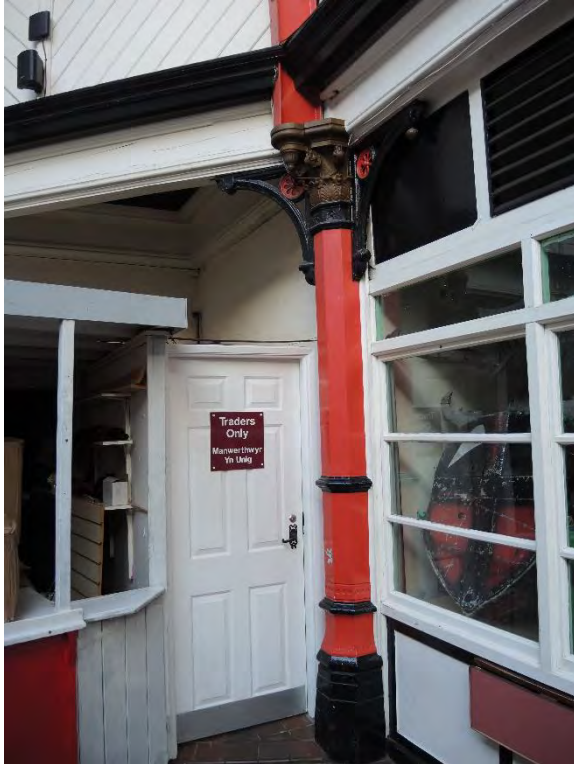
*Existing Octagonal Cast Iron Column detail with brackets*

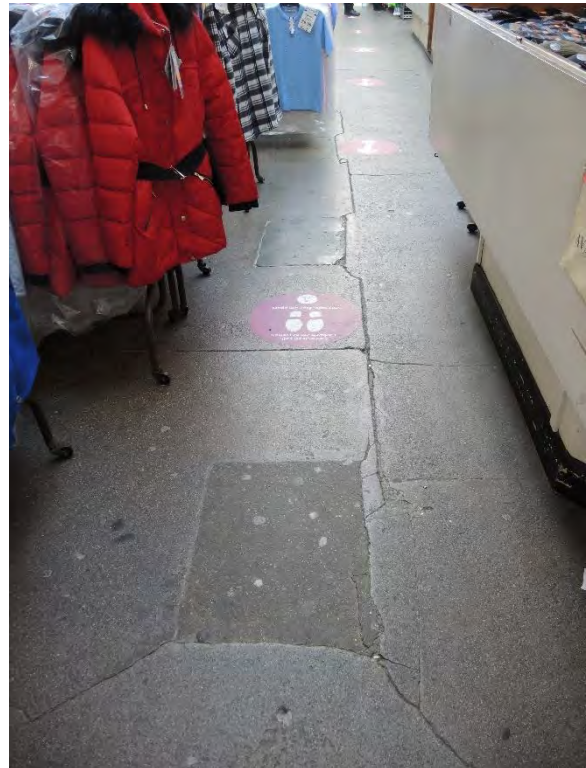
*Location of previous column bases within the concrete floor*

Whilst the details of sources vary, it is understood that The General Market was used as a dining hall by the American Medical Corp during WWII. It is understood that the market hall closed in 1943 and re-opened in 1949 with room for 15 premises. It is also suggested that the building was used by the War Office as a food and equipment store, but it can not be determined as to whether this might have been The Vegetable Market building to the north of this location. It is also unclear as to whether a mezzanine floor was introduced during this period, or whether an additional floor was introduced during an earlier time. Similarly, the date of its removal is currently unclear, though evidence of column base fixing positions remain clearly visible in the current floor finishes.
