# MULBERRY HOUSE, BURTON:

## BAT AND NESTING BIRD SURVEY

Report Ref: EE.1006.22.JK

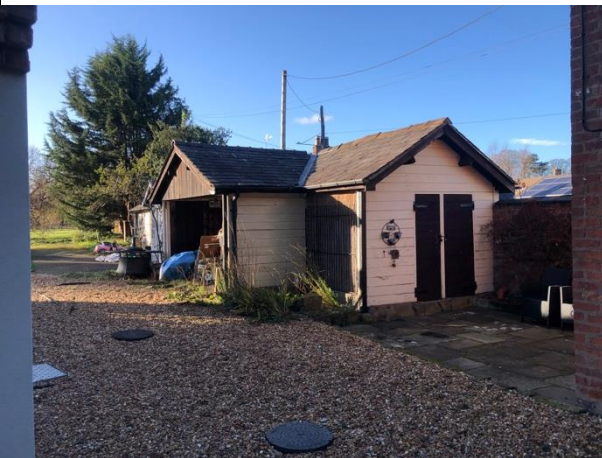
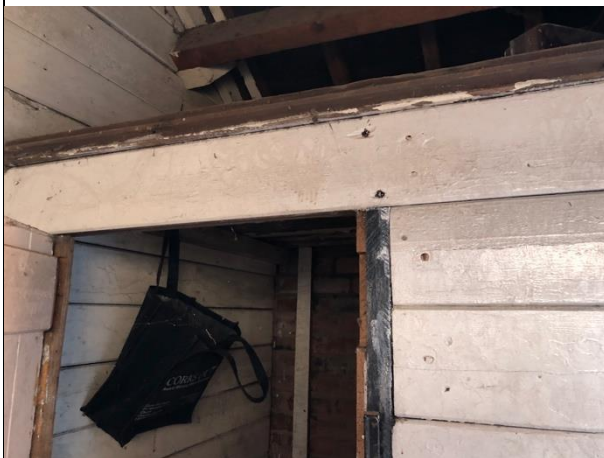
| External Description | External Photo | Internal Description | Internal Photo |
|---|---|---|---|
| Section 1 on the northern elevation was of a timber construction with a slate roof. The eastern wall was open and screened with a bamboo panel. | <br><b>NORTH ELEVATION OF OUTBUILDING</b> | The interior of Section 1 contained a timber structure to the rear that had an open mezzanine floor above. | <br><b>MEZZANINE FLOOR IN SECTION 1</b> |

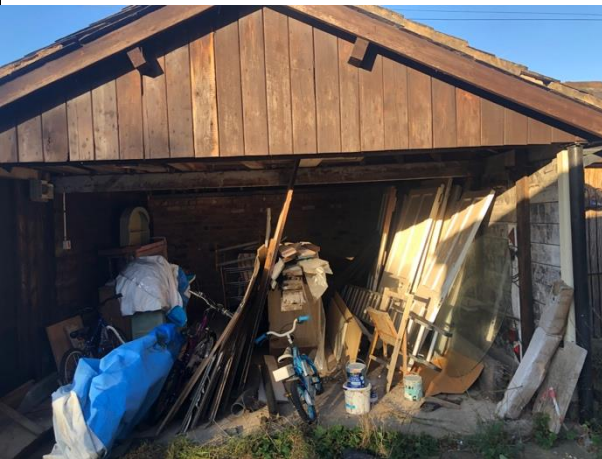
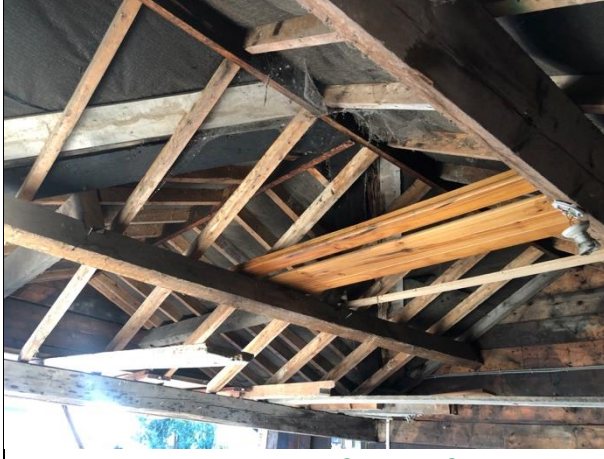
| External Description | External Photo | Internal Description | Internal Photo |
|---|---|---|---|
| The adjoining Section 2 was again timber framed and was being used for storage. It had a large open doorway. | <br><b>OPEN FRONTED SECTION 2</b> | Both these sections were open to the roof rafters with a bitumen lining under the slate tiles. | <br><b>ROOF SPACE IN SECTION 2</b> |

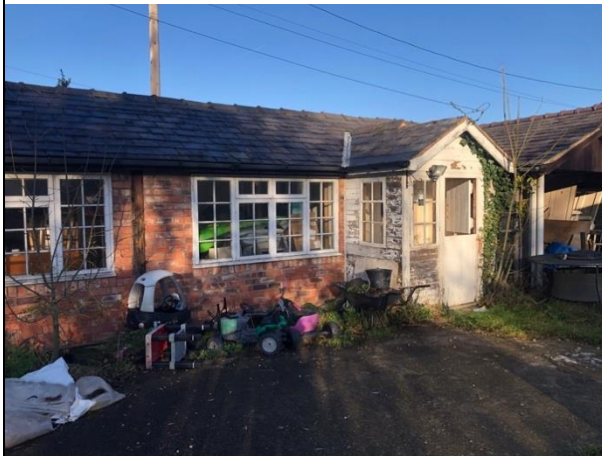
**SECTION 3 OF OUTBUILDING**

Section 3 was of a brick-built construction, with a wooden porch and a slate roof. The front and the porch were glazed.

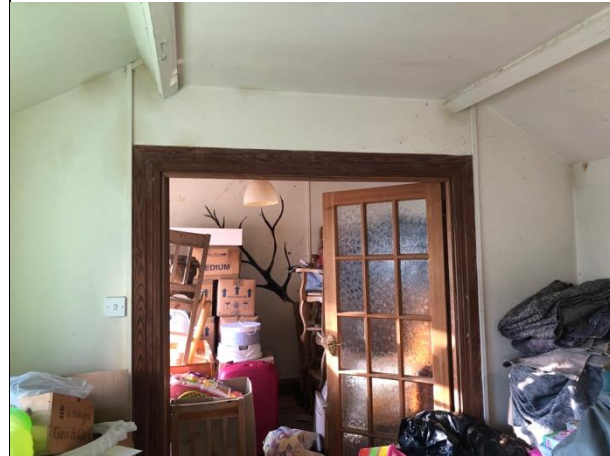
**SECTION 3 INTERIOR WITH VAULTED CEILING**

Section 3 had a vaulted ceiling with no loft space. The interior here was plastered, painted and well-sealed.

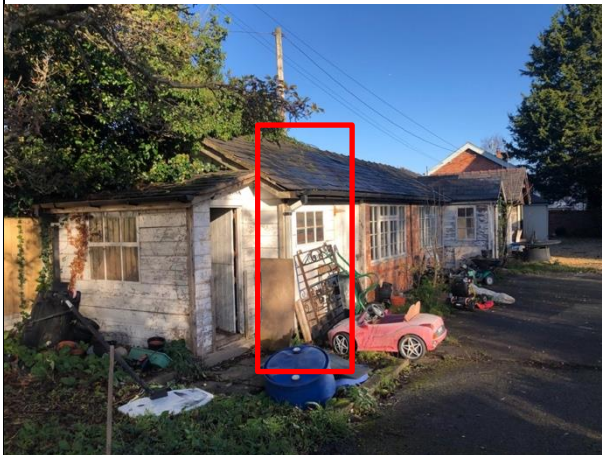
**BUILDING FROM SOUTH LOOKING NORTH –  
SECTION 4 IN RED**

Section 4 - Adjoining the brick-built section was a further timber fronted room with a single door and one glazed window.

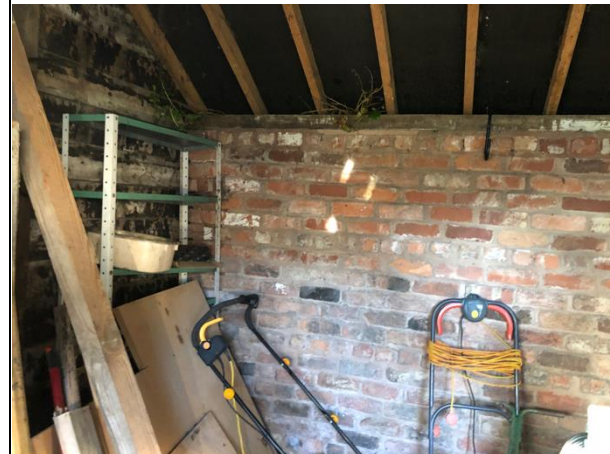
**INTERIOR OF ROOM SECTION 4**

The interior of Section 4 had a brick rear wall with the rest being timber. As in most of the building, there were openings to the exterior where the roof rafters sat on top of the walls.

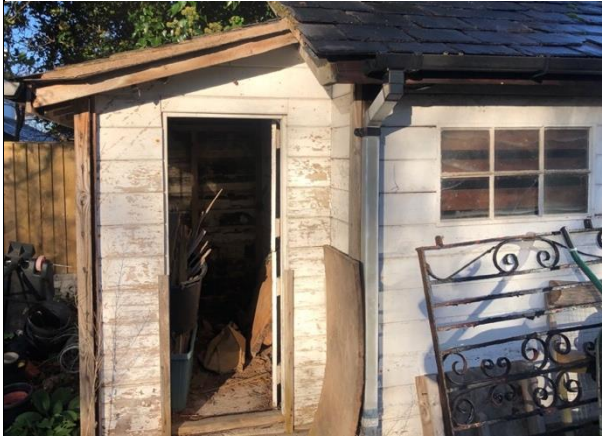
SECTION 5 EXTERIOR

Section 5 was a timber lean to with a mono-pitched slate roof. There was an open door on the front and a window to the side (end) of the building.

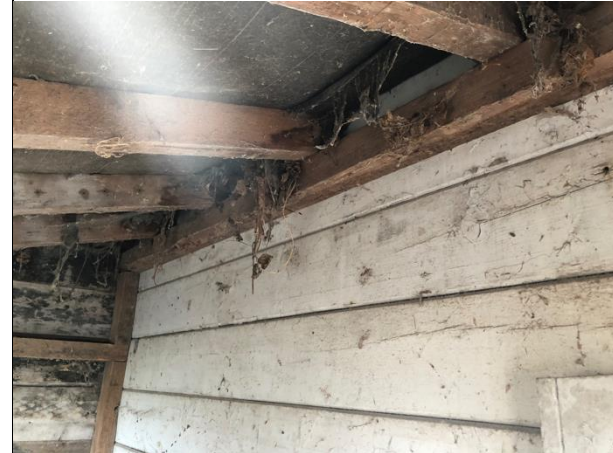
SECTION 5 INTERIOR

The bitumen lining in the lean to was hanging down in many areas.

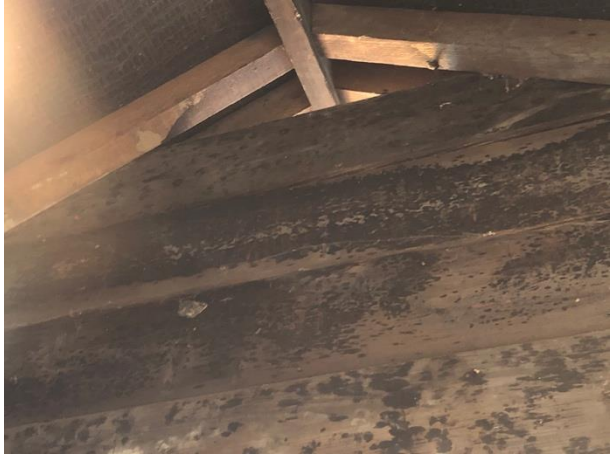
| Location | Description | Example photos |
|---|---|---|
| <p><b>Section 1</b></p> <p><b>The gable end to the northern elevation</b></p> | <p>Large gap at the top</p> | |

- 5.3.2 The access point above the gable end on Section 1 provided access into the buildings and it was here that most of the droppings were found, characteristic of pipistrelle in shape and size, as well as location being piled under the access point.

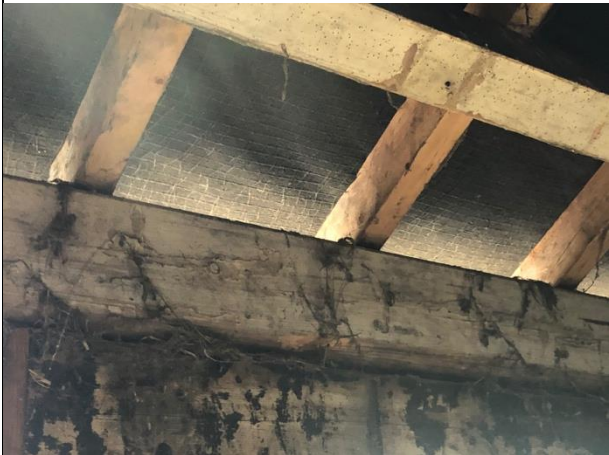
| Location | Description | Example photos |
|---|---|---|
| <p><b>Section 1,2,4 and 5</b></p> <p><b>To most elevations</b></p> | <p>Gaps between walls and the roof rafters</p> | |

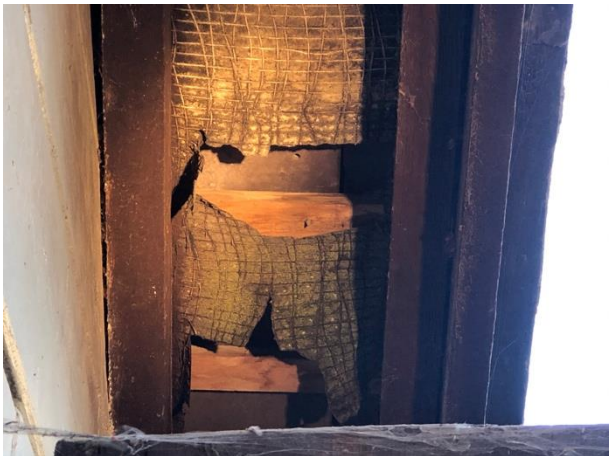
- 4.2.2 There were many potential roosting features (PRF's) for crevice dwelling bats. The bitumen lining of the roof was visible in most of the building and was in poor condition with gaps/tears both inside the buildings and on the exterior above the top of the walls. A dead mouse and mouse droppings were found in Section 3. The gaps present along the tops of walls under the roof rafters, allowed access to bats and birds into the majority of the building. Some of the ridge tiles were missing and there were gaps under others. The mortar under the slates was missing in a number of places.

| Location | Description | Example photos |
|---|---|---|
| <p><b>All Sections</b></p> <p><b>Throughout the building both externally and internally</b></p> | <p>Tears to the roof lining</p> | |

- Should the replacement roof be lined with felt, it should be lined with non-breathable Bitumen 1F felt where possible. Breathable membranes can be fatal to bats when they get caught in the fibres and cannot escape. Further roof coverings such as vaulted ceilings or wooden cladding across the tiles are acceptable. If it is absolutely necessary to use a breathable membrane then the roof of the entire building needs to be completely sealed off from the bats.

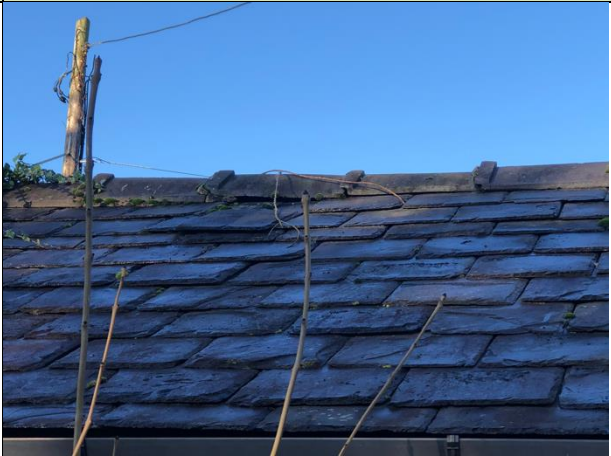
| Location | Description | Example photos |
|---|---|---|
| <b>Section 3</b><br><br><b>On roof above vaulted ceiling</b> | Raised roof and ridge tiles | |

- The removal of the all the roof structure including ridge tiles, slates, and fascia’s; must be undertaken by hand and supervised (where areas cannot be inspected beforehand) by a licensed ecologist who is named on and authorised to act under the specific licence granted by NRW for this works. Areas that can be inspected, such as the holes in the walls and behind fascia’s, will be looked at with a torch and/or endoscope prior to works commencing by the licenced ecologist. If a bat is found and accessible it should be captured and placed in an appropriate bat box that will be made available onsite prior to works commencing (which will contribute to one of the proposed mitigation bat roosts – (see 6.1.4). If a bat is found and is not accessible works will start from the furthest point from the bat and continue in a directional manner to encourage the bat to leave of its own accord. If a hibernating bat is found, it will be captured and moved to a bat box suitable for hibernation.

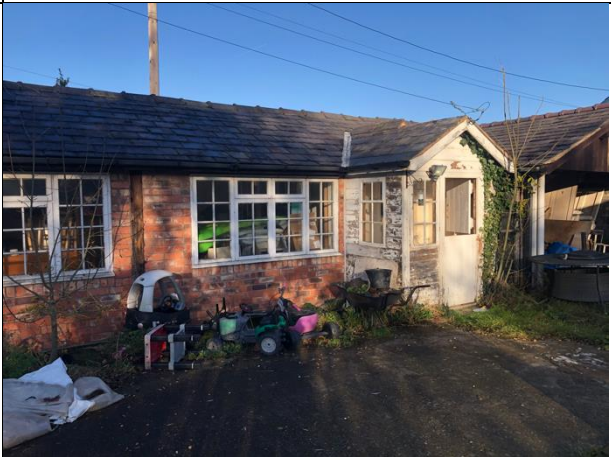
| Location | Description | Example photos |
|---|---|---|
| <b>Section 3</b><br><br><b>Above Porch</b> | Missing ridge tiles | |

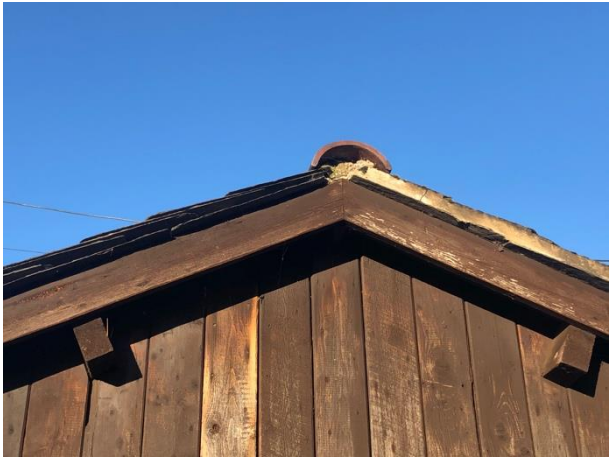
| <p><b>Section 2</b></p> <p><b>On gable ends</b></p> | <p>Mortar was missing under roof and ridge tiles</p> | |

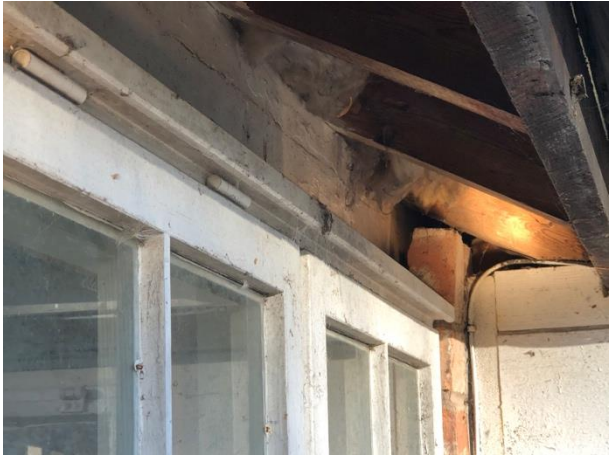
| <p><b>Section 3</b></p> <p><b>To sides of porch</b></p> | <p>Gaps between roof and wall bricks</p> | |

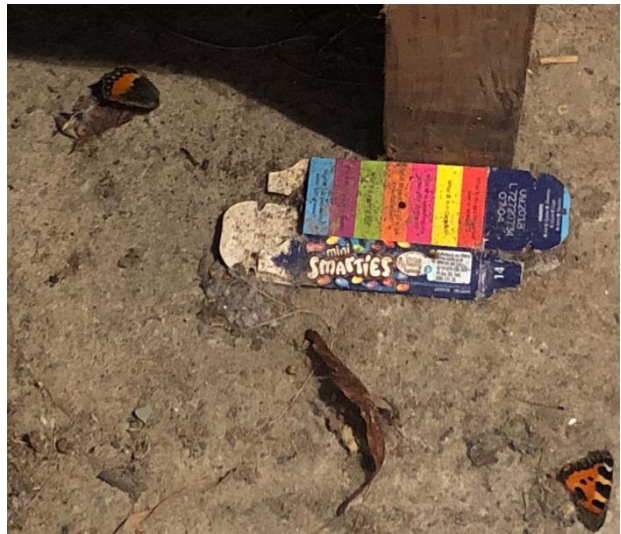
| <p><b>Sections 2 and 4</b></p> <p><b>Open timber structure to the north elevation and enclosed one to the south</b></p> | <p>Feeding remains (butterfly wings)</p> | |

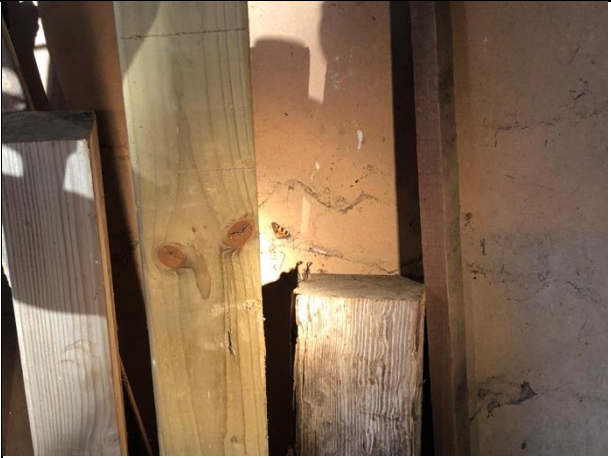
| <b>Section 4</b><br><br><b>Timber section to the south elevation</b> | Evidence of feeding remains (butterfly wings) suspended in cobwebs | |

- 5.3.3 Feeding remains in the form of butterfly wings, which can be characteristic of BLE or birds, were found in cobwebs in Section 5 of the building where there was access under the roof rafters. This section also had high light and airflow levels due to the glazing and the gaps under the rafters. Scattered individual bat droppings (characteristic of BLE) and feeding remains were also found in Section 2 of the building.

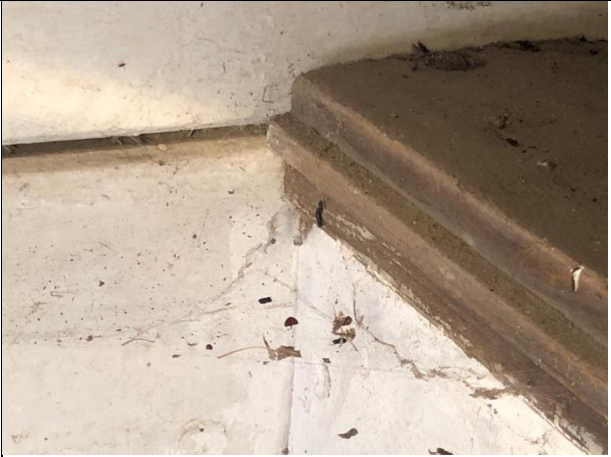
| <b>Section 1</b><br><br><b>Mezzanine floor in the northern elevation</b> | Bat droppings | |

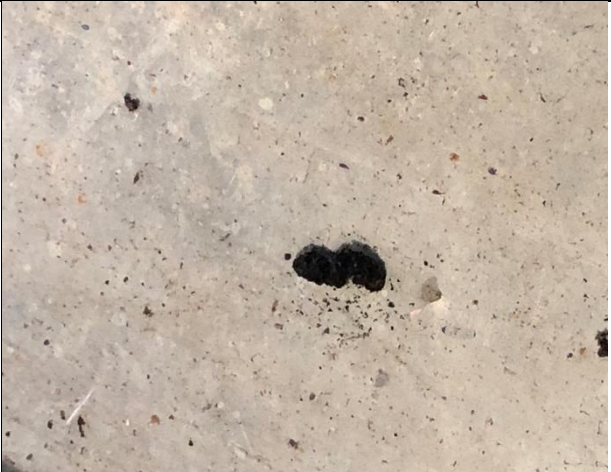
| <b>Section 2</b><br><br><b>Open section of the building</b> | Bat droppings | |

- 4.6.1 A sample of the bat droppings found in Section 2 (characteristic of BLE) was sent off for DNA analysis, but the results were inconclusive; this could be a result of degradation due to either age or is often found when droppings are exposed to sunlight/ heat. The bat droppings characteristic of *Pipistrelle* were not sent off for analysis as it is considered the emergence survey results confirm the species identification.

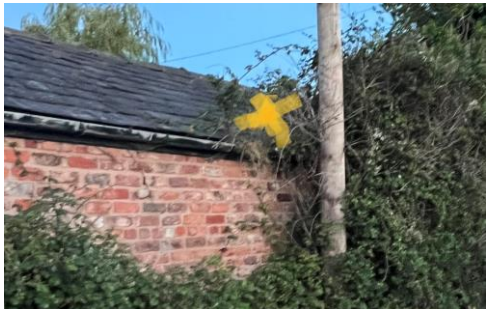
| Time | Species | Activity | Emerge? | Location |
|---|---|---|---|---|
| 22:07<br>– First bat | Soprano Pipistrelle (S.pip) | Emergence | Yes | From Section 4 of building, recorded on detector to southwest only<br><br> |

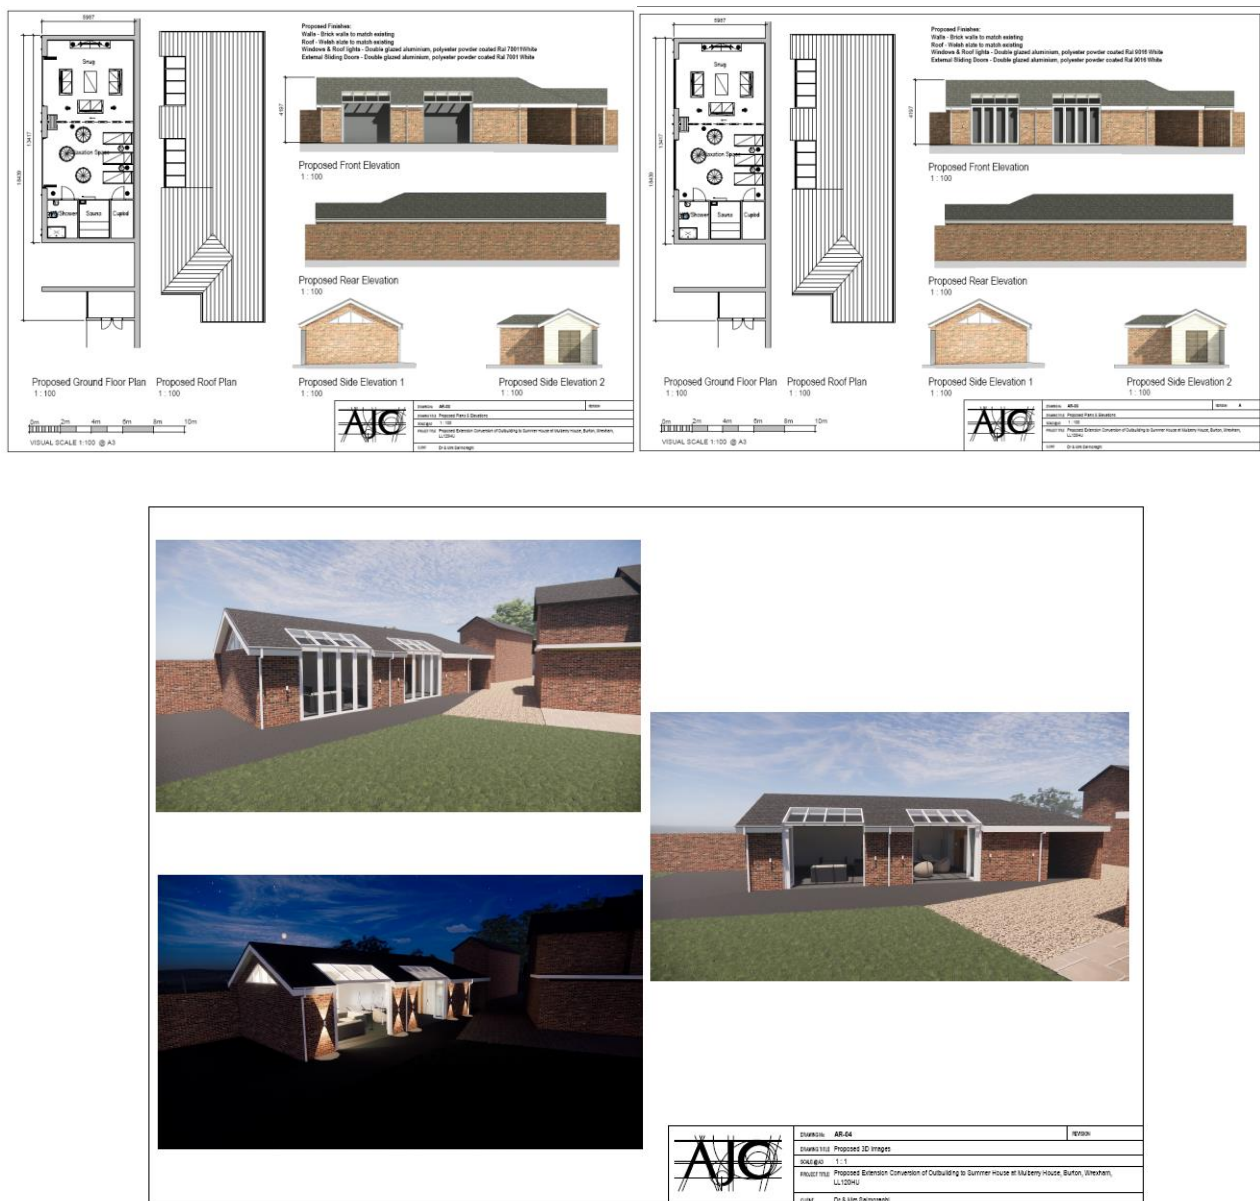
**FIGURE 5.1A – C: PROPOSED PLANS AND 3D IMAGES ©AJC**

5.1.1 The proposed works to convert the outbuildings into residential can be seen in figure 5.1a-c below including an extension and remodelling of the outbuildings. The roof in its entirety will be replaced. The current hardstanding used as a patio will be replaced with an alternative patio.

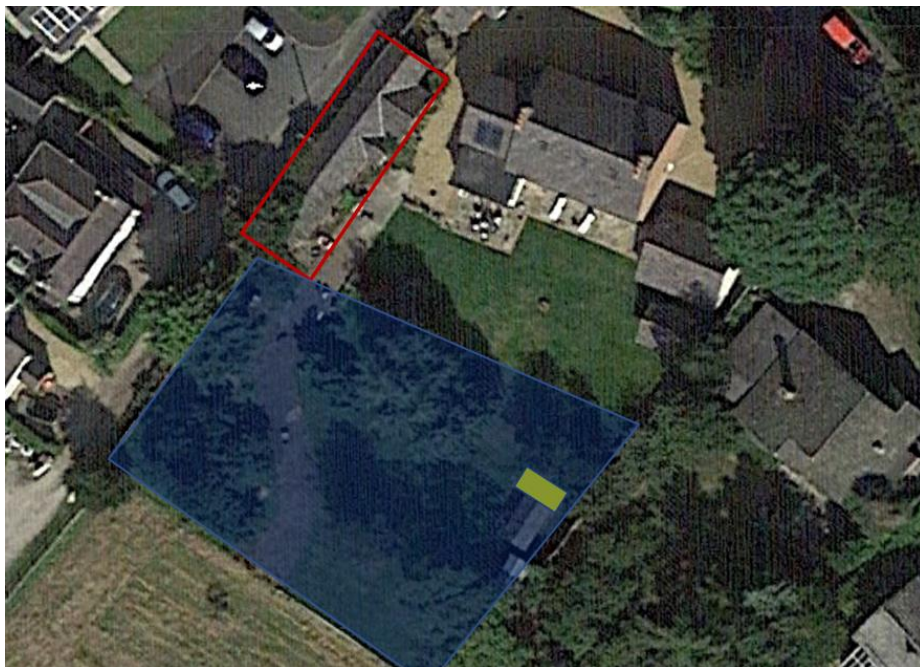
**FIGURE 6.2 – LOCATION OF MITIGATION BAT ROOST (YELLOW) IN RELATION TO BUILDING FOR WORKS (RED) AND PROPOSED DARK BUFFER ZONE (BLUE).**

- There must be no lights focused on the trees to the south of the site during or after the works. There will be no illumination of the recommended bat mitigation and bird boxes (see below) once the works are complete. There should be dark buffer zone across the southern section of the garden where the designated bat area will be created (Figure 6.2).

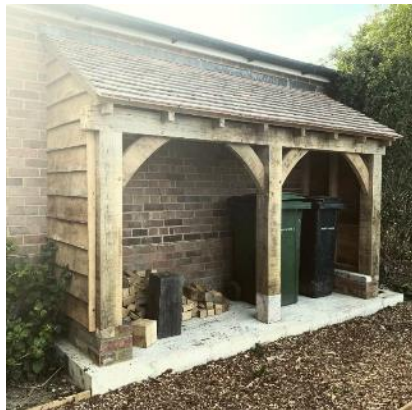
**FIGURE 6.3 – EXAMPLE OF A SINGLE PITCH STORE WITH SPECIALLY CONSTRUCTED ROOF FOR SWALLOWS**

- 6.2.7 In addition, at least two swallow nest cups must be fitted within the swallow loft. These should be attached to purlins or each gable end with at least 6cm between the top of the nest and the ceiling. Examples are available online from several suppliers, and suitable models include the eco swallow nest.

- 6.2.8 There should be rough sawn beams attached to the underside of the ceiling so bats can also use the store as a night roost.
