# PLAS MOSTYN BACH, MINERA:

## CONSERVATION PLAN

Report Ref EE.1013.22.KW

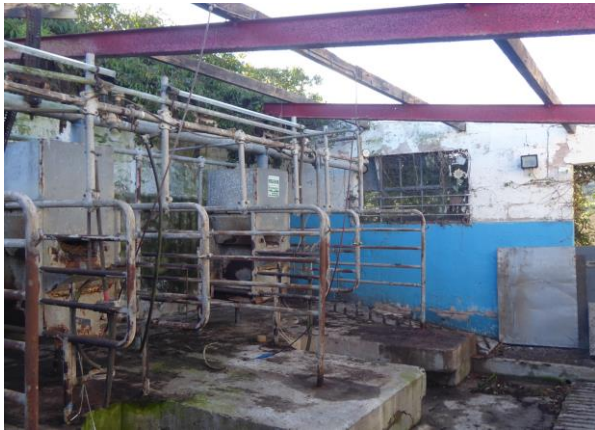
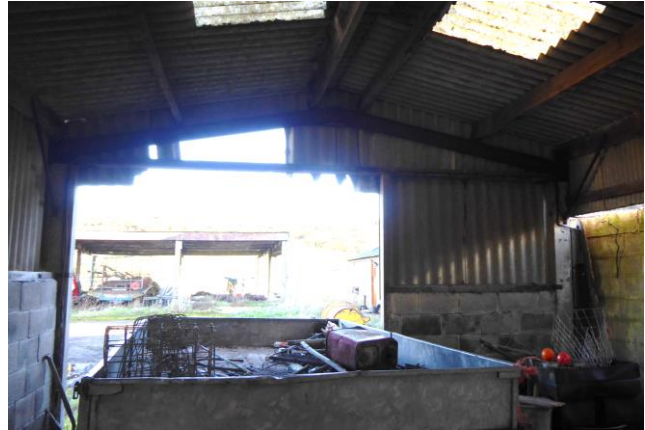
- 2.2.3 The adjoining milking parlour and the adjacent tin shed were not considered suitable for bats. There was no roof on the milking parlour and only well sealed walls remained; the tin shed was open at the gable ends with well-sealed breezeblock and corrugated metal walls and roof. There were no available features for crevice dwellings bats to roost within and the tin shed was considered unsuitable for free hanging bats to use as a day or night roost as it

was extremely exposed to light, airflow and temperature changes. There was no evidence of bats found anywhere within either of these buildings. As these buildings were considered negligible for bats, no further surveys on either of these buildings are required.

*PHOTOS 2.1: A) THE MILKING PARLOUR; B) TIN SHED*

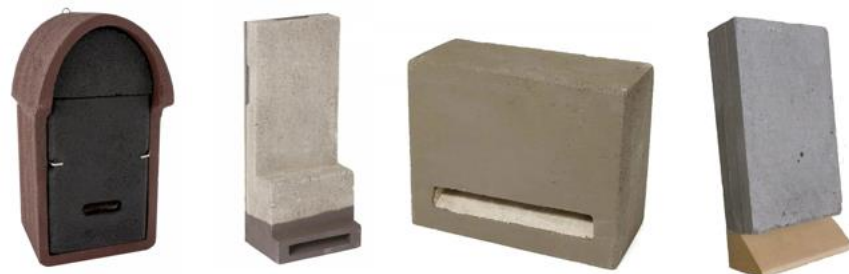
**FIGURE 3.2: A) EXAMPLE OF MULTI-CHAMBER EXTERNAL BAT BOX; B-D) EXAMPLES OF BUILT IN BAT BOXES**

- A woodstone/ woodcrete multi-chamber bat box will be erected onto a mature tree to the north of site, within the connecting hedgerow along the drive, prior to works commencing (Figure 3.1). It will be erected at least 2.5m above the ground and facing a southerly/ south westerly direction. The ecologist will agree the specific model of bat box and advise on the specific siting location (example shown in Figure 3.2).

- Two in-built bat boxes will be integrated into the converted barn as suggested in the previous bat survey report (Marches 2017); however, the location of these boxes will differ to what the previous report proposed (both on the northern elevation). One box will be installed on the northern elevation; on the main part of the building as opposed to the dormer extension so any potential future works to the extension will not impact the bat mitigation; and one on the south west corner of the southern elevation, to offer varying environments in terms of sun exposure, for different roosting requirements (See Figure 3.1 for locations). The boxes will be woodstone/ woodcrete so they are more durable and require less maintenance (Figure 3.2 for examples); as well as providing excellent insulation and consistent temperatures for roosting bats (including hibernating bats); they will be integrated into the tops of the walls as the building is extended upwards and will sit as close as possible to the eaves.

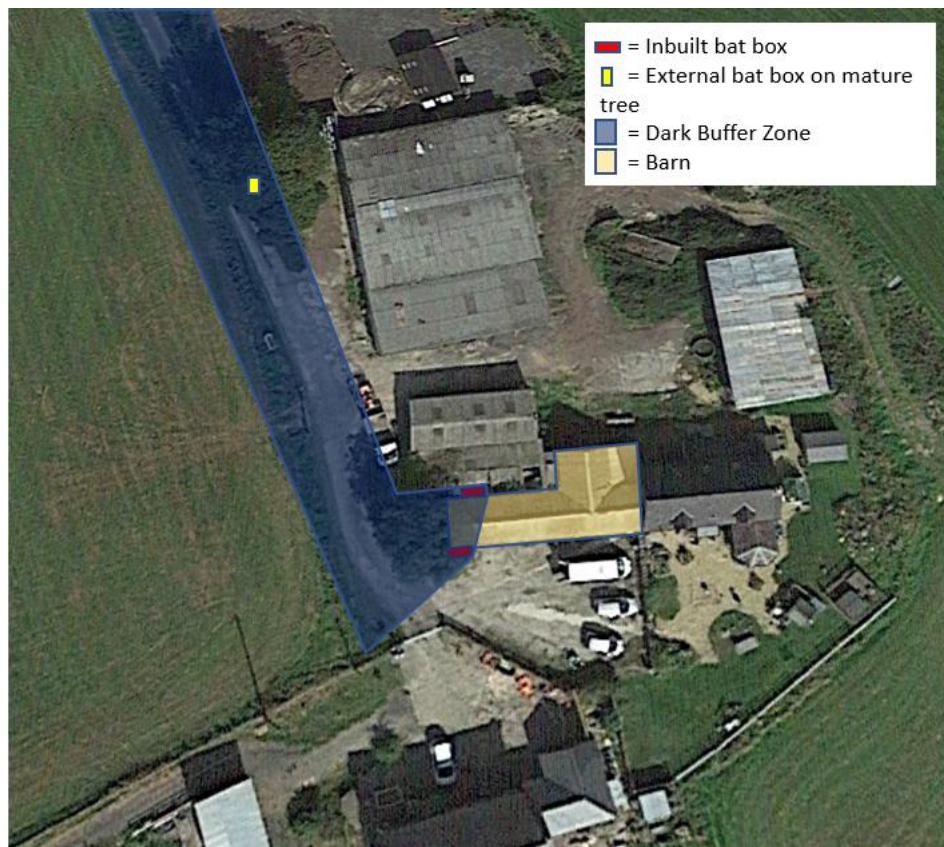
**FIGURE 3.3 – PROPOSED SITE PLAN SHOWING DARK BUFFER ZONE (BLUE) FROM THE MITIGATION ACCESS POINT AND THE SURROUNDING FORAGING HABITAT (NOT TO SCALE)**

- There must be no lights focused on the hedge-lined drive to the west or any of the surrounding mature trees, during or after the works. There will be a dark 'buffer zone' to the west of the site; which will include the proposed bat mitigation and connecting flight lines to it from the surrounding habitat; that will not be subject to light spillage (Figure 3.3). There will be no illumination of the recommended bat mitigation once the works are complete.
