Historic Building Recording at

# FORMER HSBC BANK CEFN MAWR

| Doc Ref: | LP4213C-HBR-v.1.3 |

A level 2 historic building survey (PRN213722) was carried out by L – P : Archaeology on behalf of Walter Bond Plc on 12<sup>th</sup> March 2022. The work was carried out in response to a condition of planning consent (P/2020/0266). The work was undertaken prior to the alterations of the structures, in order to make an appropriate record of the building, its fabric and development sequence.

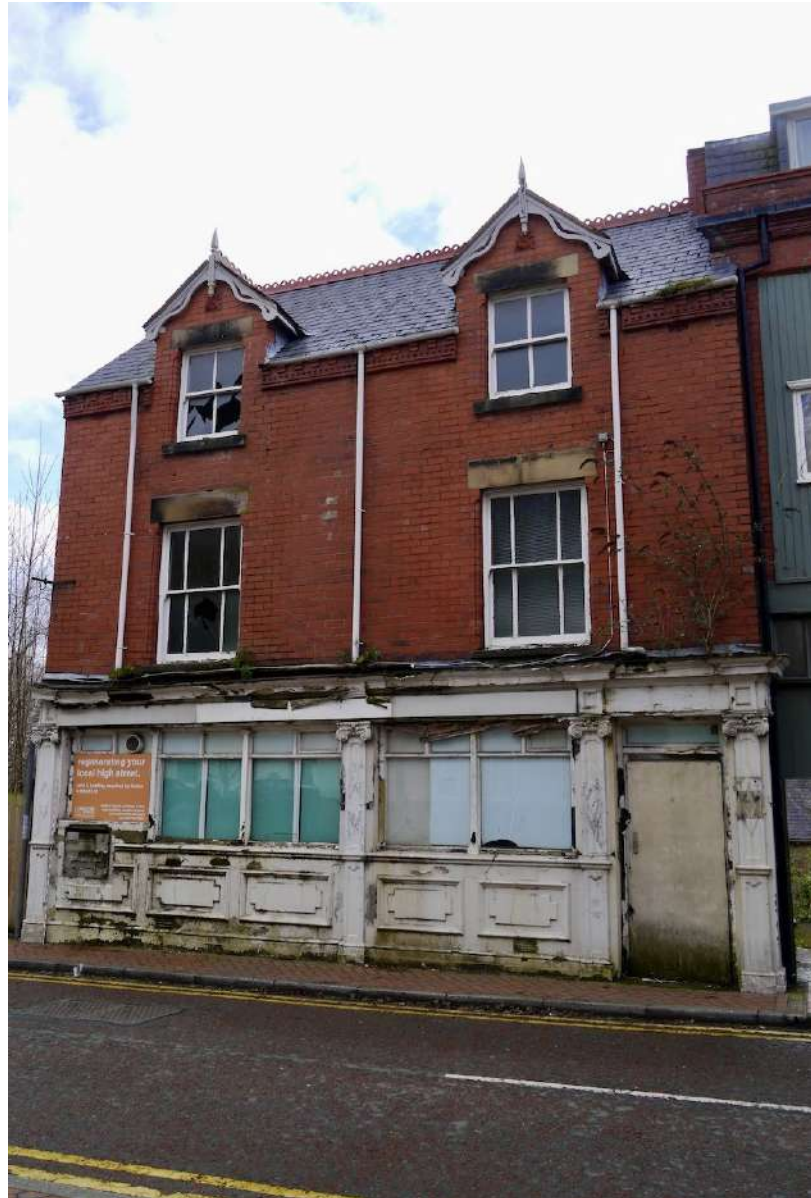
Plate 1 - Northwest elevation

6.3.2. The roof has a steep pitched, along a northeast-southwest aligned ridge, with Welsh slate tiles and series of red ceramic two hole crested ridge tiles. The facade is split into two main sections, with the ground floor presenting the wooden shopfront stall-riser element, and the first and second floors of red brick, likely locally sourced, in stretcher course bond. Below the wall plate is a string course of decorative terracotta tiles forming a cornice of alternate corbelling, with a circular motif forming a row below the corbels (PLATE 2).

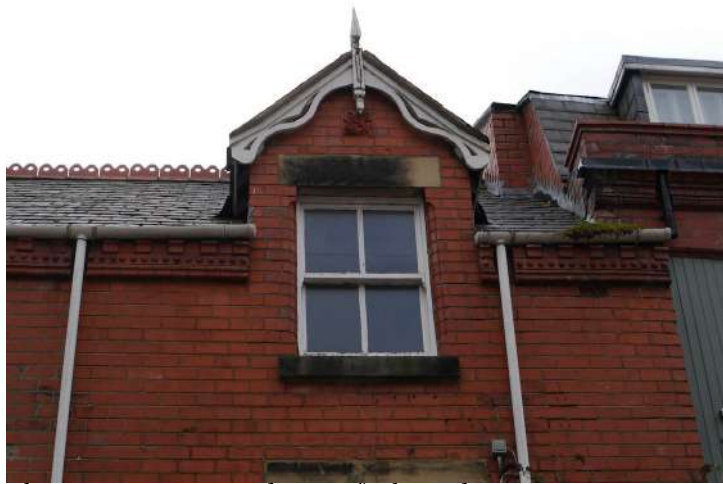
Plate 2 - Dormer window, roof tiles and terracotta cornice

6.3.3. The fenestration shows a simple and coherent form with plain stone sills and lintels, with chamfered brick edging, around the wooden sash windows (PLATE 2). The first floor contains two equally spaced six pane windows, with the second floor containing two equally spaced dormer windows of four panes (PLATE 3). The dormer windows have decorative barge boards and pointed finials. Located centrally to each dormer, above the window lintel, is a terracotta tile with oak leaf and acorn design (PLATE 2).

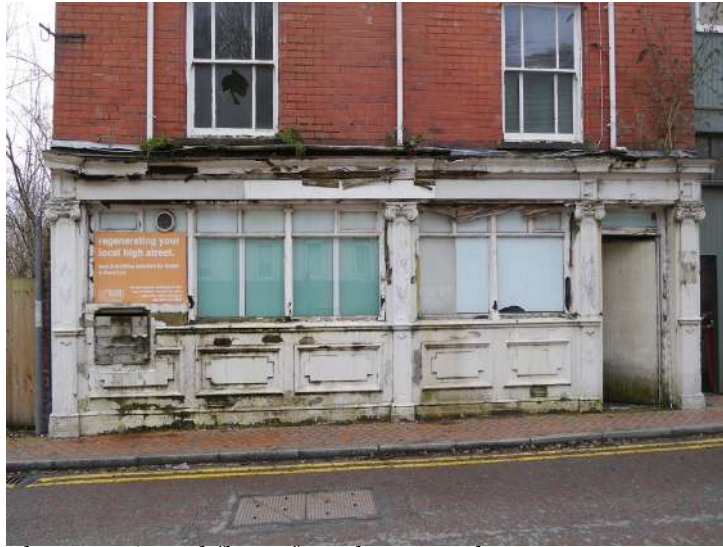
*Plate 4 - Ground floor of northwestern elevation*

6.3.4. A defunct iron sign bracket is located on the northern corner of the building, at first floor level (PLATE 4).

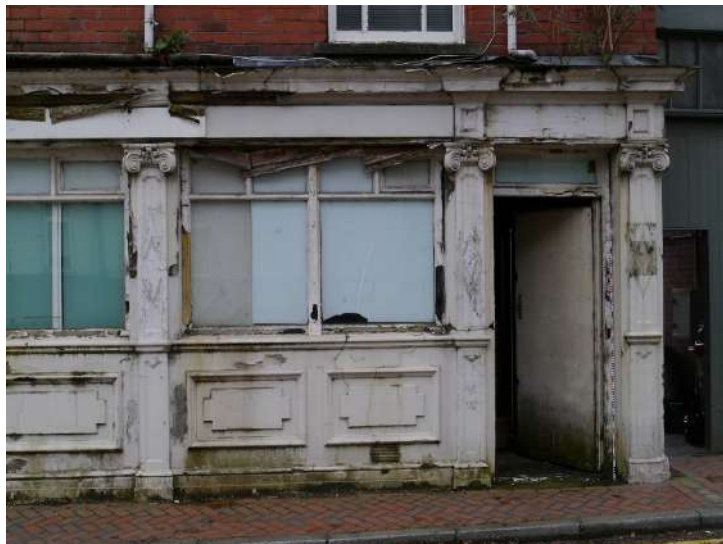
*Plate 5 - Southern end of northwestern elevation*

6.3.5. The ground floor facade is taken up by the decorative wooden stall-riser and windows. This formed an asymmetrical facade, with offset doorway on the southern end, with two unevenly spaced display sections of two bays and three bays respectively (PLATE 4). The doorway had been recently replaced with a security door, however, the rectangular transom light was still visible above (PLATE 5). Each stall rise section was divided by squared pilasters with Ionic style capitals and recess panels with mirrored chevron designs (PLATE 5). The cornice above the sections was chamfered, broken up by an extension of each pilaster capital.

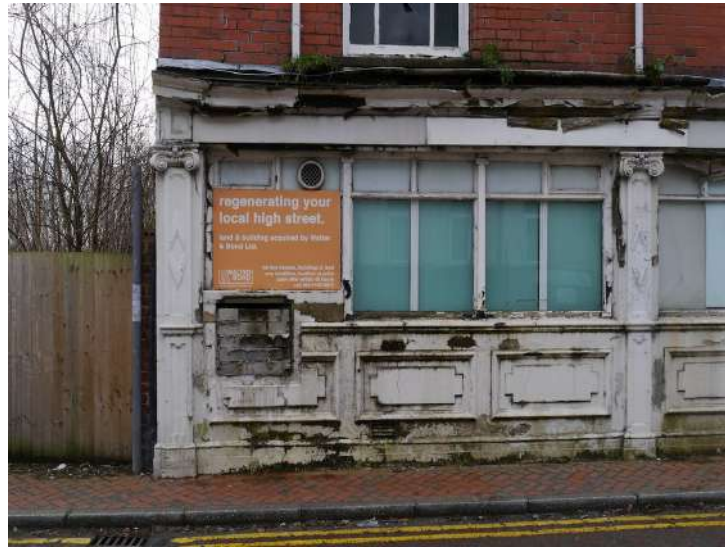
Plate 6 - Northern end of northwestern elevation

- 6.3.7. The northern end of the ground floor facade had been modified in the later 20<sup>th</sup> century for the insertion of an ATM (PLATE 6).

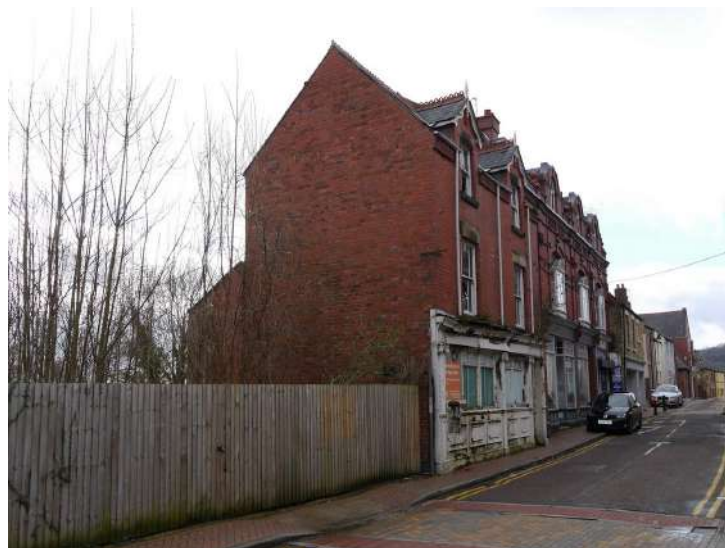
Plate 7 - Northeastern elevation

- 6.3.8. The northeastern elevation overlooked a vacant plot, where an earlier access had been to the rear of the structure. This was an undecorated gable wall of red brick, differing in finish from the northwestern facade, in that it was slightly less well fired and of lower aesthetic value (PLATE 7).

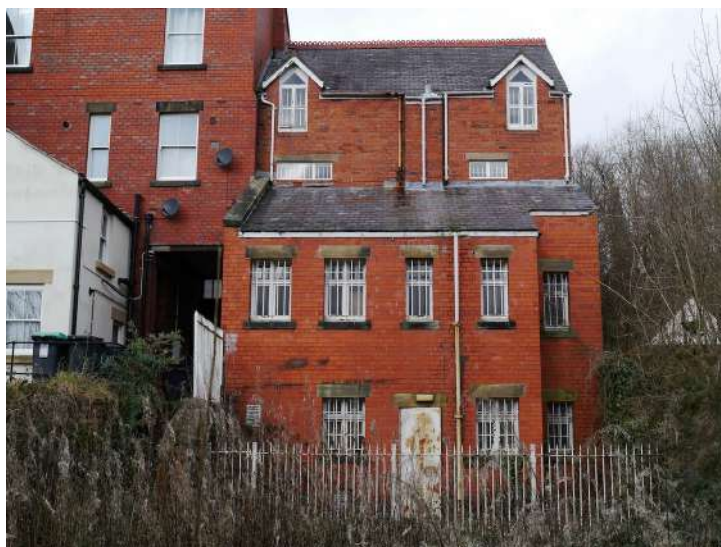
Plate 8 - Southeastern elevation

6.3.11. The southeast elevation overlooked the rear garden plot and represented the full structure height, with access to lower ground floor though to the second floor dormer windows (PLATE 8).

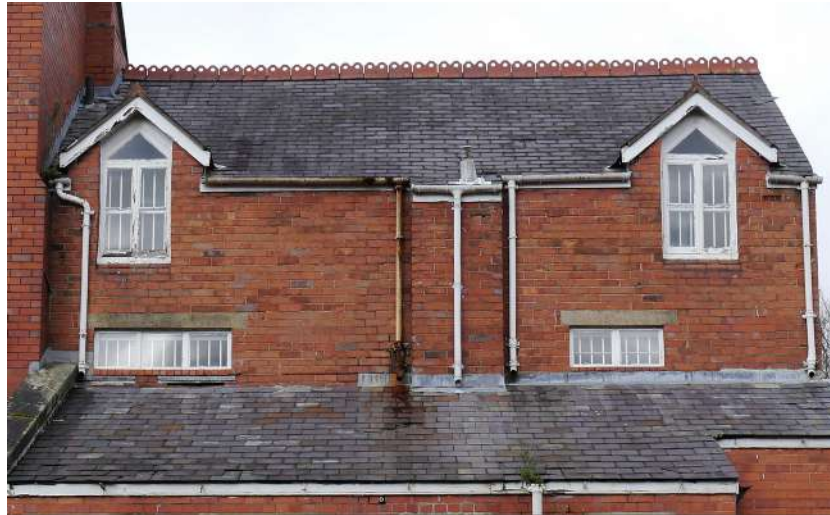
Plate 9 - Phase 1 southeastern elevation

6.3.12. The northwestern element was formed of phase 1 of the development sequence and was visible at the upper element of the first floor and second floor levels. This area continued the same brick material as the northeastern elevation, however, was of stretcher course bond.

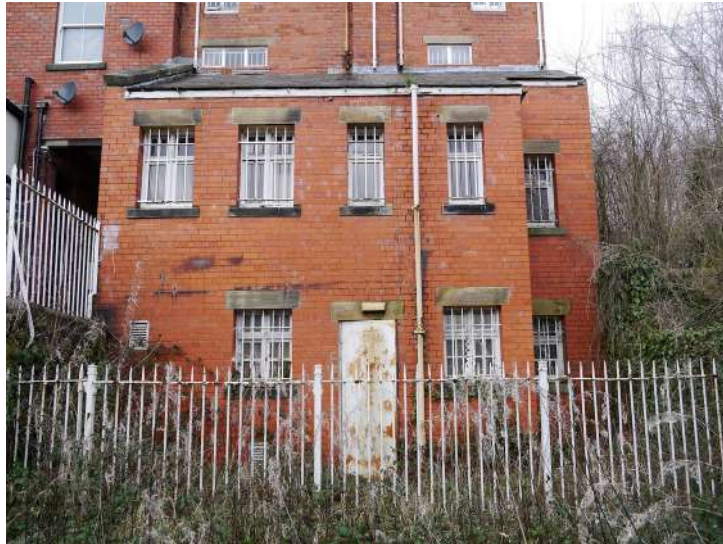
Plate 10 - Phase 3 of the southeastern elevation

- 6.3.15. The lower section of the elevation formed phase 2 of the development sequence and was of a the hard fired, lighter red, brick in stretcher course bond noted above. The dog leg in the northern part of this elevation likely accounts for the precious access route to the plot (PLATE 10).

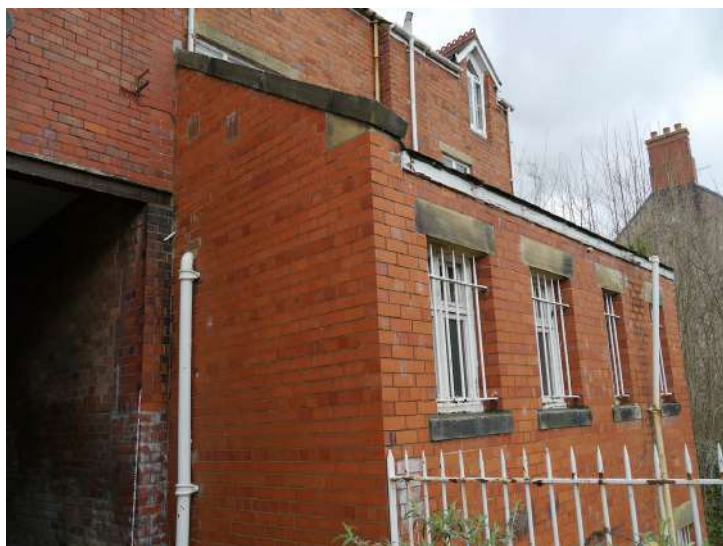
Plate 11 - Junction of phase 1 and phase 2

6.3.20. The later red brick of phase 2 butts the earlier phase 1 brickwork (PLATE 11).

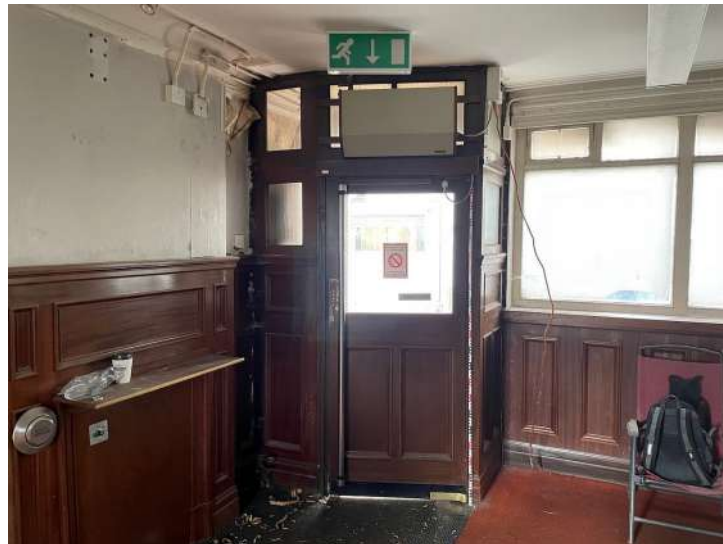
Plate 13 - Entrance to property, within G1

6.4.2. The entrance is formed by an angled wooden door set within a panel frame with transom lights above. The framework interferes with the cornice around the ceiling, indicating a later modification, likely early 20<sup>th</sup> century, with a late 20<sup>th</sup> century replacement door (PLATE 13).

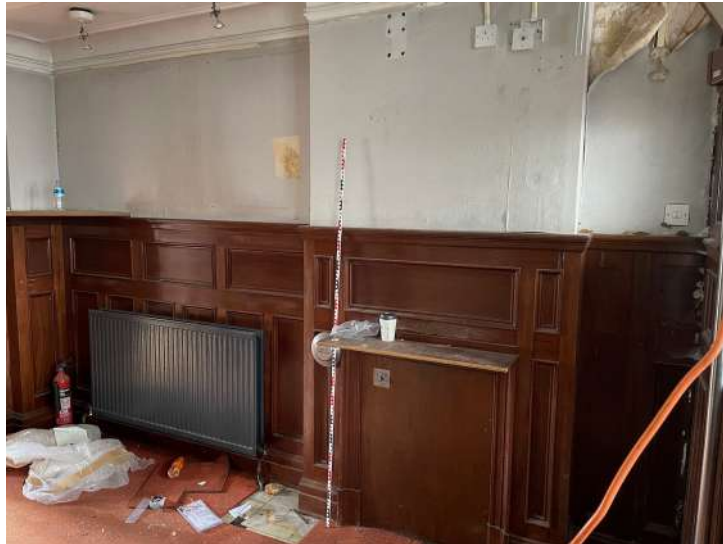
Plate 14 - Southwest wall of G1

6.4.3. The footprint of G1 is L-shaped, with a rectangular area, with half height wood panels, constructed of two vertical narrow panels and single horizontal panel above (PLATE 14). The wall is plastered and subsequently wallpapered and along the southwestern wall is a blocked fireplace, which sees the same panelling acting as the surround.

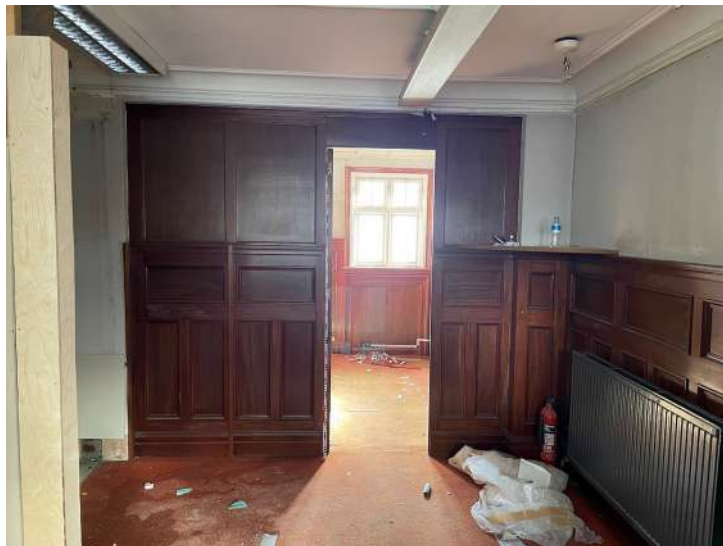
Plate 15 - Southeast wall of G1

- 6.4.4. The southeastern wall of G1 is formed by a wooden partition, extending the same panel style, with a plain panel upper section (PLATE 15). This partition represents the removal of historic fabric of phase 1 material, leading into what has been identified as the phase 2 extension (G2 and G3).

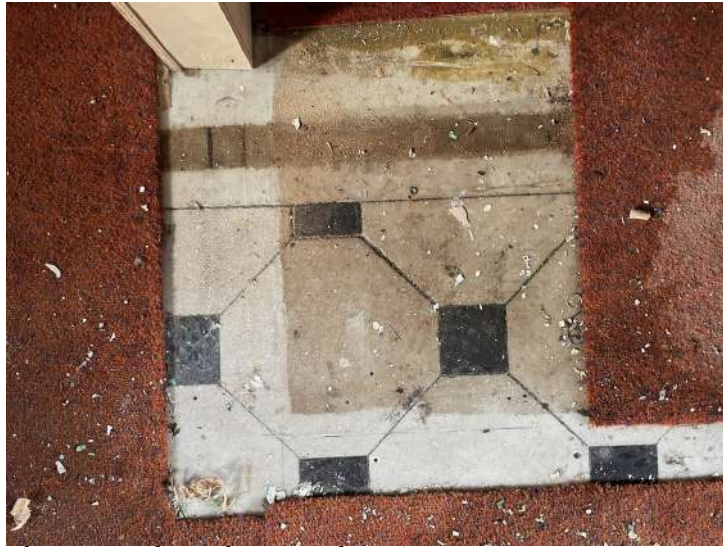
Plate 16 - Floor tiles exposed in G1

- 6.4.5. Around the ceiling is a wide, curved profile, cornice typical of late Victorian and Edwardian properties. At the corner of the blocked fireplace a small area of carpet had been lifted to expose earlier floor tiles. These appear to be a marble effect black and white tile, likely forming a geometric pattern, common from the Victorian period onwards (PLATE 16).

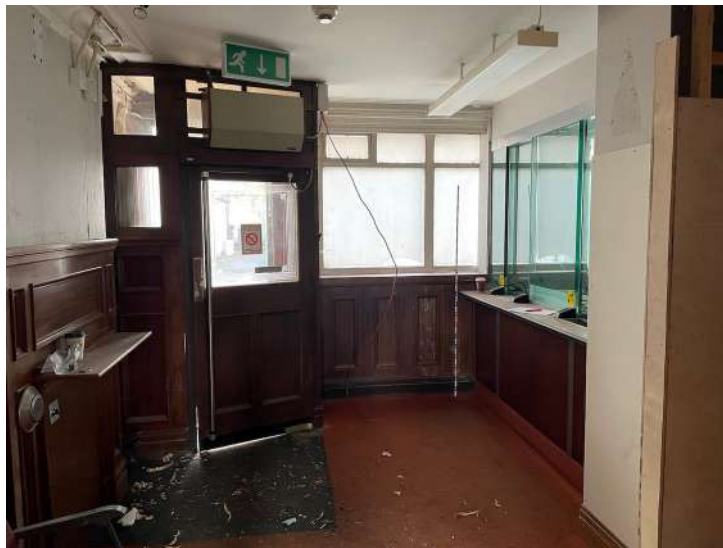
Plate 17 - Northwest wall of G1

6.4.6. The northwest wall continues the panelling, although in this area the windows above the stall-riser are present (PLATE 17). The division between G1 and G4 is a modern wooden framework with security glass upper, forming the bank counter. This is clearly a late 20<sup>th</sup> century element.

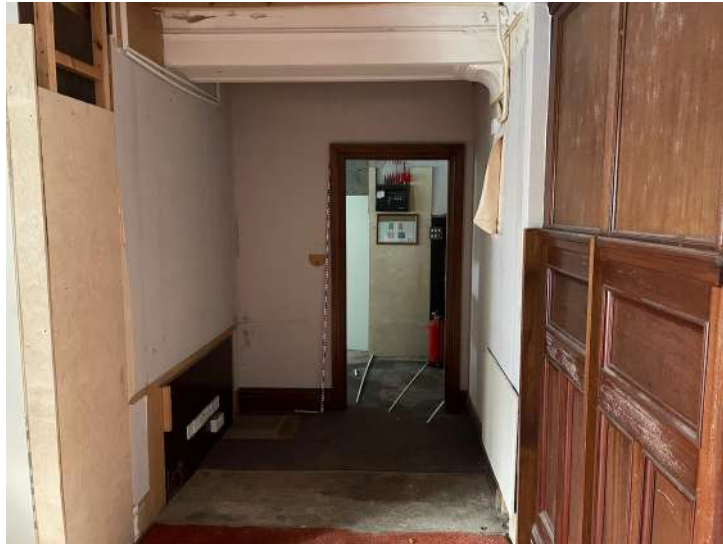
Plate 18 - Room G1, looking northeast

6.4.7. This modern division between G1 and G4 is also evidenced along the narrow dog-leg of the L-shaped room. A substantial decorative joist runs across the ceiling in a northwest-southeast alignment, with a curved corbel at the wall joint (PLATE 18). This is an original feature and forms a structural bressummer beam.

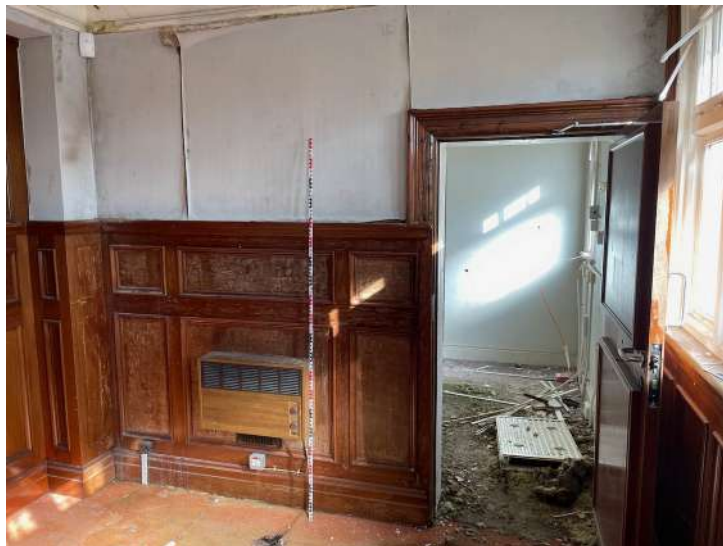
Plate 19 - Northeast wall of G2

6.4.9. Room G2 falls within phase 2 and is accessed from both G1 and G3. This is a small square room, with the same style of wood panels surrounding all four walls, with wooden architrave around the door frames (PLATE 19).

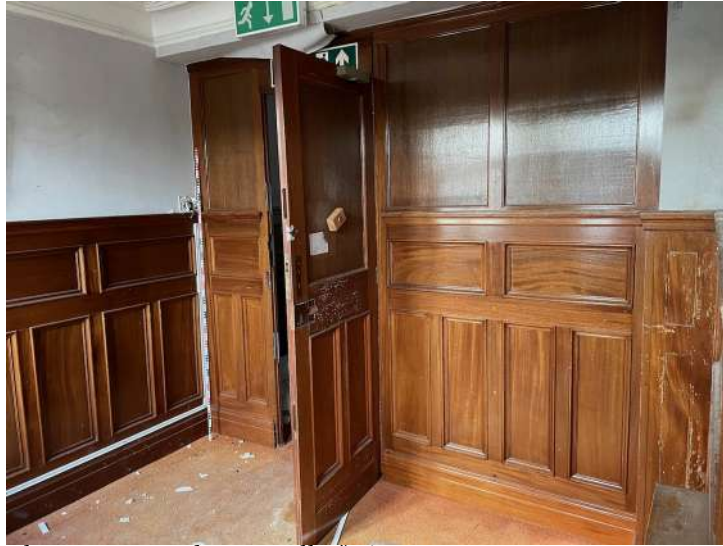
Plate 20 - Northwest wall of G2

G1, however it is slightly wider and deeper in scale. The partition nature of the wall can be seen in the supporting beam above it, indicating the earlier wall dimensions (PLATE 20).

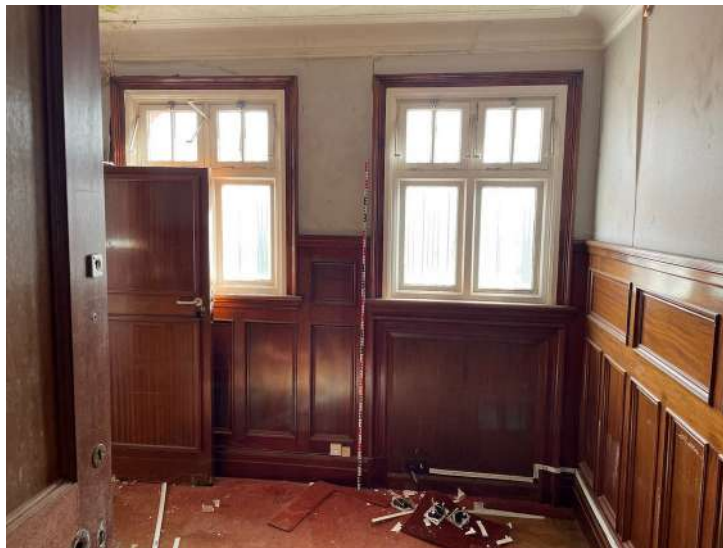
Plate 21 - Southeast wall of G2

6.4.11. The southeast wall of G2 contains two windows of wood fare, with a surrounding architrave to match the door frames (PLATE 21).

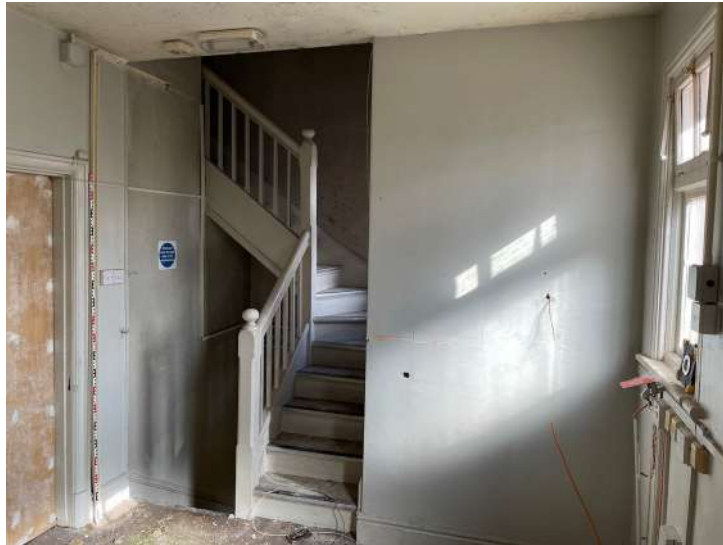
Plate 22 - Room G3, looking north

6.4.12. Room G3 was located to the north of G2 and gave access to G2, G4 and the staircase leading to the first floor and lower ground floor. The room had plain painted walls and lacked the cornice seen in G2. The architrave around the

doorframes in this room were also of a simpler style (PLATE 22).

6.4.13. The stairwell in the northwestern corner of the room had a simple step style with plain baluster and ball cap on the newel post.

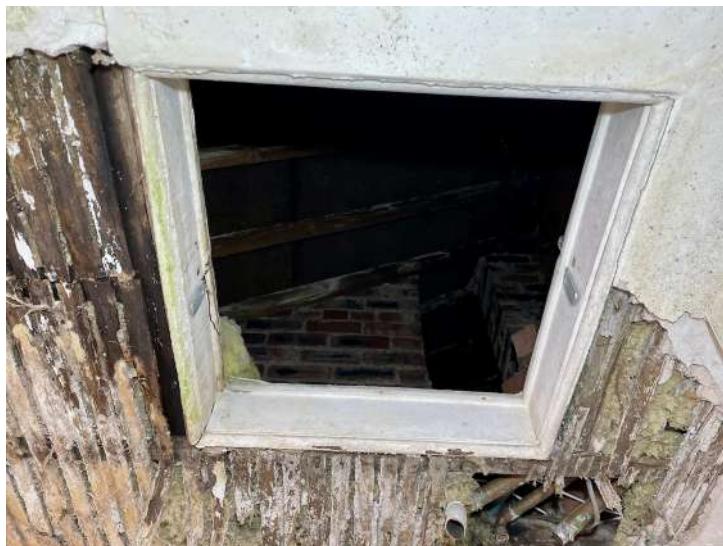
Plate 23 - G3 roof and ceiling construction

6.4.14. The room was in a poor state, which allowed visual inspection of the roof construction, which was a simple lean to form, with common rafters of machine cut wood, with felt covering (PLATE 23).

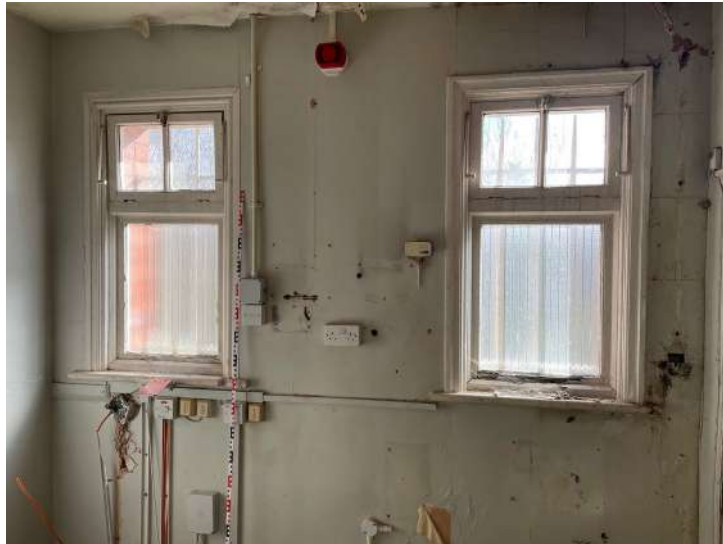
Plate 24 - Windows in G3

6.4.15. The windows within G3 were similar in style to those seen in G2, however, were narrower and lacked the decorative architrave (PLATE 24).

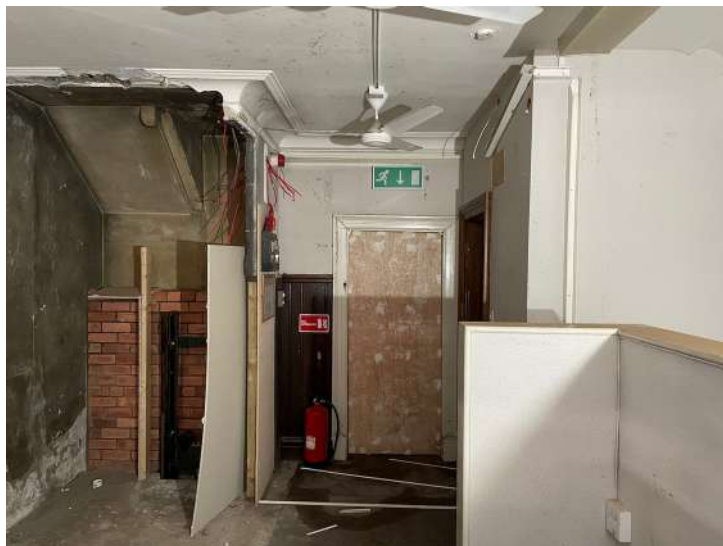
Plate 25 - Southeastern wall of G4

6.4.16. Room G4 was located at the northern end of the building and was the largest of the rooms. Within this area two types of cornice were noted. Along the southeastern wall the cornice matched that of G1, however, around the lift shaft the cornice was more similar to that seen in G2 (PLATE 25).

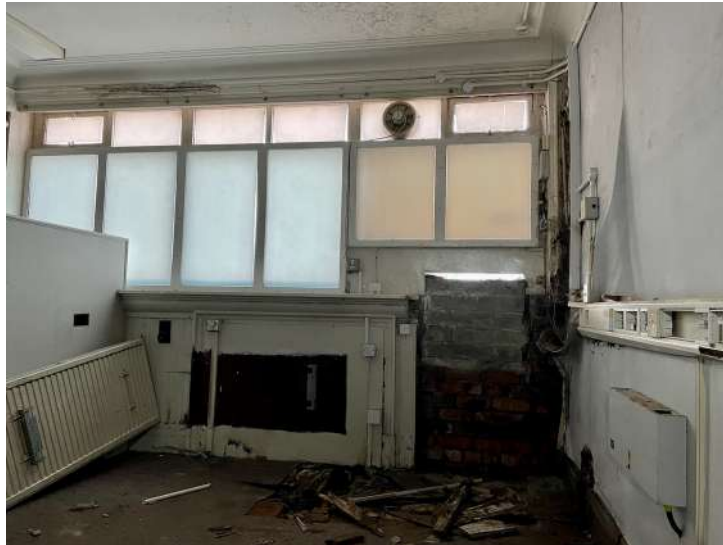
Plate 26 - Northwestern wall of G4

6.4.19. The northwestern wall was the external face and contained the stall-riser windows and showed the extent of damage caused by the insertion of the ATM (PLATE 26). Of note along this wall was the earlier wooden panelling, pre-dating phase 2 panels seen in G1 and G2. This was a more simple vertical tongue and groove style of Victorian shopfronts (PLATE 27).

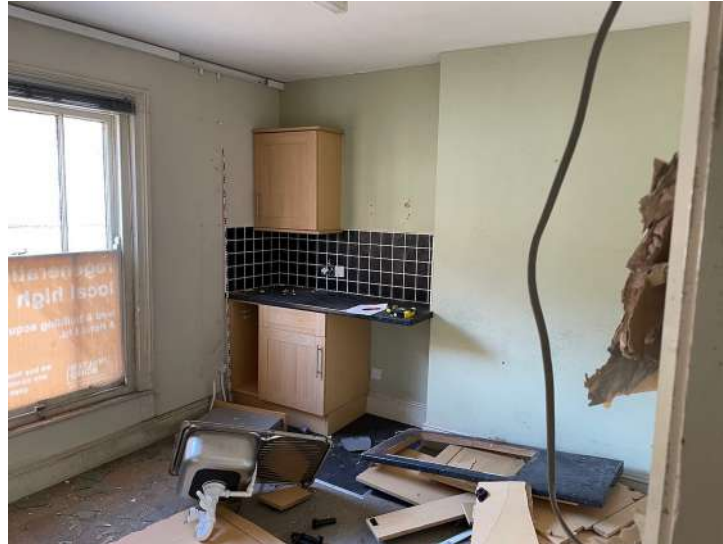
Plate 30 - Room F2 looking north

6.4.23. Room F2 was located at the northern corner of the building and overlooked Well Street. The space had been used as a kitchen/canteen area with a small kitchenette unit in the northern corner (PLATE 30). The recess in this area likely represents an alcove by the side of a blocked fireplace or chimney breast.

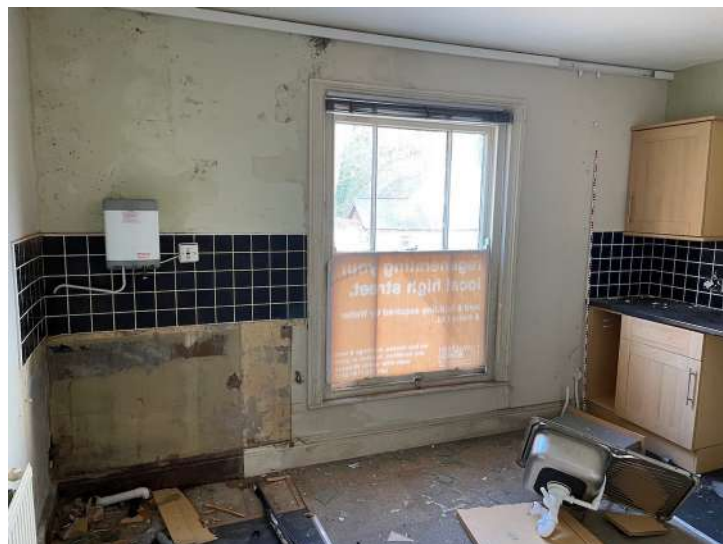
Plate 31 - Northwestern wall of F2

6.4.24. A single large window took up the central area of the northwestern wall with decorative wooden architrave surround (PLATE 31). This is thought to be an original feature of phase 1 development.

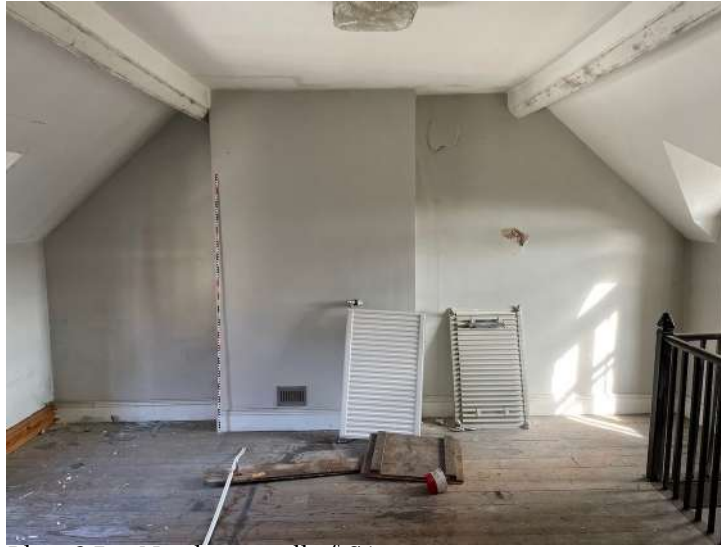
Plate 35 - Northeast wall of S1

6.4.30. Room S1 was located in the northeastern half of the building and was accessed via the stairs from F1. This was an open plan room with sloped ceiling, following the roof line. The purlins were exposed throughout, suggesting a raised tie truss configuration (PLATE 35).

6.4.31. The northeast wall contained a chimney breast with small vent at floor level. This indicates a blocked fireplace (PLATE 35). The southeastern part of the room contained the access staircase and a dormer window overlooking the rear yard (PLATE 36). The four pane rectangular casement window had a triangular static pane above and lay flush with the wall face, rather than extending out from the property. The ceiling recess was also triangular in form. The stairwell had a simple surrounding rail, matching the balusters and posts seen at first floor level.

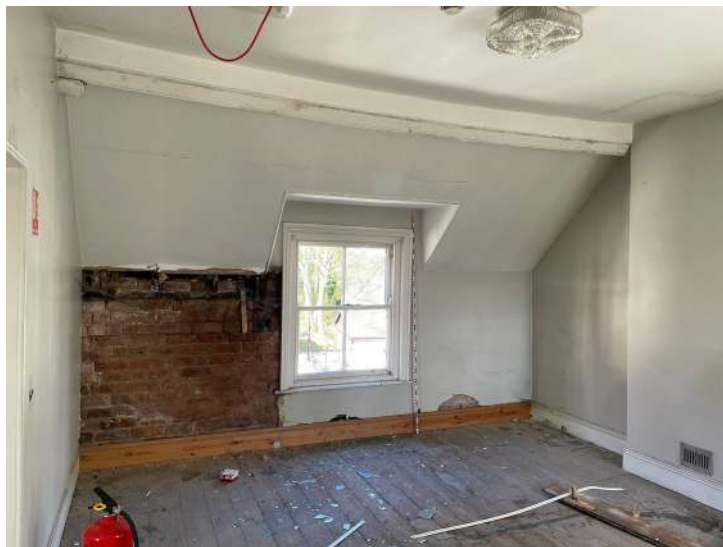
Plate 37 - Northwestern wall of S1

6.4.32. The northwestern wall included the dormer window overlooking Well Street, which was of slightly different form to the southeastern dormer. The northwestern dormer had a square profile ceiling recess and four pane sash window, with decorative architrave (PLATE 37). To the south of the window the exposed brickwork was of the original phase 1 construction with later repair.

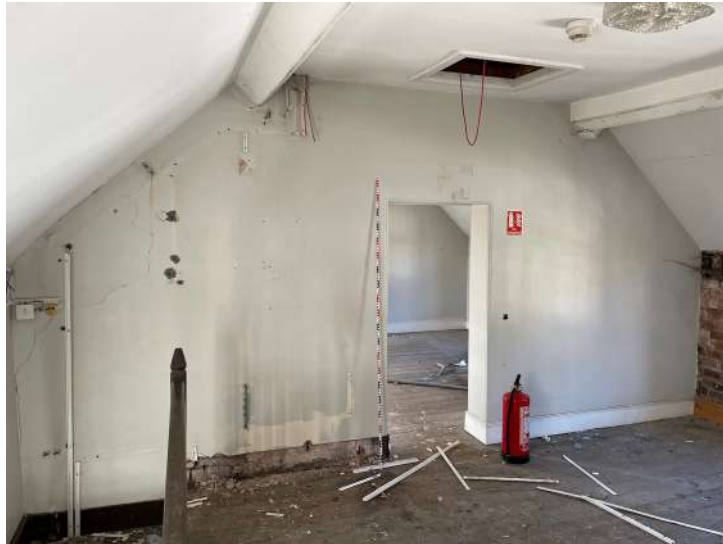
Plate 38 - Southwestern wall of S1

6.4.33. The flooring of S1 was early to mid 20<sup>th</sup> century plain wooden boards. Access to S2 was via a doorway on the southwestern wall of S1, which appears to be an original feature (PLATE 38).

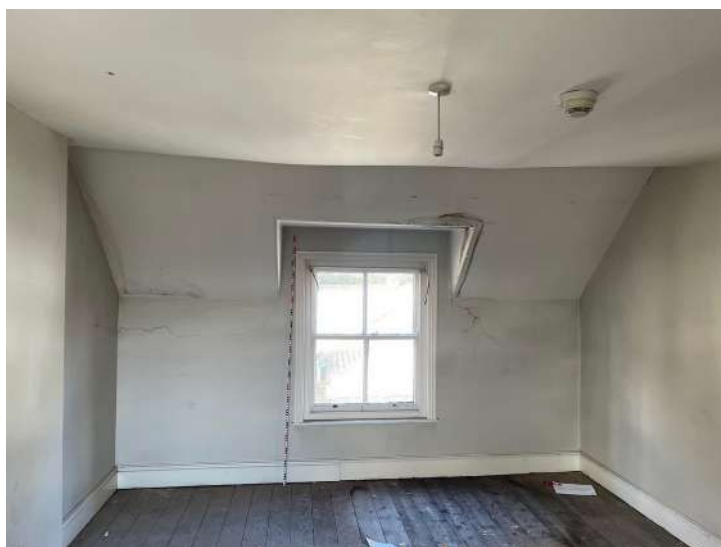
Plate 40 - Northwestern wall of S2

held within the roof space, rather than on display. The northwestern wall matched the northwestern wall of S1 with a square, decorative, sash window and square profile flush dormer (PLATE 40).

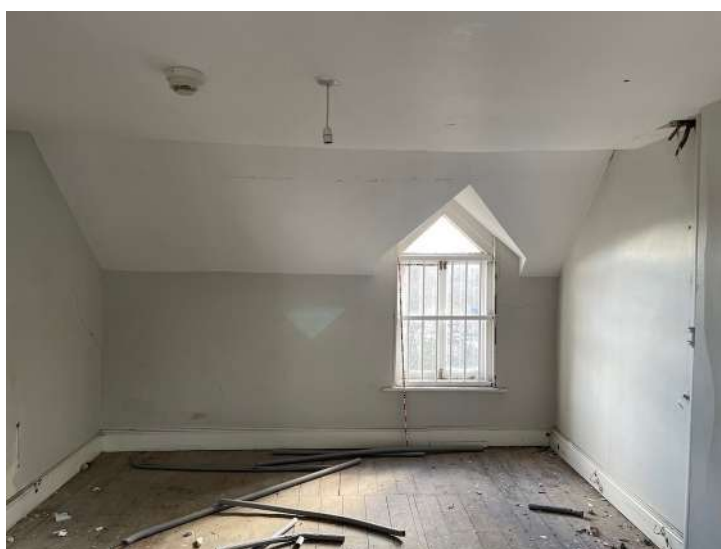
Plate 41 - Southeastern wall of S2

6.4.37. The southeastern wall was also a mirror of S1 with triangular form dormer window (PLATE 41).

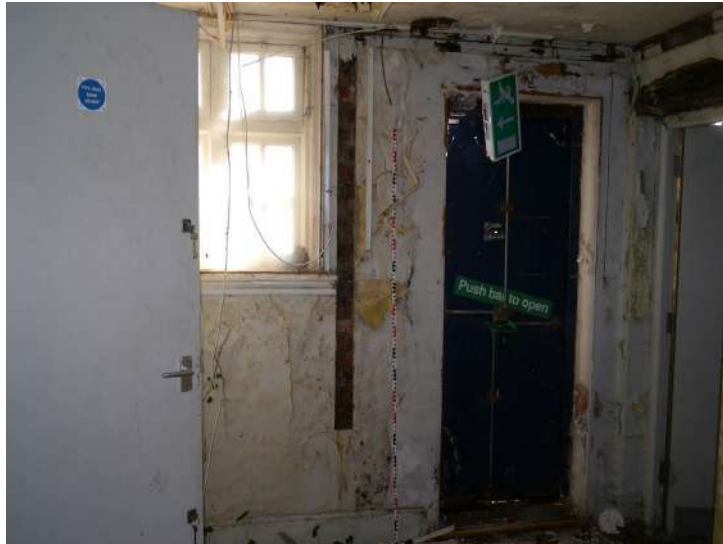
Plate 44 - Southeastern wall of L1

6.4.41. The rear wall contained a single wood frame window and metal doorway acting as a fire escape (PLATE 44).

6.4.42. The southwest and northwest walls were plastered and plain in appearance with access to L2 via a doorway at the southeastern end (PLATE 44) and access to L3 via an opening on the northwest wall (PLATE 45).

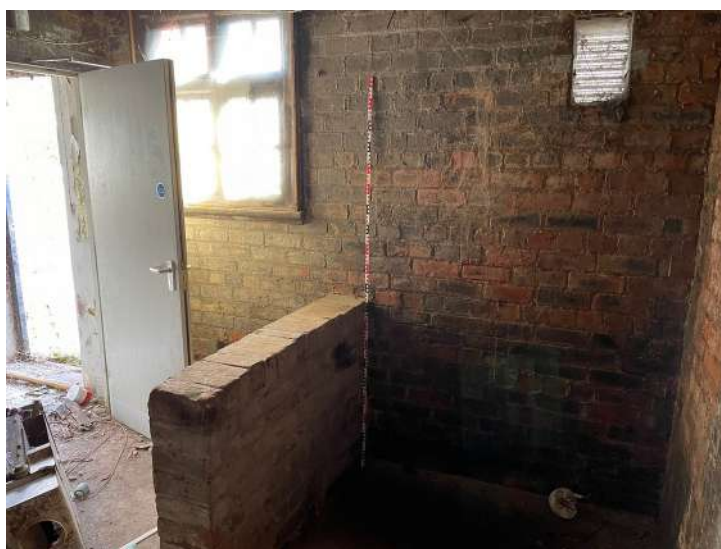
Plate 47 - Southeastern wall of L2

6.4.44. The southeastern wall of L2 was of 20<sup>th</sup> century brickwork, with a window at the northeastern end and a vent at the southeastern end (PLATE 47). A half height, around 1m high, brick wall divided the southern corner of the room, and would likely have been a store for fuel (PLATE 47).

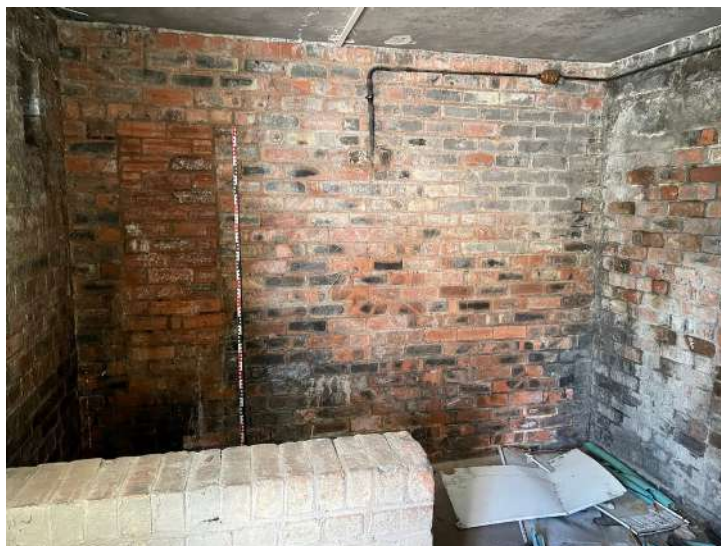
Plate 48 - Southwest wall of L2

6.4.45. The southwestern wall of L2 was also of 20<sup>th</sup> century brickwork and contained a blocked area at southeastern end (PLATE 48), which appears to be an infilled hatch or void. As this butts the embankment to the southwest and external stairs from the rear yard to the ground floor level at Well Street, this may be a

defunct delivery system for coal or fuel that would have allowed the materials to be deposited in a chute at ground floor level, into the store at lower ground floor level. Modern concrete and modification at ground floor level obscure any trace of this beyond the blocked feature in L2.

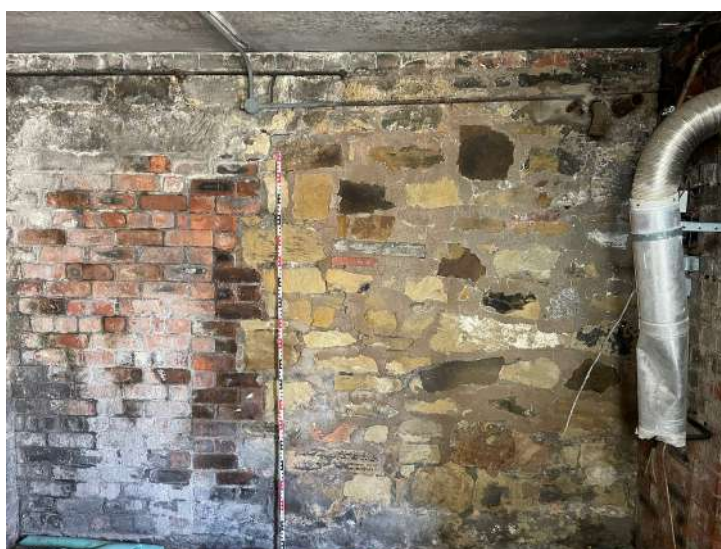
Plate 49 - Northwest wall of L2

6.4.46. The northwestern wall of L2 is of interest in that it contains both sandstone and brick construction materials (PLATE 49). It is likely that the sandstone blockwork in random coursed rough material represents the original foundations of the building, with the brickwork representing the early 20<sup>th</sup> century modification.

- 7.2.2. Phase 1a is defined by a sandstone wall present on the northwestern wall of room L2. It is known that earlier sandstone buildings were present in Cefn Mawr, and likely along Well Street. However, sandstone was also used as foundation material for the Victorian development as well; It is possible that this wall reflects the foundation of Phase 1. It may also represent an earlier structure that sat below the line of Well Street prior to the early 19<sup>th</sup> century.

- 7.2.3. Outside of L2 the wall was covered in plaster and the construction material was not visible. It is the opinion of the author that the sandstone represents foundations associated with Phase 1.

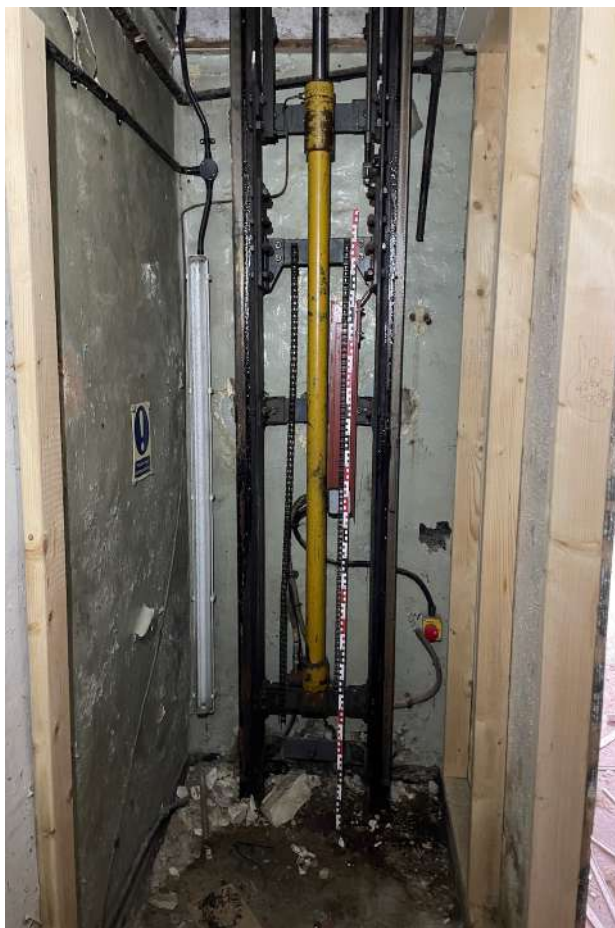
Plate 50 - Lift mechanism in L3

6.4.47. Room L3 was an area set aside for the electrical and mechanical equipment for the bank. This area contained the lift mechanism (PLATE 50).

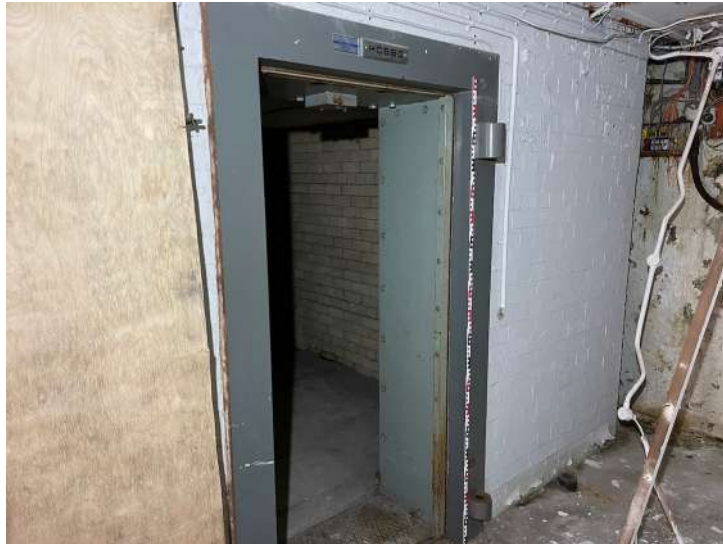
Plate 51 - Vault access in L3

6.4.48. The room itself was nondescript with plastered wall and no features of note (PLATE 51). It is, however, this room that allows access to the vault, L4, at the southwestern side (PLATE 51). The vault was built away from the walls giving a void on three sides between the vault wall and building walls (FIGURE 16). This is most visible at the southeastern corner of F3, where a portion of the wall has been removed to give an inspection area (PLATE 52).

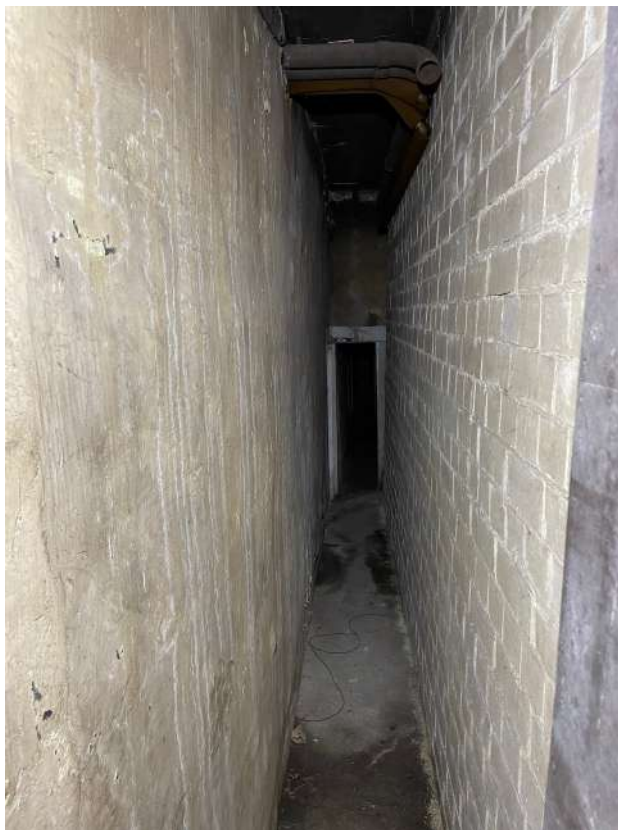
Plate 52 - Void between structure walls and vault

6.4.49. At the southwest and southeast corners of the void, angled mirrors had been erected to allow for a full view of the void L3 via an inspection area.

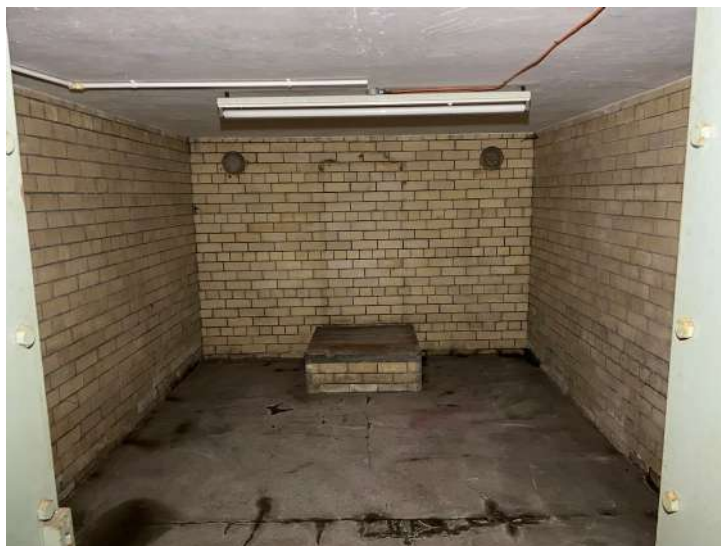
Plate 53 - Vault L4

6.4.50. Room L4 was the 20<sup>th</sup> century vault for the bank and was constructed of cream coloured fire resistant brick with a heavy metal door on the northeast wall. The door at the time of survey was a later replacement dating from the late 20<sup>th</sup> century.

- 7.2.6. Phase 3 represents the insertion of the vault or strong room and likely conversion of the building into a bank for the first time. The construction material may be late Victorian or Edwardian, and is hard fired cream coloured brick. Although the door is a later 20<sup>th</sup> century replacement, original fixings, such as the wall plates record the manufacturer as Hobbs, Hart & Co Limited, of London. Although Charles Hobbs had established Hobbs & Co by 1851, and they were advertising as Hobbs, Hart & Co by 1868, it is in 1887 that they

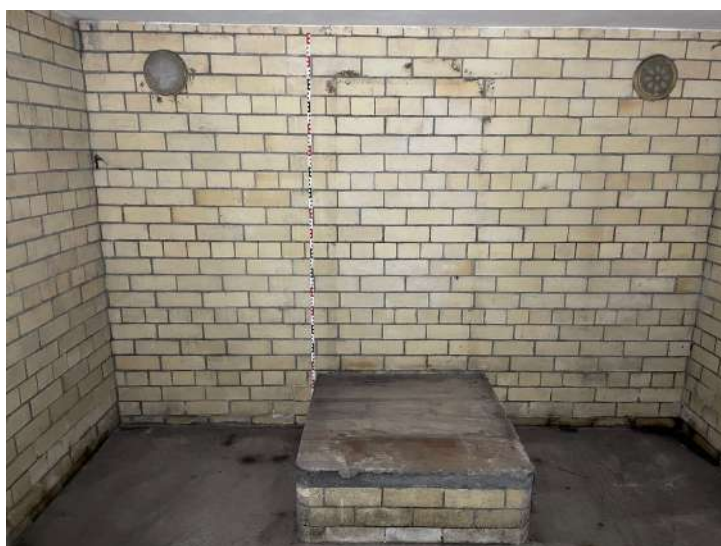
Plate 54 - Brick platform and ghosting of safe

6.4.51. Internally, the vault was simple with a raised brick platform located centrally along the southwestern wall, thought to be for a large safe (PLATE 53). All walls were of the same material and the floor was of concrete. Staining on the wall gave the location of where the safe had been sited (PLATE 54).

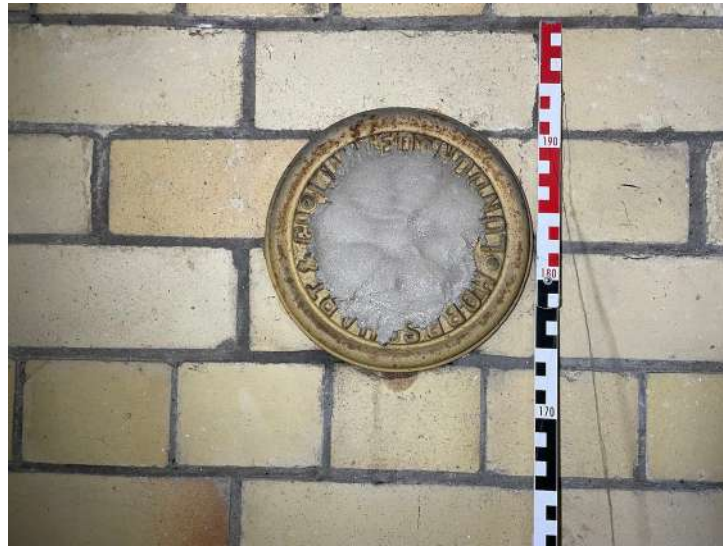
Plate 55 - Circular plate in L4

6.4.52. At approximately 1.8m above the floor, at the four corners of the room, were circular metal plates (PLATE 55). Two were present on the northeast wall and two on the southwest wall. These metal plates contained makers information, stating Hobbs, Hart & Co Limited, London.
