Historic Building Recording at

# FORMER HSBC BANK CEFN MAWR

| Doc Ref: | LP4213C-HBR-v.1.3 |

A level 2 historic building survey (PRN213722) was carried out by L – P : Archaeology on behalf of Walter Bond Plc on 12<sup>th</sup> March 2022. The work was carried out in response to a condition of planning consent (P/2020/0266). The work was undertaken prior to the alterations of the structures, in order to make an appropriate record of the building, its fabric and development sequence.

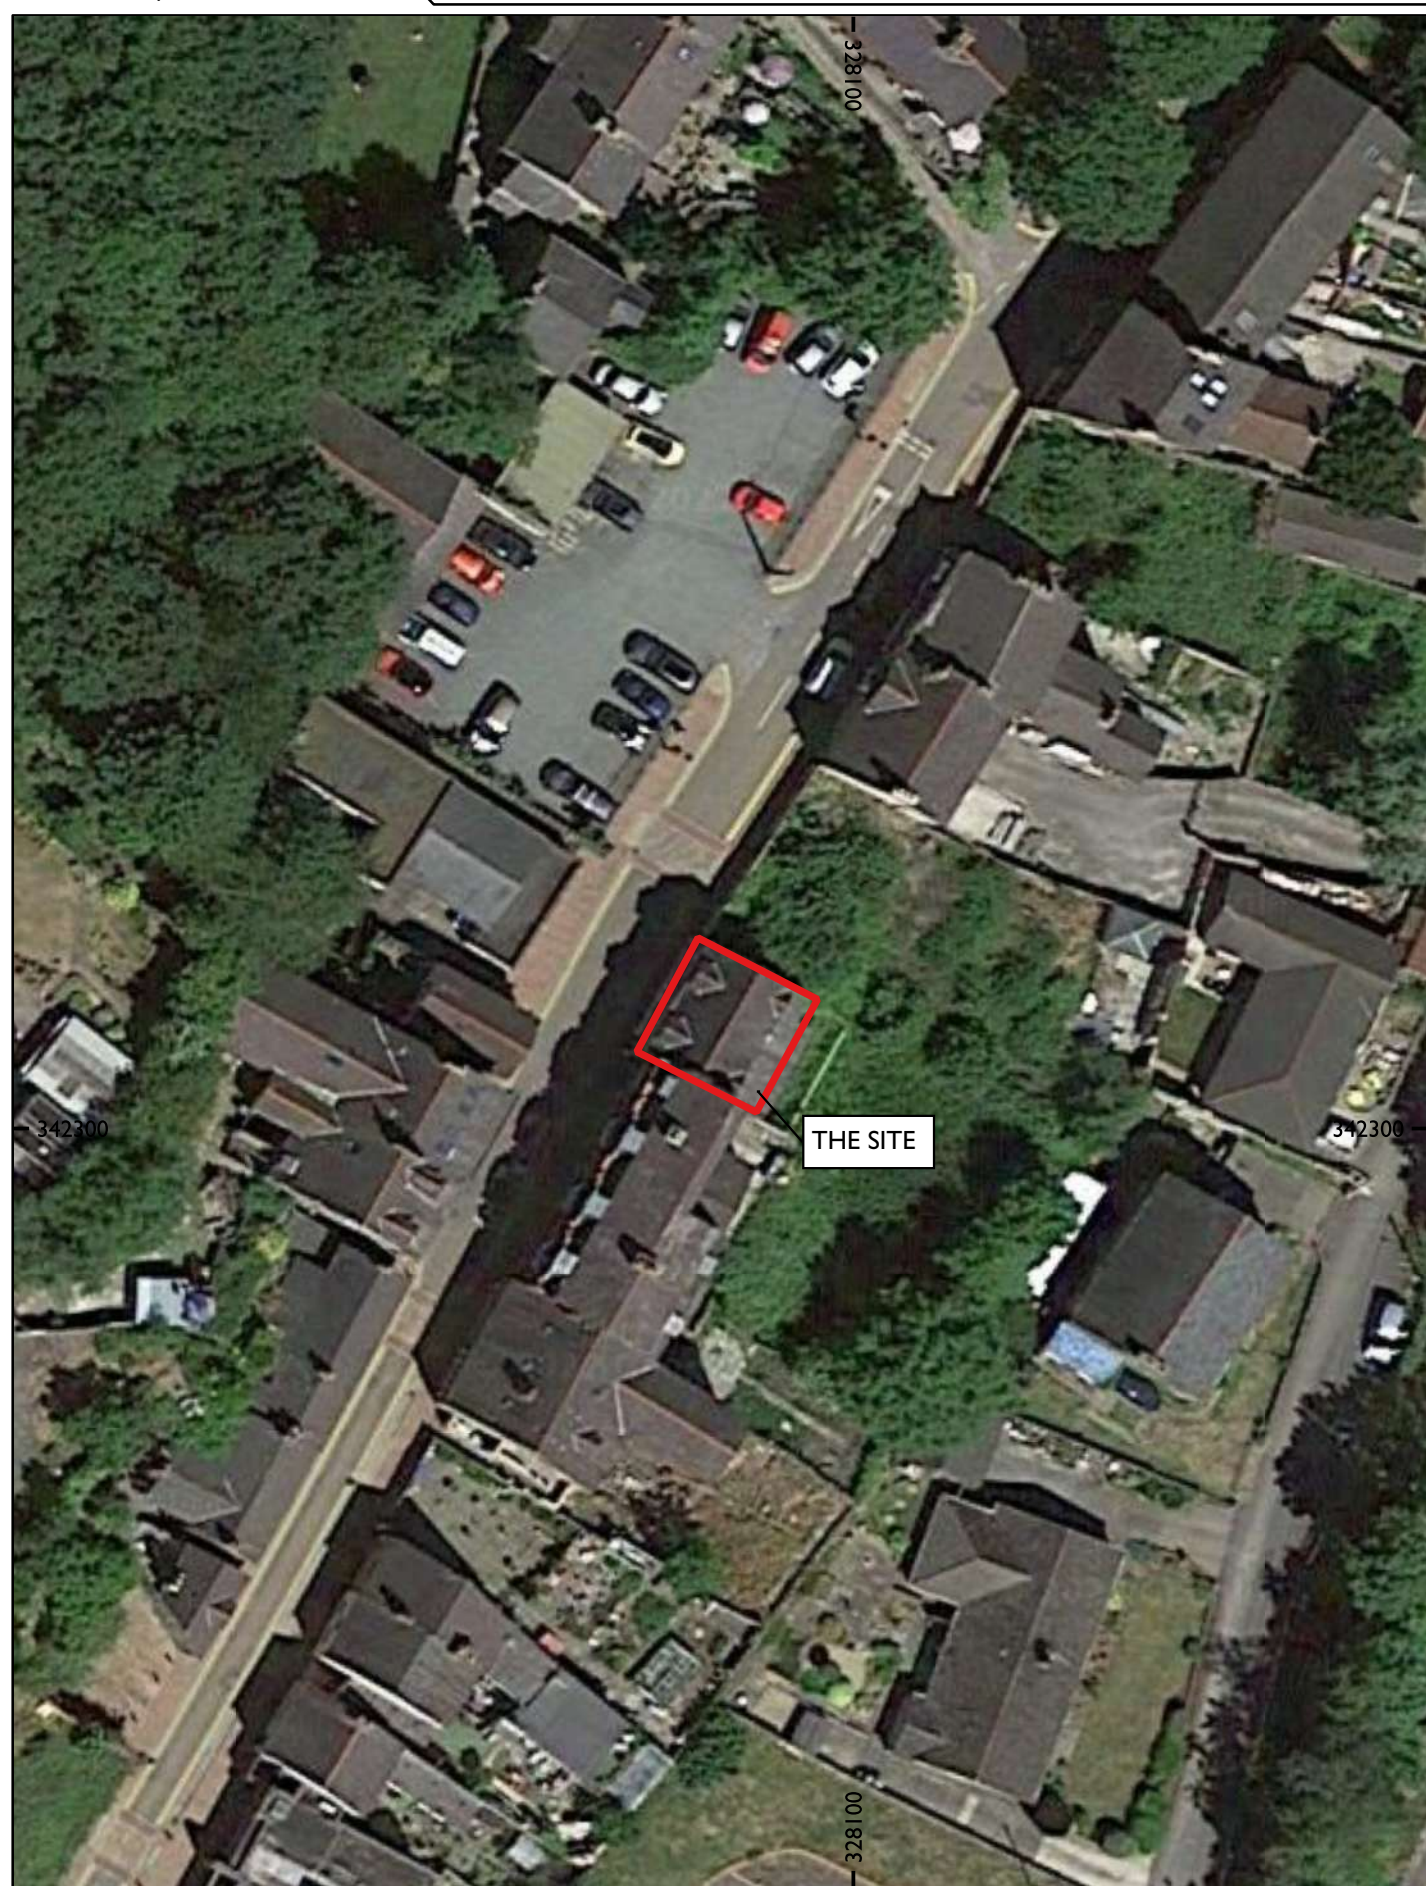
FIGURE 3 // Study Structure

2.4.2. The site (FIGURE 2) is located in the village of Cefn Mawr, approximately 10km to the southwest of Wrexham and 6.5km east of Llangollen. The village is situated on a high area overlooking the River Dee to the south. Well Street represents the historic main route through the village from Ruabon and the study structure lies along the southeastern side of the road, occupying a prominent location (FIGURE 3).

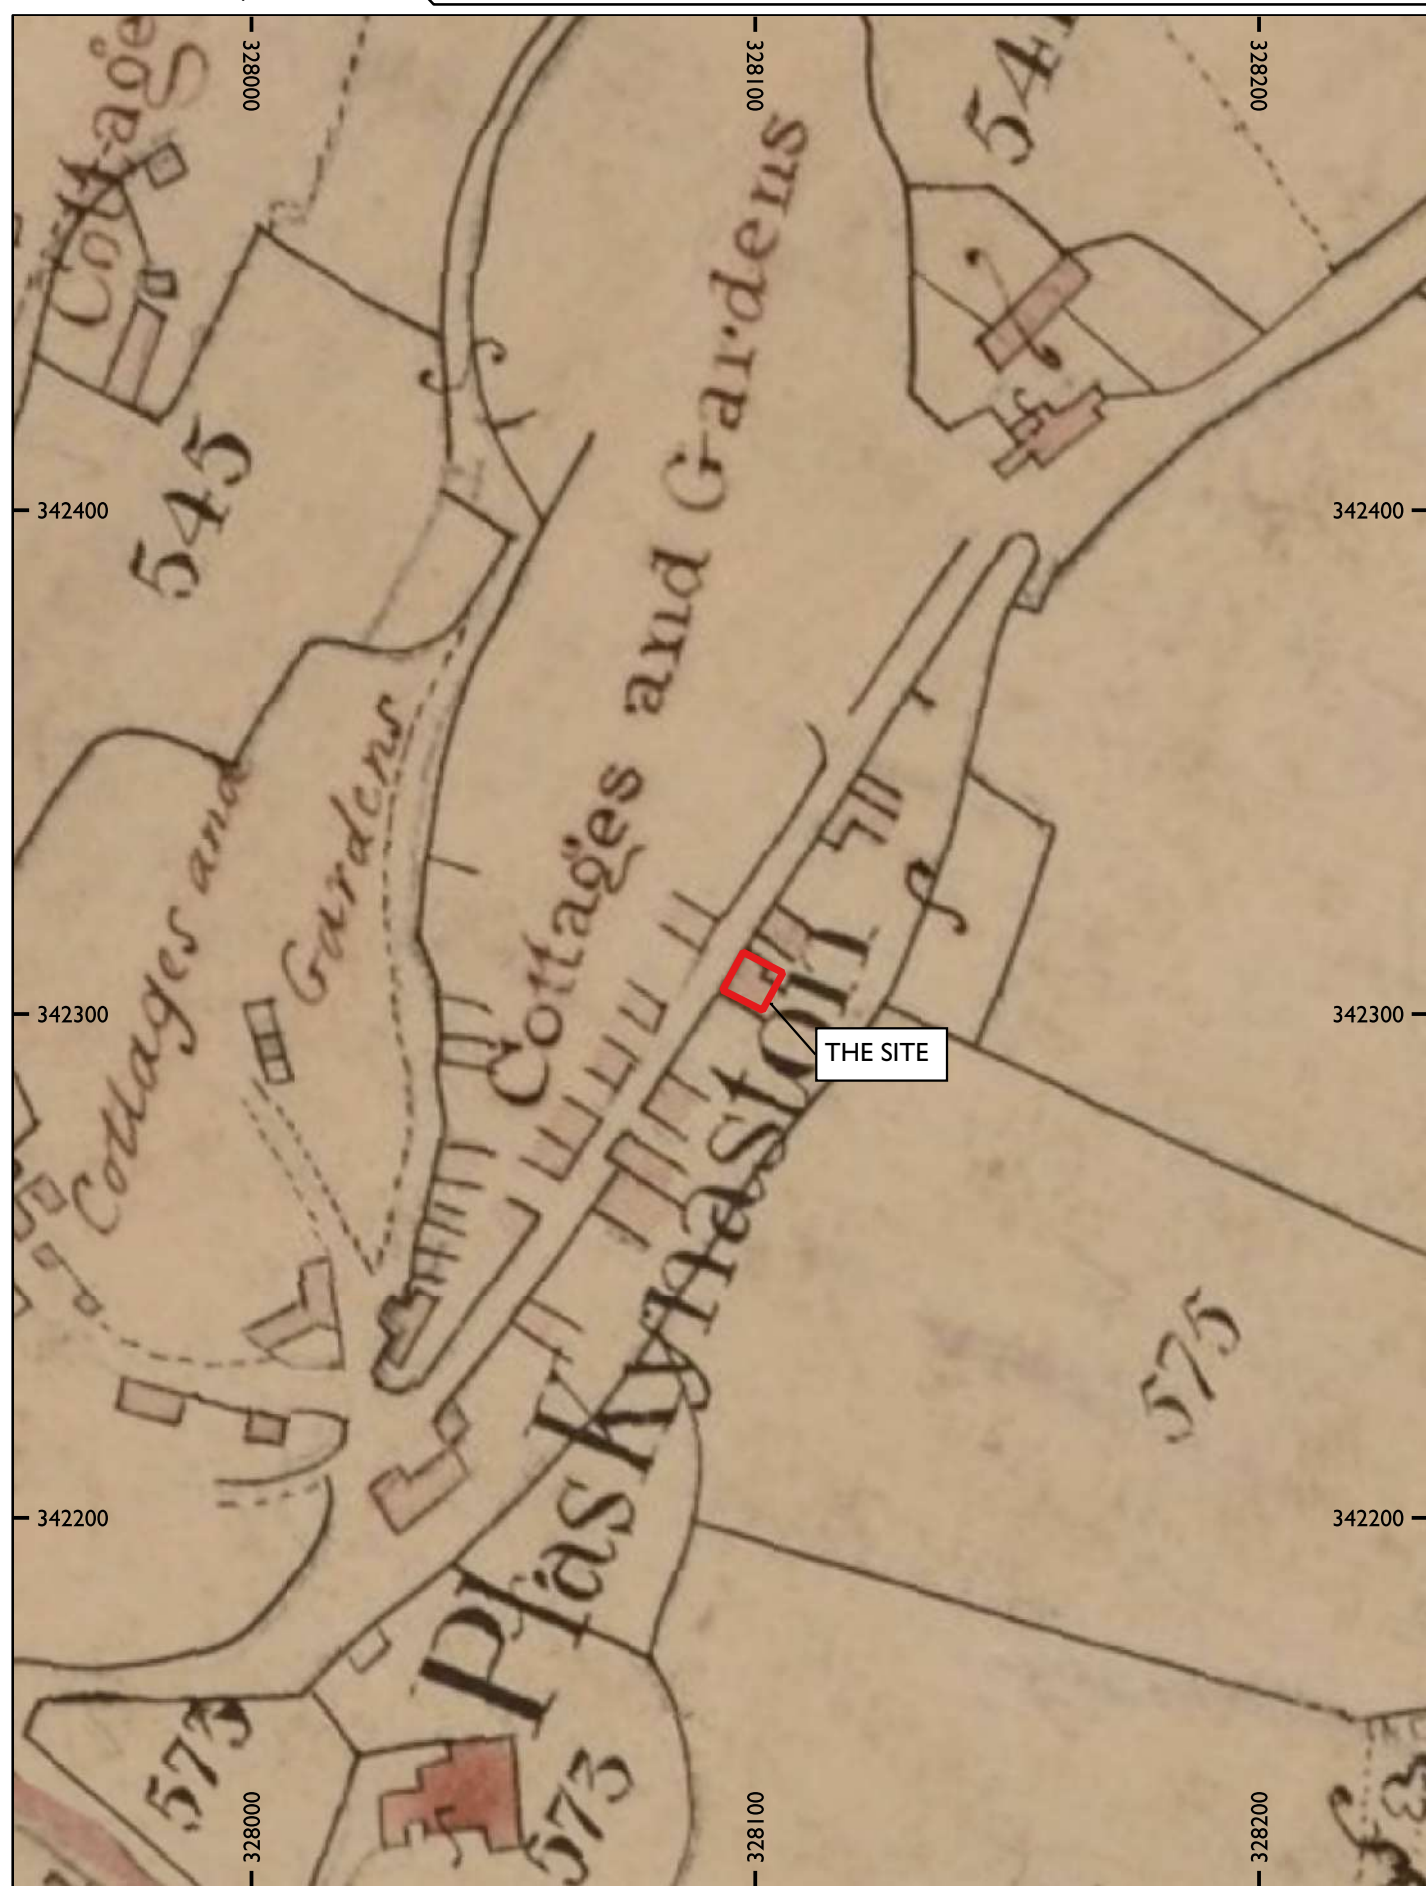
FIGURE 4 // 1845 Tithe Map

4.3.1. The earliest depiction of the site is on the 1845 tithe map of Cefn Mawr (FIGURE 4). This shows an L-shaped building prominent along the south side of Well Street taking up the majority of the existing footprint. The footprint may indicate that at this stage there had already been some modification of the structure. Its location on the steep slope means access to the lower floor can be gained externally from the base of the slope, lower than Well Street.

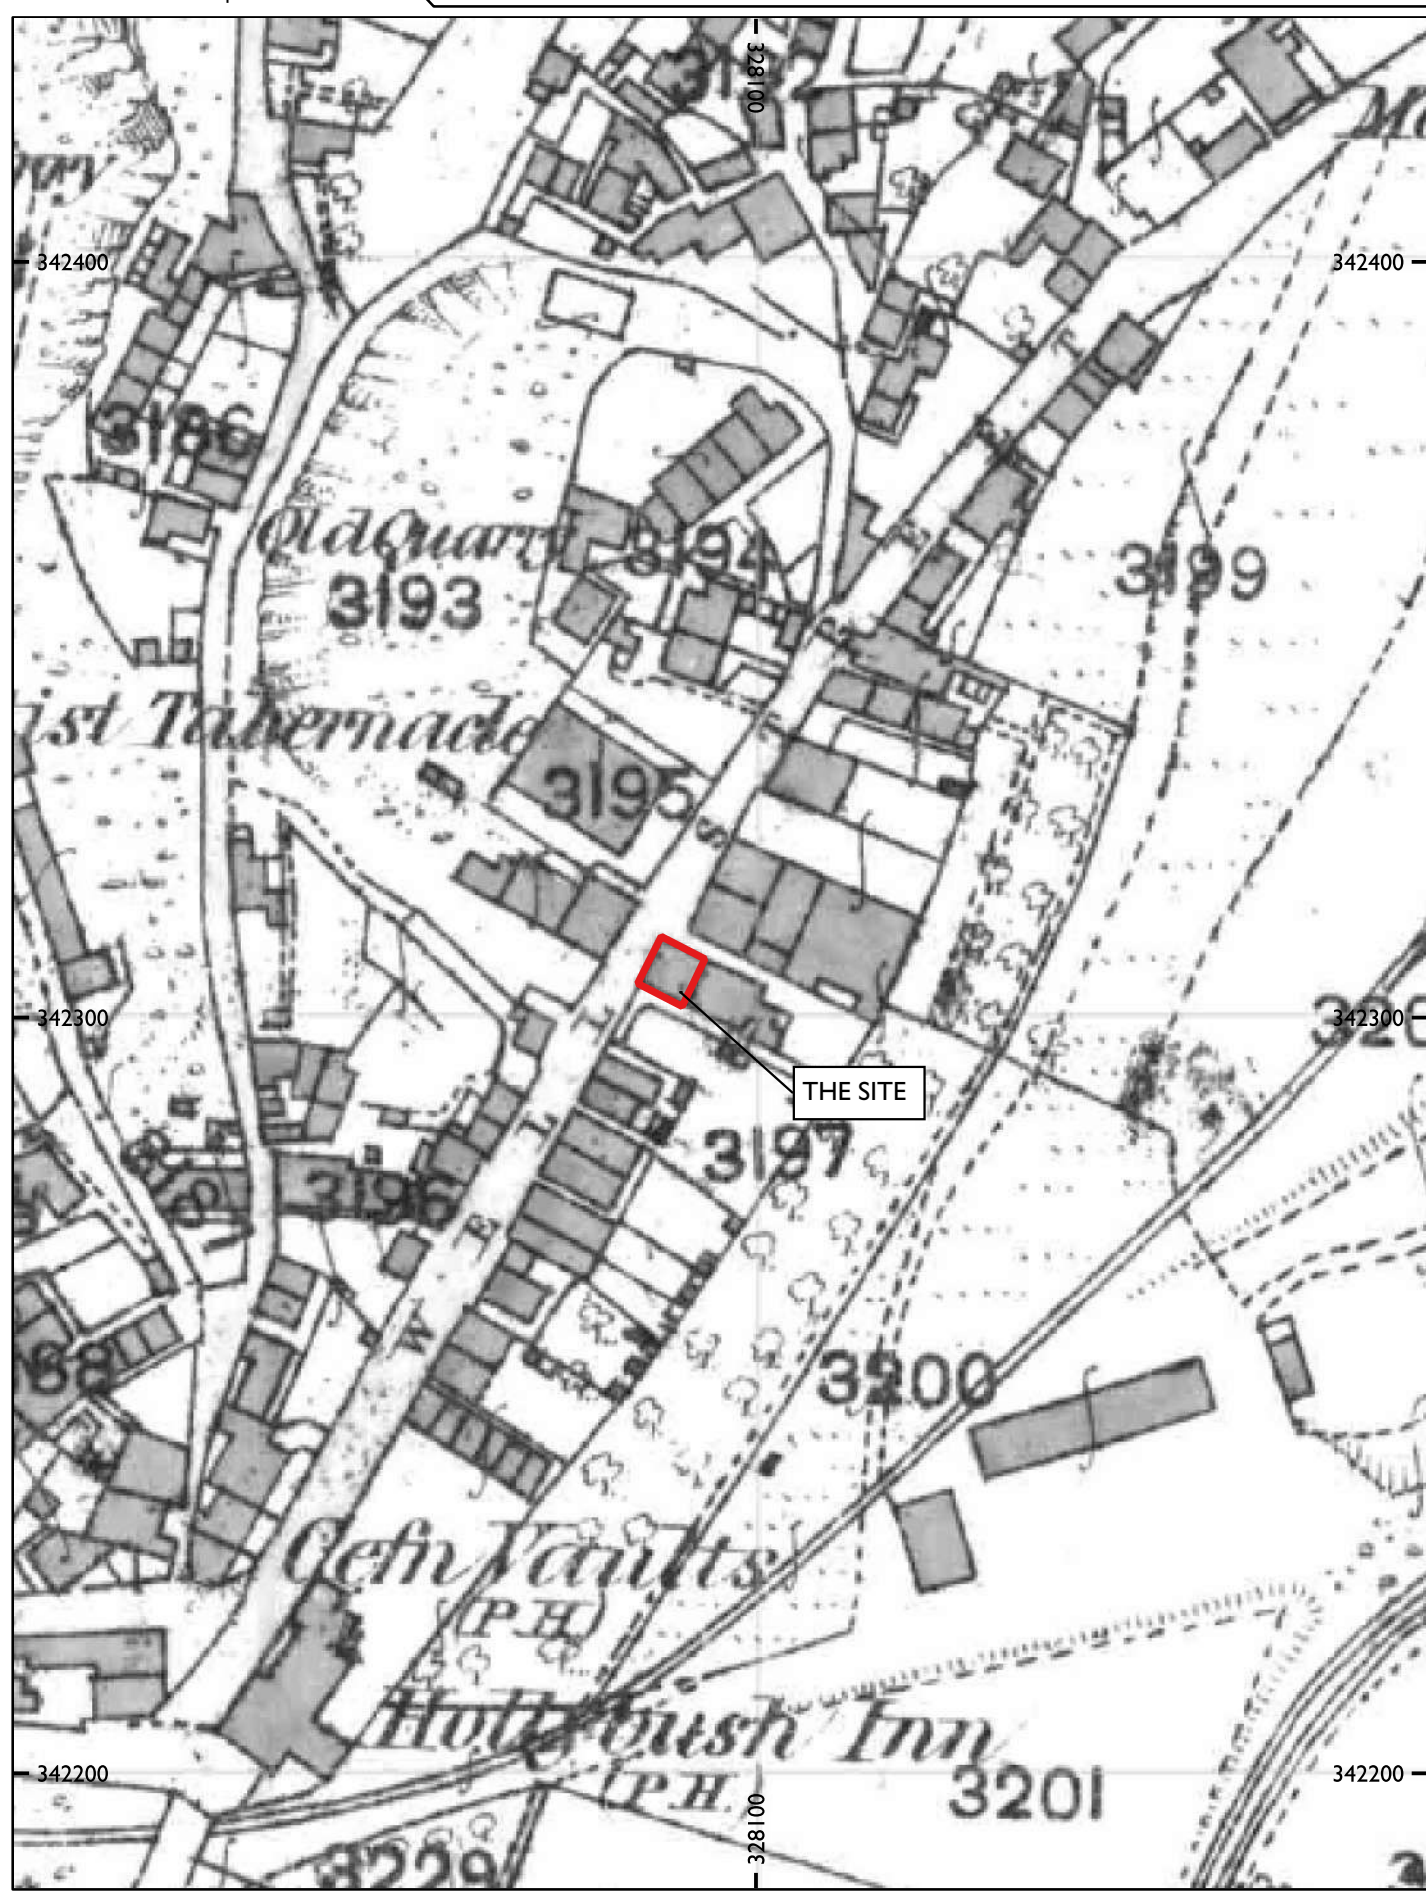
FIGURE 8 // 1959 OS Map

- 4.3.5. The 1912 OS map (FIGURE 7) shows the same footprint, however, the frontage is shown divided into two areas, which may suggest a short term division of space, as by the 1959 OS map (FIGURE 8) the division is not present.
