Johnstown

Proposed Residential Development

Geo Environmental Report - Rev A

Gower Homes

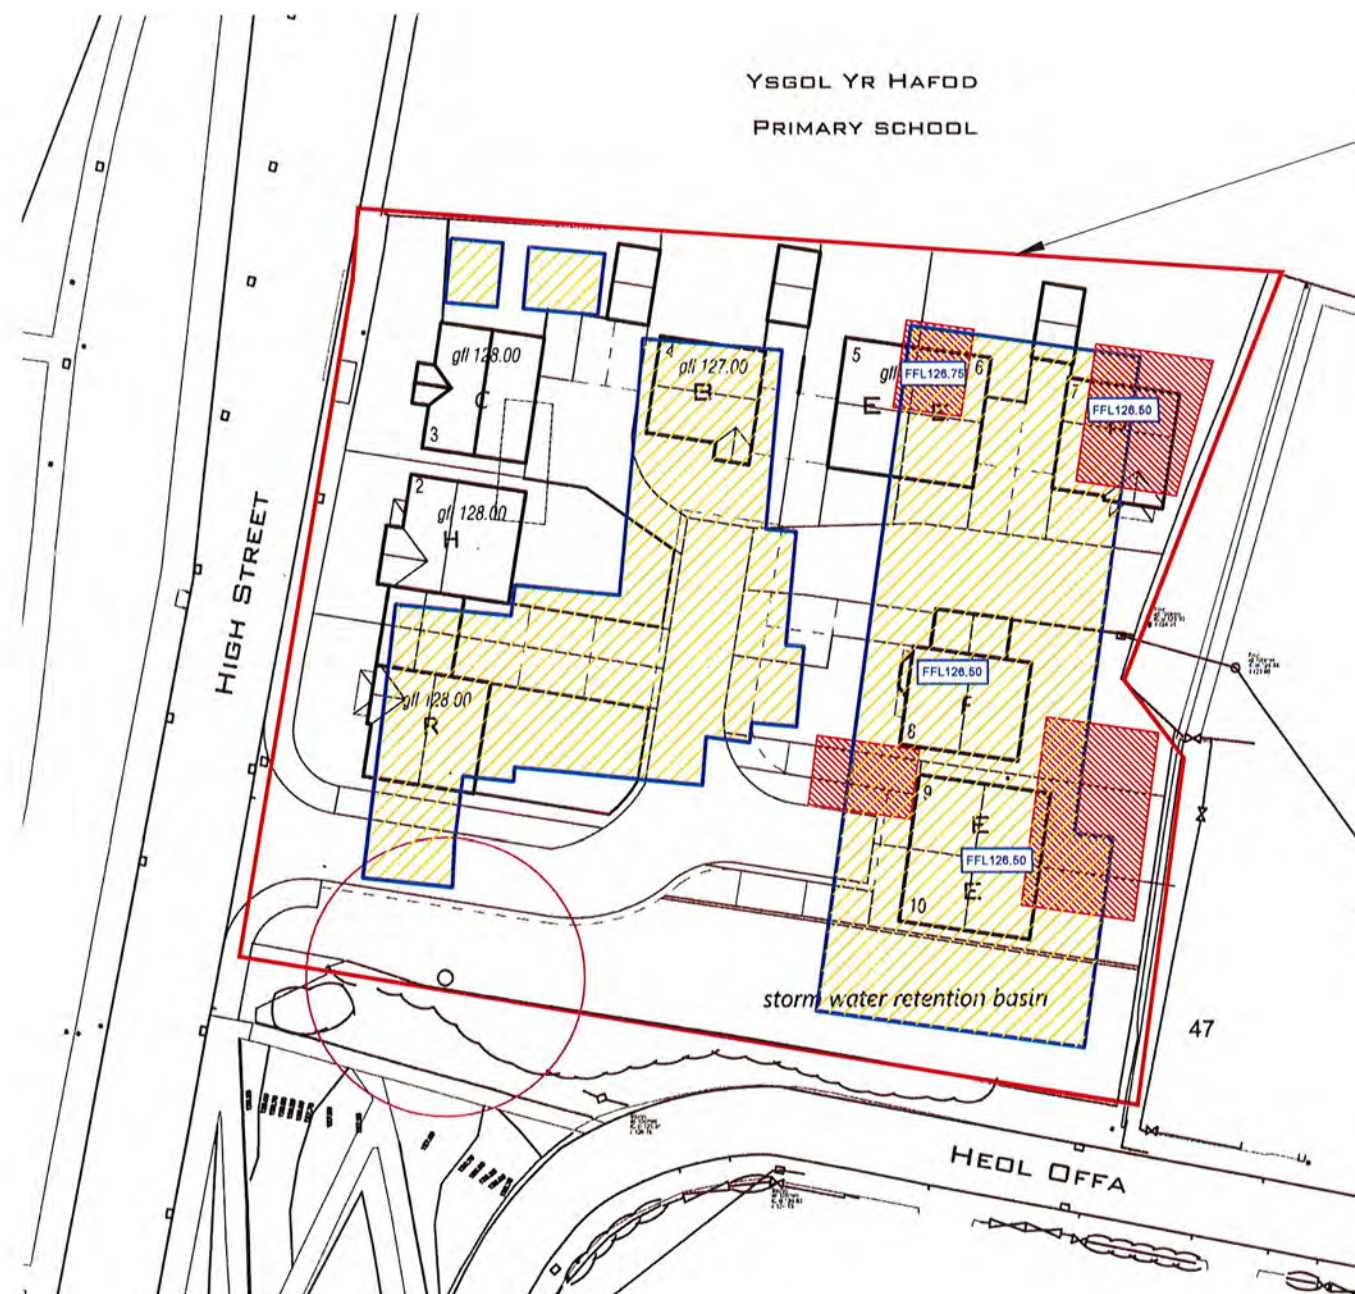
FIGURE 5

However, the chemical testing results failed to record any exceedances of contaminants when compared to the strictest end use of Residential with Gardens at 1% SOM. A small amount of asbestos was identified in TP06 which was quantified at 0.14%. Further testing in this area failed to encounter any asbestos in the made ground. However, it should be noted that in this area large areas were excavated and processed through the crusher due to excessive concrete obstructions in the ground, see Figure 5.

To assist with the geotechnical recommendations, and planning the site works, a geotechnical constraints drawing has been produced, see Figure 5. This shows the location of the proposed plots in conjunction with the location of the existing buildings on site.

The existing buildings and hardstandings on site, along with the concrete floor slabs, and existing foundation where they interfere with new foundation, have now been demolished, see Figure 5.

During demolition several large foundations and an old basement were encountered and these have also been broken out to depths of around 4.5m. In addition, the demolition and additional trial pits confirmed the general thickness of made ground beneath the building to be between 1.3 and 2.0m thick. In hindsight, it would have probably been necessary to raise ground levels in this area to create an operational yard for the building when it was constructed.

Prior to filling in the western section of the site a firm formation should be established, which should be proof rolled and any loose/soft areas further excavated and replaced with well compacted granular material. Prior to filling any old service runs will also need to be excavated with the resulting excavations backfilled as described above.

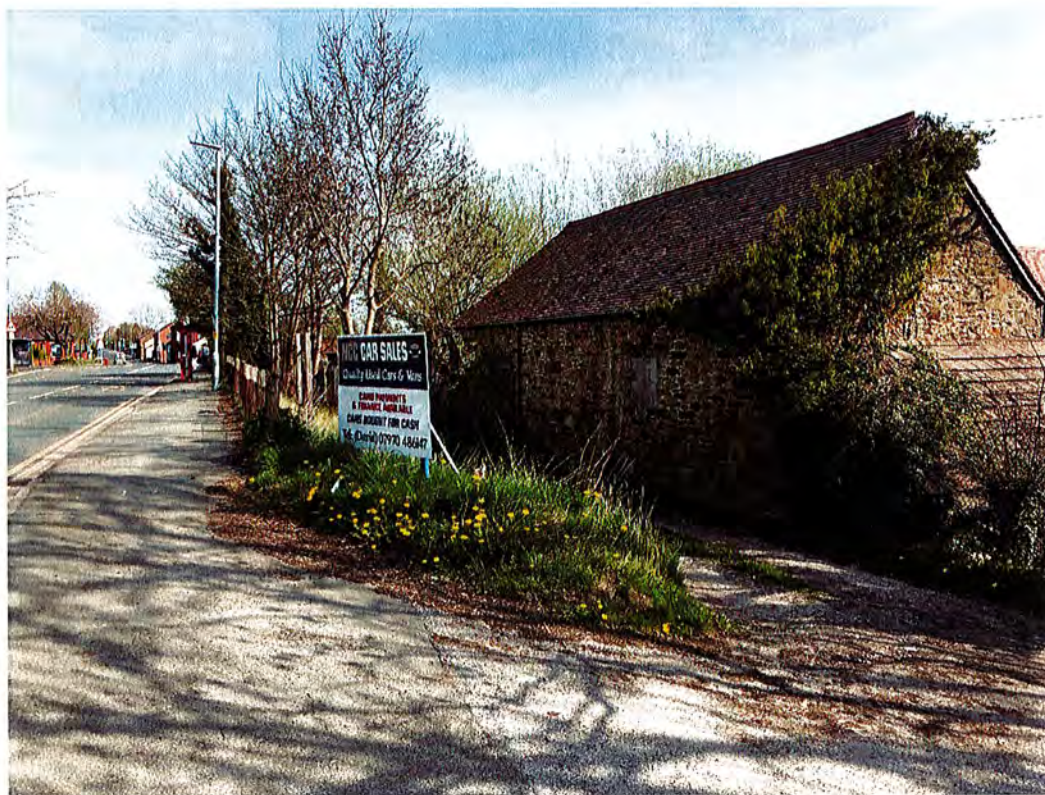
Photograph 2 – Western boundary of site showing elevation difference from Ruabon Road

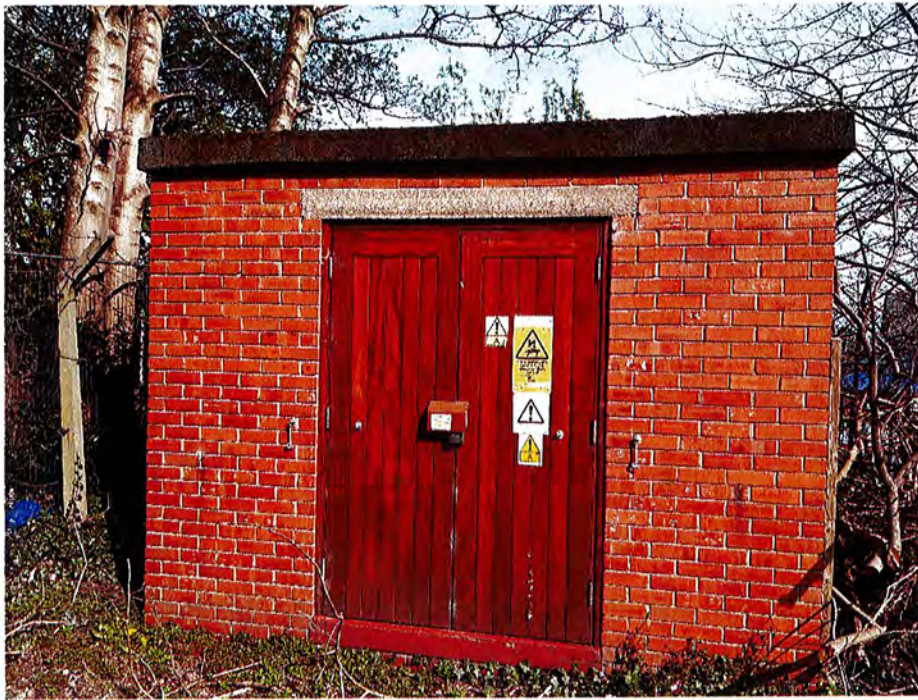
An electrical substation is also situated immediately northwest of the site, together with a bunded fuel tank, although no evidence of leaks was noted during the site walkover.

Photograph 5- Facing north showing the substation.

Also, a hand excavated trial pit adjacent to the sub-station failed to encounter any visual or olfactory evidence of contamination, which again was confirmed by the chemical testing.

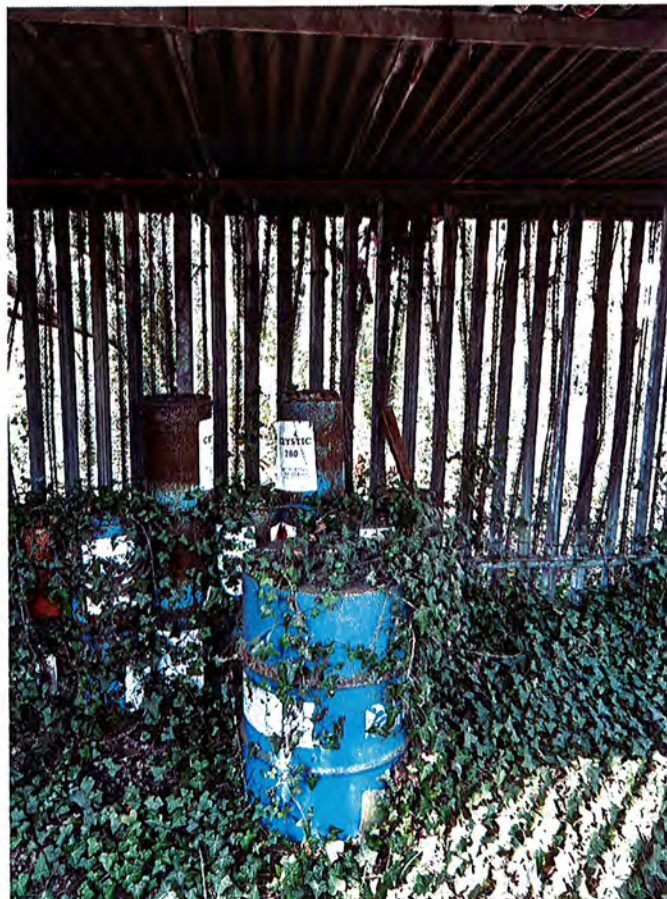
Photograph 6- Showing the chemical storage facility.

Additional testing has been undertaken beneath the chemical storage area, and the results will be forwarded to the Local Authority on receipt. However, it should be noted that ground levels are to be raised in the garden areas of Plots 1 to 3, which will provide sufficient cover to address any residual risks.

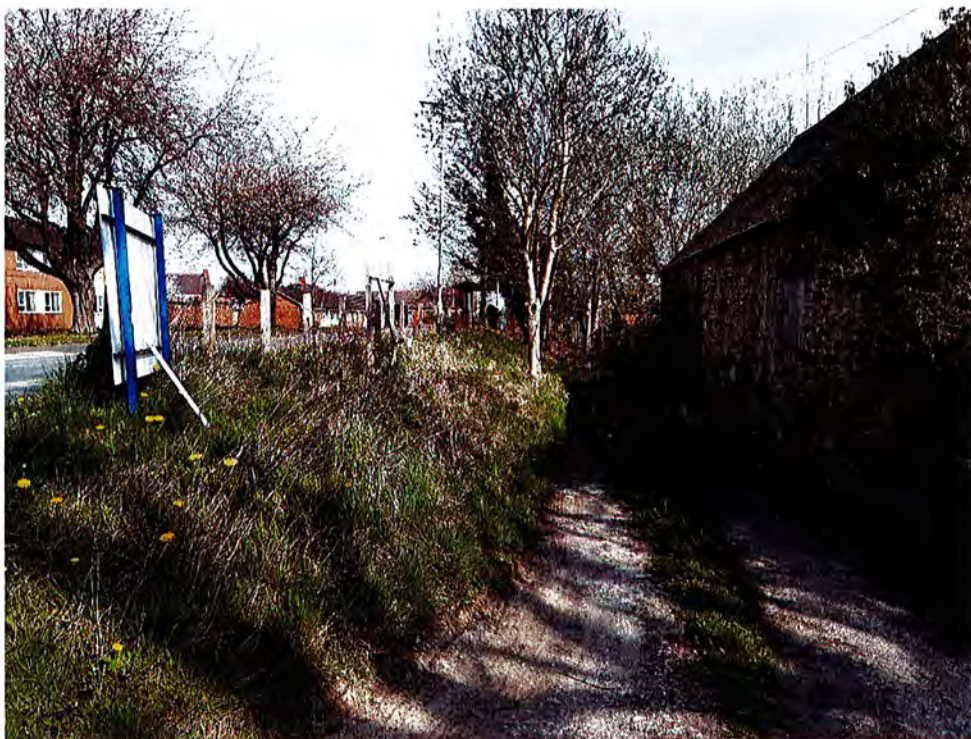
Photograph 7- Facing North showing difference in road and site level.

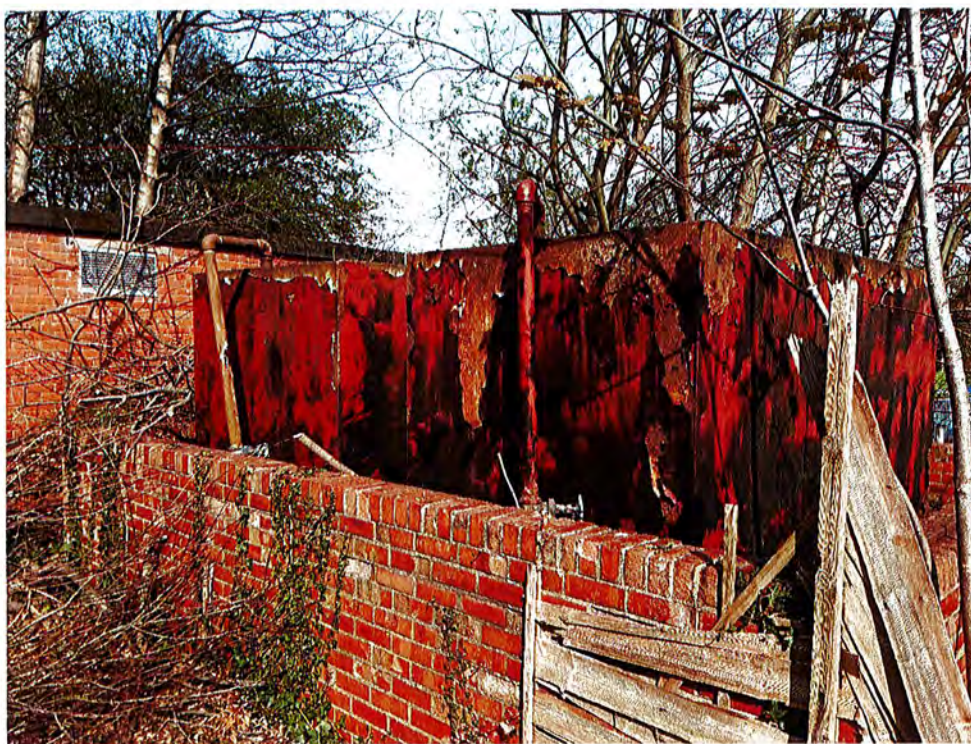
The desk study has revealed that the site has historically been in residential use, and later used as a factory, before being used as a car/tyre sales and vehicle repair centre, with fuel tanks still visible on site, although these are above ground and bunded, with no evidence of fuel spills outside of the tank perimeter.

Photograph 8- Showing tanks on site.

The bunded fuel tanks have been removed during the demolition works and TP101, excavated at their location, failed to reveal any visual or olfactory evidence of any hydrocarbon contamination, which was confirmed by the subsequent testing. In addition, no pipes leading from the tanks were encountered during their removal.

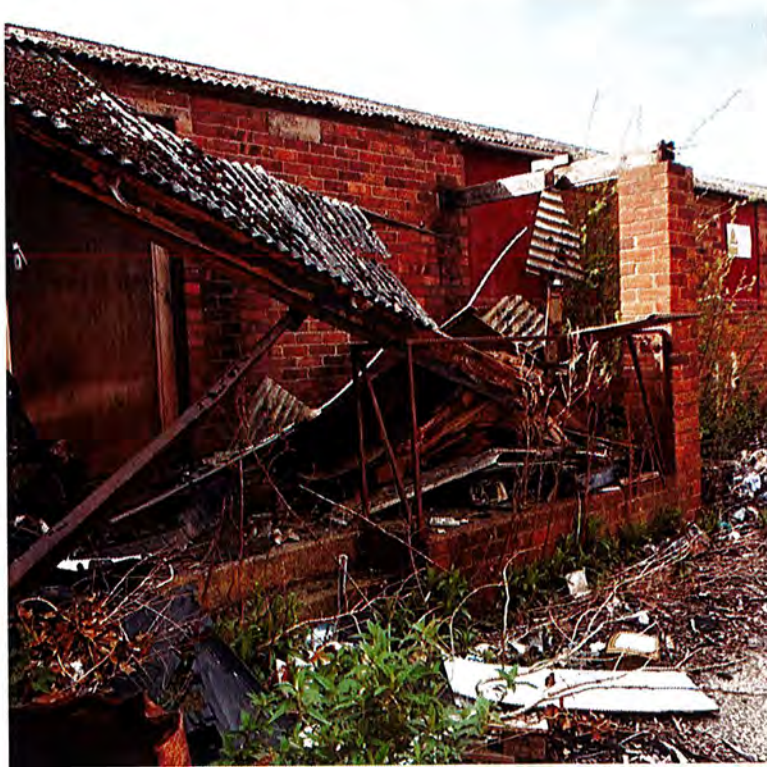
Photograph 10- Facing west showing partly demolished extension to the masonry building.

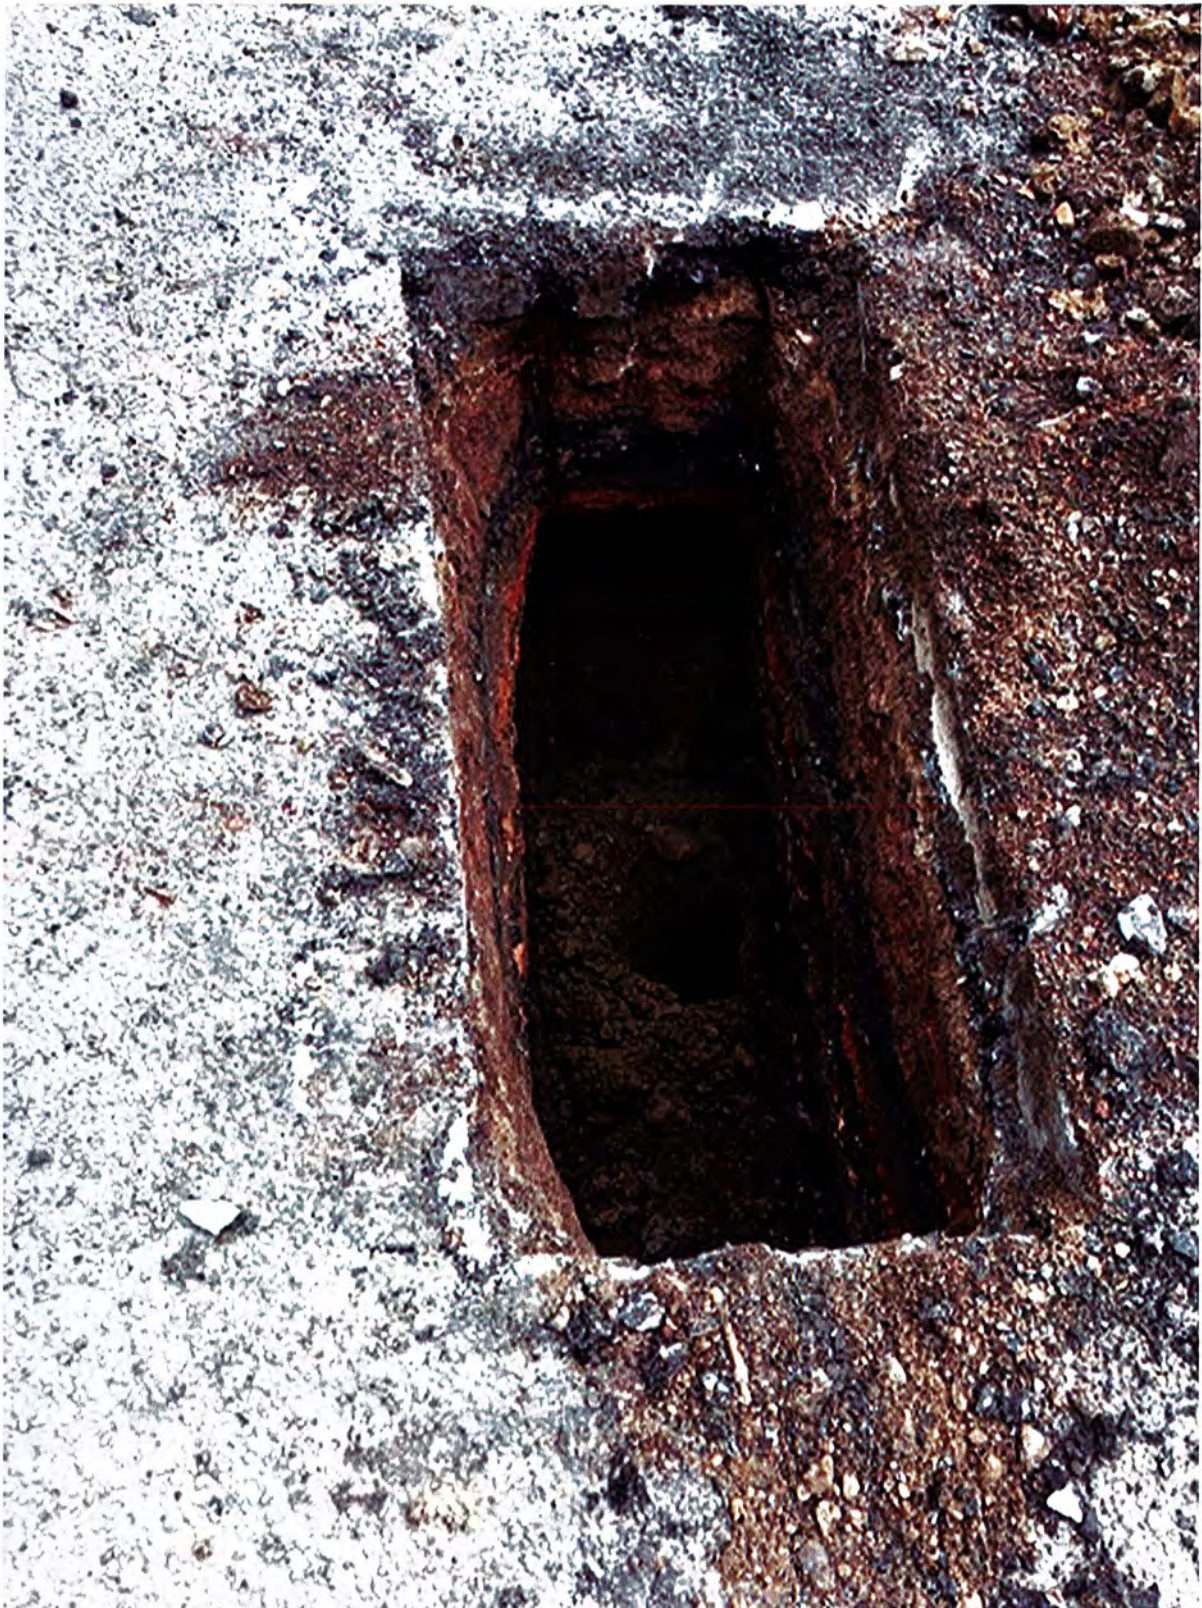
Trial Pit 1

1. Trial pit machine excavated to 1.00m then continued by auguring to 1.70m.
2. Minor seepage noted at 1.00m.
3. Sides of pit stable.
4. Samples taken at 0.20m for chemical testing
5. Samples taken at 1.20m for physical testing
6. Soakaway test carried out.

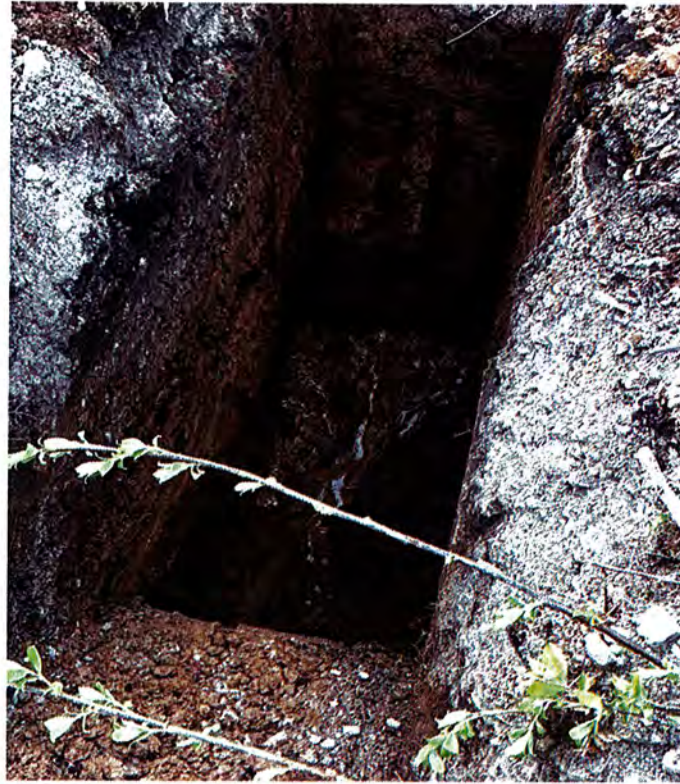
TP06- Pit Walls

However, loose bundles of Chrysolite Asbestos were detected in TP06, which was subjected to quantification testing, recording a value of 0.14%.

Asbestos was detected in the northeastern corner of the site, although these were very low (0.14%) and not considered to present a risk, if covered by a building/ hardstandings or a suitable thickness of inert material. In addition, additional testing in this area failed to encounter any further asbestos.
