**Althrey Woodhouse**  
**Overton Road**  
**Bangor-on-Dee**  
**LL13 0DA**

## **Interim Bat Survey Report**

**Moss Company**

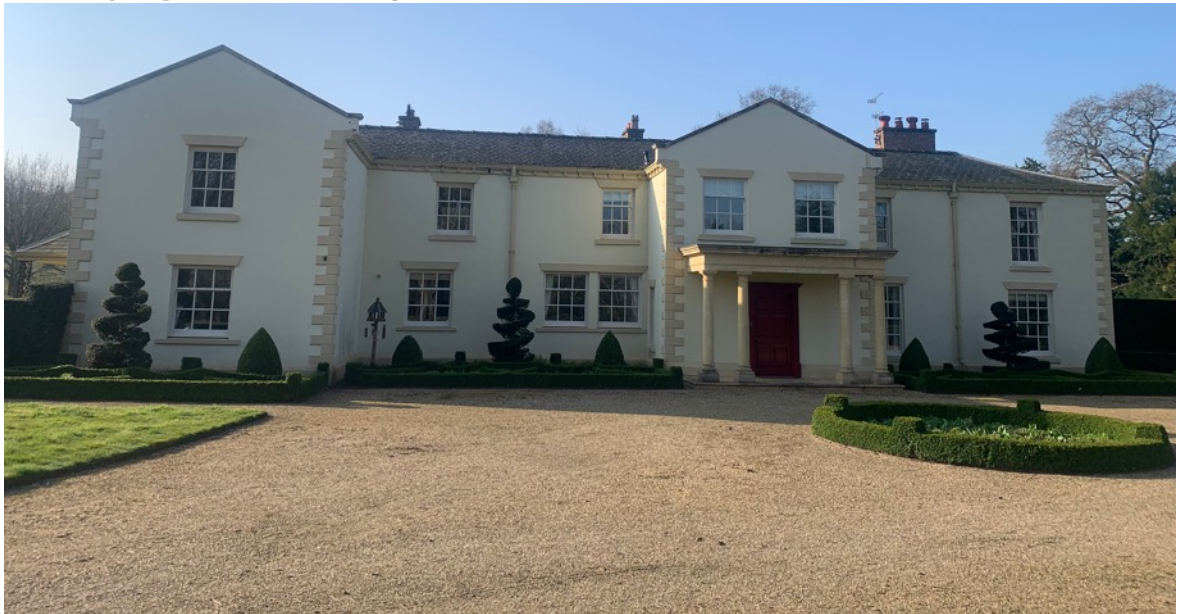
**Photograph 1.** Althrey Woodhouse

Althrey Woodhouse is a detached dwelling (**Photograph 1**) with lawns and shrub beds to the west and south and an area of tarmac forming a parking area to the east of the house.

The existing house was brick built with all external walls rendered and painted. Each corner of the house features stone quoins. The house is rectangular in outline with two pavilions extending from the eastern elevation (**Photograph 1**).

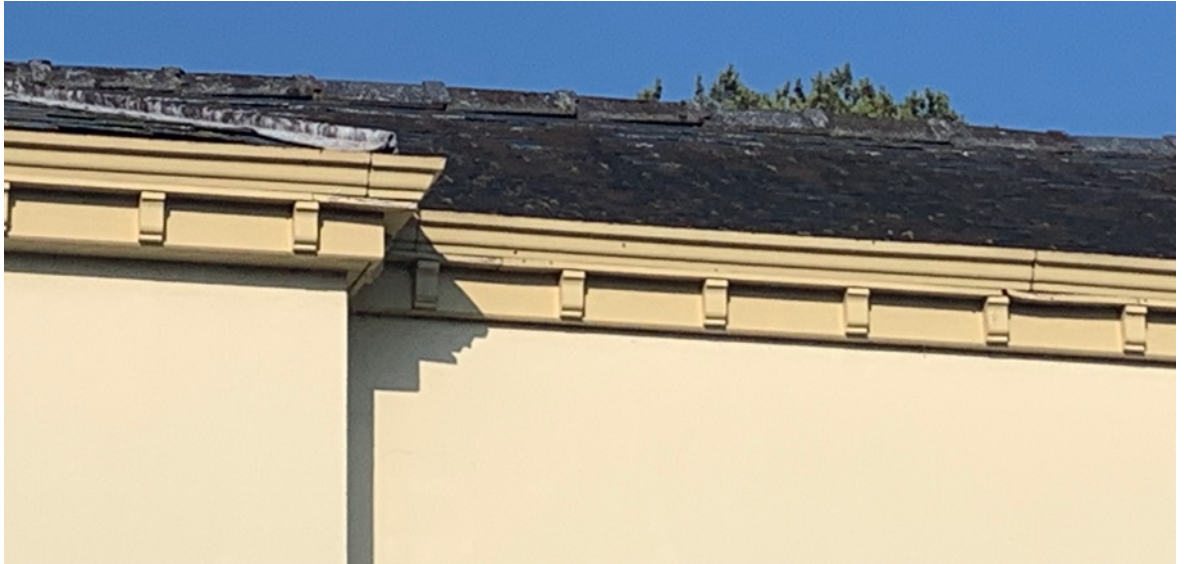
**Photograph 2.** Althrey Woodhouse

The house was brick built with all external walls rendered. The roof was slated with clay ridge tiles on the main ridge with lead flashing over hipped ridges and around chimney stacks. Wooden soffit boxes were present on all elevations with wooden framed windows present.

- Gaps beneath slates (**Photograph 2**).
- Gaps at ridge tiles (**Photograph 2**).
- Gaps around lead flashing (**Photograph 2**).
- Damage to soffit boxes (**Photograph 3**).

The PRA survey concluded that the building is of moderate suitability for roosting bats. A minimum of two nocturnal presence/absence (dusk 'emergence' and dawn 'return to roost') surveys are required prior to any works to evaluate if bats are entering/exiting the building at dawn/dusk, in addition to identifying bat species and numbers/type of roosts (if present).

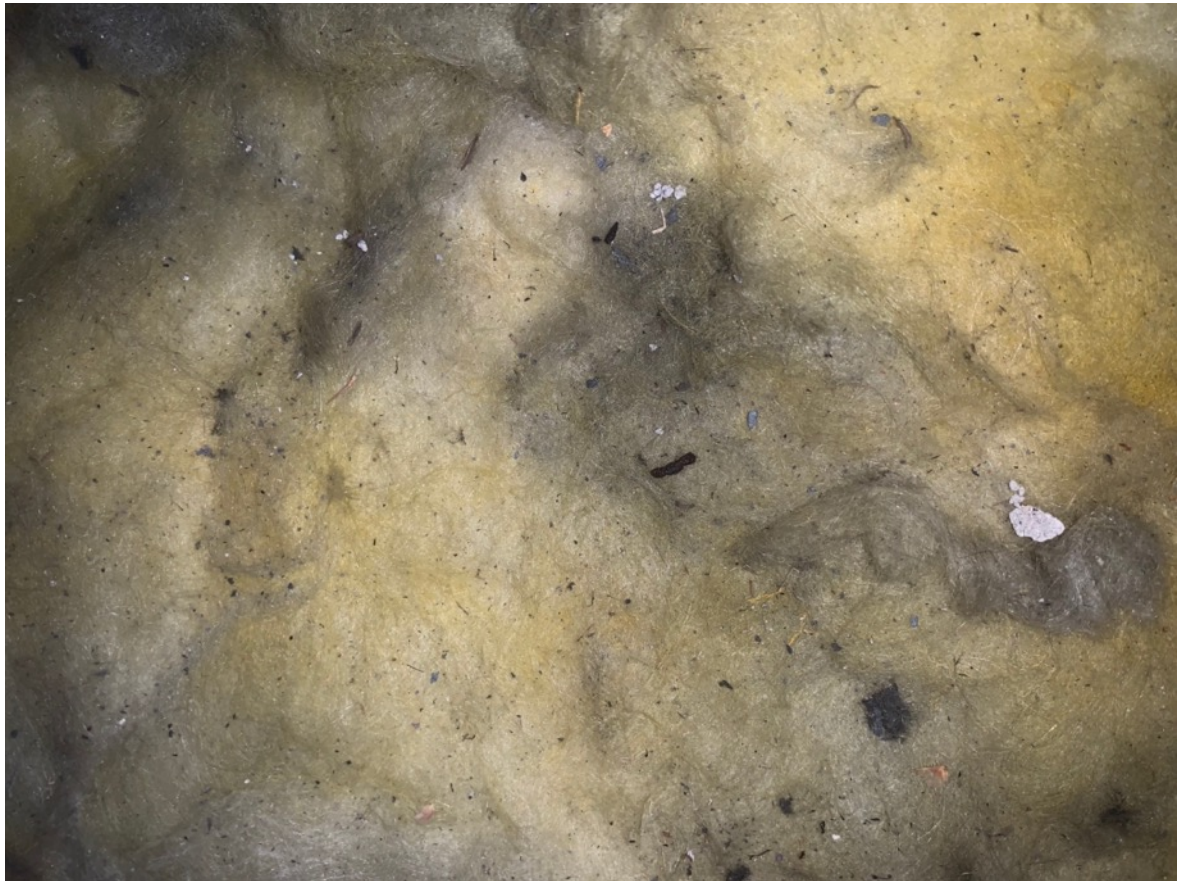
**Photograph 4.** Bat dropping within roof void

The roof void was inspected. The accessible areas were either lined with bitumen felt or 1F lining over a wooden frame and loft floors are insulated with rock wool.

Within the accessible area of the void ten relatively old scattered bat droppings were present (**Photograph 3**), not obviously associated with any PRFs.

Given the presence of PRFs and old bat droppings, the house was assessed to be of **MODERATE POTENTIAL** for roosting bats (**Table 1**).
