## RAFA CLUB, WREXHAM

# PRELIMINARY ROOST ASSESSMENT & REASONABLE AVOIDANCE METHOD STATEMENT

Report Ref: EE.1007.22.LB

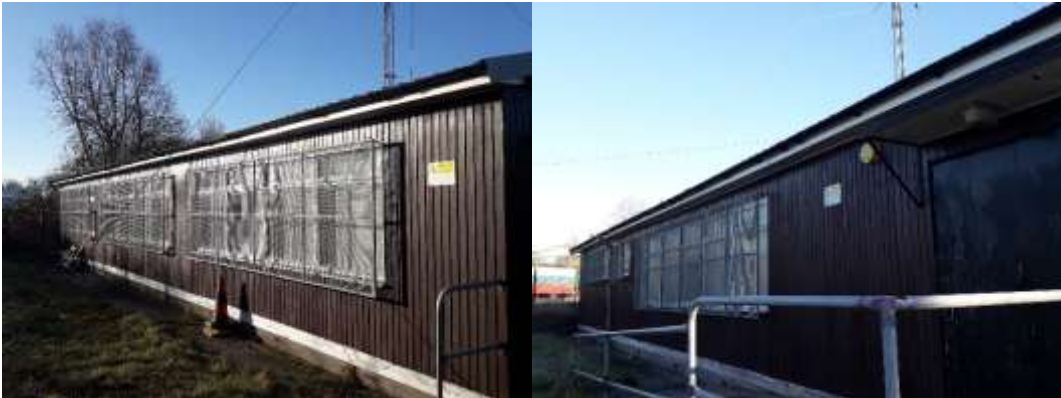
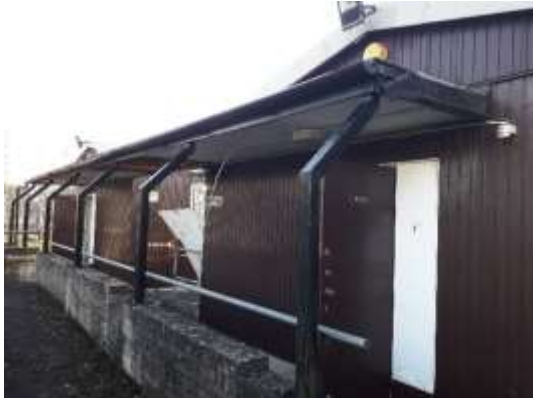
| Description | Photo |
|---|---|
| <ul style="list-style-type: none"><li>• Two single storey buildings with corrugated metal pitched roofs</li><li>• Plastic roofline</li><li>• Clad with wooden panelling</li><li>• Canopy comprised two layers of wooden boarding, with a gap of approx. 10cm between, split into sections by the internal wooden framework.</li></ul> | <p><i>EASTERN AND WESTERN ELEVATIONS</i></p> <p><i>WOODEN CANOPY TO THE NORTH OF THE BUILDINGS</i></p> |

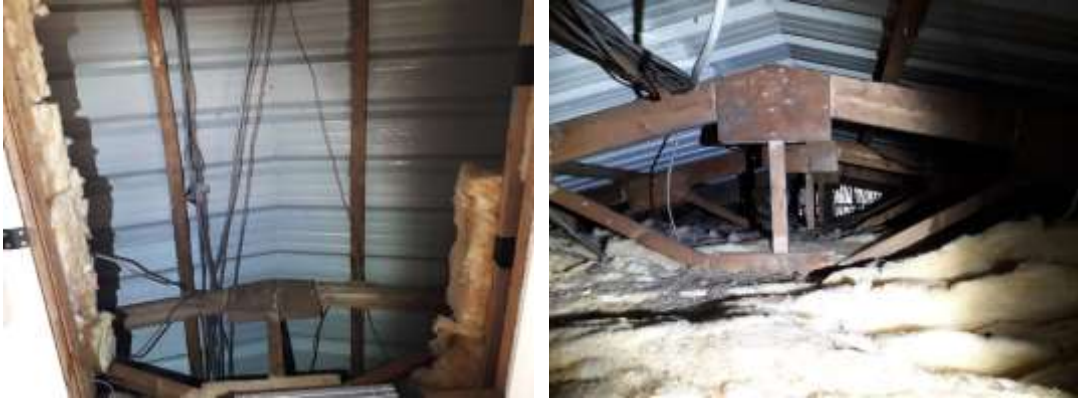
| Description | Photo |
|---|---|
| <ul style="list-style-type: none"><li>• Single skin, corrugated metal roof with a wooden frame.</li><li>• Approx. 50cm to the roof apex</li><li>• Glass fibre insulation present</li></ul> | <p><i>Roof Void</i></p> |

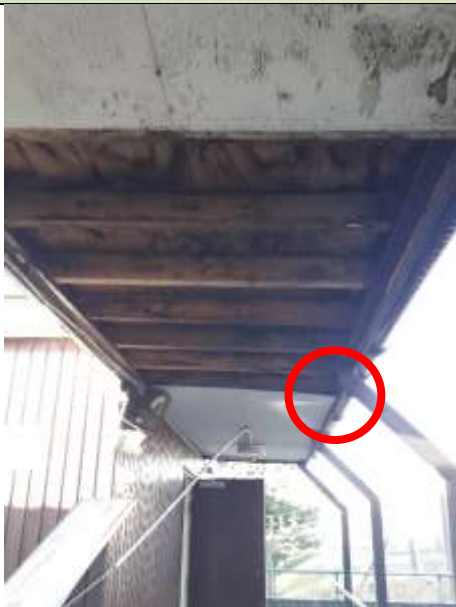
**TABLE 5.1 POTENTIAL ROOSTING FEATURES FOR BATS AND BIRDS**

- 5.1 No bats or signs of bats were found externally or internally.
- 5.2 The wooden cladding, fascias, soffits and bargeboards were all in very good condition with no potential roosting features identified. The roof space was well sealed and had very limited potential for roosting internally. A few of the wooden panels were missing from the walkway canopy, and one board was coming away at the corner leaving a small potential gap to enter. Details of this feature is provided in Table 5.1.

| Description | Photo |
|---|---|
| A piece of the wooden panelling forming the canopy was coming away at the corner, leaving a potential gap to enter the structure. | |

- The wooden boarding, forming the canopy along the front of the buildings, must all be removed by hand, and checked for the presence of bats before being fully removed and discarded.
