# Arboricultural Impact Assessment

| <b>Site Address</b> | Kronospan, Maesgwyn Farm, Wrexham LL14 5NT |
| <b>Proposal</b> | Creation of an Engineering Store to the South West of the Kronospan site |
| <b>Report Reference</b> | 220627-1.1-AIA-ESK-T21-MW |

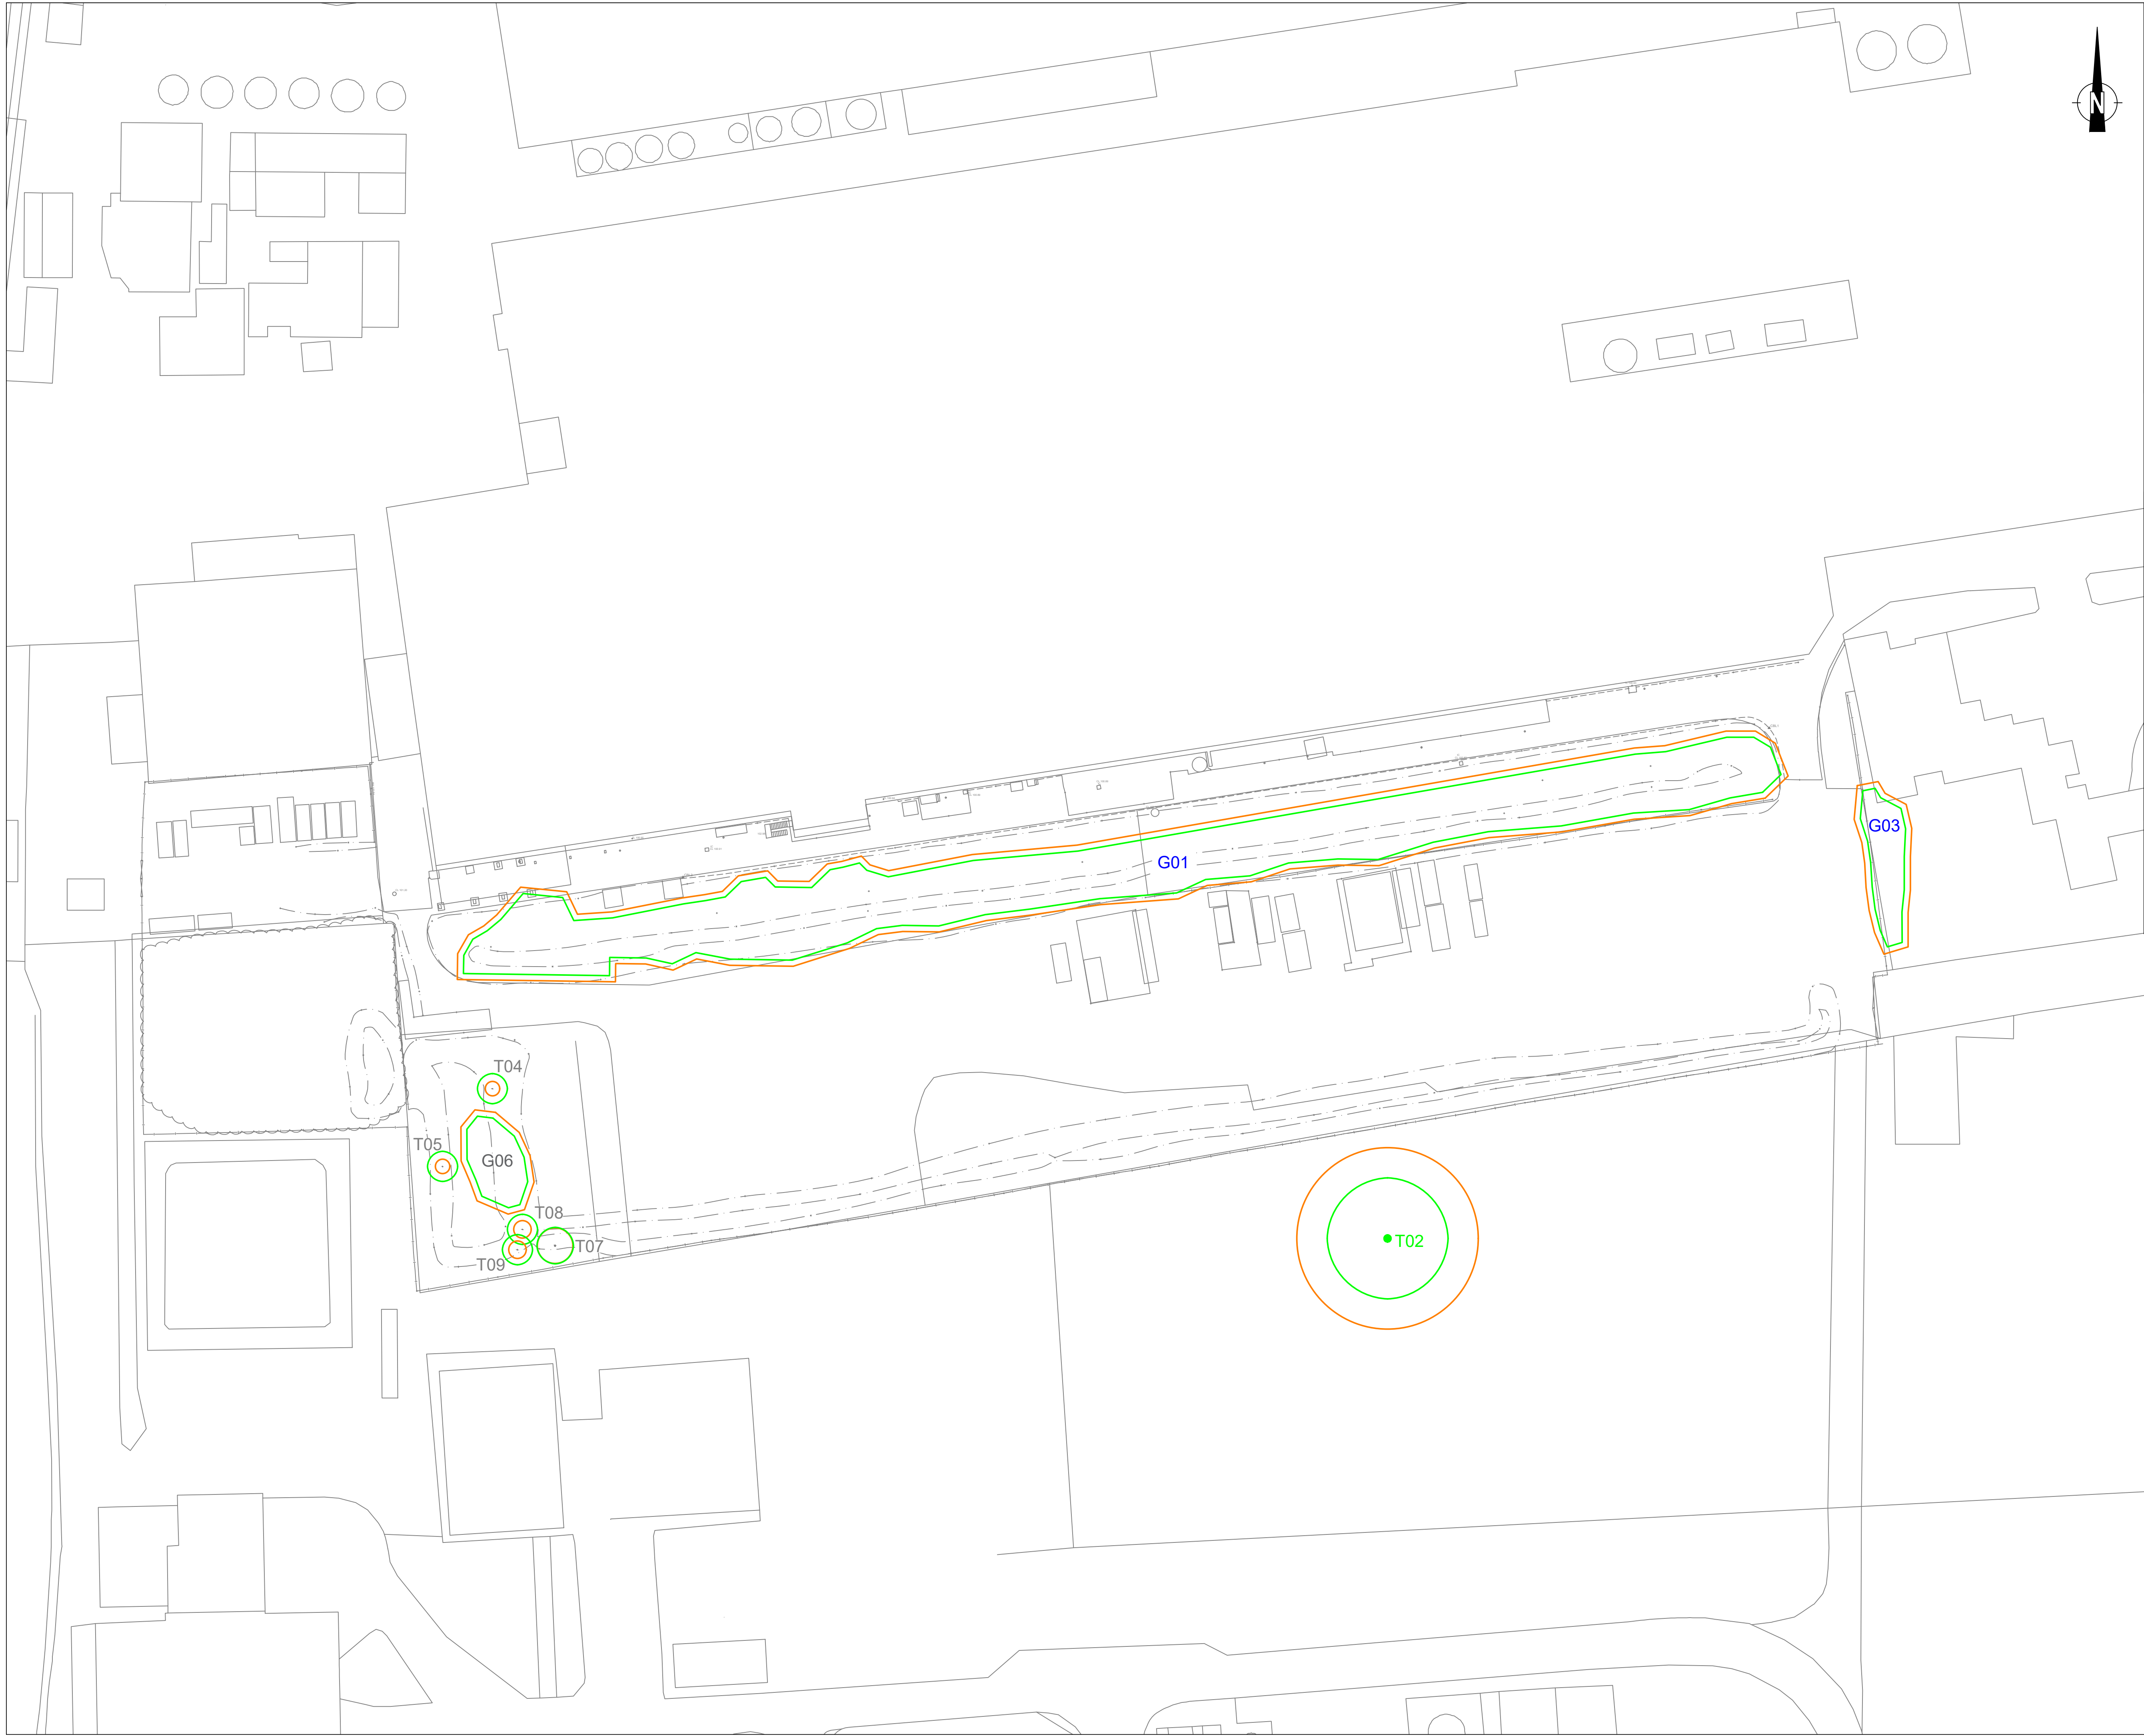
220303-1.0-ESKC-TCP-AM

- 10.1 The site occupies an existing stock pile area on the south west of the site. An early mature Leyland Cypress screen (G01) has been planted on an existing bund, which helps soften and screen the Kronospan Plan from the south. The stockpile area, located between G01 and the boundary fence to the south is generally level, with various paraphernalia associated with the Kronospan plant. There is another soil bund between the stock pile area and the boundary fence to the south, which continues to the west. Trees on this soil bund (T04, T05, G06, T07-T09), to the west are not considered valuable, although they do have some limited wildlife opportunity. T02 is a valuable mature Oak outside of the site and does not extend into the site, above or below ground. This tree is also separated by the existing boundary fence, to the south of the bund. G03, is situated in the onsite 'Farmhouse' land and is also separated by an existing fence.

**Plan showing constraints imposed on development layout by trees considered during the design process.**

- 12.1 Constraints are presented in the Tree Schedule in Appendix A and the TCP in Appendix B. These constraints are also considered further below.
- 12.2 The TCP, (Appendix B) illustrates the RPA for the trees identified in the Tree Data Schedule (Appendix A). This represents the minimum area in m<sup>2</sup> which should ideally be left undisturbed around the trees. The TCP also shows a representation of the crown spread of each tree measured in four cardinal directions. The RPA has been calculated in accordance with BS5837:2012 Trees in Relation to Design, Demolition & Construction – Recommendations.
- 12.3 The TPP (Appendix C), illustrates tree removal, retention and protective measures where considered appropriate.
