# MIDLAKE HOUSE, GRESFORD, WREXHAM:

## BAT AND NESTING BIRD SURVEYS

Report Ref: EE.920.21.JK

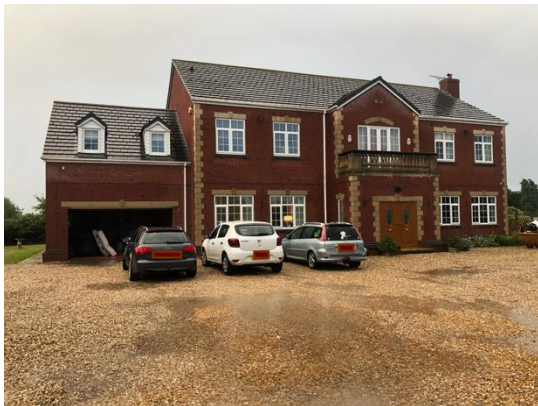
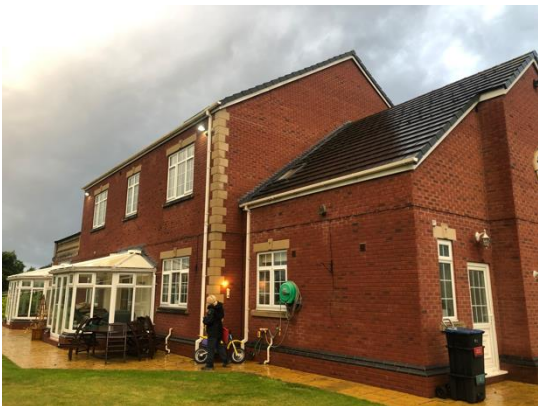
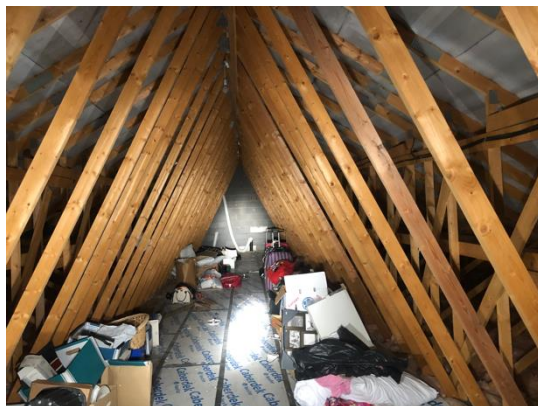
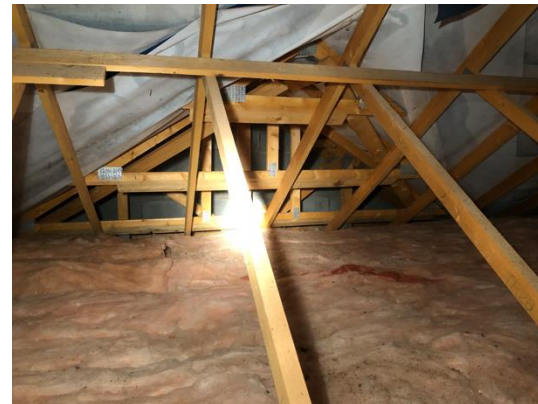
| Building Description | | | |
|---|---|---|---|
| <p>The building comprised a detached, 2 storey, red brick house built on a large plot in 2003.</p> <p>The main roof was pitched with concrete tiles and ridge. End caps on the gable ends on the main house and the garage were of a continuous dry verge system.</p> <p>The fascia's were wooden with plastic guttering.</p> <p>On the southern elevation was a single chimney breast that finished at the apex of the gable end.</p> | <p><b>WESTERN ELEVATION</b></p> <p><b>EASTERN ELEVATION</b></p> | <p>The loft space was continuous and ran the length of the main house (approx. 17m x 11m). The apex was 3.5-4m in height with a wooden frame. Gable ends were breeze block.</p> <p>On the eastern elevation, the roof space continued into the front gable.</p> <p>Underneath the concrete tiles was a breathable membrane lining.</p> | |

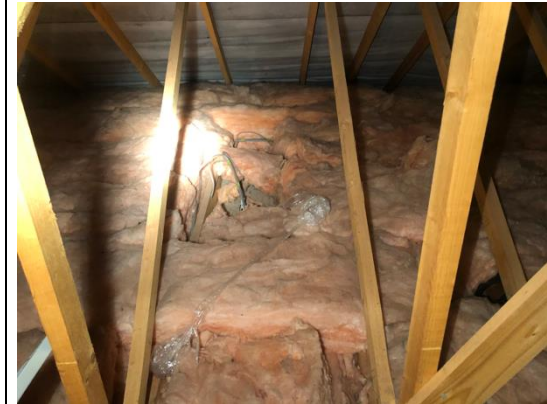
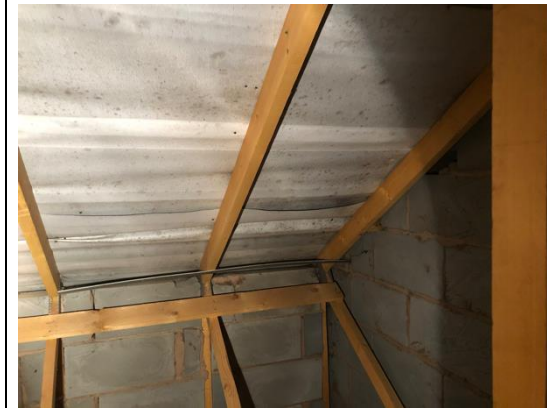
Where visible, the loft floor was boarded with the majority having a covering of insulation

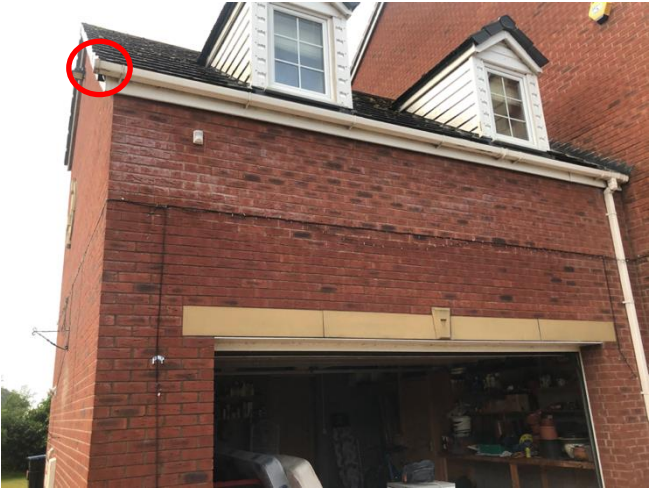
The continuous dry verge was in good condition; however, the end caps were missing on all dry verges, leaving the potential for bats to gain entrance under the roof tiles. On the northern elevation, the gable fronted dormer windows above the garage offered roosting opportunities for crevice dwelling bats where they tied in with the roof.

| Feature | Description | Example Photos |
|---|---|---|
| 1 | Missing end caps on all of the continuous dry verge giving roosting potential to crevice dwelling bats and access for birds and bats to the loft space | |

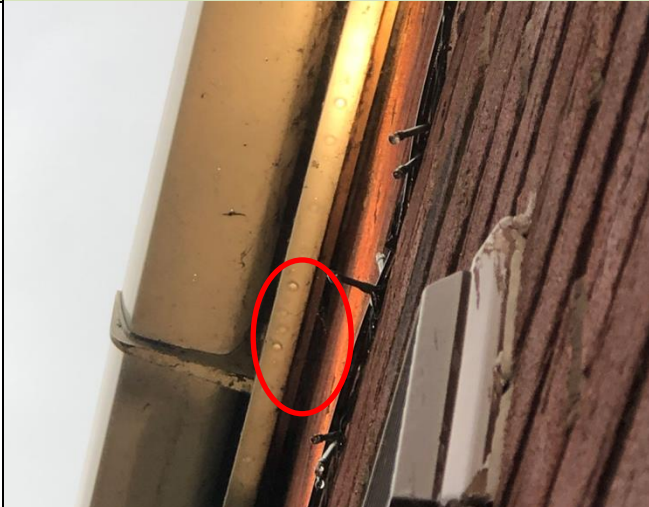
On all elevations the house had flush eaves with fascia boards in close proximity to the walls and with no soffit boards. In many areas, there were gaps behind the fascia where it appeared that mortar was missing, these were large enough to offer further roosting opportunities for bats. The lower part of the chimney on the southern elevation had gaps in places between the dry verge and the brickwork, again, offering roosting opportunities for birds and bats.

| Feature | Description | Example Photos |
|---|---|---|
| 2 | Missing mortar behind fascia boards to some elevations | |

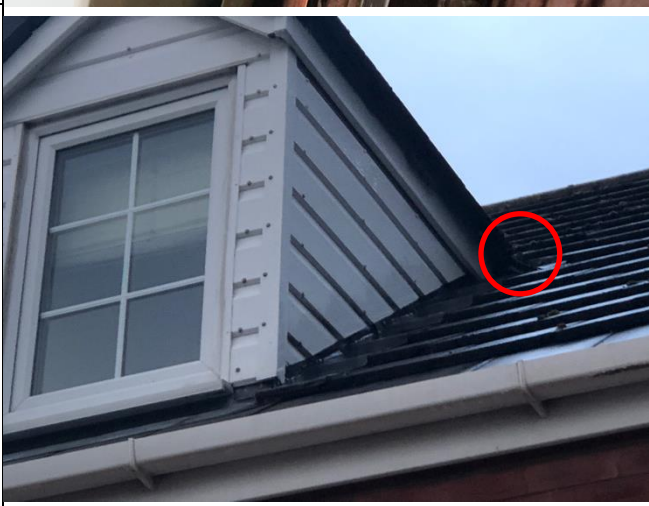
| Feature | Description | Example Photos |
|---|---|---|
| 3 | There were roosting opportunities for crevice dwelling bats under the lead flashing, where the gable fronted dormer windows above the garage tied in with the roof. | |

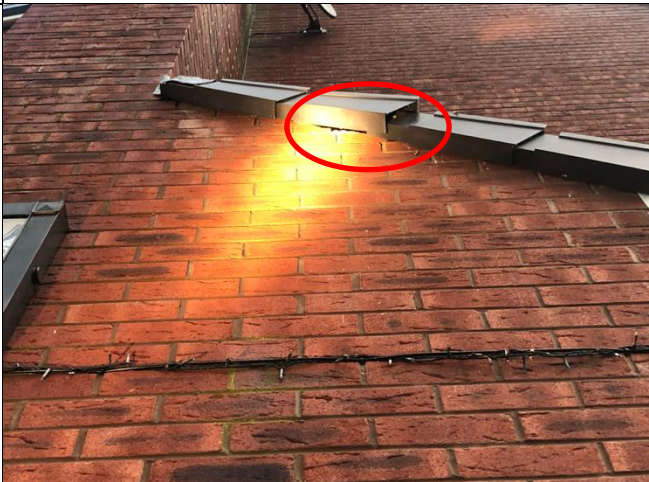
| Feature | Description | Example Photos |
|---|---|---|
| 4 | The chimney on the southern elevation had gaps between the brickwork and the continuous dry verge. These could provide roosting potential for birds and bats. | |

The chimney on the southern elevation had gaps between the brickwork and the continuous dry verge which could provide roosting potential for both birds and bats. There was no evidence of birds nesting within the building at the time of survey. The hedgerows and scattered trees around the building would also provide suitable habitat for nesting birds.

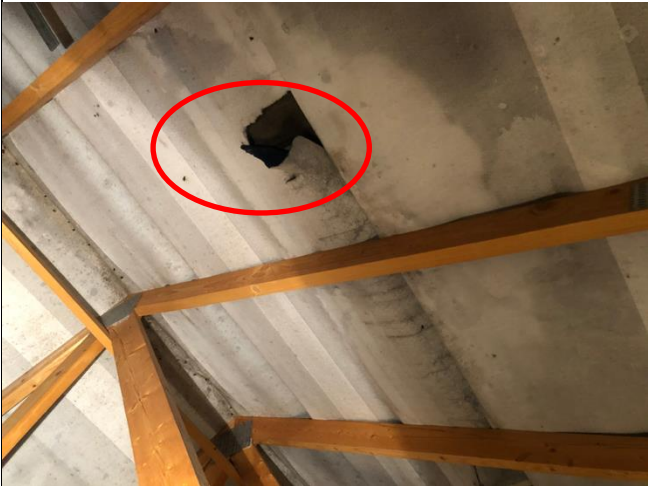
No light gaps were evident in the loft but there were a number of gaps in the membrane lining, one was a tear toward the southern elevation and another was around the flue towards the northern elevation. In many areas, the lining appeared to be loose. There were no gaps on the northern gable but the southern gable had gaps around the breezeblock into the cavity wall.

| Feature | Description | Example Photos |
|---|---|---|
| <p><b>5 –<br/>Internal<br/>Loft<br/>Space</b></p> | <p>There were holes in the breathable membrane lining and in some areas the lining was loose.</p> | |

- Should the replacement roof of the building be lined with felt, it should be lined with non-breathable Bitumen 1F felt. Breathable membranes can be fatal to bats when they get caught in the fibres and cannot escape. If it is necessary to use breathable membranes within the new roof, then the roof and tiles will be completely sealed and inaccessible by bats.
- Sufficient compensatory roosting opportunities and enhancements will be provided for bats within the site to contribute to biodiversity net gain (see 6.1.5), in the form of externally erected bat boxes around the site.

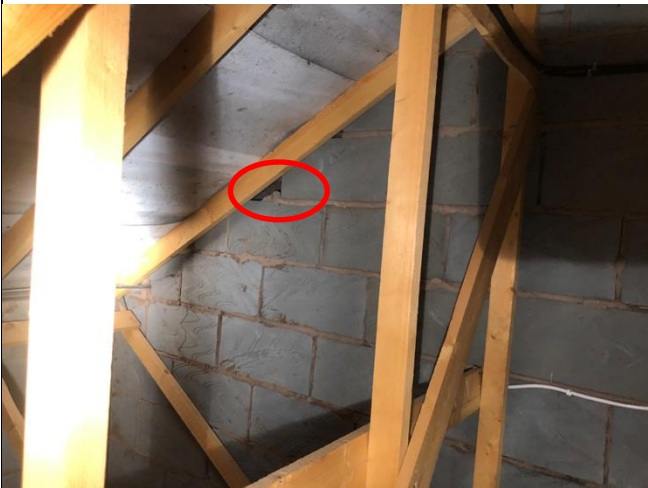
| Feature | Description | Example Photos |
|---|---|---|
| <p><b>6 -<br/>Internal<br/>Loft<br/>Space</b></p> | <p>On the southern gable end, were gaps from the loft space into the cavity wall. No gaps were seen on the northern gable.</p> | |

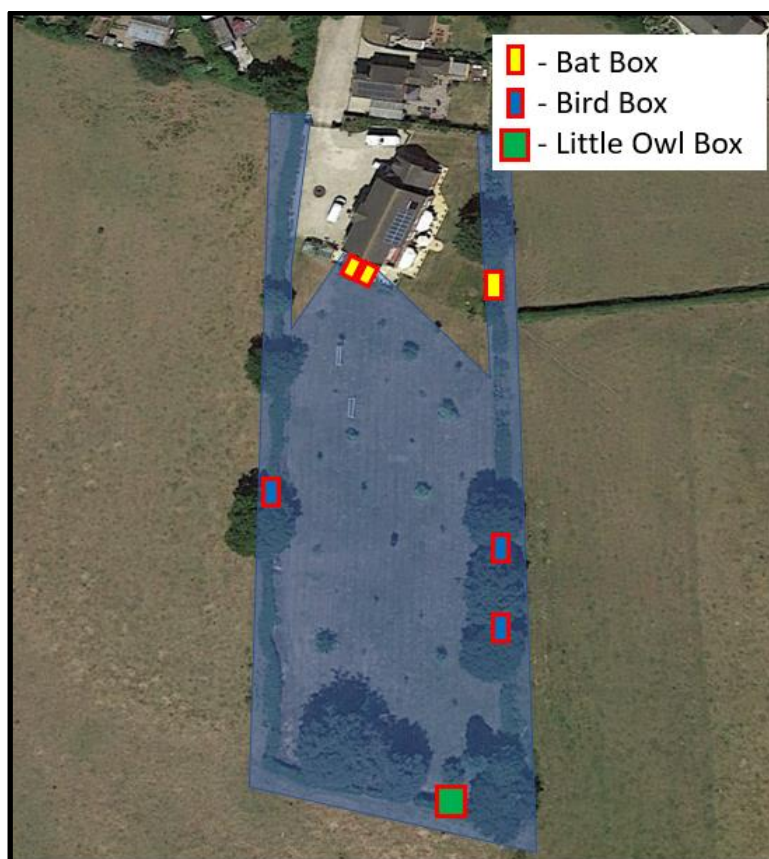
**FIGURE 6.2 – PROPOSED DARK BUFFER ZONE (BLUE) AND LOCATION OF THE PROPOSED BAT AND BIRD BOXES (NOT TO SCALE). BASE IMAGE ©GOOGLE EARTH 2021**

- There must be no lights focused on the adjacent hedgerows to the east and west of the site. There will be a dark 'buffer zone' along these hedgerows and over the garden to the south that will not be subject to light spillage (Figure 6.2). There will be no illumination of the recommended bat mitigation and bird boxes (see below) once the works are complete.

pole mounted amongst the retained hedgerows and trees to the east and west of the site (Figure 6.2 for locations), at least 3m off the ground.
