**FORMER COAL YARD, LLOYD'S LANE,  
CHIRK**

**HYDROCARBON REMOVAL VERIFICATION  
REPORT**

**May 2018**

**Report Ref: R2280-R04 v1**

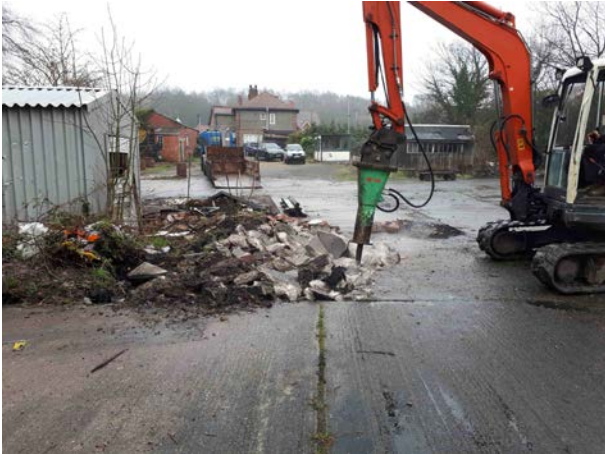
1.

12.04.18 – Breaking out of concrete hardstanding in a 2m radius around TP4.

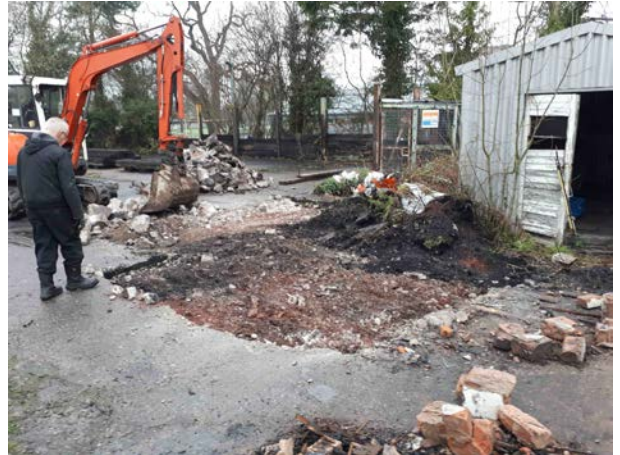
2.

12.04.18 – Exposed made ground following the removal of concrete hardstanding, consisting of crushed brick.

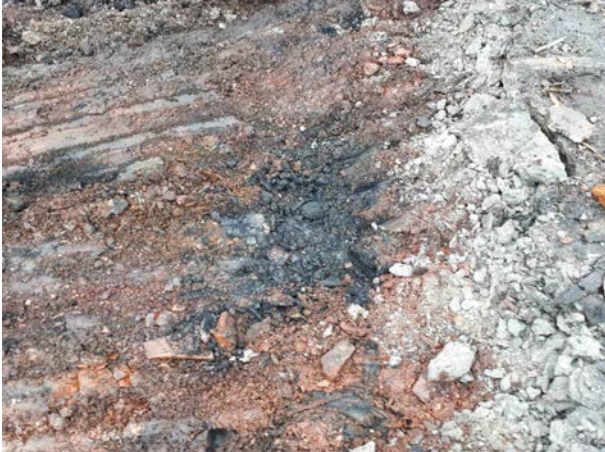
3.

12.04.18 – Minor diesel staining within the made ground.

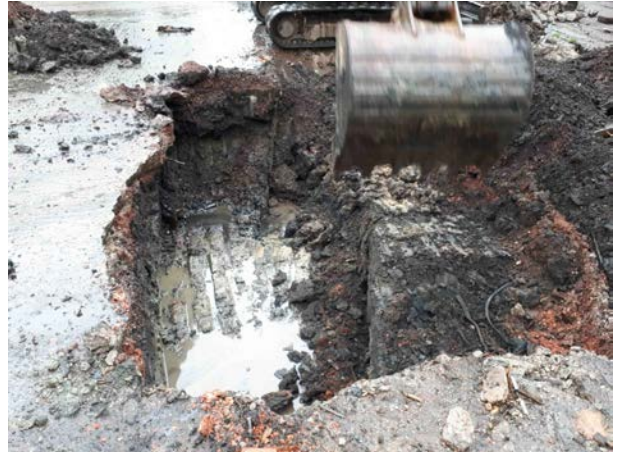
4.

12.04.18 – Excavation of made ground identified mixed waste with diesel staining. Underlying natural clay exposed.

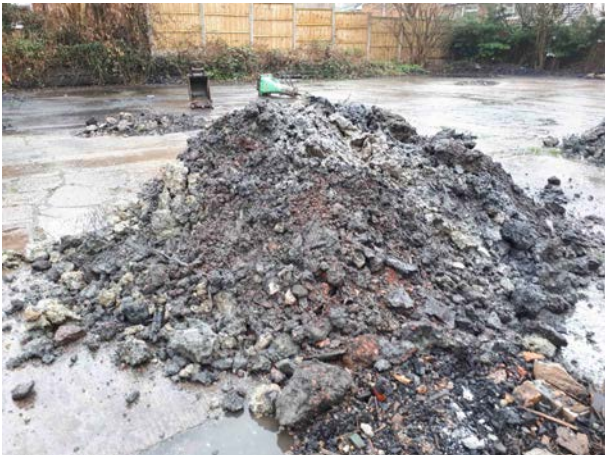
5.

12.04.18 – Diesel impacted arising segregated and placed on concrete hardstanding surface.

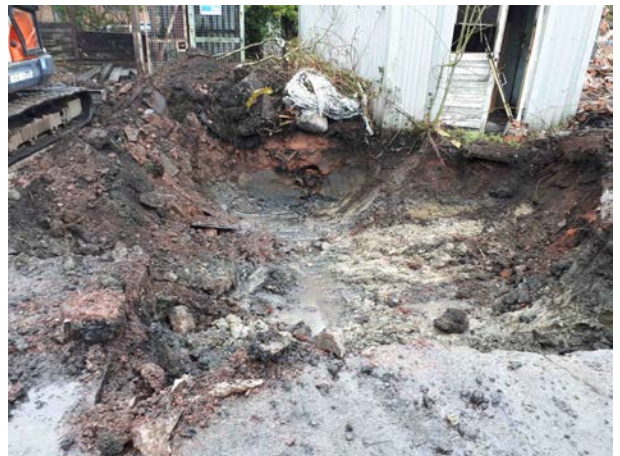
6.

12.04.18 – Made ground excavated to natural clay, disused water pipe visible at the centre of the image.

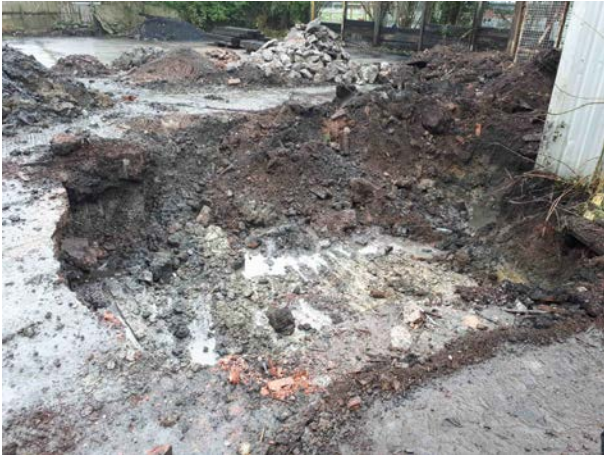
7.

12.04.18 – All diesel impacted made ground segregated from the excavation.

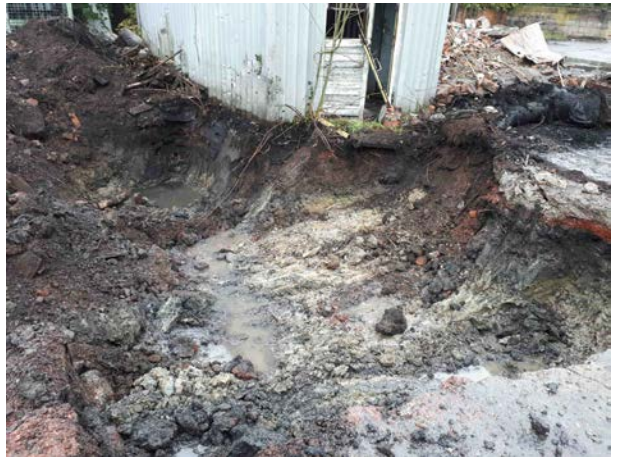
8.

12.04.18 – Pockets of water present within the made ground.

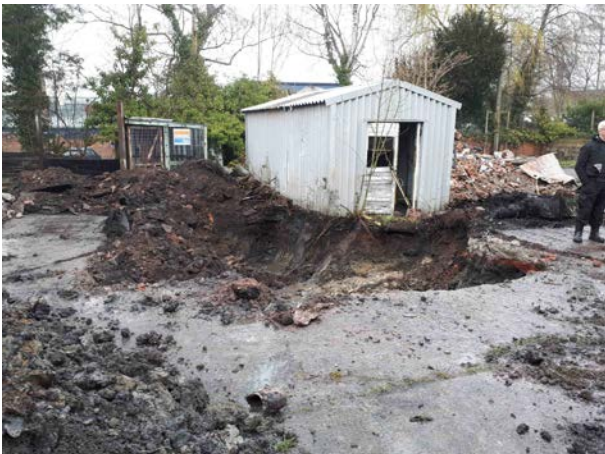
9.

12.04.18 – Facing north towards the initial excavation.

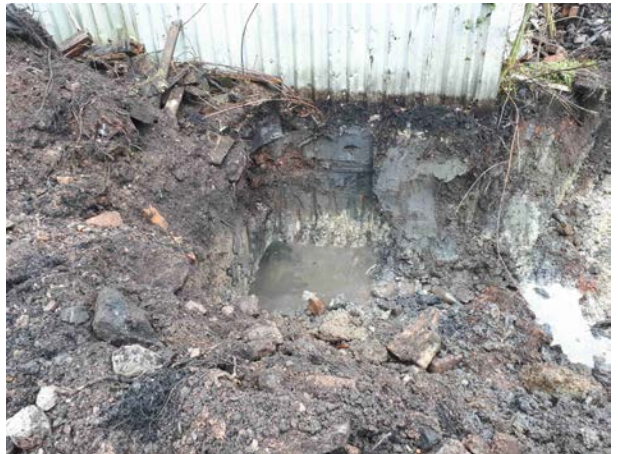
10.

12.04.18 – Excavation along the old water pipeline northwards adjacent to the tin shed.

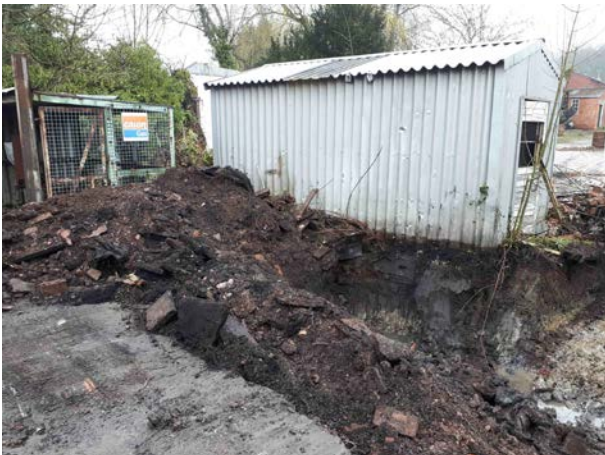
11.

12.04.18 – Extent of northwards excavation of the pipeline to the northern boundary of the site.

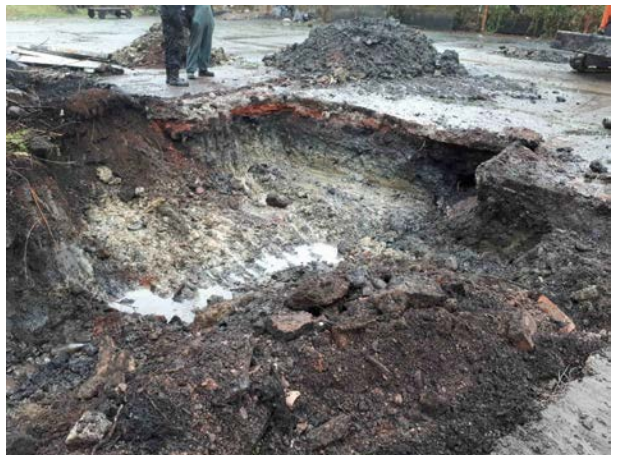
12.

12.04.18 – Visible diesel impacted made ground present to the south of the initial excavation.

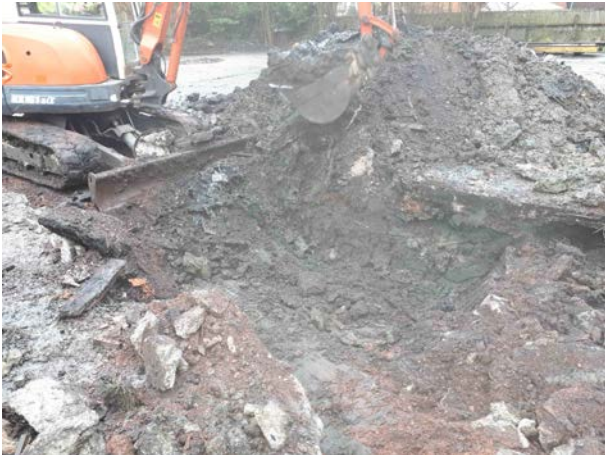
13.

12.04.18 - Excavation continues southwards along the extent of the old water pipeline.

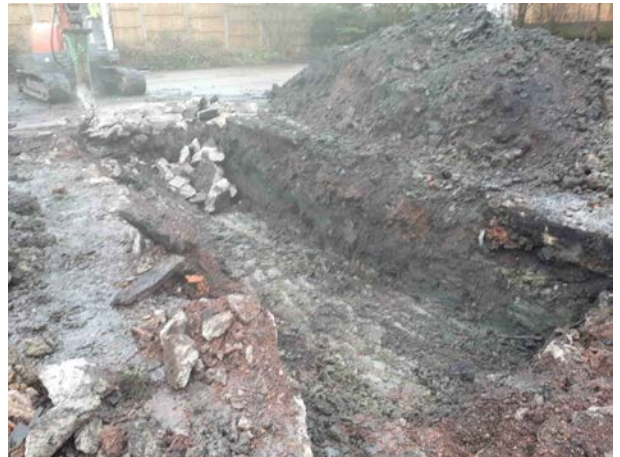
14.

12.04.18 - Excavation undertaken to underlying natural clay, diesel impacted made ground stockpiled to the west of the excavation.

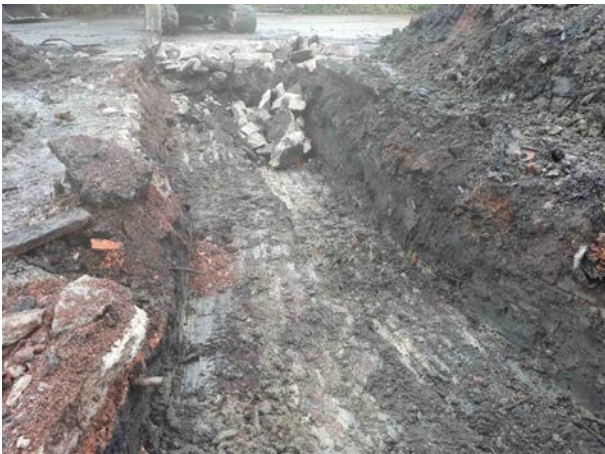
15.

12.04.18 - Exposed clay along the central extent of the excavation continuing southwards.

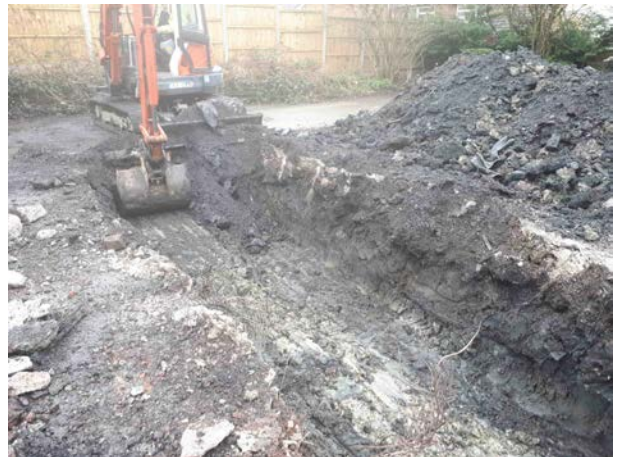
16.

12.04.18 – Made ground being excavated to the natural clay.

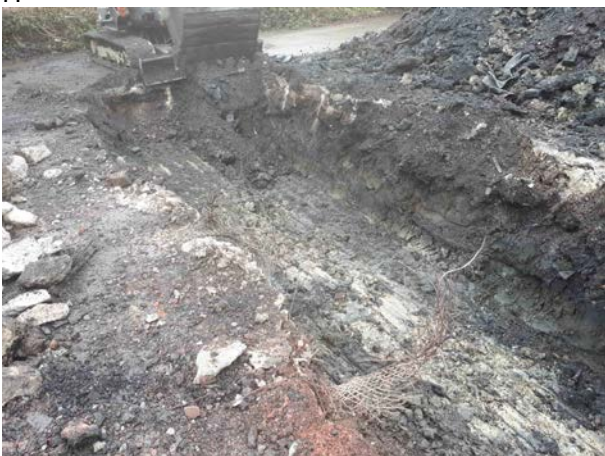
17.

12.04.18 – The western portion of excavation continued to a greater depth as the trench continued into the underlying clay.

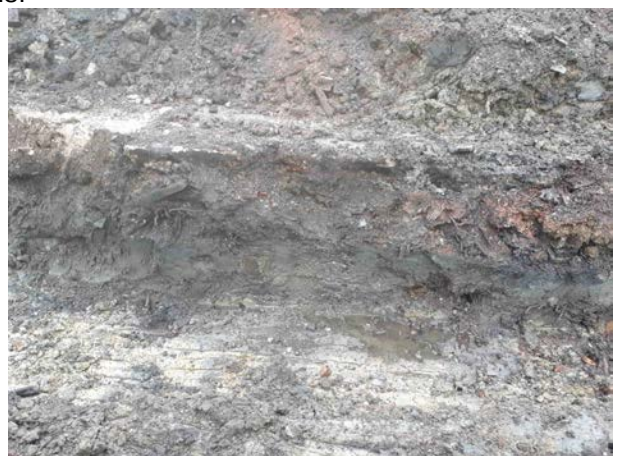
18.

12.04.18 - Typical cross section through the excavation, concrete hardstanding, crushed brick, mixed soil and inert wastes and natural clay.

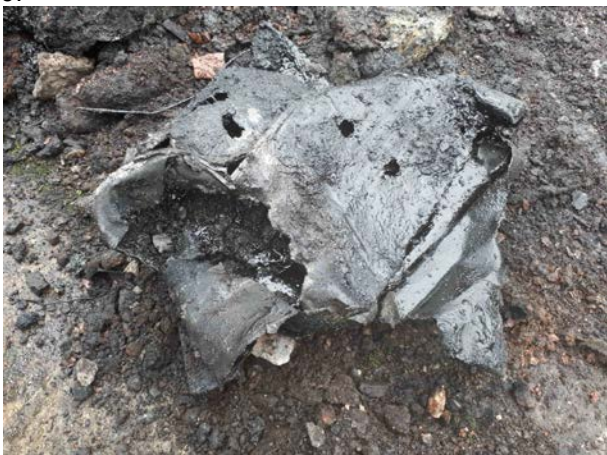
19.

5.1.2. The shallow ground conditions encountered were consistent with that described within previous intrusive reporting. A drum with residual oil/diesel present was removed from the southern portion of the excavation and is believed to be the source of the hydrocarbon contamination hotspot.

12.04.18 - Suspected contamination source following removal, an old oil drum with oily diesel residue within.

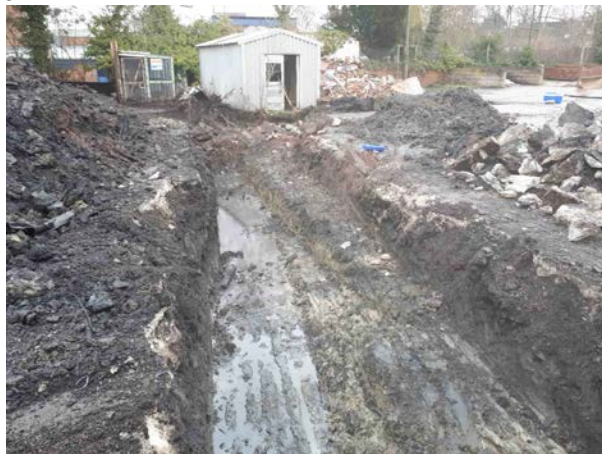
20.

12.04.18- Facing north along the extent of the excavation with impacted material to the west and clean arisings to replace to the east.

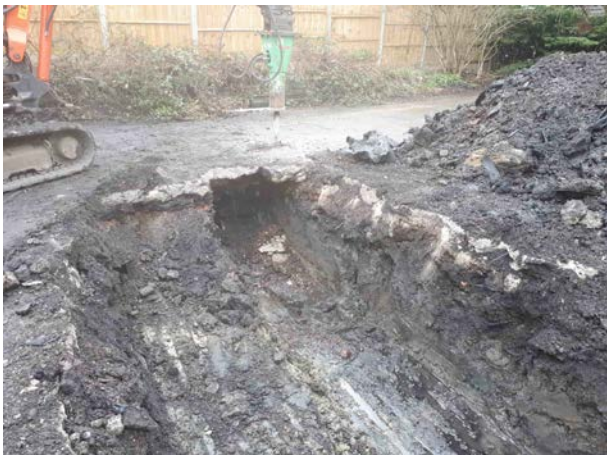
21.

12.04.18 – Breaking out concrete to the south of the drum removed to confirm contamination has only moved northwards.

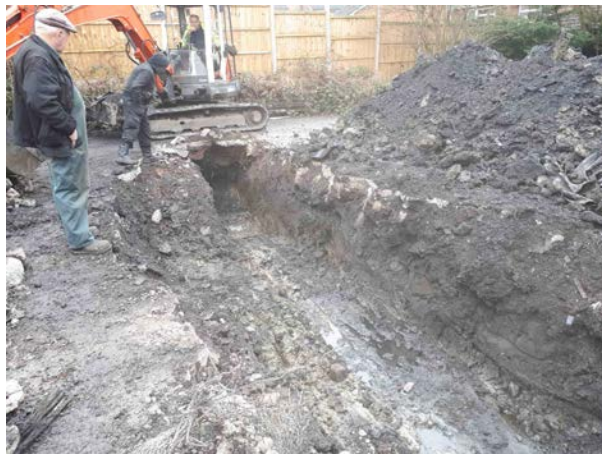
22.

12.04.18 – Excavation continued south confirms no diesel impacted made ground to the south of the drum.

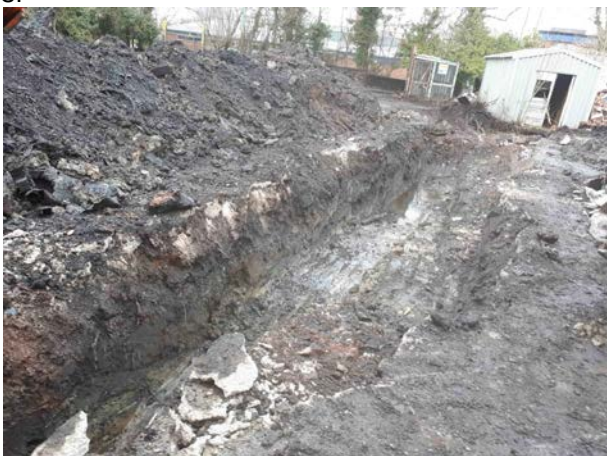
23.

12.04.18 – Extent of excavation prior to replacement of unimpacted arisings.

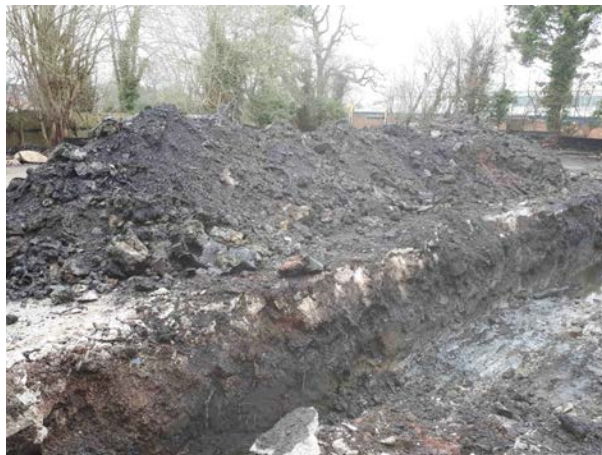
24.

12.04.18 – Extent of impacted waste material from the excavation placed in concrete hardstanding adjacent to the excavation.

4.2.7. Excavation arisings were still on site at time of writing. A representative sample (TP4HS-WASTE) of the material was submitted for a waste characterisation suite to allow an appropriate disposal route to be confirmed. The arisings must be removed by a licensed carrier to a permitted facility.

- Removal of arisings from the hotspot excavation from site;
  - Segregation and strip of ACMs from all buildings prior to demolition;
  - Removal of any surface wastes (where present);
