Phase I Geoenvironmental Site Assessment  
Bryn Lane, Wrexham Industrial Estate

Reference:14-892-R1-1  
Date: August 2021

Bryn Lane  
Grafters Ltd, Unit 6  
Wrexham Industrial Estate  
LL13 9UT

Prepared for:  
Portal Construction N.W. Ltd

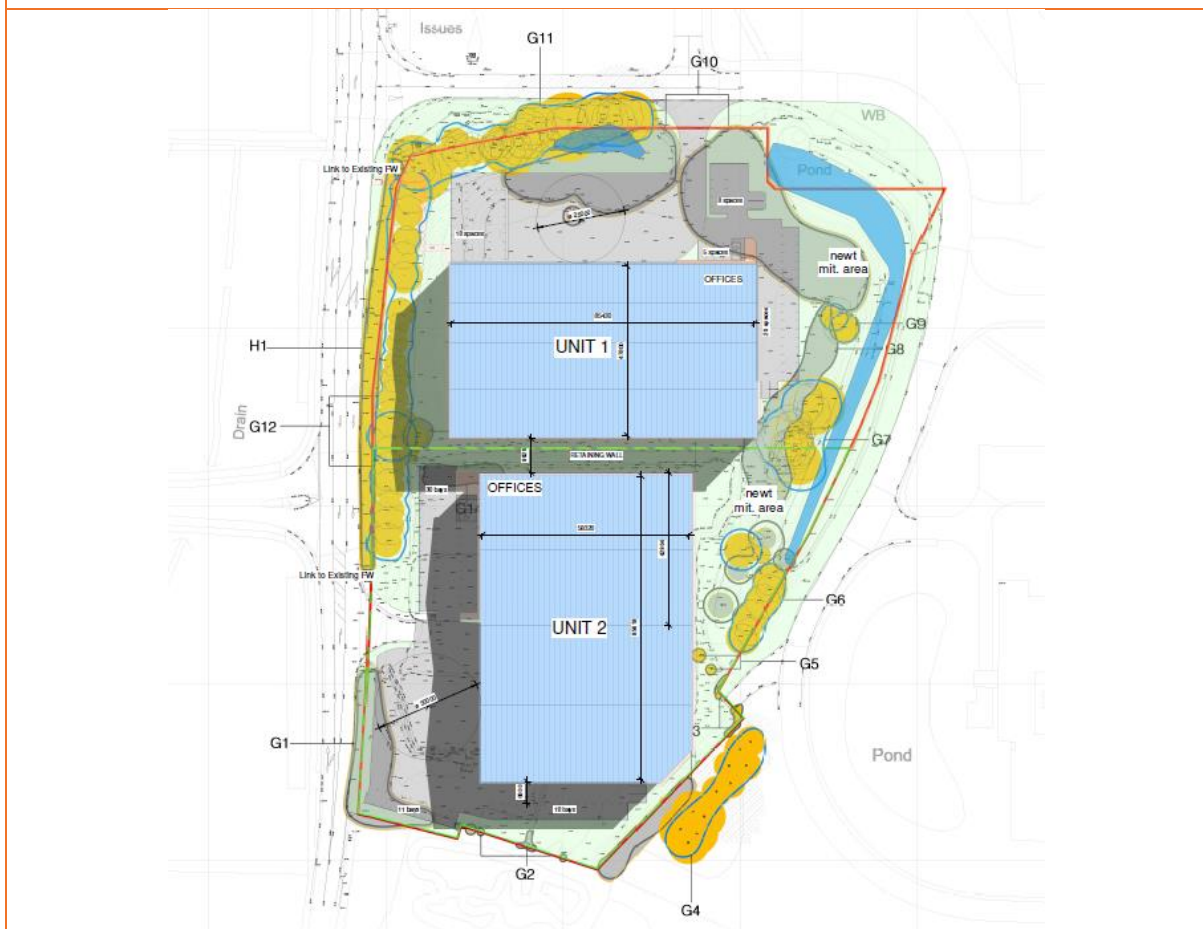
FIGURE 1.1 SNAPSHOT OF PROPOSED DEVELOPMENT OPTIONS

A snapshot of the proposed development layouts is indicated in Figure 1.1.

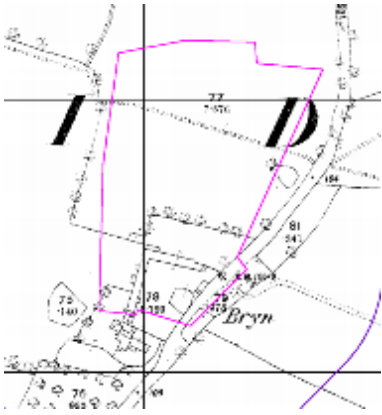
| MAP EDITION | HISTORICAL LAND USE | HISTORICAL MAP EXCERPT |
|---|---|---|
| <p><b>1873</b><br/><b>1:2,500</b></p> | <p>The site is predominantly agricultural land with a pond located along the eastern boundary and one located to the south of the site. Unspecified structures are located in the south of the site.</p> | |

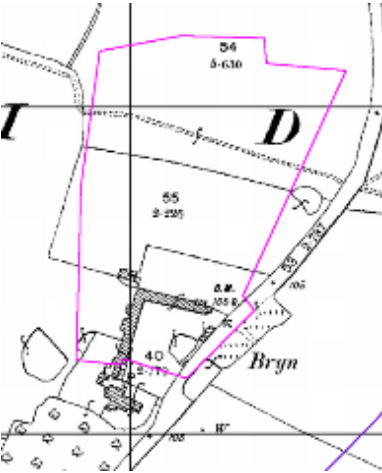
| MAP EDITION | HISTORICAL LAND USE | HISTORICAL MAP EXCERPT |
|---|---|---|
| <p><b>1899</b><br/><b>1:2,500</b></p> | <p>Two pumps are recorded on the southern boundary of the site with close proximity to the buildings present.</p> | |

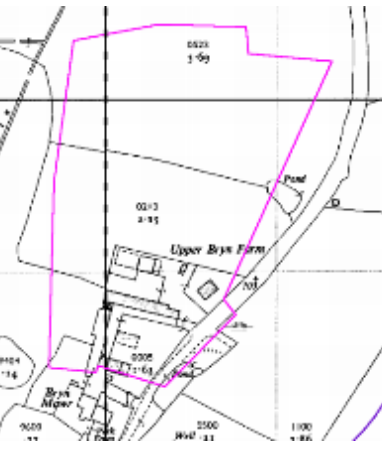
| MAP EDITION | HISTORICAL LAND USE | HISTORICAL MAP EXCERPT |
|---|---|---|
| <p><b>1961</b><br/><b>1:2,500</b></p> | <p>Several more buildings have been developed in the site noted as Upper Bryn Farm, that extends from the centre and to the south of the site farm buildings are noted as Bryn Mawr and Park Farm. The pond in the south of the site is no longer recorded.</p> | |

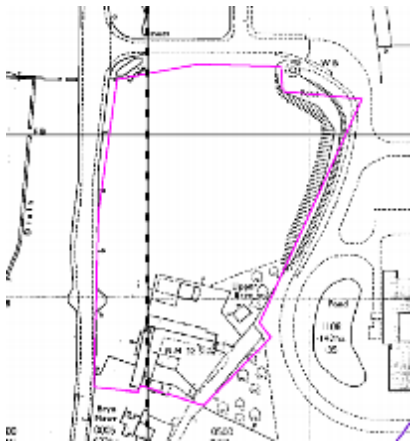
| MAP EDITION | HISTORICAL LAND USE | HISTORICAL MAP EXCERPT |
|---|---|---|
| <p><b>1972-1974</b><br/><b>1:2,500</b></p> | <p>A pond is present in the north-eastern corner of the site and extends along the eastern boundary. The area in the northeast of the site has been excavated to create the pond with an embankment formed around the perimeter. A drain is recorded in the northwest of the site. New roadways have been built around the site.</p> | |

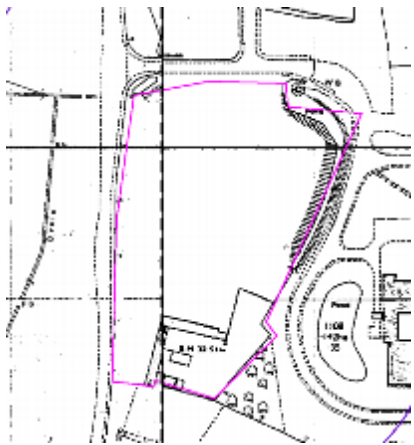
| MAP EDITION | HISTORICAL LAND USE | HISTORICAL MAP EXCERPT |
|---|---|---|
| <p><b>1982</b><br/><b>1:2,500</b></p> | <p>The farm buildings associated with Upper Bryn Farm have been demolished, with only a few buildings remain in the south of the site.</p> | |

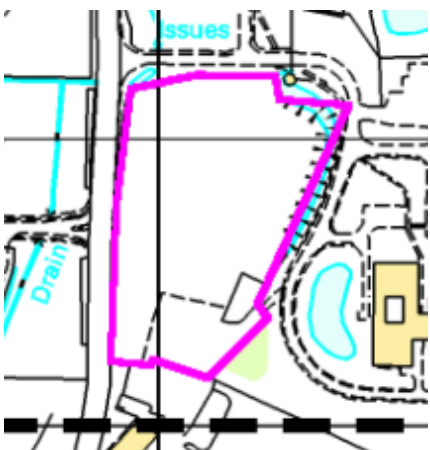
| MAP EDITION | HISTORICAL LAND USE | HISTORICAL MAP EXCERPT |
|---|---|---|
| <p><b>2006</b><br/><b>1:10,000</b></p> | <p>The remaining buildings in the south of site have been demolished.</p> | |

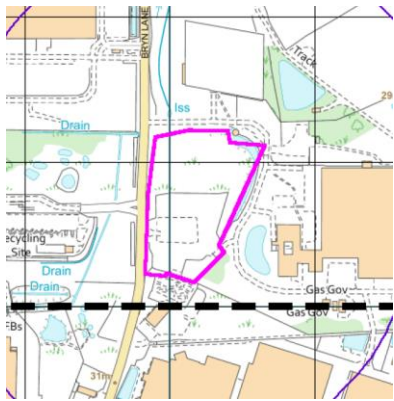
| MAP EDITION | HISTORICAL LAND USE | HISTORICAL MAP EXCERPT |
|---|---|---|
| <p><b>2006</b></p> <p><b>1:10,000</b></p> | No significant changes to site. | |

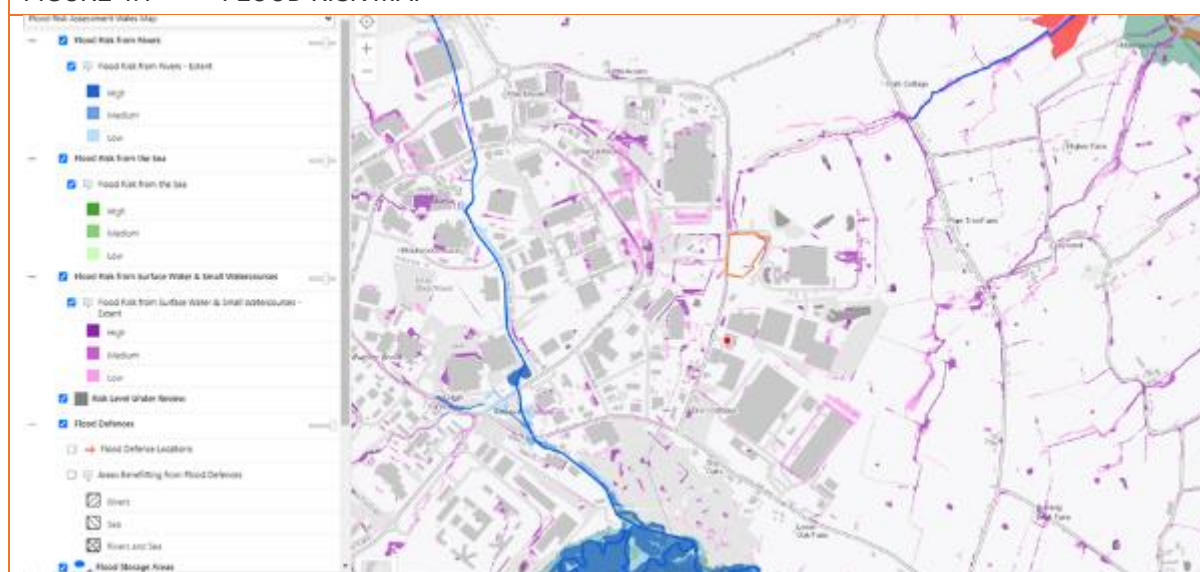
FIGURE 4.1 FLOOD RISK MAP

The site is predominantly located within a currently defined "Flood Risk Zone 1"; defined as land assessed as having less than 1 in 1,000 annual probability of river or sea flooding (< 0.1%), and as such is considered to be unaffected by river flooding. In addition, the Envirocheck report states there is a limited potential for groundwater flooding to occur at the site. The Natural Resource Wales Flood Risk Map for the site is presented as Figure 4.1.

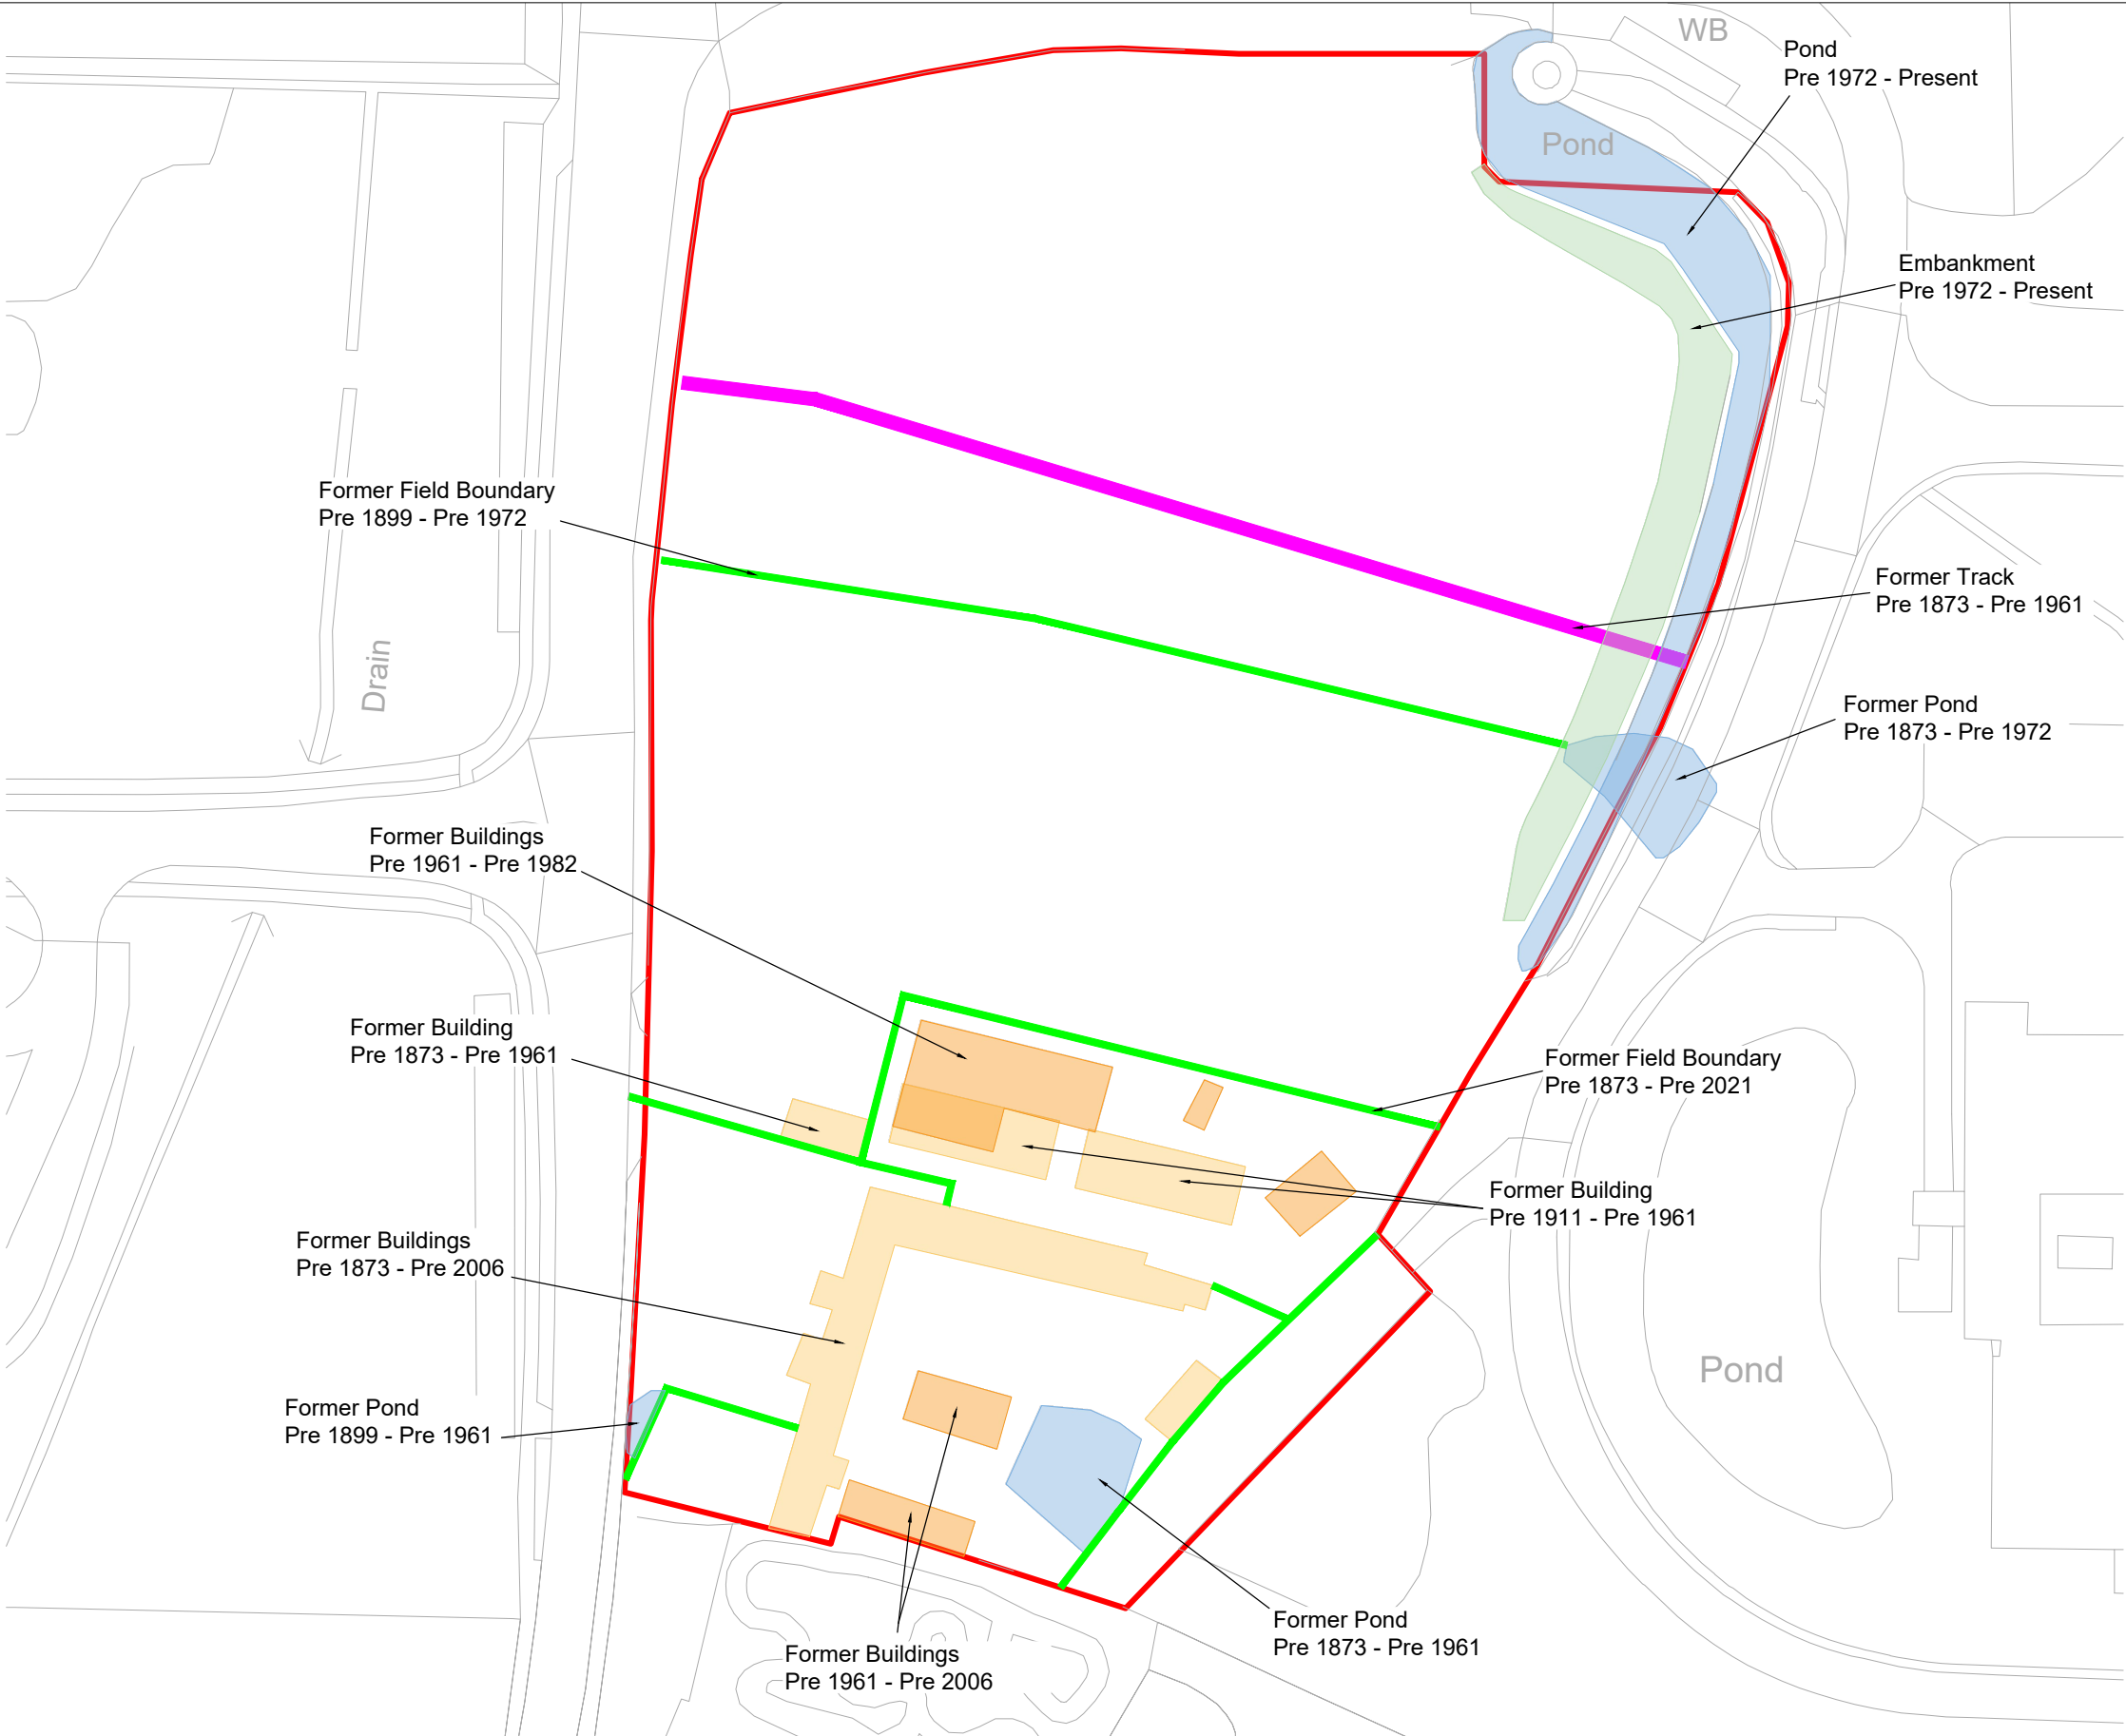
Historical Features

- Pond
- Embankment
- Former Buildings
- Former Buildings
- Former Field Boundary
- Former Track

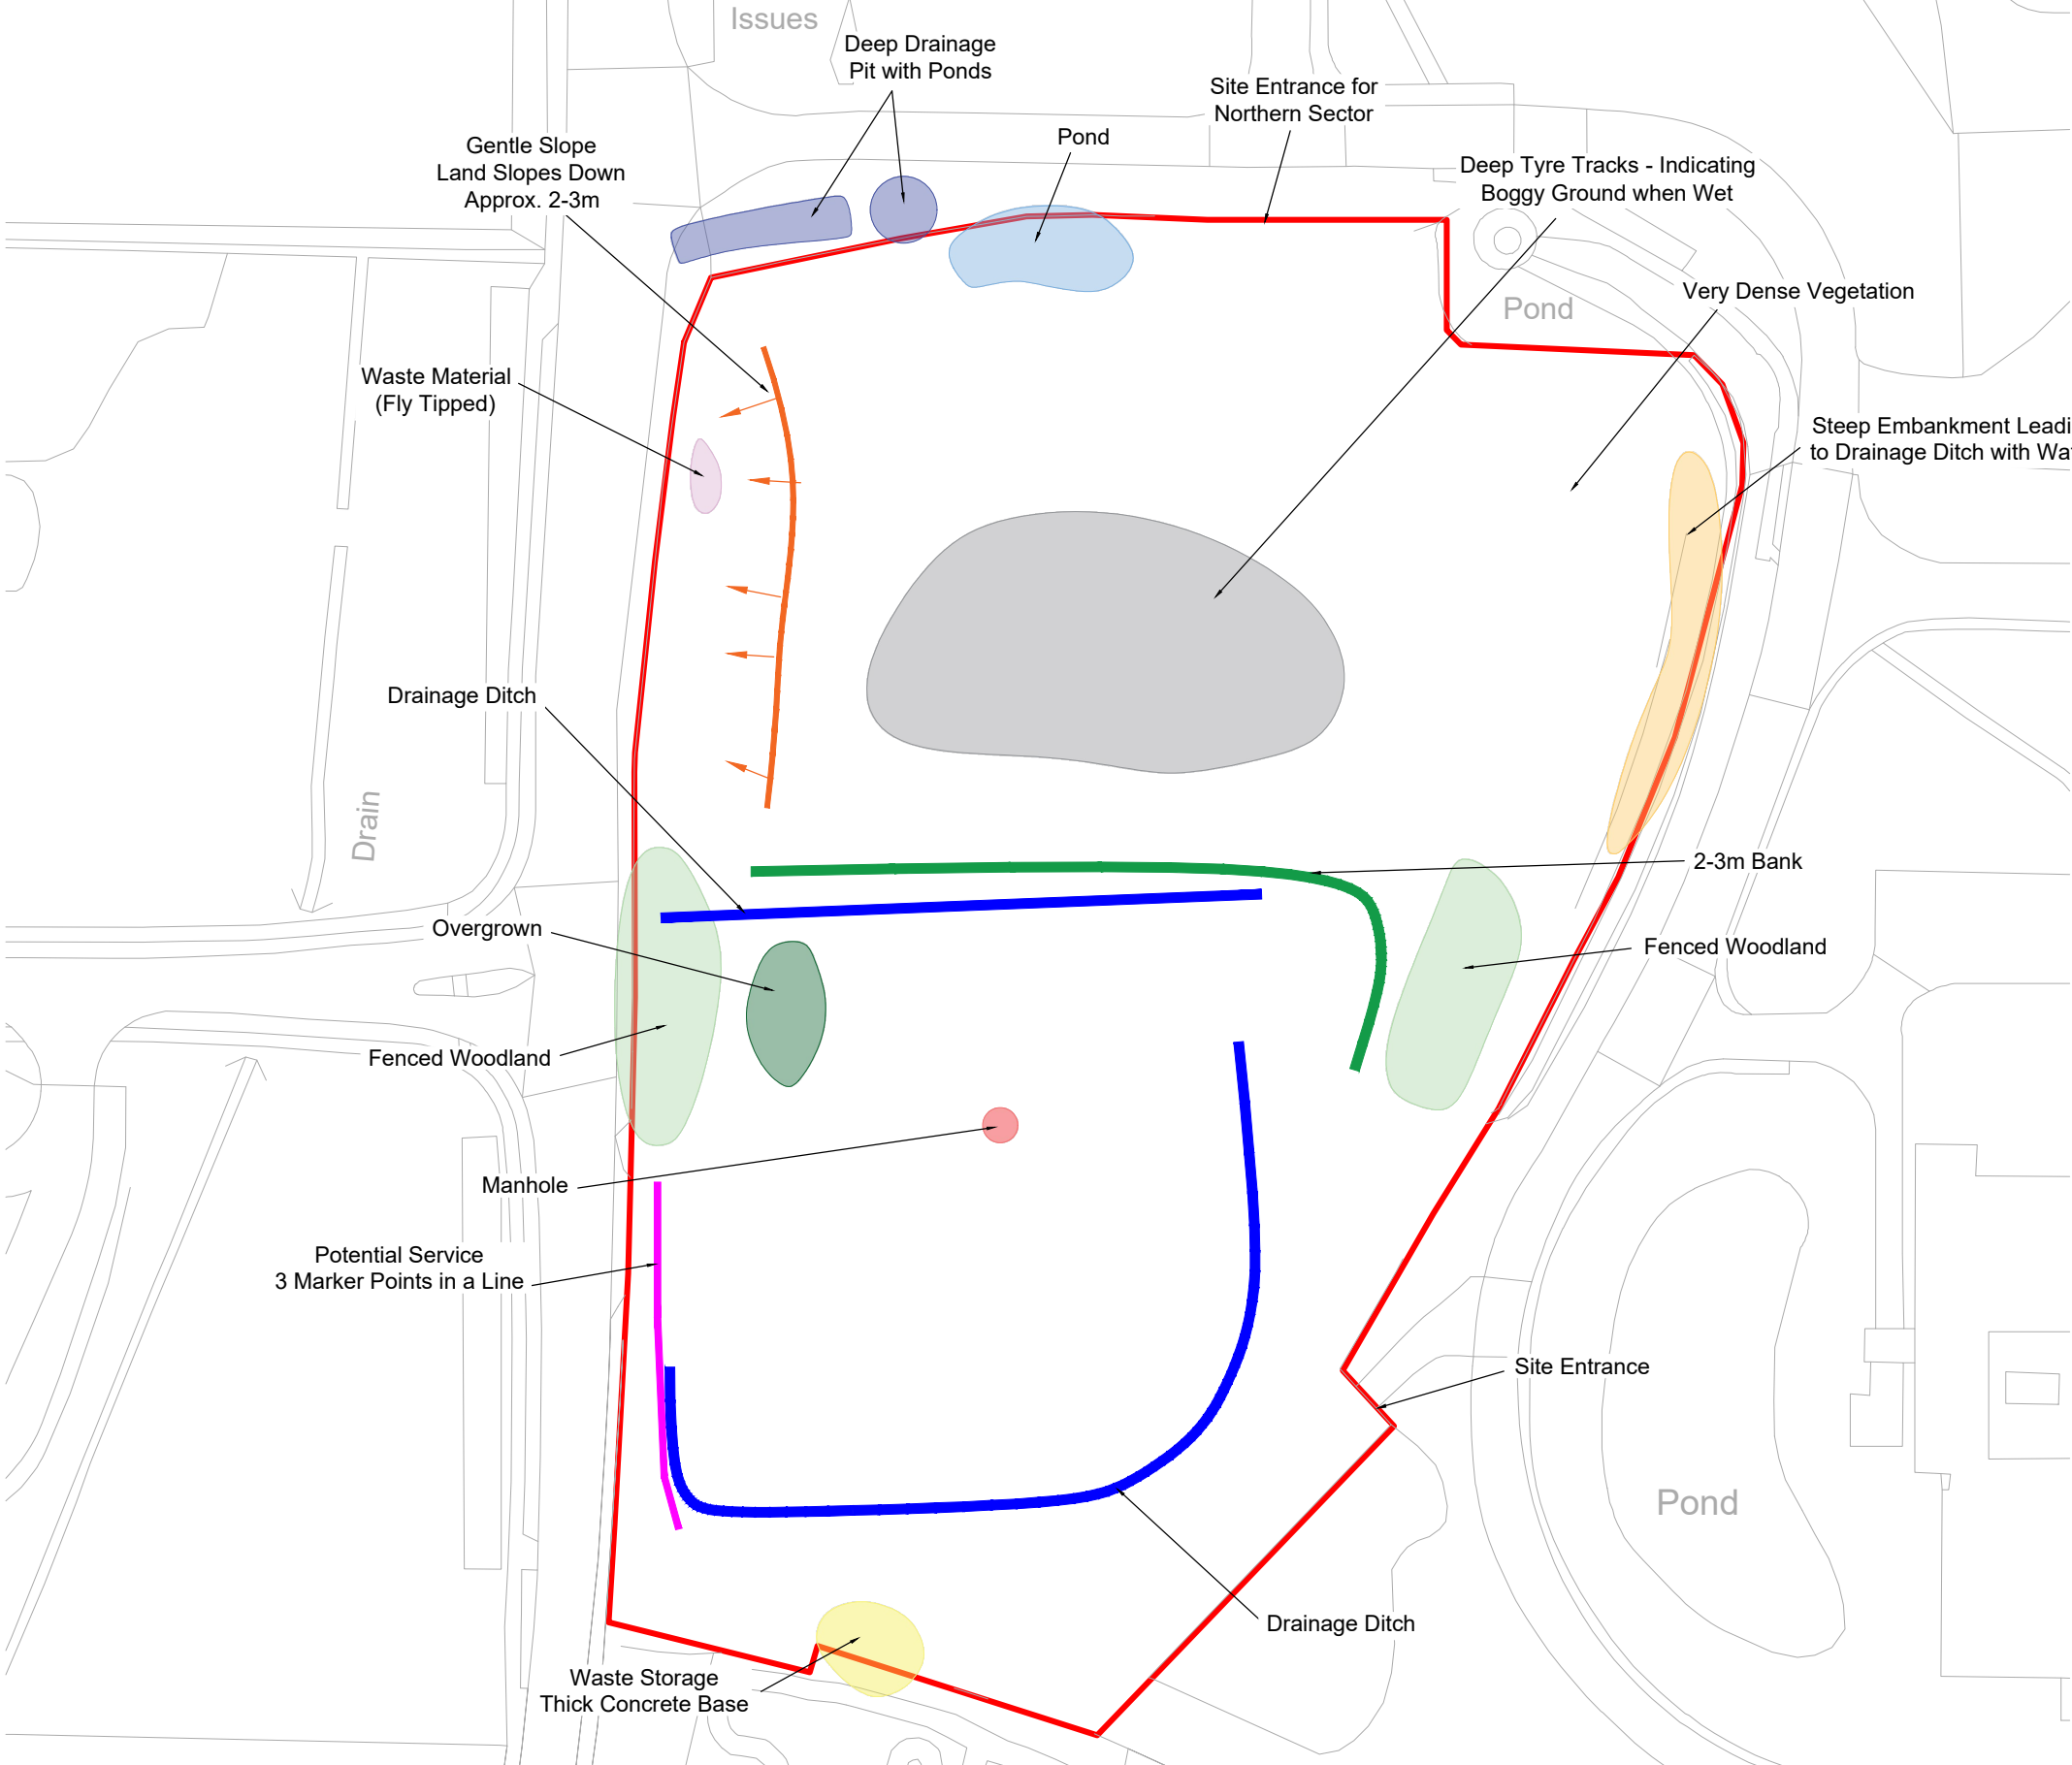
| <div>Current Site Features</div> <div><div><div><div></div><div>Pond</div></div><div><div></div><div>Steep Embankment Leading to Drainage Ditch</div></div><div><div></div><div>Fenced Woodland</div></div><div><div></div><div>Overgrown/Dense Vegetation</div></div><div><div></div><div>Deep Drainage Pit with Ponds</div></div><div><div></div><div>Waste Material (Fly Tipped)</div></div><div><div></div><div>Waste Storage Thick Concrete Base</div></div><div><div></div><div>Manhole</div></div><div><div></div><div>Deep Tyre Tracks - Indicating Boggy Ground when Wet</div></div></div><div><div><div></div><div>Drainage Ditch</div></div><div><div></div><div>Potential Service</div></div><div><div></div><div>2-3m Bank</div></div><div><div></div><div>Slope</div></div></div></div> | | | | | <div>Notes:</div> | | | | | <div>Client:</div> <div>Portal Construction<br/>N.W. Ltd</div> | | <div>Job No:</div> <div>14-892</div> | <div>Date:</div> <div>27.07.2021</div> | <div><div><div></div><div>e3p</div></div><div>Environmental Engineering Partnership Ltd<br/>Taylor Road, Trafford Park<br/>Urmston, Manchester, M41 7JQ<br/>Tel: 0161 707 9612<br/>E-mail: info@e3p.co.uk<br/>Website: www.e3p.co.uk</div></div> | |

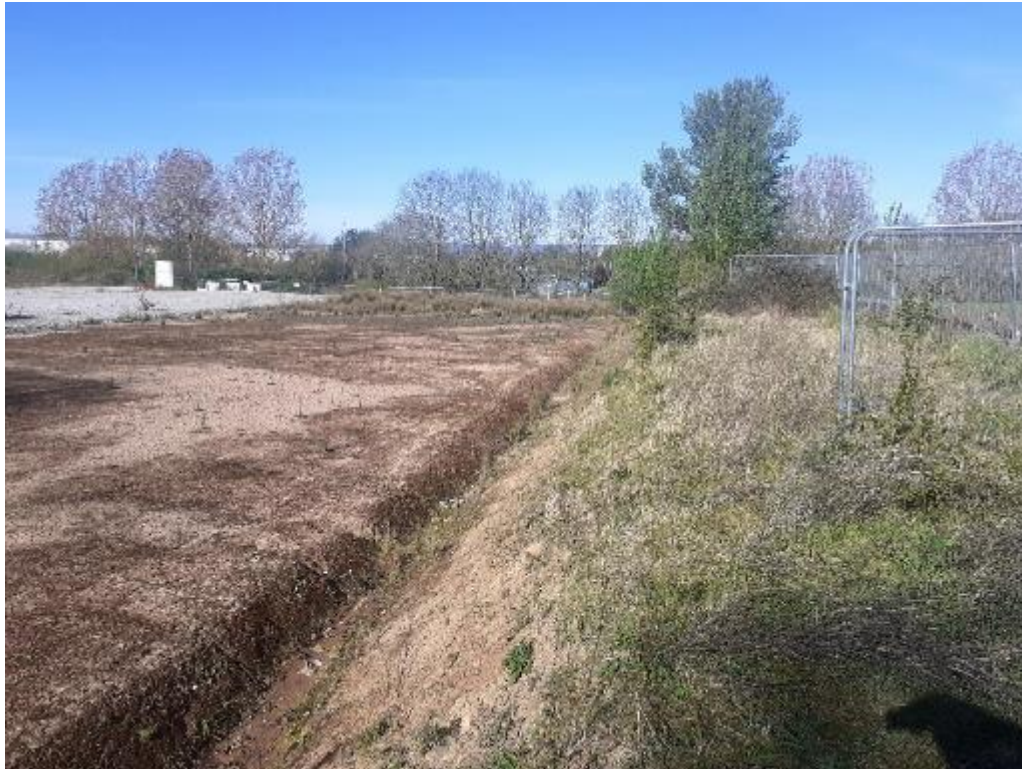
PLATE 1 SOUTH OF THE SITE – 2-3 m LOWER IN ELEVATION

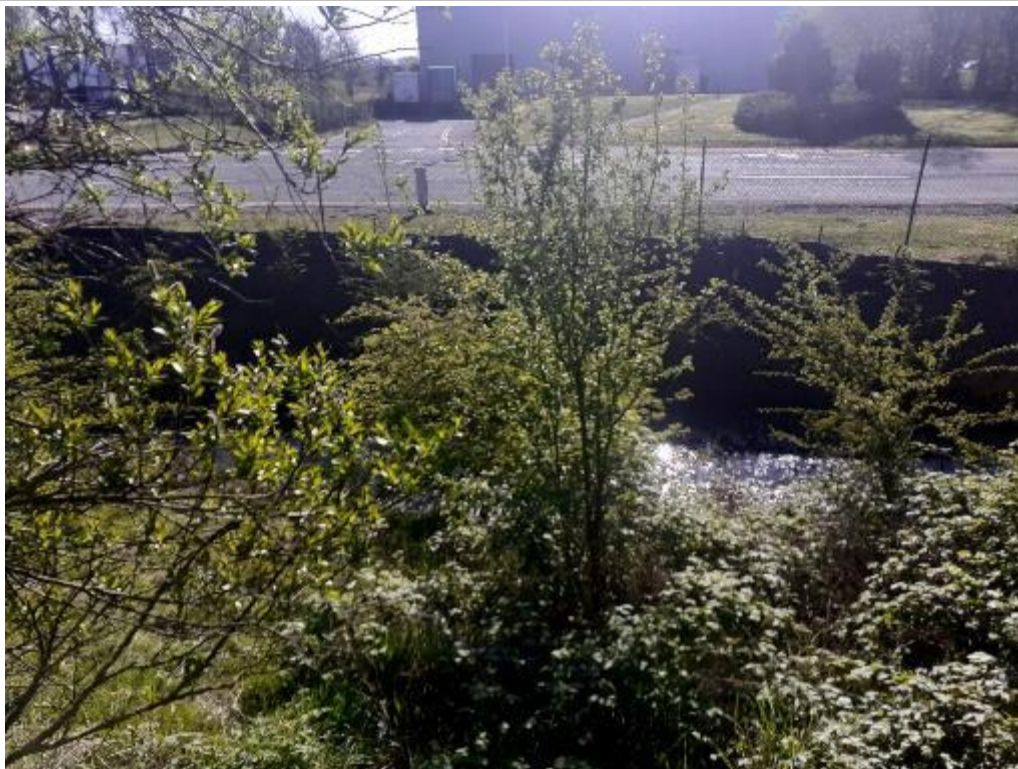
PLATE 2 DRAINAGE DITCH ALONG THE EASTERN BOUNDARY

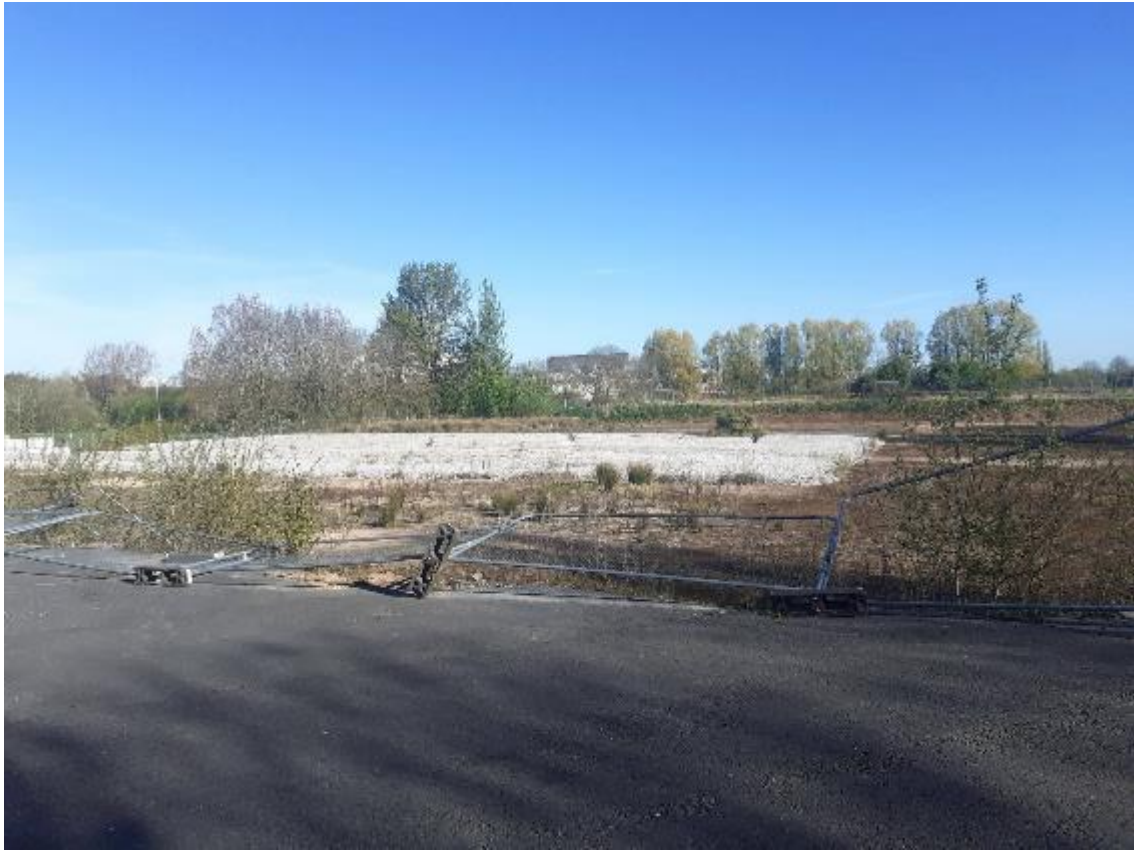
PLATE 6 POSSIBLE ACCESS TO SITE FROM BRYN LANE
