**Report Type:** Ecological Appraisal

**Site Address:** Brunett Barns  
Lower Wych Lane  
Ty Broughton  
Whitchurch  
SY13 3BA

**Report Reference:** 20-05 107.2R

**Date of Issue:** 10<sup>th</sup> March 2022

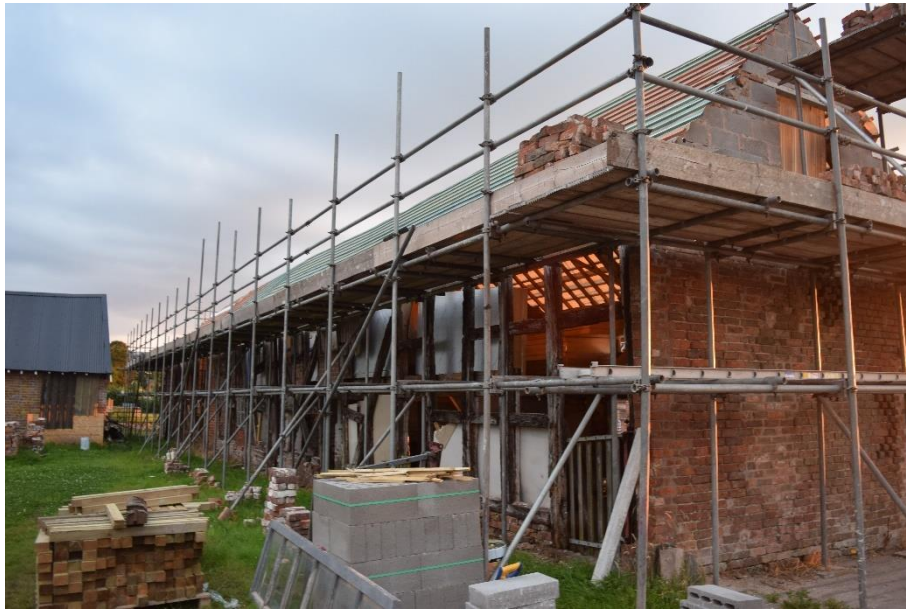
**Figure 4.2. Building 1.1**

Since the previous survey in 2017, the roof of building 1 has been stripped and the metal roof replaced with modern breathable membrane. There are significant gaps along the eastern elevation of the building where, for structural reasons, the building has had to be strapped and secured.

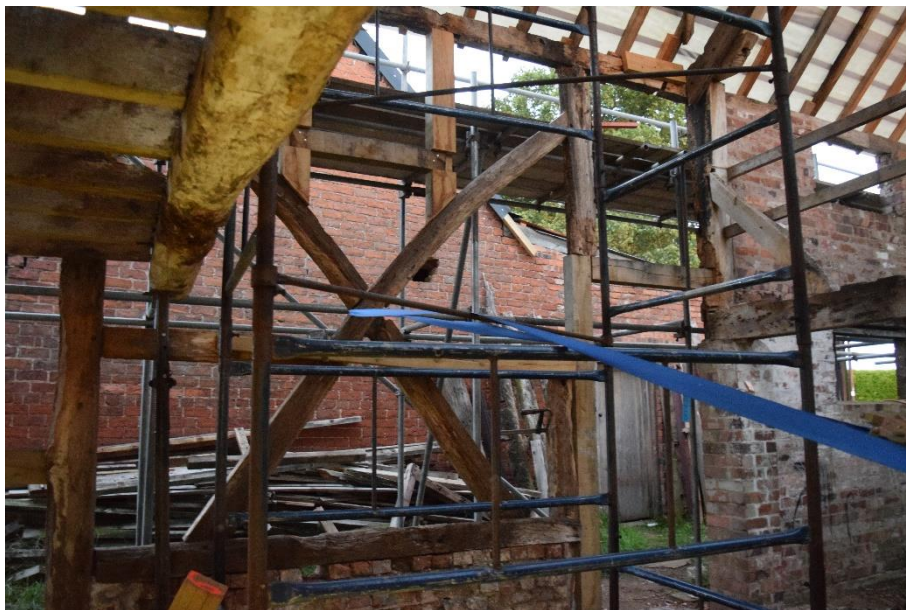
**Figure 4.3. View from interior through eastern elevation**

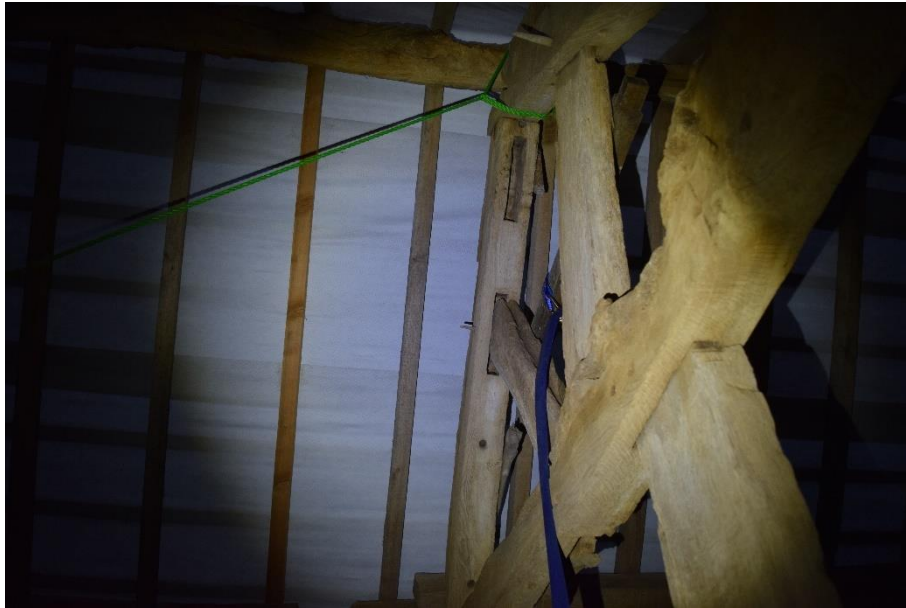
Scattered bat droppings were seen on the mezzanine floor to the north of the building. These seemed to be associated with areas where there remains open mortice joints in the timbers.

**Figure 4.4. Open mortice joint in roof timbers**

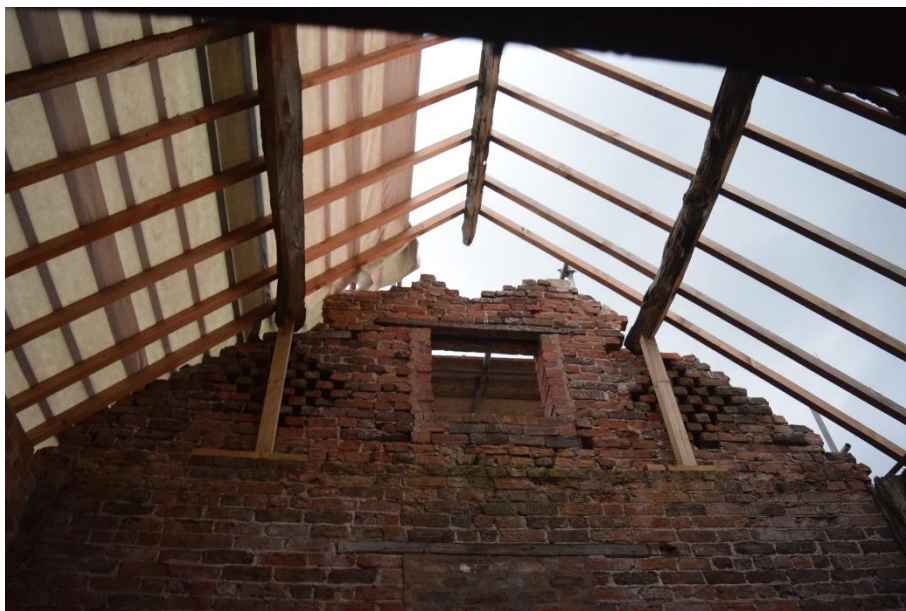
Work has been stopped on this building by the council. The southern gable end was seen to be in as poor condition as in 2018.

**Figure 4.5. Southern gable end**

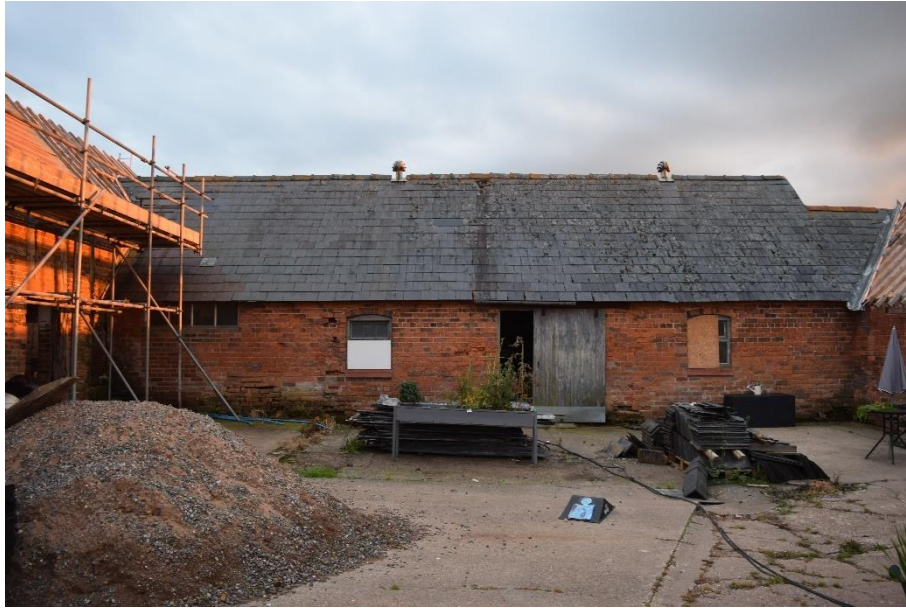
**Figure 4.6. Barn 1.2**

Barn 1.2 has not been worked on by the current client.

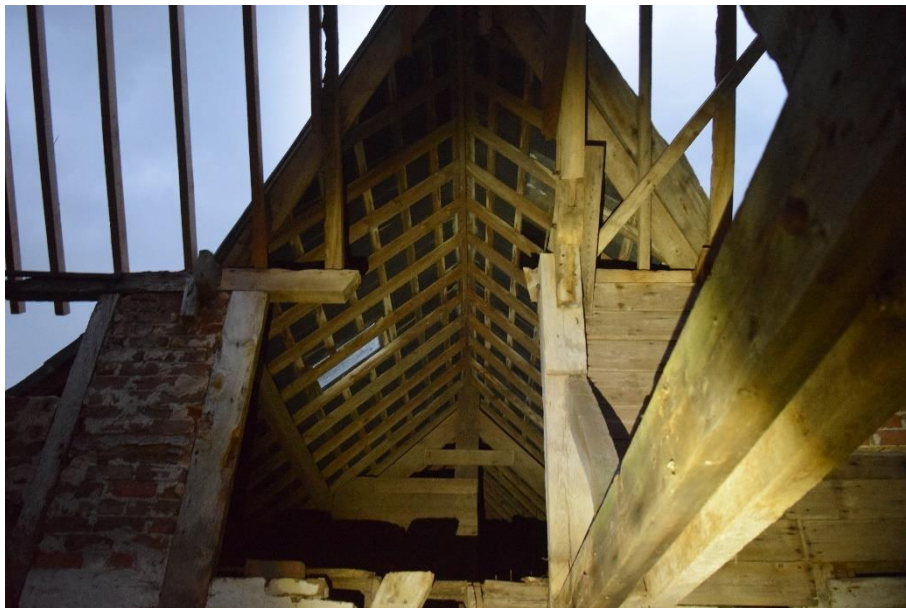
The eastern end of this building opens into barn 1.1.

**Figure 4.7. Opening into barn 1.1**

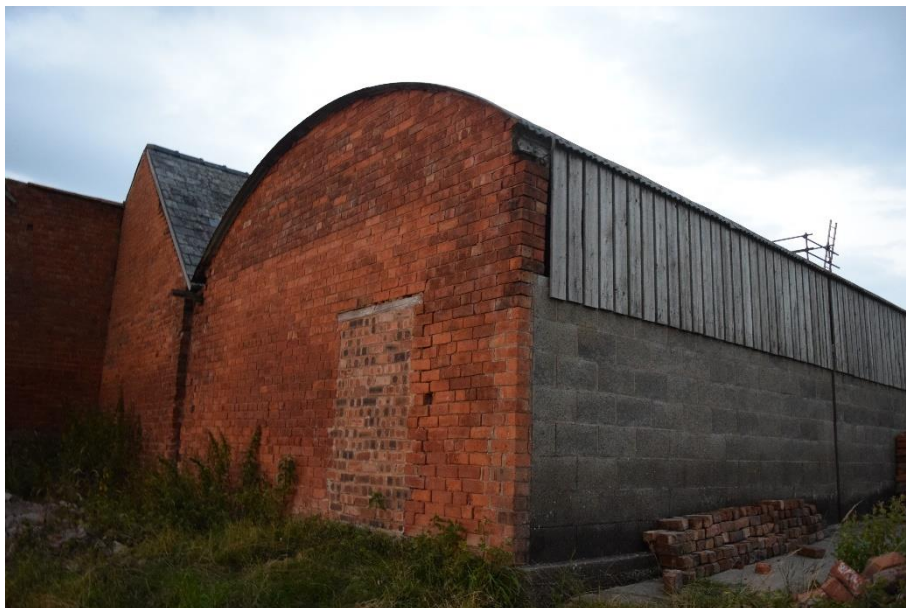
**Figure 4.11. Building 1.4**

There have been no alterations to building 1.4 since 2018. This is still a metal roofed structure with block and timber on the southern elevation.

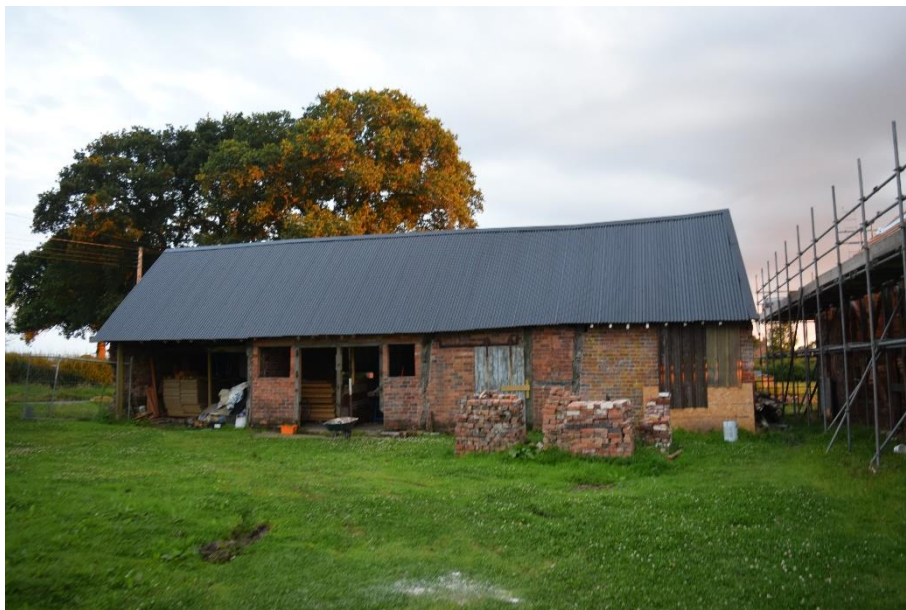
**Figure 4.13. Building 2**

Barn 2 has been re-roofed with a replacement metal roof and breathable membrane.

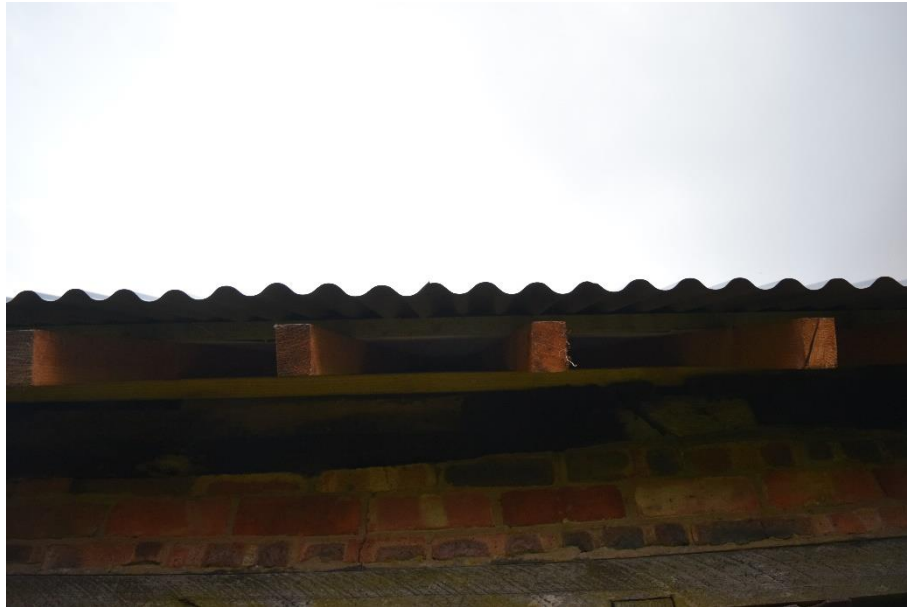
Large spaces are visible into the roof void of the building which allows continued access for bats.

**Figure 4.14. Showing potential bat access areas.**

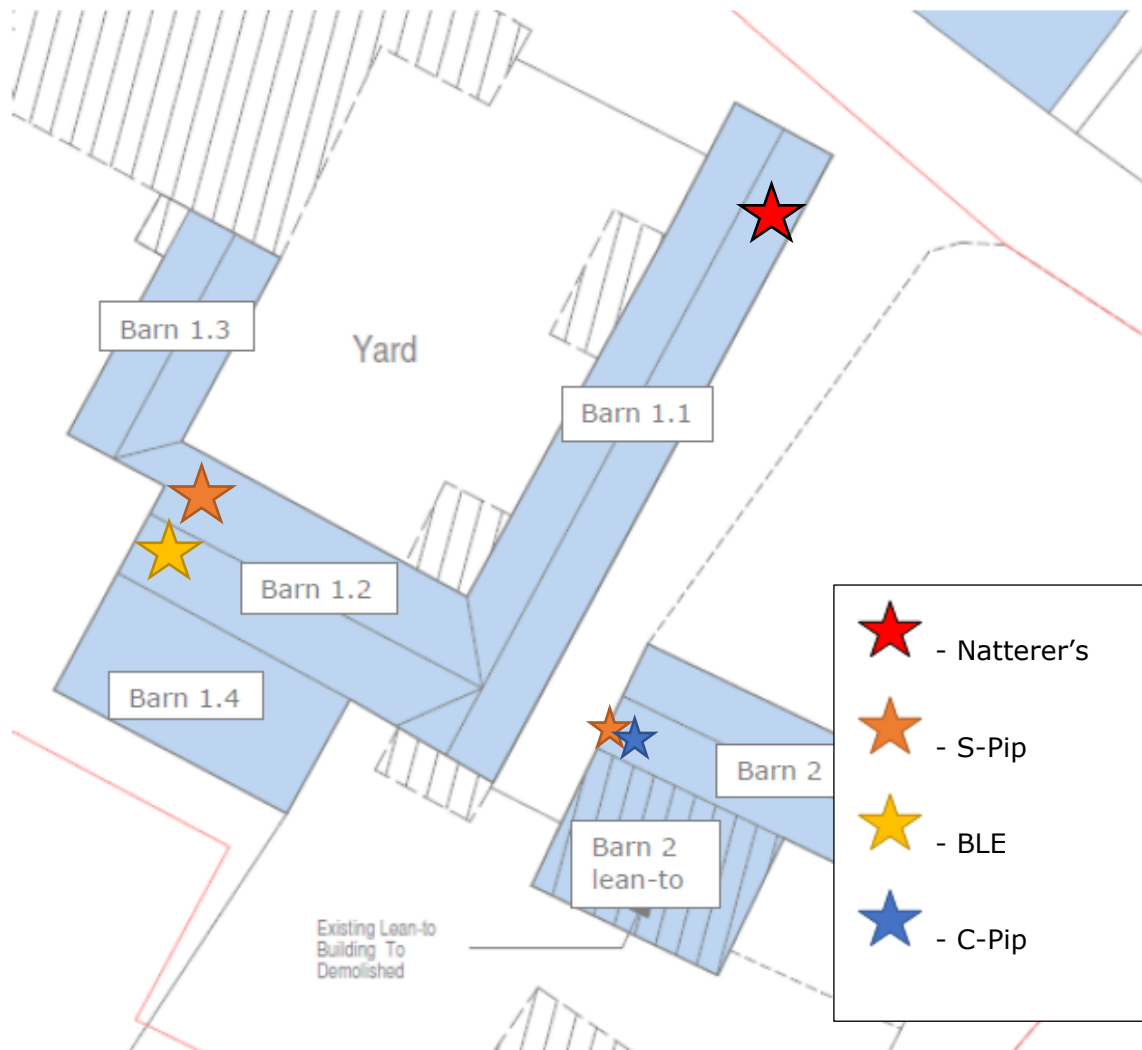
**Figure 4.18. Roost location summary**

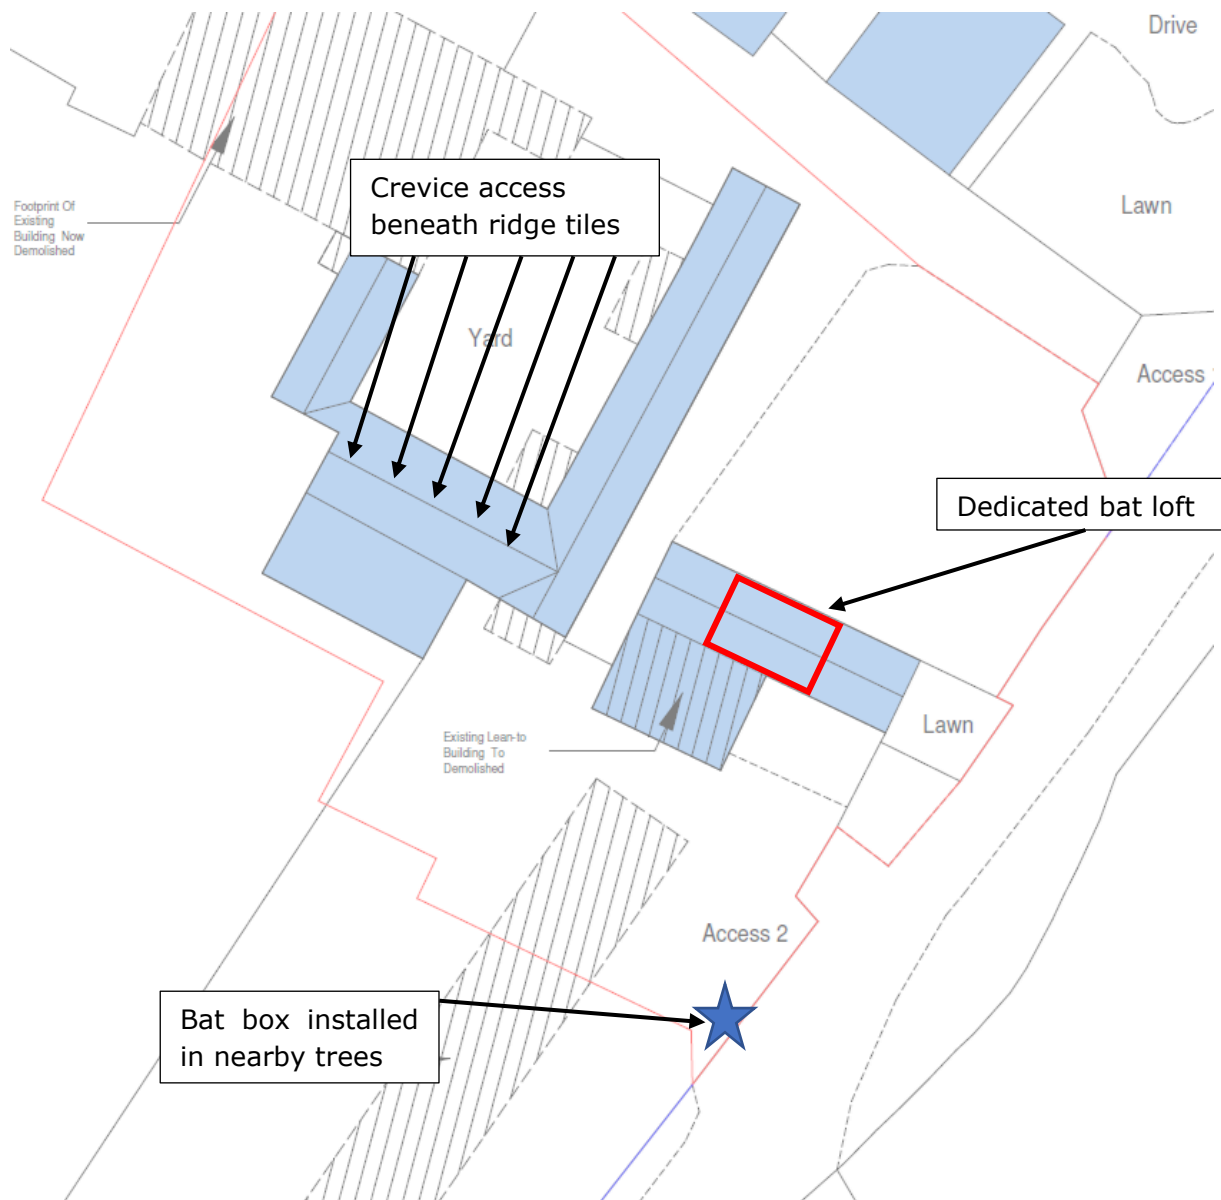
**Figure 5.2. Bat Compensation Summary**

Note that the above plan is the “existing site plan” from 2018 and does not reflect changes made in 2021. No plans to that effect currently exist, and no proposed plans have been drawn up for the new proposal at the time of writing. The areas highlighted for compensation in the figure above will, however, be retained.

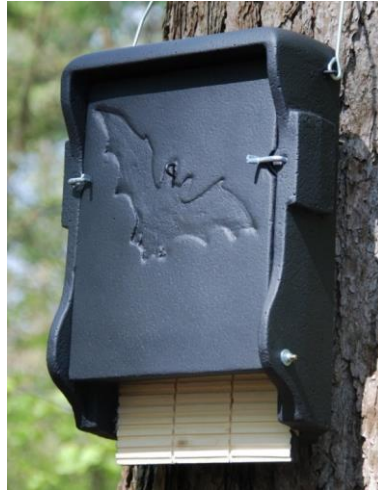
**Figure 5.3. Example woodcrete bat box: Schwegler 1FF**

Provision will be made for roosting opportunities for bats with the erection of at least one woodcrete bat box suitable for day roosts on a tree to the southeast of barn 2. A Schwegler 1FF box or equivalent will be erected.

This will be erected at a height of 3-4 m and in a westerly facing direction.

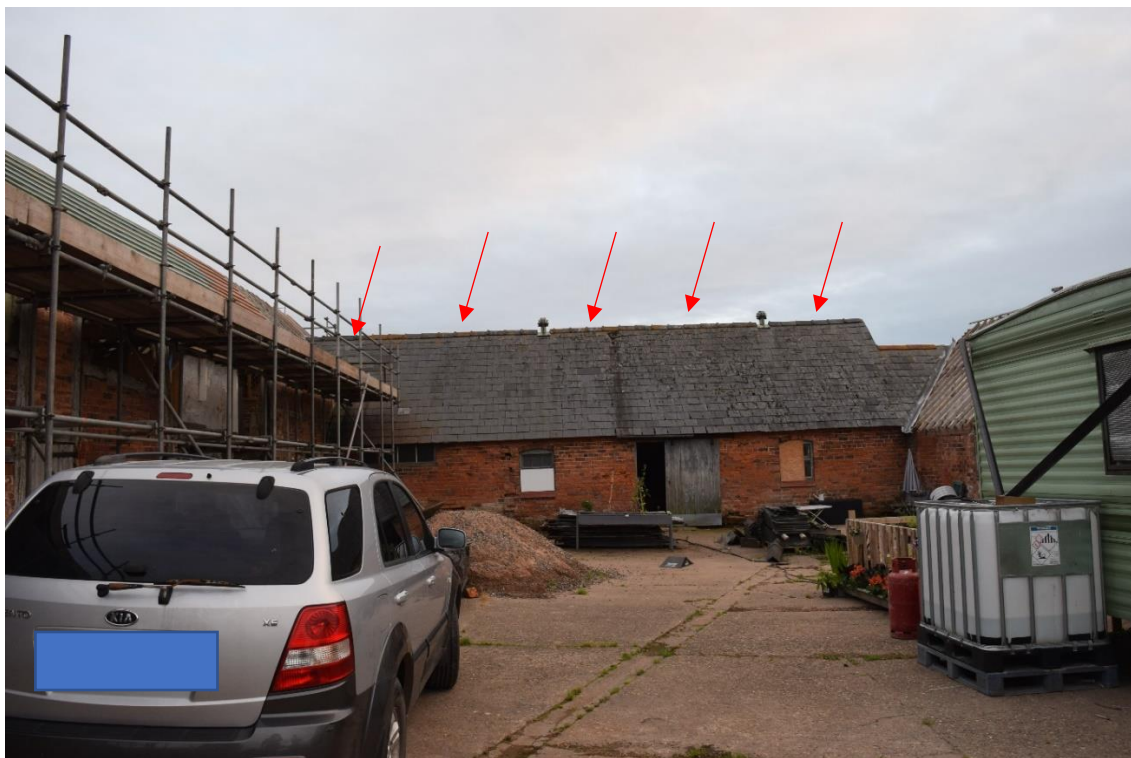
**Figure 5.4. Showing approximate positions of bat access under ridge tiles on 1.2**

Bat access will be prepared along the ridge of barn 1.2 and 1.3.

1. The roofs will be lined with bitumen hessian felt and a 15mm deep and 20mm wide gap will be left under five ridge tiles.

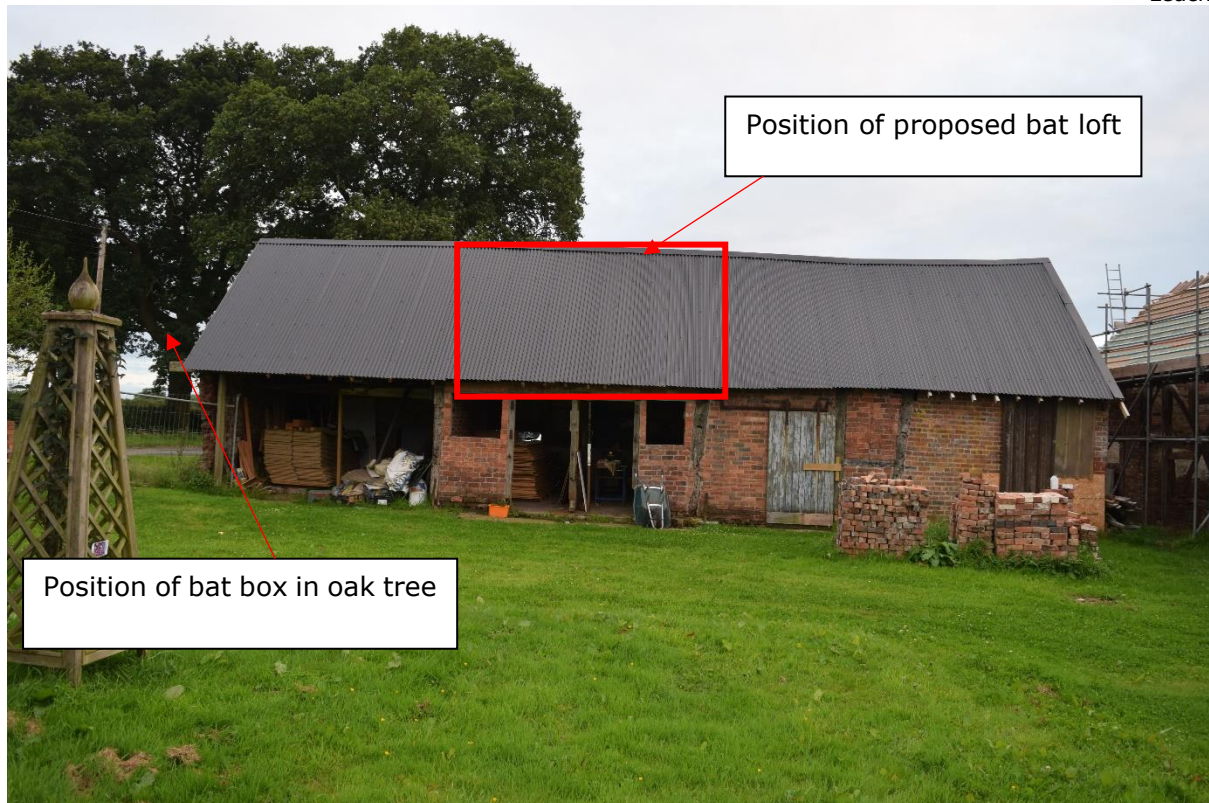
**Figure 5.5. Mitigation on barn 2 and tree**

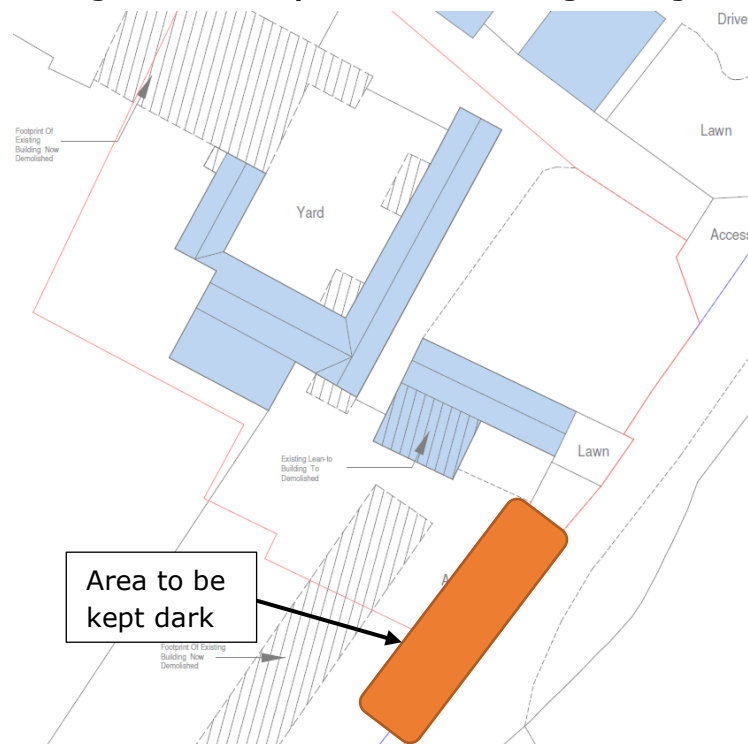
**Figure 5.7. Dark area map**
