## Bronwylfa Hall, Wrexham

### Arboricultural Report

November 2021

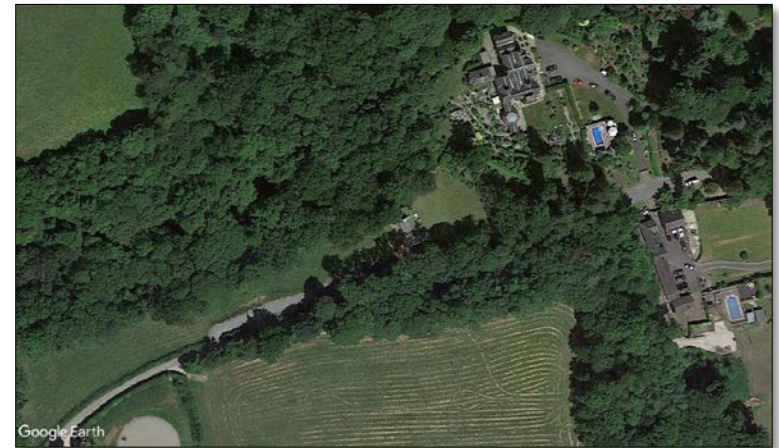
**Figure 1**

The site is described in detail in the Planning, Design and Access Statement. In simple terms, the site is a grass field to the south west of Bronwylfa Hall. The site is an elevated parcel of land above the lane screened by a bank of broadleaved trees (Figure 1).

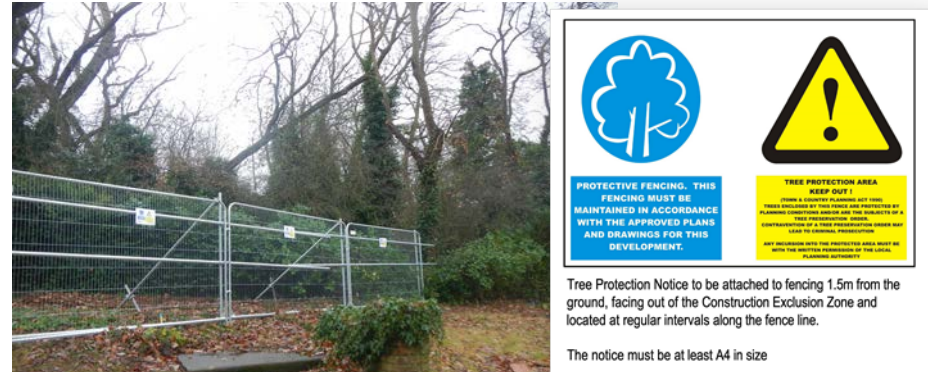
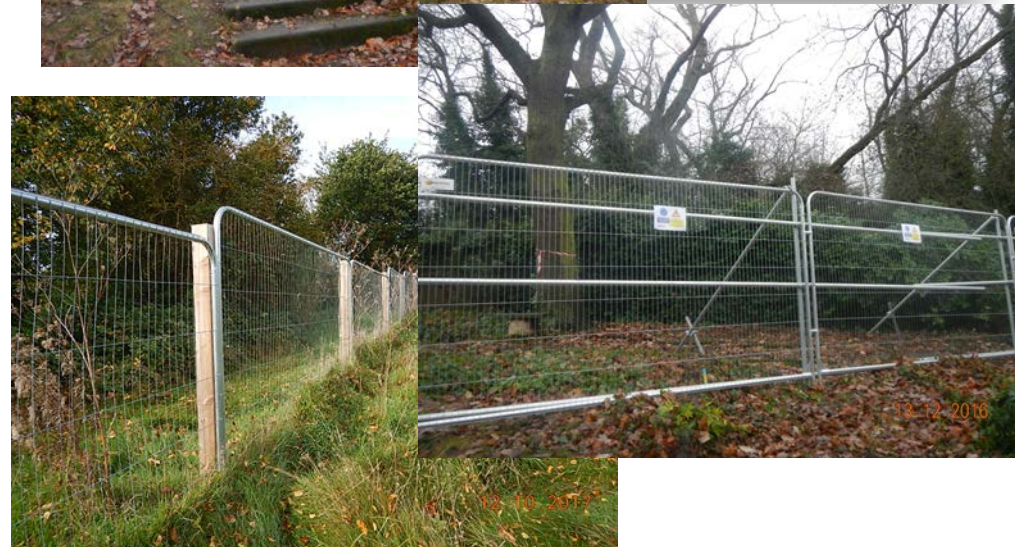
Due to the nature of the works, standard BS 5837 fencing will be used. The Construction Exclusion Zone fence will be heras fence panels fixed to a scaffold framework. Alternatively, heras panels fixed to timber posts. The location will be marked on site by the Arboricultural Consultant and are also shown on the Drawing No. – TPP/4486/Y/300. The requirement will be assessed on a weekly basis by the ACoW.

- Heras fencing fixed to a scaffold framework or timber posts as illustrated.
- Fencing installed at locations shown on the plan (ARB/4486/Y/200) and marked on site.
- Location and adequacy signed off by Arboricultural Consultant and LPA advised.
- Tool Box Talk – make construction staff aware of the importance of areas by site manager.
- Signs to be erected advising of the area's importance.
- Fence to be adjusted as noted in the Construction Timetable.
