# Outbuildings at Brunette Farm, Lower Wych Road, Ty Broughton, Wrexham SY13 3BA

Historic Building Record Level 2

Project Code: A0318.1

Report no. 0304

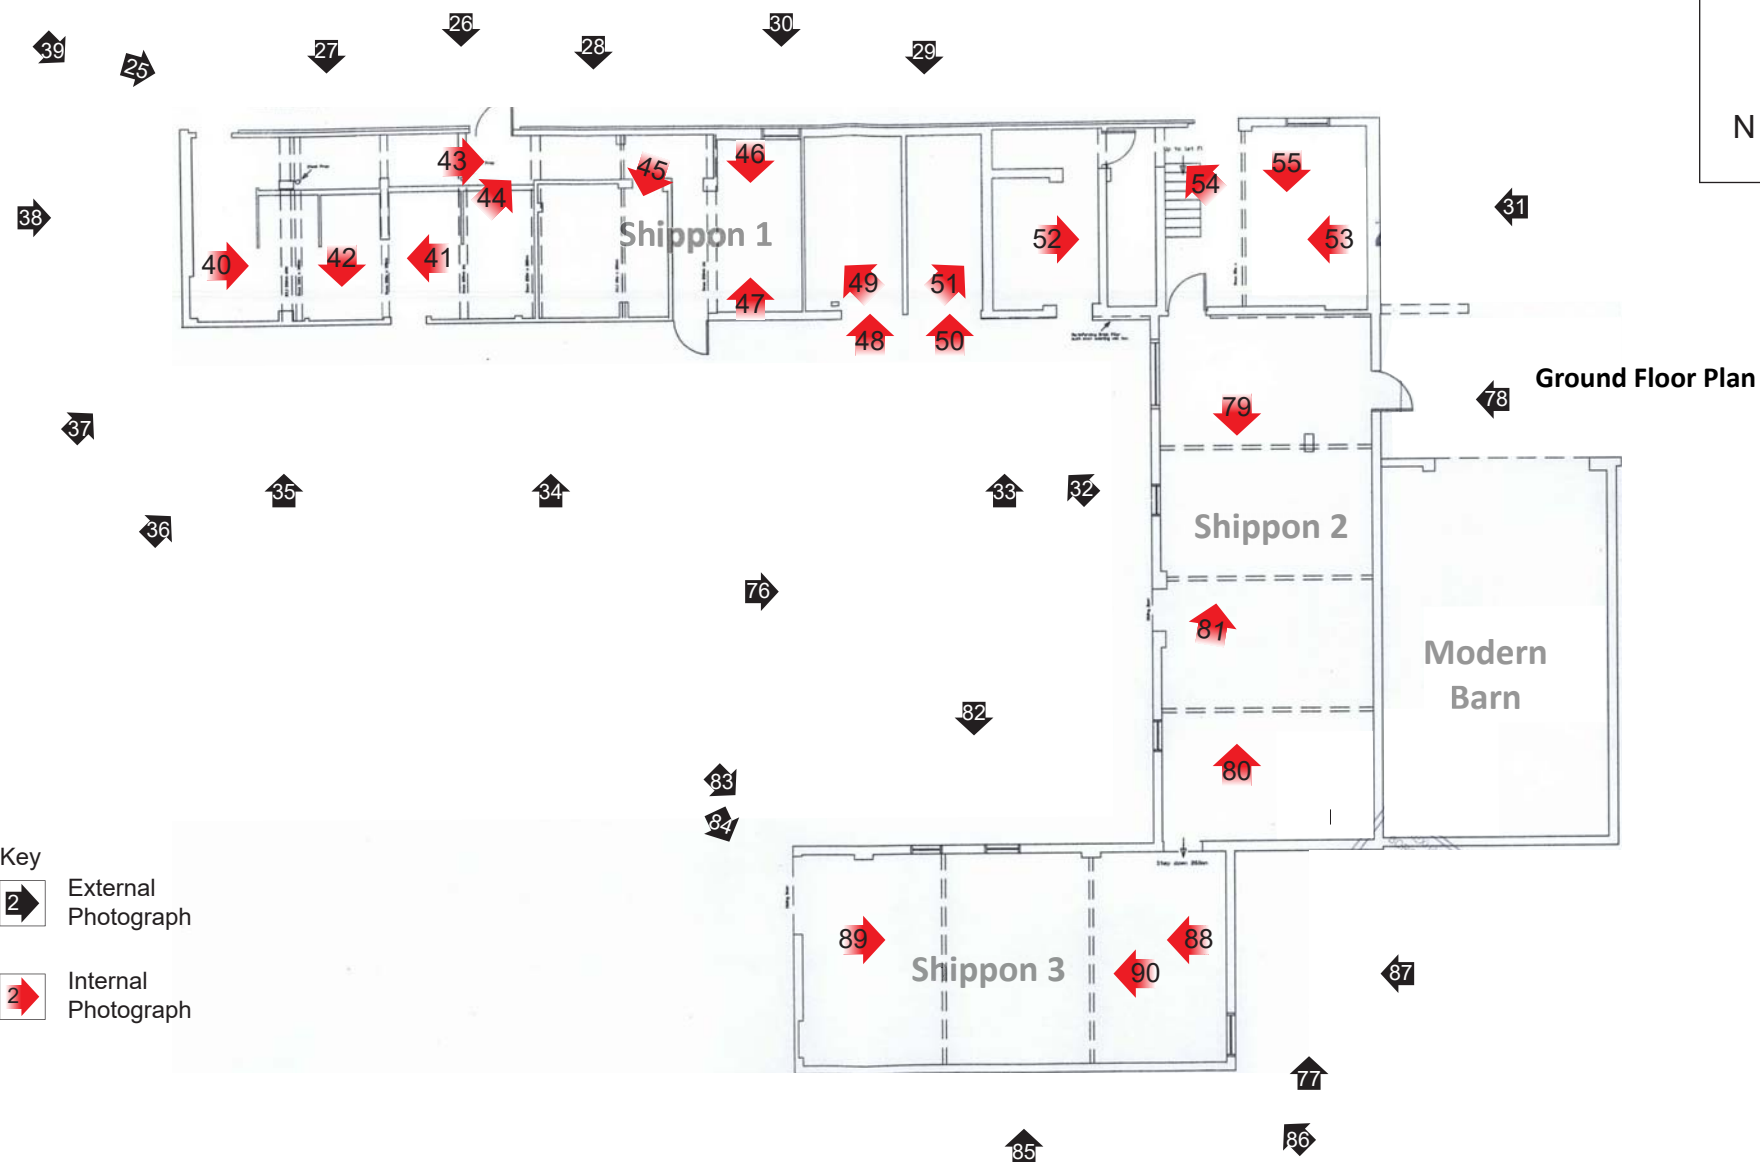
**Figure 09:** Floor Plans of Shippons 1,2 & 3 showing the direction of photographic plates at Brunett Farm, Lower Wych Road, Ty Broughton, Wrexham, SY13 3BA. Scale 1:200 at A4.

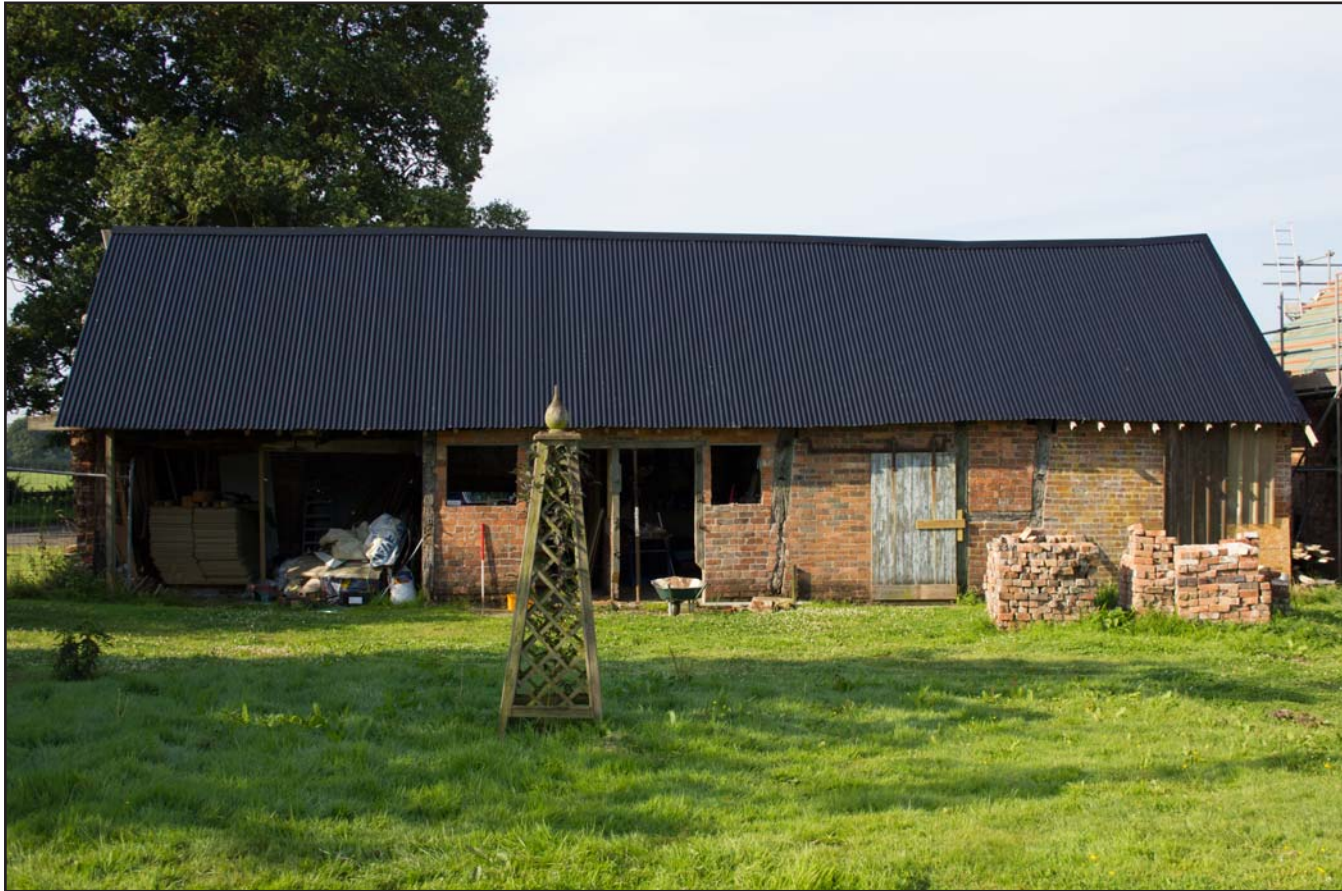
**Plate 01:** Northeast facing elevation of the Stable Building at Brunette Farm, Ty Broughton, Wrexham - from the northeast - scale 1m

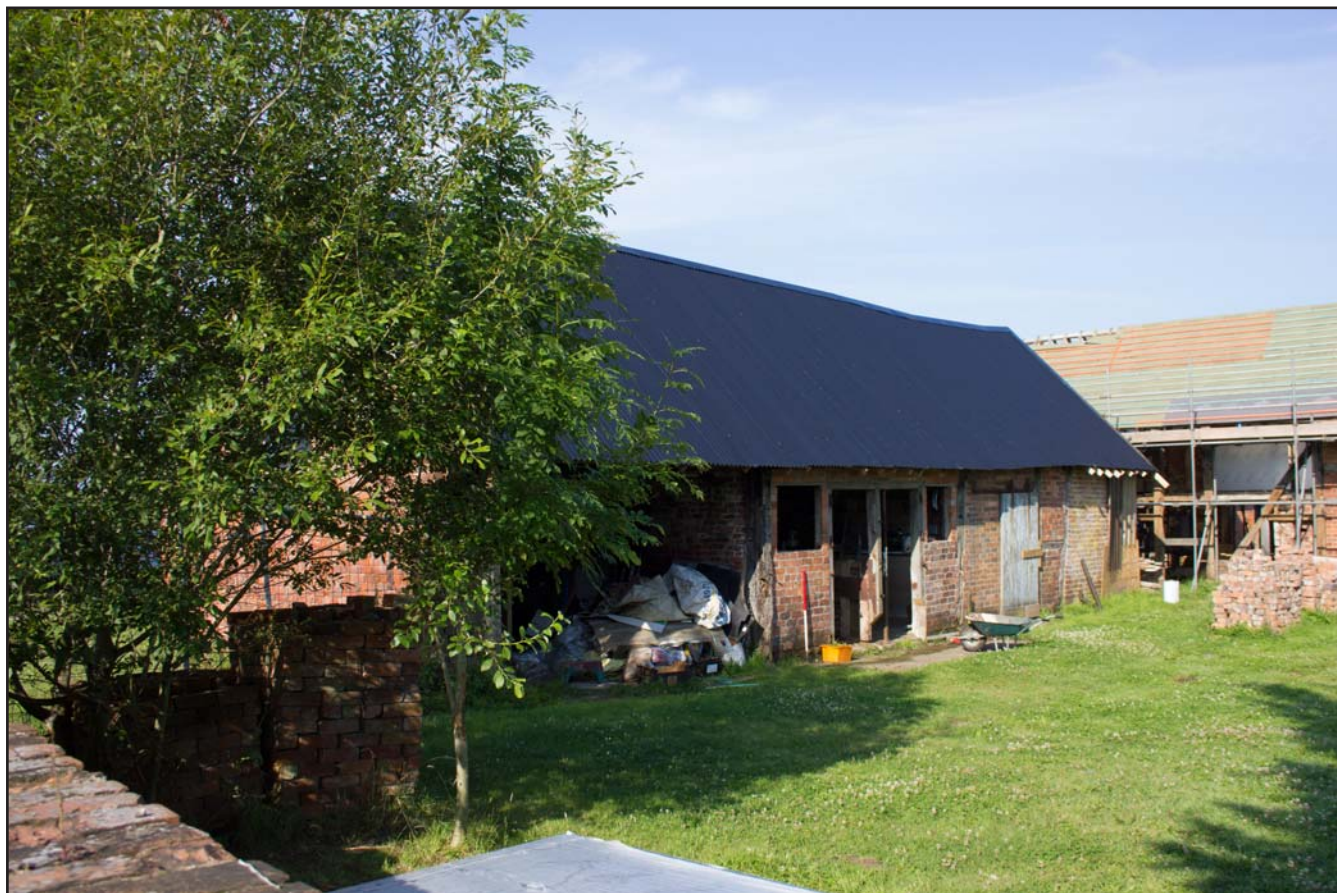
**Plate 02:** Oblique shot of northeast facing elevation of the Stable at Brunette Farm, Ty Broughton, Wrexham - from the east - scale 1m

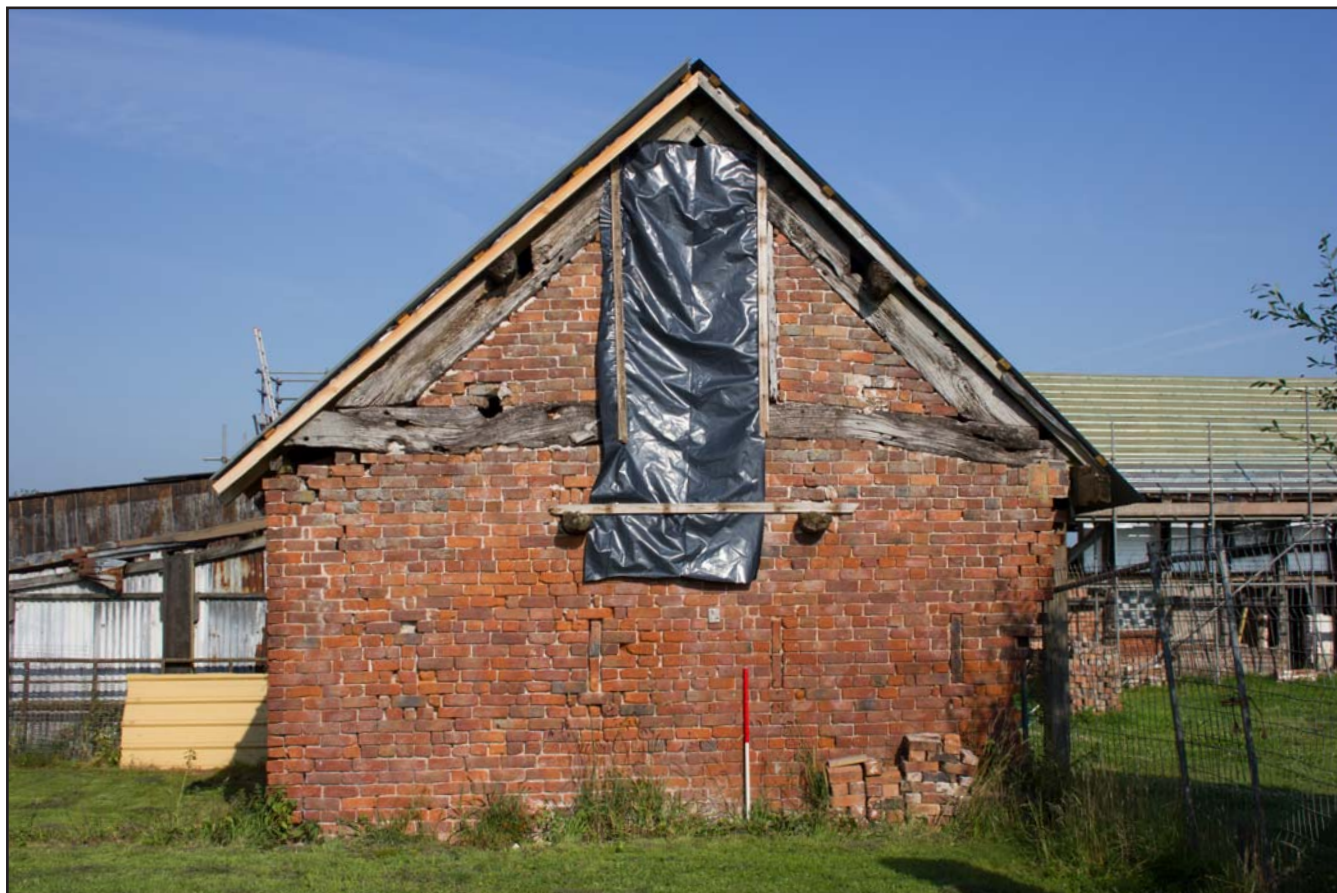
**Plate 03:** Southeast facing gable elevation of the Stable at Brunette Farm, Ty Broughton, Wrexham - from the southeast - scale 1m

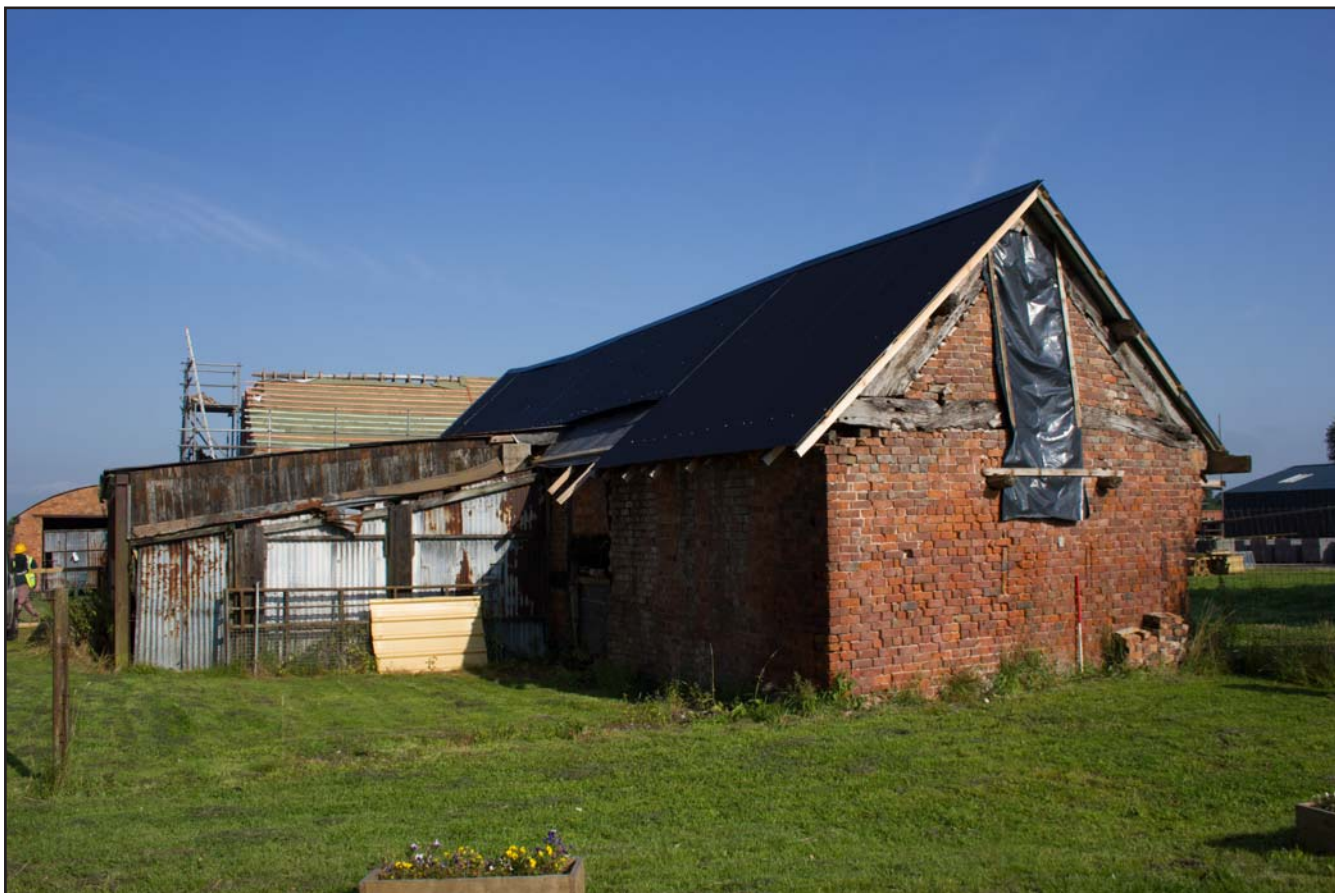
**Plate 04:** Southeast and southwest elevations of the Stable at Brunette Farm, Ty Broughton, Wrexham - from the south - scale 1m

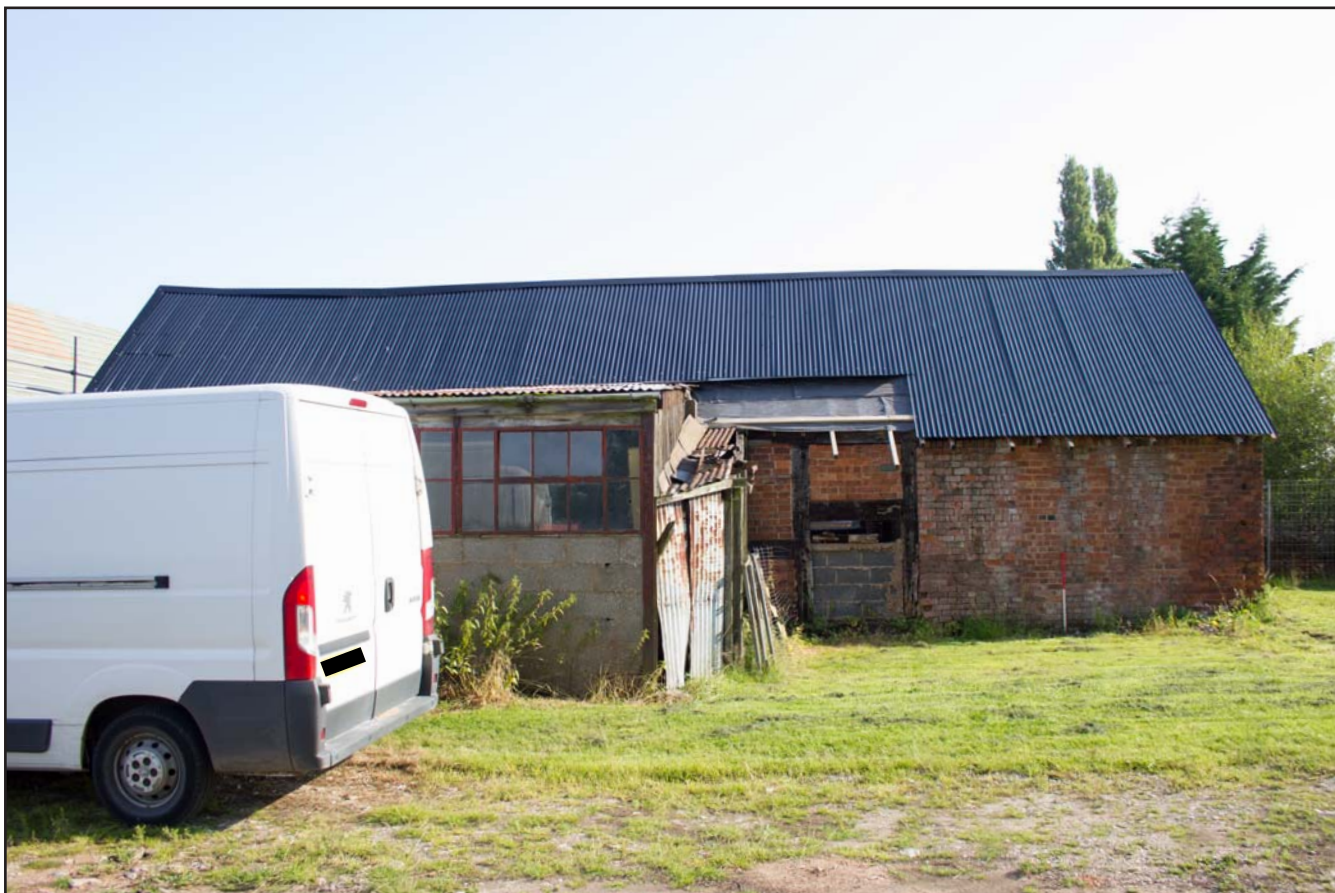
**Plate 05:** Southwest facing elevation of the Stable at Brunette Farm, Ty Broughton, Wrexham - from the southwest - scale 1m

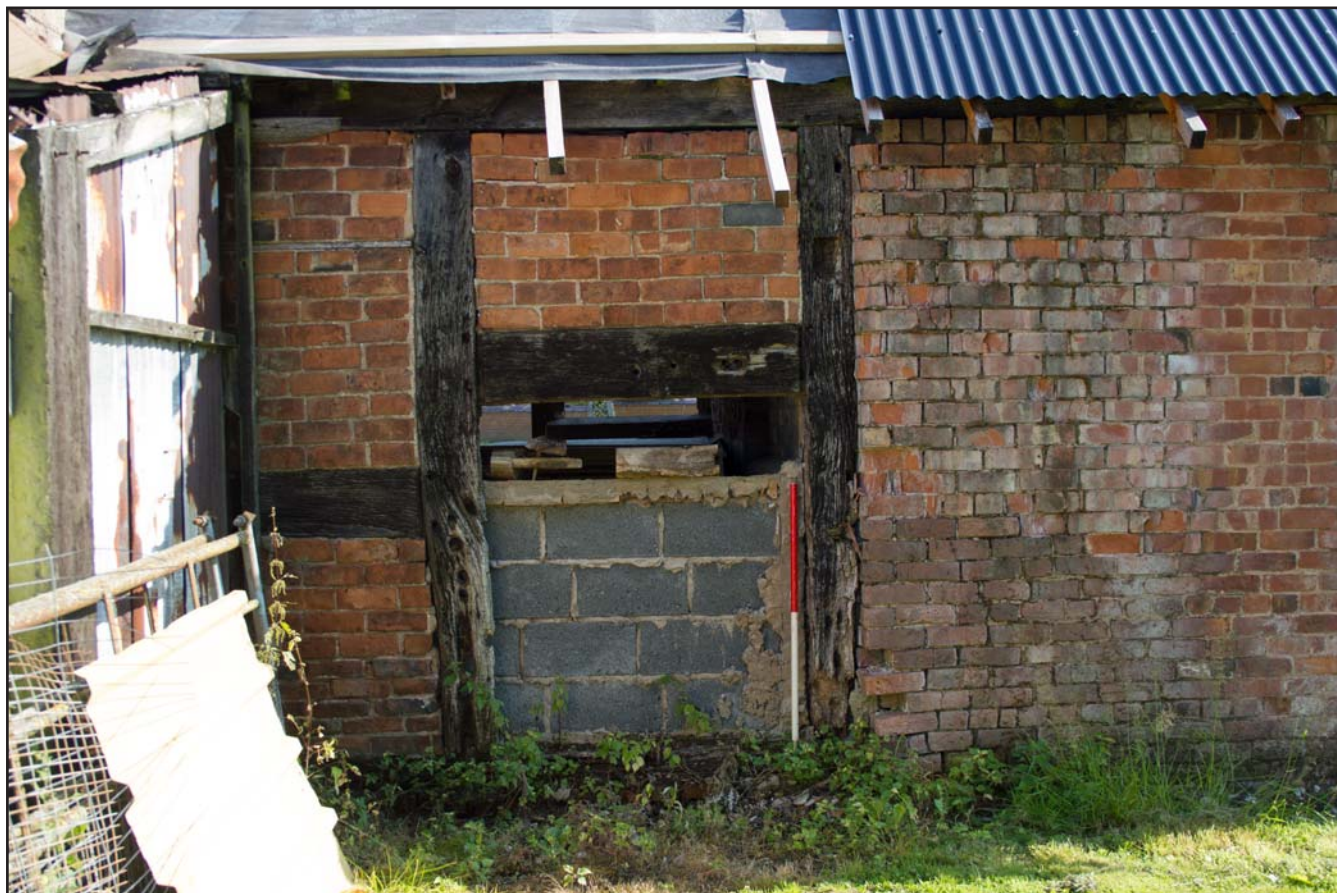
**Plate 06:** Right hand end of southwest elevation of the Stable at Brunette Farm, Ty Broughton, Wrexham - from the southwest - scale 1m

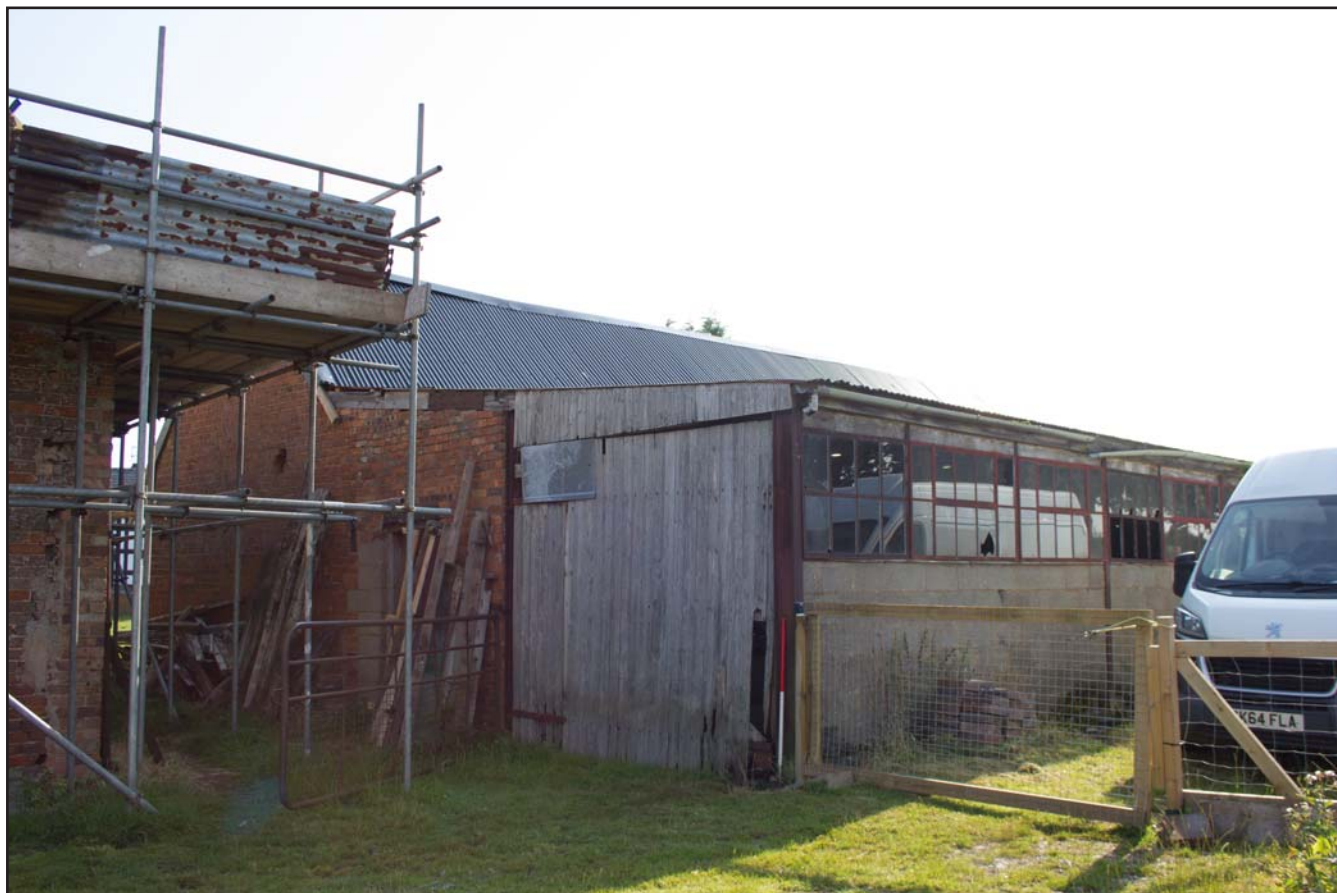
**Plate 07:** Southwest and northwest elevations of the Stable at Brunette Farm, Ty Broughton, Wrexham - from the west - scale 1m

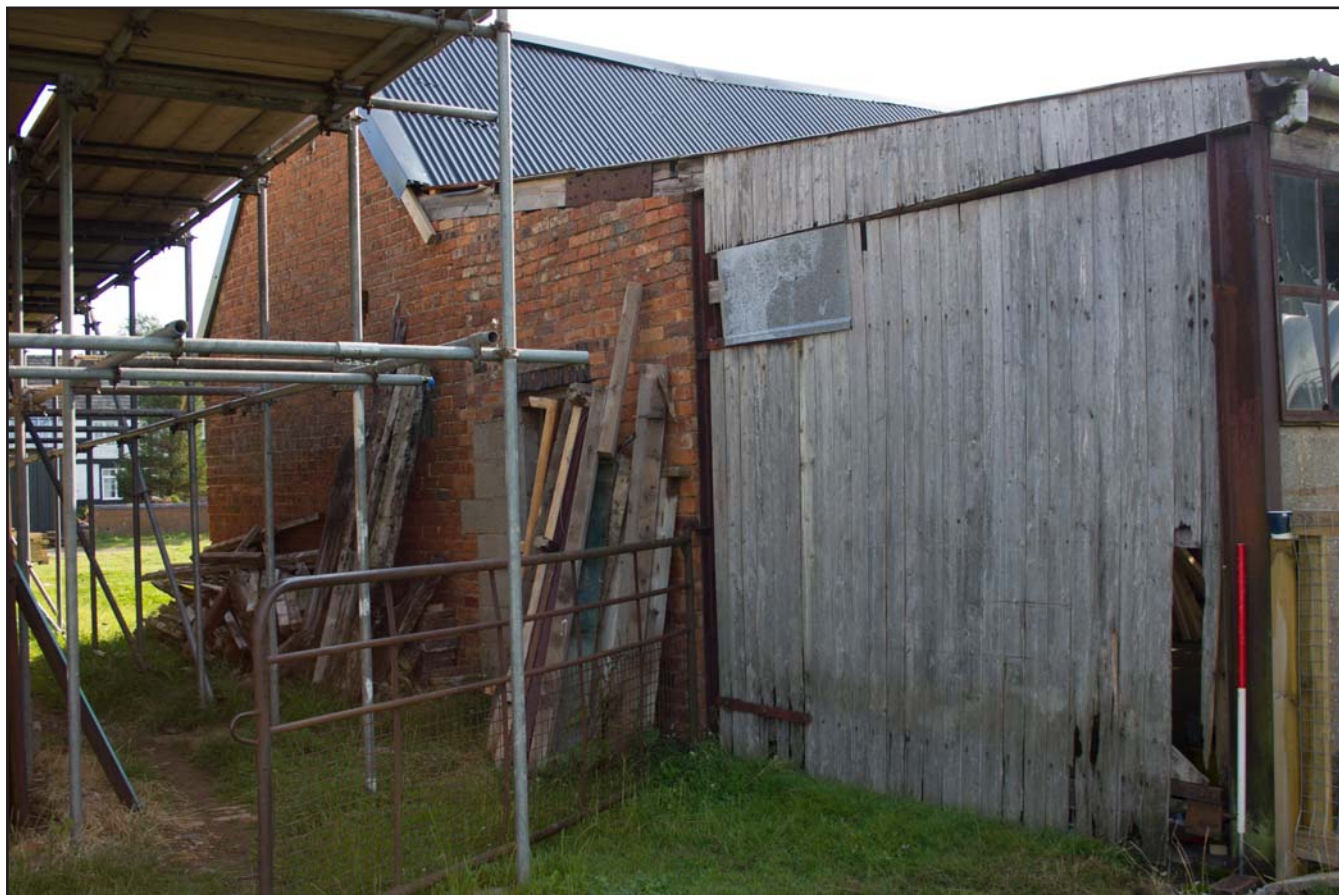
**Plate 08:** Oblique shot of northwest elevation of the Stable at Brunette Farm, Ty Broughton, Wrexham - from the west - scale 1m

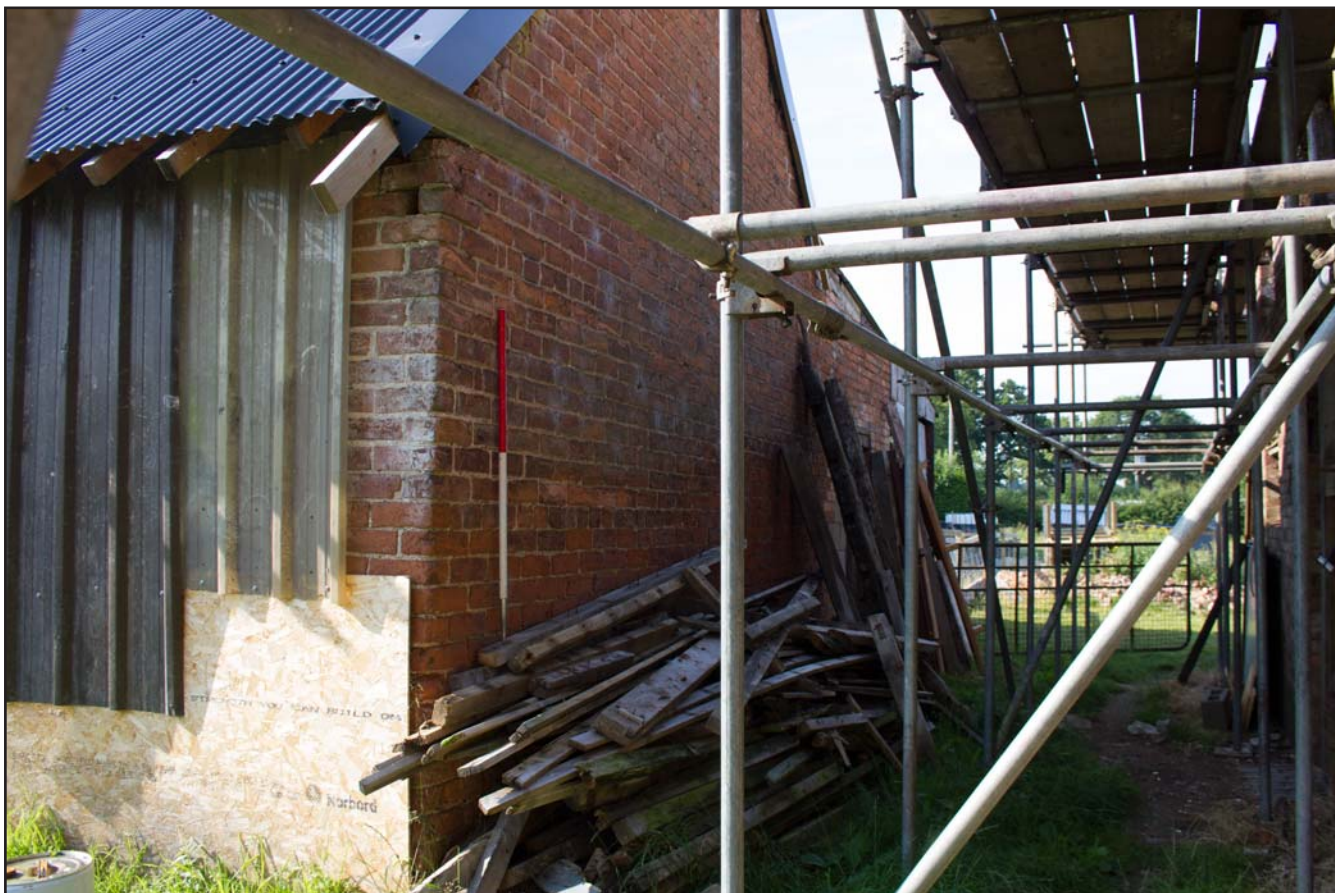
**Plate 09:** Oblique shot of northwest elevation of the Stable at Brunette Farm, Ty Broughton, Wrexham - from the north - scale 1m

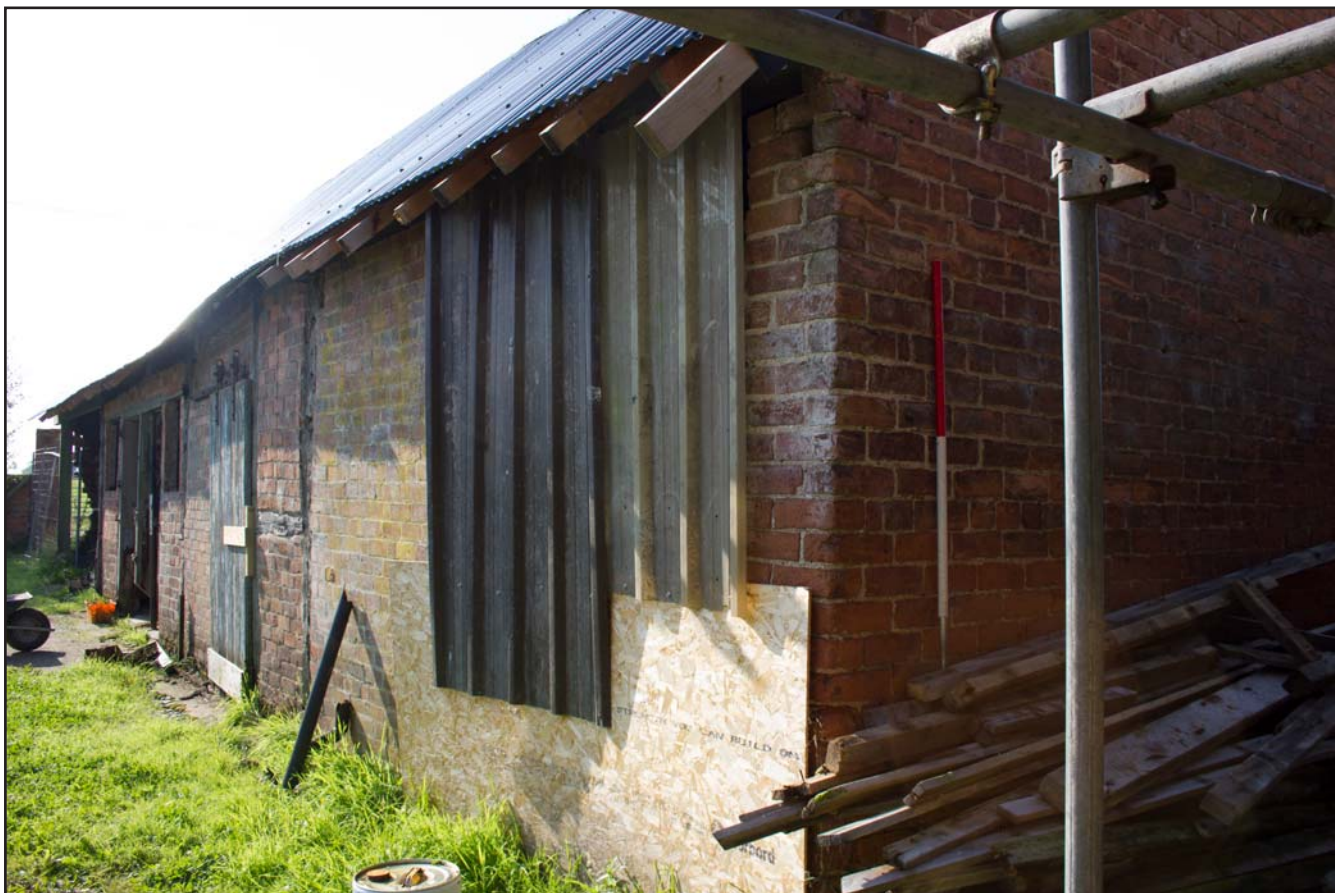
**Plate 10:** Northwest and northeast elevations of the Stable at Brunette Farm, Ty Broughton, Wrexham - from the north - scale 1m

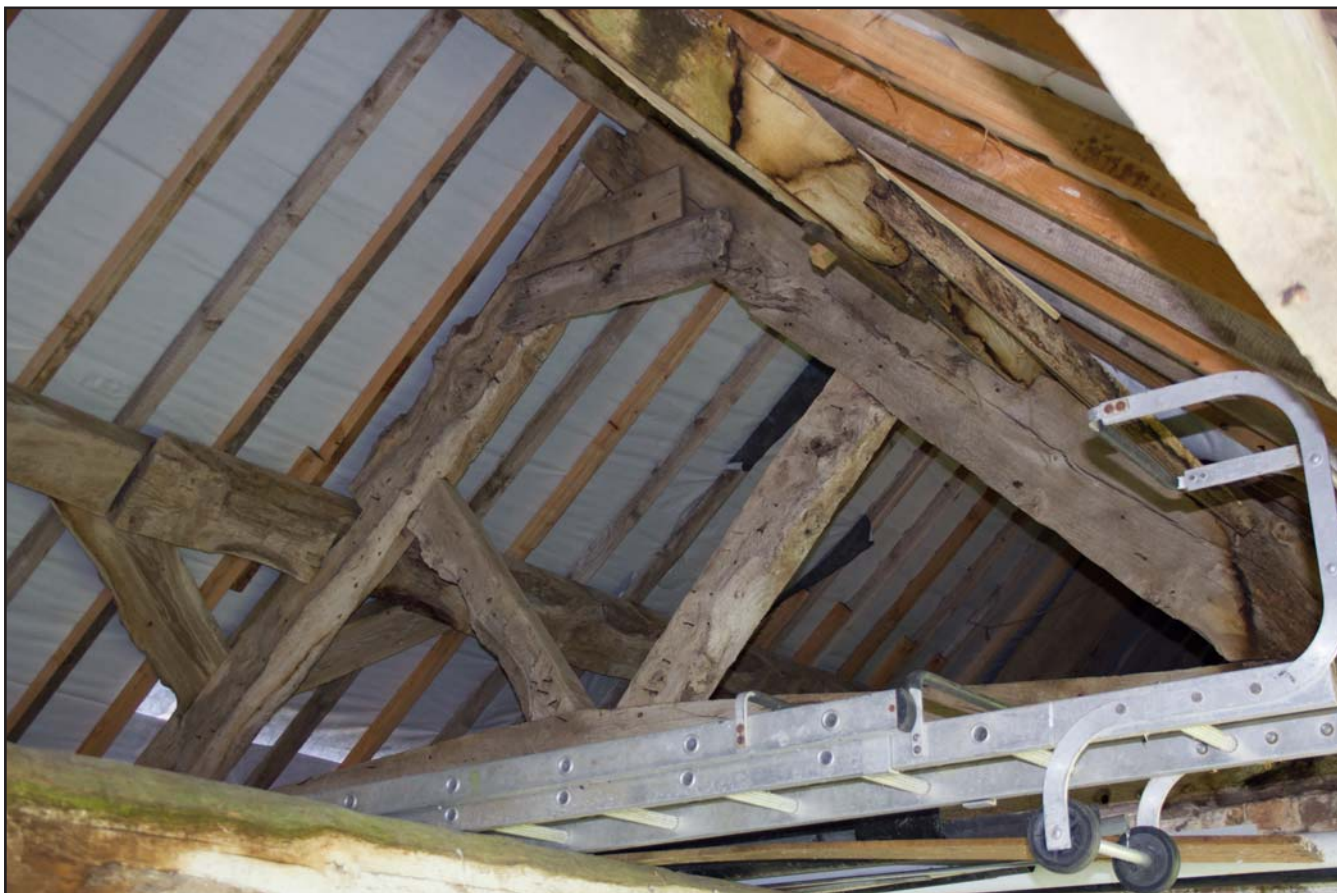
**Plate 14:** North western handhewn truss and blades in Room 1, Stable at Brunette Farm, Ty Broughton, Wrexham - from the east - no scale

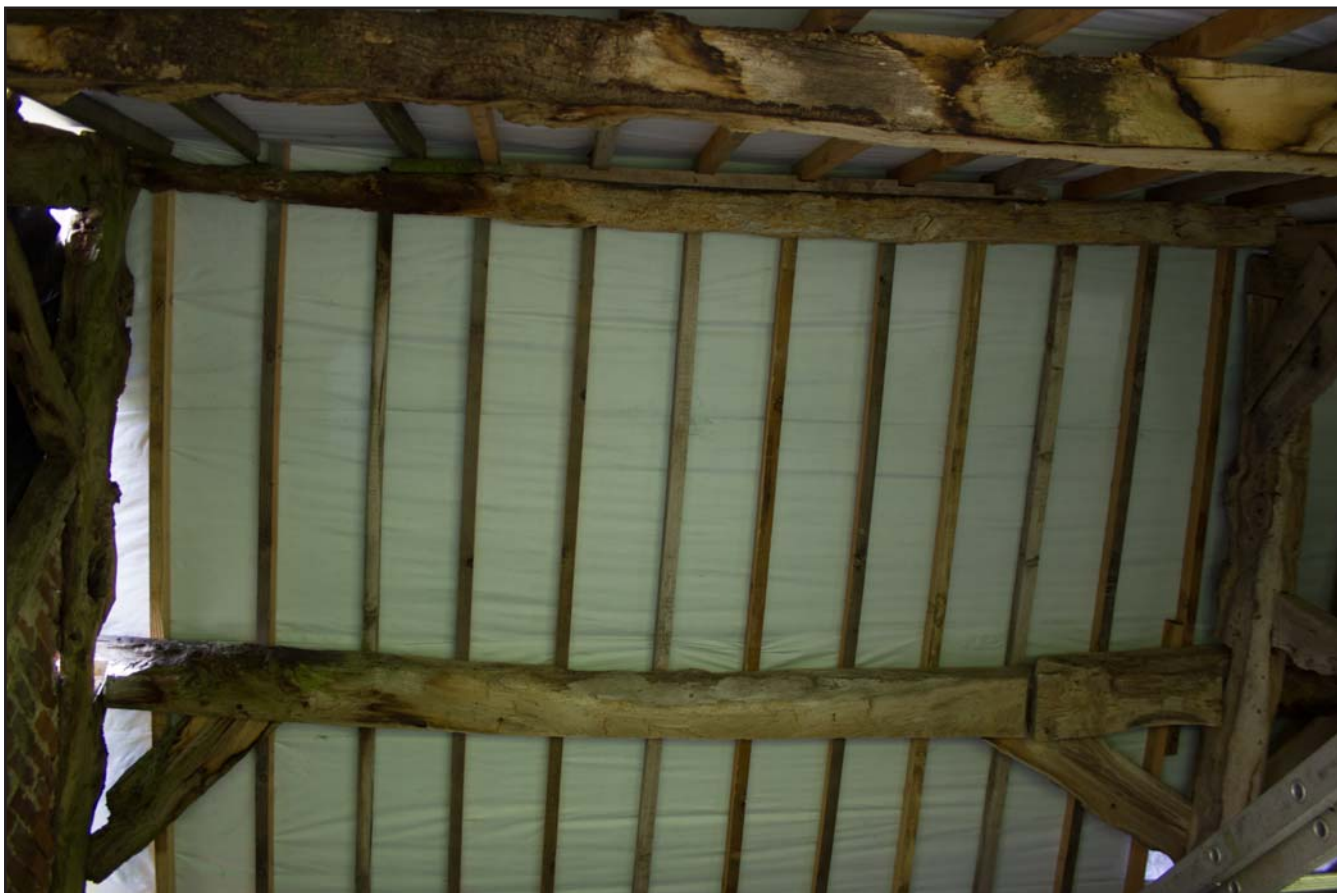
**Plate 15:** Handhewn purlins, ridgebeam and blade in Room 1, Stable at Brunette Farm, Ty Broughton, Wrexham - from the northeast - no scale

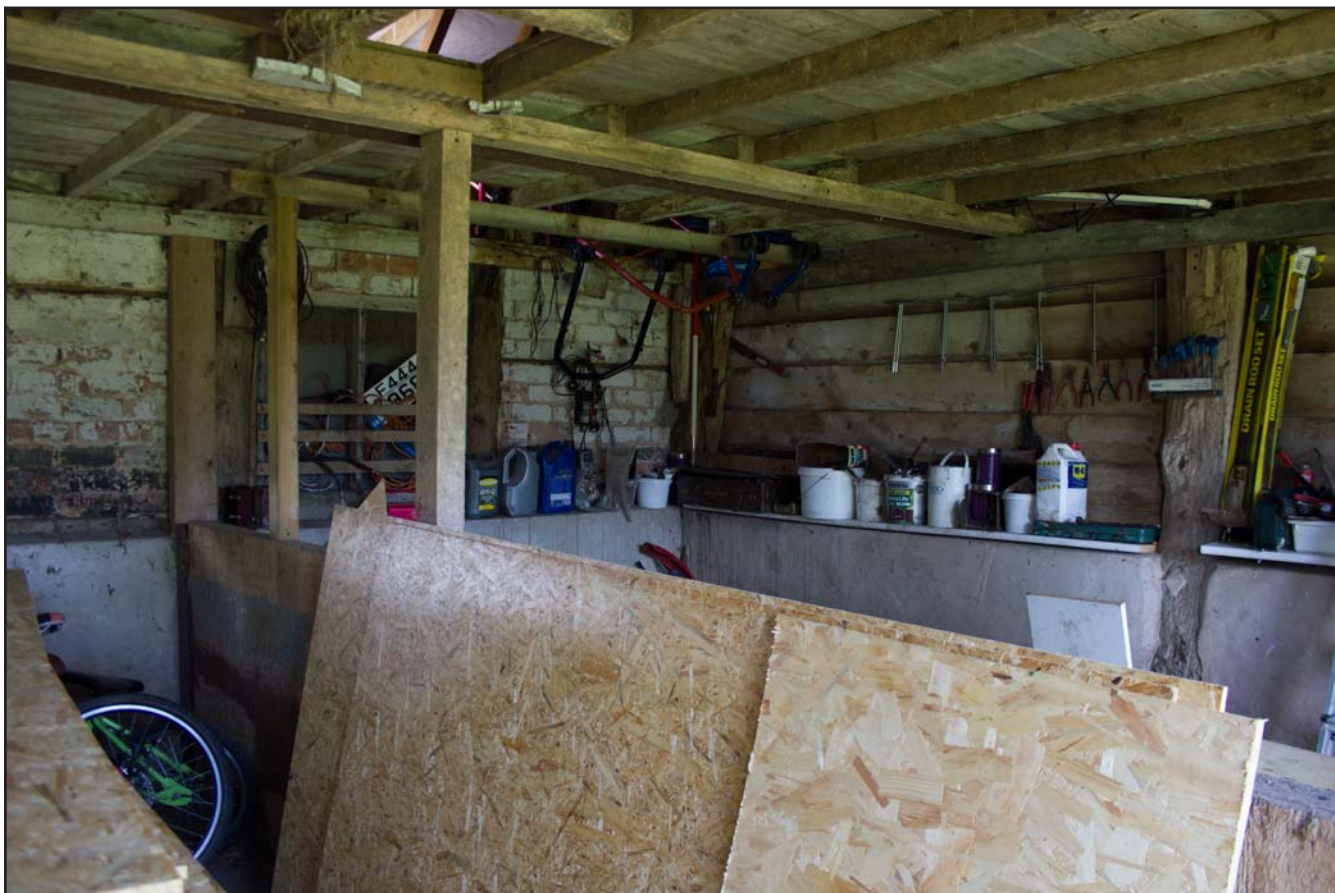
**Plate 16:** Room 2 within the Stable at Brunette Farm, Ty Broughton, Wrexham - from the east - scale 1m

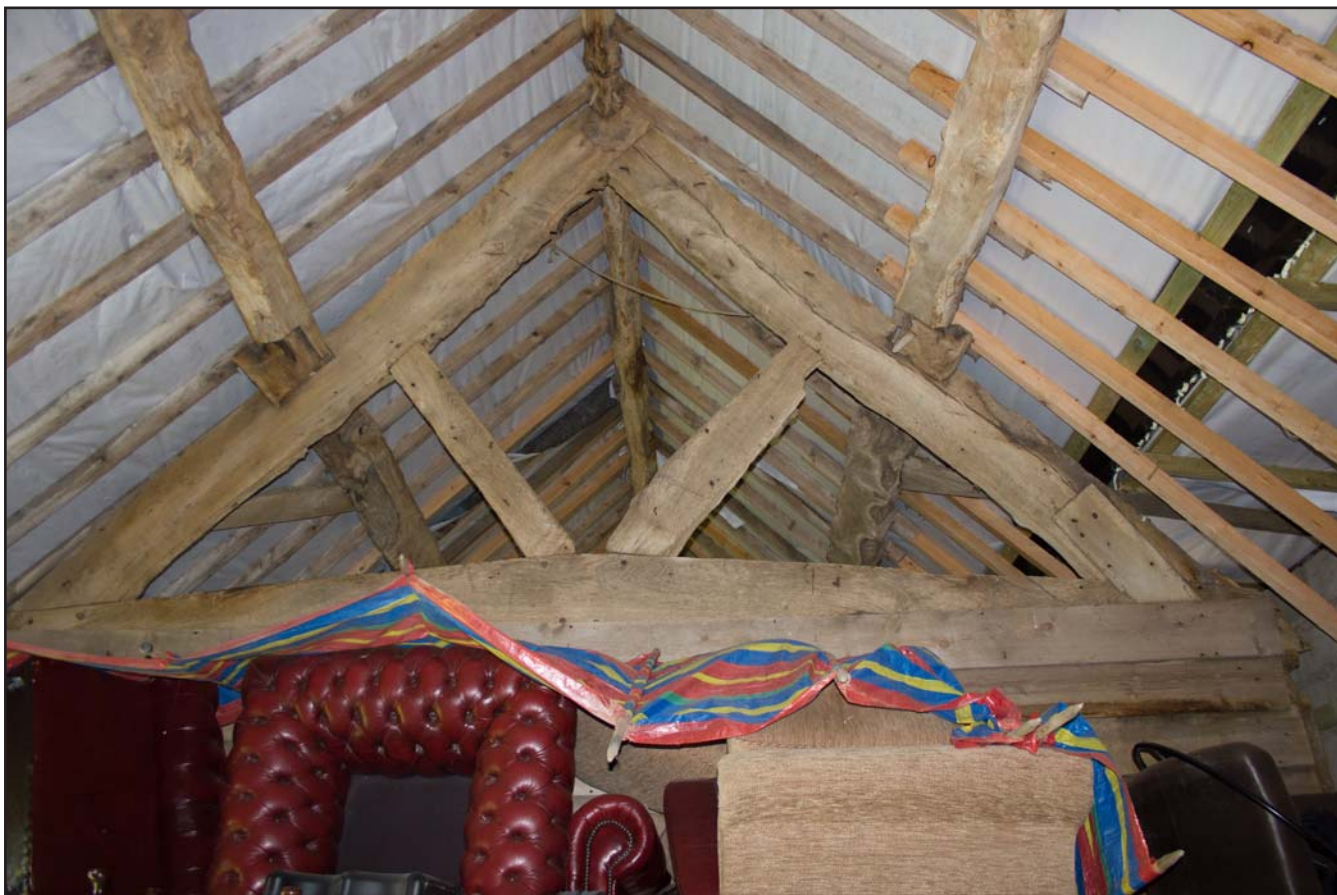
**Plate 22:** South eastern handhewn truss in Room 3, Stable at Brunette Farm, Ty Broughton, Wrexham - from the northwest - no scale

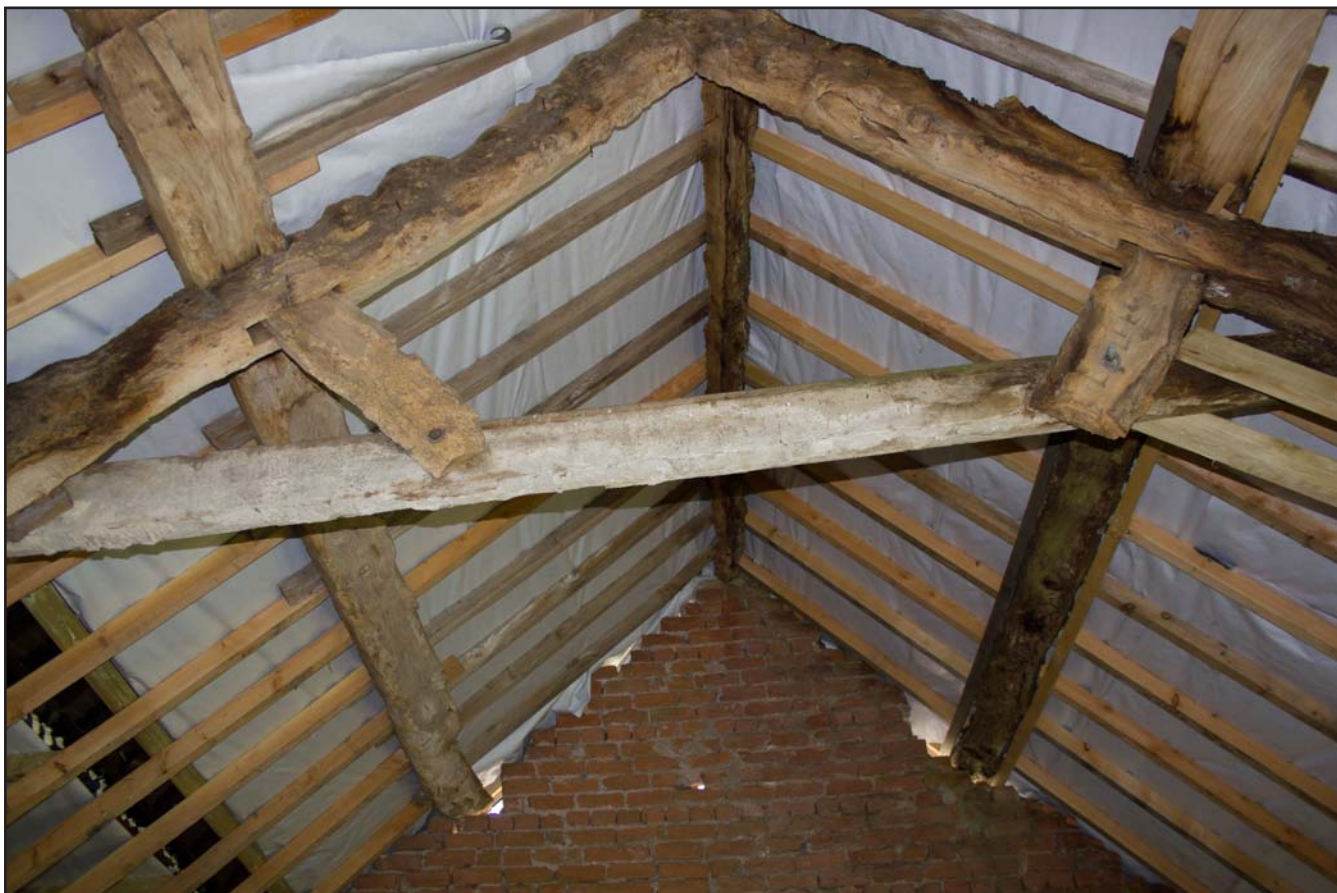
**Plate 23:** North western handhewn truss in Room 3, Stable at Brunette Farm, Ty Broughton, Wrexham - from the southeast - no scale

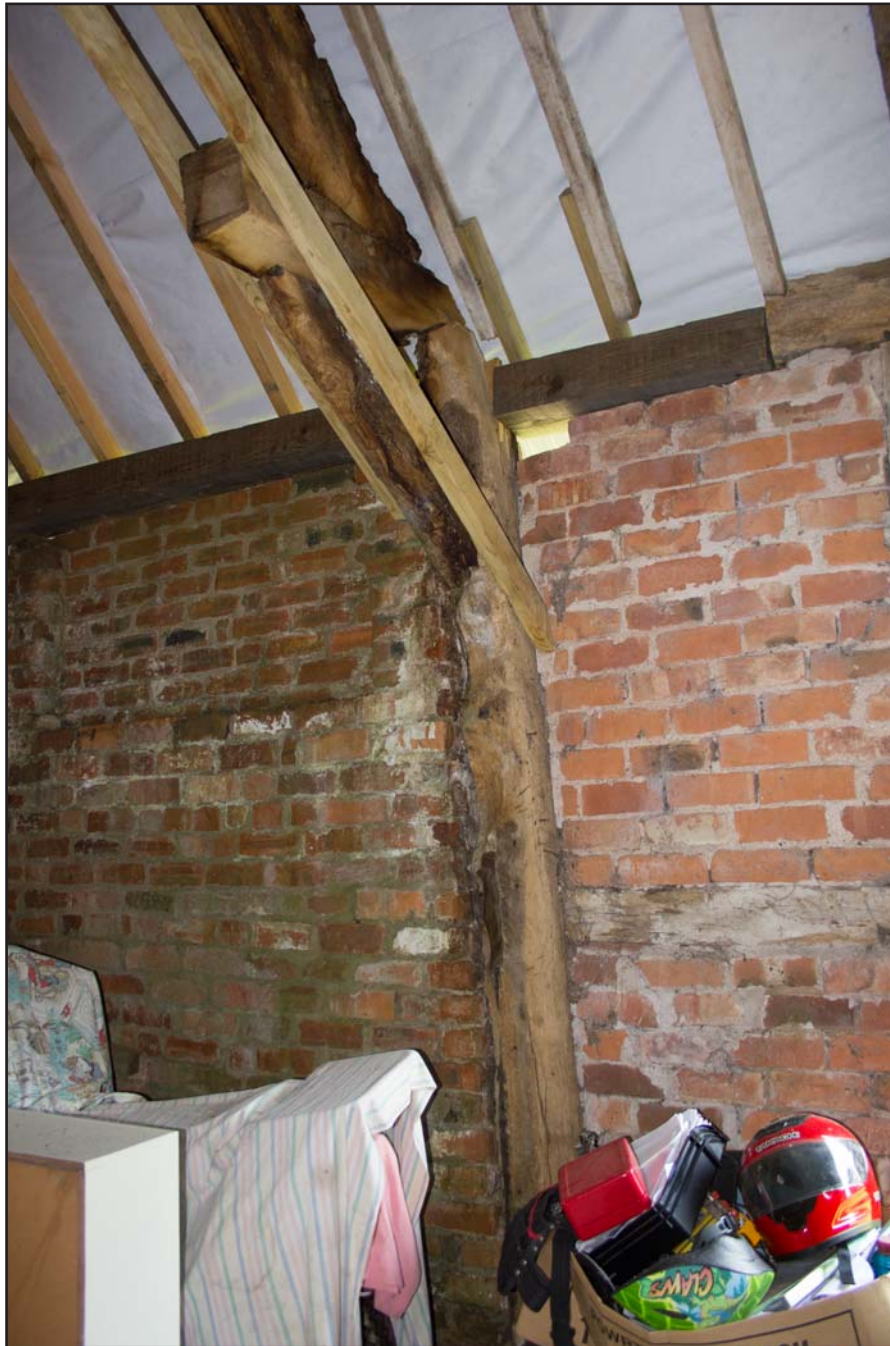
**Plate 24:** Handhewn upright post supporting north eastern trusse in Room 3, Stable at Brunette Farm, Ty Broughton, Wrexham - from the south - no scale

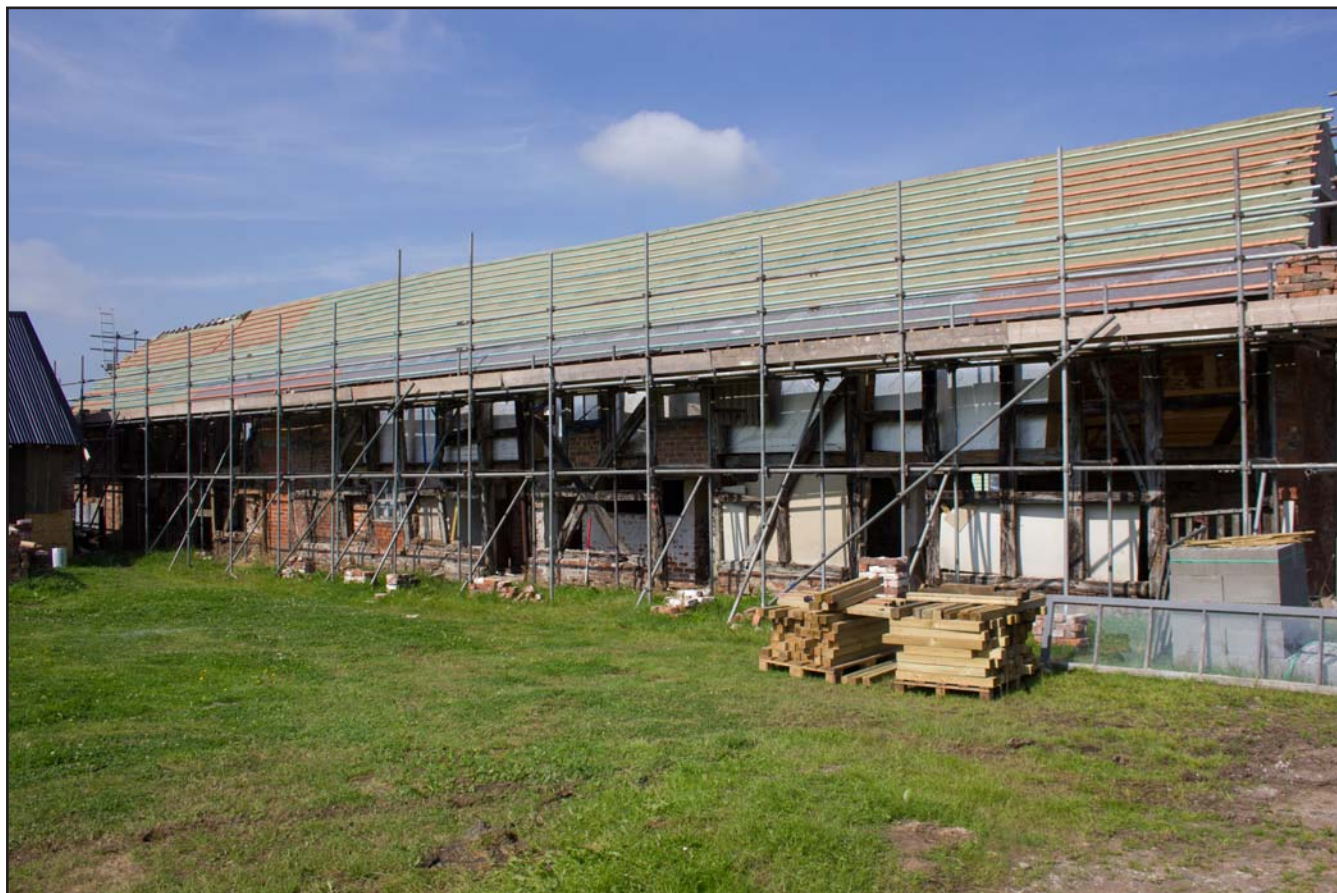
The south western gable of the Shippon is entirely made from handmade, red-brick bonded by lime mortar in a Common/American bond. The gable end has diamond pattern ventilators and a loft opening at eaves height and two hourglass pattern ventilators at ground level.

**Plate 25:** Oblique shot of southwest elevation of Shippon 1 at Brunette Farm, Ty Broughton, Wrexham - from the east - scale 1m
