# Outbuildings at Brunette Farm, Lower Wych Road, Ty Broughton, Wrexham SY13 3BA

Historic Building Record Level 2

Project Code: A0318.1

Report no. 0304

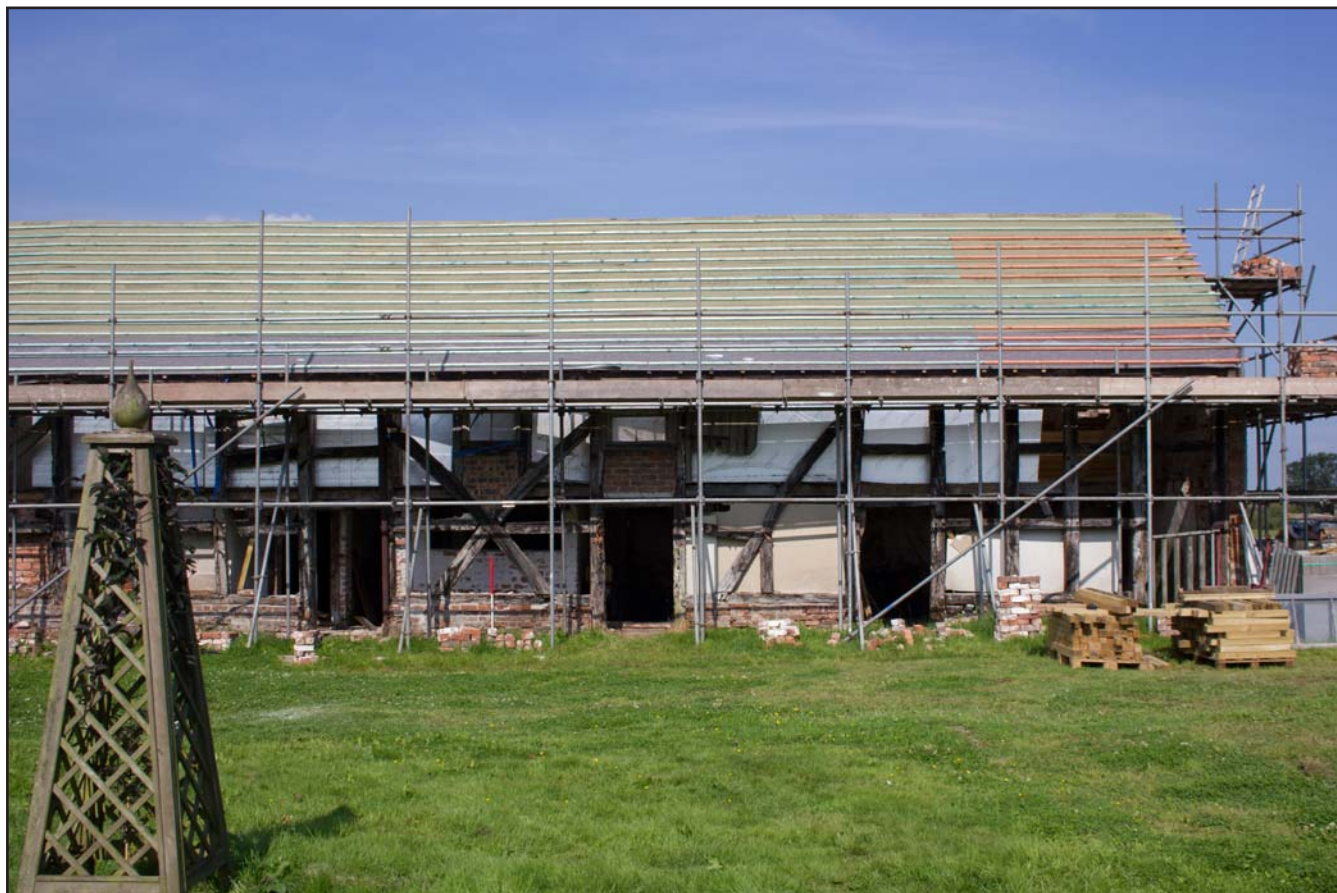
**Plate 26:** Right hand end of southeast elevation of Shippon 1 at Brunette Farm, Ty Broughton, Wrexham - from the southeast - scale 1m

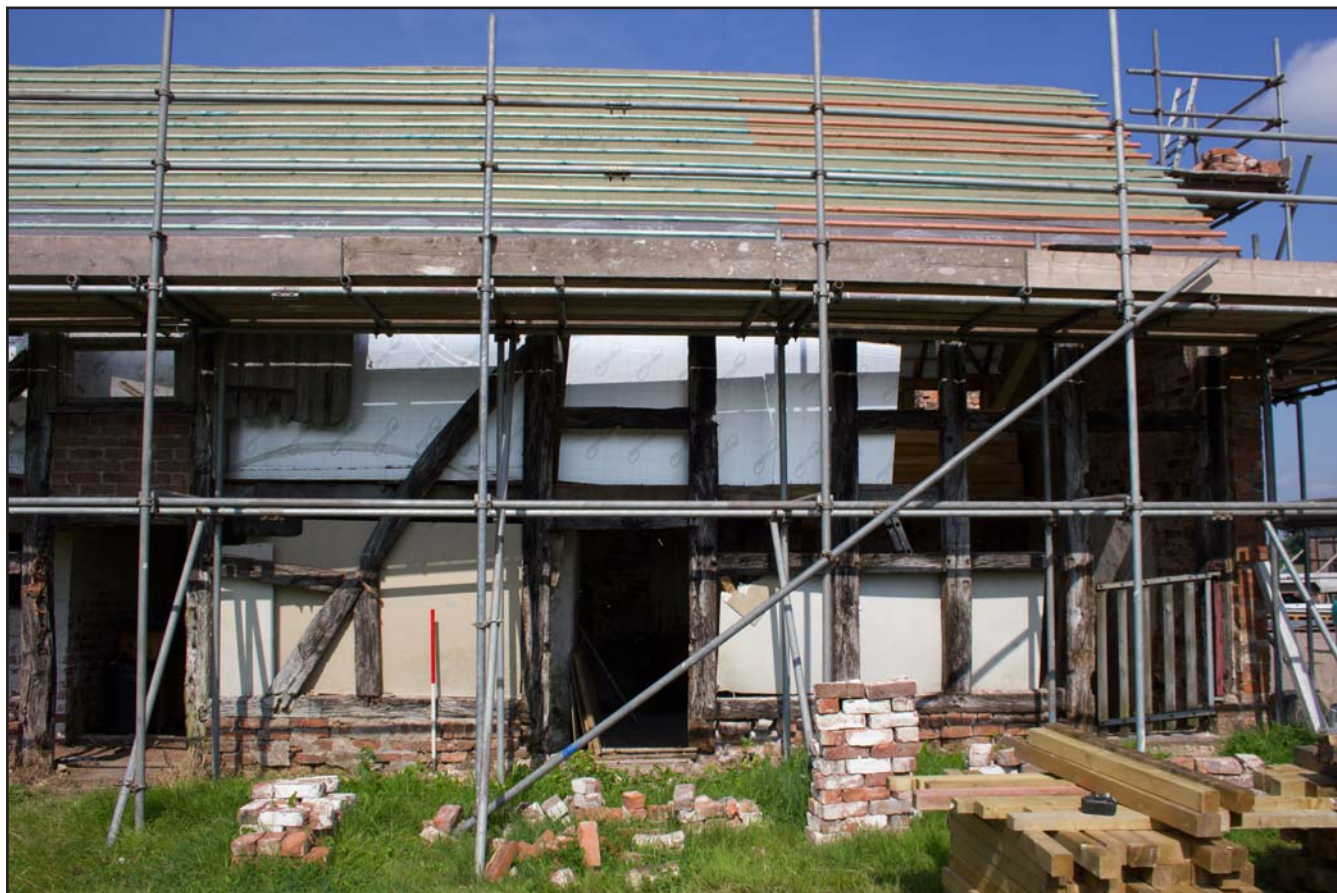
**Plate 27:** Far right hand end of southeast elevation of Shippon 1 at Brunette Farm, Ty Broughton, Wrexham - from the southeast - scale 1m

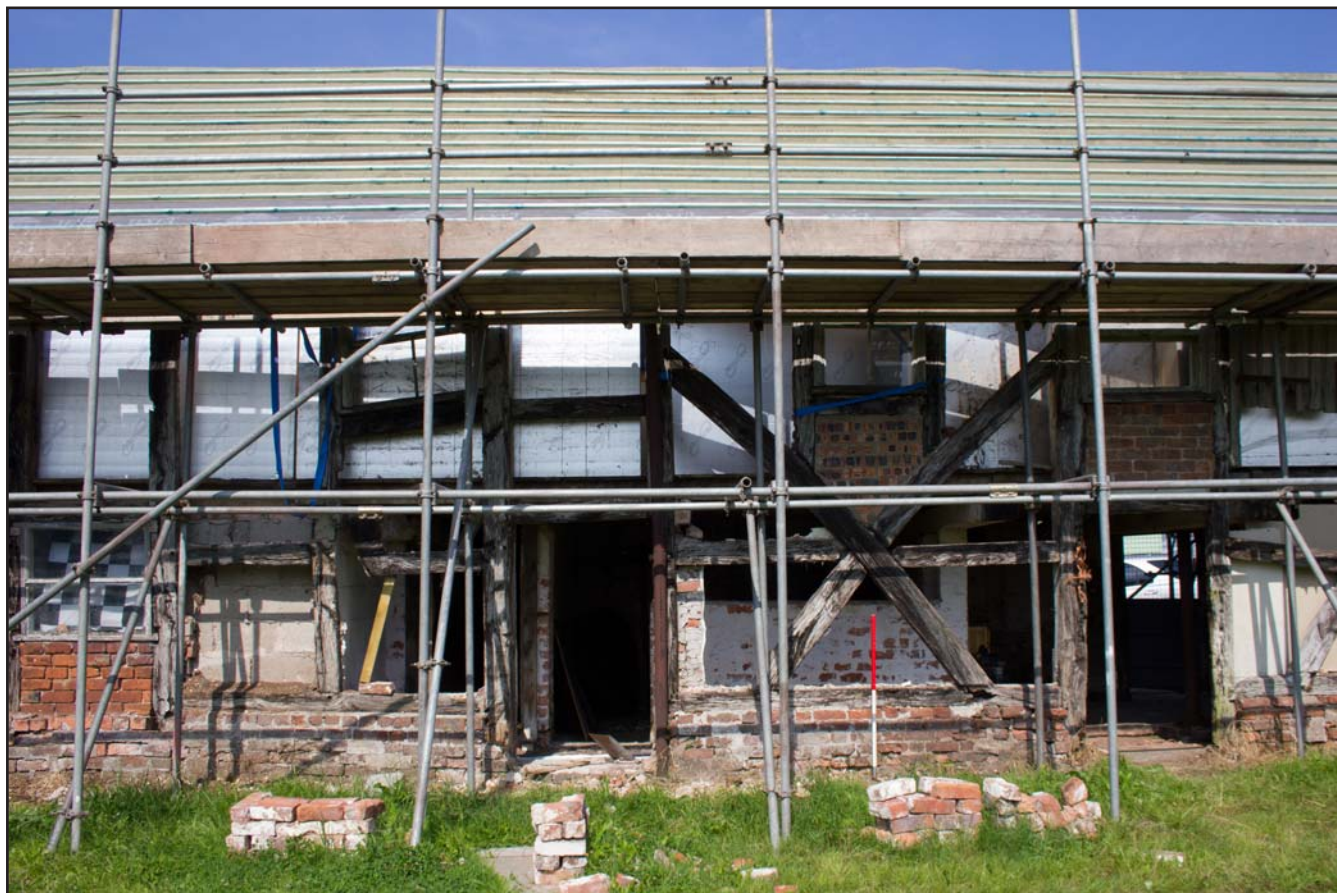
**Plate 28:** Centre of southeast elevation of Shippon 1 at Brunette Farm, Ty Broughton, Wrexham - from the southeast - scale 1m

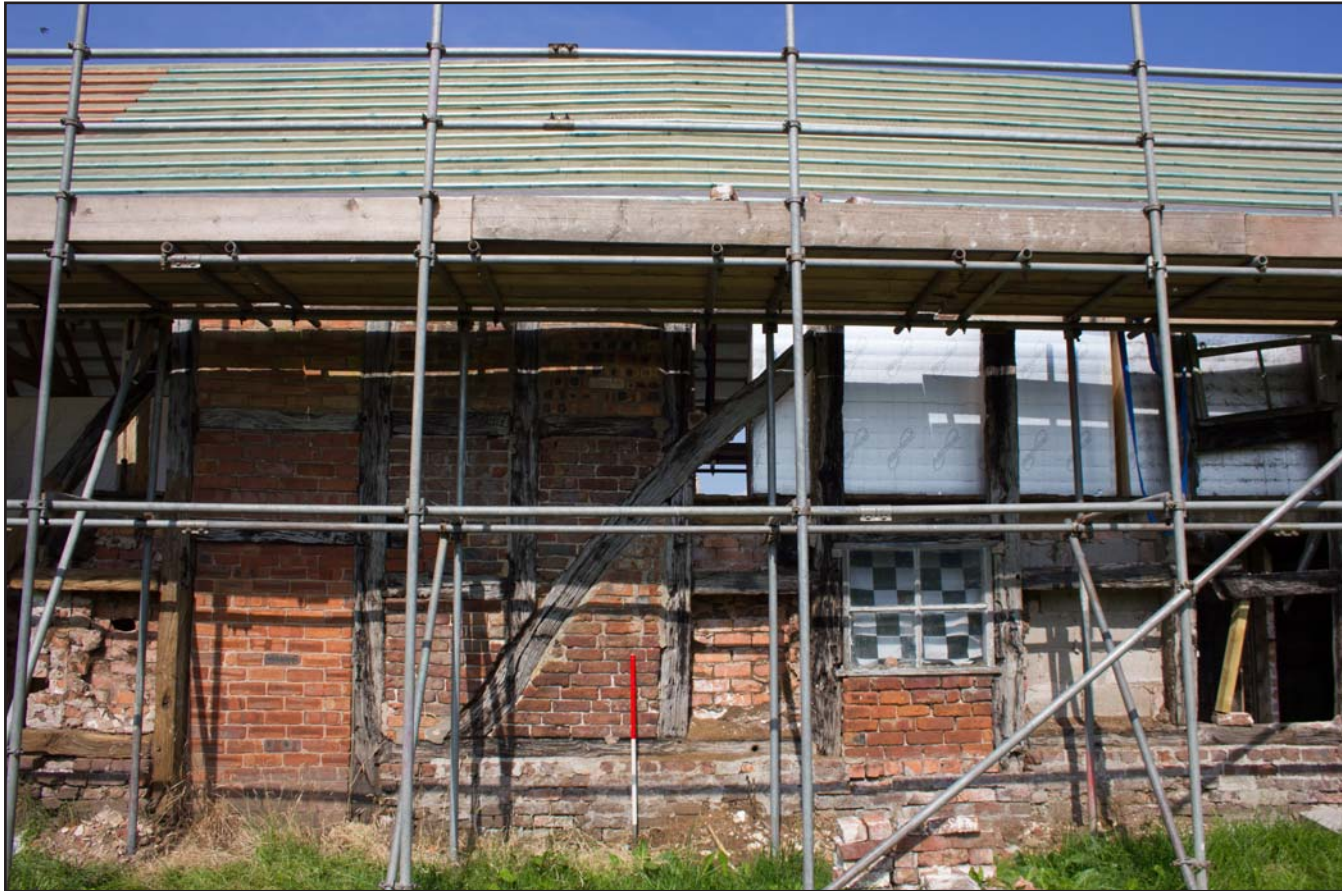
**Plate 29:** Far left hand end of southeast elevation of Shippon 1 at Brunette Farm, Ty Broughton, Wrexham - from the southeast - scale 1m

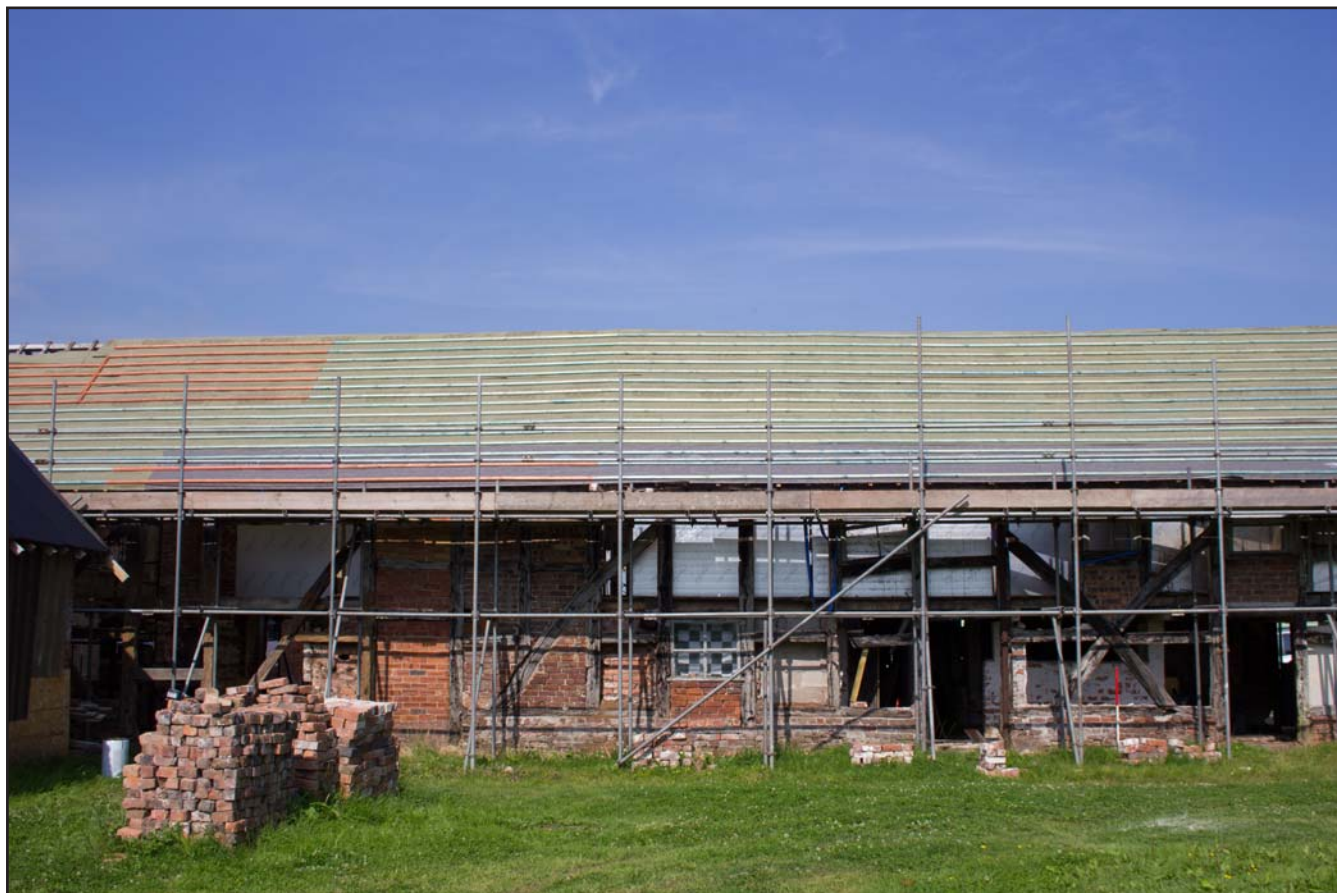
**Plate 30:** Left hand end of southeast elevation of Shippon 1 at Brunette Farm, Ty Broughton, Wrexham - from the southeast - scale 1m

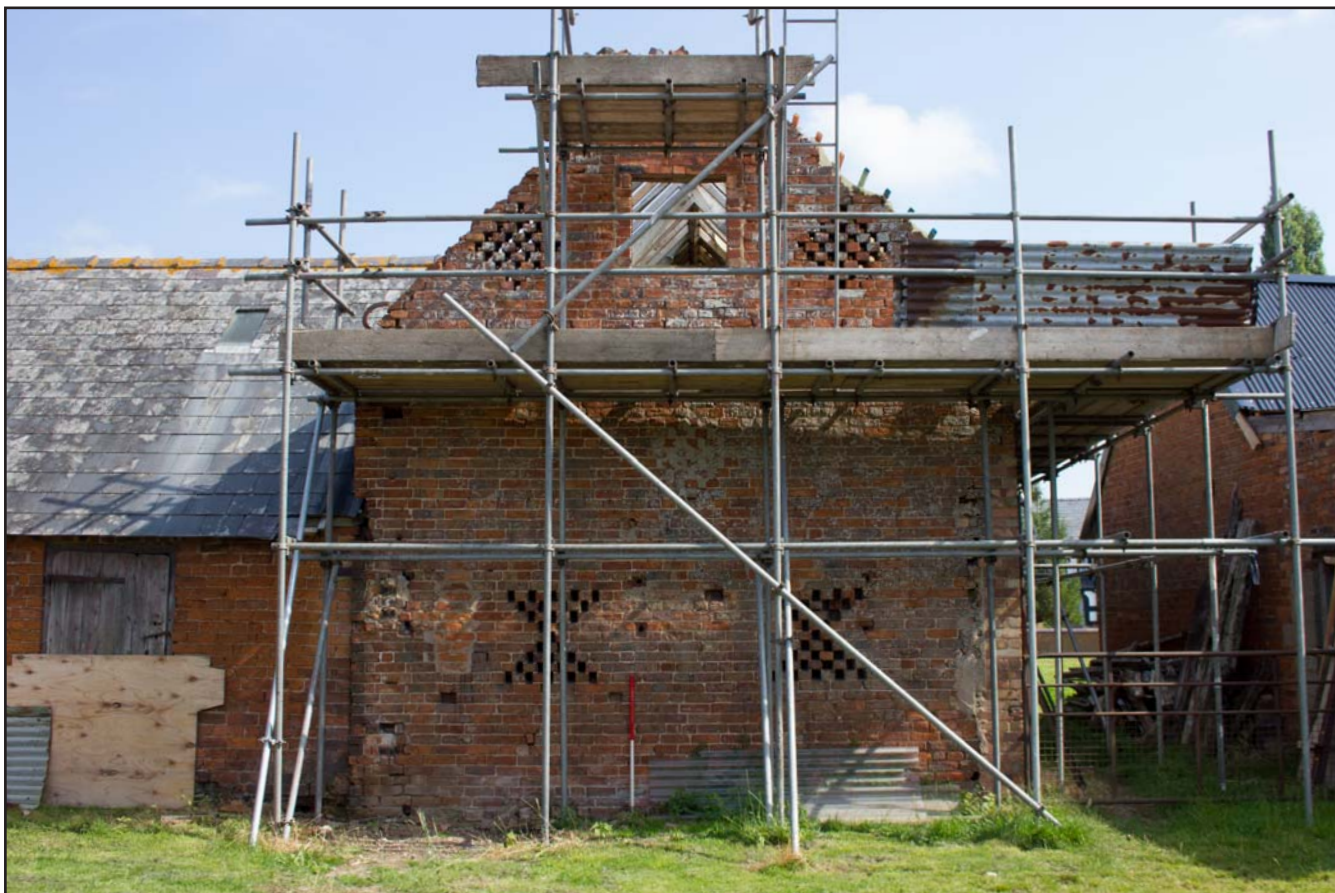
The south western gable of the Shippon is entirely made from handmade, red-brick bonded by lime mortar in a Common/American bond. The gable end has diamond pattern ventilators and a loft opening at eaves height and two hourglass pattern ventilators at ground level.

**Plate 31:** Southwest facing gable elevation of Shippon 1 at Brunette Farm, Ty Broughton, Wrexham - from the southwest - scale 1m

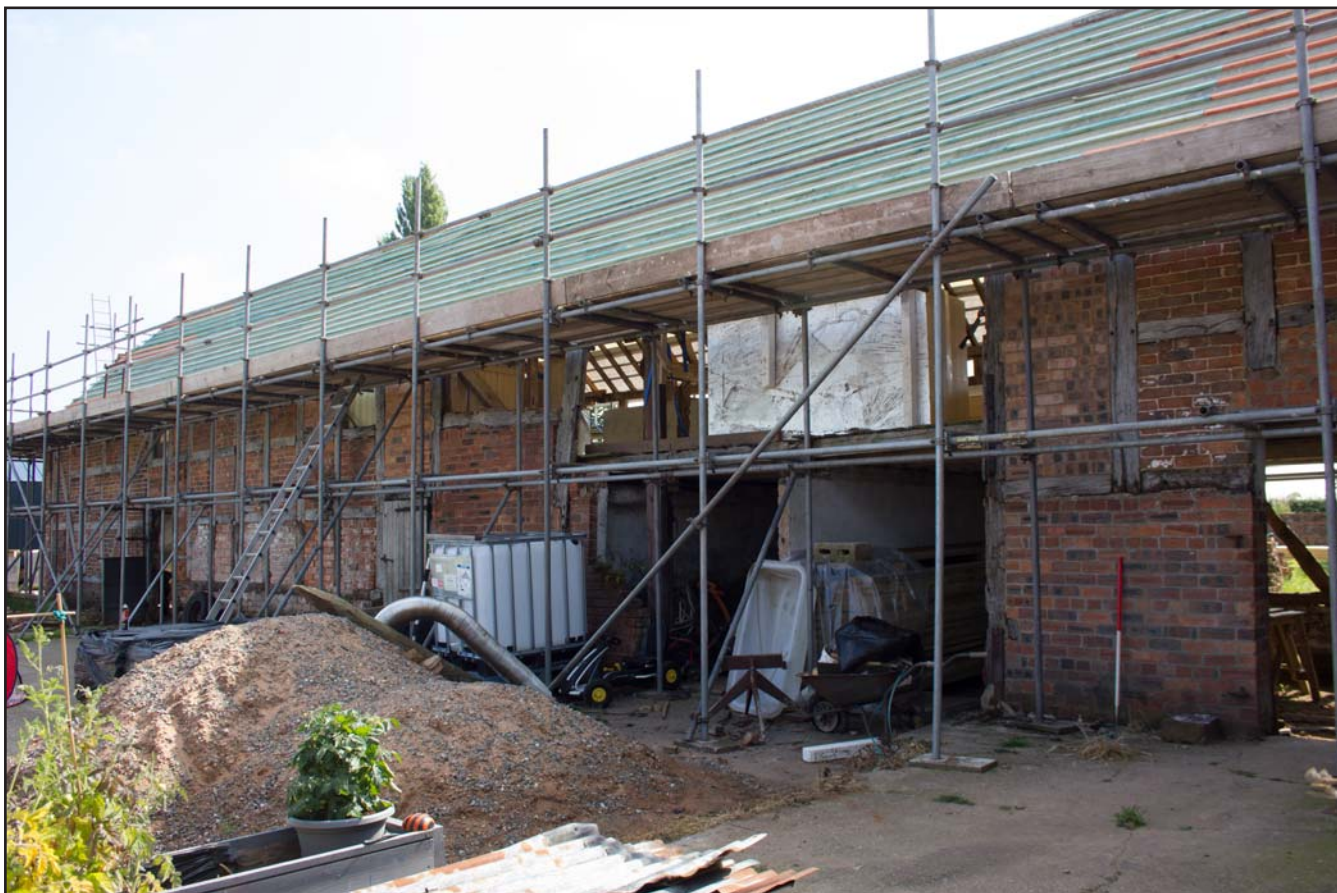
**Plate 32:** Oblique shot of northwest elevation of Shippon 1 at Brunette Farm, Ty Broughton, Wrexham - from the west - scale 1m

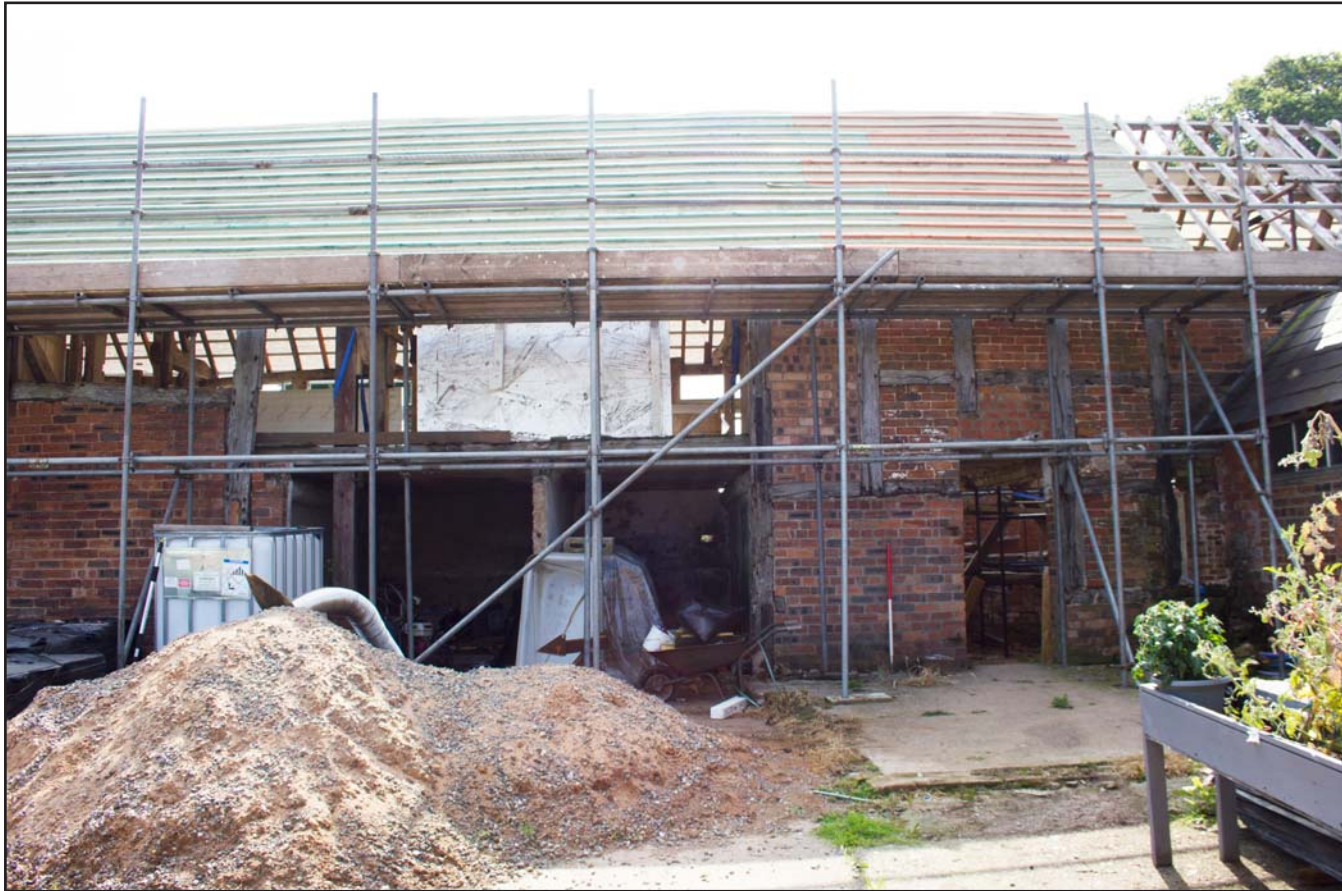
**Plate 33:** Right hand end of northwest elevation of Shippon 1 at Brunette Farm, Ty Broughton, Wrexham - from the northwest - scale 1m

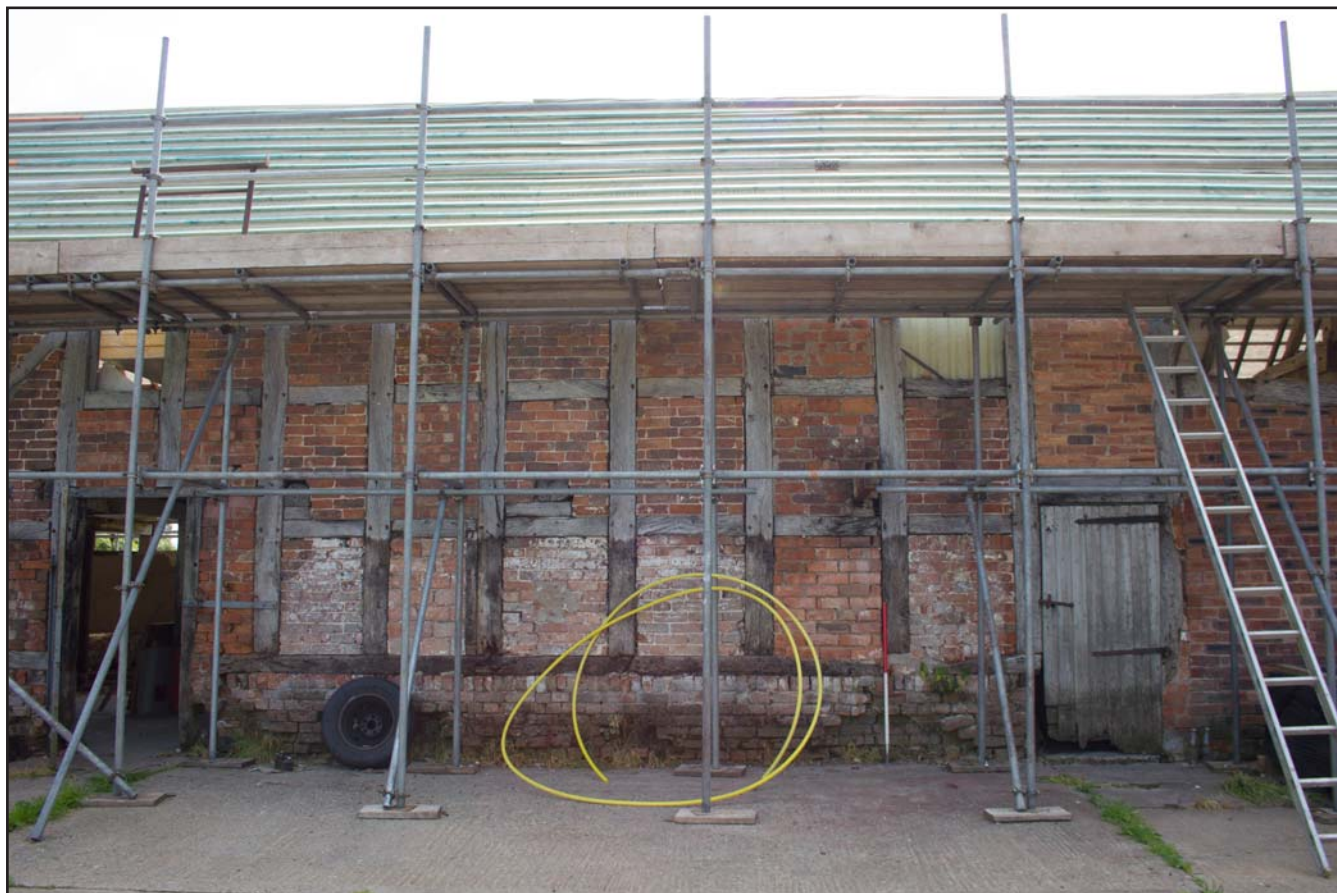
**Plate 34:** Centre of northwest elevation of Shippon 1 at Brunette Farm, Ty Broughton, Wrexham - from the northwest - scale 1m

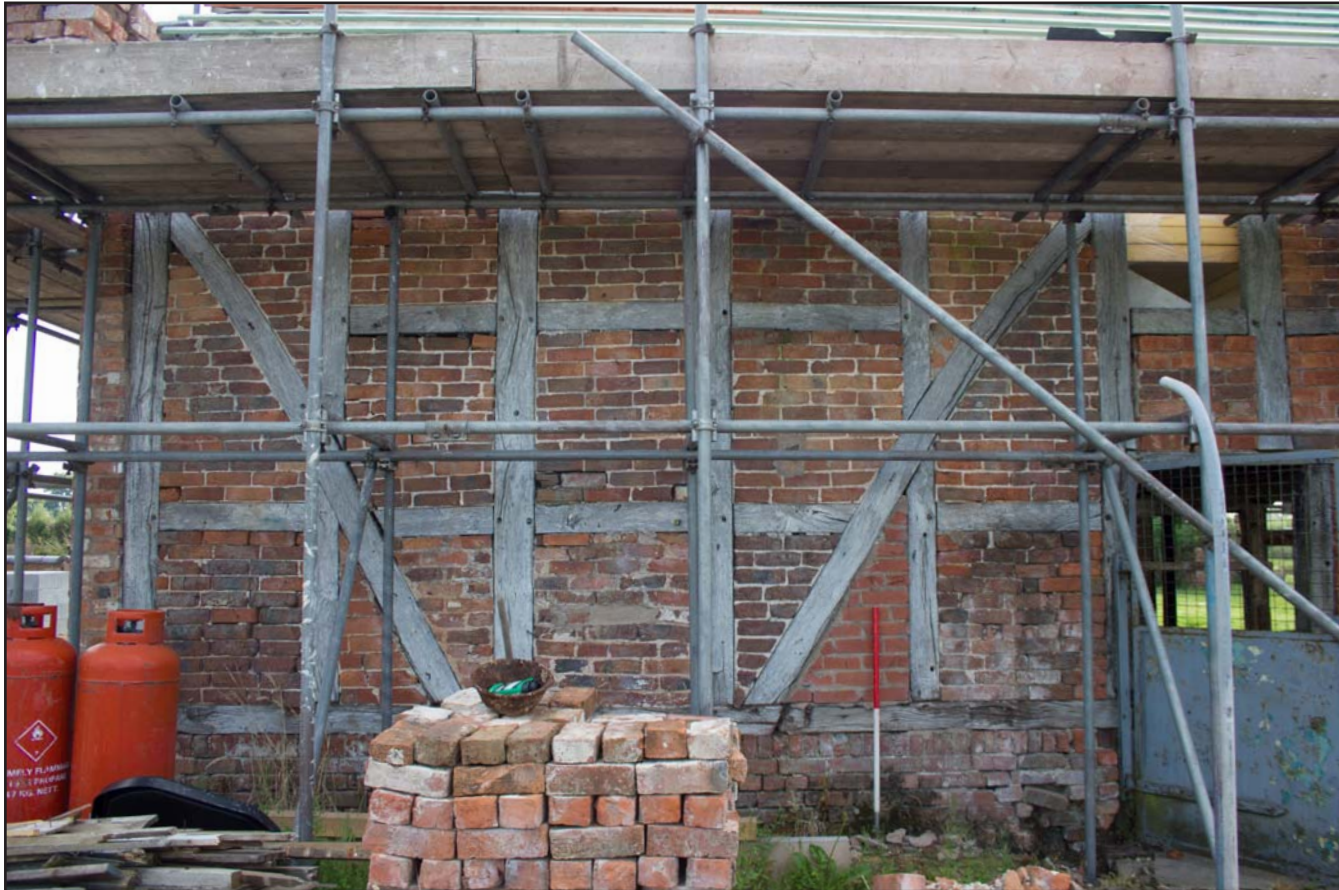
**Plate 35:** Left hand end of northwest elevation of Shippon 1 at Brunette Farm, Ty Broughton, Wrexham - from the north - scale 1m

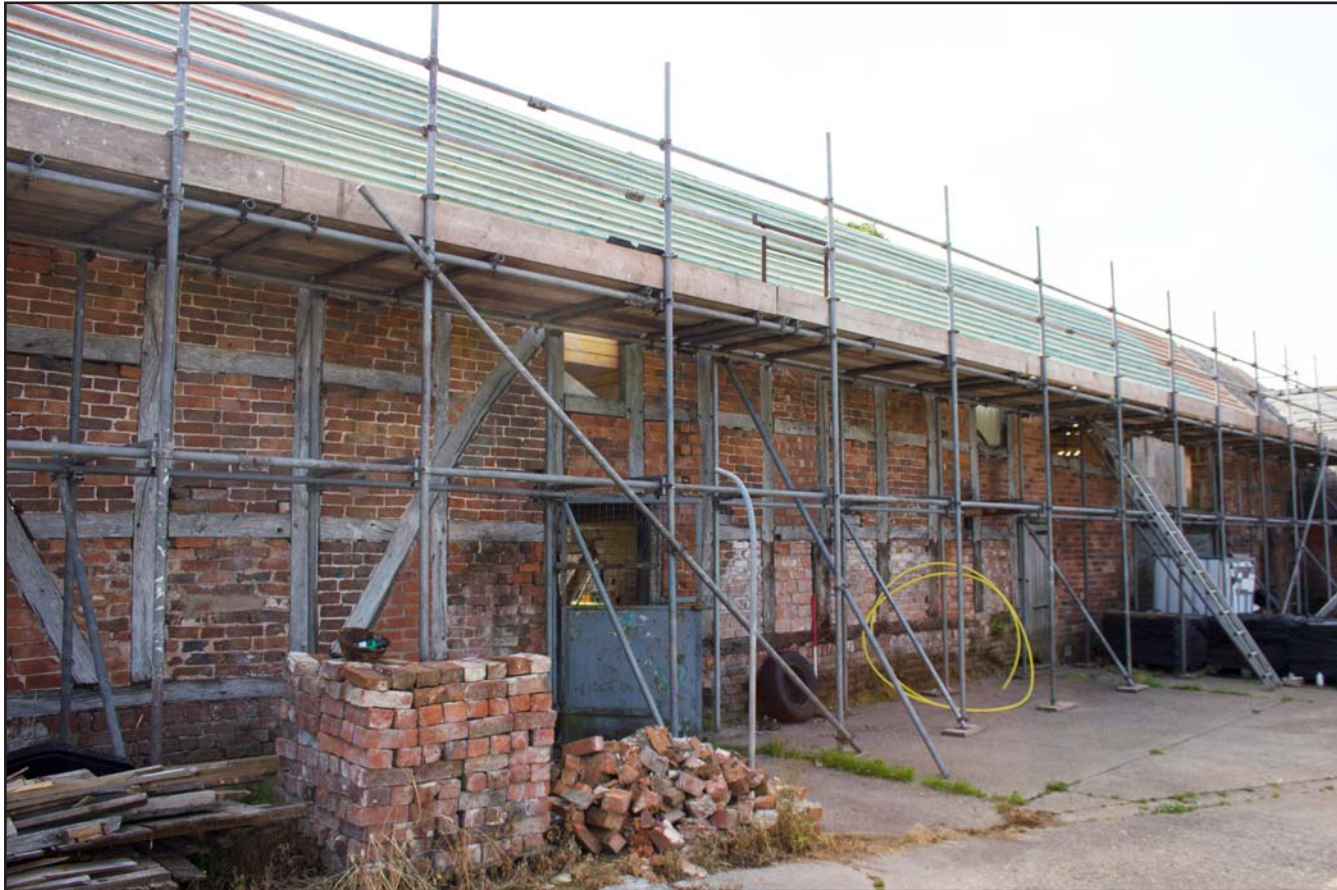
**Plate 36:** Oblique shot of northwest elevation of Shippon 1 at Brunette Farm, Ty Broughton, Wrexham - from the west - scale 1m

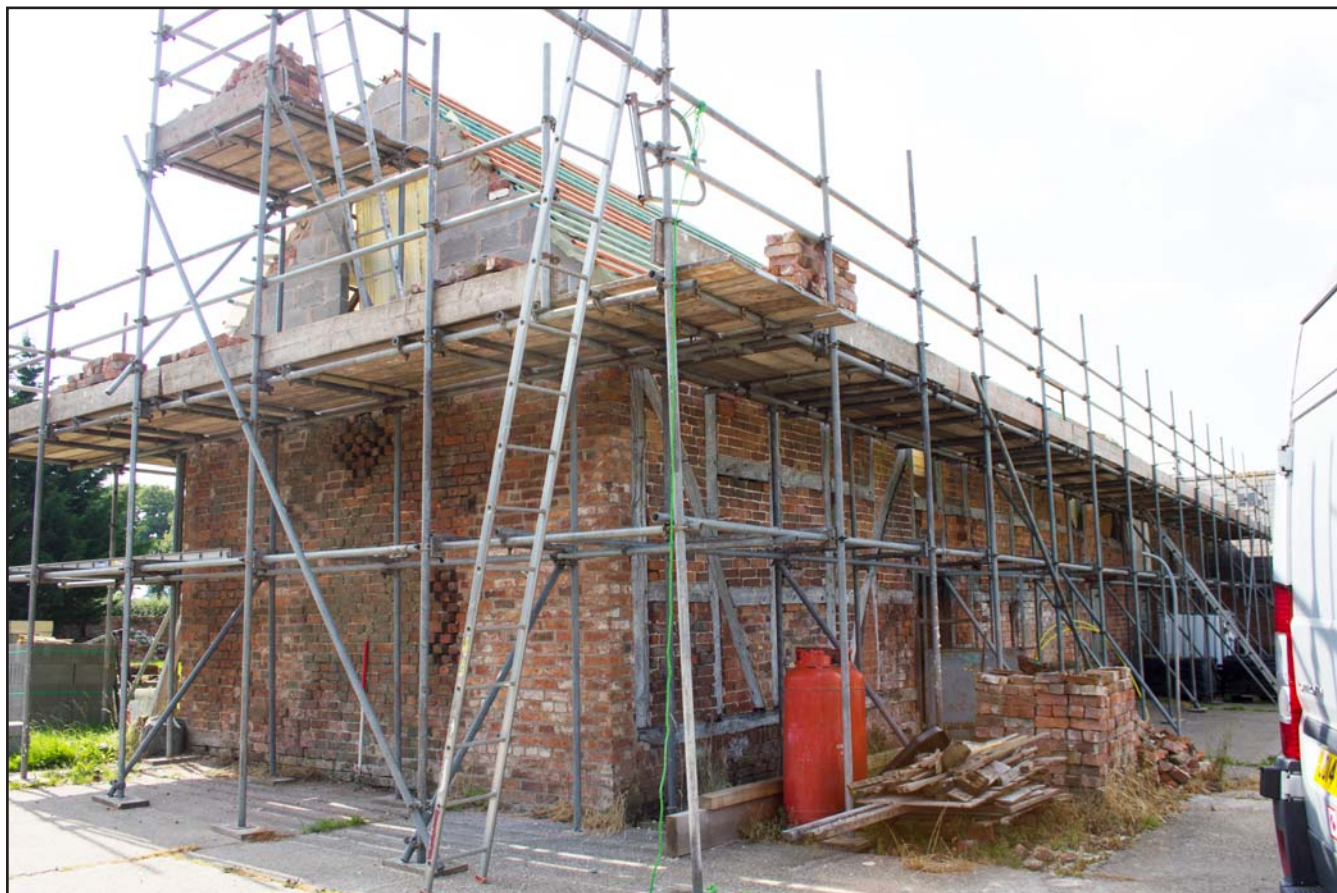
**Plate 37:** Northwest and northeast elevations of Shippon 1 at Brunette Farm, Ty Broughton, Wrexham - from the north - scale 1m

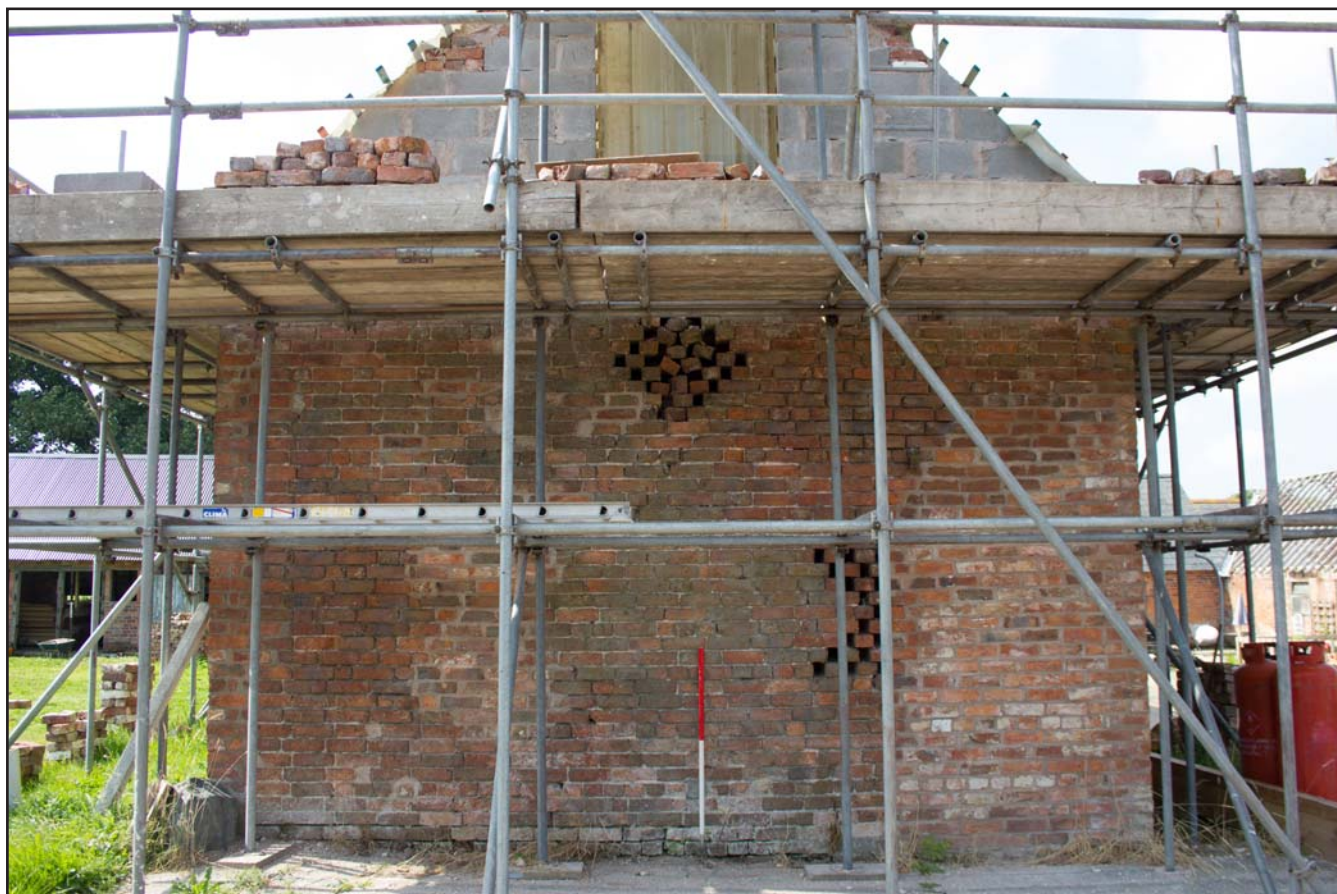
**Plate 38:** Northeast facing gable elevation of Shippon 1 at Brunette Farm, Ty Broughton, Wrexham - from the northeast - scale 1m

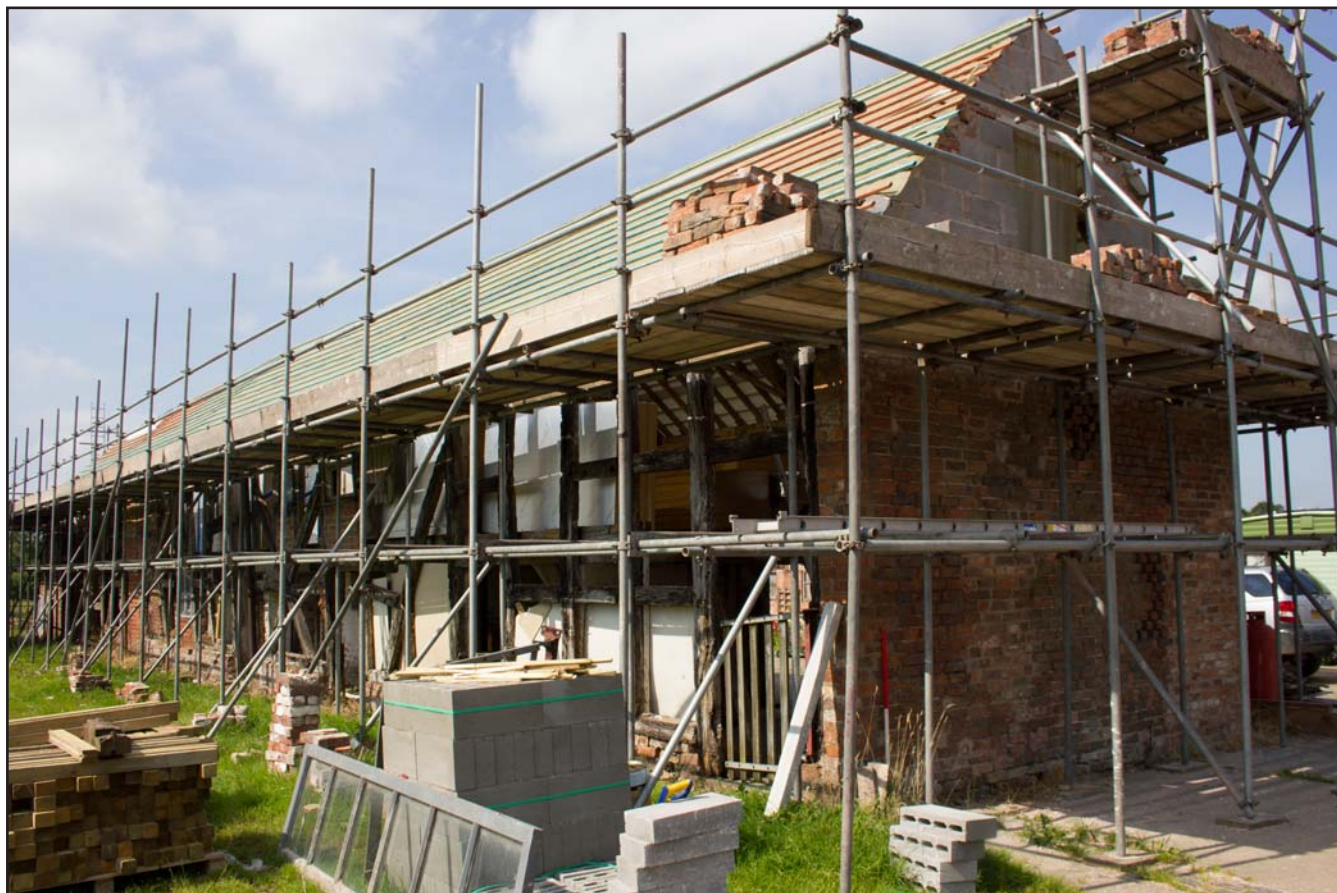
**Plate 39:** Northeast and northwest elevations of Shippon 1 at Brunette Farm, Ty Broughton, Wrexham - from the east - scale 1m

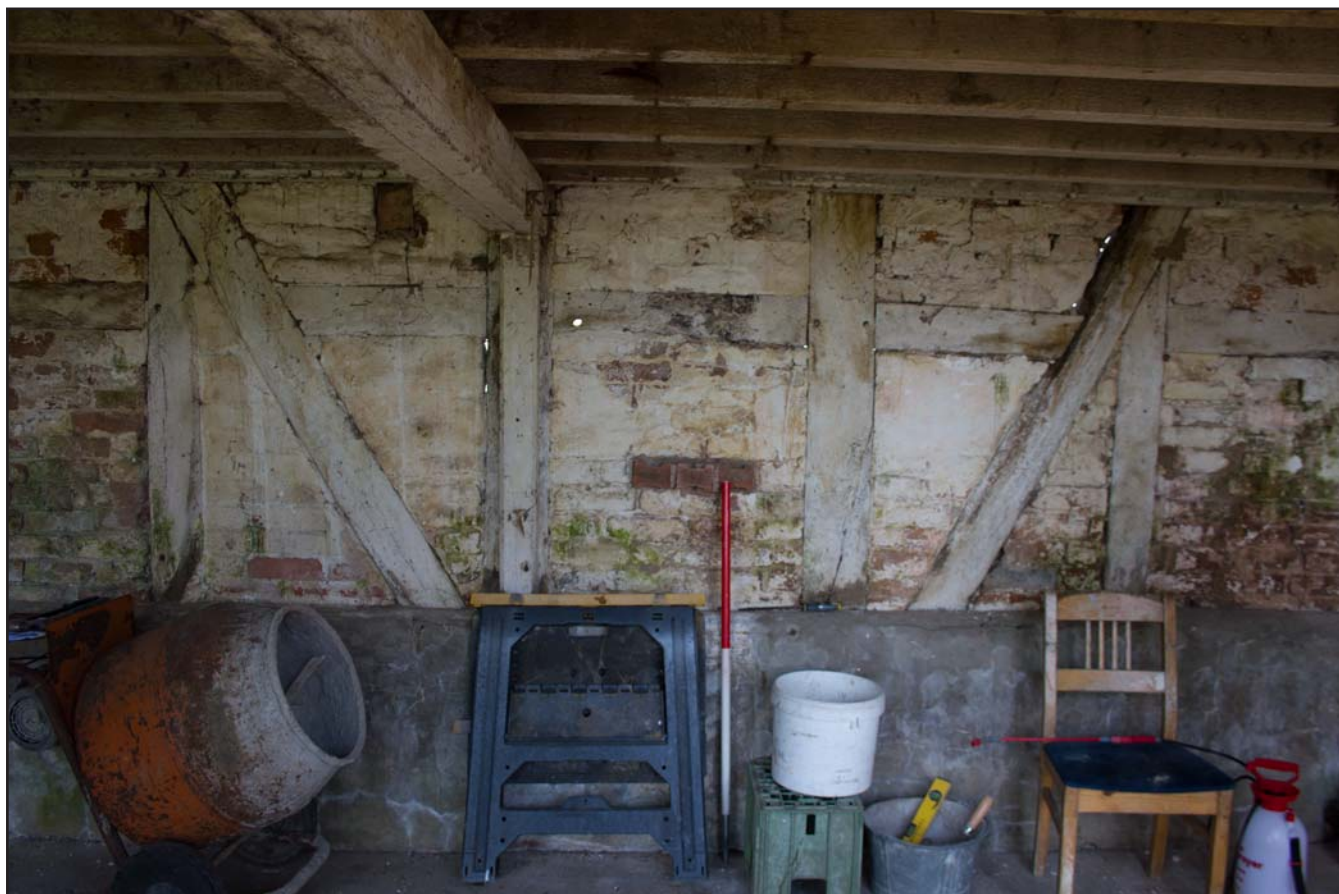
**Plate 42:** Northwest elevation within Room 1, ground floor, Shippon 1 at Brunette Farm, Ty Broughton, Wrexham - from the southeast - scale 1m

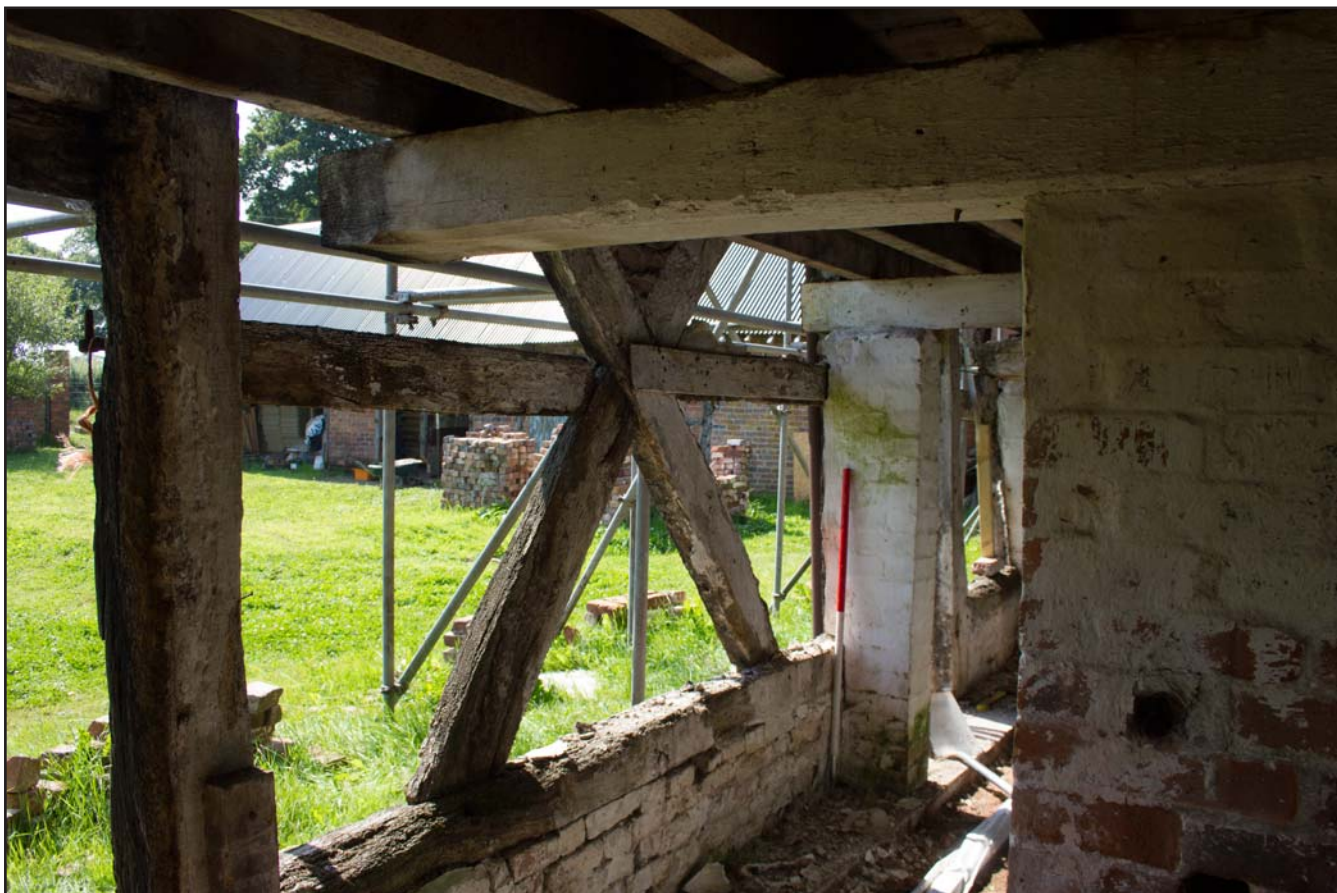
**Plate 44:** Full height diagonal cross braces in Room 1 and passageway, ground floor, Shippon 1 at Brunette Farm, Ty Broughton, Wrexham - from the north - no scale

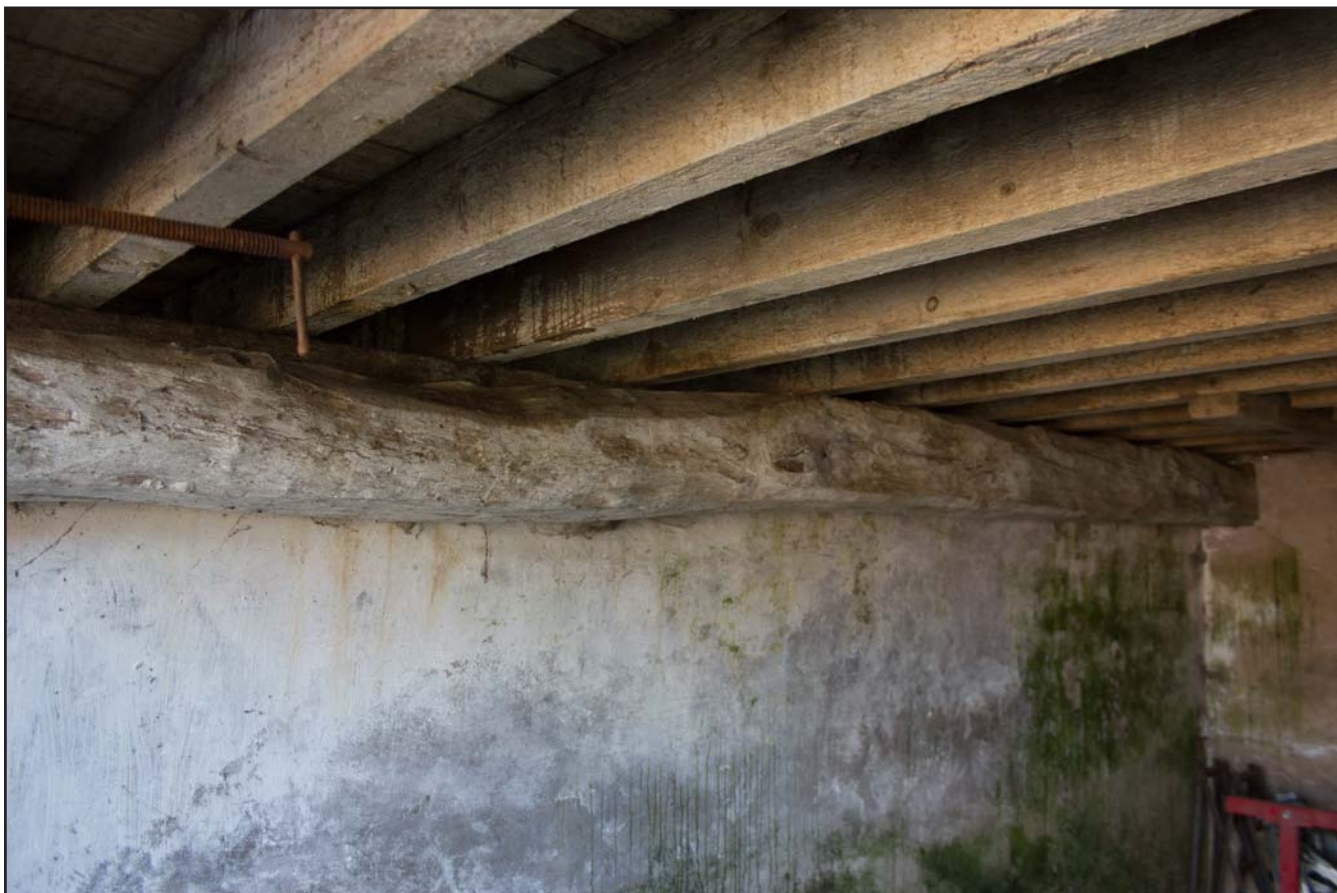
**Plate 49:** Handhewn beam within Room 4, ground floor, Shippon 1 at Brunette Farm, Ty Broughton, Wrexham - from the west - scale 1m

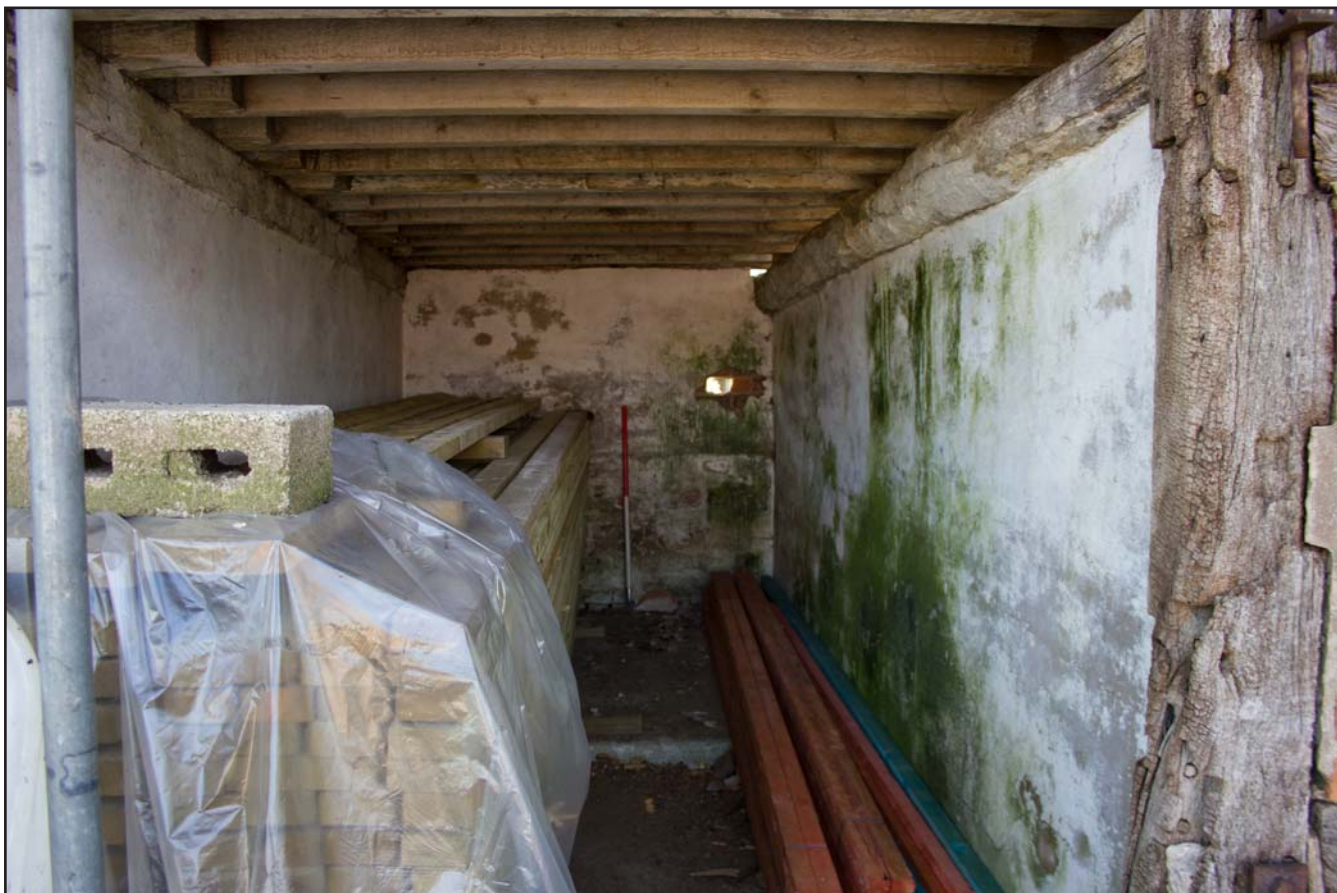
**Plate 50:** Room 5, ground floor, Shippon 1 at Brunette Farm, Ty Broughton, Wrexham - from the northwest - scale 1m
