# Outbuildings at Brunette Farm, Lower Wych Road, Ty Broughton, Wrexham SY13 3BA

Historic Building Record Level 2

Project Code: A0318.1

Report no. 0304

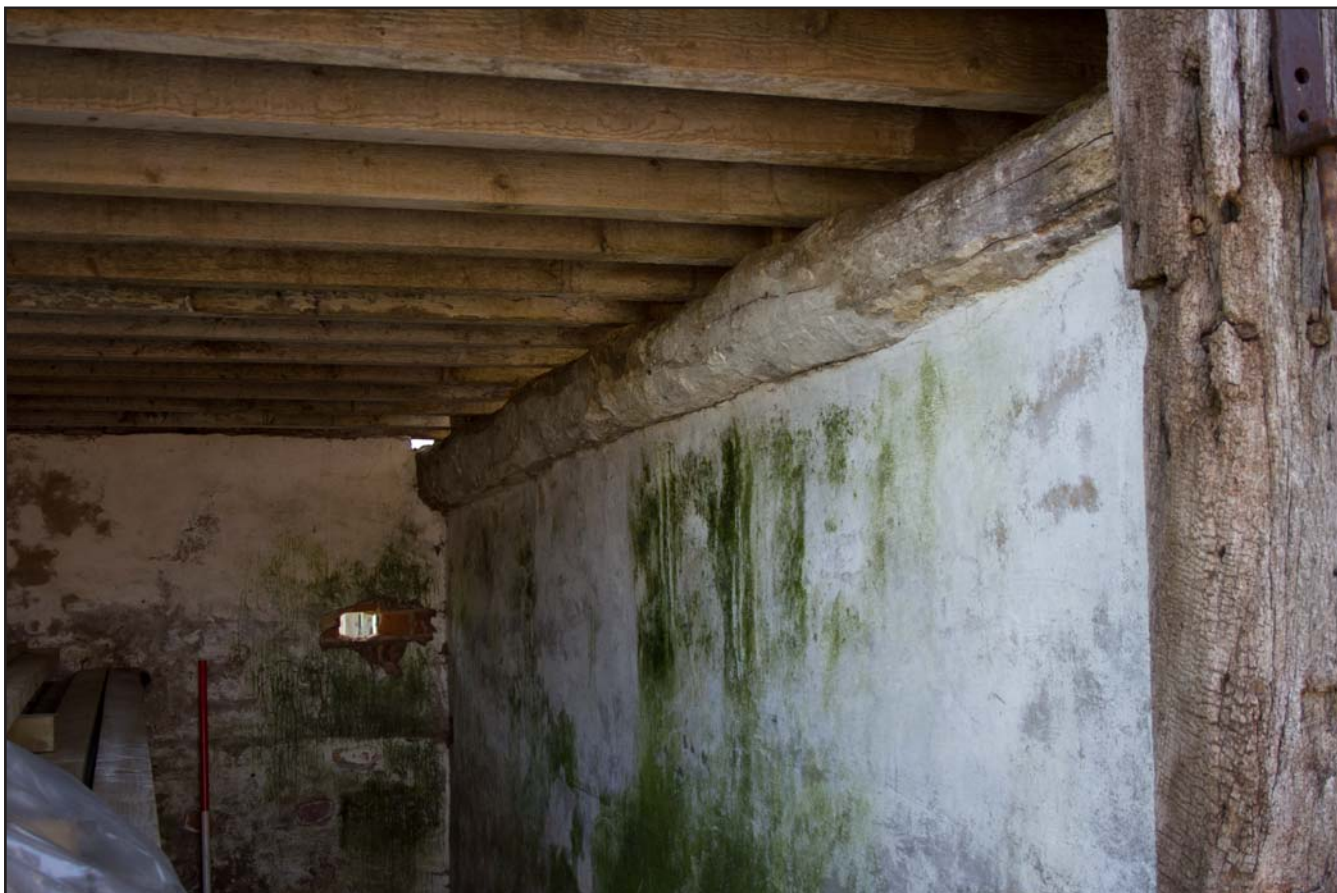
**Plate 51:** Handhewn beam within Room 5, ground floor, Shippon 1 at Brunette Farm, Ty Broughton, Wrexham - from the north - scale 1m

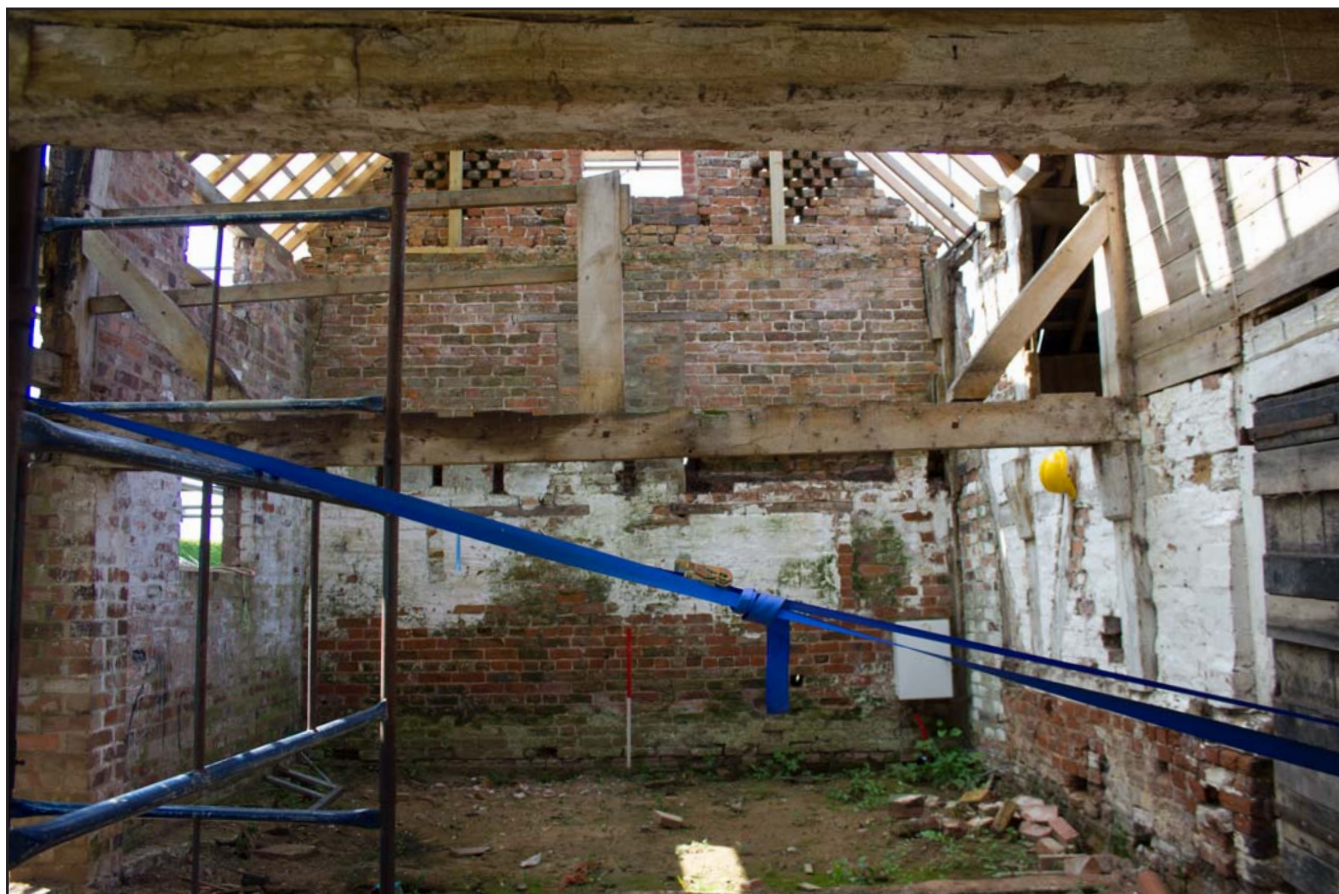
**Plate 52:** Room 6, ground floor, Shippon 1 at Brunette Farm, Ty Broughton, Wrexham - from the northeast - scale 1m

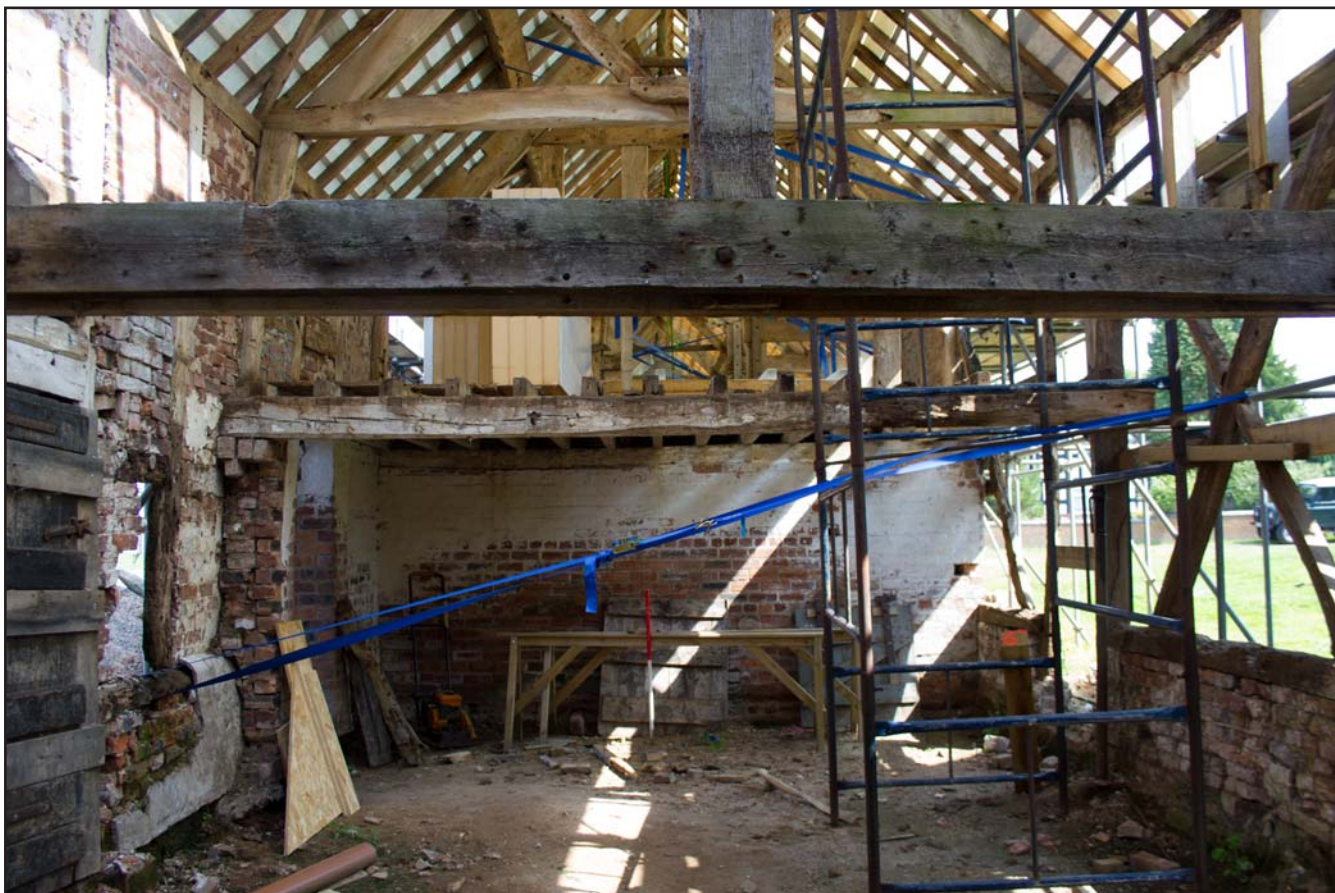
**Plate 53:** Room 6, ground floor, Shippon 1 at Brunette Farm, Ty Broughton, Wrexham - from the southwest - scale 1m

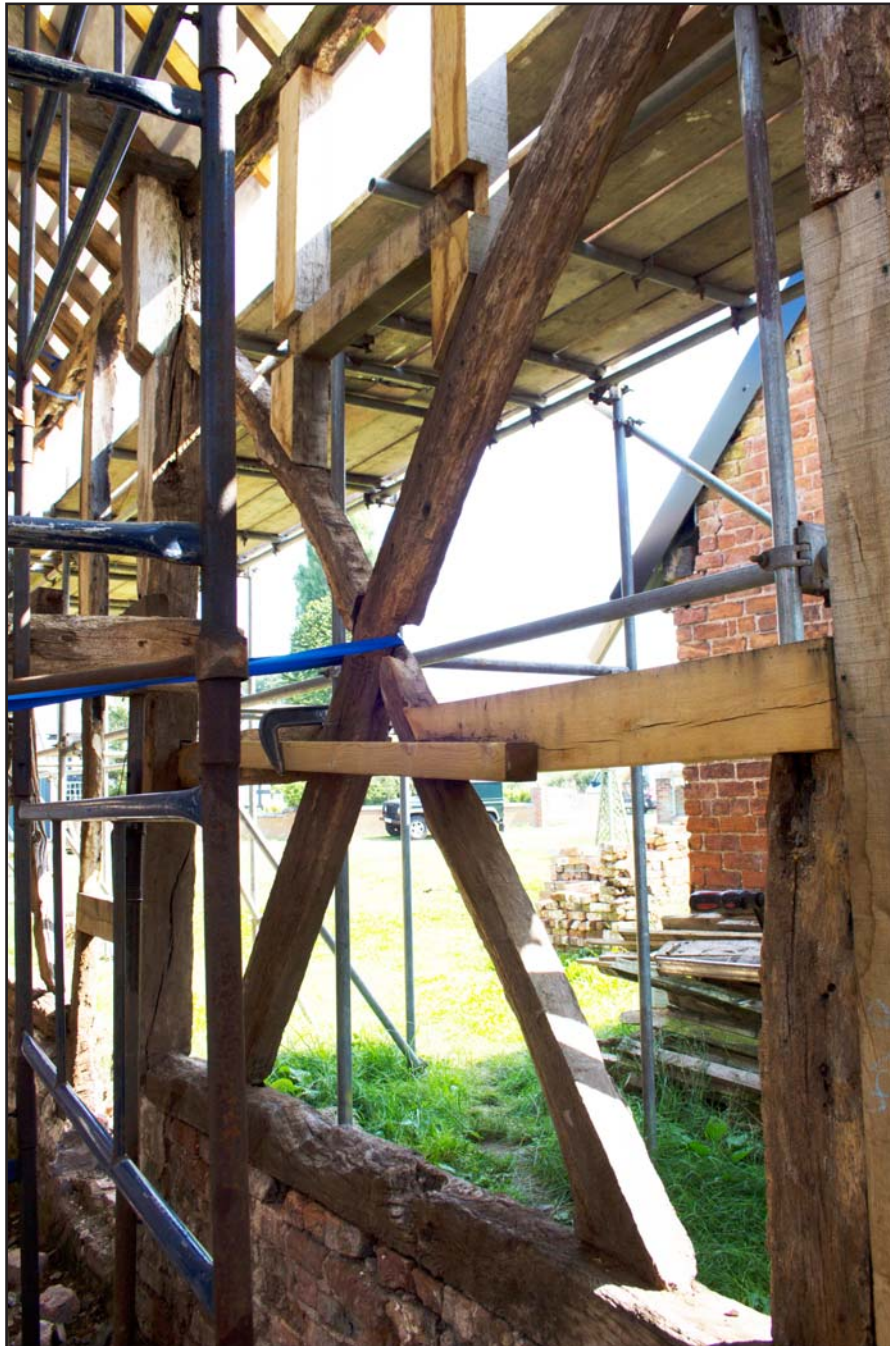
**Plate 54:** Full height diagonal cross braces in Room 6, ground floor, Shippon 1 at Brunette Farm, Ty Broughton, Wrexham - from the west - no scale

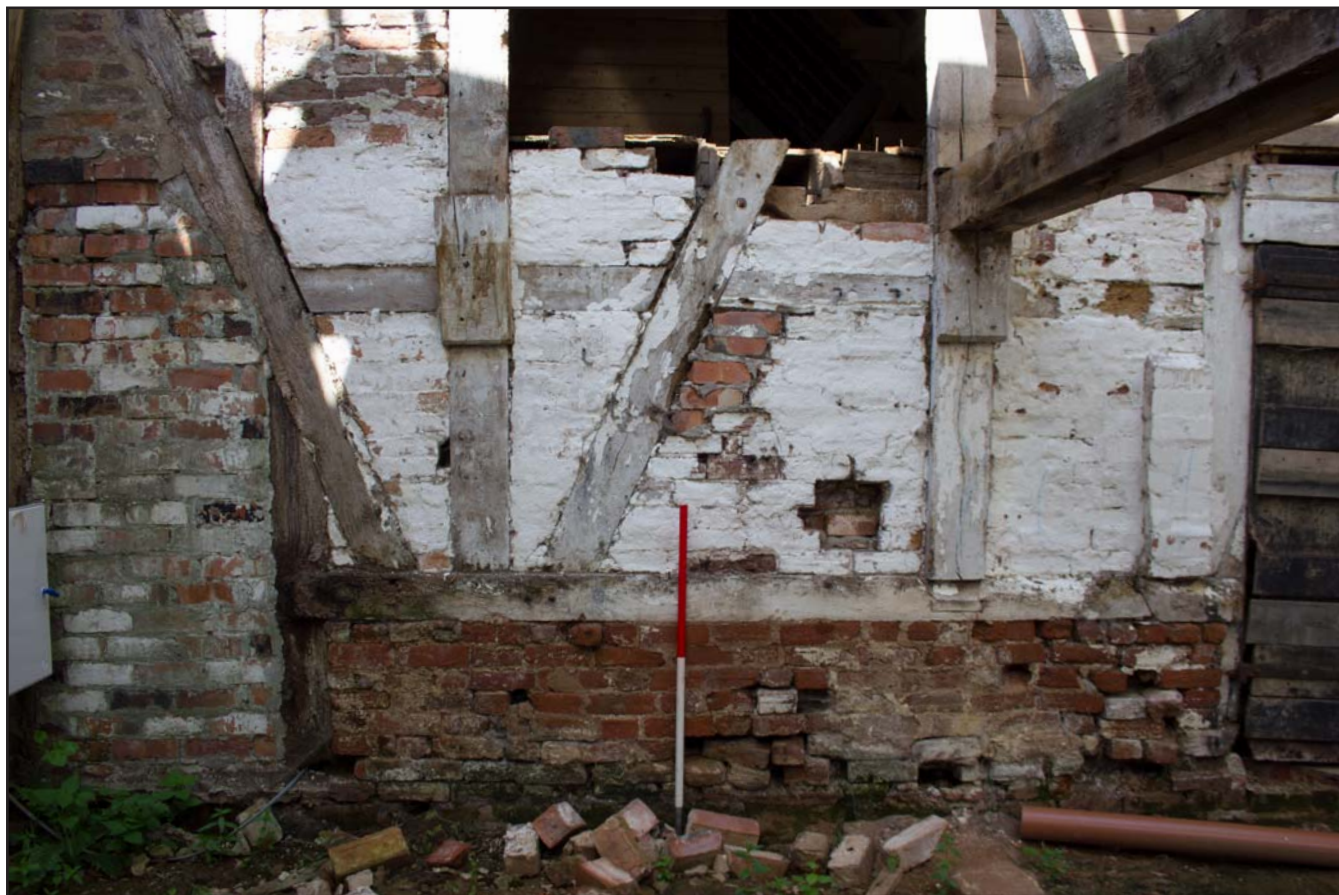
**Plate 55:** Northwest elevation within Room 6, ground floor, Shippon 1 at Brunette Farm, Ty Broughton, Wrexham - from the southeast - scale 1m

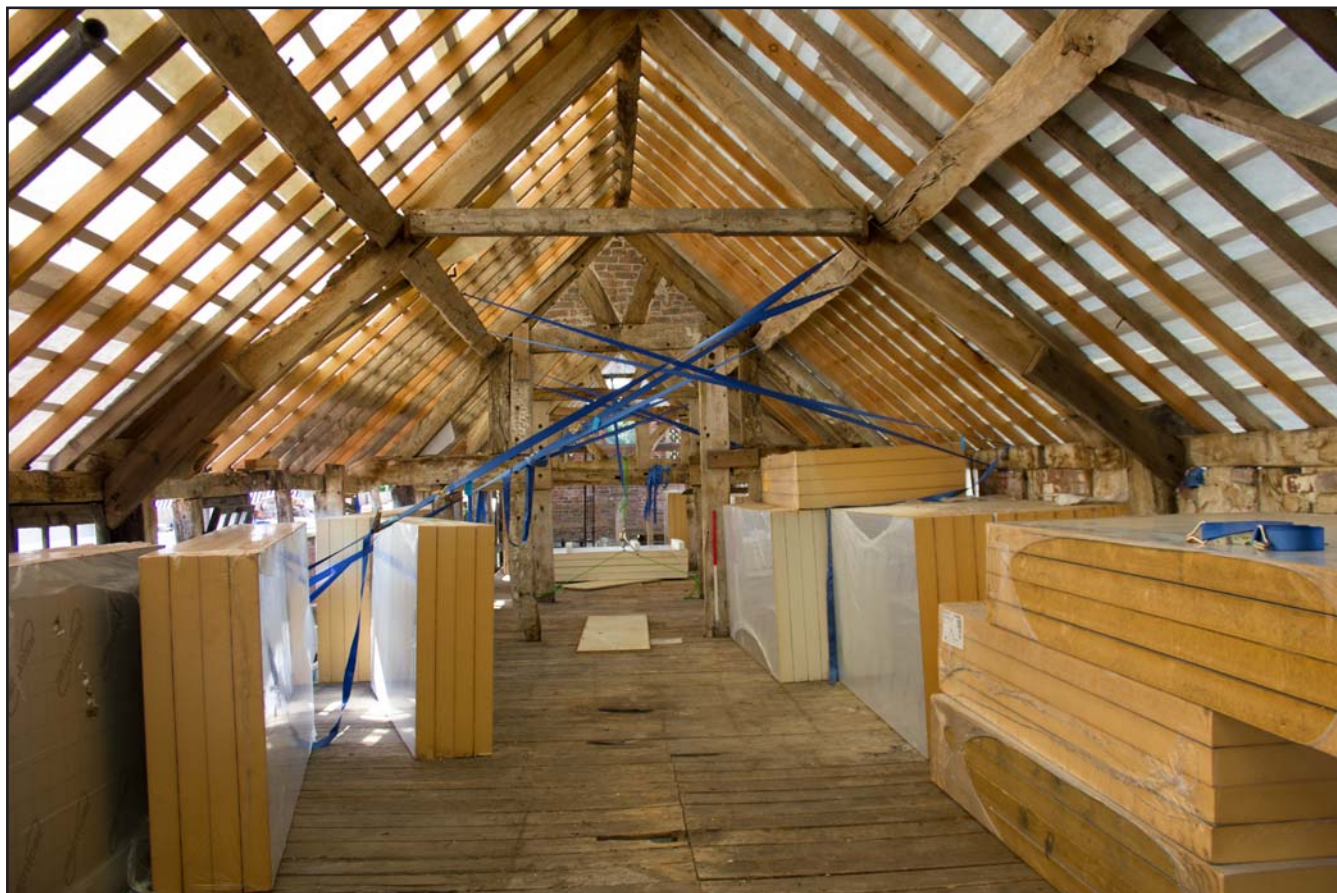
**Plate 56:** First floor, Shippon 1 at Brunette Farm, Ty Broughton, Wrexham - from the northeast - scale 1m

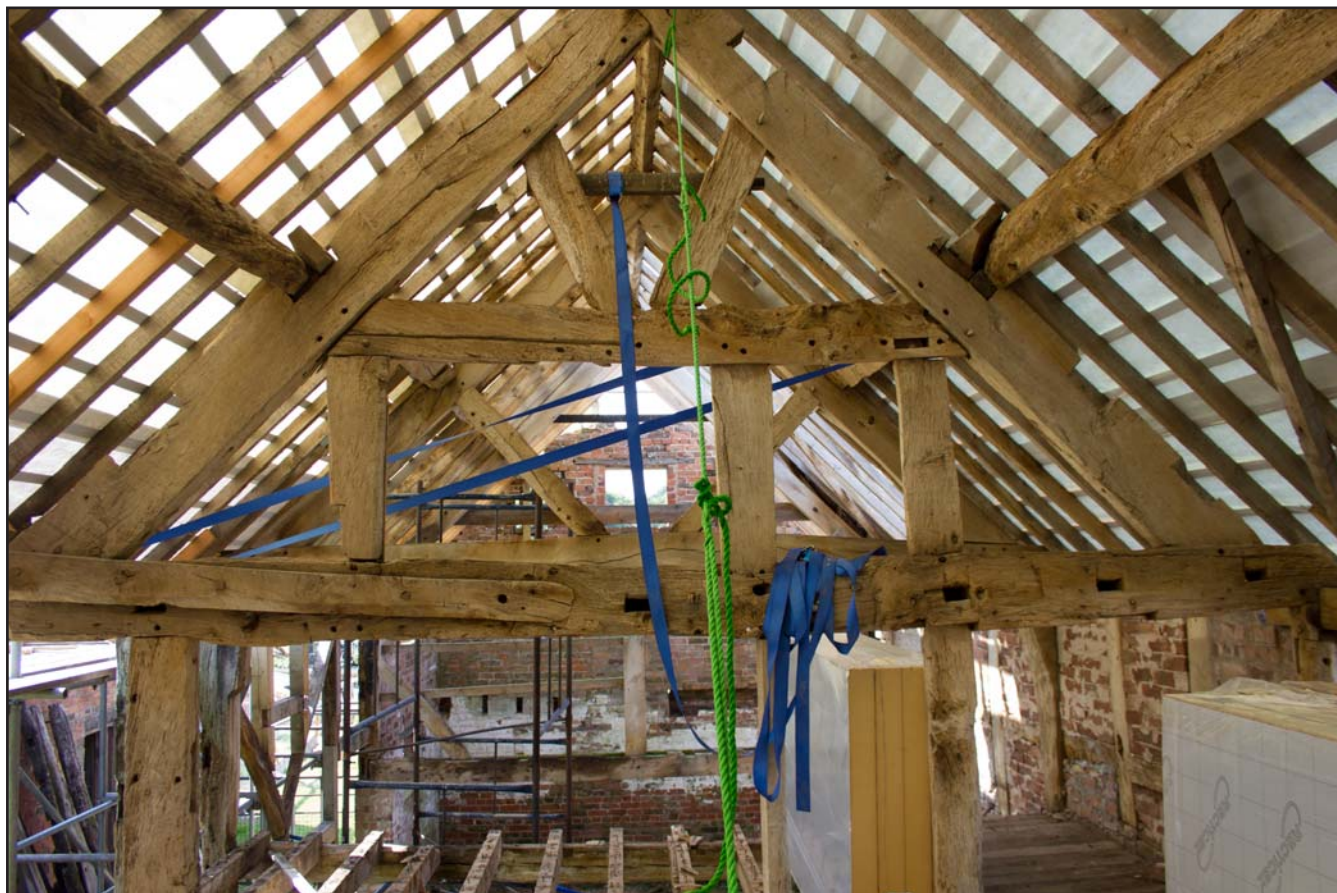
**Plate 57:** Truss 1, First floor, Shippon 1 at Brunette Farm, Ty Broughton, Wrexham - from the northeast - no scale

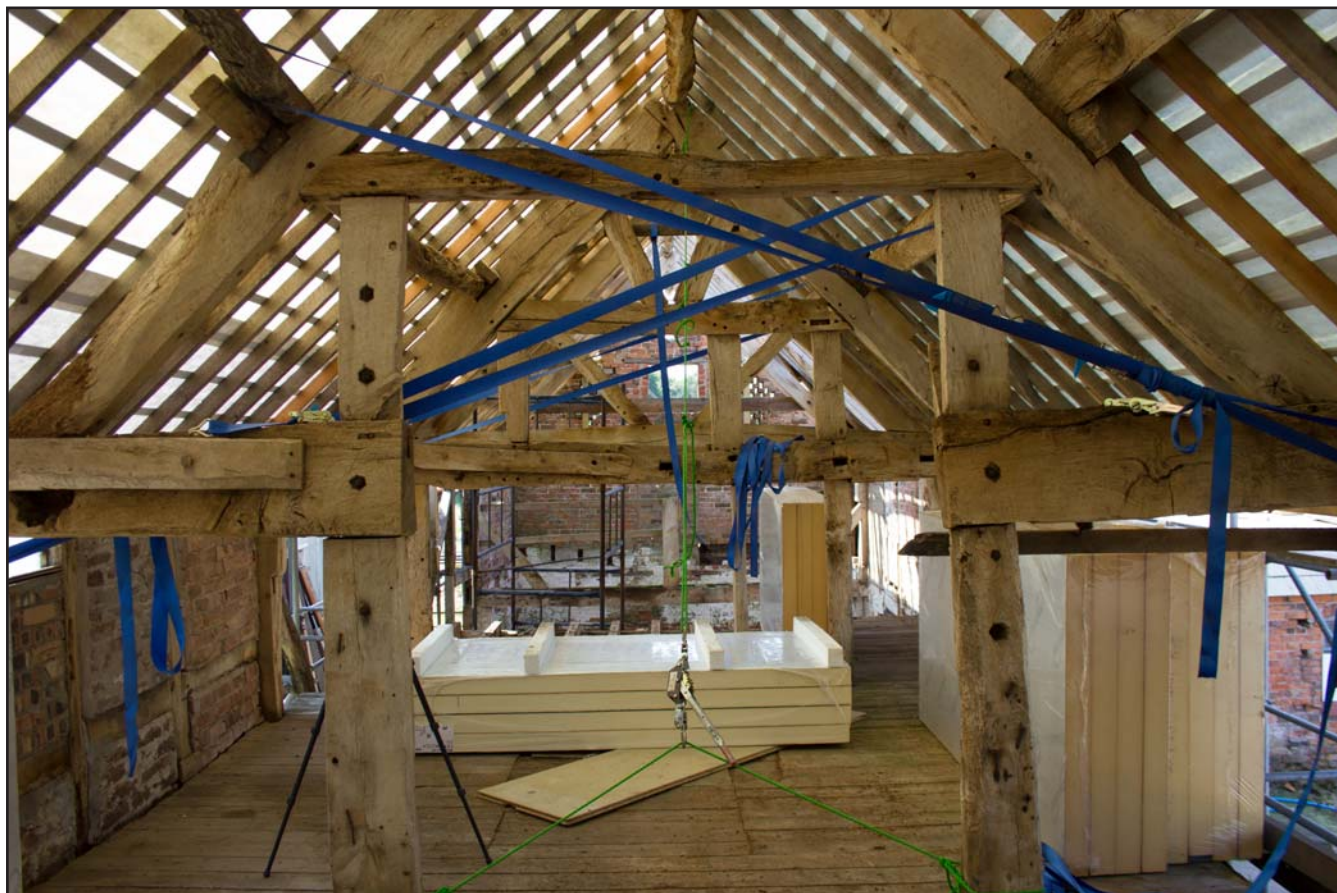
at the apex between the double-crown struts, demonstrating that it was once the original north eastern gable of the building end prior to the first extension. The central truss within this configuration (*Truss 2*) is intriguing as both the tie beam and the collar have a number of carved mortice joints visible to the northeast this suggests that it may have been reused. A repair at the left-hand end has been made using hand-hewn timber and wooden dowels which is also of considerable age. The south western most truss (*Truss 1*) crossbeam also has stops showing that it has also probably been reused. These three trusses (*Trusses 1, 2 and 3*) are the oldest in the whole building. The substantial cross beams of truss 2 and 3 have also been sawn through and removed to create openings between the bays at first floor height.

**Plate 58:** Truss 2, First floor, Shippon 1 at Brunette Farm, Ty Broughton, Wrexham - from the northeast - no scale

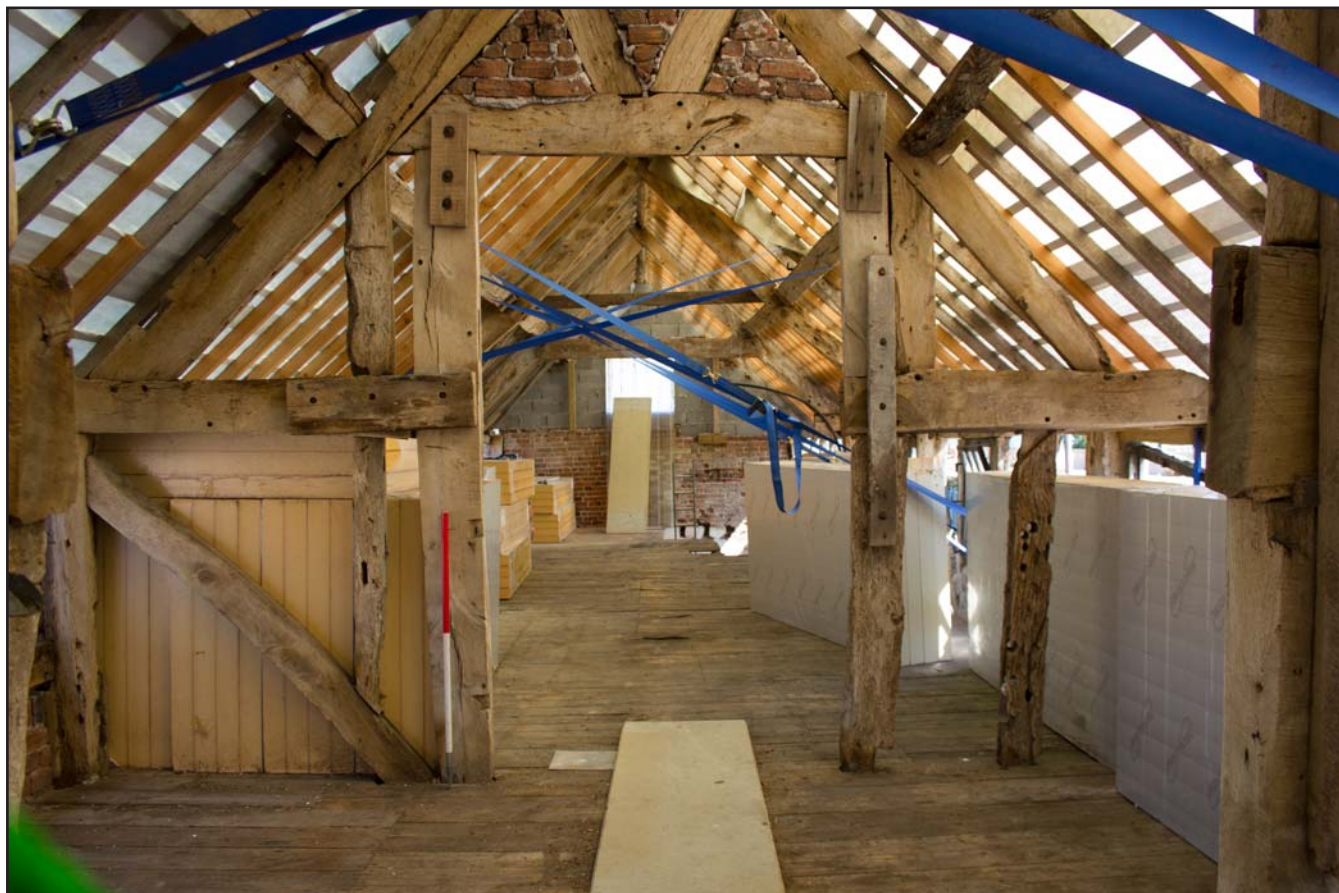
**Plate 59:** Truss 3, First floor, Shippon 1 at Brunette Farm, Ty Broughton, Wrexham - from the southwest - scale 1m

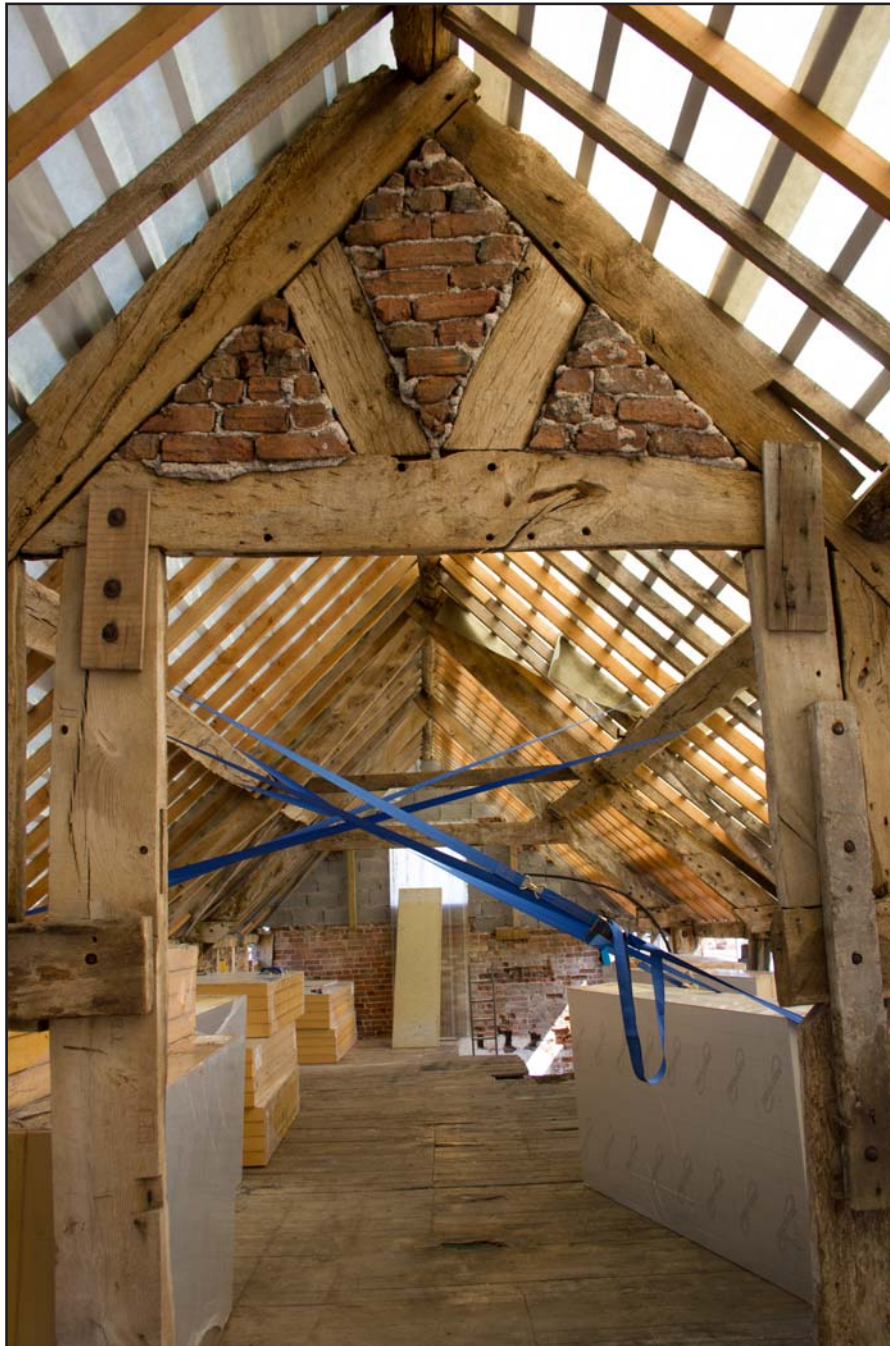
**Plate 60:** Crown/ridge of Truss 3, First floor, Shippon 1 at Brunette Farm, Ty Broughton, Wrexham - from the southwest - no scale

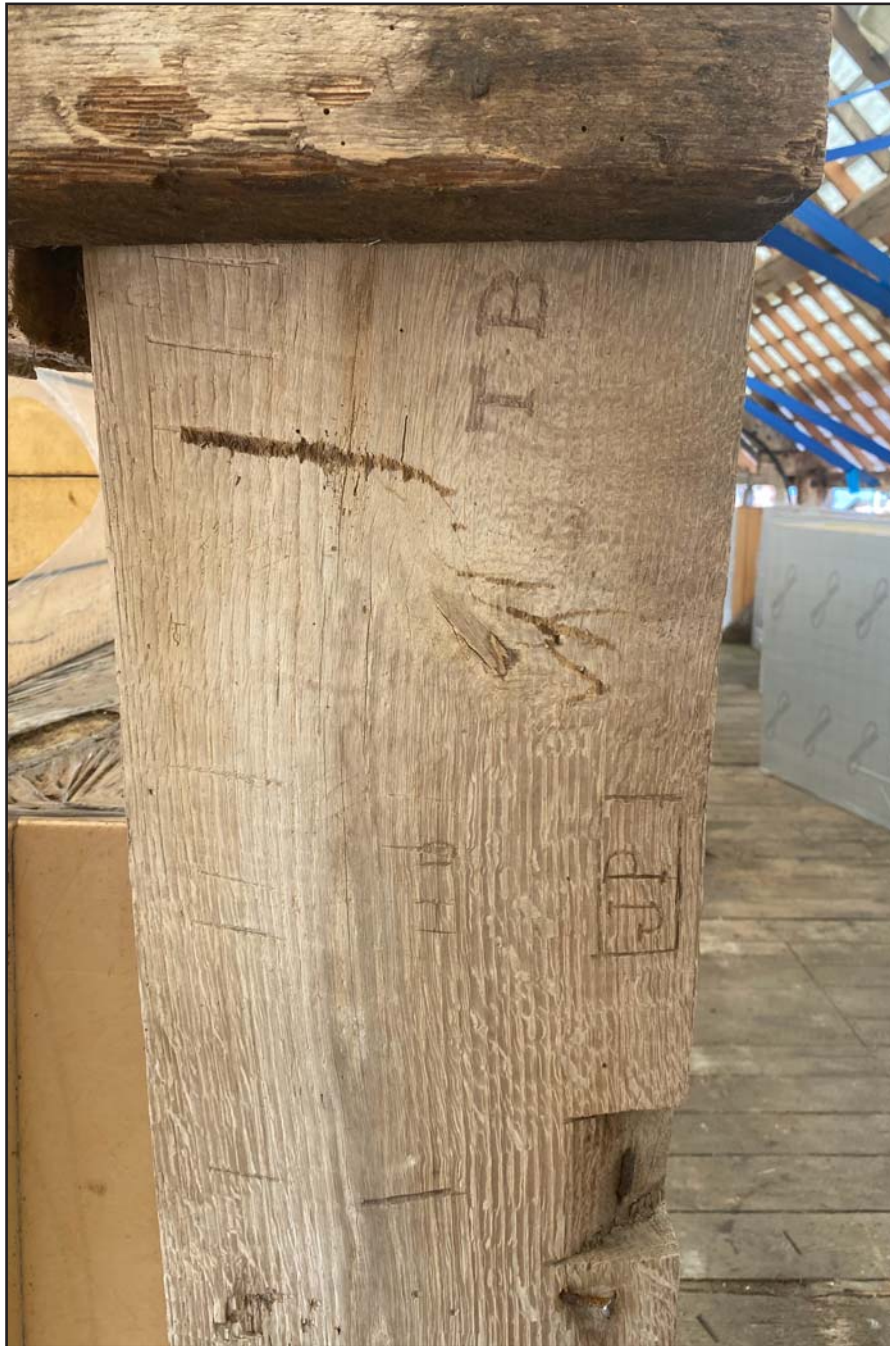
**Plate 62:** Carved graffiti on northwest stud, Truss 2 within Shippon 1 at Brunette Farm, Ty Broughton, Wrexham - from the southwest - no scale

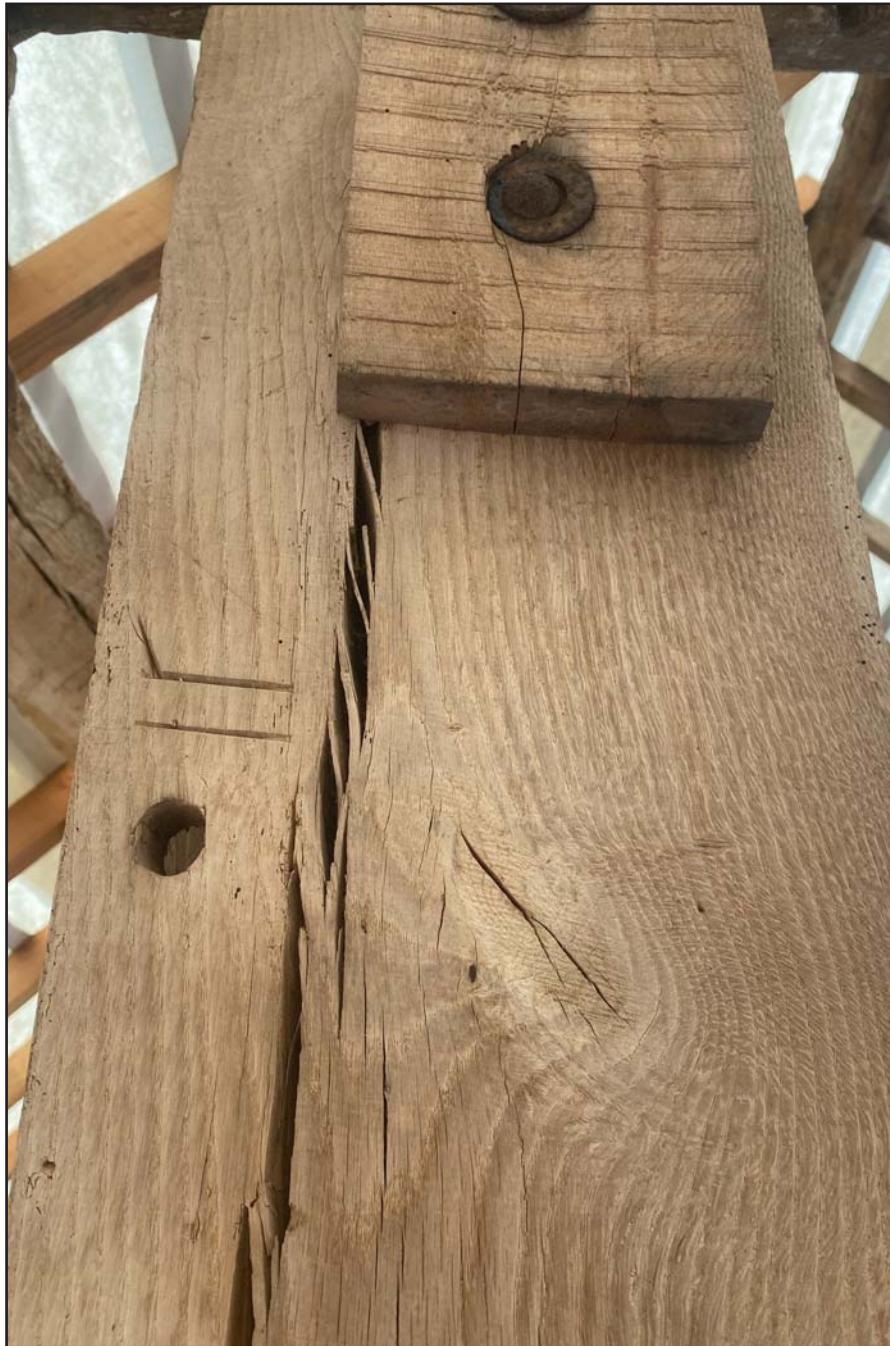
**Plate 63:** Carpenter's marks (II) on northwest stud, Truss 2 within Shippon 1 at Brunette Farm, Ty Broughton, Wrexham - from the southwest - no scale

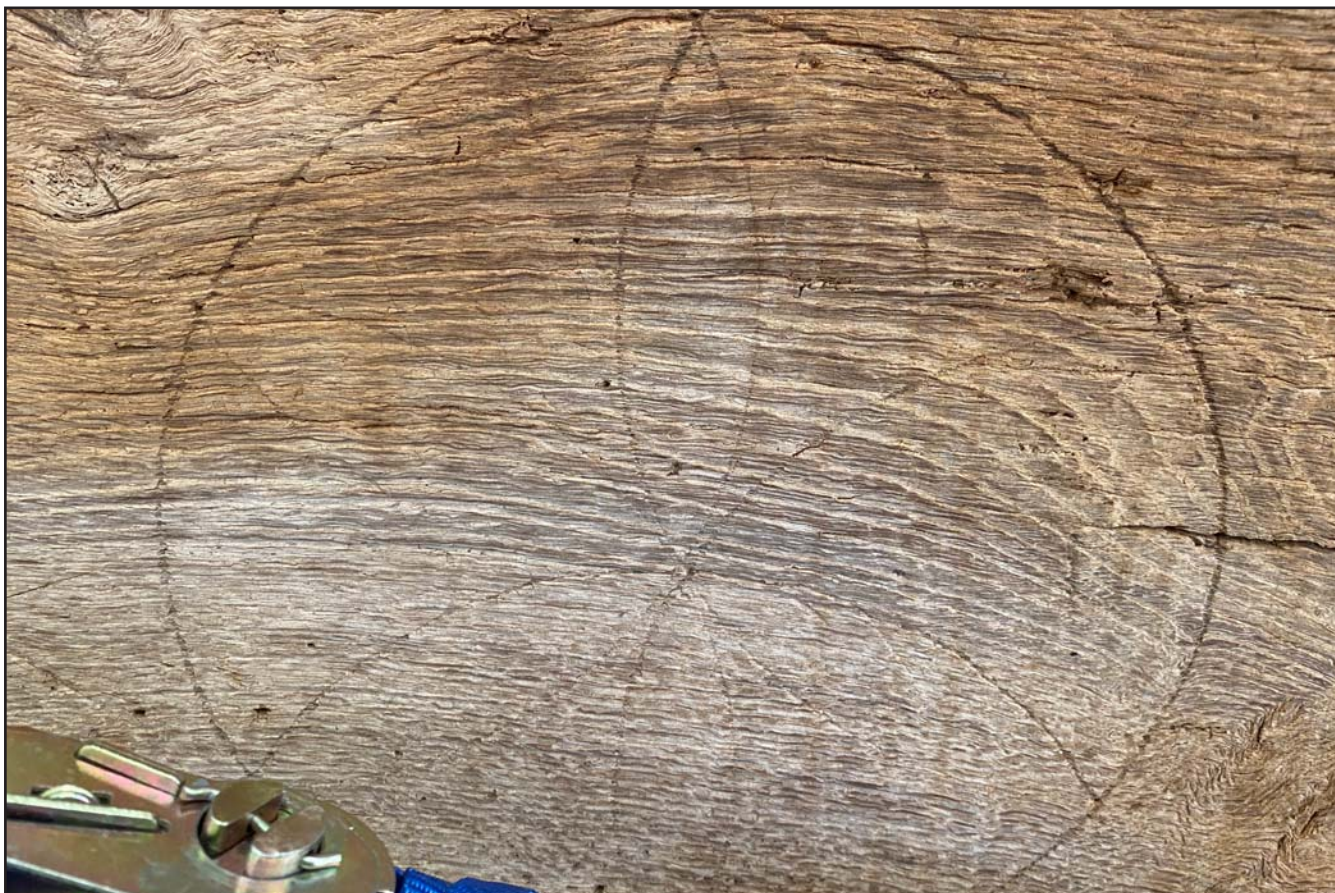
The most common apotropaic mark is the daisy wheel, or hexafoil, which is a six petal "flower" drawn with a pair of compasses. Daisy wheels comprise a single, endless line which supposedly confused and entrapped evil spirits (*Plates 67 – 72*).

**Plate 67:** Apotropaic Mark, Hexafoil 'Daisy-Wheel' on southeast side of handhewn tie beam of Truss 2, within Shippon 1 at Brunette Farm, Ty Broughton, Wrexham - from the southwest - no scale

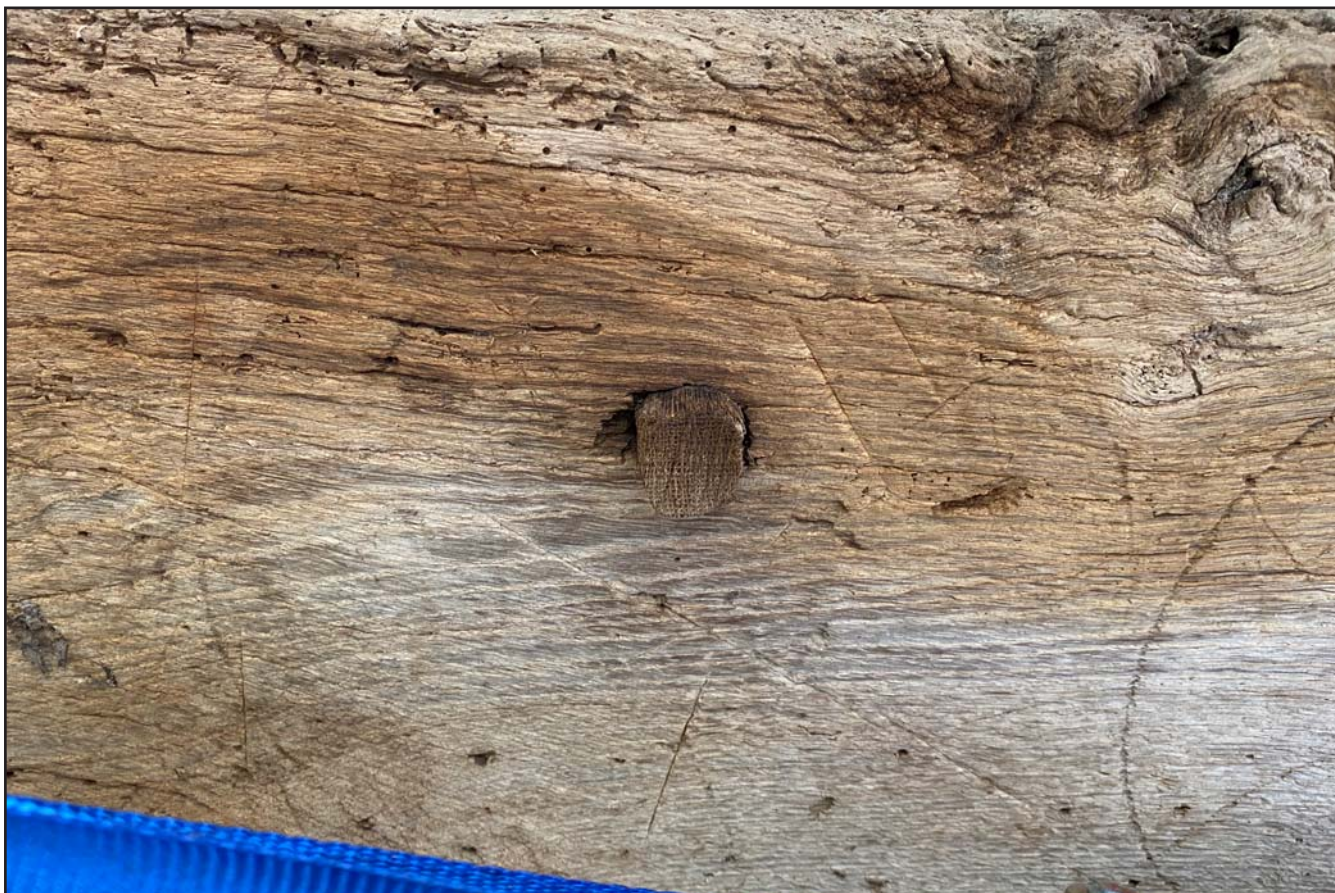
**Plate 68:** Apotropaic Mark, Hexafoil 'Daisy-Wheel' on southeast side of handhewn tie beam of Truss 2, within Shippon 1 at Brunette Farm, Ty Broughton, Wrexham - from the southwest - no scale

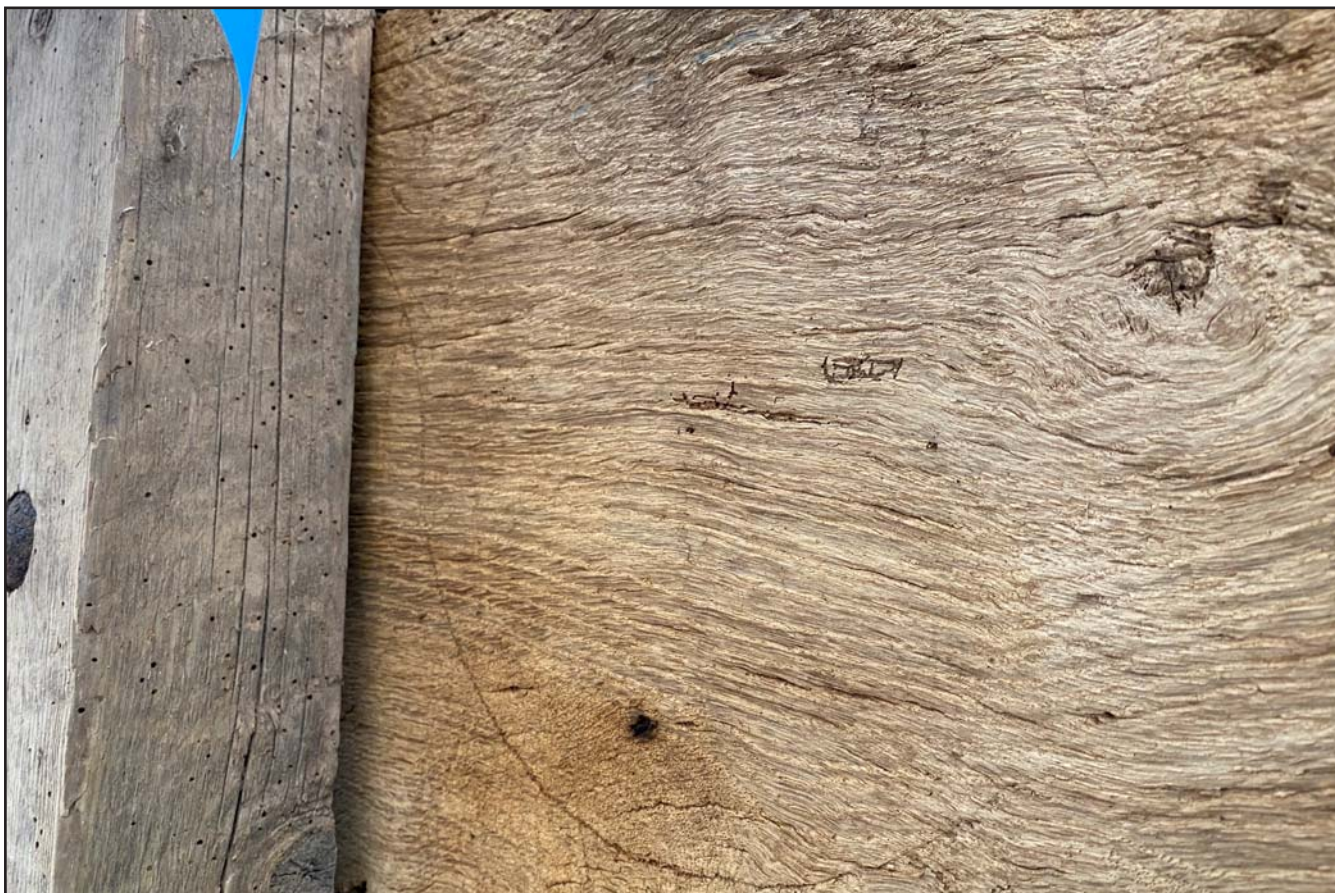
**Plate 69:** Apotropaic Mark, Hexafoil 'Daisy-Wheel' on southeast side of handhewn tie beam of Truss 2, within Shippon 1 at Brunette Farm, Ty Broughton, Wrexham - from the southwest - no scale

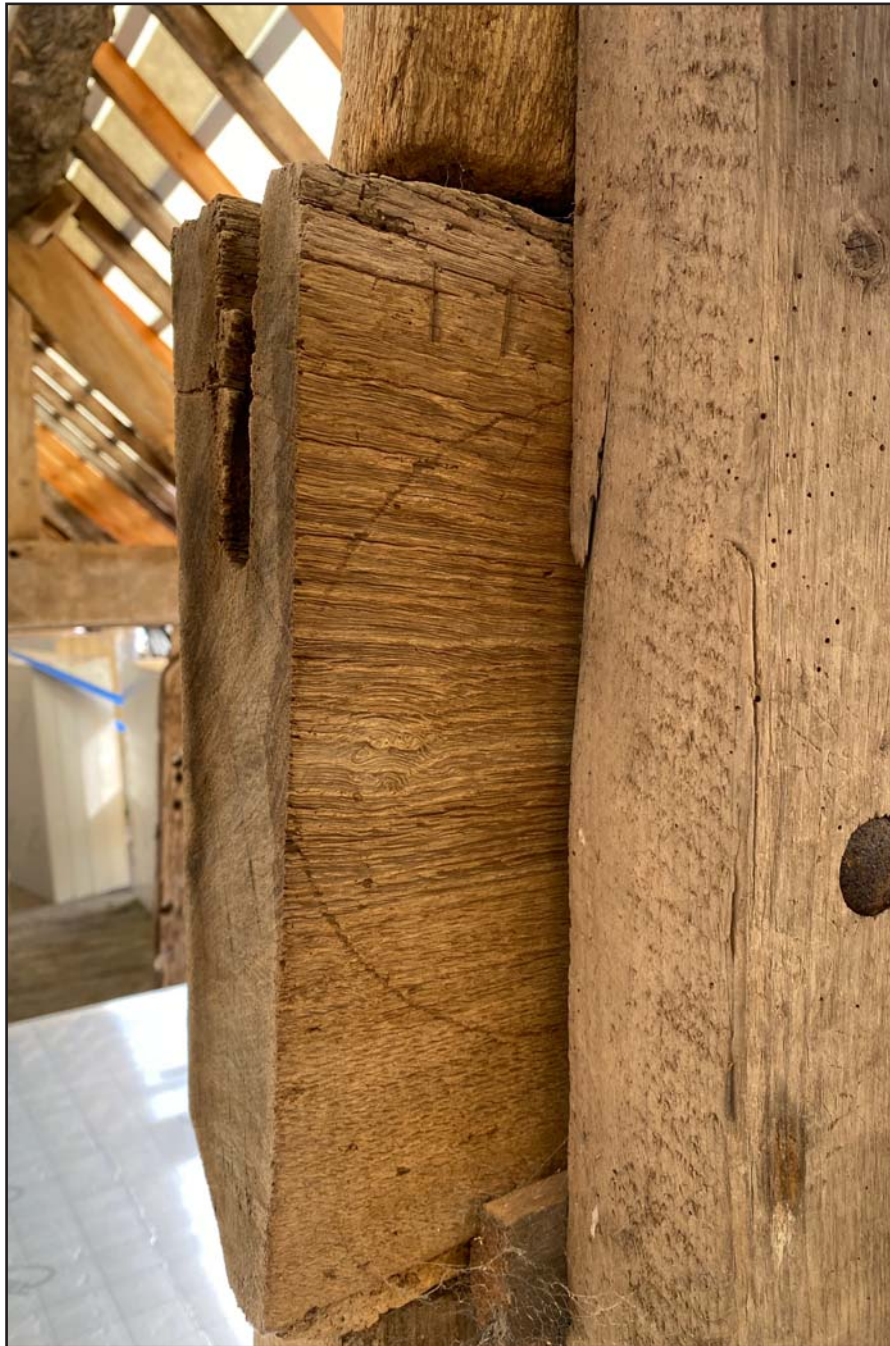
**Plate 70:** Apotropaic Mark, Hexafoil 'Daisy-Wheel' on southeast side of handhewn tie beam of Truss 2, within Shippon 1 at Brunette Farm, Ty Broughton, Wrexham - from the south - no scale

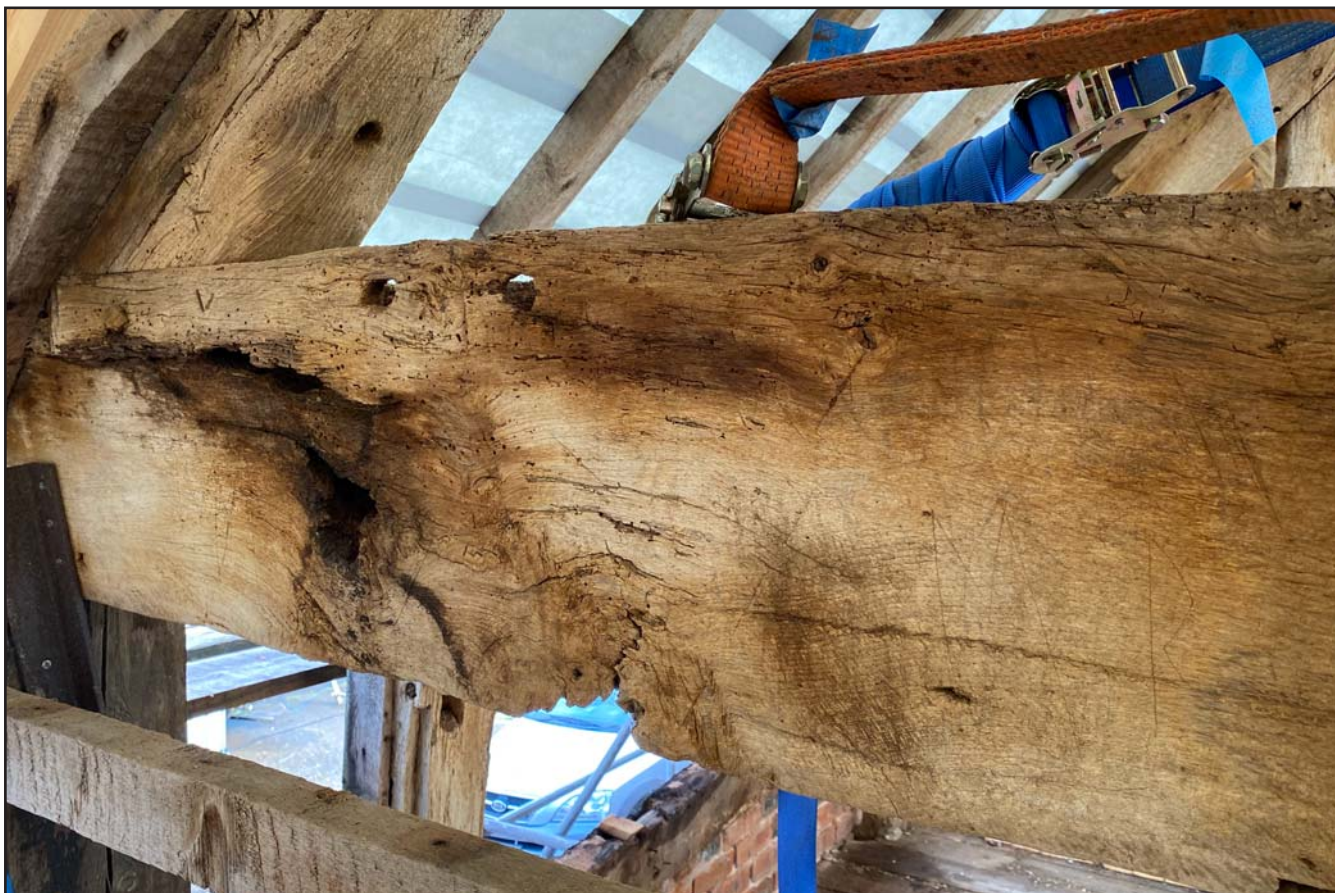
**Plate 71:** Apotropaic Mark, Hexafoil 'Daisy-Wheel' on northwest side of handhewn tie beam of Truss 2, within Shippon 1 at Brunette Farm, Ty Broughton, Wrexham - from the east - no scale

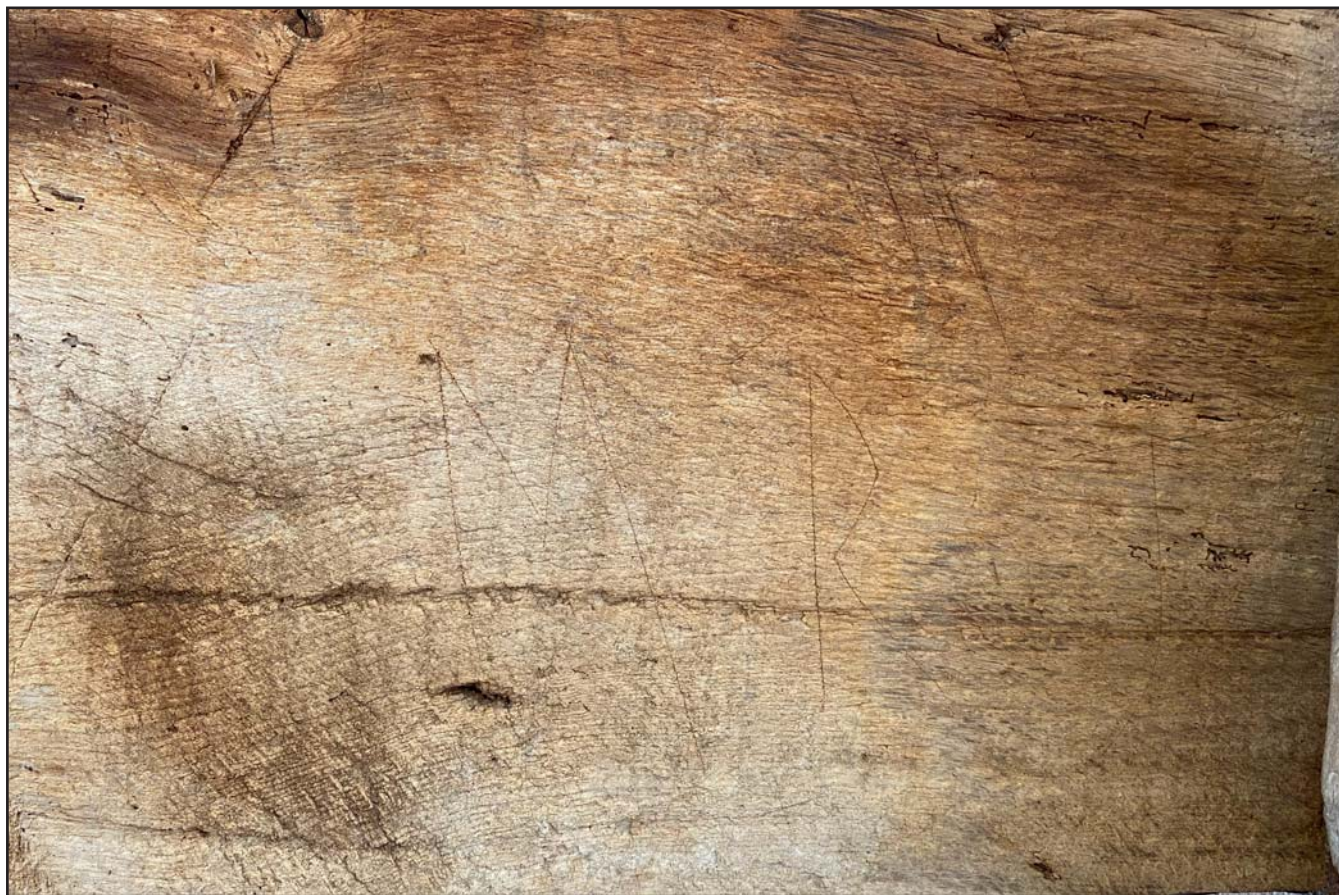
**Plate 72:** Faint Apotropaic Marks on northwest side of handhewn tie beam: Marian & Hexafoil? Truss 2, within Shippon 1 at Brunette Farm, Ty Broughton, Wrexham - from the southwest - no scale
