# Outbuildings at Brunette Farm, Lower Wych Road, Ty Broughton, Wrexham SY13 3BA

Historic Building Record Level 2

Project Code: A0318.1

Report no. 0304

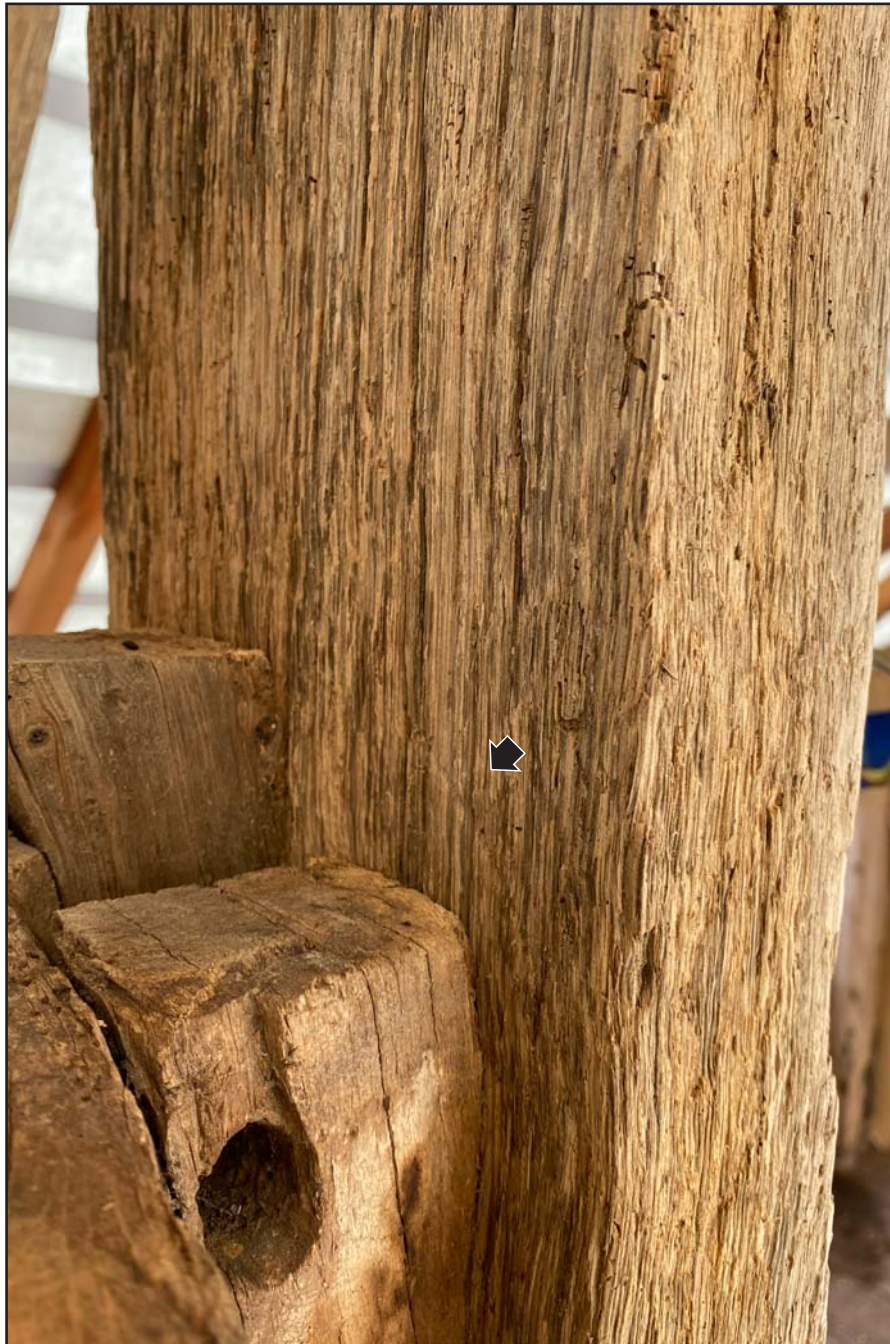
**Plate 73:** Possible faint Apotropaic Marks on northwest stud of Truss 2, within Shippon 1 at Brunette Farm, Ty Broughton, Wrexham - from the east - no scale

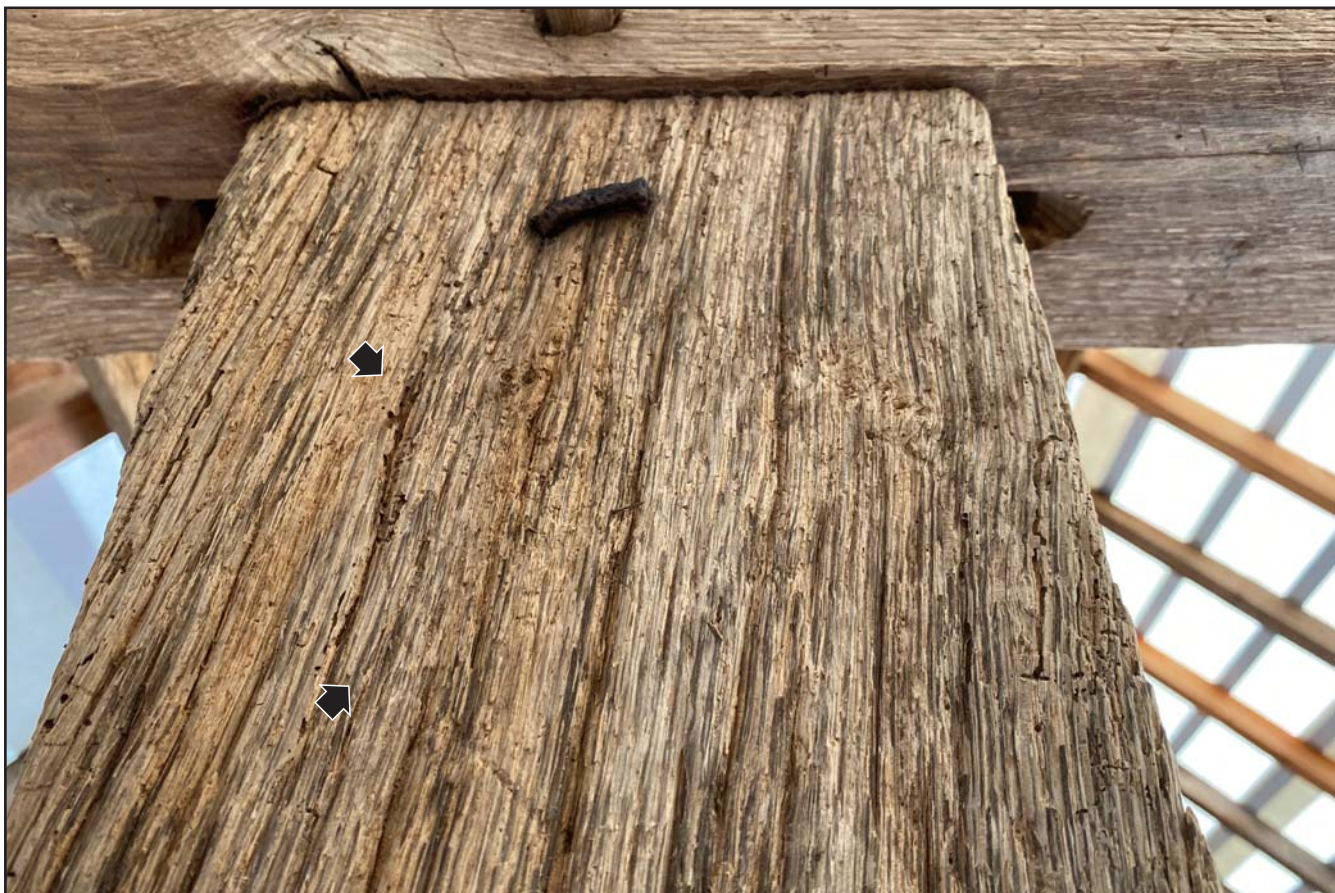
**Plate 74:** Possible faint Apotropaic Marks on northwest stud (near collar) of Truss 2, within Shippon 1 at Brunette Farm, Ty Broughton, Wrexham - from the east - no scale

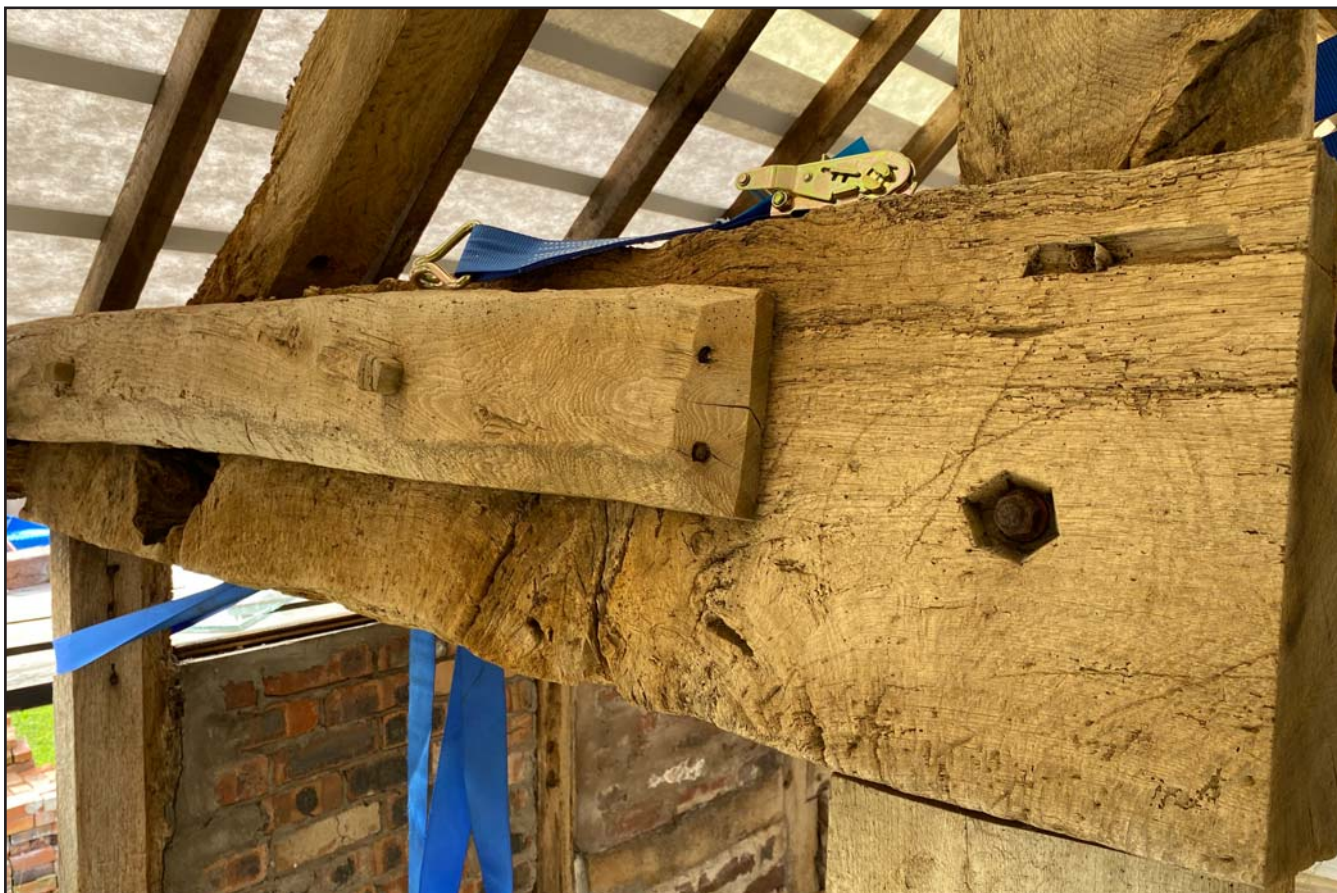
**Plate 75:** Possible faint Apotropaic Marks on northwest side of handhewn tie beam: Marian & Hexafoil? Truss 2, within Shippon 1 at Brunette Farm, Ty Broughton, Wrexham - from the southwest - no scale

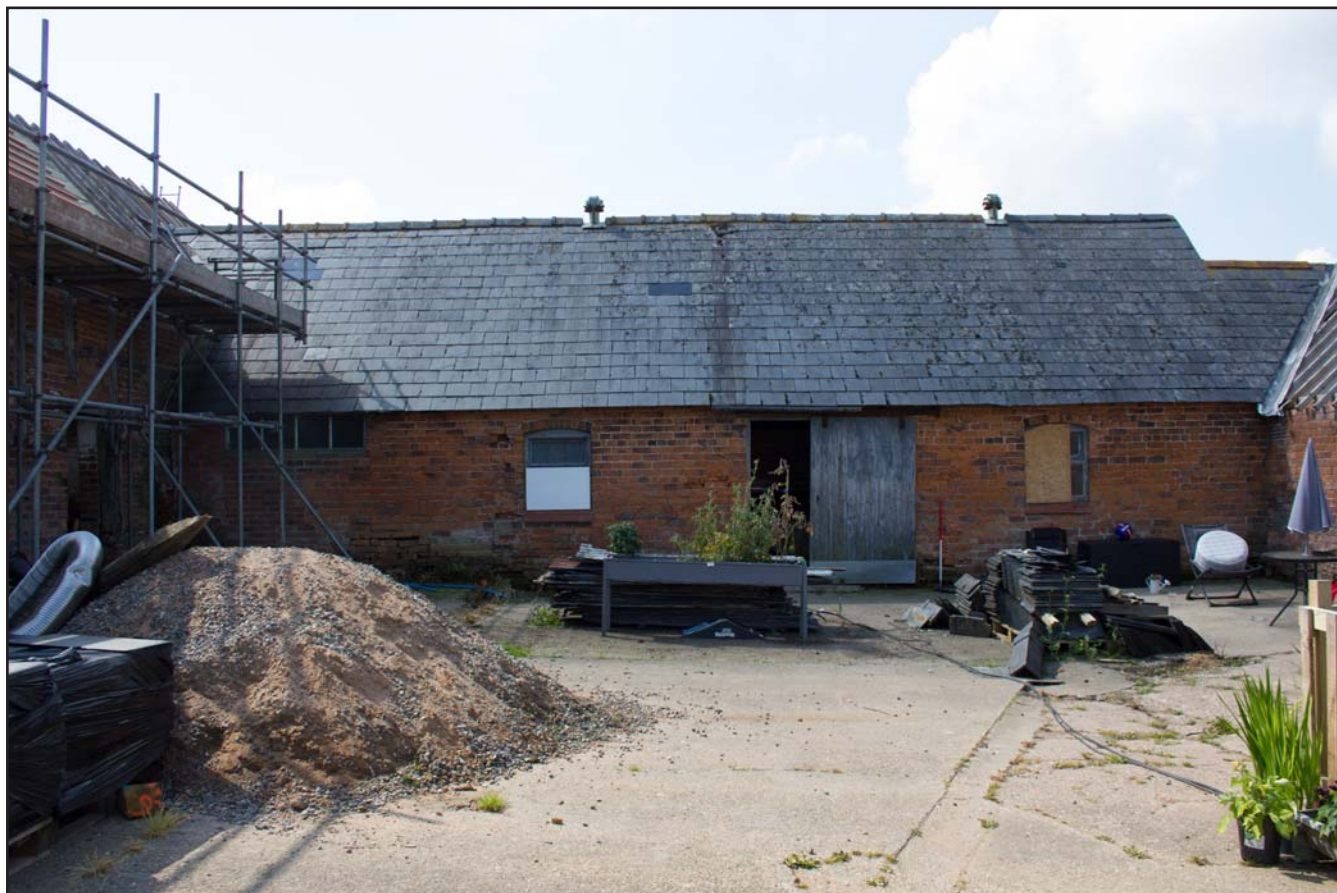
This is a large rectangular room orientated northwest to southeast measuring 13.86m long by 5.61m wide. The ceiling is open to the roof pitch which consists of sawn wooden batons, sawn wooden rafters and three equally spaced sawn King post trusses which support sawn wooden purlins. The elevations are all of handmade brick bonded by mortar and painted white. The northeast elevation has a single doorway opening to the left of centre permitting access to the external yard via a horizontally sliding wooden board door. There are two equally spaced windows to the left and right of this door consisting of five-pane casement windows in grey painted wooden frames. At the right-hand end is a four-pane fixed window in grey painted wooden frame.

**Plate 76:** Northeast facing elevation of Shippon 2 at Brunette Farm, Ty Broughton, Wrexham - from the northeast - 1m scale

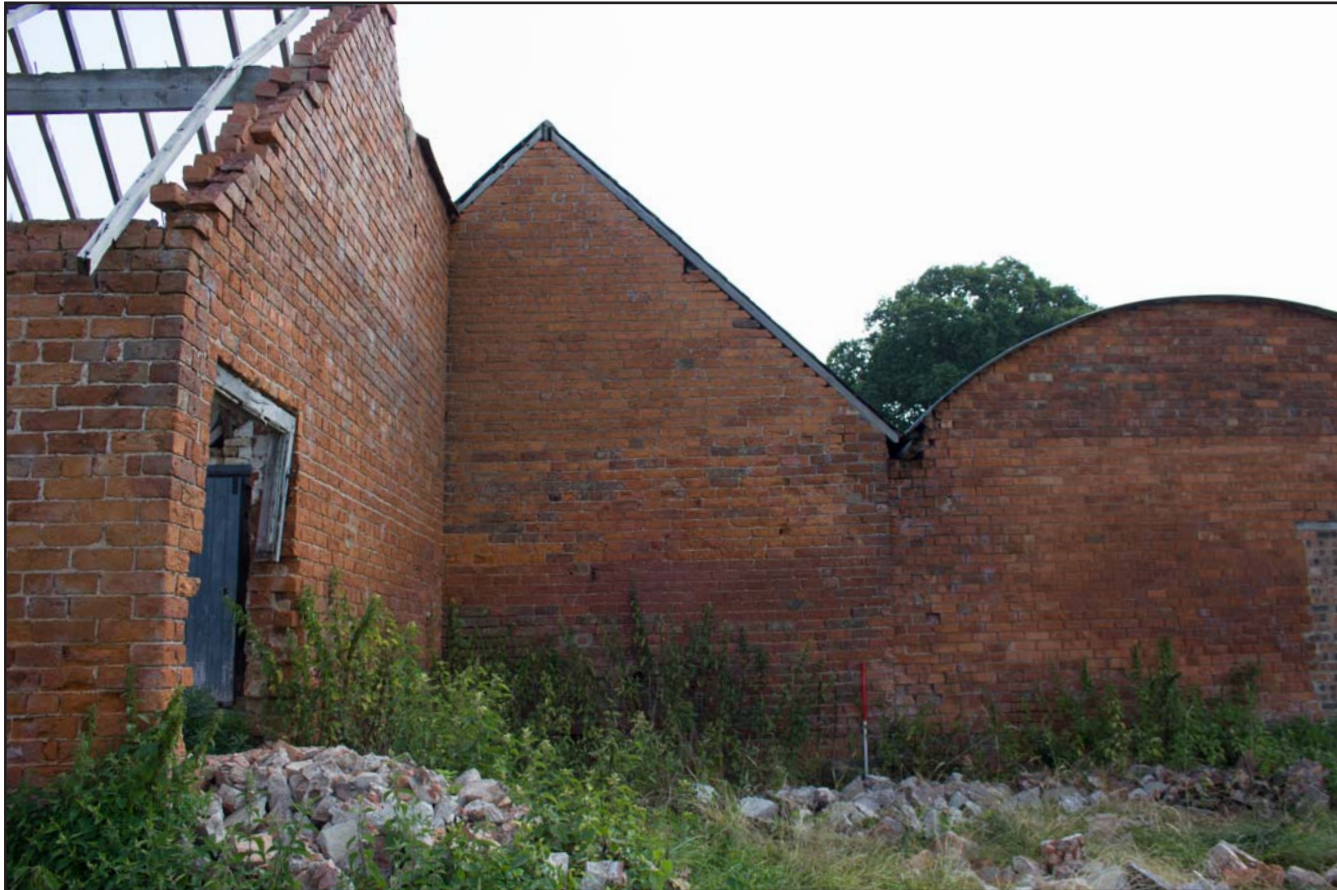
The southeast elevation is that of *Shippon 1* and is described above. The southwest elevation has a single doorway opening at the left-hand end permitting access to the rear of the building via a batten and plank door in plain unpainted wooden frame. The north western elevation has a single doorway opening at the right-hand end permitting access to *Shippon 3*, now without door but with blue painted wooden frame. The floor is of poured concrete with linear drainage channel suggesting that this room was probably used as a cow house.

**Plate 77:** Northwest facing elevation of Shippon 2 at Brunette Farm, Ty Broughton, Wrexham - from the northwest - 1m scale

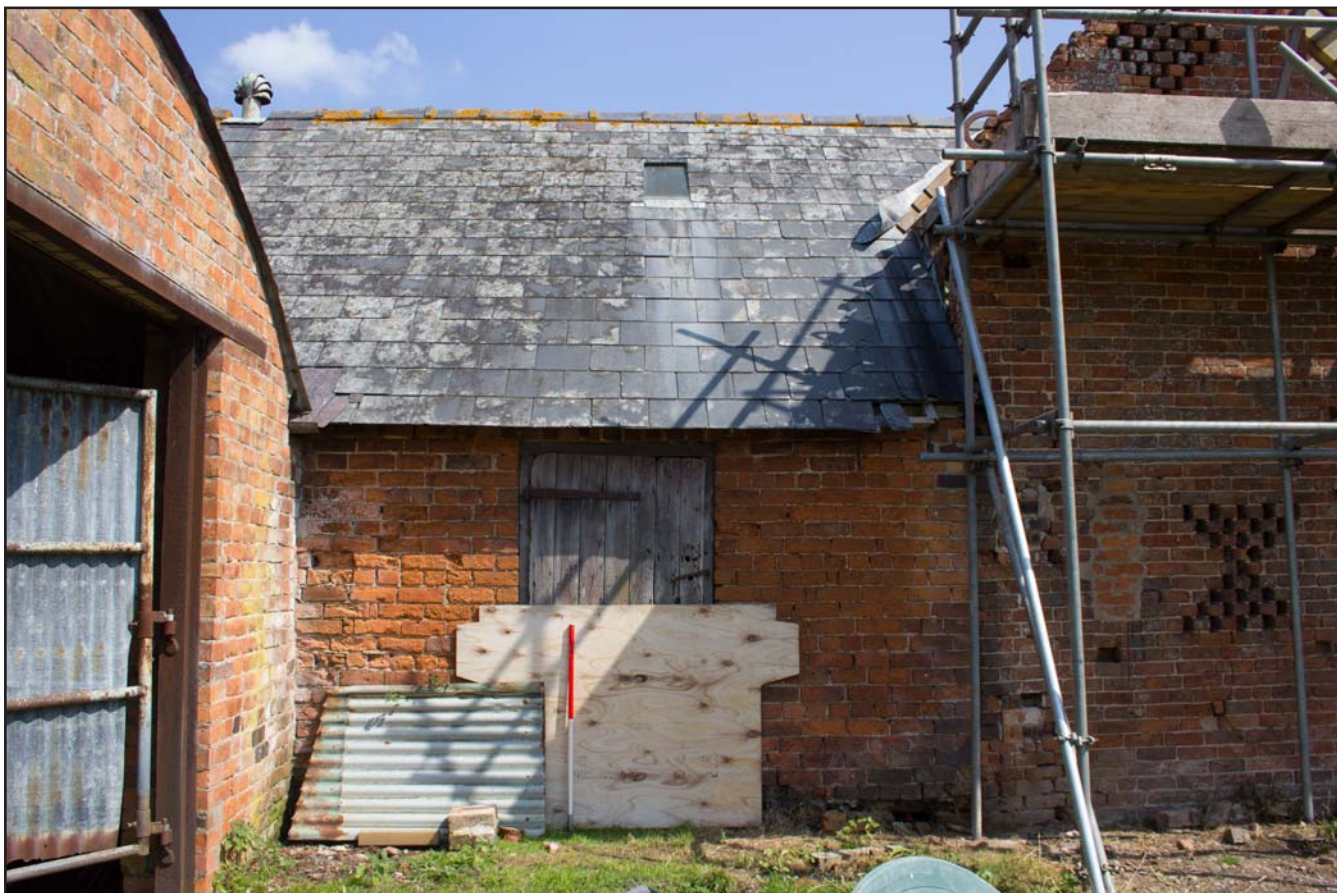
**Plate 78:** Southwest facing elevation of Shippon 2 at Brunette Farm, Ty Broughton, Wrexham - from the southwest - 1m scale

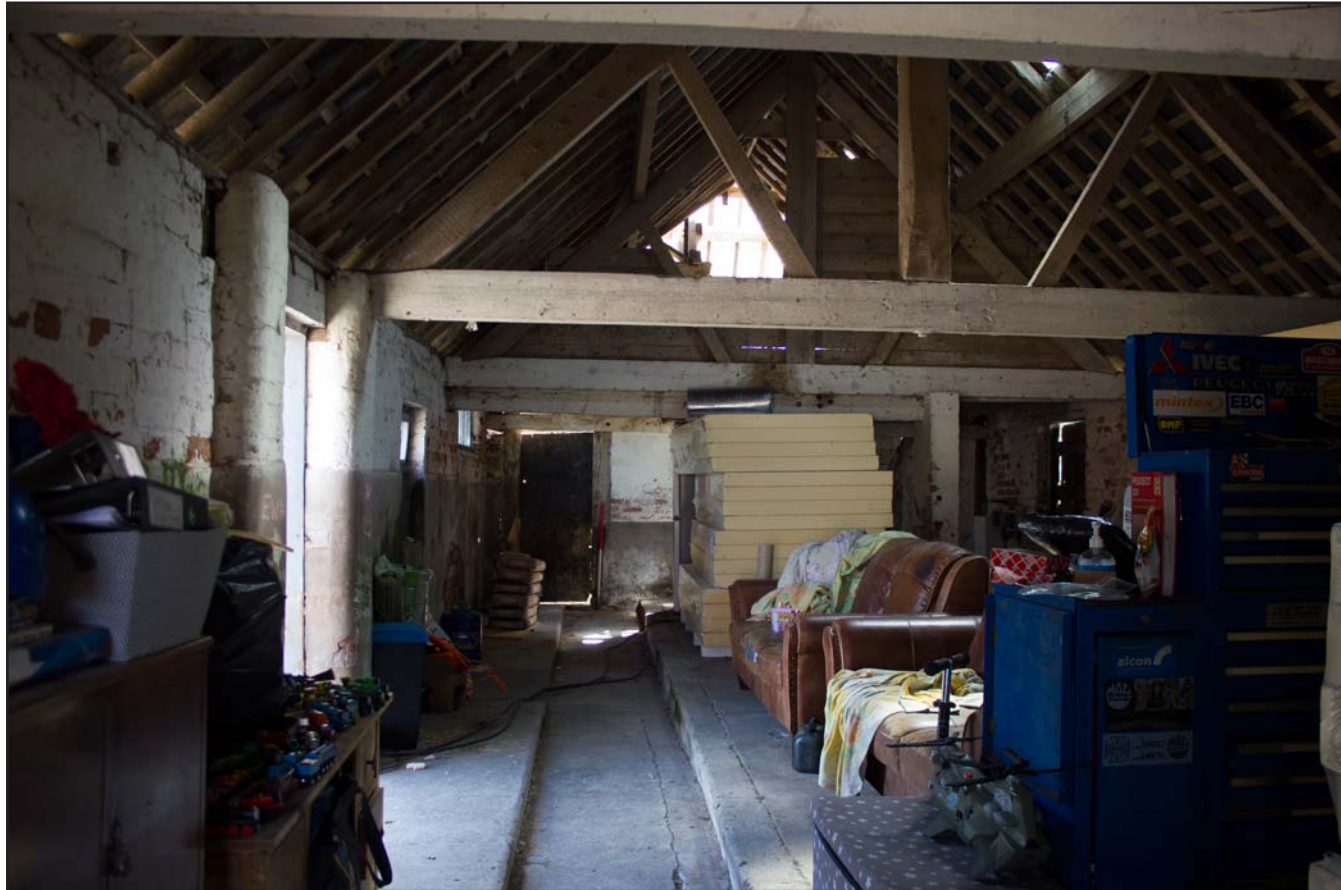
**Plate 80:** Internal shot of Shippon 2 at Brunette Farm, Ty Broughton, Wrexham - from the northwest - 1m scale

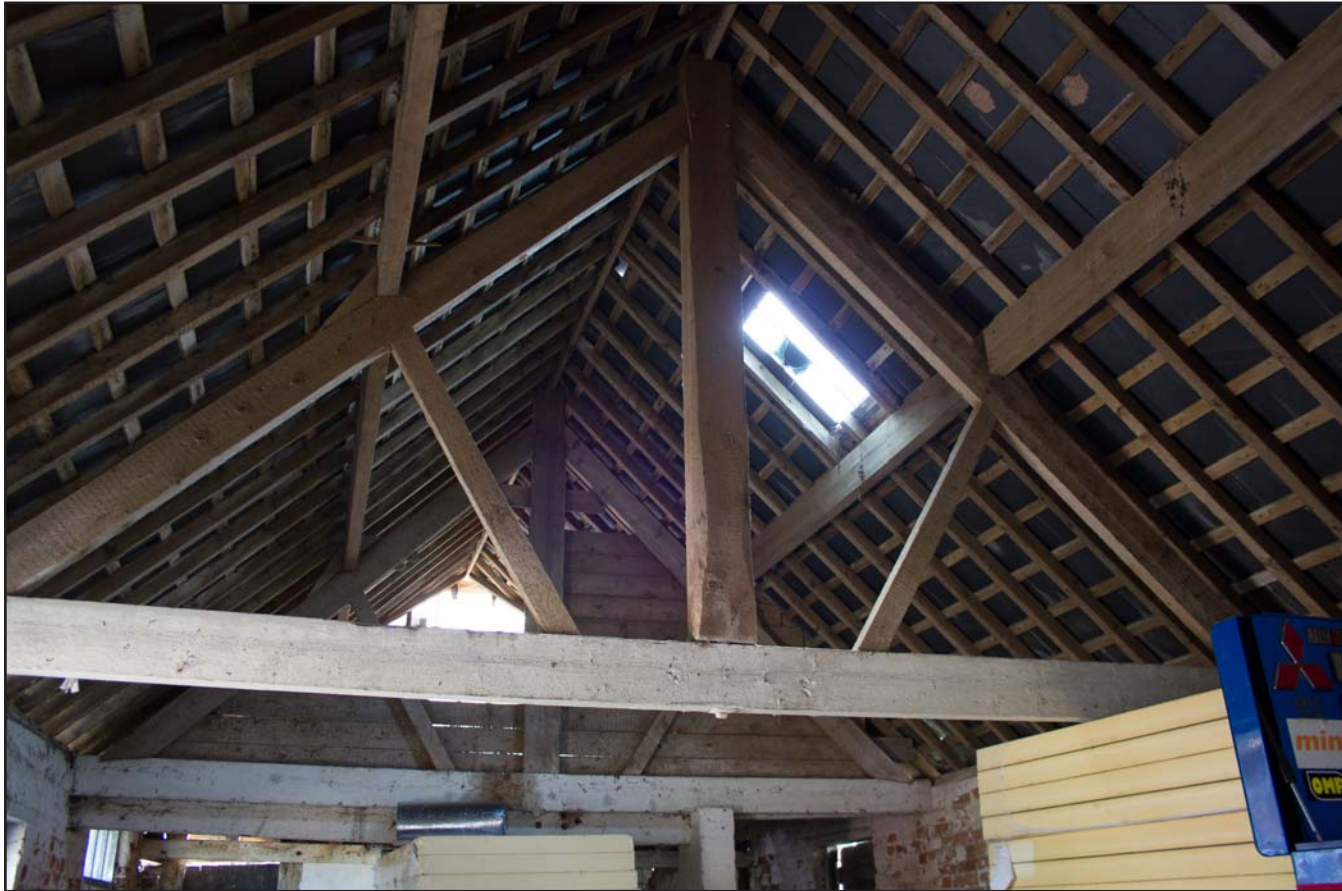
**Plate 81:** Kingspost truss within Shippon 2 at Brunette Farm, Ty Broughton, Wrexham - from the northwest - no scale

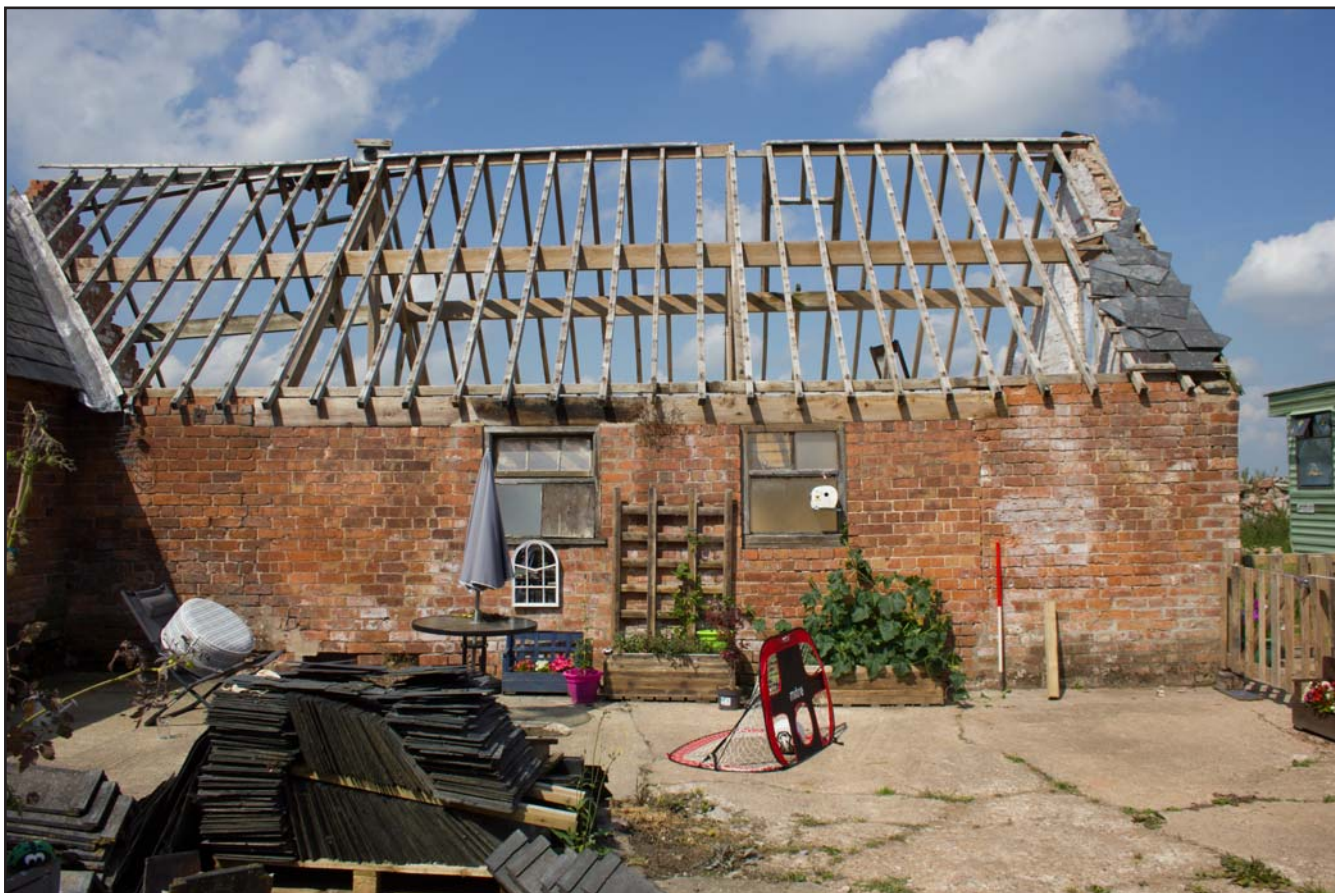
The southeast elevation has two equally spaced windows to left of centre consisting of a five-pane and a three-pane casement window in wooden frames. At the right-hand end a single doorway opening permits access into *Shippon 2*. The south western elevation has a single doorway opening at the right-hand end permitting access to the rear of the building now without door and frame. The northwest elevation is featureless. The floor is of bare earth.

**Plate 82:** Southeast facing elevation of Shippon 3 at Brunette Farm, Ty Broughton, Wrexham - from the southeast - 1m scale

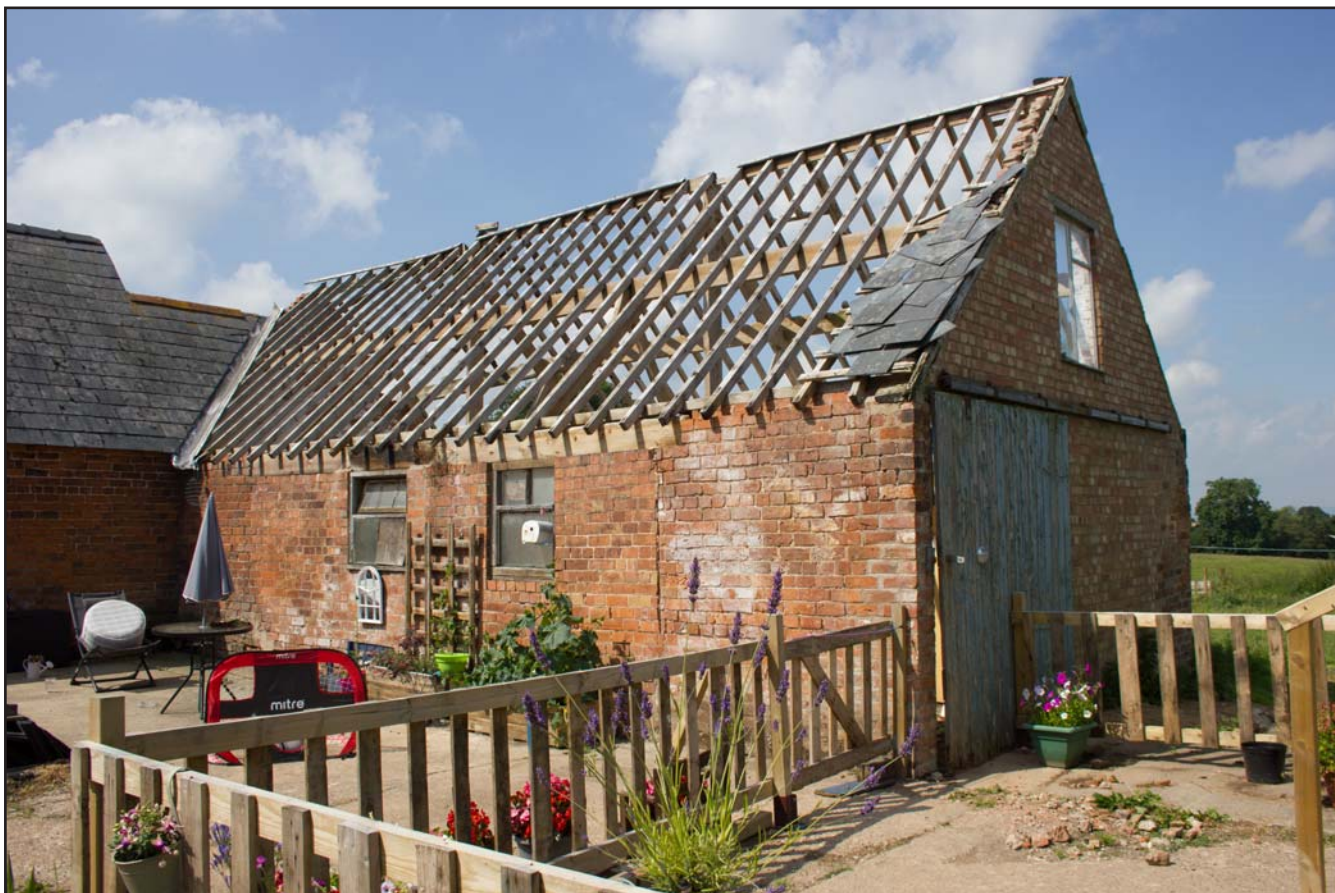
**Plate 83:** Oblique shot of northeast and southeast elevations of Shippon 3 at Brunette Farm, Ty Broughton, Wrexham - from the east - scale 1m

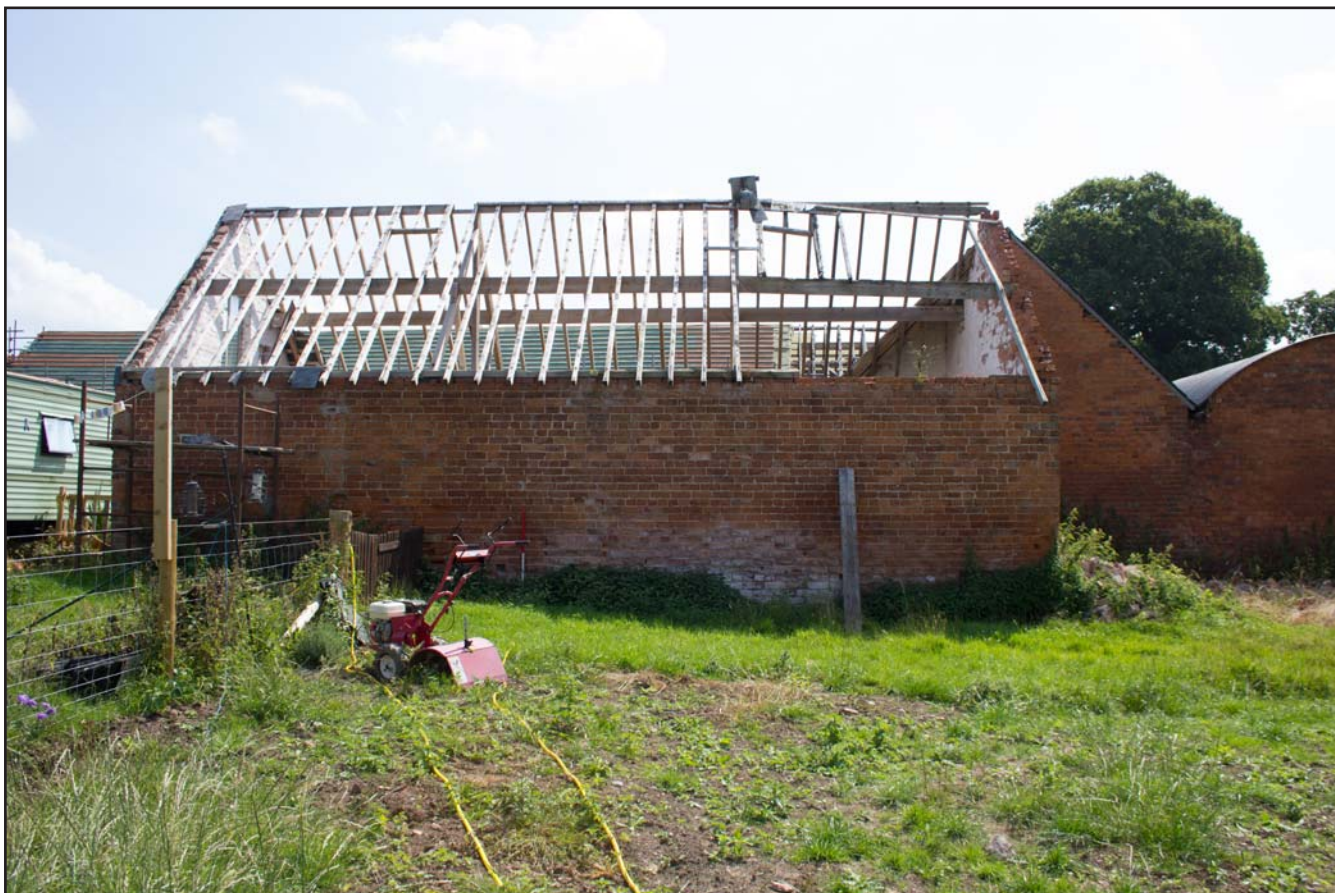
**Plate 85:** Northwest facing elevation of Shippon 3 at Brunette Farm, Ty Broughton, Wrexham - from the northwest - 1m scale

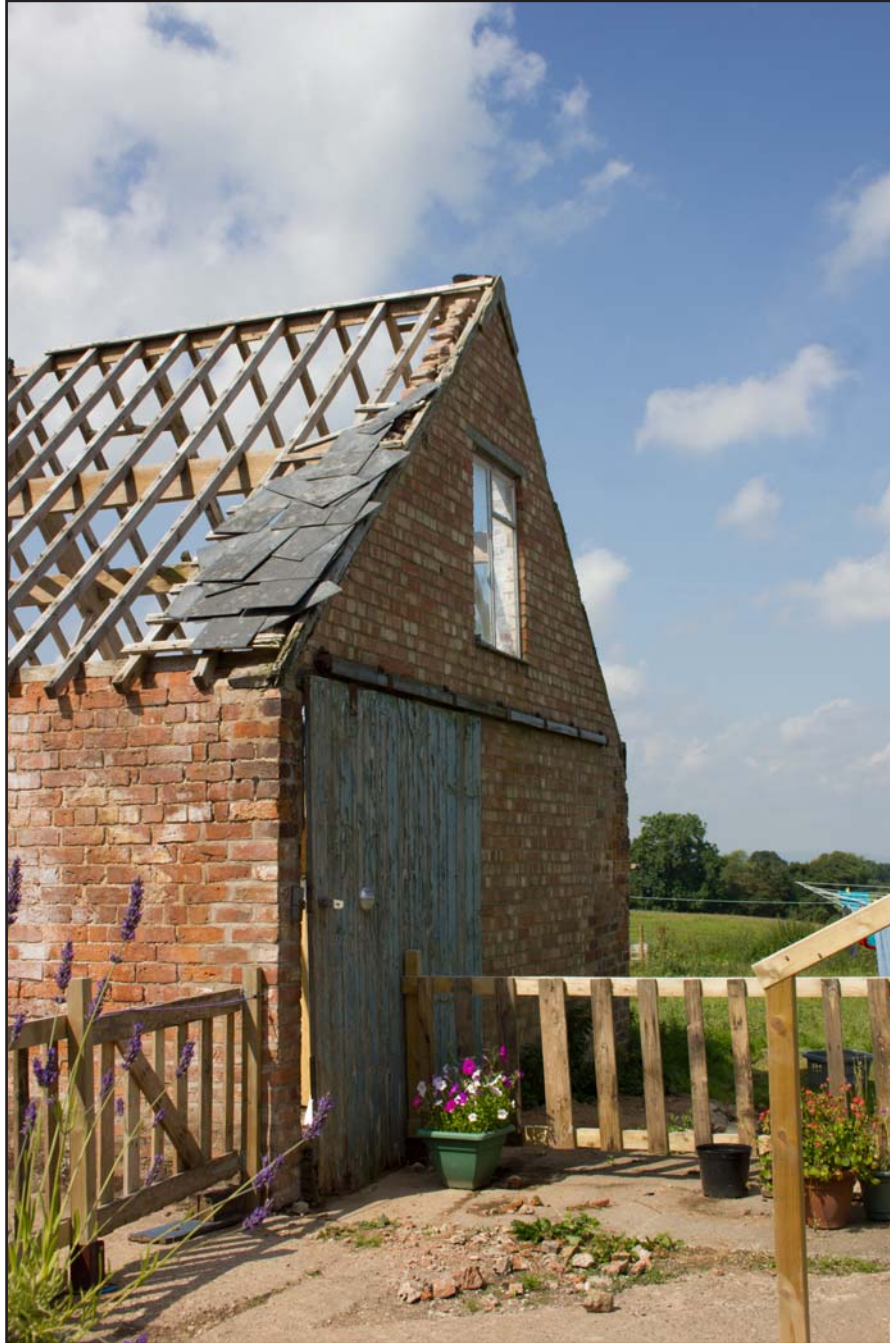
The northeast elevation has a three-pane fixed window in white painted wooden frame at eaves height and at ground floor level there is a double doorway opening at the right-hand end permitting access to the front of the building via a horizontally sliding green painted wooden ledged and braced door.

**Plate 84:** Northeast facing elevation of Shippon 3 at Brunette Farm, Ty Broughton, Wrexham -  
from the northeast - 1m scale

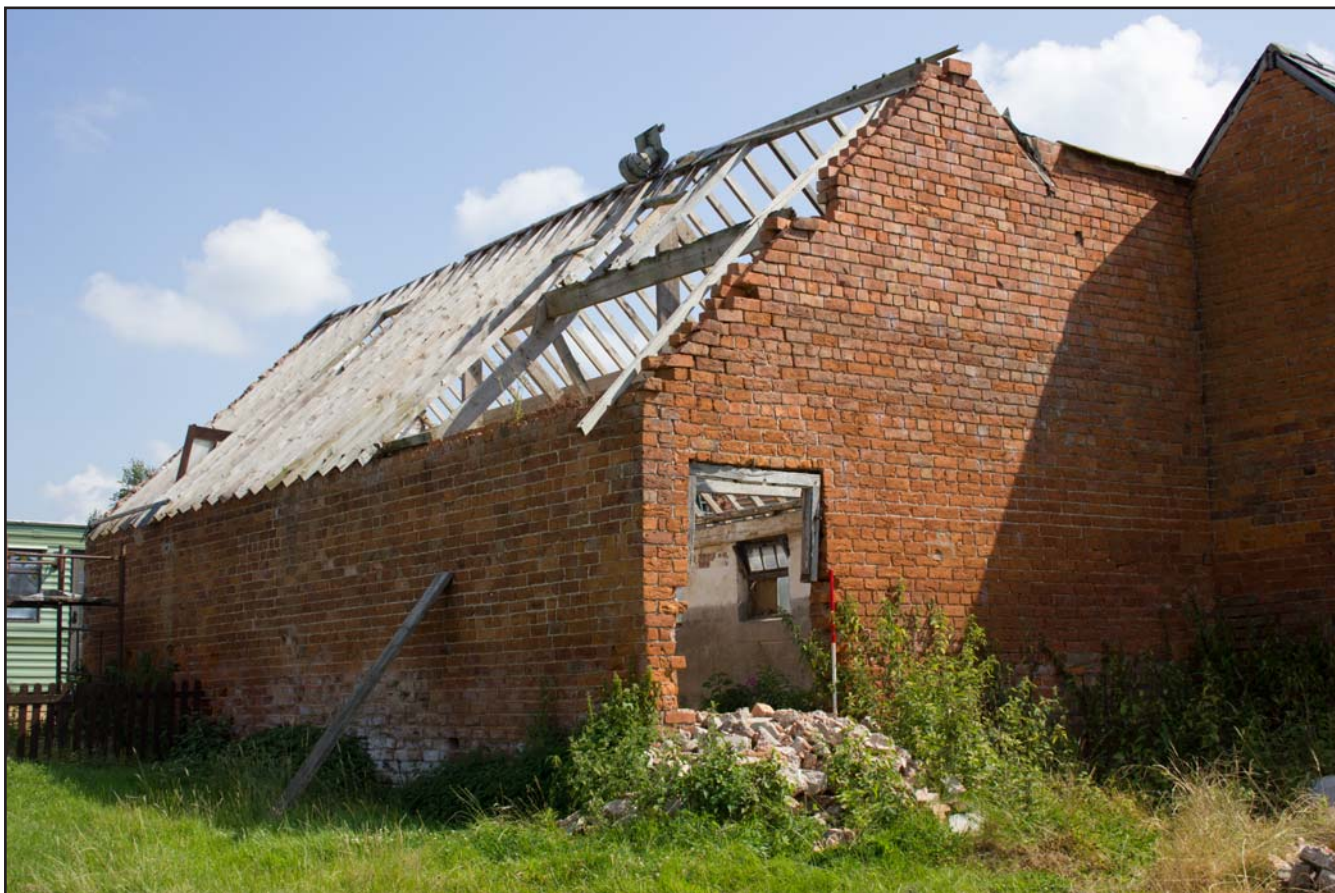
**Plate 86:** Oblique shot of northwest and southwest elevations of Shippon 3 at Brunette Farm, Ty Broughton, Wrexham - from the south - scale 1m

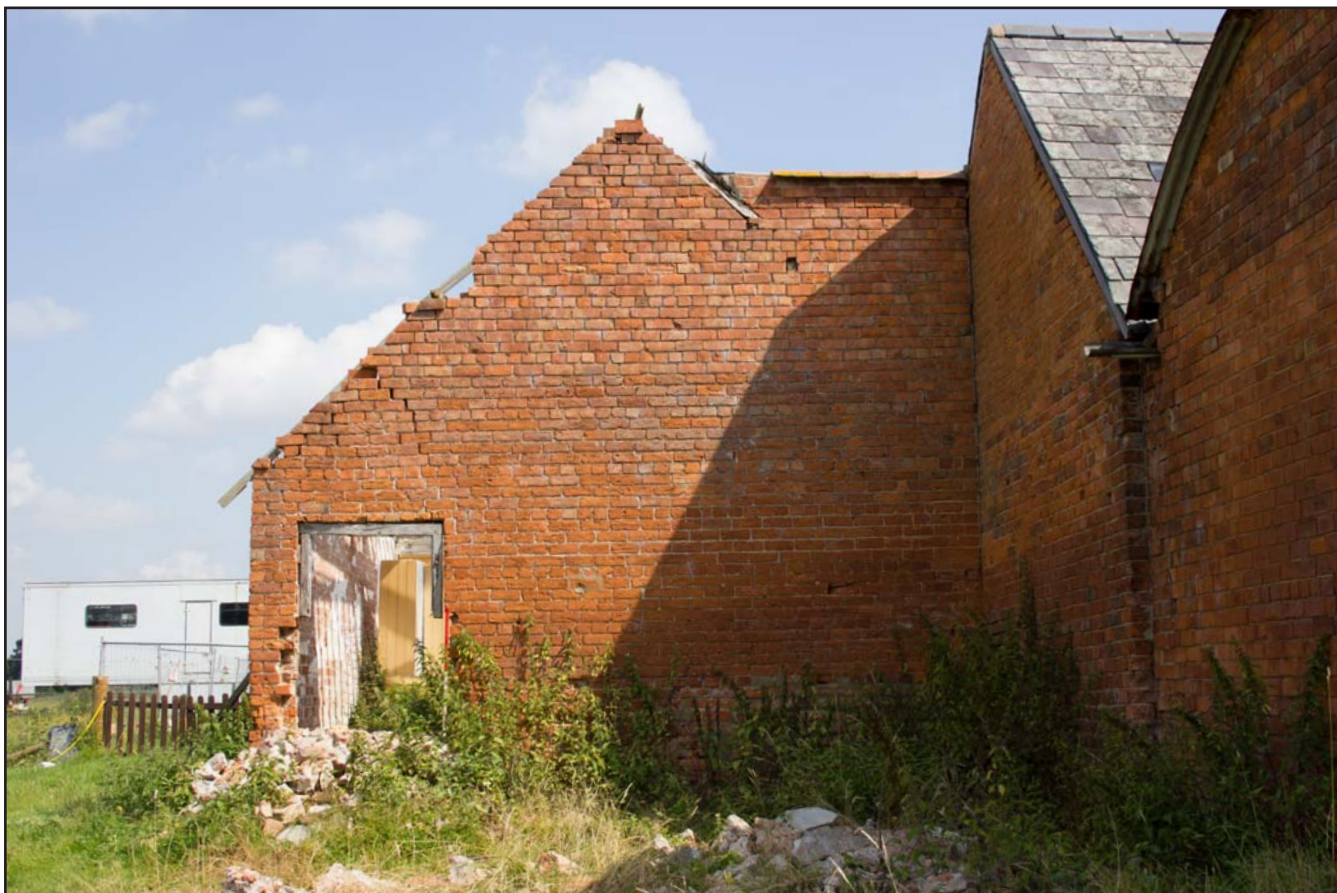
**Plate 87:** Southwest facing elevation of Shippon 3 at Brunette Farm, Ty Broughton, Wrexham - from the southwest - scale 1m

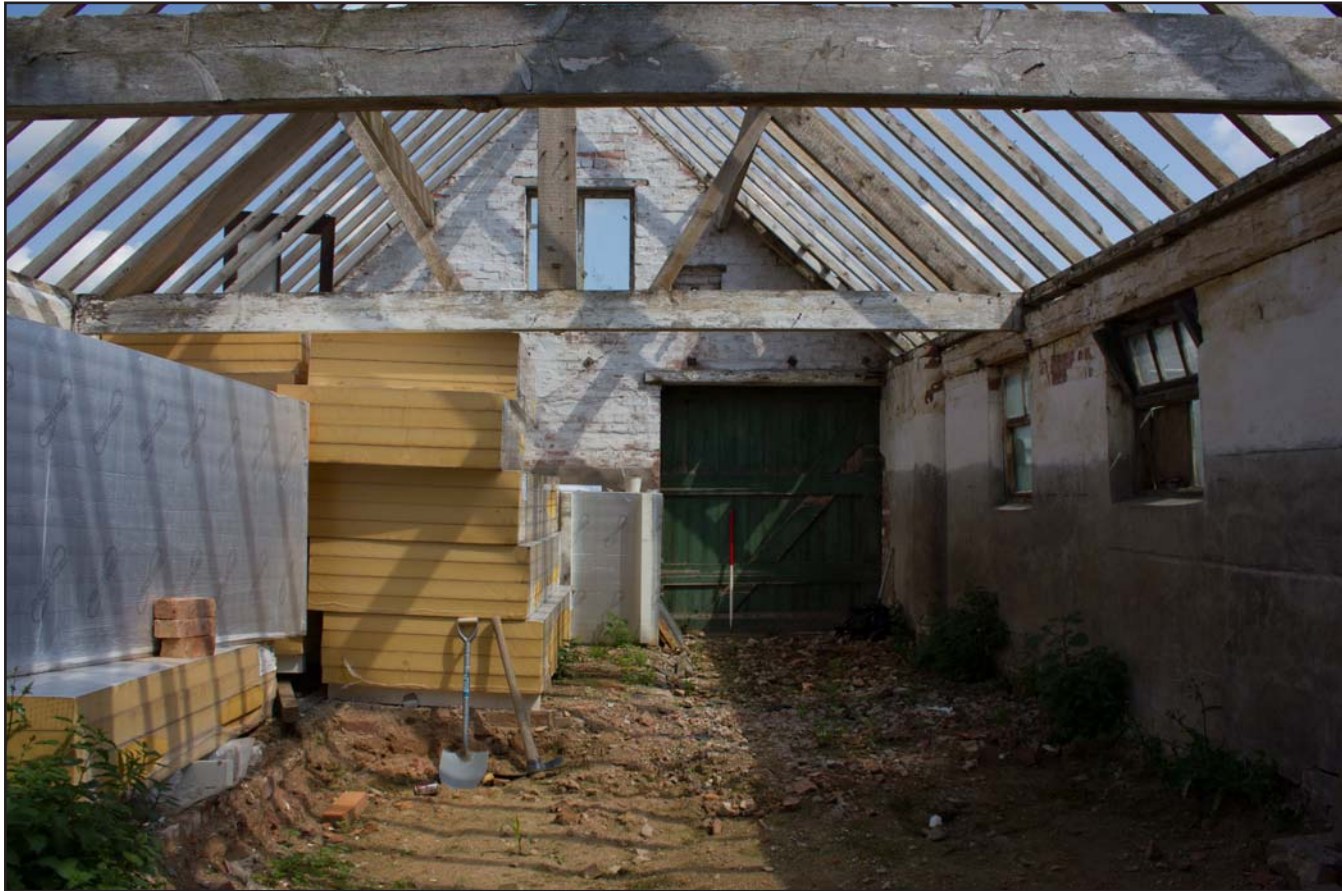
**Plate 88:** Internal shot of Shippon 3 at Brunette Farm, Ty Broughton, Wrexham - from the southwest - 1m scale

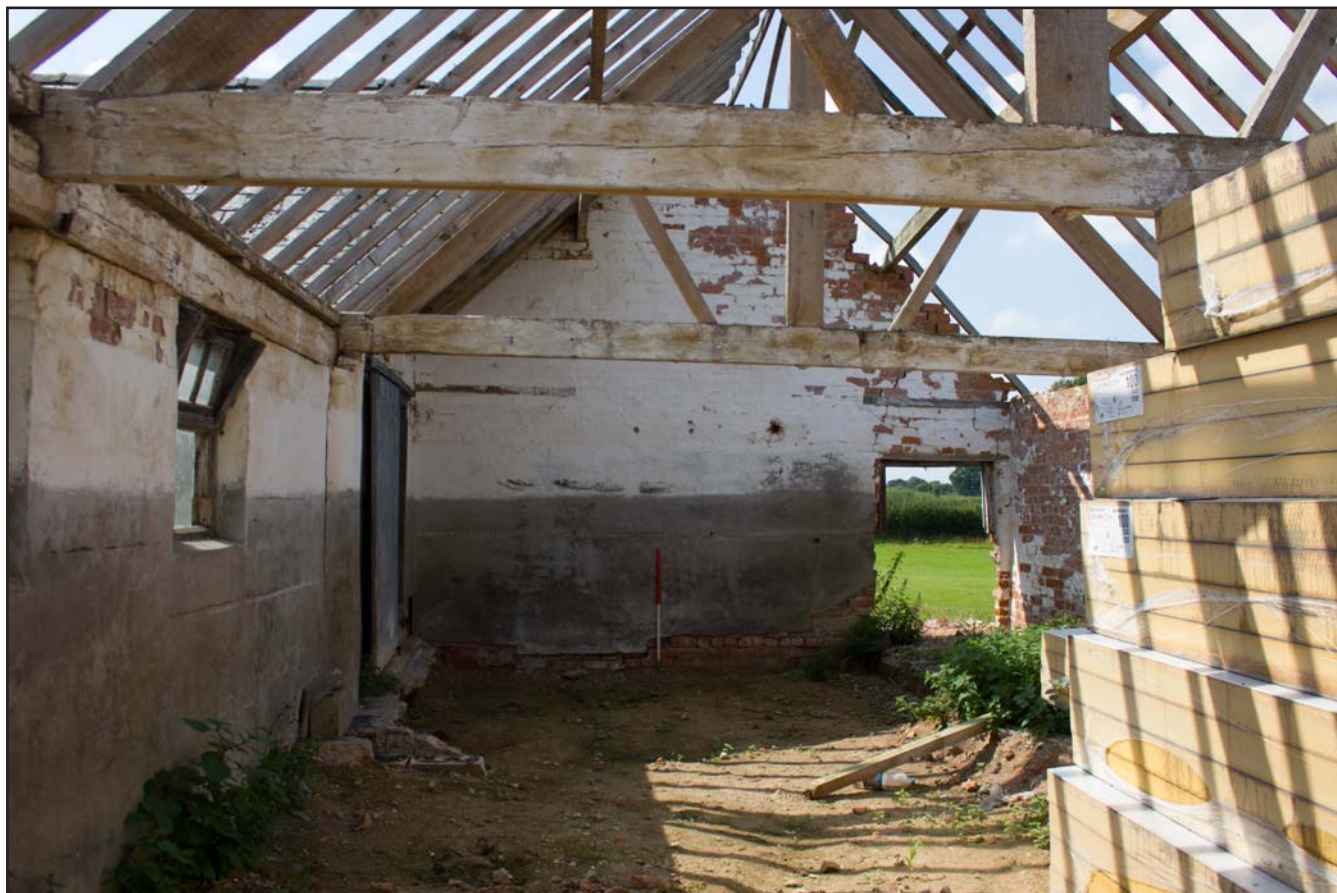
**Plate 89:** Internal shot of Shippon 3 at Brunette Farm, Ty Broughton, Wrexham - from the northeast - 1m scale

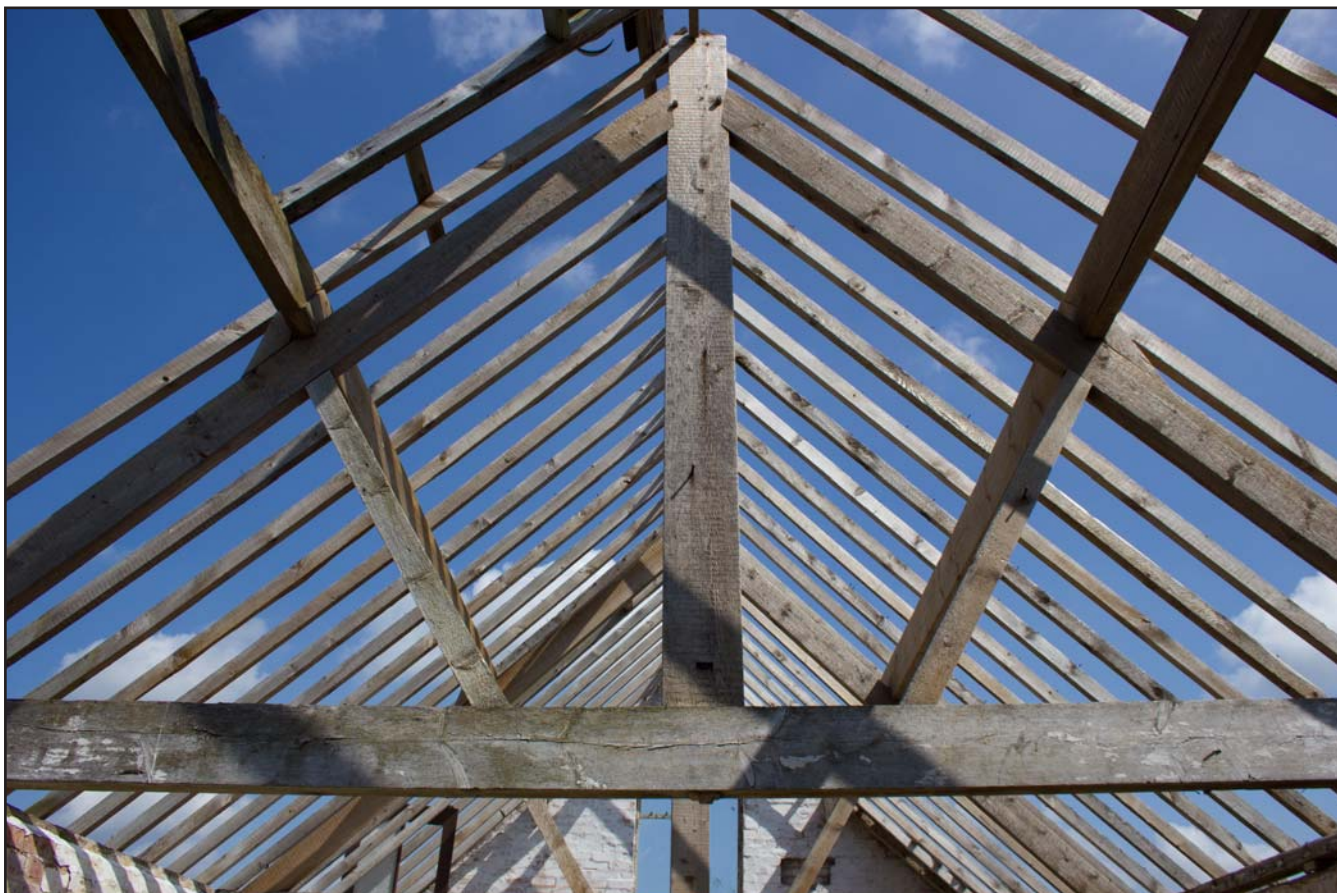
**Plate 90:** Kingspost truss within Shippon 3 at Brunette Farm, Ty Broughton, Wrexham - from the southwest - no scale
