**BRONYDD  
QUARRY ROAD  
GLYN CEIRIOG  
LLANGOLLEN  
WREXHAM  
LL20 7DA**

**BAT CONSERVATION PLAN**

| <b>Reference</b> | <b>012022/BCP/TL</b> |

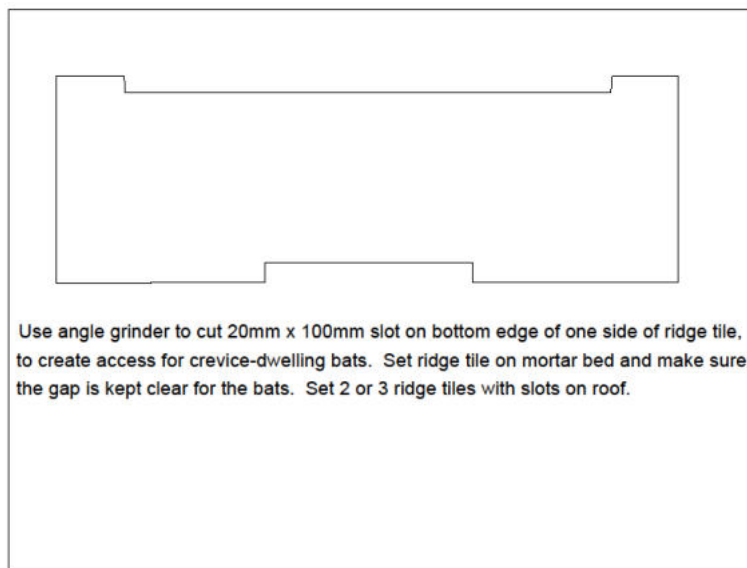
Figure 1: Gaps under ridge tiles.

Three ridge tiles on the roof of the dedicated bat loft and the proposed new dwelling will have 20mm x 100mm gaps cut in one of the lower edges, to allow access for bats (see *Appendix 2 – Mitigation Details*). Additional bat access for crevice-dwelling species will be provided in the proposed outbuilding/storage shed, in the form of gaps (10-20mm x 100mm) under slates/ridge tiles/eaves/bargeboards etc.

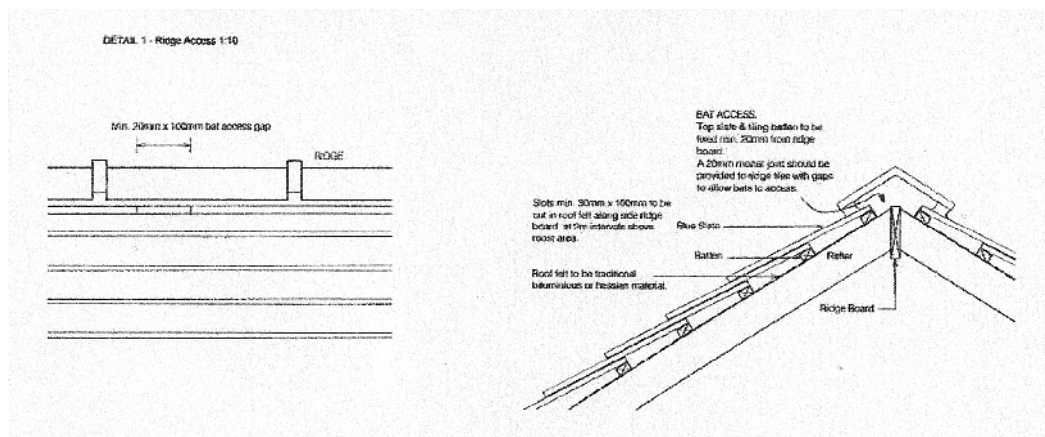
Figure 2: Ridge tile detail.

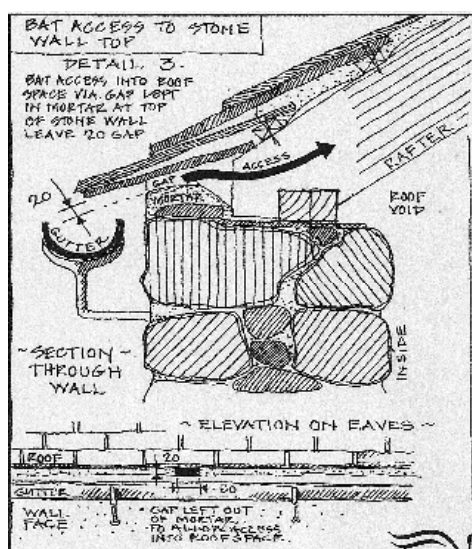
Figure 3: Gaps in eaves detail.

It is recommended that bat friendly features be incorporated into the proposed development, in order to keep in line with the Local Biodiversity Action Plans. To provide suitable conditions for bats, the use of warm roofs should be avoided. Traditional cold roofs with air circulation should be used. Whichever roof construction is to be used (closed eaves with a fascia; eaves with a soffit; barge board with or without soffit; closed verge pointed with undercloak), gaps (10-20mm x 100mm) will be left by the fascia/soffit/undercloak for bats to gain access to the inner gable walls.
